# National Transportation Safety Board

WPR24FA053

## **AIRFRAME AND ENGINE EXAMINATION REPORT**

Location: Eloy, Arizona  
Date: December 8, 2023  
Time: 1329 Local  
Airplane: N66180, Kitfox Series 5

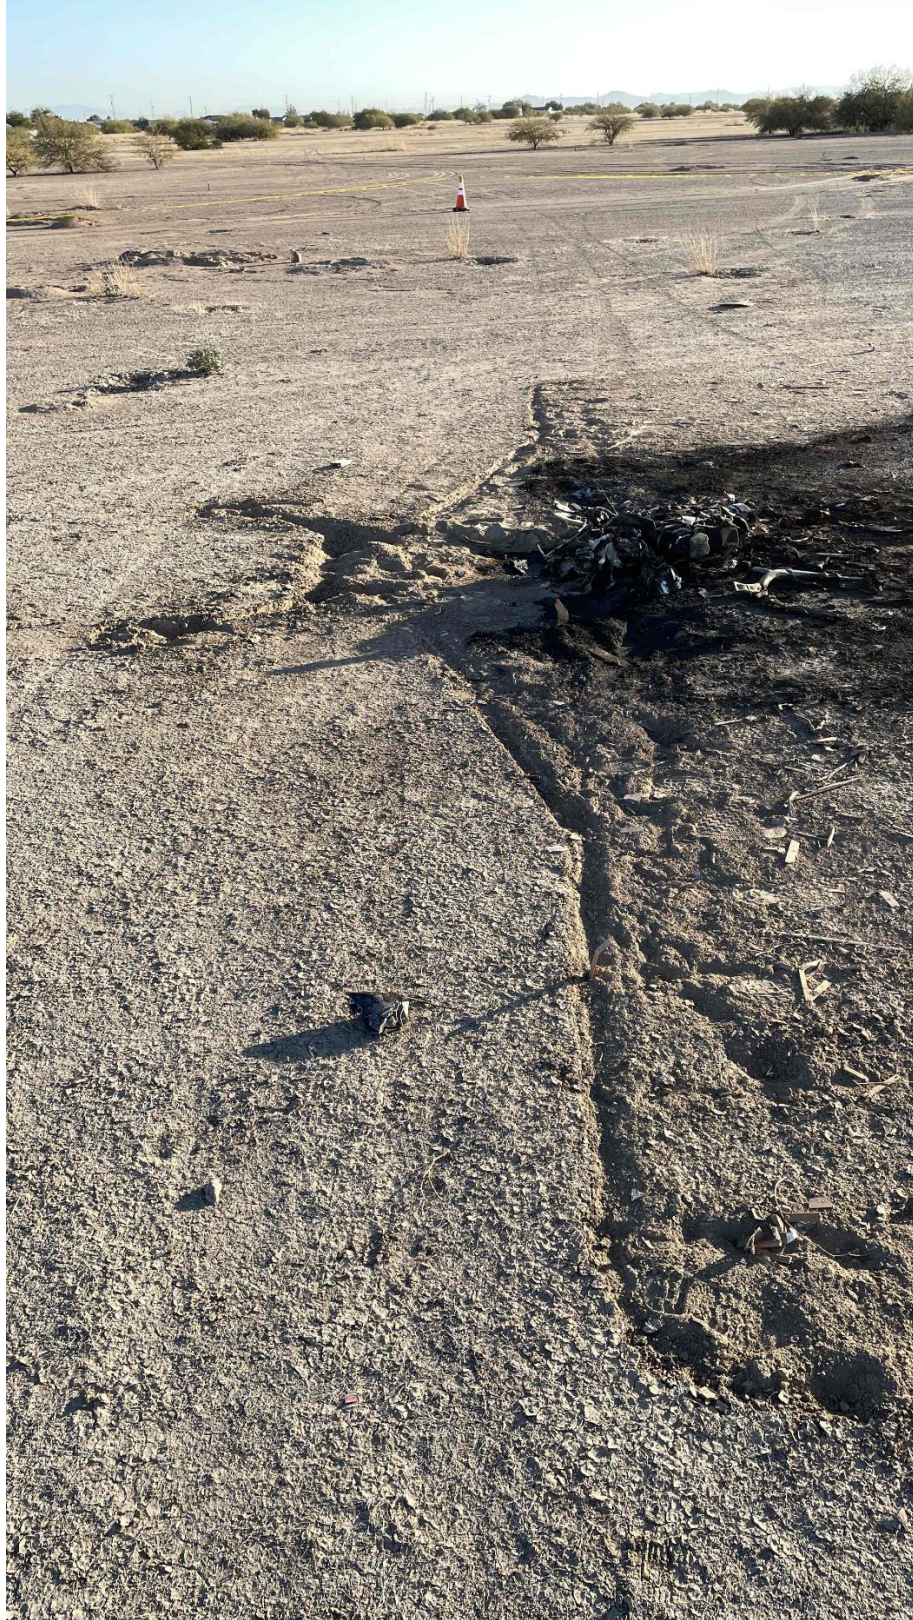
**Figure 1 - Airplane-shaped impression**

The first identified point of impact was an almost complete impression in the dirt of the airplanes front profile, including both main landing gear, wheels, the wings, and lift struts. (Figure 1). The engine had detached and was in the center of the impression. About 20 feet beyond, both wings had come to rest in line with the impact point. Next in the debris field was the cabin and tail structure which was

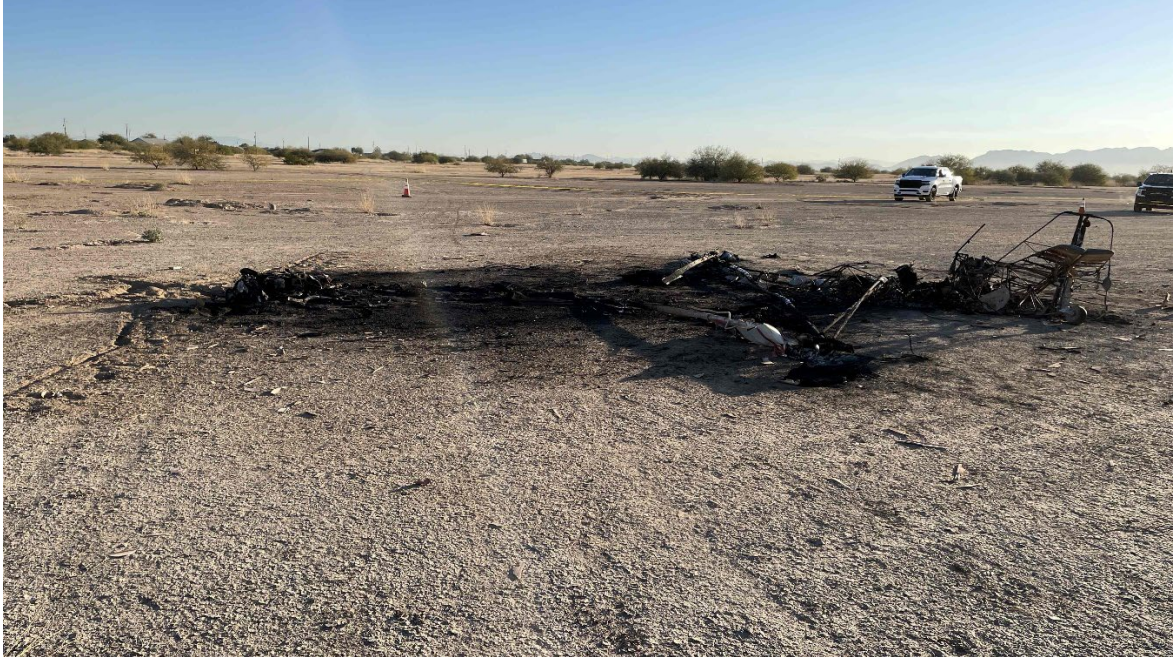
**Figure 2 - Main wreckage**

crushed aft, such that the foot pedals were comingled with the remnants of the empennage (Figure 2).

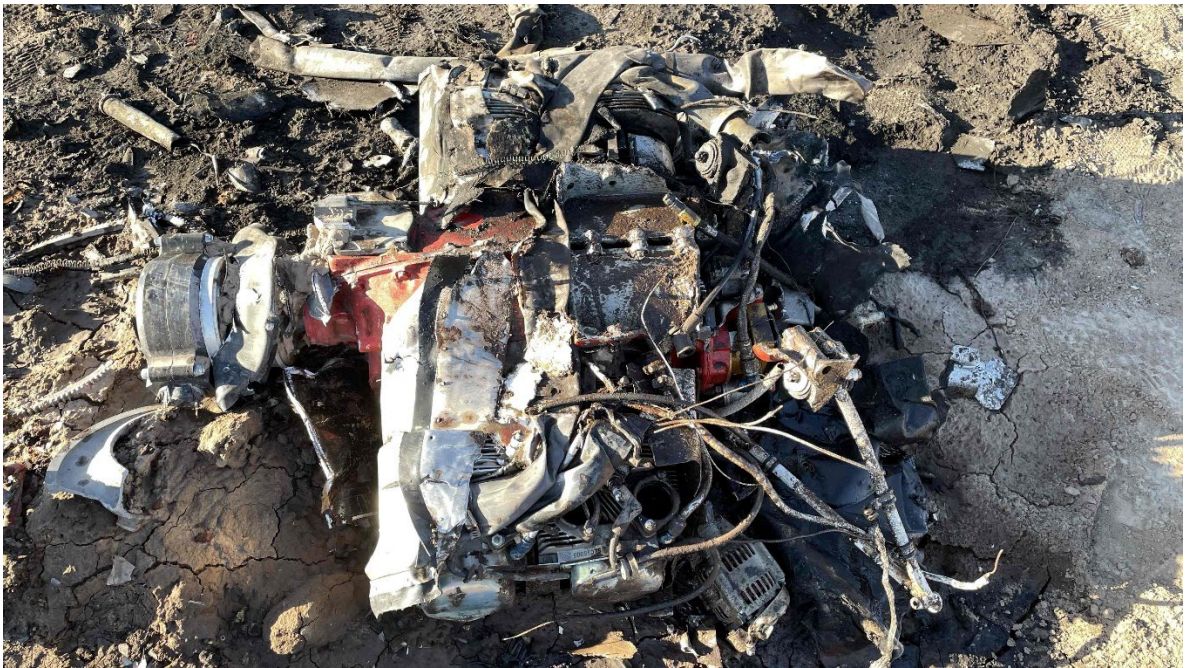
**Figure 3 - Engine**

The engine sustained extensive impact damage and remained attached to the engine mount by its upper mounting lugs (Figure 3). The lower lugs remained attached to the mount but had broken away from the crankcase. The oil sump was fragmented, exposing the lower crank area. The crankcase was intact, with no evidence of perforation or internal component expulsion or catastrophic internal failure. The accessory case had been breached, exposing the accessory gears, which were intact, and coated in oil. The engine appeared to be equipped with two "E-Mags" both of which remained attached to their pads.

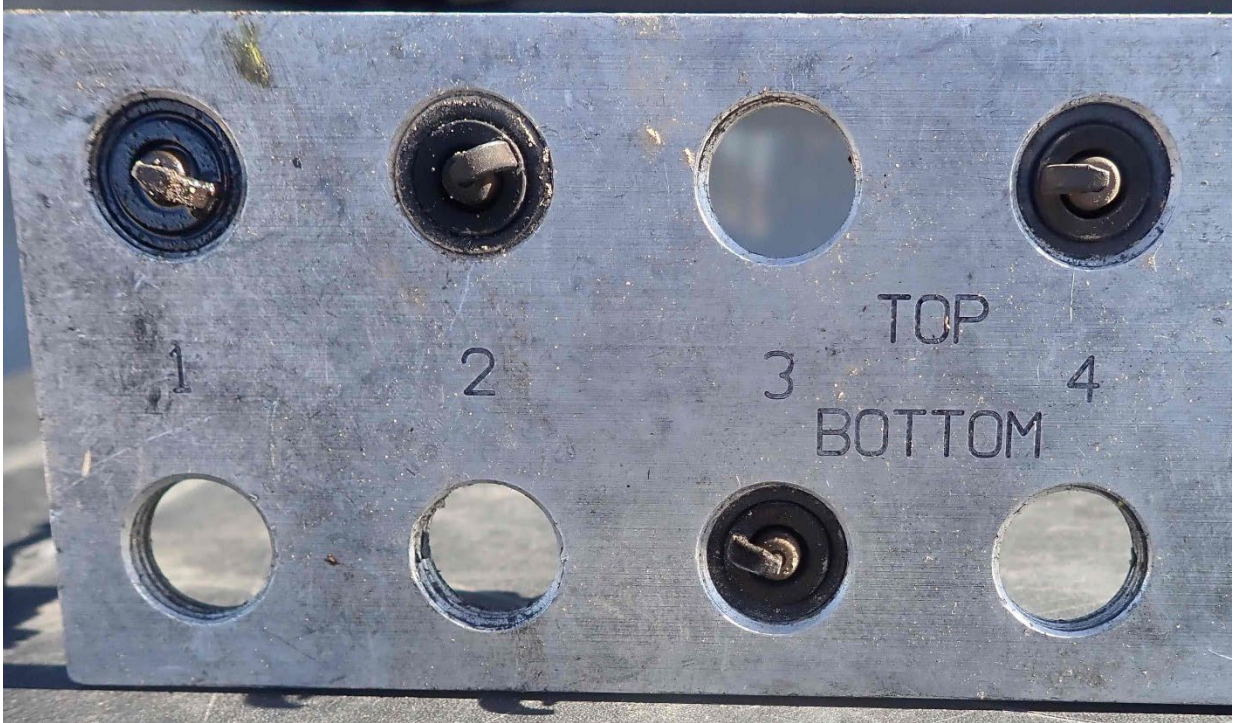
**Figure 4 - Spark plugs**

One spark plug from each cylinder was removed. They were all automotive types and exhibited dark grey coloration to their electrodes (Figure 4). The cylinders were examined with a borescope through the spark plug bores, and there was no evidence of catastrophic engine failure. The piston domes and combustion surfaces were coated in light-to-dark grey deposits. The exhaust pipes were crushed, and the exposed inner surfaces were coated in similarly colored deposits.

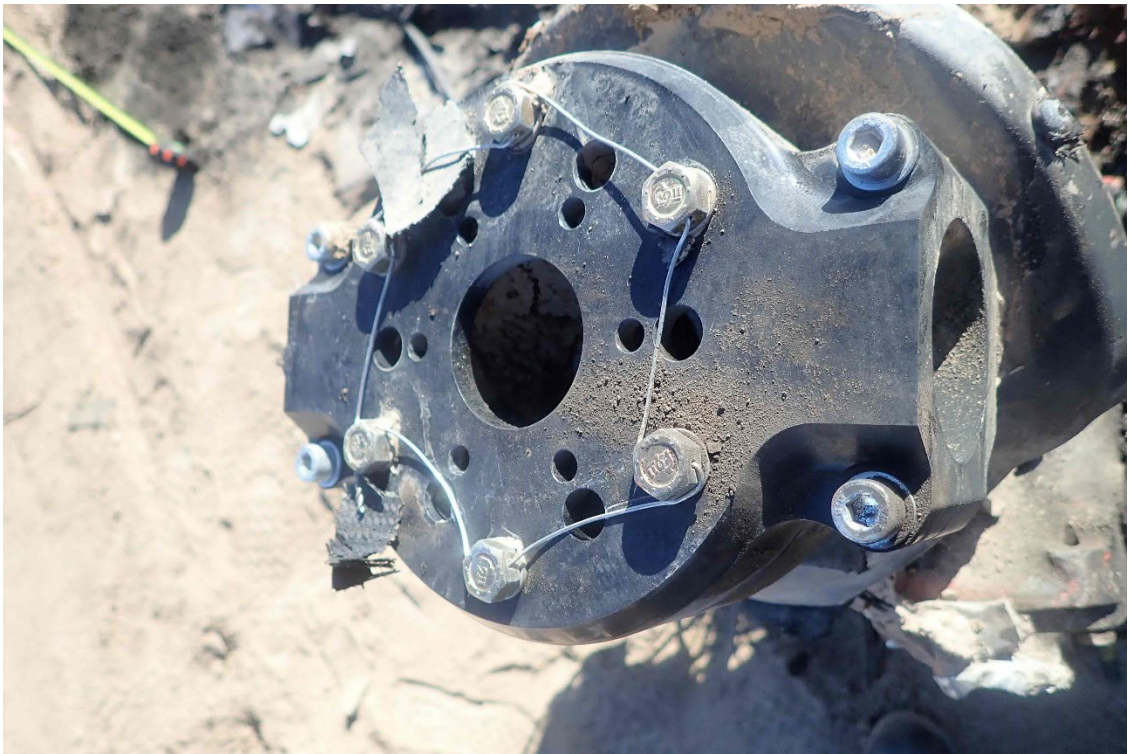
**Figure 5 - Propeller hub**

The propeller hub remained attached to the engine crankshaft flange (Figure 5). The ring gear and flywheel had fragmented and detached, along with the spinner. One blade root remained within the hub, but the blade had broken away and was found burnt within the main wreckage. The other blade was not located in the main wreckage and found ½ mile from the airplane, between the runway and the main accident site. That blade was undamaged and appeared to have come completely free from the hub (Figure 6).
