# National Transportation Safety Board

WPR24FA054

## **WRECKAGE AND IMPACT SUMMARY**

Location: Topock, AZ  
Date: December 10, 2023  
Time: 1555MST  
2255GMT  
Airplane: 1975 Beechcraft A36

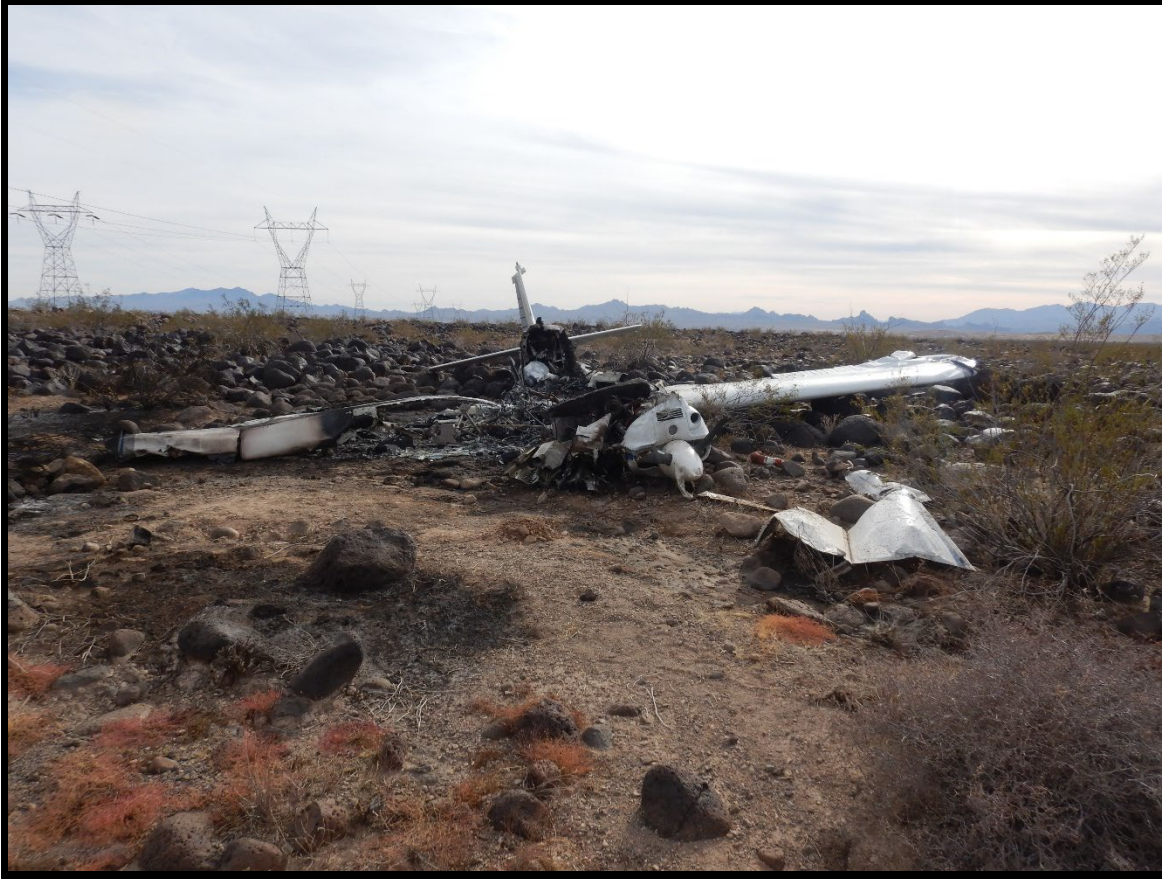
**Figure 1:** North to south view of high-tension powerline wires, and a forward-to-aft view of the airplane with thermal and impact damage sustained

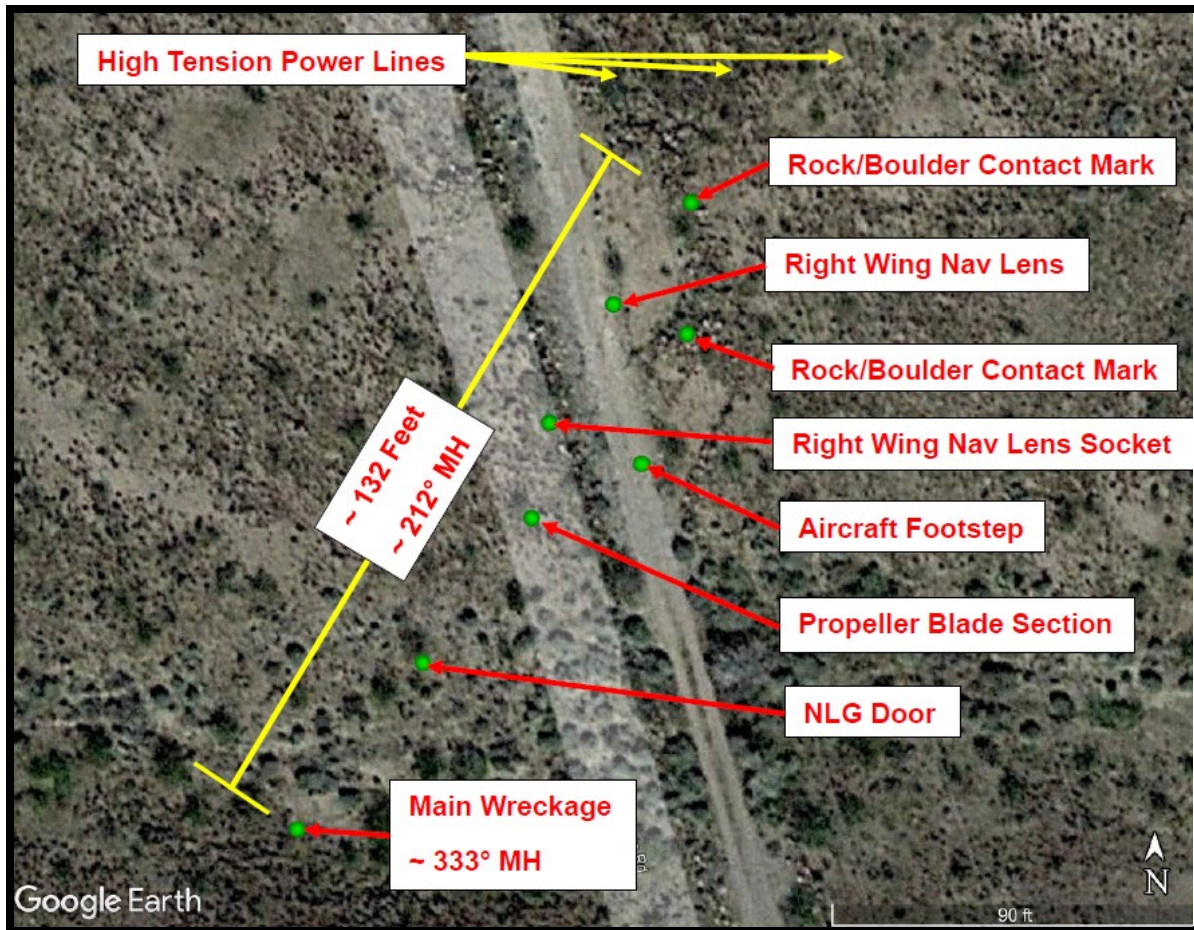
The main wreckage came to rest with the nose of the airplane oriented on a heading of 333°. The engine had partially separated from the airplane and came to rest inverted. The cockpit to engine control cables for the propeller, throttle, and mixture sustained thermal damage. The propeller spinner sustained minor impact damage, while all three of the wood propeller blades separated between 9 inches to 12 inches from the hub. The instrument panel and cabin sustained impact and thermal damage.

**Figure 3:** Wreckage and debris path diagram

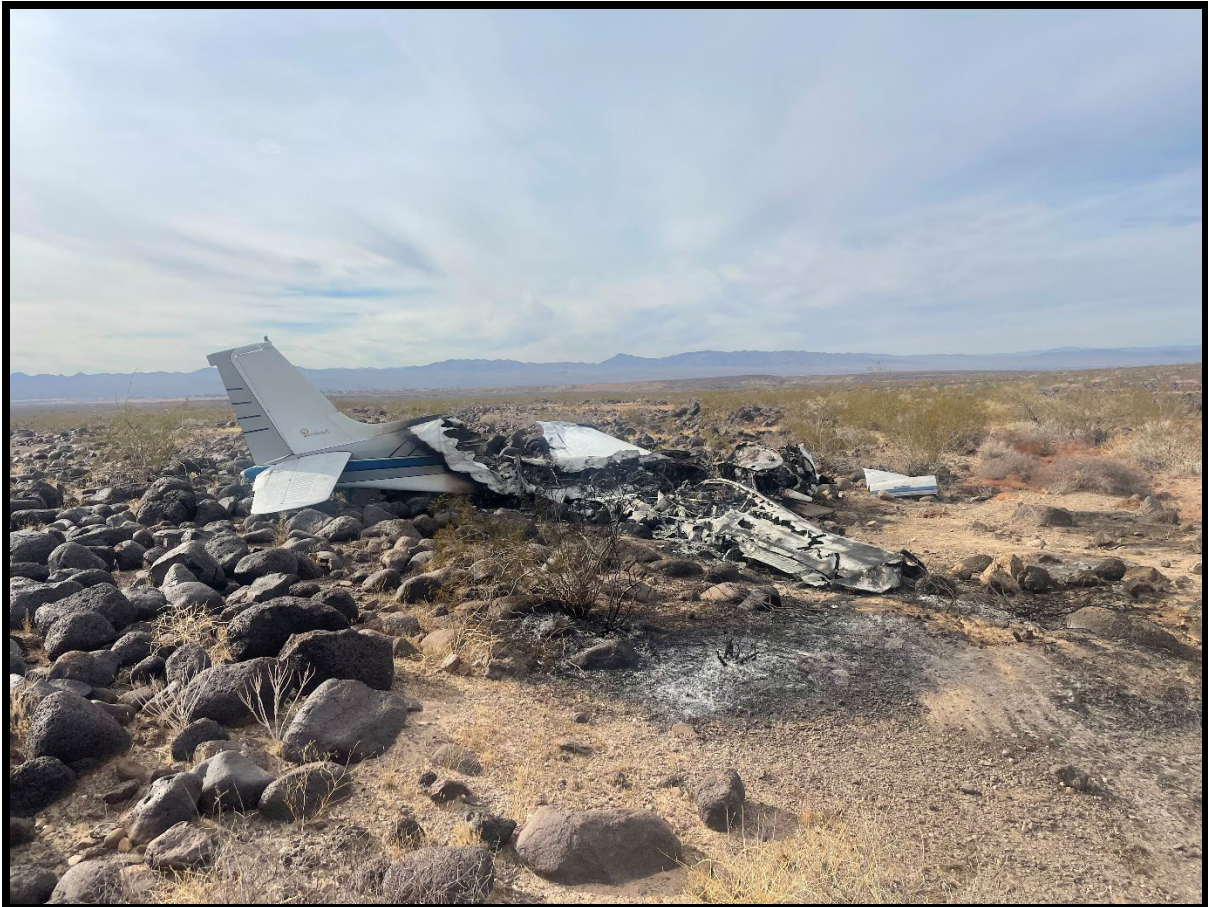
The right wing sustained impact and thermal damage, with the landing gear retracted within the wheel well. The left wing sustained impact damage but was largely intact, with the landing gear retracted within the wheel well. The left wing fuel cell was intact and was not breached. The right wing fuel cell was consumed by fire. Control continuity of the left and right wing aileron and flap were confirmed. The

**Figure 4:** View of the impact and thermal damage sustained to the right side of the N4171S

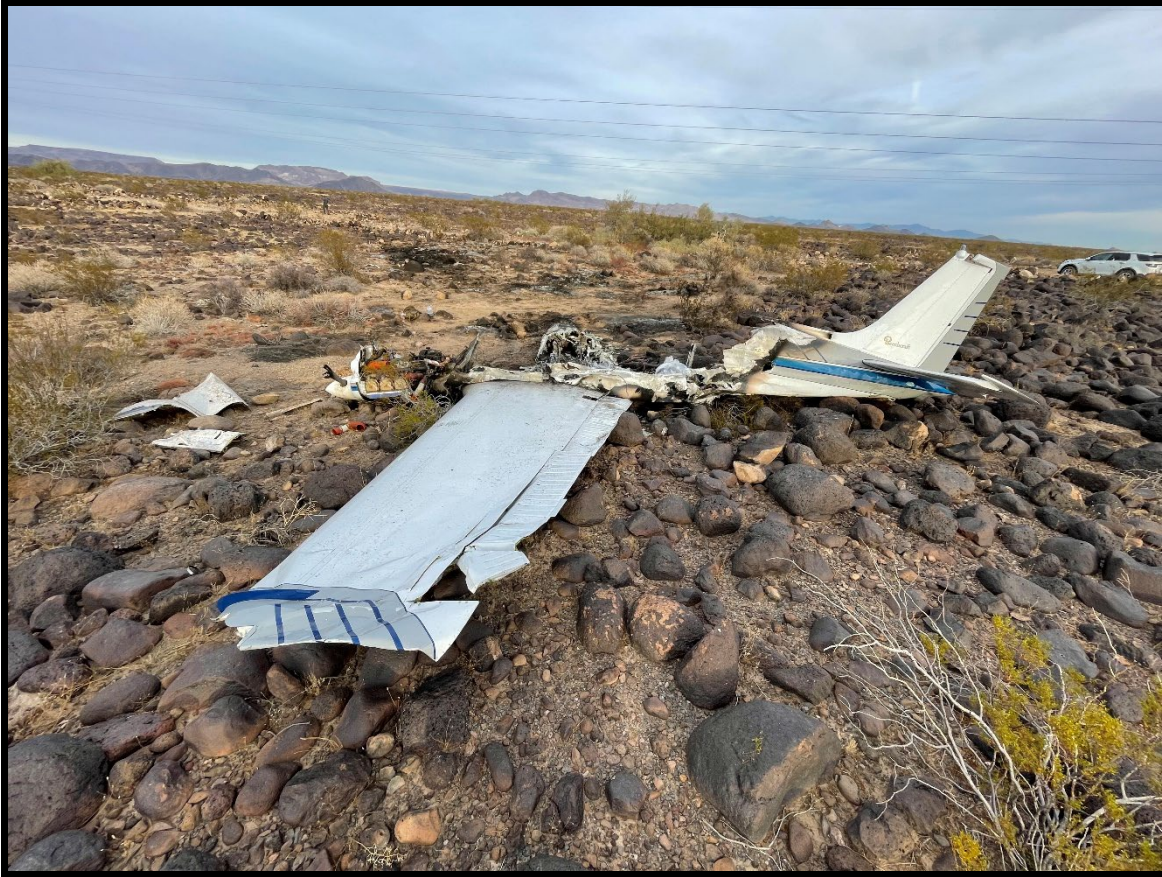
**Figure 5:** View of high-tension powerline wires, along with the thermal and impact damage sustained to the left side of N4171S

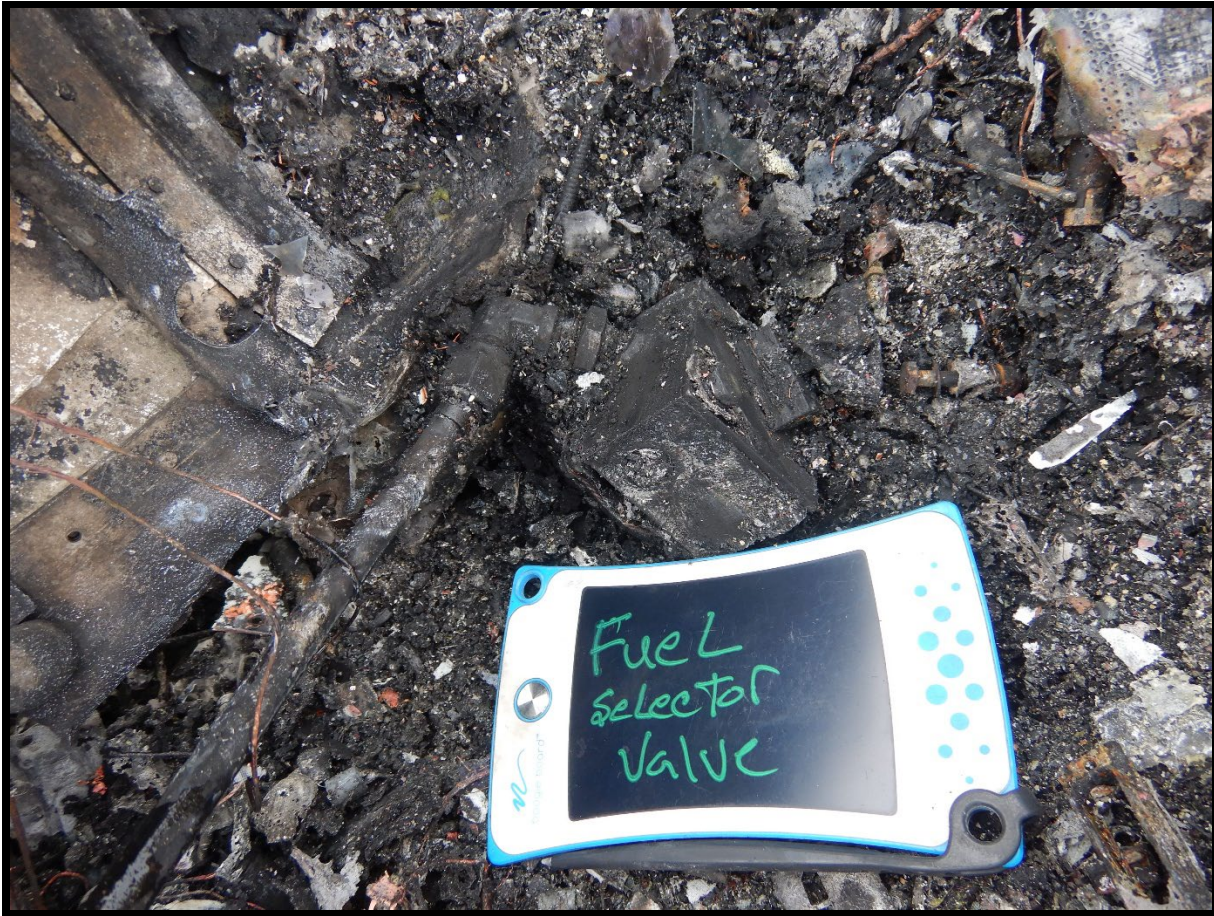
The cockpit sustained thermal damage; however, the fuel selector was found in the Off position. The ignition switch sustained thermal damage. The boost pump sustained thermal damage, yet the fuel line elbow fitting sustained impact damage that allowed fuel from the left wing to seep into the cabin.

**Figure 6:** Fuel selector in the Off position
