# National Transportation Safety Board

WPR24FA054

## **ENGINE EXAMINATION**

Location: Topock, AZ  
Date: December 10, 2023  
Time: 1555MST  
0355UTC  
Airplane: Beechcraft A36

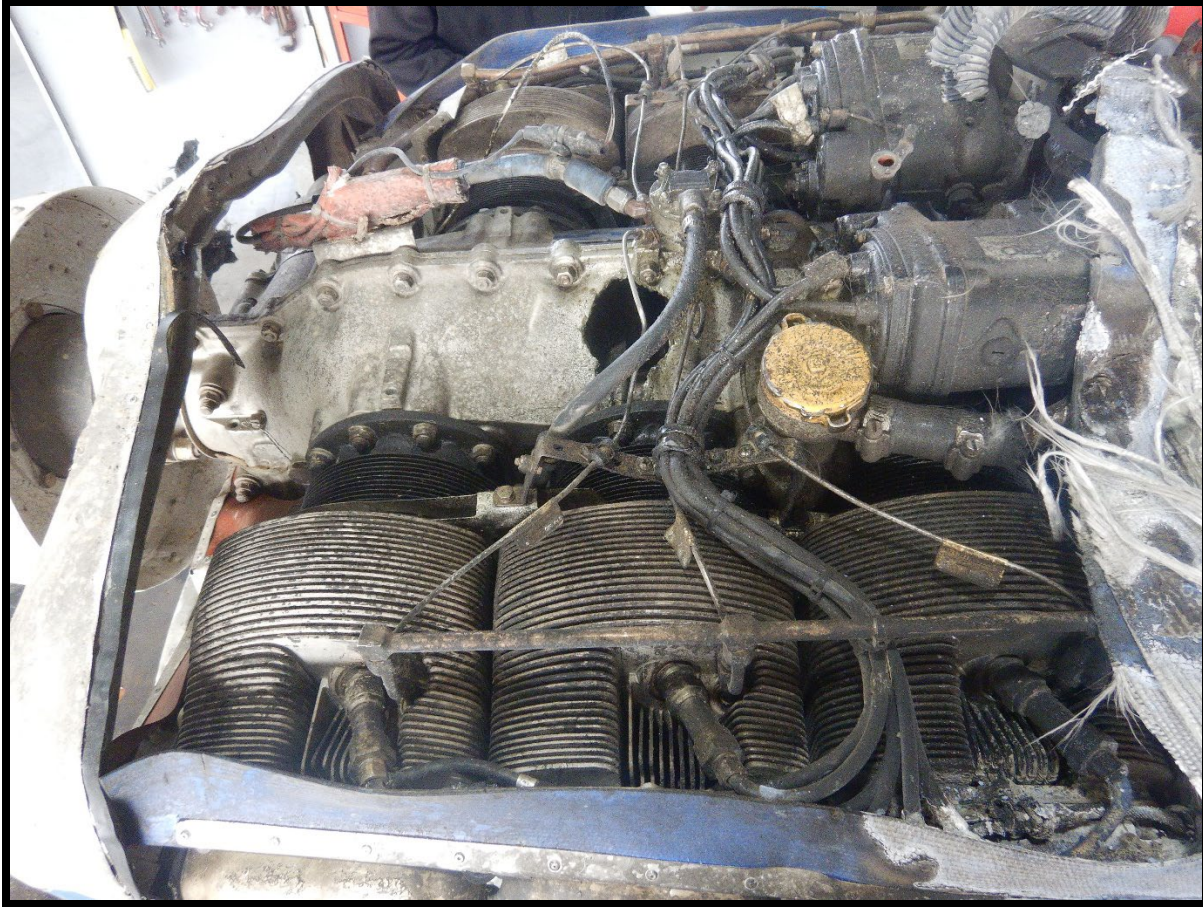
The examination revealed that a failure of the No. 4 piston connecting rod breached the top of the crankcase. Failure of the connecting rod was attributed to an oil starvation event between the main bearing and the No. 4 piston connecting rod cap. The No. 4 piston connecting rod cap, and bearings, were fracture-separated and parts of each were found in the engine sump. One of the connecting rod cap retention bolts was found lodged under the camshaft. The associated connecting rod cap nut and the opposite side bolt and nut were not readily identifiable, however metallic debris consistent with the bolt and nut were in the oil sump.

The fuel manifold remained intact and attached to top of the crankcase. A 3-inch x 2-inch puncture existed on the top side of the crankcase above the No. 4 cylinder (Figure 2). The fuel metering valve remained partially attached via the lower mount bolts. The mixture and throttle cables remained attached and unremarkable. The mixture and throttle cables were cut in preparation for transport to the factory for further examination. The oil sump remained attached and unremarkable.

**Figure 2:** Top view of the crankcase with a 2.5-inch x 2-inch hole above No. 4 cylinder

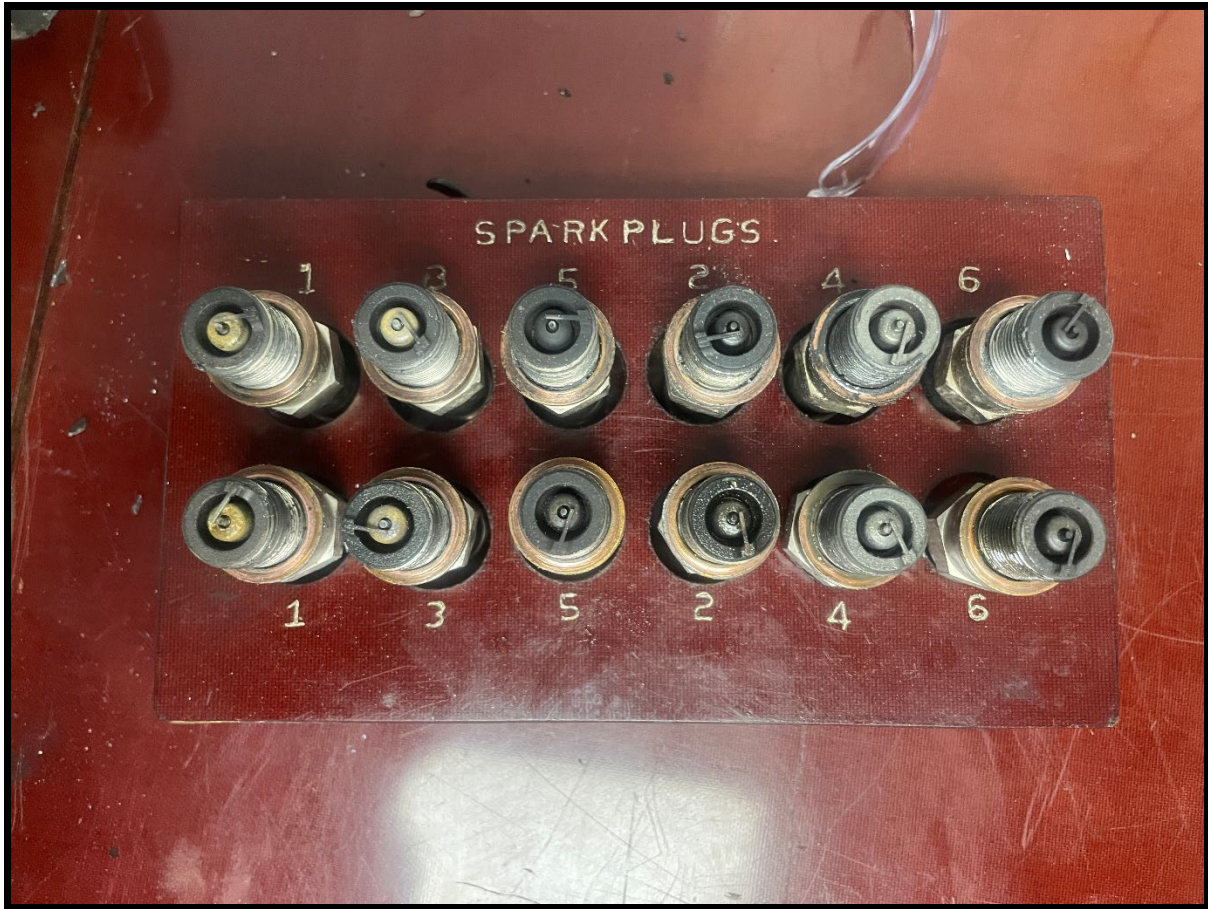
Spark Plugs (Figure 3)  
s/n: URHB32S

No. 2, 5, 6 Top: Carbon Fouled

No. 5, 6 Bottom: Carbon Fouled

No. 2 Bottom: Oil Residue and Carbon Fouled

No. 4 Top & Bottom: Lead Fouled

No. 1 & 3 Top & Bottom: Normal

**Figure 3:** View of top and bottom spark plugs

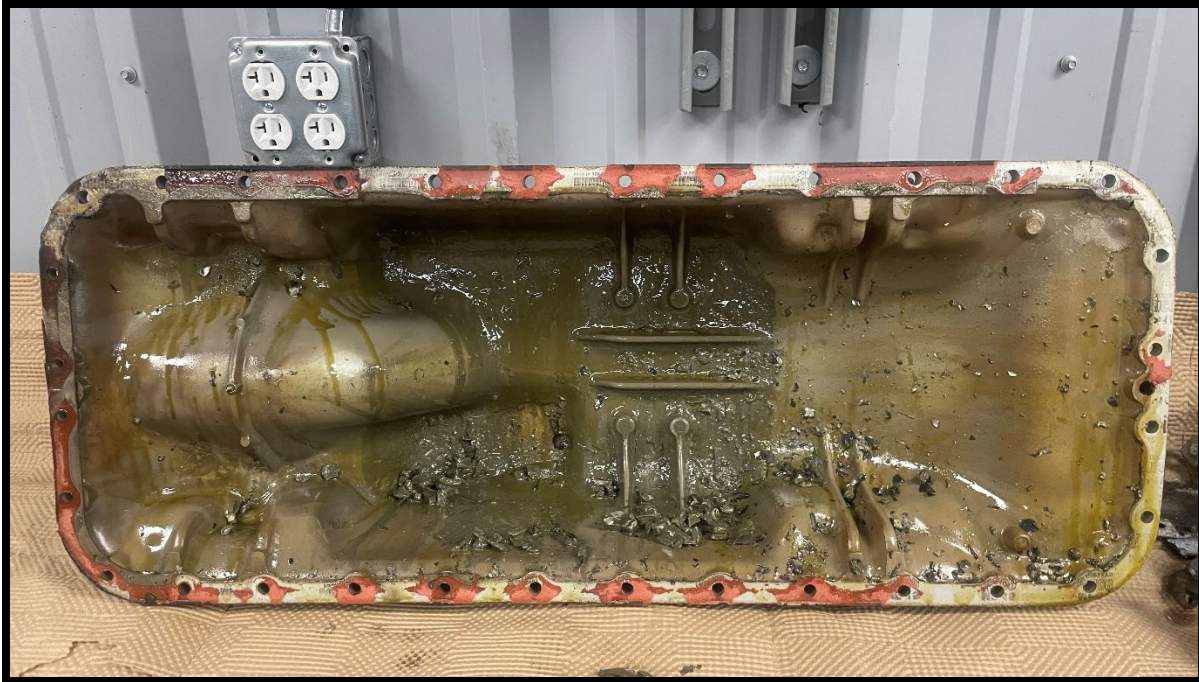
When the oil sump was removed (Figure 4), metallic debris (piston), along with pieces of the connecting rod, bearings, retention nuts and bolts were found in the sump. The four, sump case half connecting bolts (long) that were installed, were not Continental manufactured bolts. The six, sump case half connecting (small) bolt nuts that were installed, were not Continental manufactured. The oil sump pickup tube screen was unremarkable.

**Figure 4:** View of metallic debris in the oil sump

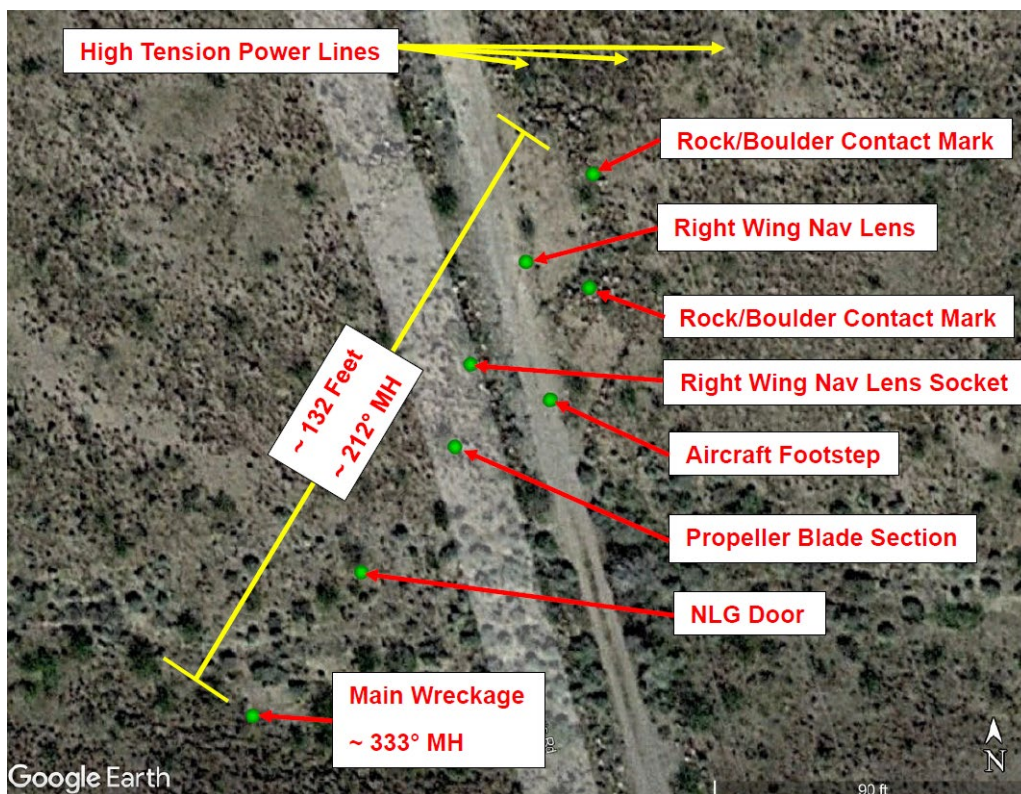
The first identifiable point of contact was a boulder with blue paint transfer markings found underneath high-tension powerline wires on the north side of (Figure 2). The right wing's green position light lens fragments were found in the debris path underneath the powerlines. Additional debris within the path between the initial point of impact and the main wreckage consisted of right wing skin, a right wing rib, fuel vent line, and a section of a propeller blade. The direction of travel from the initial point of impact to the main wreckage was oriented on a heading of about 212° magnetic and was about 132 ft in length. Additionally, between the initial point of impact and the main wreckage was a swath of terrain about 50 ft in diameter, which sustained thermal signatures.

**Figure 2:** Wreckage and debris path diagram

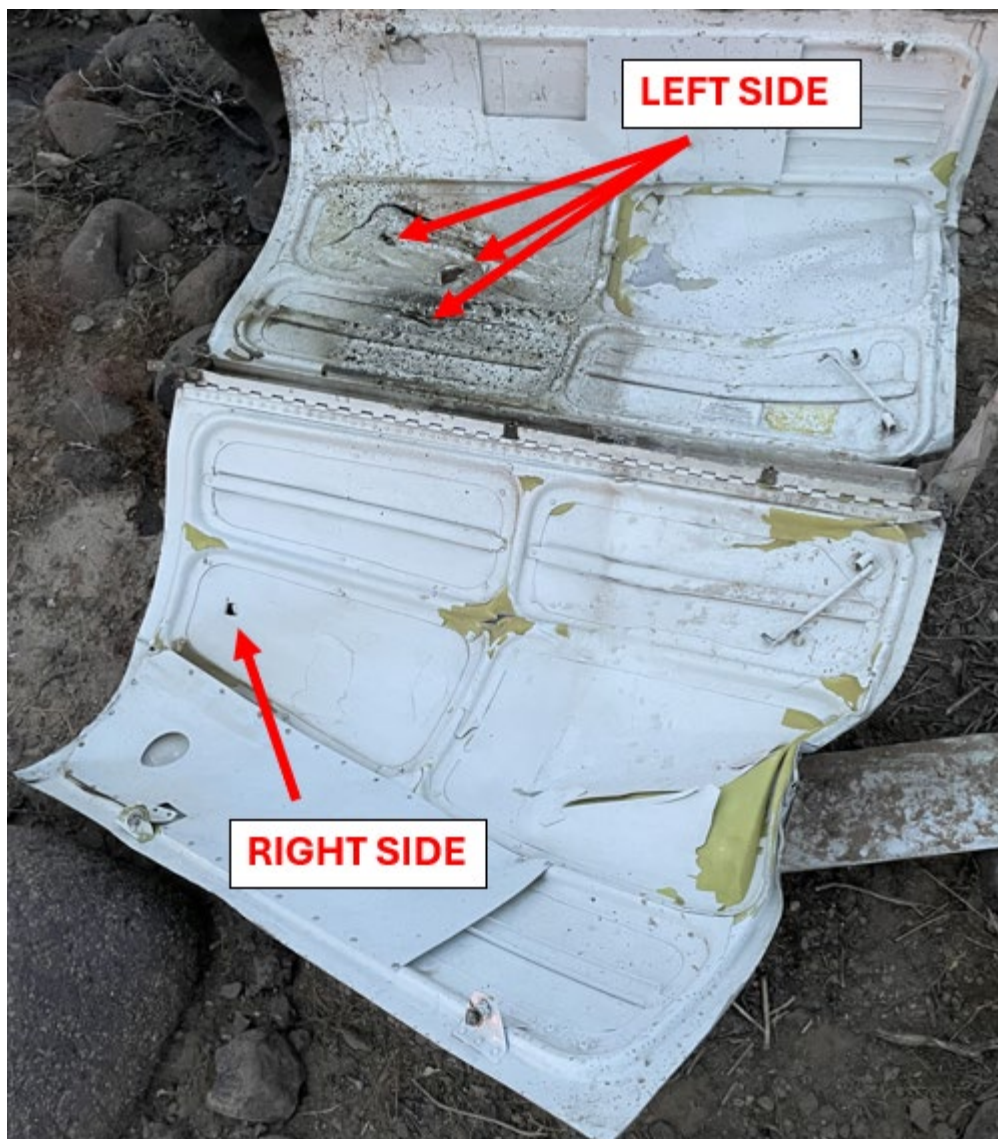
hub. The instrument panel and cabin sustained impact and thermal damage. The right wing sustained impact and thermal damage, with the landing gear retracted within the wheel well. The left wing sustained impact damage but was largely intact, with the landing gear retracted within the wheel well. The left wing fuel cell was intact and was not breached. The right wing fuel cell was consumed by fire. Control continuity of the left and right wing aileron and flap were confirmed. The empennage was not damaged and unremarkable. Control continuity from the cockpit to the rudder, elevator, and both trim surfaces, were confirmed. The engine compartment upper cowling was separated from the airframe and came to rest about 3 ft from the engine. The left and right forward areas of the cowling, revealed puncture signatures emanating from the inside of the cowling, with the skin curling about the exterior of the cowling (Figure 3). The left side cowling sustained multiple protrusions, while the right side cowling sustained a single protrusion.

**Figure 3:** View of the left and right upper engine cowling protrusions

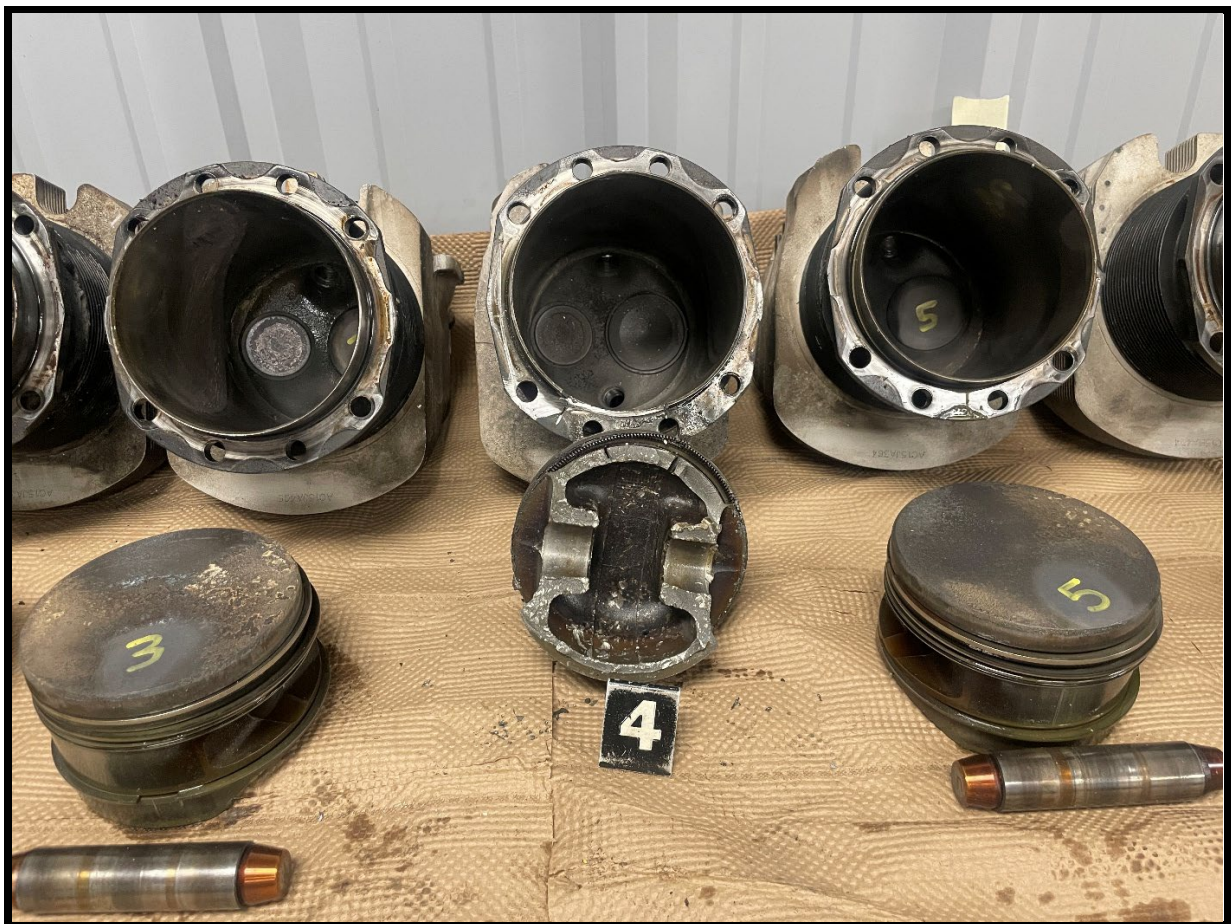
Cylinder No. 4 (Figure 5)

The piston face revealed exhaust valve contact signatures. The manganese phosphate coating was eroded; the Ni-Resist steel ring land was present and unremarkable. The graphite coated skirt was missing about 66 percent and the piston

pin had separated from the piston. The top compression, and second compression rings and lands were unremarkable and traveled freely. The oil retention ring and land were damaged, and the oil scraper ring and grooves were not present. The piston pins and plugs were not present but recovered at the accident site. The airplane impacted rocky desert terrain while oriented on a southeasterly heading.

**Figure 5:** View of No. 4 cylinder removed from crankcase and its associated piston

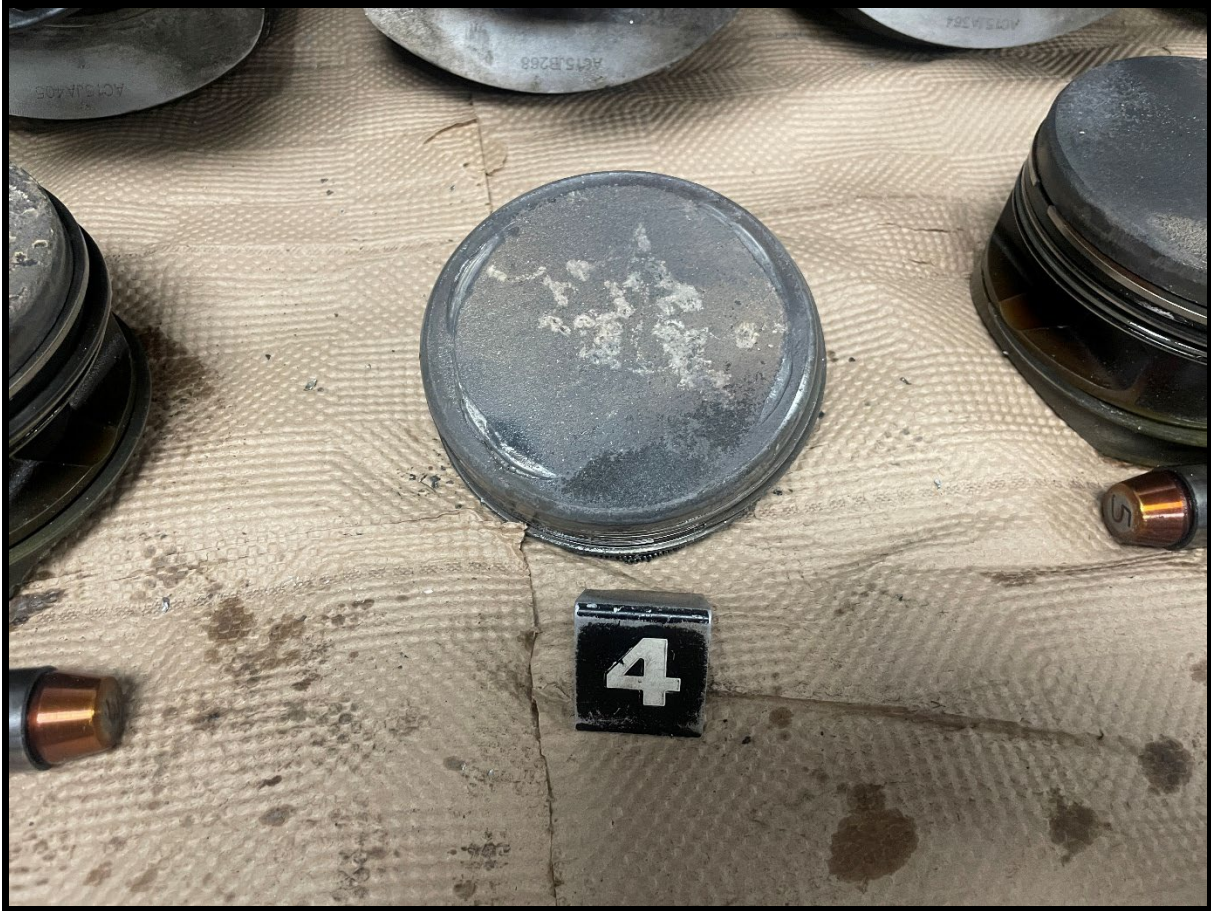
**Figure 6:** View of the remaining No. 4 cylinder piston

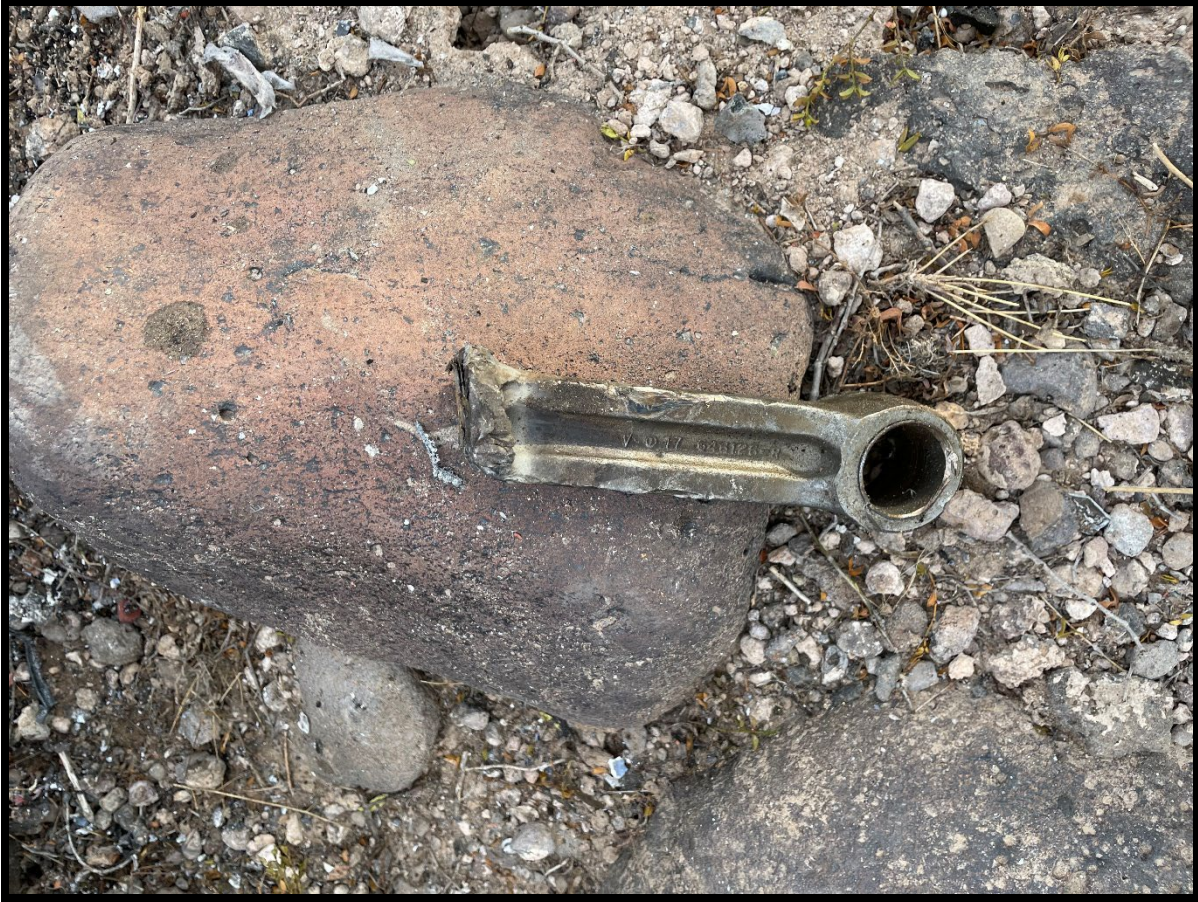
Postaccident examination of the engine revealed that the No. 4 connecting rod was separated from the crankshaft and piston and was located adjacent to the engine. The No. 4 crankshaft journal sustained material deformation with dark grey/black thermal signatures. The main bearing gallery was unobstructed, and the crankshaft oil passage was unobstructed. The No. 4 connecting rod bearing shoulders were not present, with material deformation at the base of the bearing housing and into the i-beam. The bearing end of the i-beam showed a thermal discoloration that appeared white/light grey in color, with dark grey progression emanating from the trapezoidal contour at the tower base and web to flange transition radius. The piston pin bushing was present with material deformation observed around bushing and housing radius on both sides. The No. 4 main bearing provided lubrication to the No. 4 piston crankshaft journal. The No. 4 piston connecting rod cap, and bearings, were fracture-separated and parts of each were found in the engine sump. One of the No. 4 piston's connecting rod cap retention bolts was found lodged between the camshaft and the crankcase. The associated connecting rod cap nut and the opposite side bolt and nut were not readily identifiable, however metallic debris consistent with the bolt and nut were found in the oil sump (Figure 4).

**Figure 7:** View of No. 4 piston connecting rod at the accident site

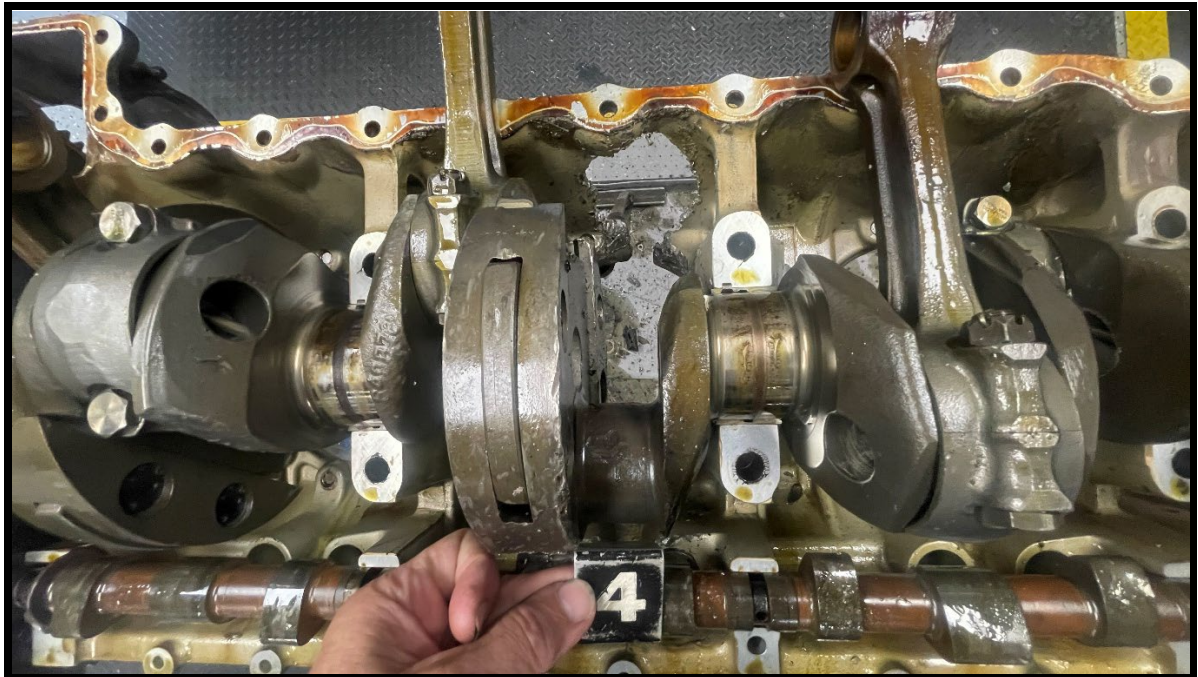
**Figure 8:** View of the crankshaft No. 4 piston connecting rod journal

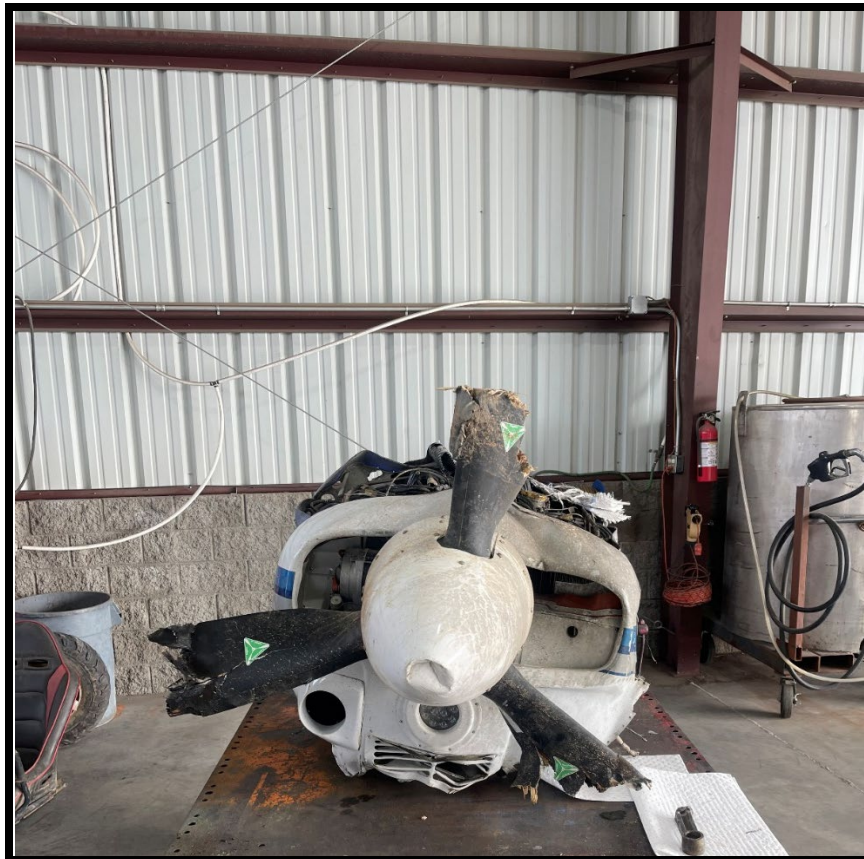
The main wreckage came to rest on a heading of 333°magnetic. The engine had partially separated from the airframe and came to rest inverted. The cockpit to engine control cables for the propeller, throttle, and mixture sustained thermal damage. The propeller spinner sustained minor impact damage, while all three of the wood propeller blades separated between 9 inches to 12 inches outboard of the propeller

**Figure 9:** View of impact damage to propeller blades and spinner
