National Transportation Safety Board

WPR24FA056

**INVESTIGATIVE SUPPLEMENTAL MATERIAL**

Location: Corona, CA  
Date: 12.16.2023  
Time: 1151 Pacific standard time  
Airplane: Vans RV-8

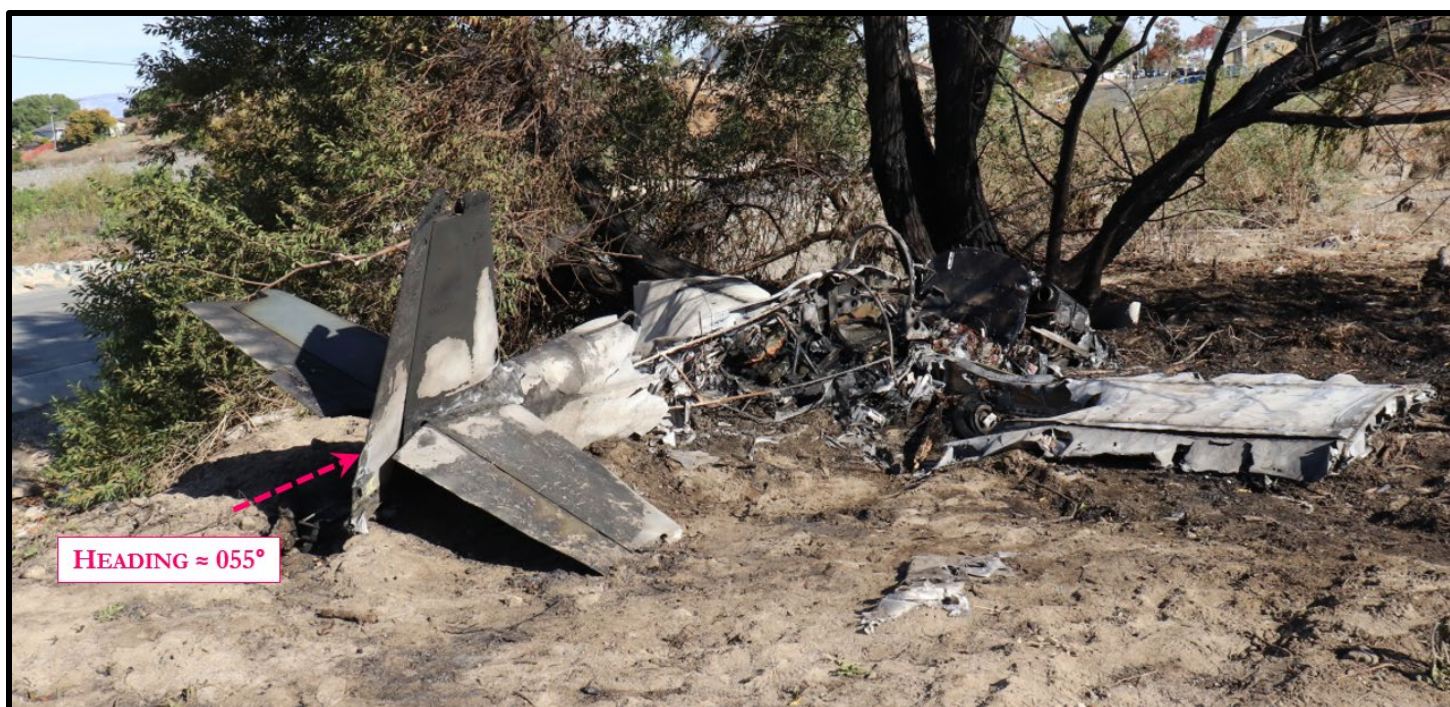
Figure 5: Main Wreckage

The wreckage was consumed by post-impact fire and a majority of the fuselage, wings and skin panels were charred, puddled aluminum and ash. The airplane was on a magnetic bearing of about 055 degrees. The entire airplane was located at the accident site with the exception of portions of the wheel pants and outboard left wing, which was all found in the debris path.

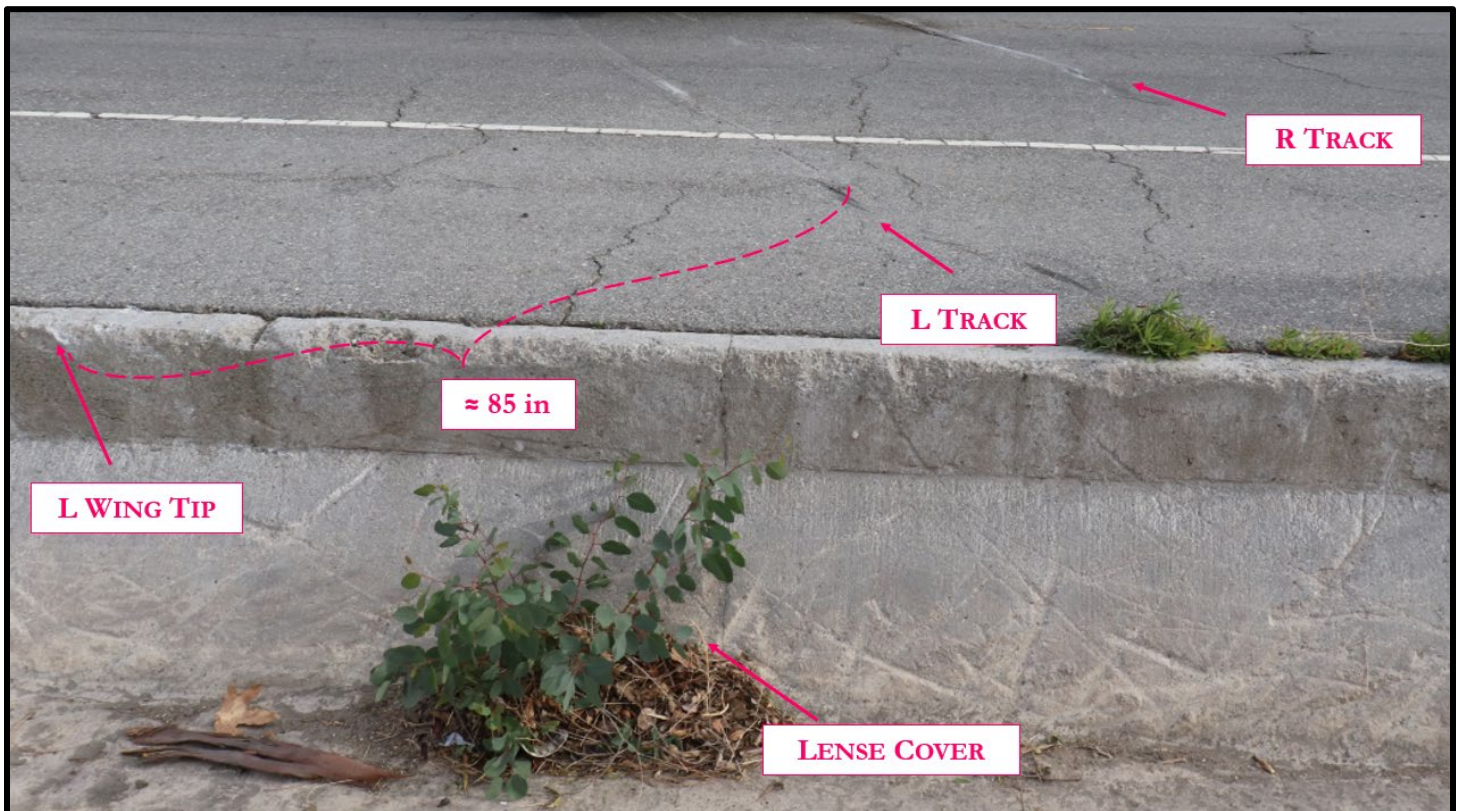
Figure 8: Initial Impact

The first impact was a groove in the edge of the concrete wall making the lip of the road, consistent with contact from the left-wing tip. There were paint transfers and a small pile of paint chips adjacent to the divot. Small pieces of grey and white paint chips were scattered in the area as well as large portions of curved plexiglass that was similar in convex and had hardware pattern to that of the wingtip-light housing.

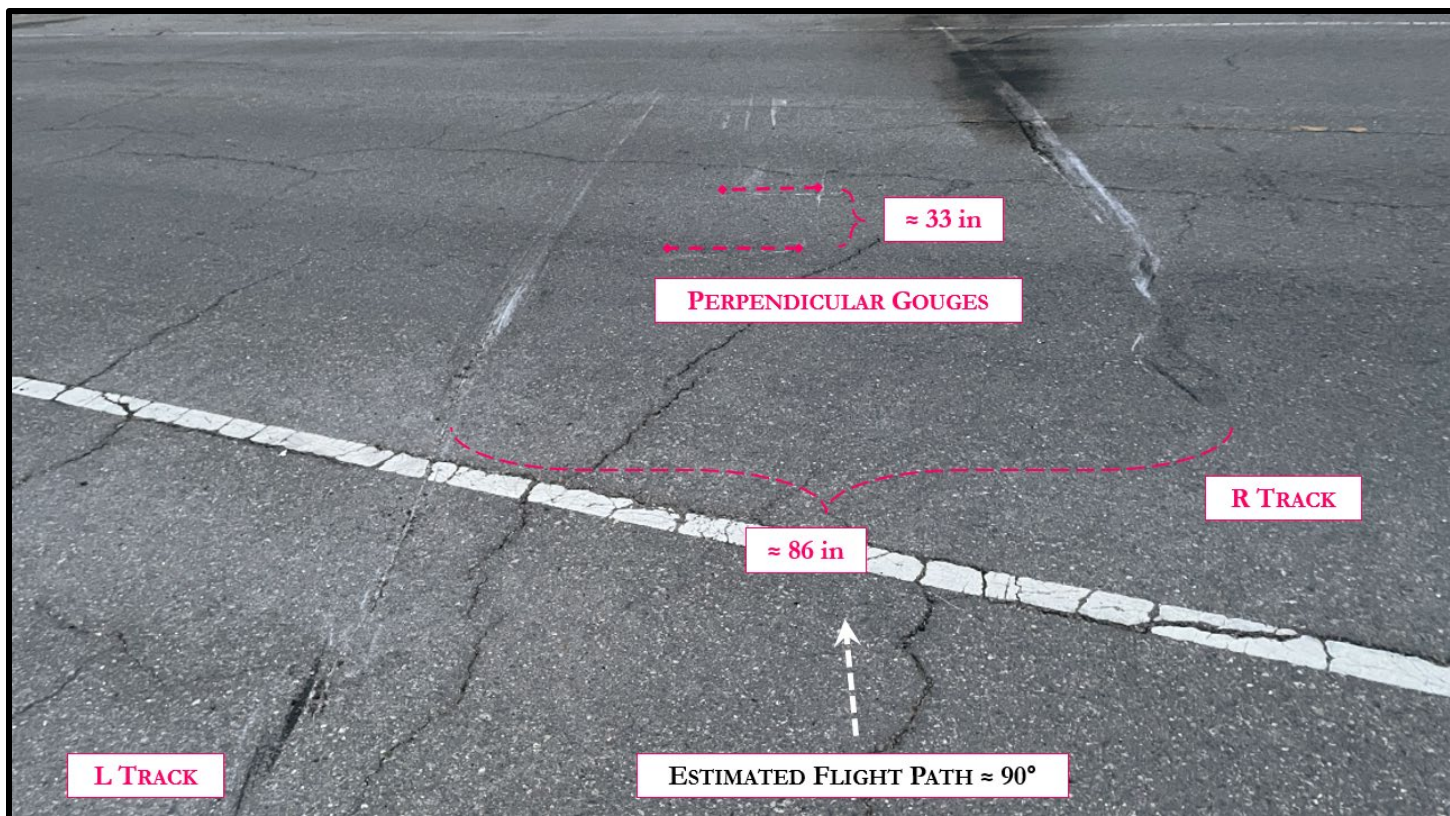
Figure 9: Start of Debris Field

There were several pieces of the left wheel-pant located to the left of the left-track and pieces of the right wheel-pant located to the right of the right path. About 12 ft from the first right track black smudge mark was an 18 in gouge in the concrete that was oriented perpendicular and in between the two parallel right and left tracks. Another perpendicular gouge was 15 in forward of from the first track. These gouges were consistent with propeller slashes.

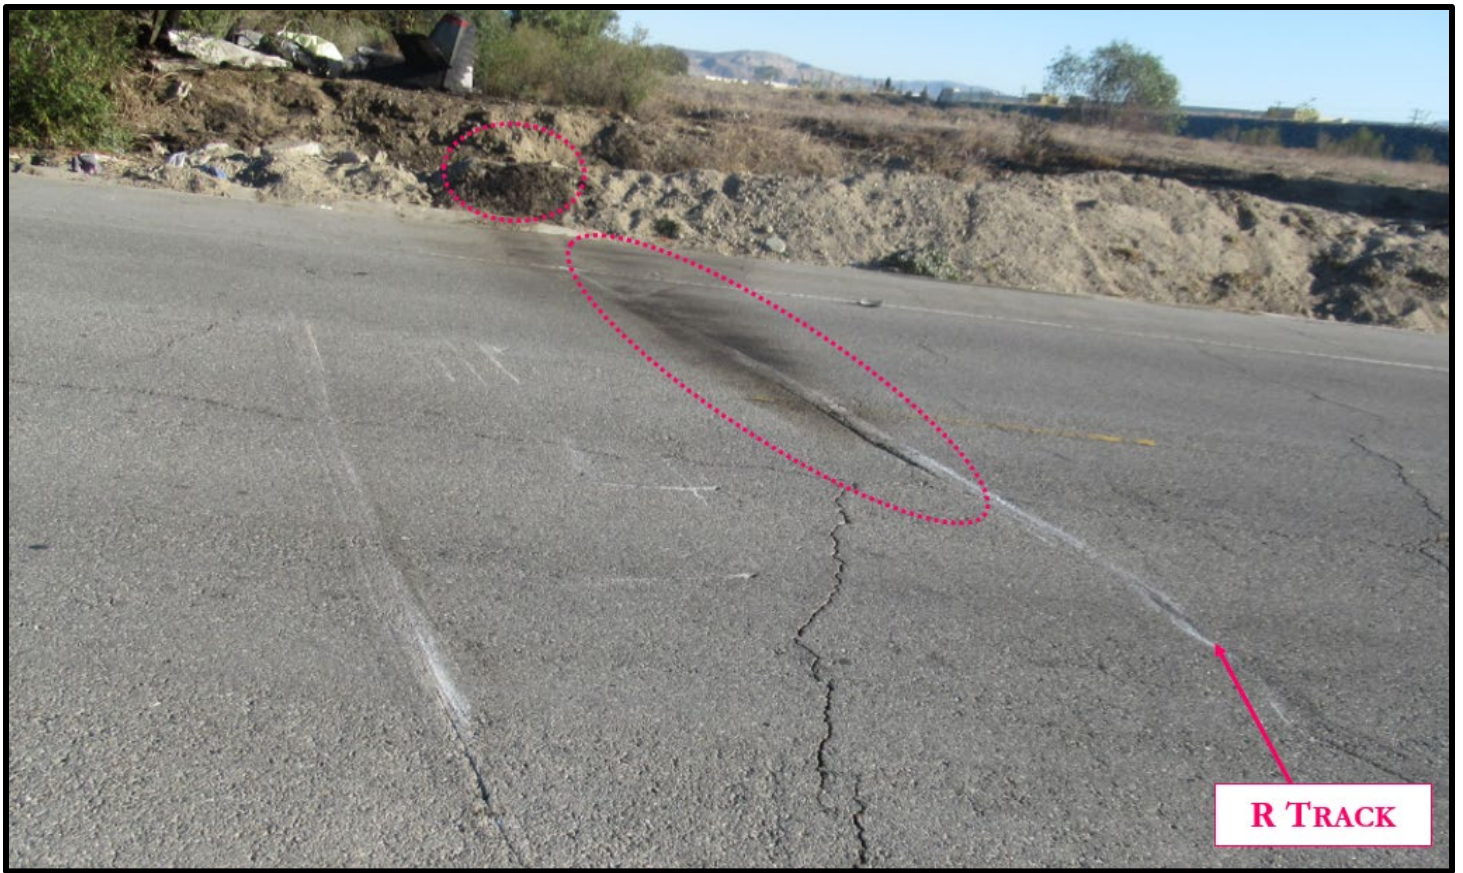
At the deep groove midway in the right track, there was a black residue that feathered to the south as the track continued toward the main wreckage. After the east end of the road there was a shallow concrete ravine that paralleled the road. Located in the ravine, was an outboard portion of the left wingtip. The fiberglass was deformed and a light was hanging from the wiring. There was yellow tape on the inside of the tip, which was similar to pieces of yellow tape in the debris field on the road. The paint shop owner stated that this was the same tape they use during the painting process and should be removed during the installation of the fairings. After the ravine, there was a small dirt berm that was dark in color with no odor; the substance that was darkening the terrain is unknown. There was a second, steeper berm thereafter that had a disruption of terrain that continued up the slope to the main wreckage.

*Figure 10: Black Residue Near the Right Track and the Darkened Berm*

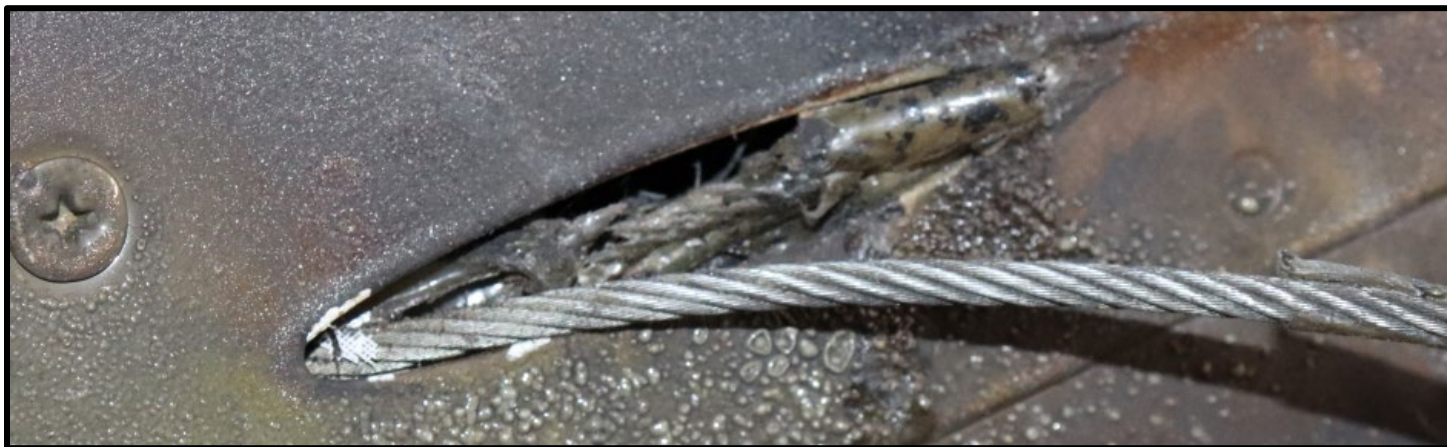
Figure 14: Left Rudder Cable Through Empennage

Partial control continuity was established onsite. The control cables were continuous to molten bellcranks and portions of the airframe. Continuity was established for the ailerons, elevator, and right rudder cable. The left rudder cable was frozen in the lightning hole and could not be moved. It appeared that material around the hole had melted around the wire binding it into place. The elevator trim tab was in the down position, consistent with the proper takeoff procedure.

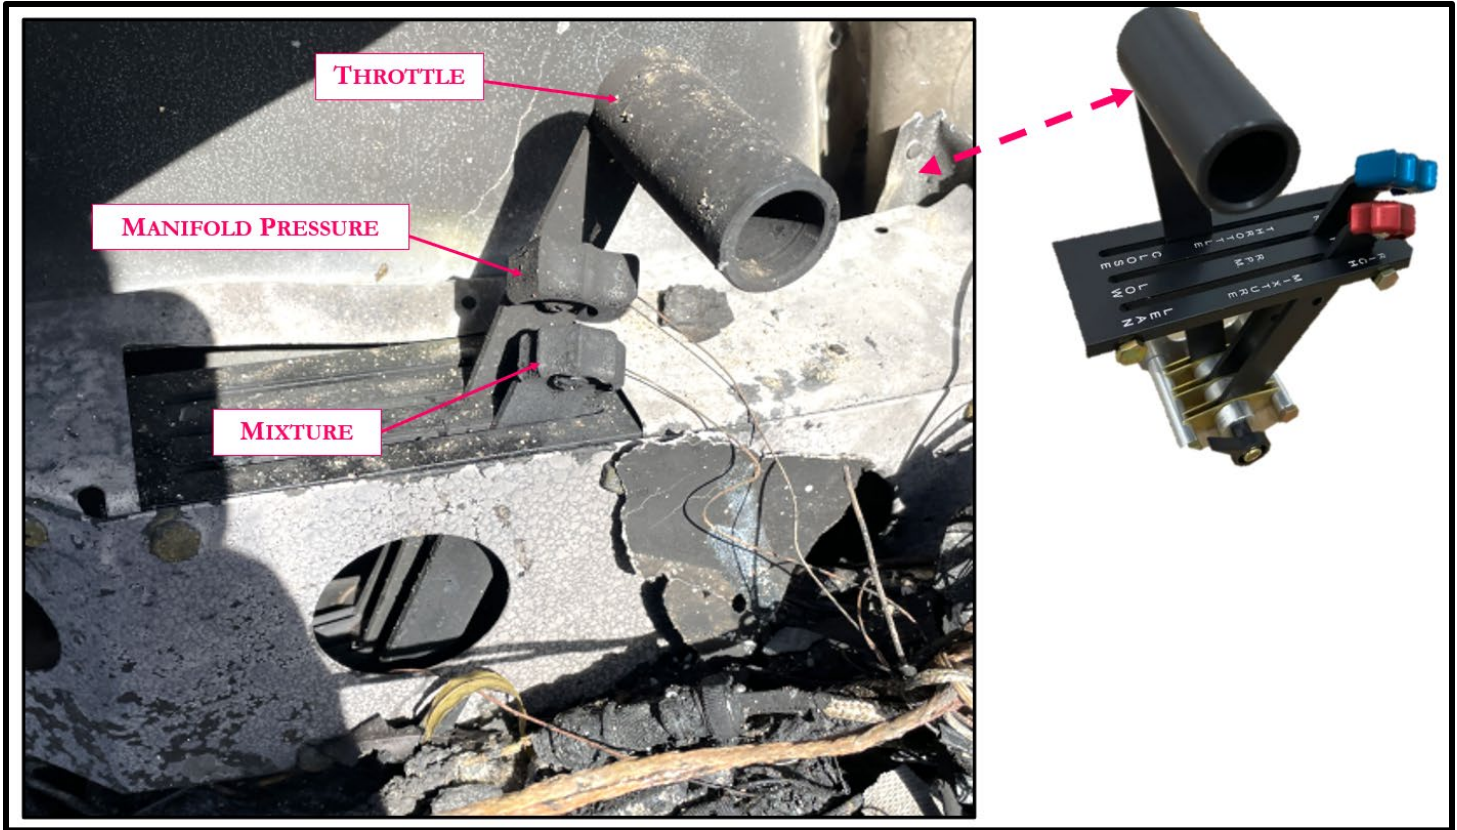
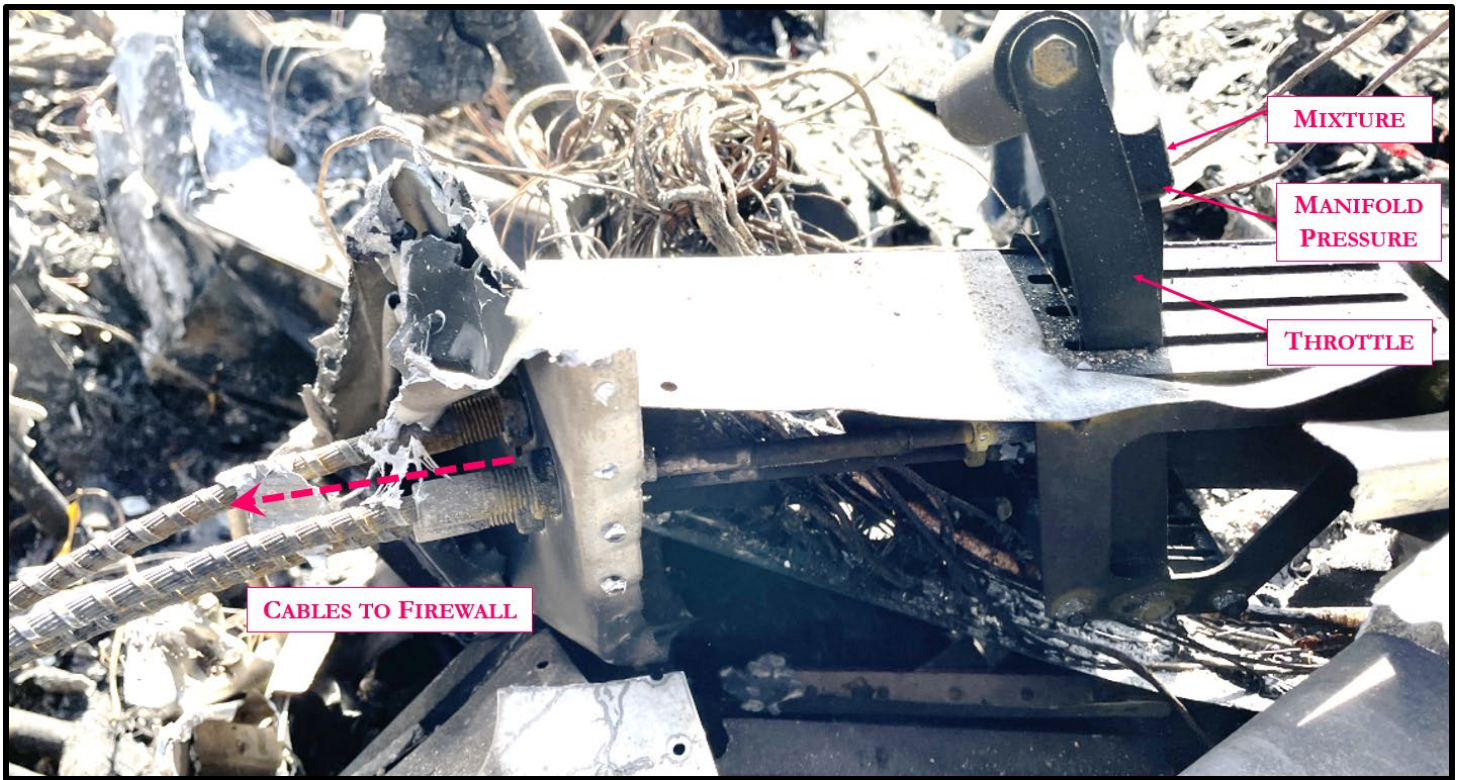
The throttle quadrant was burned and displaced from the interior trim it had been mounted to. The throttle, manifold pressure, and mixture handles were all in the fully forward position. The handles were slightly bent to the left; the cables were

all attached to their respective levers at the bottom of the handles. Continuity could not be established from the throttle quadrant to the respective fittings on the engine components, due to impact damage and crush deformation.

Figure 15: Throttle Quadrant (right side)

Figure 16: Throttle Quadrant Showing Cables Connect (showing left side)

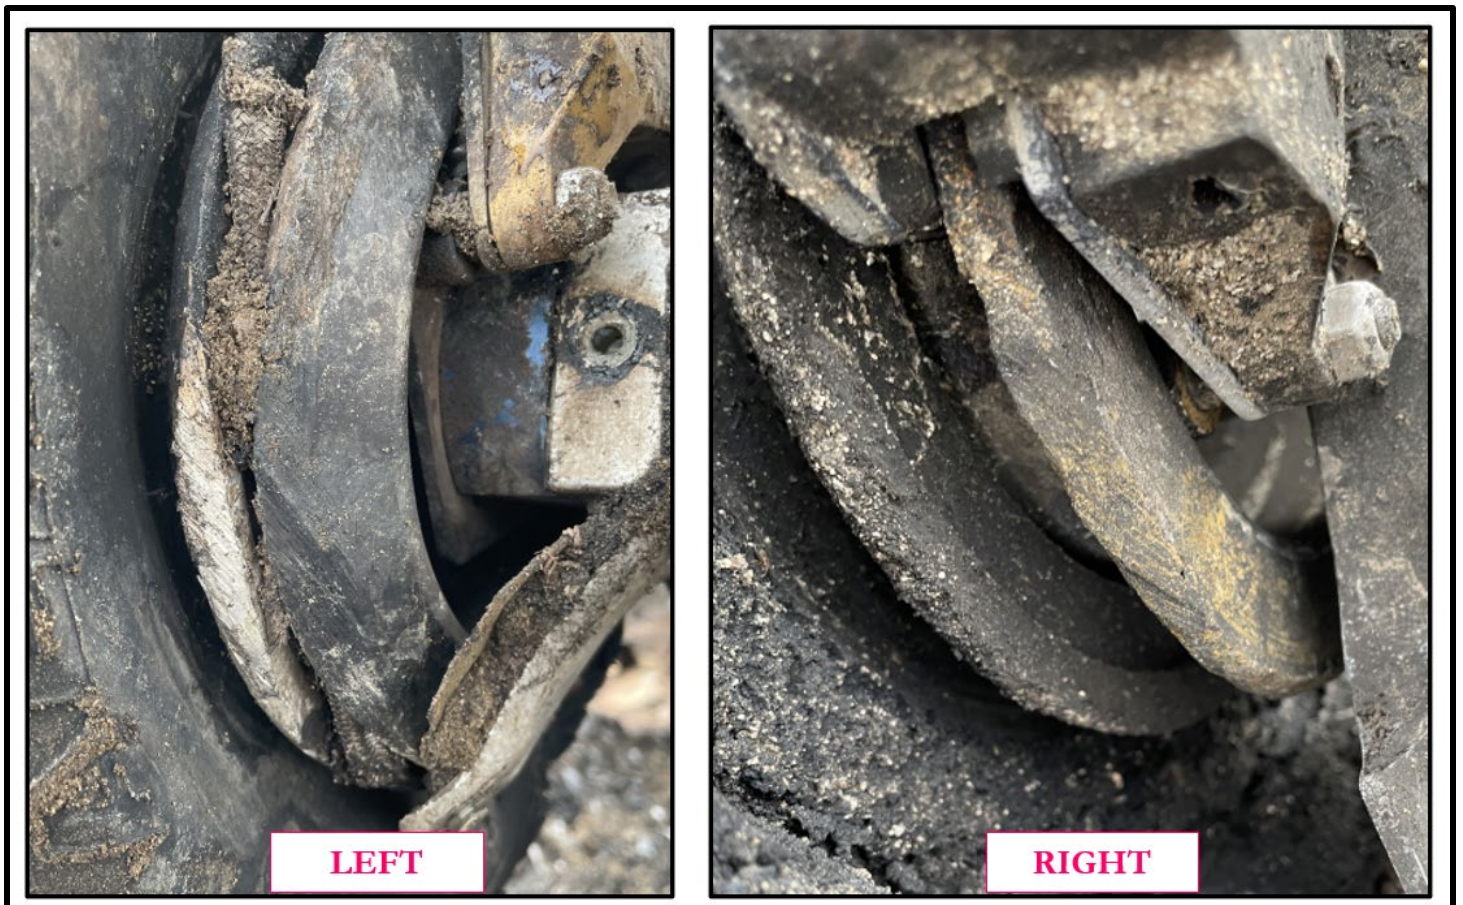
The main landing gear remained with the airframe and were folded aft and located under the wings. The left and right rotors on the wheels were shaved down with flat areas. The wear was consistent with sliding against the pavement during the accident sequence.

*Figure 17: Damage on the Rotors on Both Wheels*

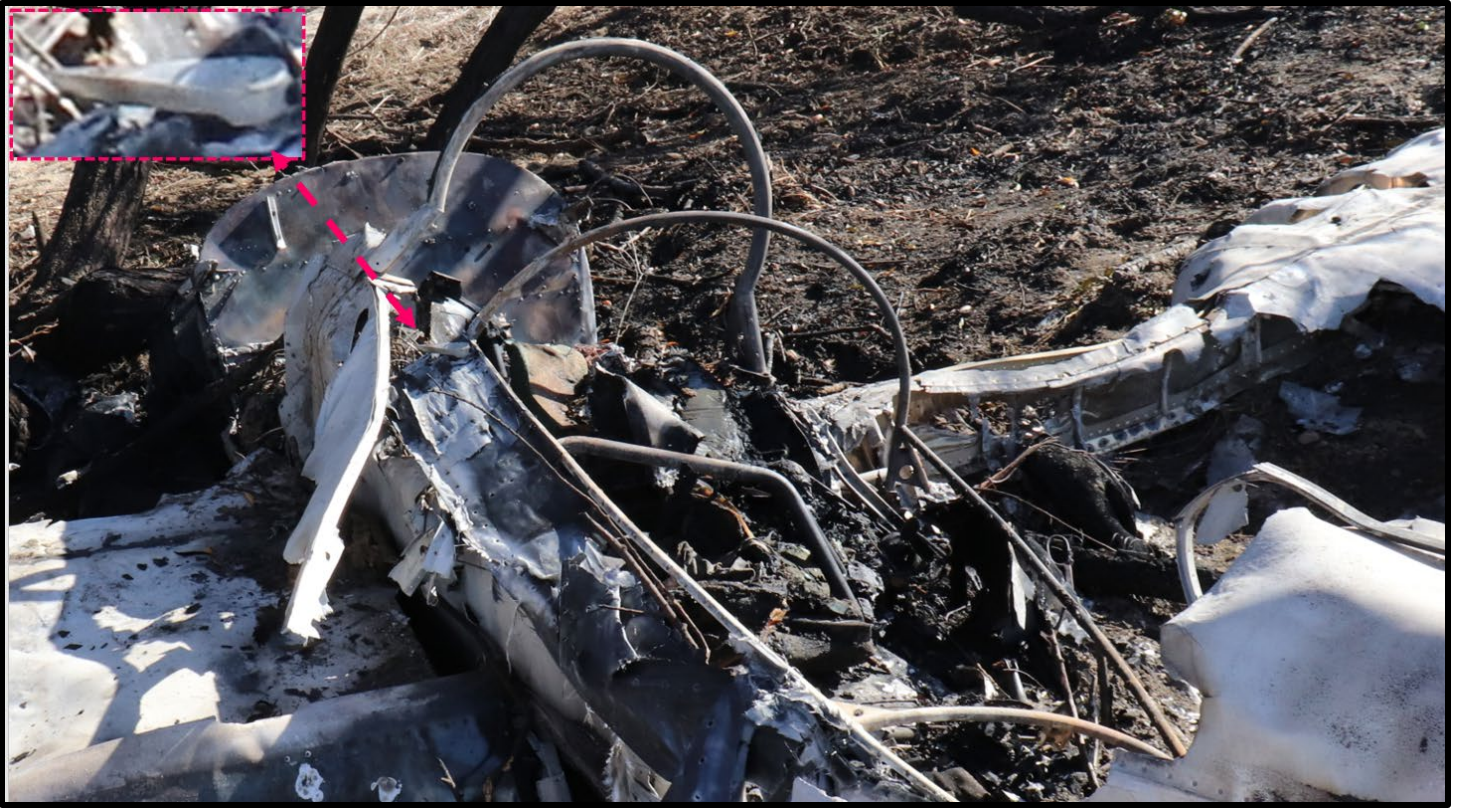
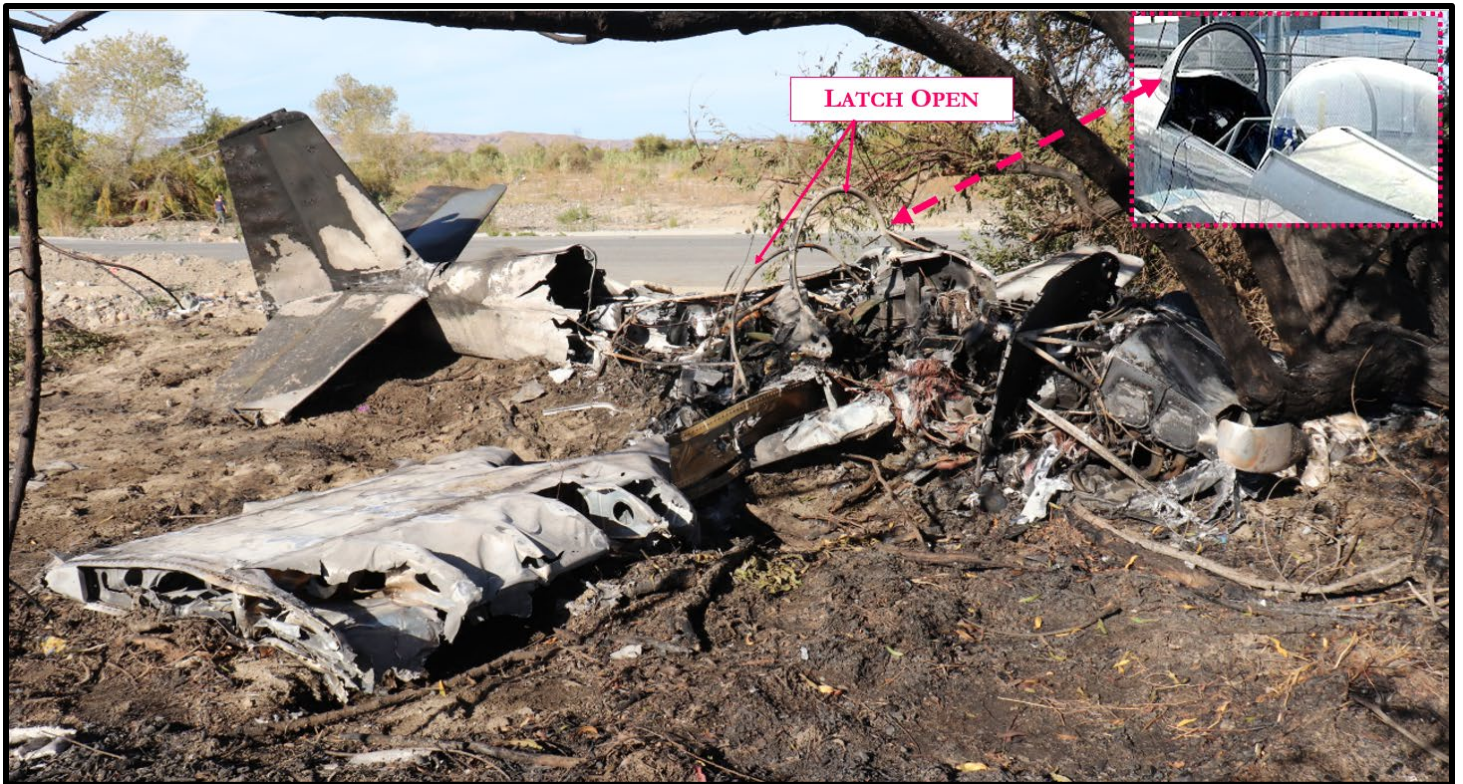
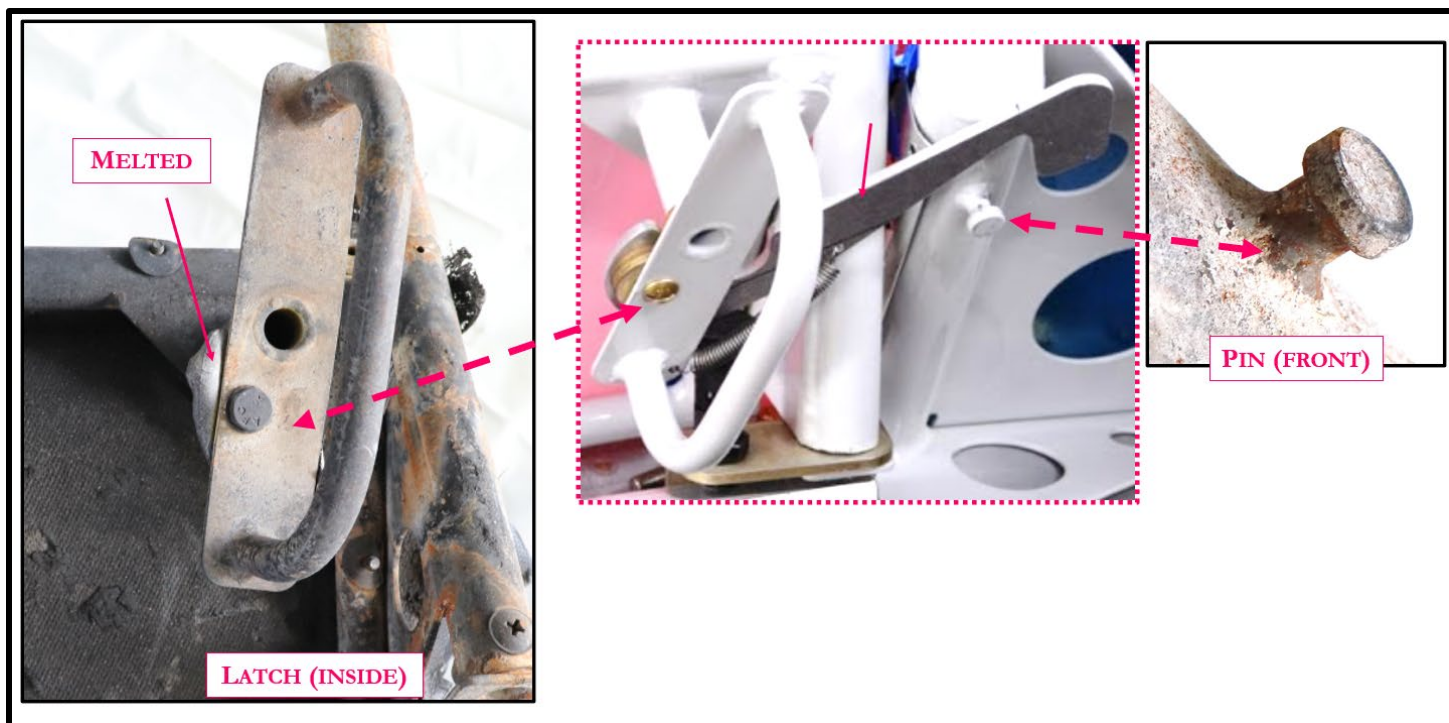
The canopy was found unlatched and open (slid back).

Figure 20: Latch Components (as found compared to newly built)

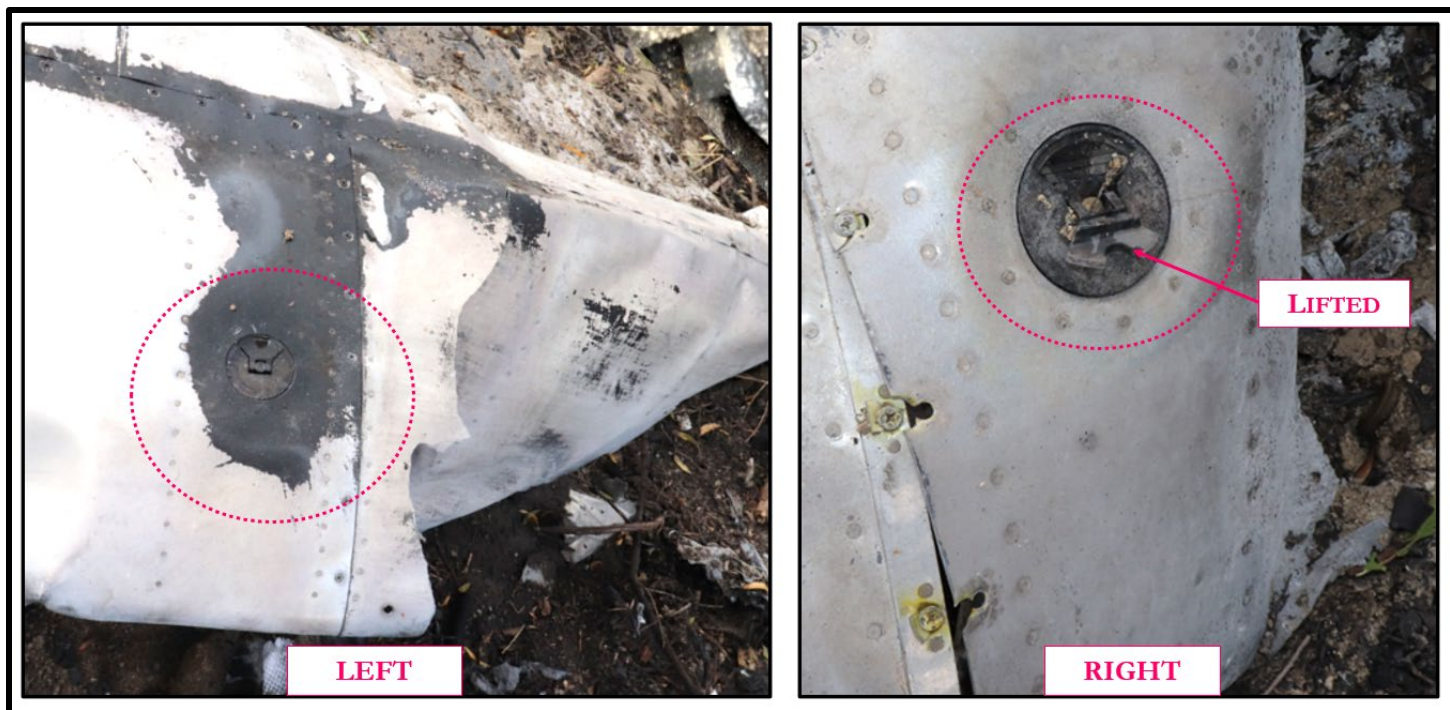
Figure 23: Fuel Caps

The majority of the fuel system sustained major thermal damage. The right-wing fuel-cap was secured on the wing tank with the top tab flipped and affixed open. The left-wing fuel-cap was secured and flush on the wing. According to an RV-8 owner, it is common practice to keep the top tab lifted up when on the ground to help it vent (reduce the pressure from the heating on the ground).

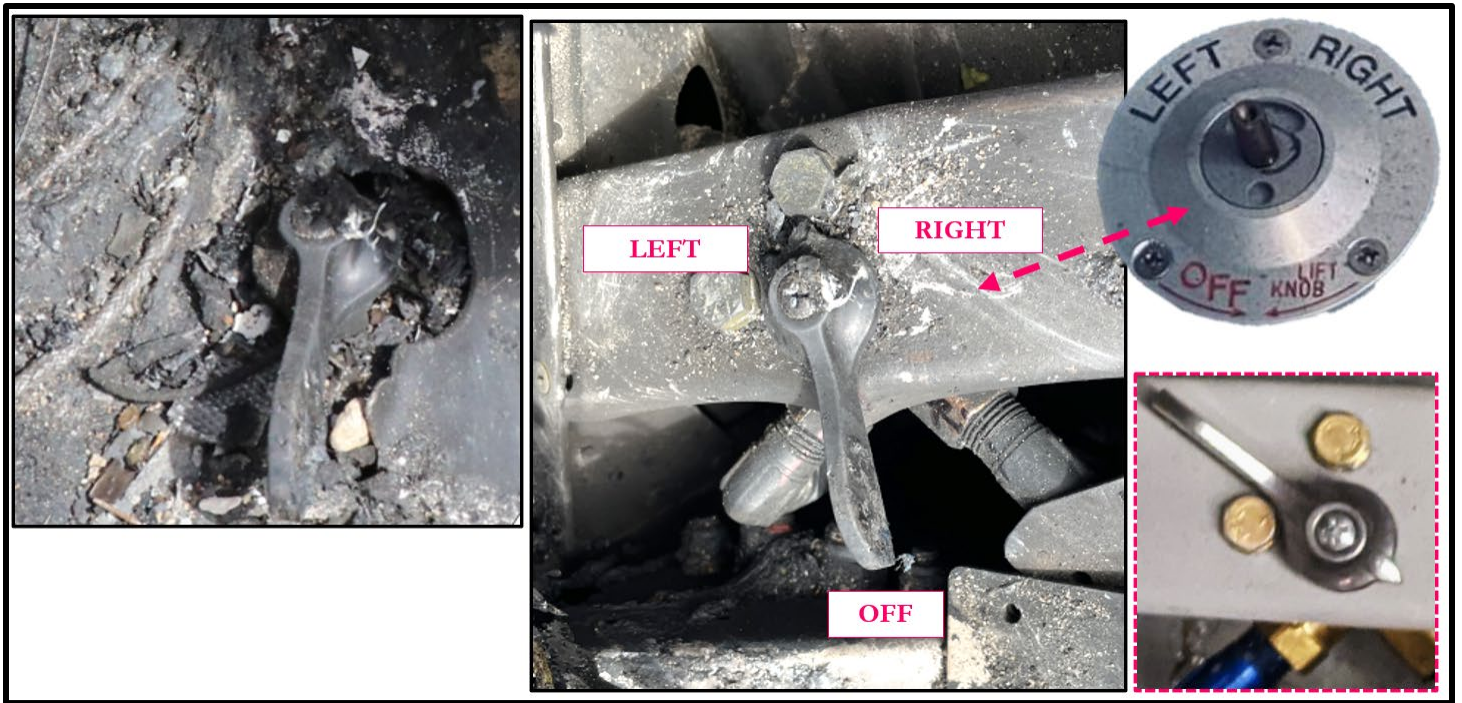
Figure 24: Fuel Selector

The fuel filter screens in both wings were melted. From the wings, the fuel lines were intact to the fuel selector valve, located on the left side of the cockpit. The selector handle was resting in a presumed “LEFT” or in-between selection, but was not attached to the stem and freely swung around with any movement.

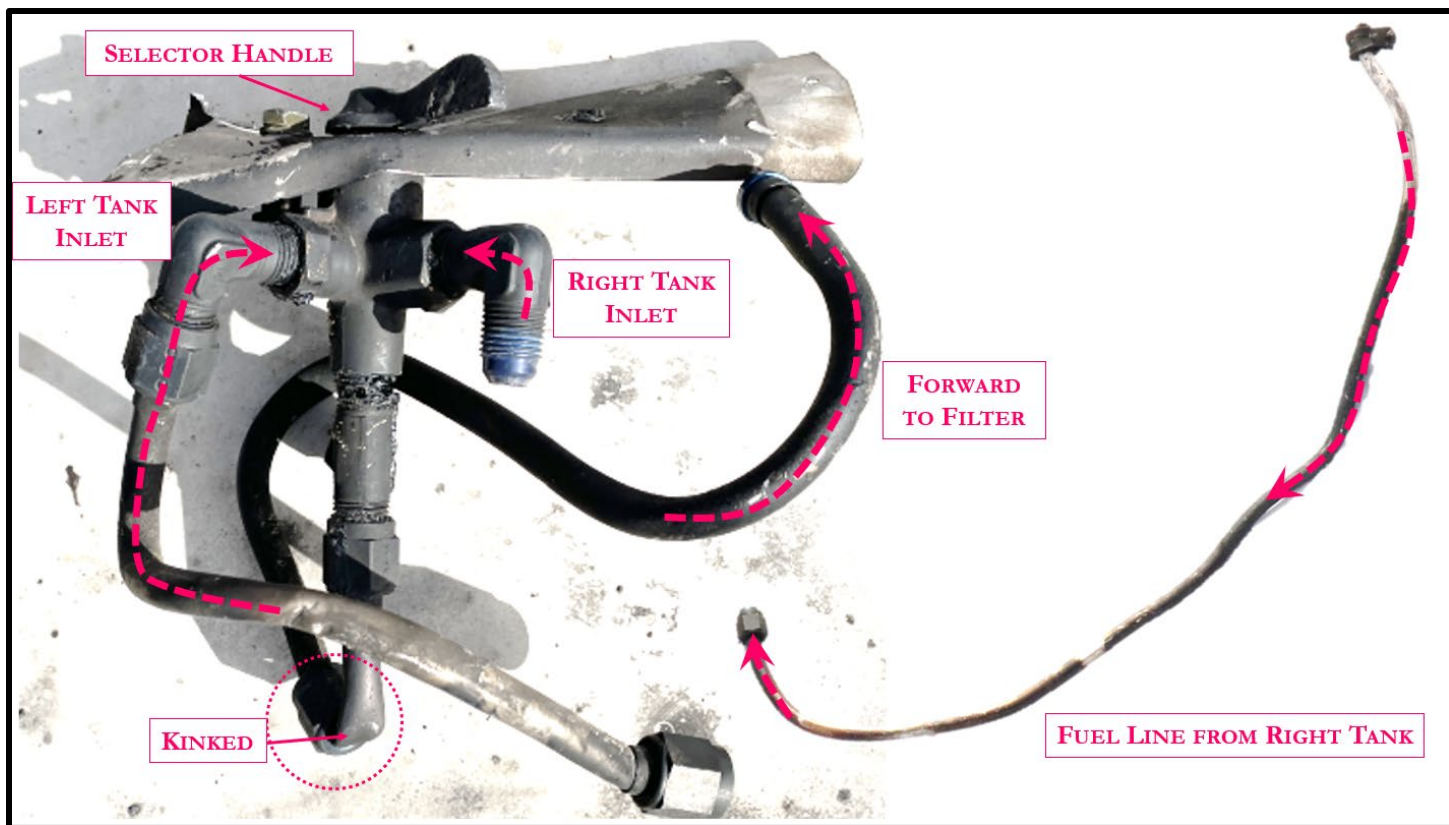
Figure 25: Fuel Lines to/from the Selector

The fuel lines from the tank to the selector were not directly routed and instead were looped before attaching to the valve's inlet fittings. The fuel line from the selector valve's outlet to the fuel filter was kinked at the bottom of a loop. It is unknown if the crushing of the fuel line was a result of the impact. Trace amounts of liquid exited from the valve when manipulated; when subjected to water-detecting paste, the liquid tested positive for water, which is consistent with fire suppression efforts.

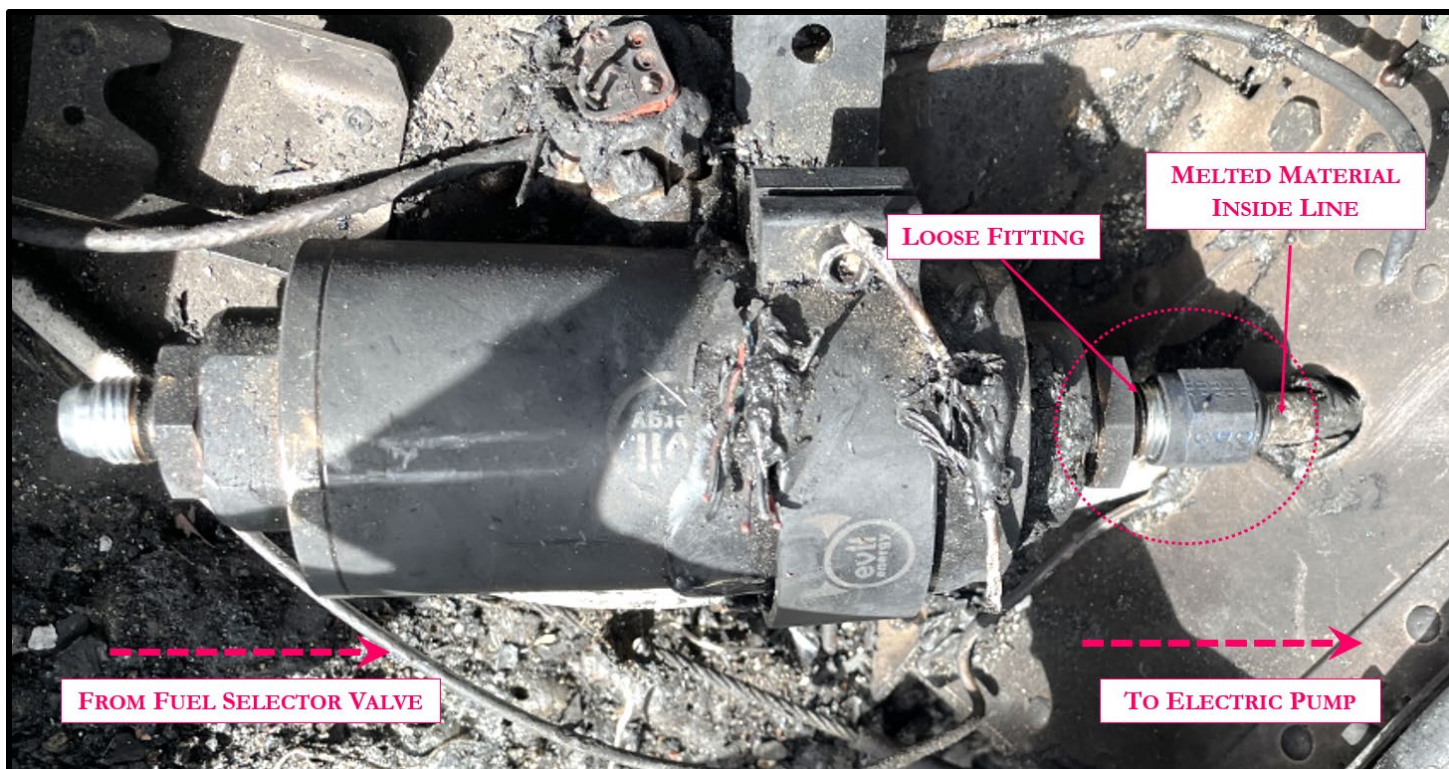
Figure 26: Fuel Filter

From the fuel selector valve, there was a 40-micron fuel filter manufactured by Evil Energy. There were numerous wires that were connected to the filter, but the connection or purpose was not known. The outlet fitting was loose and the entire fitting assembly could be moved in and out of the filter body. The fuel line connected to the filter outlet was filled with a tan-colored melted material.

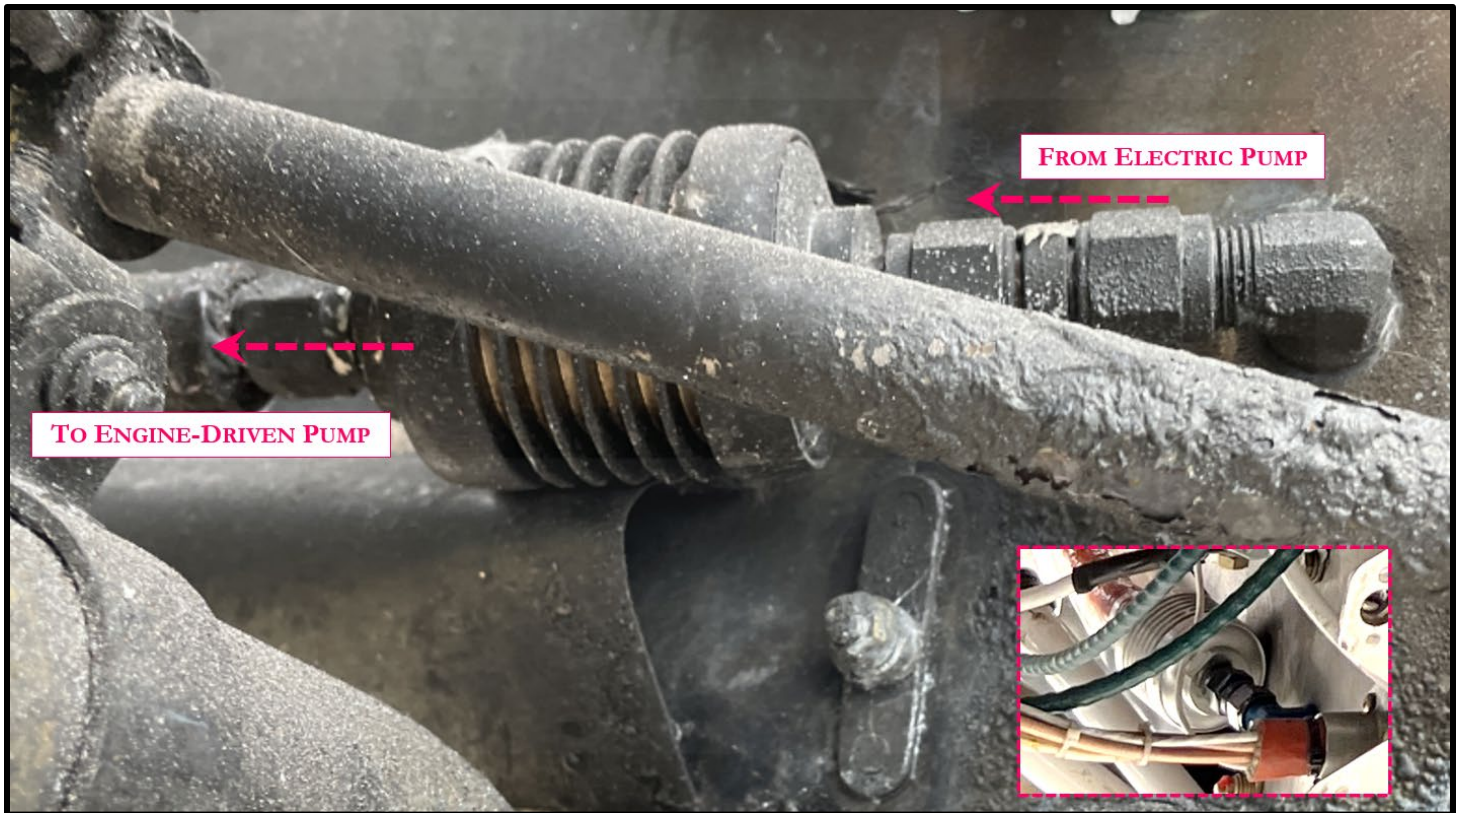
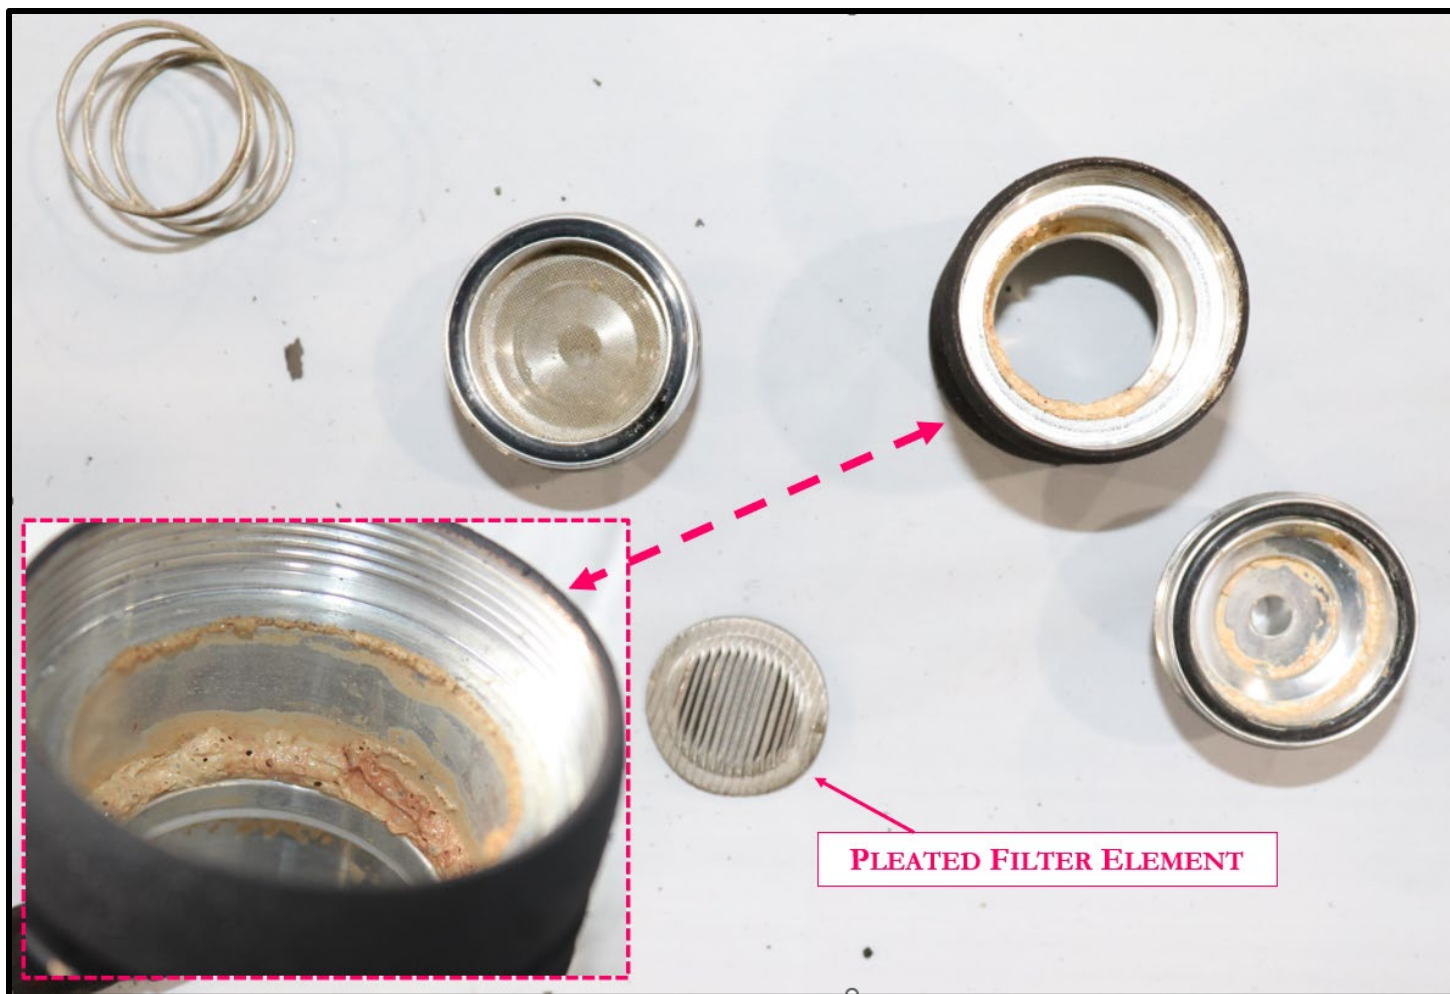
The fuel line continued to the electric (boost) pump<sup>1</sup>, which was mounted on the floor, aft of the firewall. The pump and connected return line system remained affixed in the brackets. The wet-pump rotary gears could be turned. The fuel line from the pump to the firewall was a sloped line. After passing through the firewall, the fuel line was routed in a 90-degree elbow to a cylindrical 10-micron filter<sup>2</sup> with accordioned pleats. The filter was burned on the outside but remained attached to the firewall. The filter contained a hard tan material.

*Figure 28: Inside Firewall Fuel-Filter*

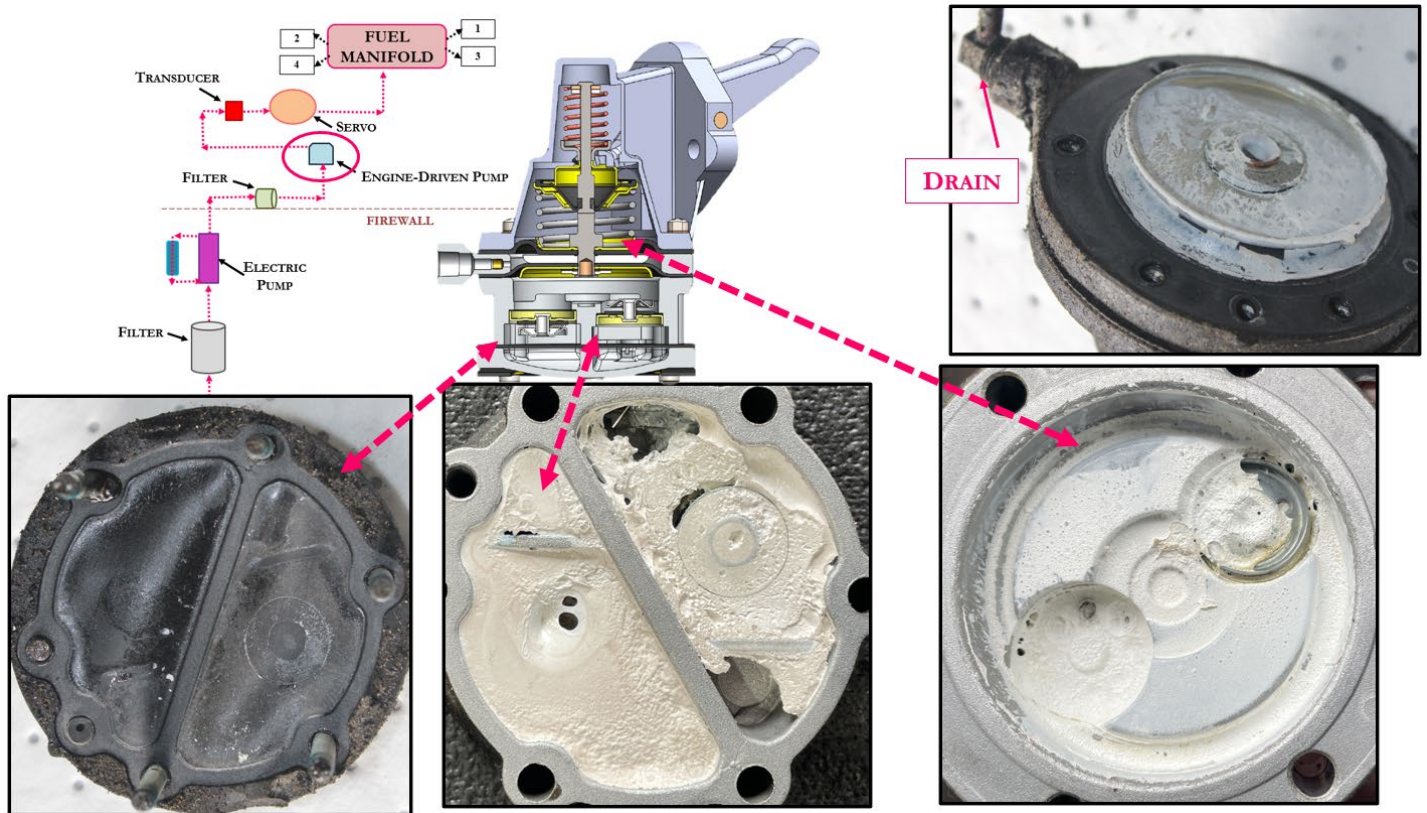
Figure 29: Inside Mechanical Fuel Pump

The fuel line continued to the engine-drive fuel pump. Disassembly of the pump revealed that there was a hardened off-white material similar in appearance to a hard taffy. The material had air pockets and was located in the fuel chamber with no evidence of it having entered the air chamber.

A post accident investigation revealed that there was a white substance in the mechanical fuel pump, AF-15473.

Caution! Before introducing sealer into the tank, the entire interior of the tank must be dry. If only one small area of the tank is not dry or has foreign matter that may keep the sealer from adhering, the sealer will not stick to those areas and could come loose and float around in your tank and eventually come through the fuel pick up tube and clog the fuel pump and carburetor.
