National Transportation Safety Board

WPR24FA056

**INVESTIGATIVE SUPPLEMENTAL MATERIAL**

Location: Corona, CA  
Date: 12.16.2023  
Time: 1151 Pacific standard time  
Airplane: Vans RV-8

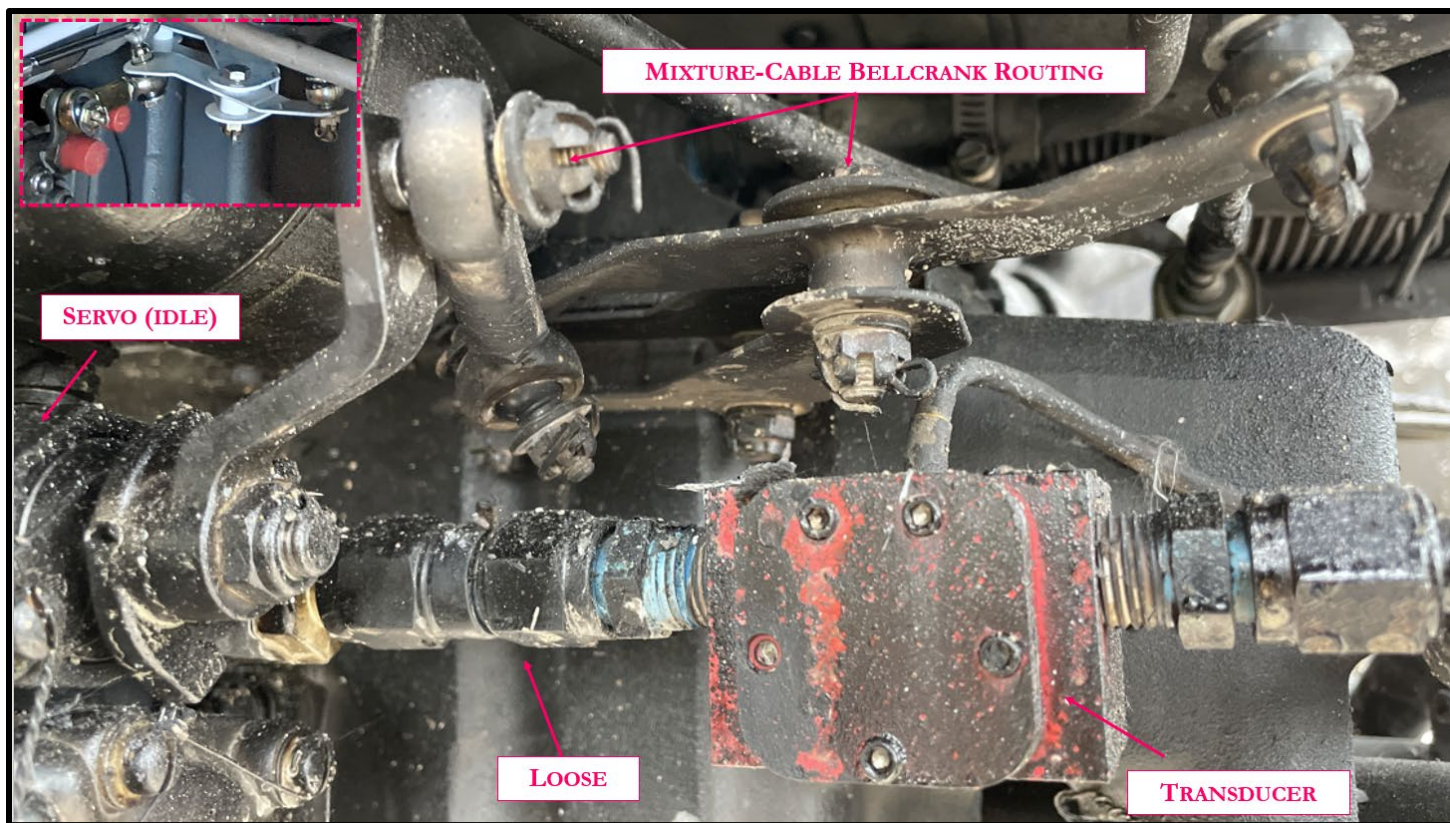
Figure 30: Transducer

The fuel was then was routed forward under cylinder Nos. 4 and 2. After passing under the cylinders, there was an elbow inward where the line connected to a transducer. The transducer was not mounted, nor was the surrounding fuel lines. The transducer and surrounding fittings lightly burned with their distinctive red and blue coloration predominant. There was evidence of a white material on the inboard threads of the fittings. The inboard fitting on the union from the transducer to the servo (throttle body) was loose and could be manipulated by hand.

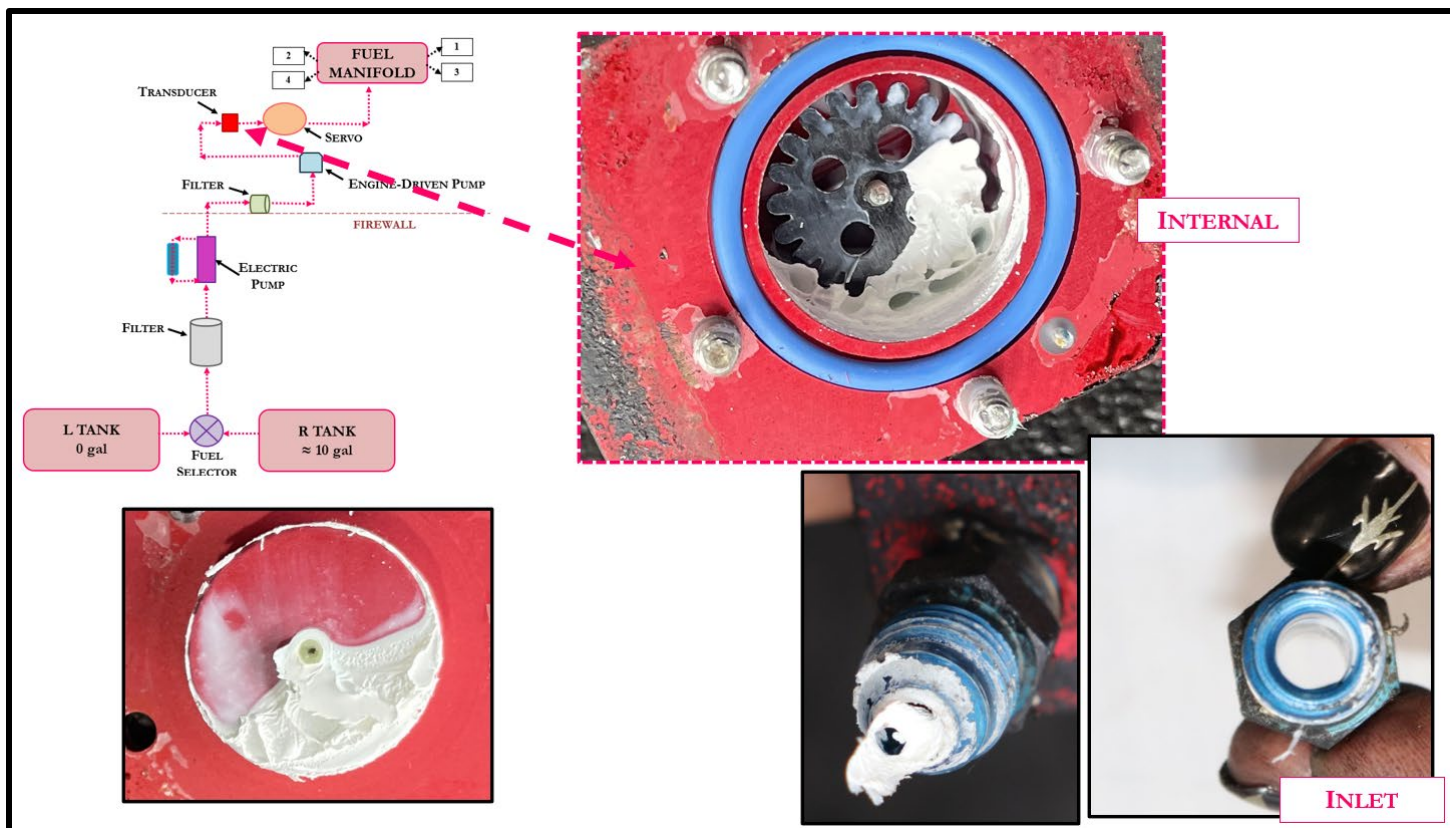
Figure 31: Inside of the Transducer

Removal of the transducer revealed that there was a brute white material packed into the inlet fitting. Disassembly of the transducer revealed that the white substance was wrapped in the wheel inside the body.

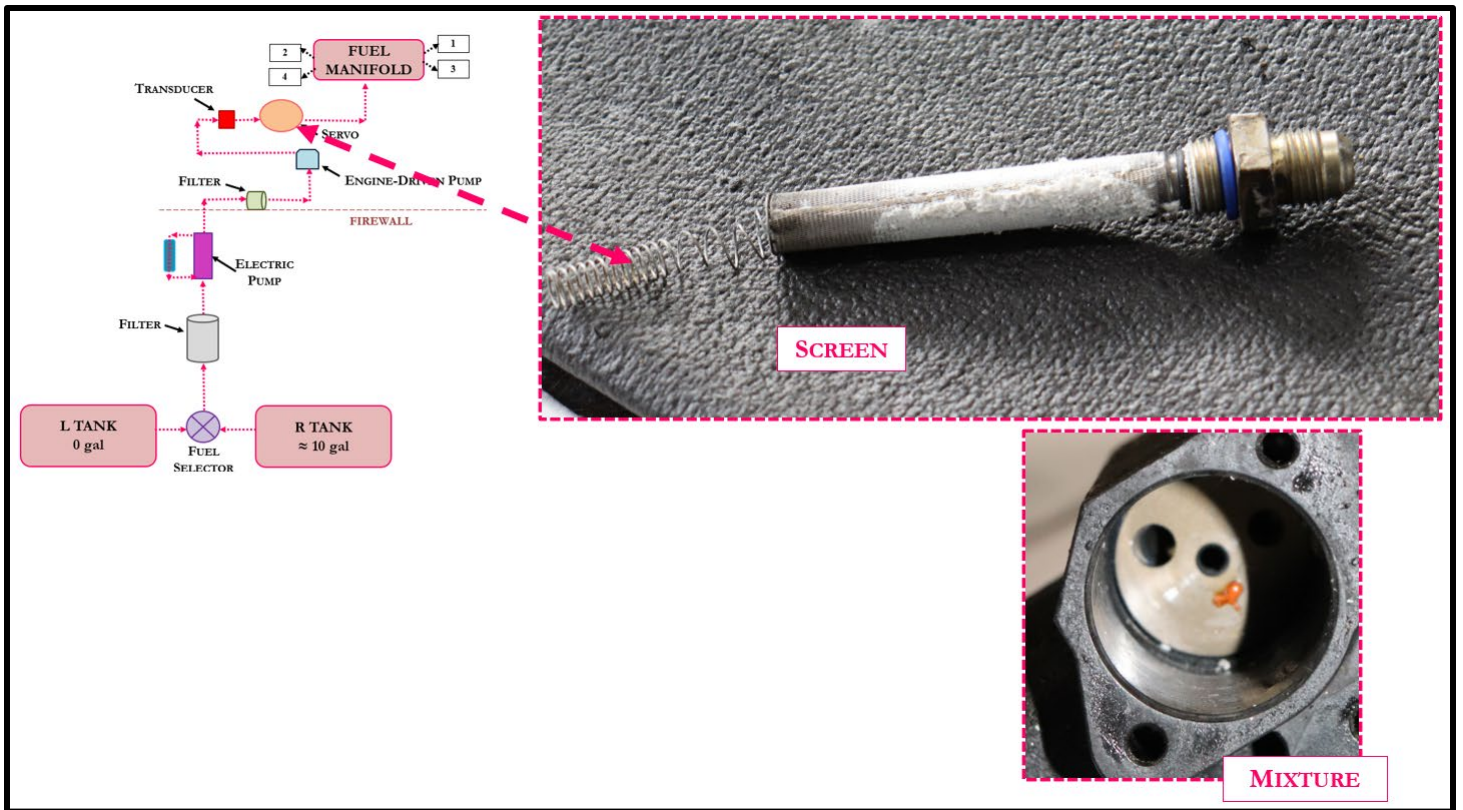
Figure 32: Servo Screen and Mixture Body

The fuel servo was attached to the engine. The mixture arm was in the idle position. Disassembly of the servo revealed that the screen was full of a bright-white material. The mixture valve had an orange material within and a trace of white material.

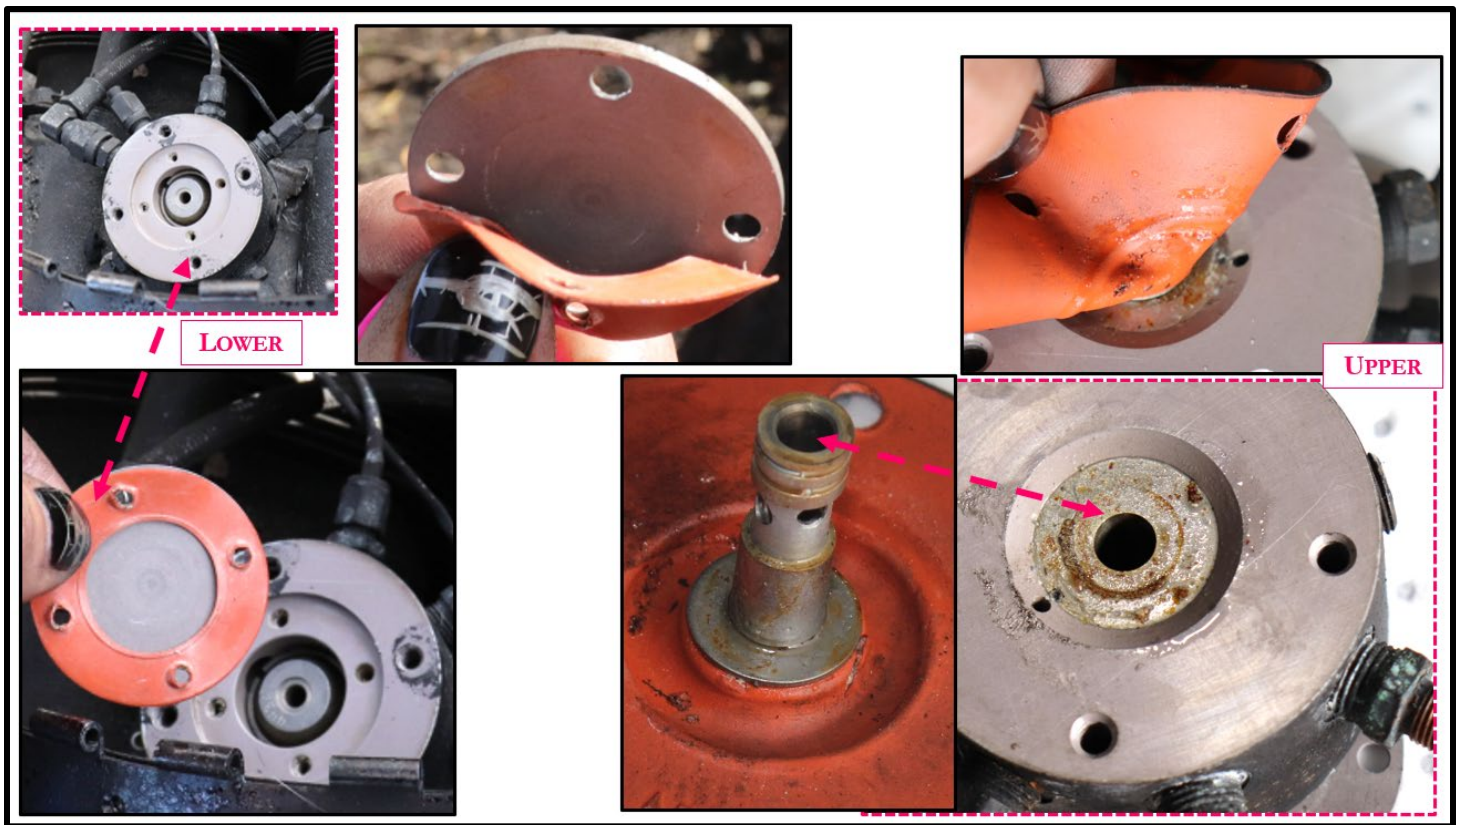
Figure 33: Fuel Distributer (spider)

The fuel distributor (spider) was disassembled revealing the diaphragm seal was present; there was no liquid contained in the body. The diaphragm was clean and the valve was unremarkable.

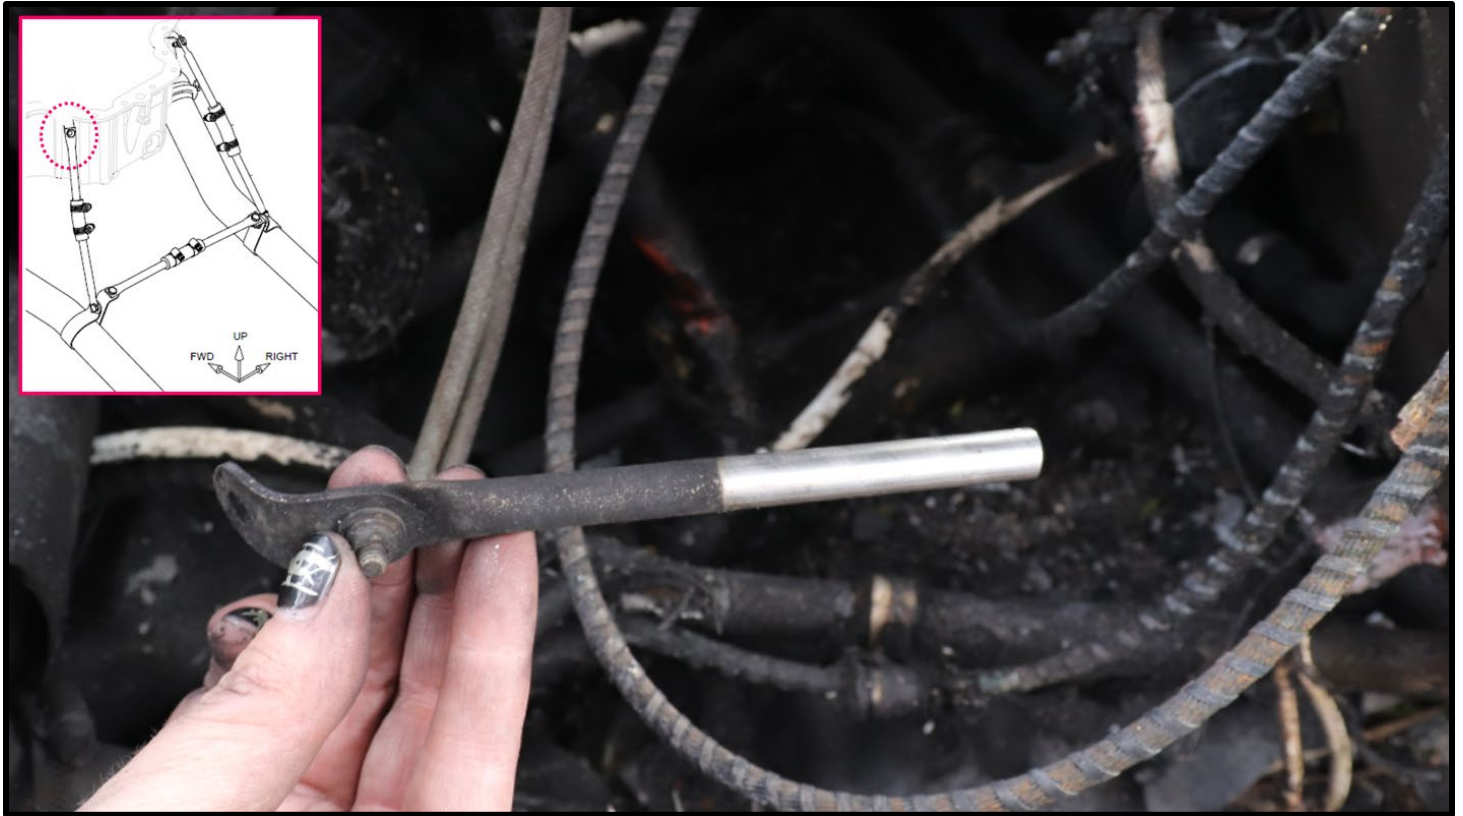
The exhaust brace on the left side was loose with no hardware visible that was attached to the engine case.

*Figure 36: Exhaust Brace (loose)*

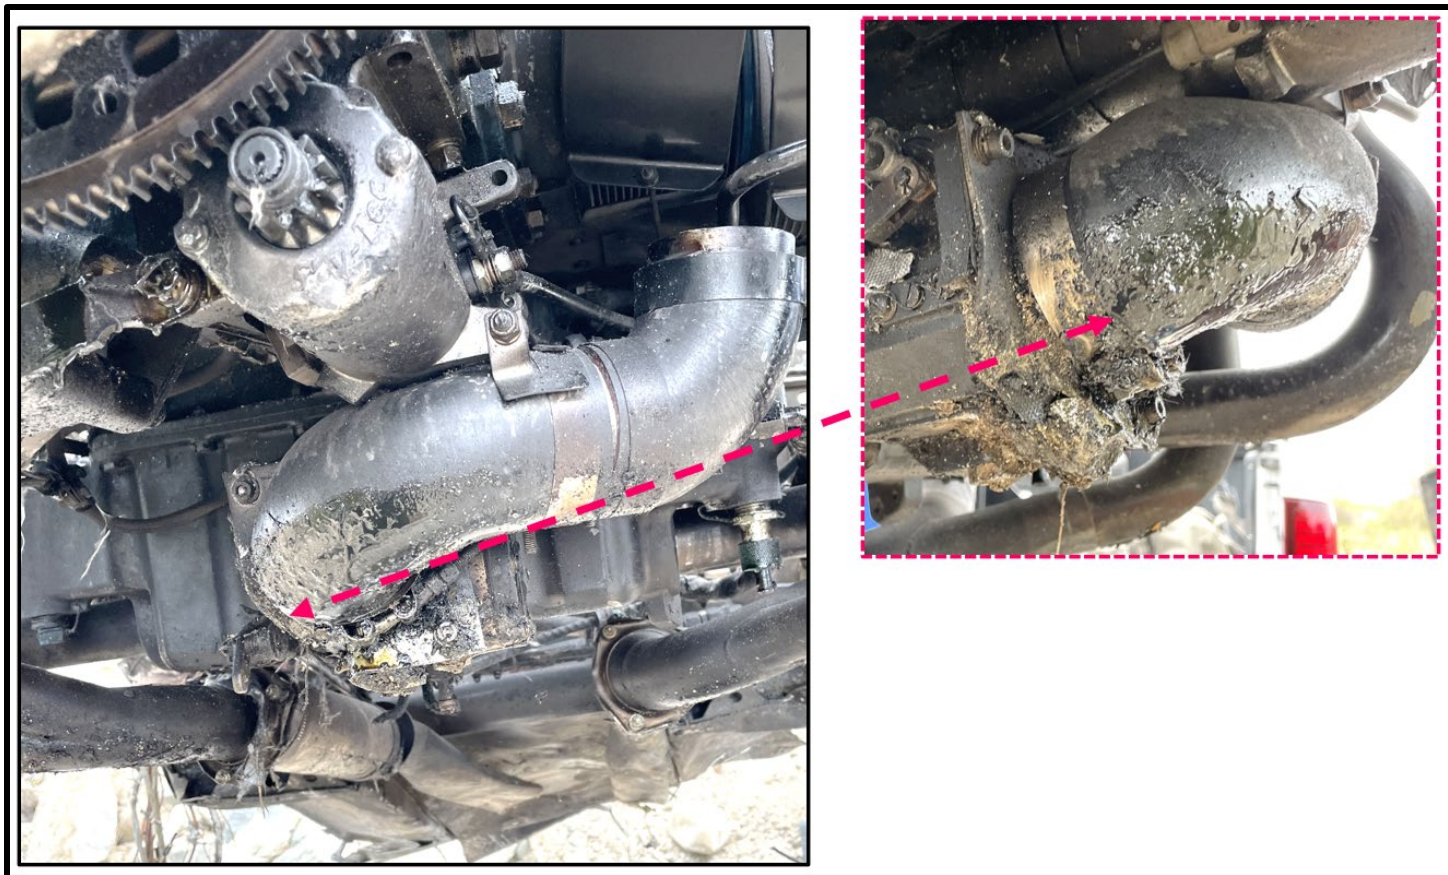
Figure 38: Oil Near Air Intake Tubing
