# National Transportation Safety Board

WPR24FA056

## **MATERIALS LABORATORY**

Factual Report 24-085

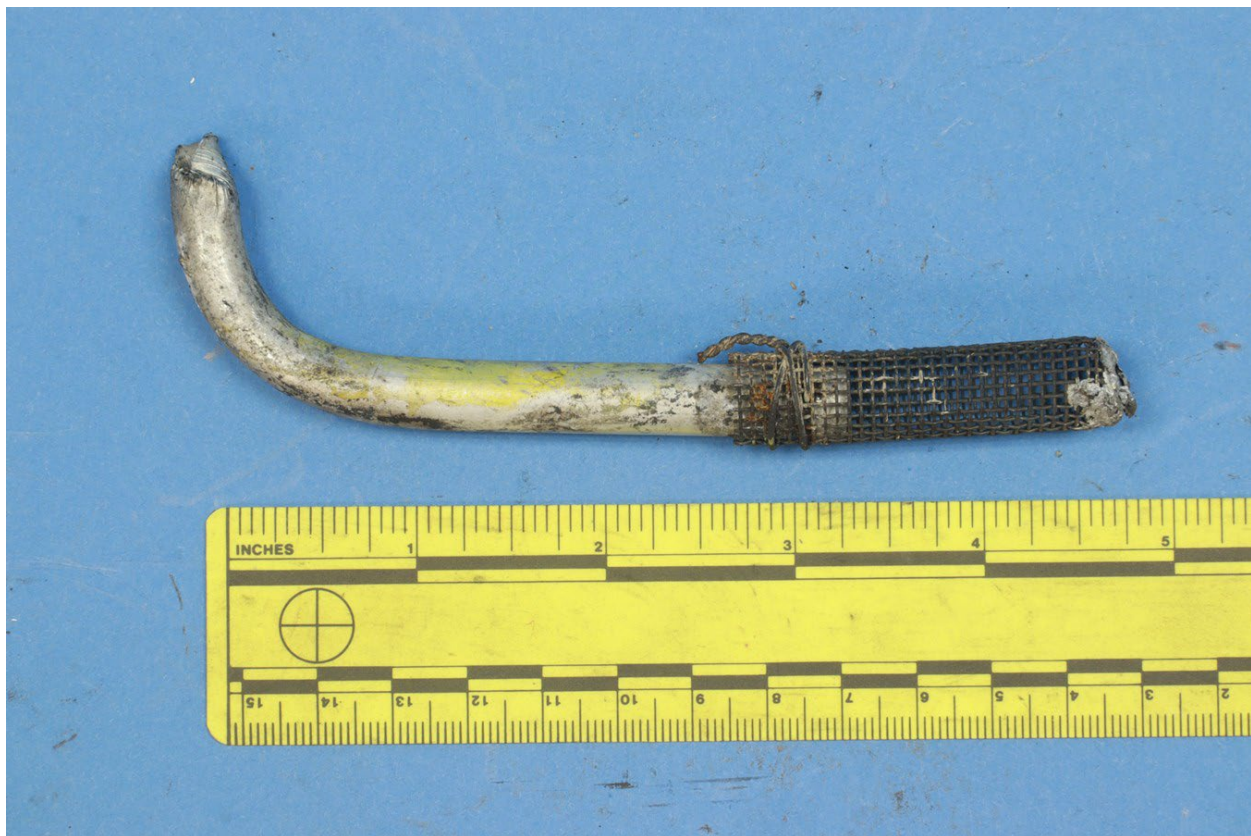
Figure 2 shows a portion of a fuel tank pickup with a finger screen attached as received. A deposit consistent with molten and resolidified metal was observed on the end of the screen. The tube was deformed and fractured just above the 90° bend, consistent with overstress separation.

**Figure 2.** Photograph of the fuel tank pickup with attached screen which was fractured above the tubing bend. A deposit of molten metal was observed at the end of the screen.

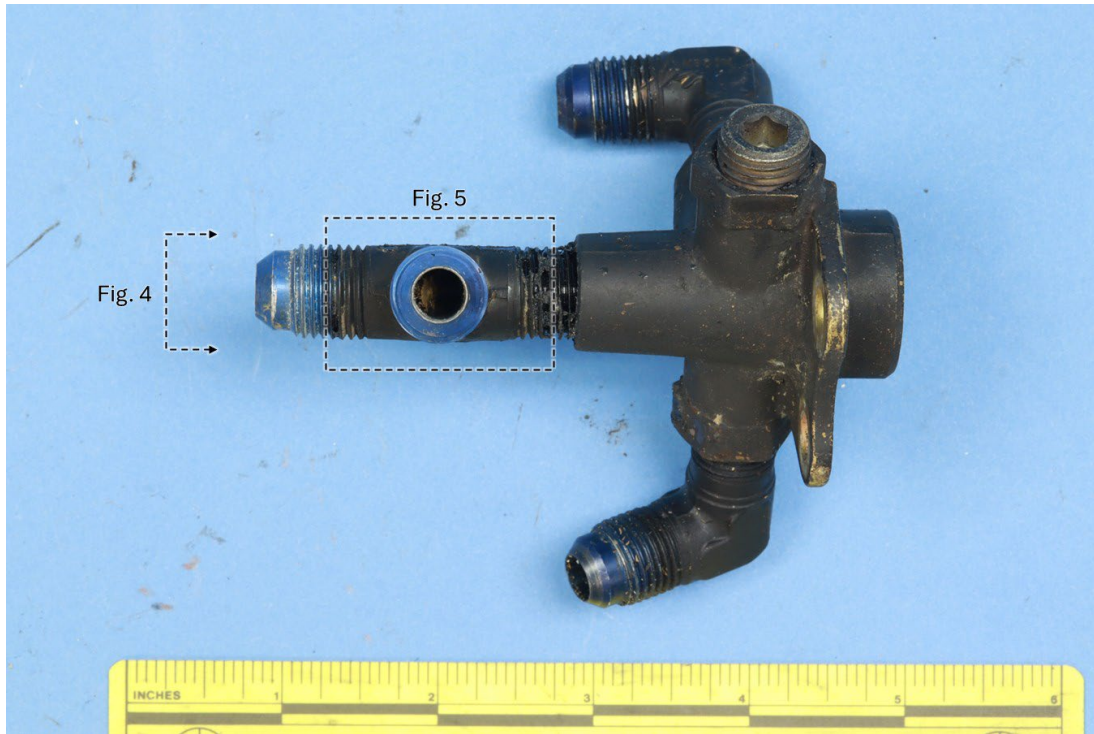
**Figure 3.** Photograph of the fuel selector. Closer views of the indicated areas are shown in subsequent figures.

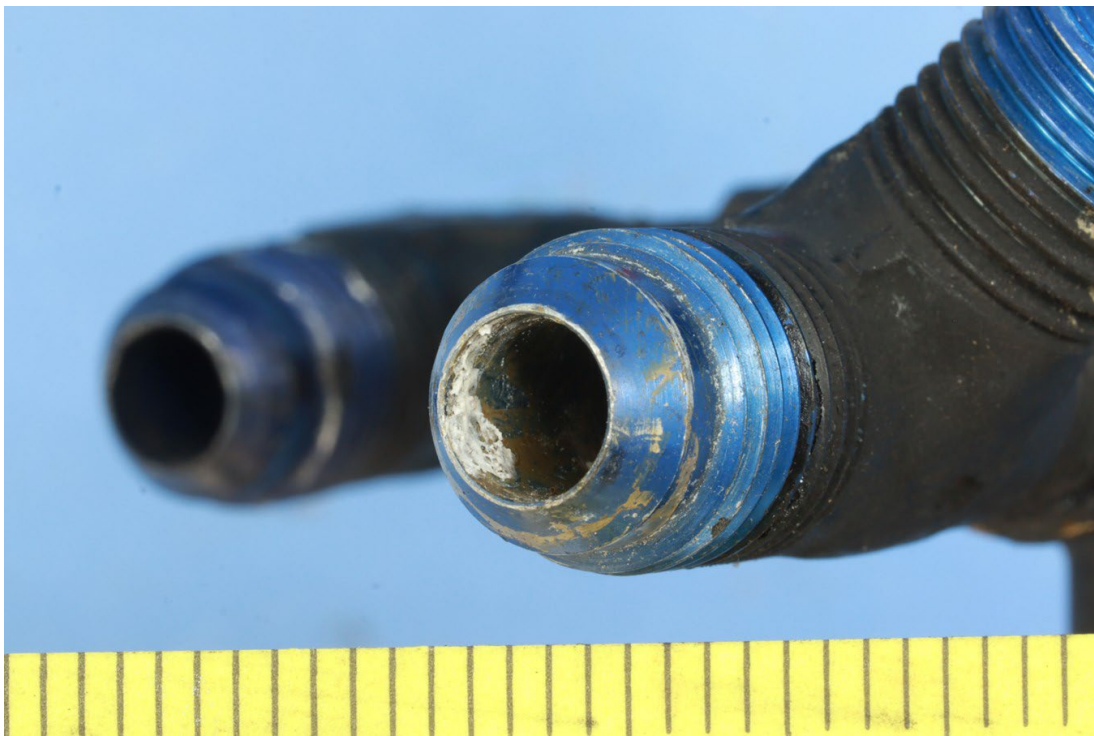
Figure 3 shows a photograph of the fuel selector as received. Closer views of the indicated areas are shown in subsequent figures. A deposit of white material was observed on the inner surface of the exposed straight run end of the T-shaped fitting as shown in figure 4. A glossy variegated-tan and bubbled material was adhered to the inner surface of the branch of the T-shaped fitting as shown in figure 5. This material was removed with metallic tweezers and is shown from opposite sides in the right images. Chemical analysis was performed on the white and tan materials and results are detailed later in this report.

**Figure 4.** Closer view of the fuel selector fitting indicated in figure 3 where a white material deposit was observed on the inner surface of the fitting.

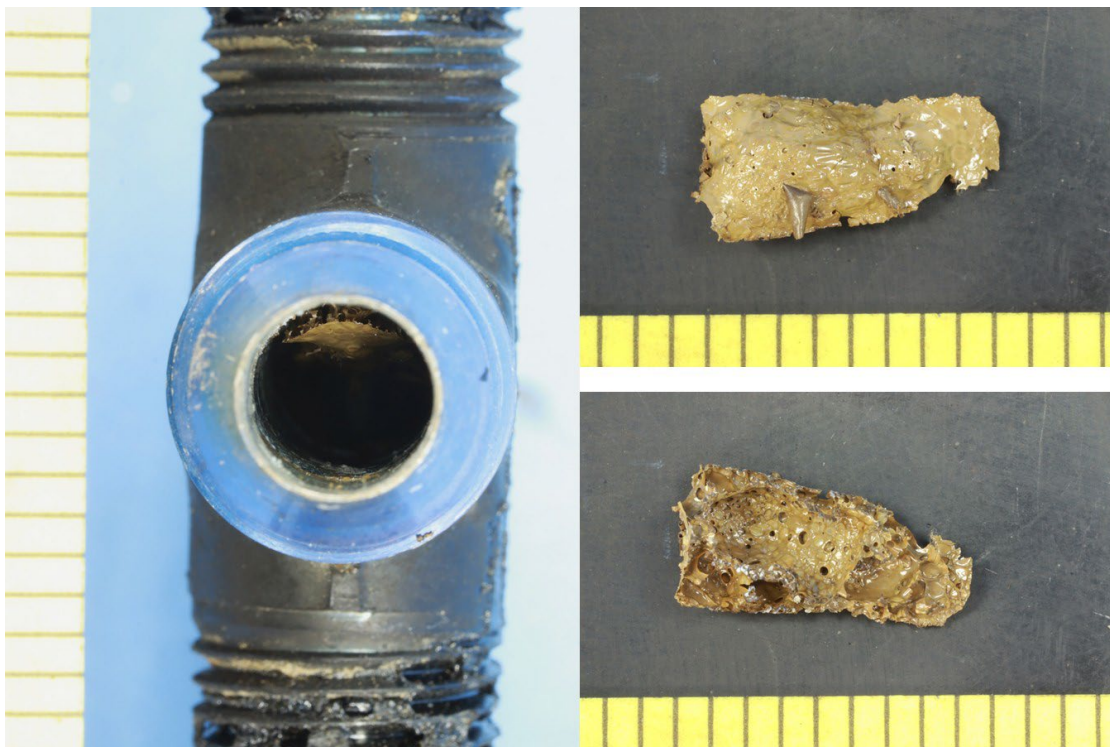
**Figure 5.** Closer view of the fuel selector fitting indicated in figure 3 where a tan material was observed on the inner surface of the fitting. The right images show opposite sides of the tan material after extraction from the fitting.

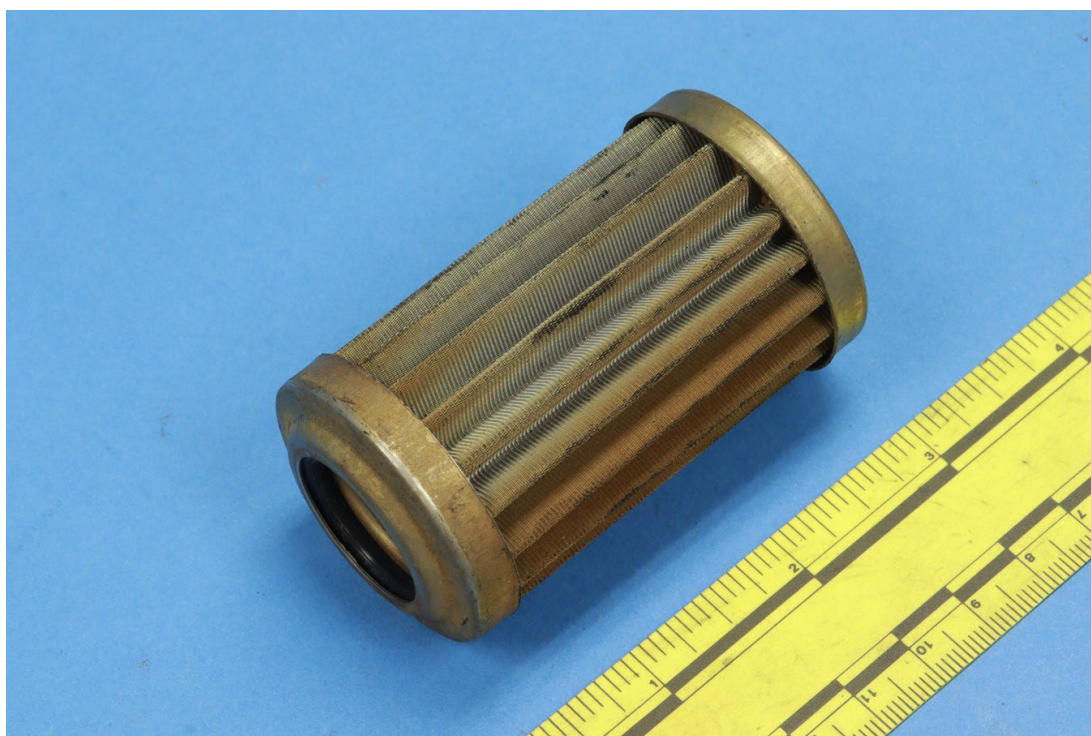
Figure 6 shows a view of the 40-micron fuel filter as received which had a brownish appearance.

**Figure 6.** Photograph of the 40-micron fuel filter element.

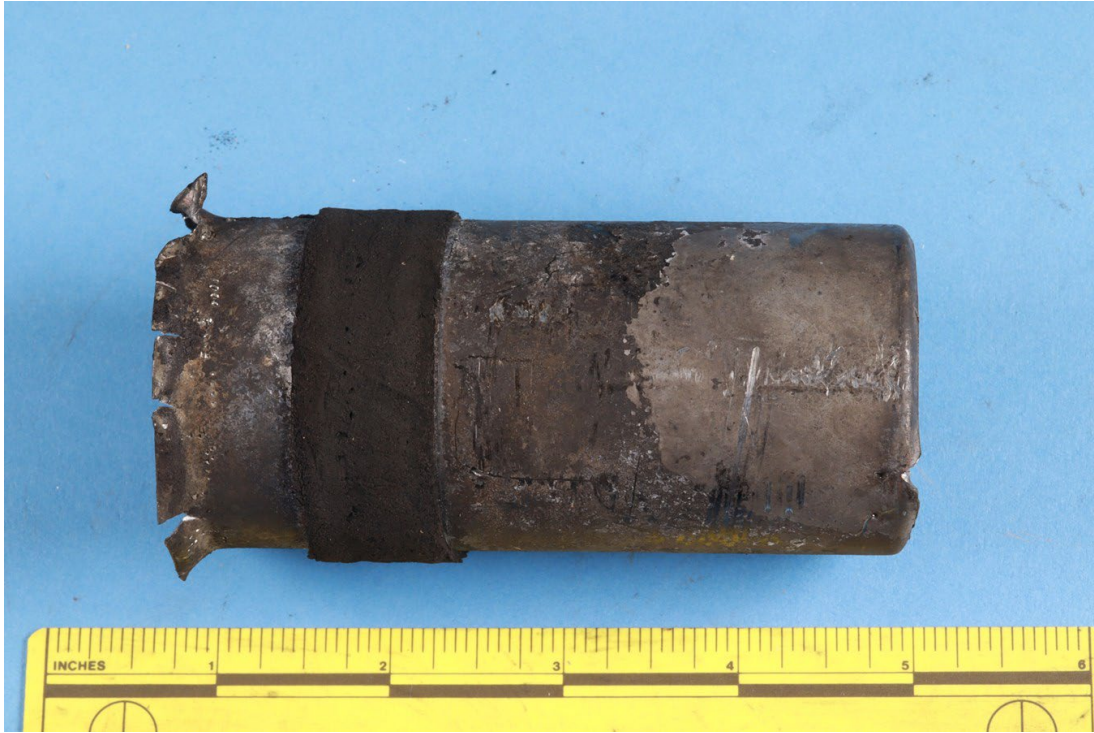
Figure 7 shows a view of the exterior surface of the electric fuel pump housing which was covered by black soot deposits. Interior views of the electric fuel pump are shown in the subsequent figures. A solid white, slightly glossy piece of material was observed between two curved plate magnets. A distinct groove was observed along the length of the piece and rounded amorphous mounds protruded around the corners of the plate magnets as shown more closely in figures 8 and 9. The overall appearance was consistent with molded and melted plastic. The white piece of material was extracted for chemical analysis, results of which are detailed later in this report.

**Figure 7.** Photograph of the exterior of the electric fuel pump housing. Black soot deposits were observed covering the outer surface.

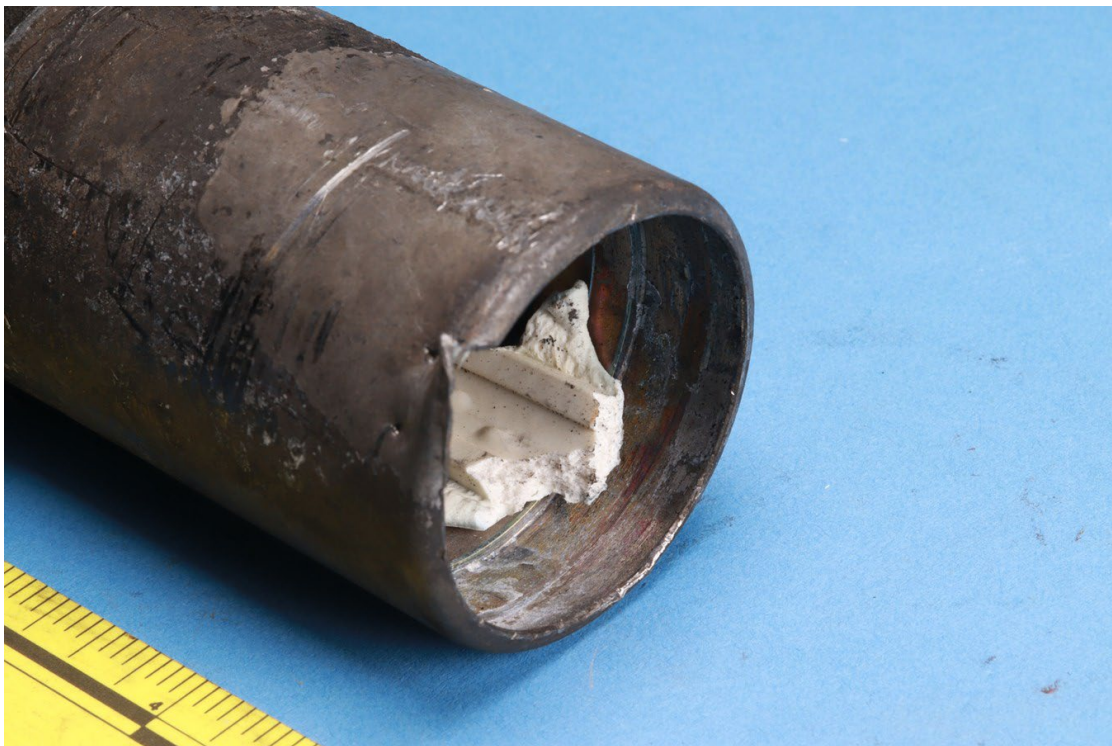
**Figure 8.** Photograph of one end of the electric fuel pump housing where a white material was observed inside the housing.

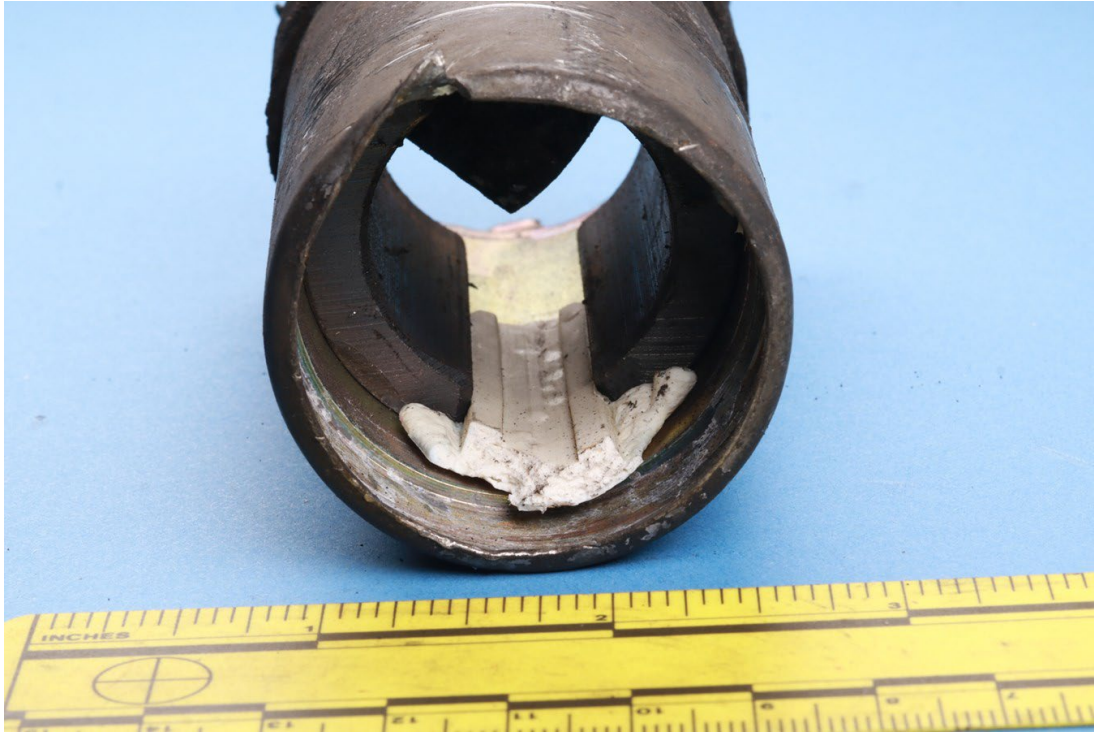
**Figure 9.** Photograph looking axially through the electric fuel pump housing showing another view of the white material observed between two curved plate magnets in the housing.

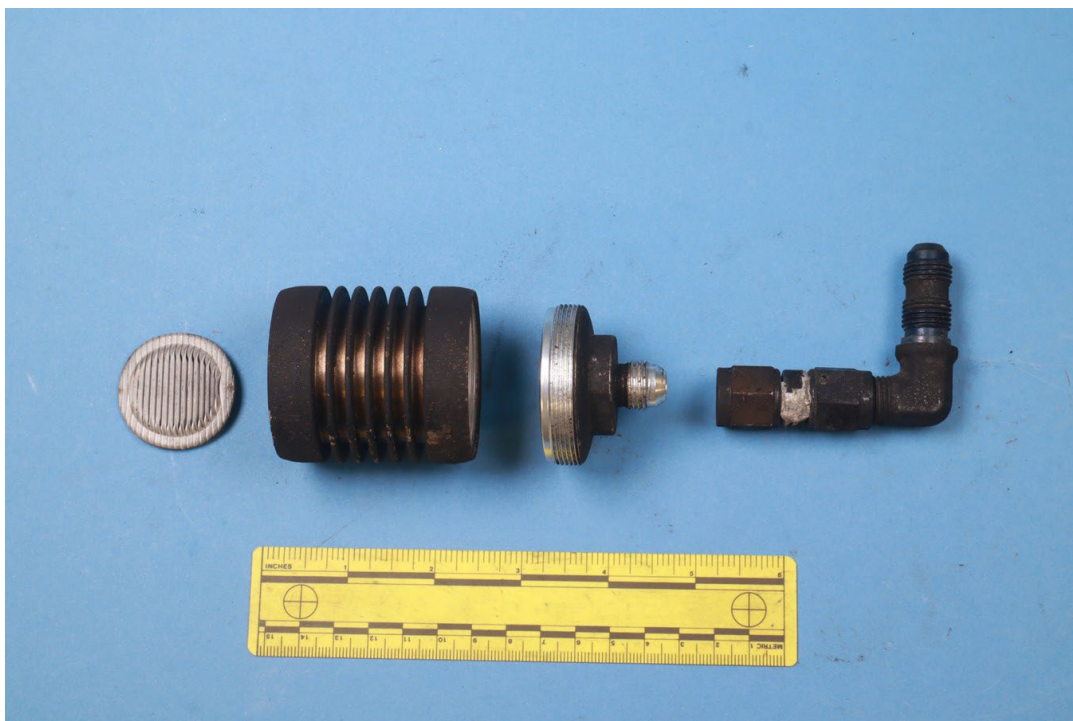
Figure 10 shows a view of connected fittings, which made up the 90° firewall elbow, arranged in series with a disassembled filter housing and a pleated 10-micron filter, as received. The exterior surfaces of these components (except the pleated filter element) were covered by black soot deposits. Closer views of each end of the firewall elbow fittings are shown in figure 11, where a tan and bubbled material was observed adhered to the inner surface of the fittings. A sample of this material was extracted from the fittings for chemical analysis, results of which are detailed later in this report.

**Figure 10.** Photograph of the firewall elbow placed in series relative to the 10-micron fuel filter housing (disassembled) and the pleated filter element.

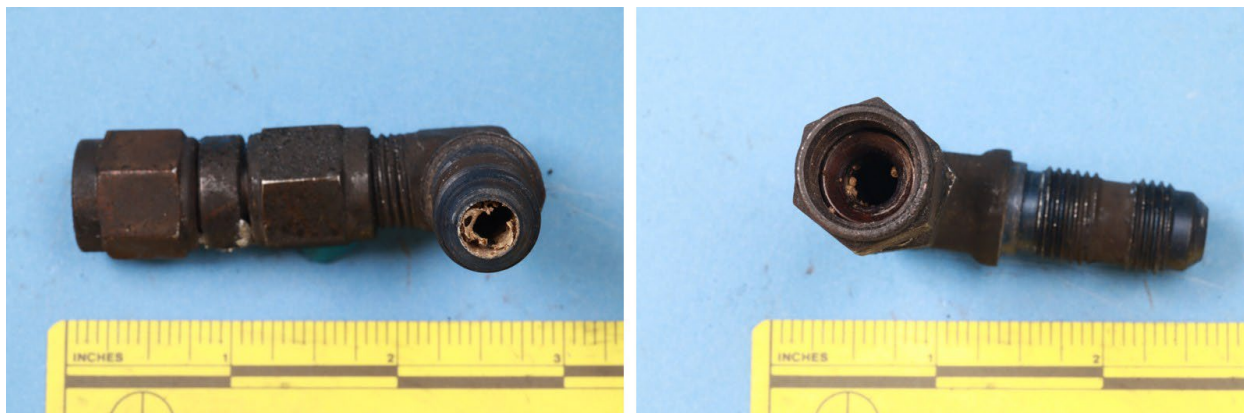
**Figure 11.** Closer views of each end of the firewall elbow fittings where tan material deposits were observed on the inner surfaces of the fittings.

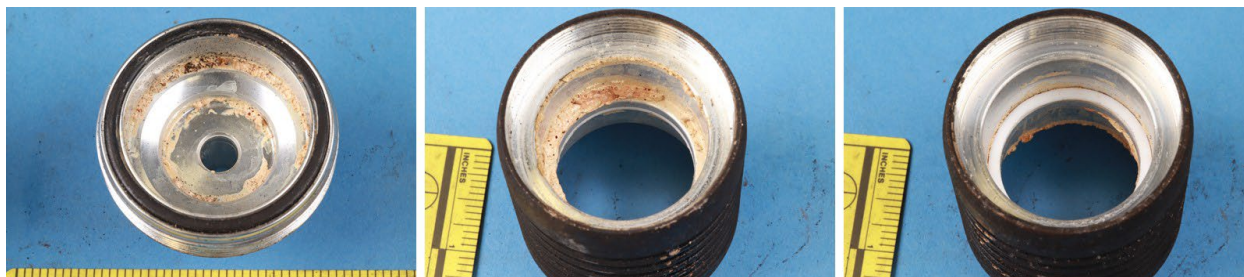
Figure 12 shows interior views of the filter housing shown in figure 10. A hard, shiny off-white and bubbled material was observed adhered to areas of the internal surface of the housing. A white plastic ring was present on one side of the filter housing, visible in the right image. Closer views of each side of the 10-micron filter element are shown in figure 13. A similar off-white material was visible between filter pleats as indicated by yellow arrows. Samples of the off-white material were extracted from the filter housing and element for chemical analysis, results of which are detailed later in this report.

**Figure 12.** Photographs of the interior surfaces of the 10-micron fuel filter housing where off-white material deposits were observed.

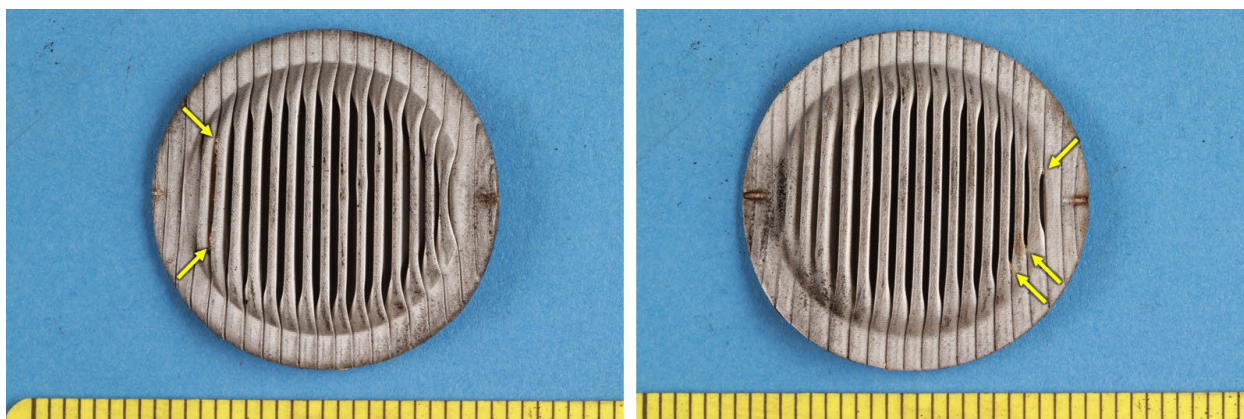
**Figure 13.** Photographs of each side of the 10-micron filter element where off-white material deposits were observed between filter pleats, examples of which are indicated by yellow arrows.

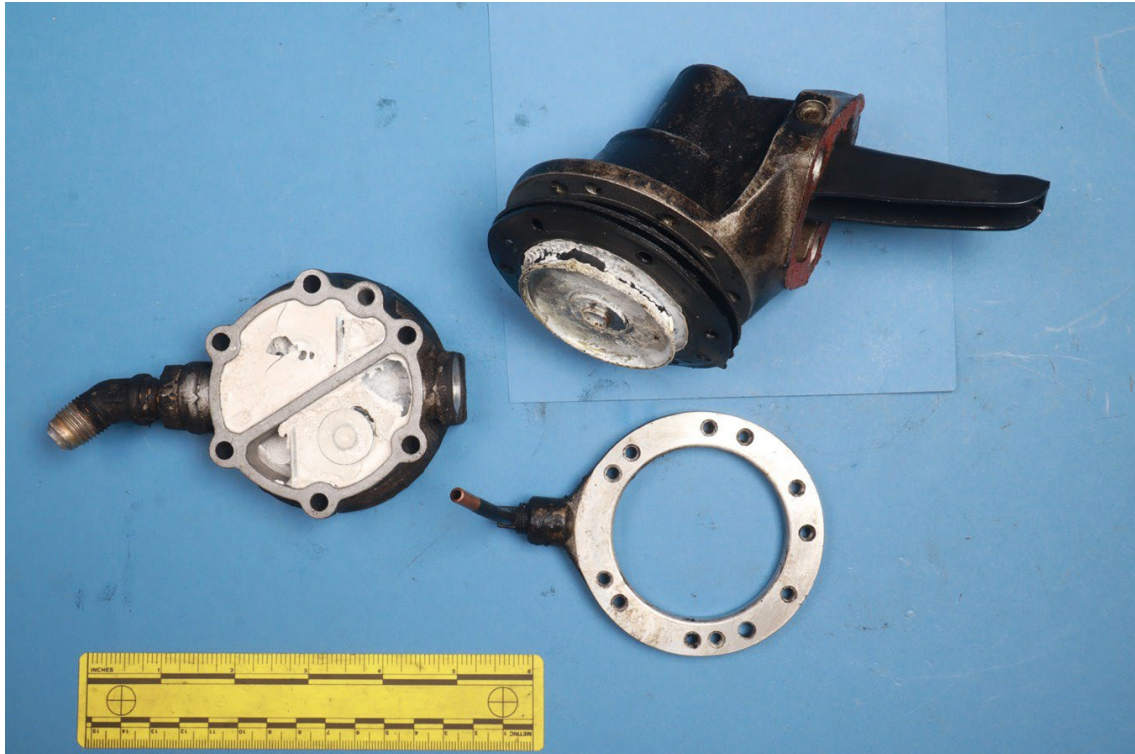
Figure 14 shows a photograph of the disassembled engine driven fuel pump, as received. A hard, glossy white material was observed in the fuel chambers of the pump as shown more closely in figures 15 - 17. A sample of this white material was extracted from the fuel pump for chemical analysis, results of which are detailed later in this report.

**Figure 14.** Photograph of the disassembled engine driven fuel pump.

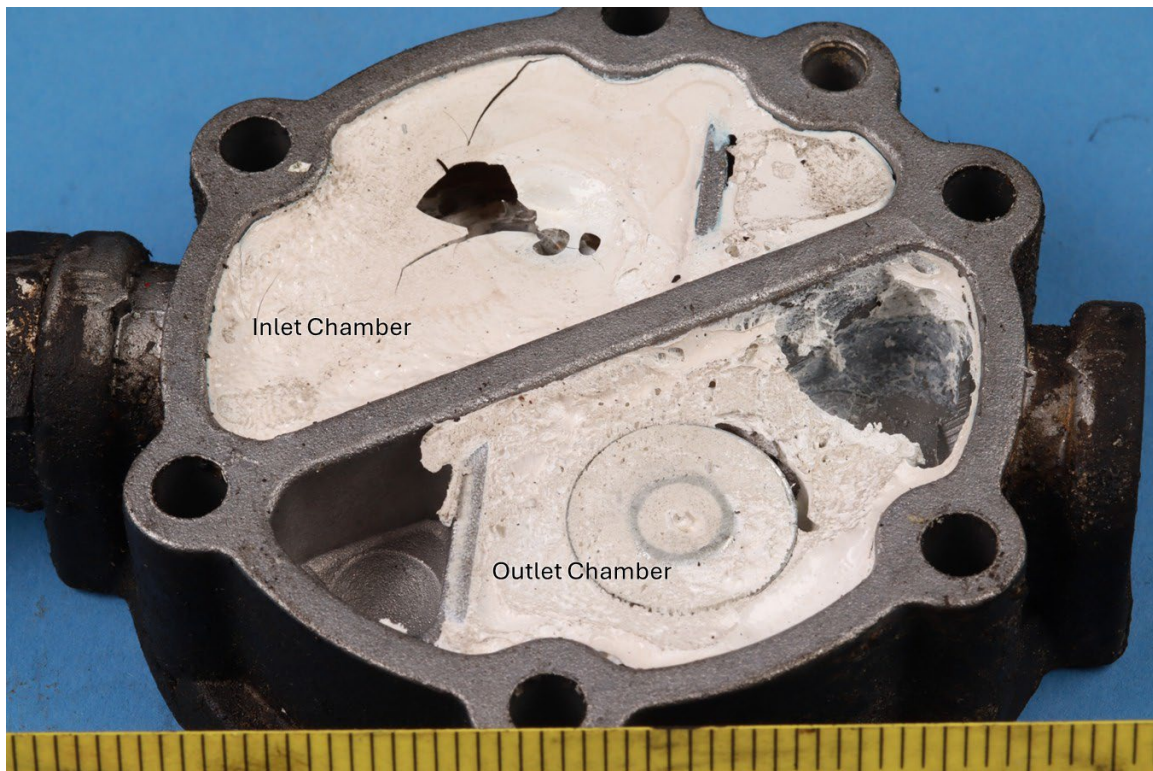
**Figure 15.** Closer view of the base of the engine driven fuel pump where a white material was observed filling the inlet and outlet chambers.

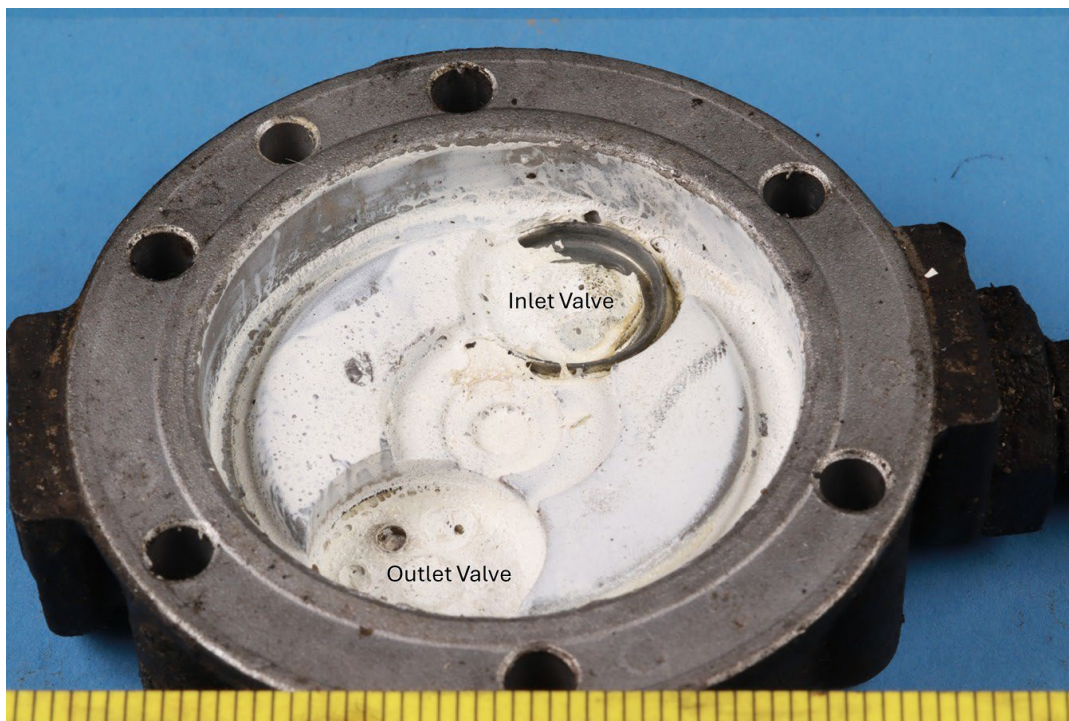
As a test to assess flow between the fuel chambers, the inlet chamber was filled with water, which slowly dripped through the check valve to the opposite chamber under gravitational force. When the opposite chamber (reference figure 16) was filled with water, it slowly dripped back into the inlet chamber under gravitational force with no appreciable water observed flowing to the outlet chamber. When blown with compressed air from the outlet chamber side, small bubbles were observed emanating from around the outlet check valve in the opposite side chamber,

consistent with small open pathways through the valves, with more significant flow observed on the inlet valve side.

**Figure 16.** Closer view of the opposite side of the base of the engine driven fuel pump shown in the previous figure. A similar white material was observed in this chamber and surrounding the valves.

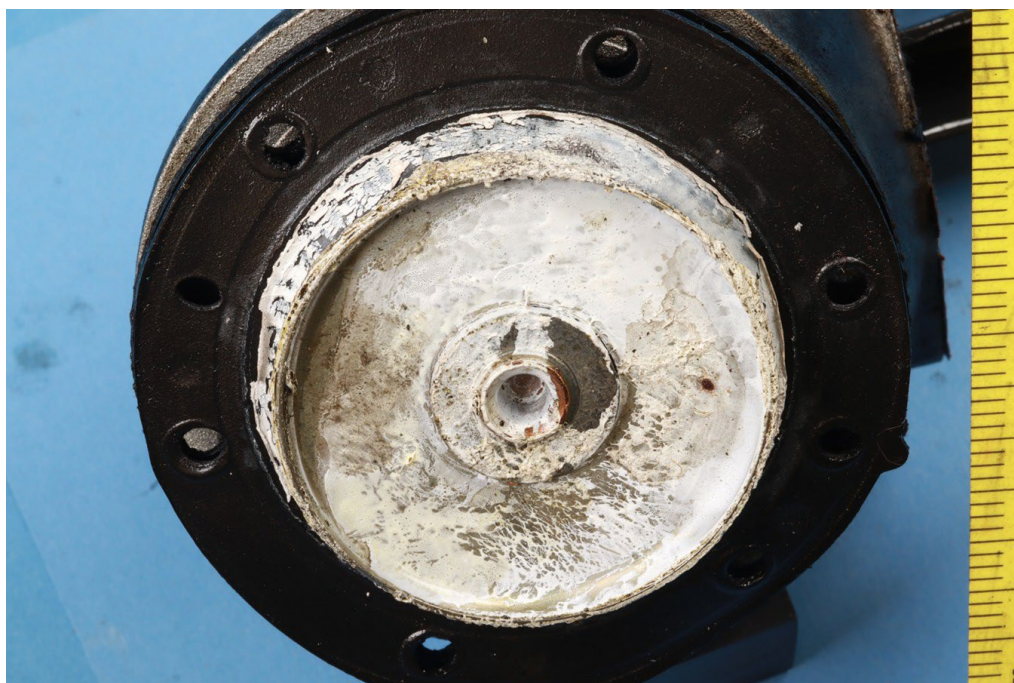
**Figure 17.** Photograph of the fuel pump body with the diaphragm seals as viewed from the pumping chamber side. A similar white material was observed covering the pumping chamber components.

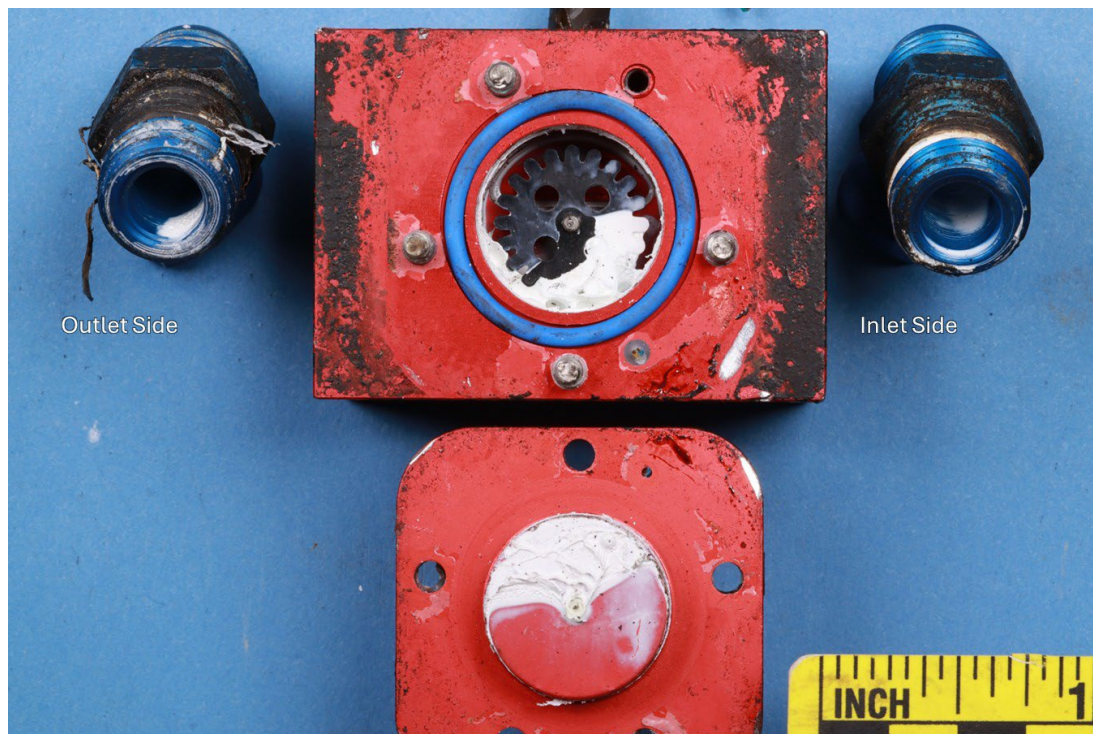
Figure 18 shows a view of the fuel flow transducer with cover removed and inlet/outlet fittings as received. Black soot deposits were observed on exposed outer surfaces. A white material, similar in appearance to that observed in the engine driven fuel pump, was observed inside the transducer, and pooled on the inner surfaces of the inlet and outlet fittings. The black wheel component inside the transducer was entangled in and partially covered by the white material and could not be rotated by hand. A closer view of the white material observed inside the transducer is shown in figure 19. A sample of this white material was extracted from the transducer for chemical analysis, results of which are detailed later in this report.

**Figure 18.** Photograph of the fuel flow transducer with cover plate removed and inlet/outlet fittings (disassembled). A white material was observed inside the transducer and on the inner surfaces of the fittings.

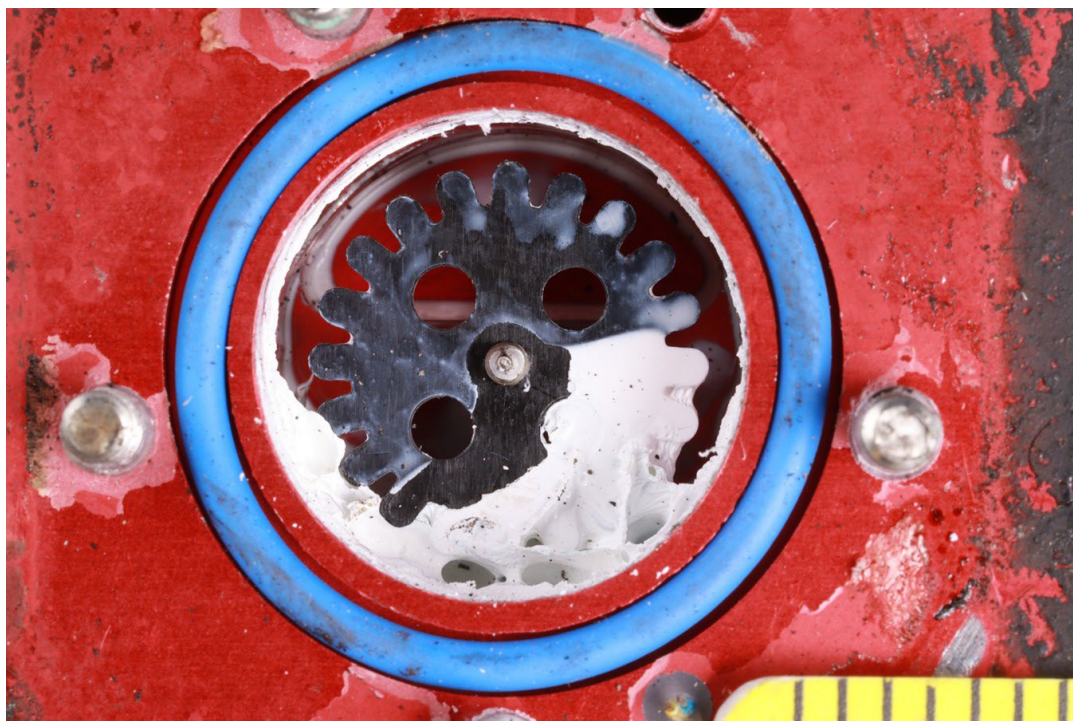
**Figure 19.** A closer view of the interior of the fuel flow transducer shown in the previous figure showing a black wheel component entangled in a white material.

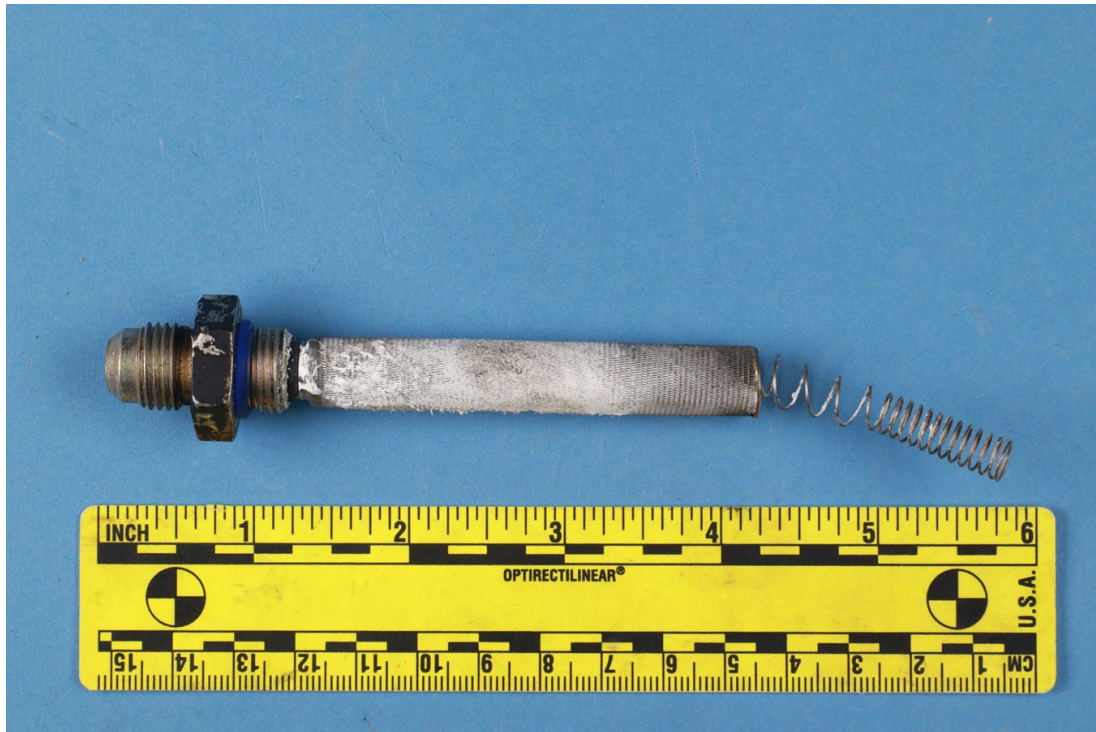
Figure 20 shows a view of the fuel injector servo filter and fitting as received. The wrench flats of the end fitting were covered with black soot deposits, a blue elastomeric O-ring was present on the filter side of the fitting, and a smaller black elastomeric O-ring was present around the filter at the base of the fitting. A hard white material similar to that observed in the engine driven fuel pump and the fuel flow transducer appeared to fill and protrude from the screen filter element. Figure 21 shows a view looking down into the open end of the fitting, toward the filter, showing similar white material obstructing the interior of the fitting. A sample of this white material was extracted from the servo filter for chemical analysis, results of which are detailed later in this report.

**Figure 20.** Photograph of the fuel injector servo filter where a white material was observed on and protruding from the filter screen element.

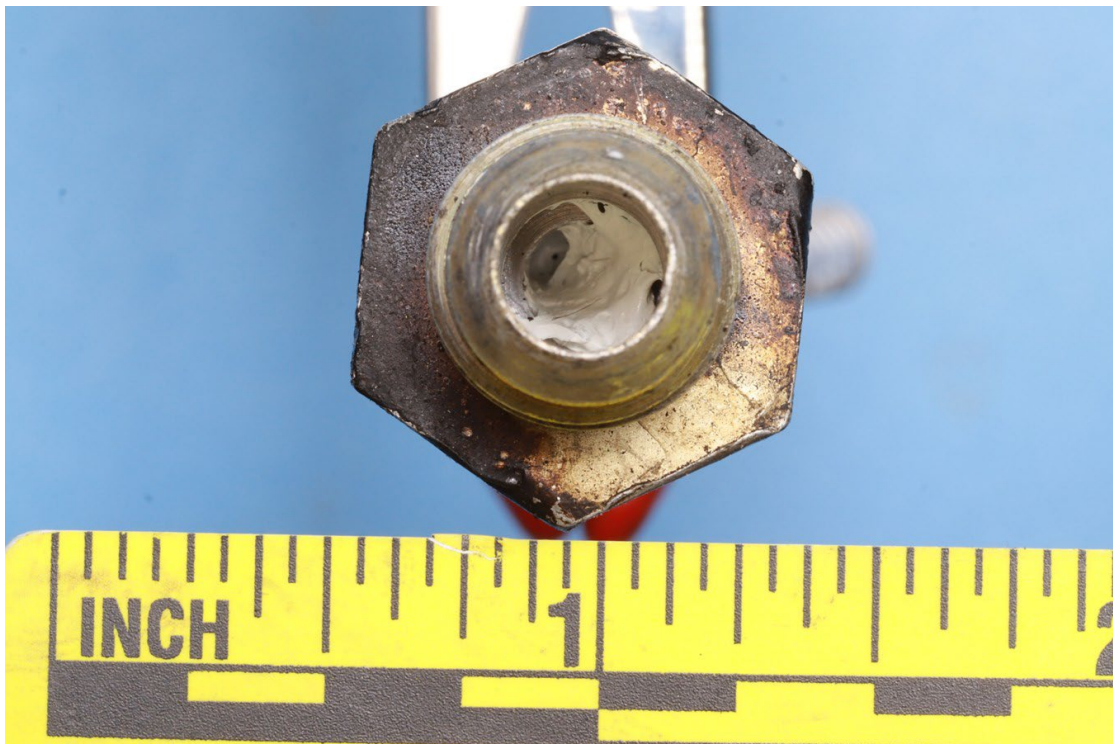
**Figure 21.** A view looking into the fitting of the servo filter element where a white material obstructed the interior of the fitting.
