# National Transportation Safety Board

WPR24FA057

## **AIRFRAME AND ENGINE EXAMINATION REPORT**

Location: Independence, Oregon  
Date: December 16, 2024  
Time: 1623 Pacific standard time  
Airplane: Cessna 172G / N3992L

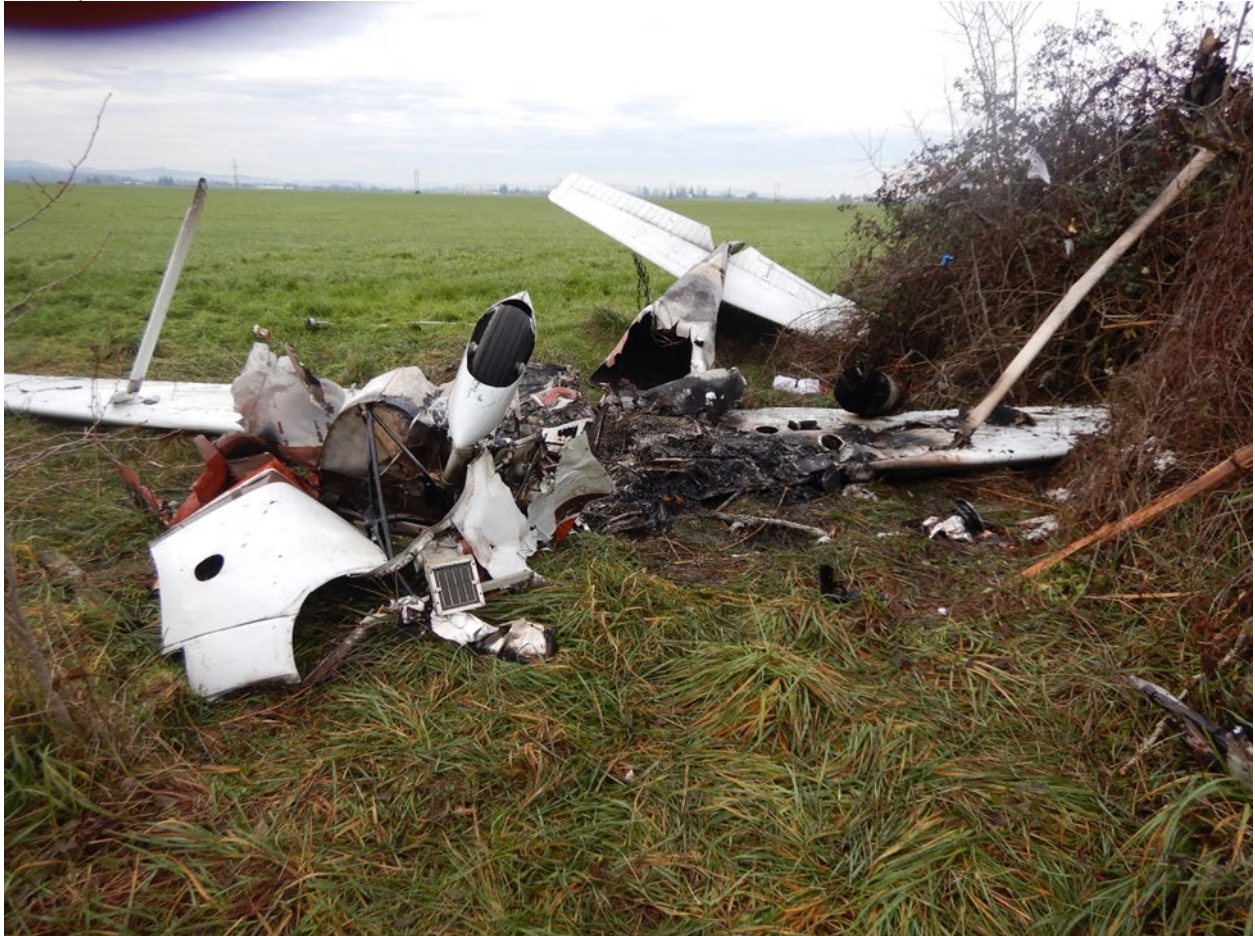
The airplane came to rest inverted in a flat open field. The fuselage, from aft of the firewall to about mid-section of the aft fuselage, was destroyed by a postaccident fire. The only part that remained was the section just forward of the empennage and the upper section between the wings. The engine cowling area was fractured into multiple sections.

Figure 1. N3992L at the accident site, front view.

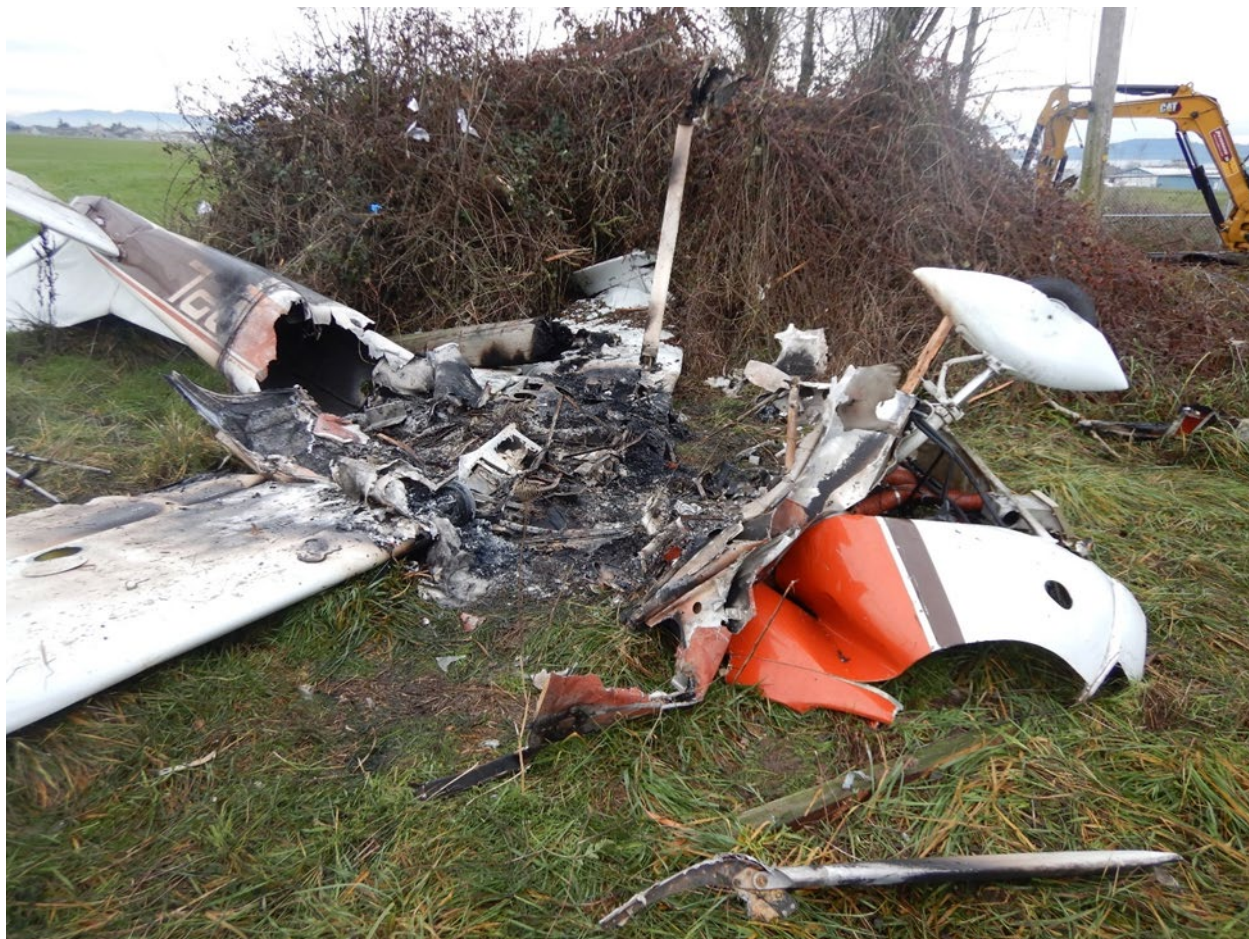
Figure 2. Front, left-side view.

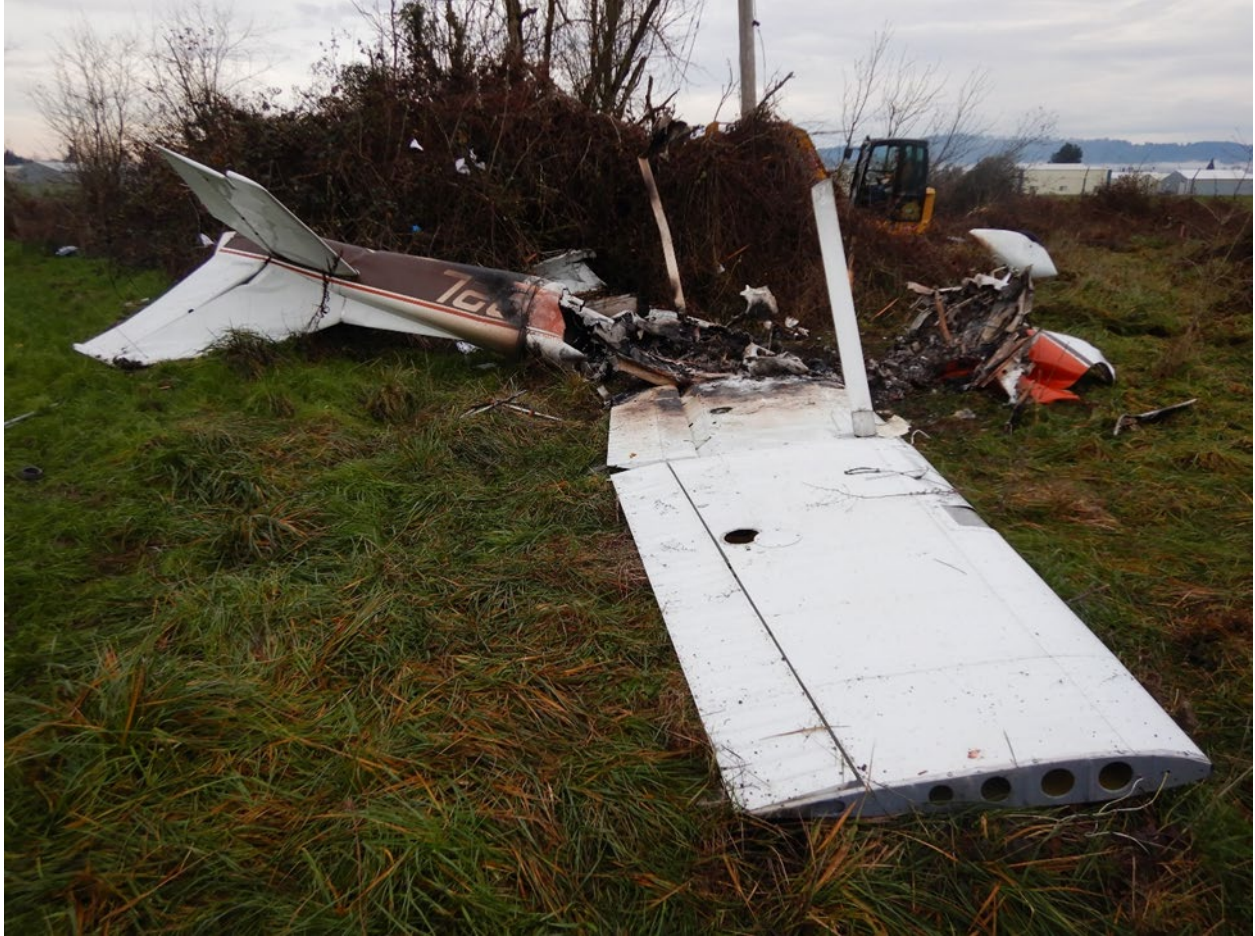
Figure 3. Left-side view.

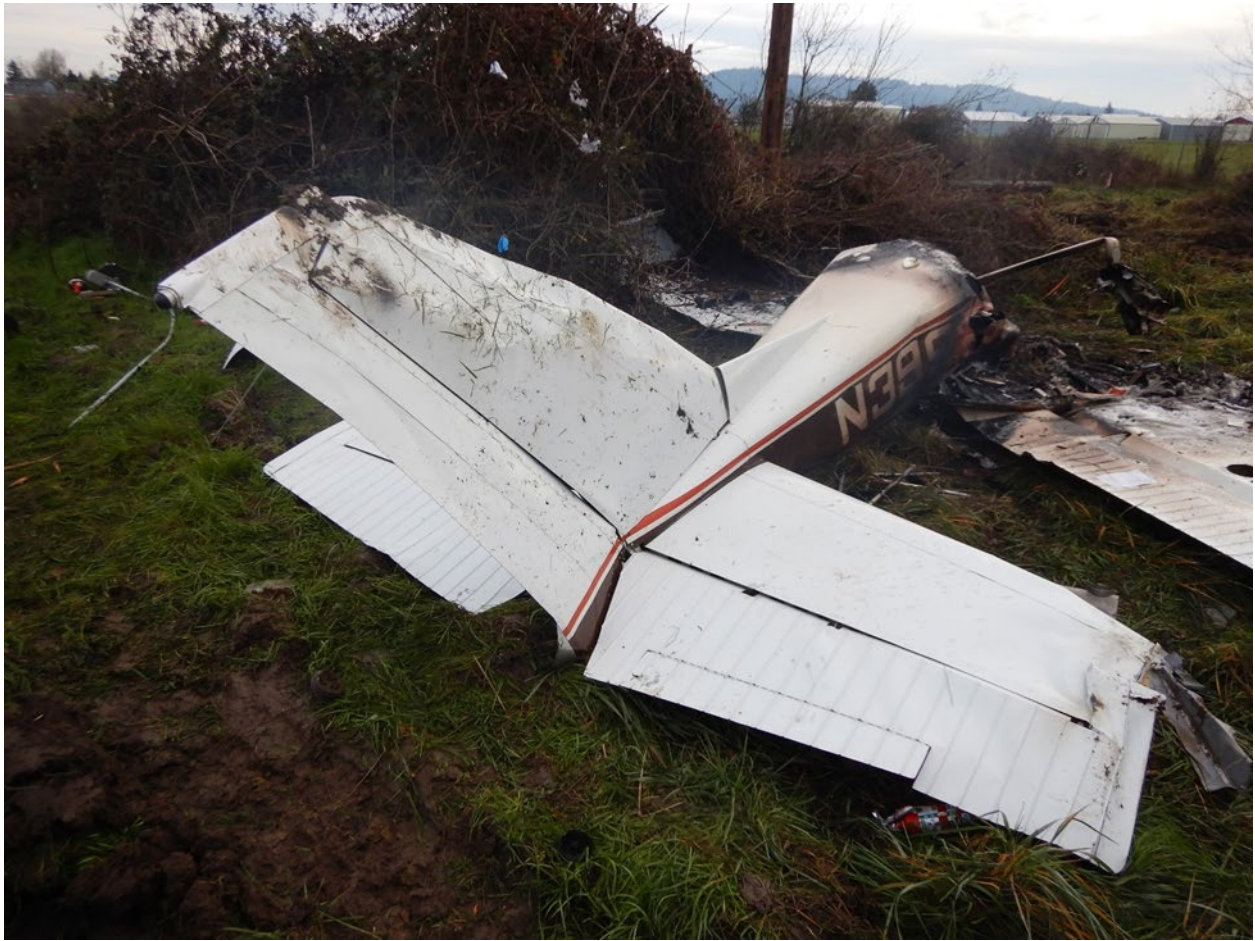
The aft section of the fuselage was thermally damaged. The thermal damage ended to about the area of the vertical stabilizer dorsal fin. The empennage remained attached to the aft section of the fuselage. The vertical stabilizer came to rest on the ground and exhibited impact damage to the leading edge and displacement to the left. The vertical stabilizer also exhibited dents and sheet metal wrinkling. The rudder remained attached to the vertical stabilizer at its attachment points and exhibited the same left displacement and wrinkling of the sheet metal.

The right horizontal stabilizer and elevator remained attached to the fuselage, came to rest on the ground and exhibited substantial damage at the outboard section nearest the tip in the form of downward bending. The left horizontal stabilizer and elevator remained attached to the fuselage and exhibited substantial damage to the elevator in the form of an upward bend mid-span.

Figure 4. Empennage right-side view.

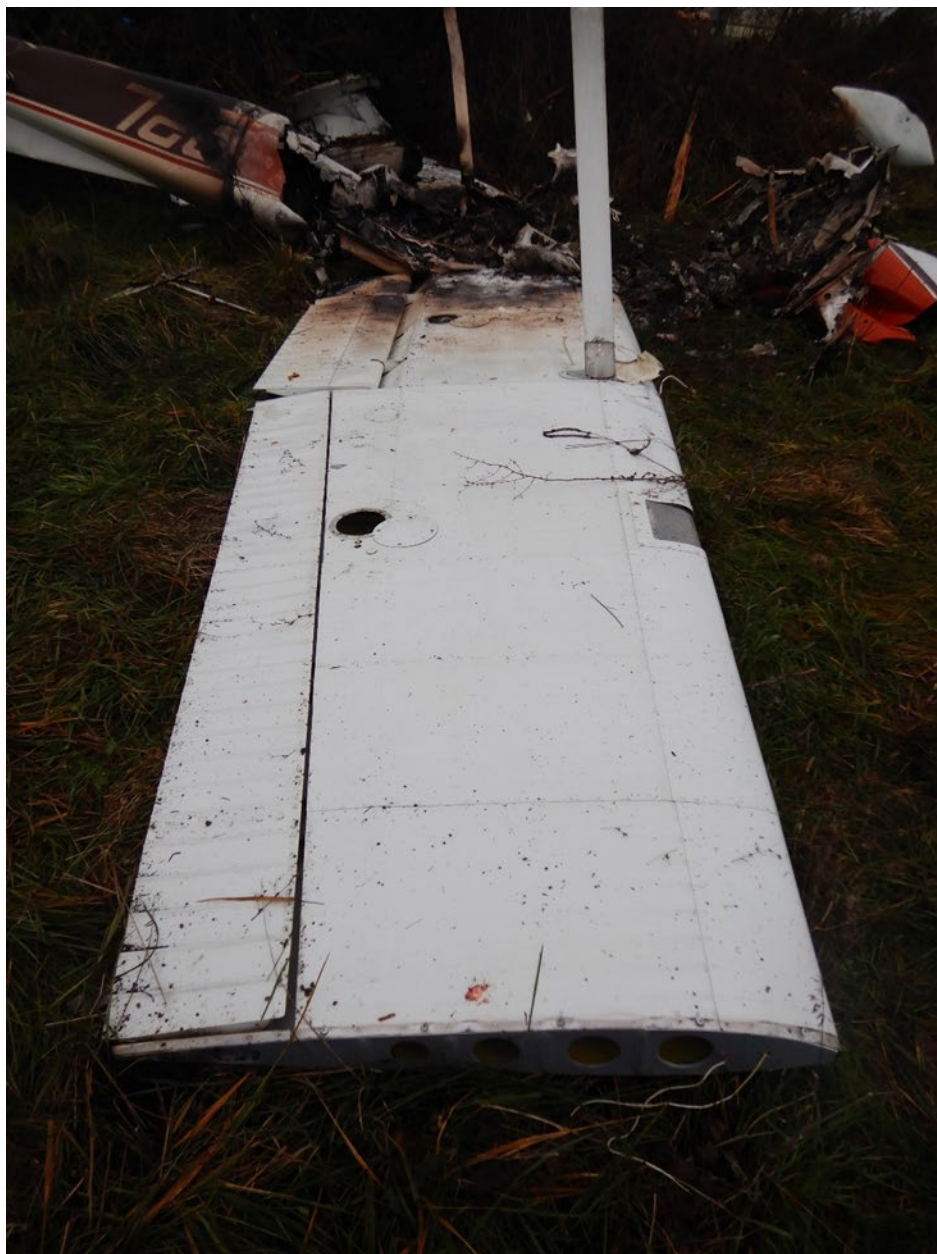
The left and right wings remained attached to the upper section of the fuselage. The left wing was thermally damaged from the root of the wing outboard to about mid-flap. The remainder of the wing was not thermally damaged. The wing strut remained attached to the underside of the wing but separated from the thermally damaged fuselage mount. The left flap remained attached to the wing at all attachment points and was thermally damaged from the inboard section nearest the fuselage to about mid-span. The flap appeared to be up. The left aileron remained attached to the wing at all attachment points and exhibited minor damage from the underside. The composite tip separated from the wing. The landing light assembly remained attached to the leading edge of the wing. The pitot tube remained attached to the underside of the left wing.

Figure 5. Left wing, bottom view.

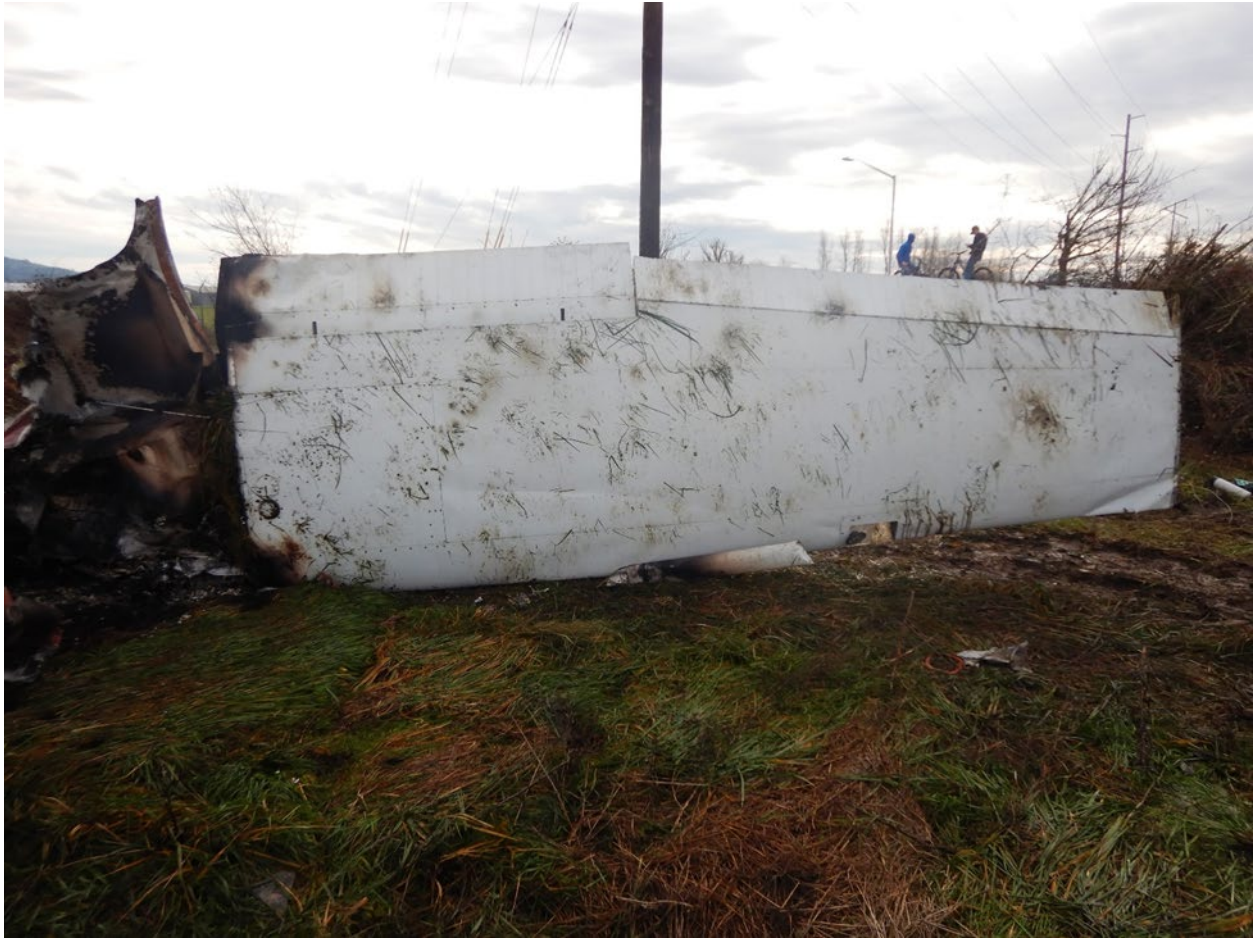
Figure 6. Left wing, top view.

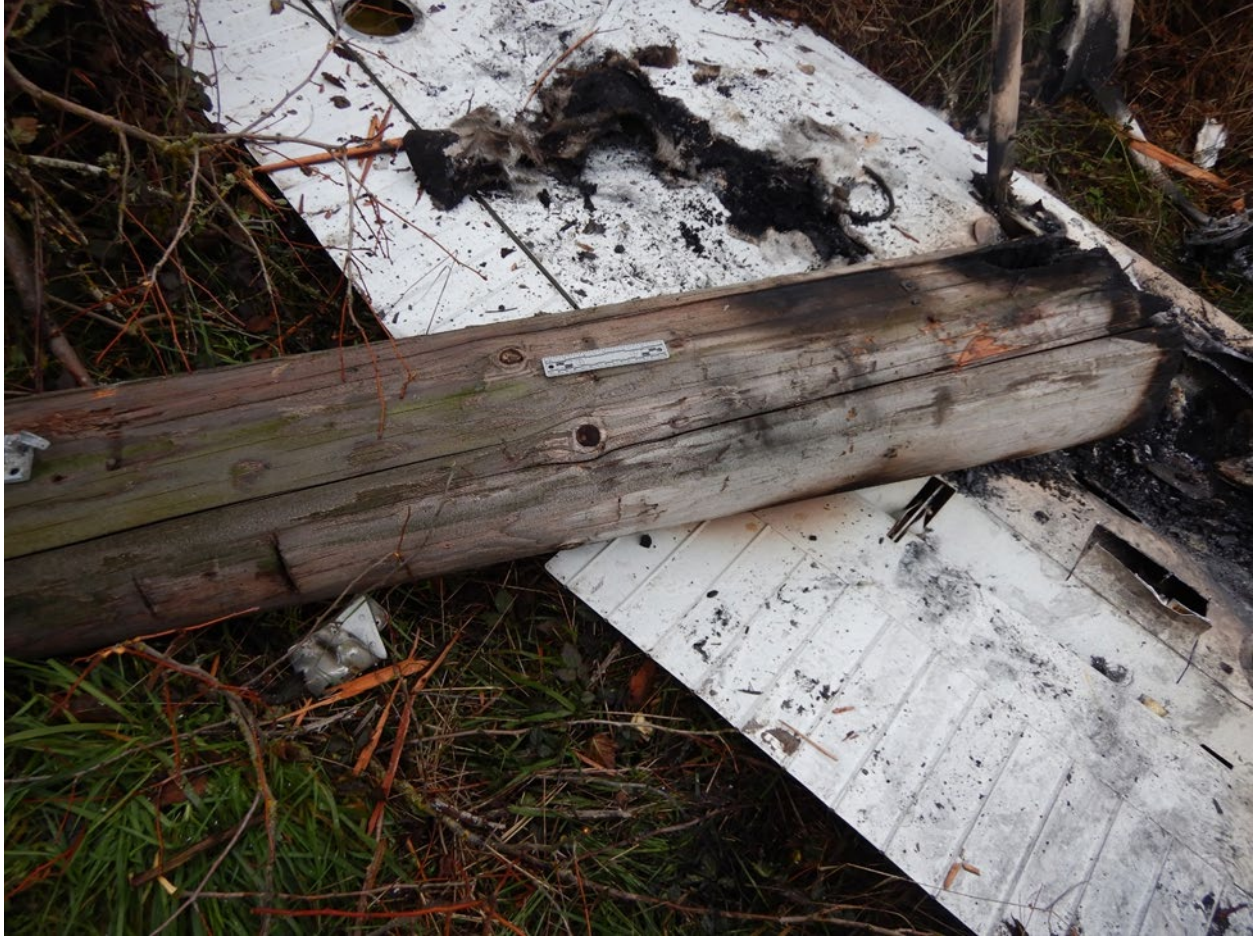
The right wing remained attached to the upper section of the fuselage. A large amount of the fuselage ash covered the right wing at the root. The right wing was thermally damaged from the root outboard to about the wing strut mount. The wing strut remained attached to the underside of the wing but separated from the thermally damaged fuselage mount. The right flap remained attached to the wing at all attachment points. A section of the fractured wooden power distribution line support pole came to rest on the right flap. The flap appeared to be up. The right aileron remained attached to the right wing at all the attachment points and exhibited impact marks consistent with contact from the fallen pole.

Figure 7. Right wing, bottom view.

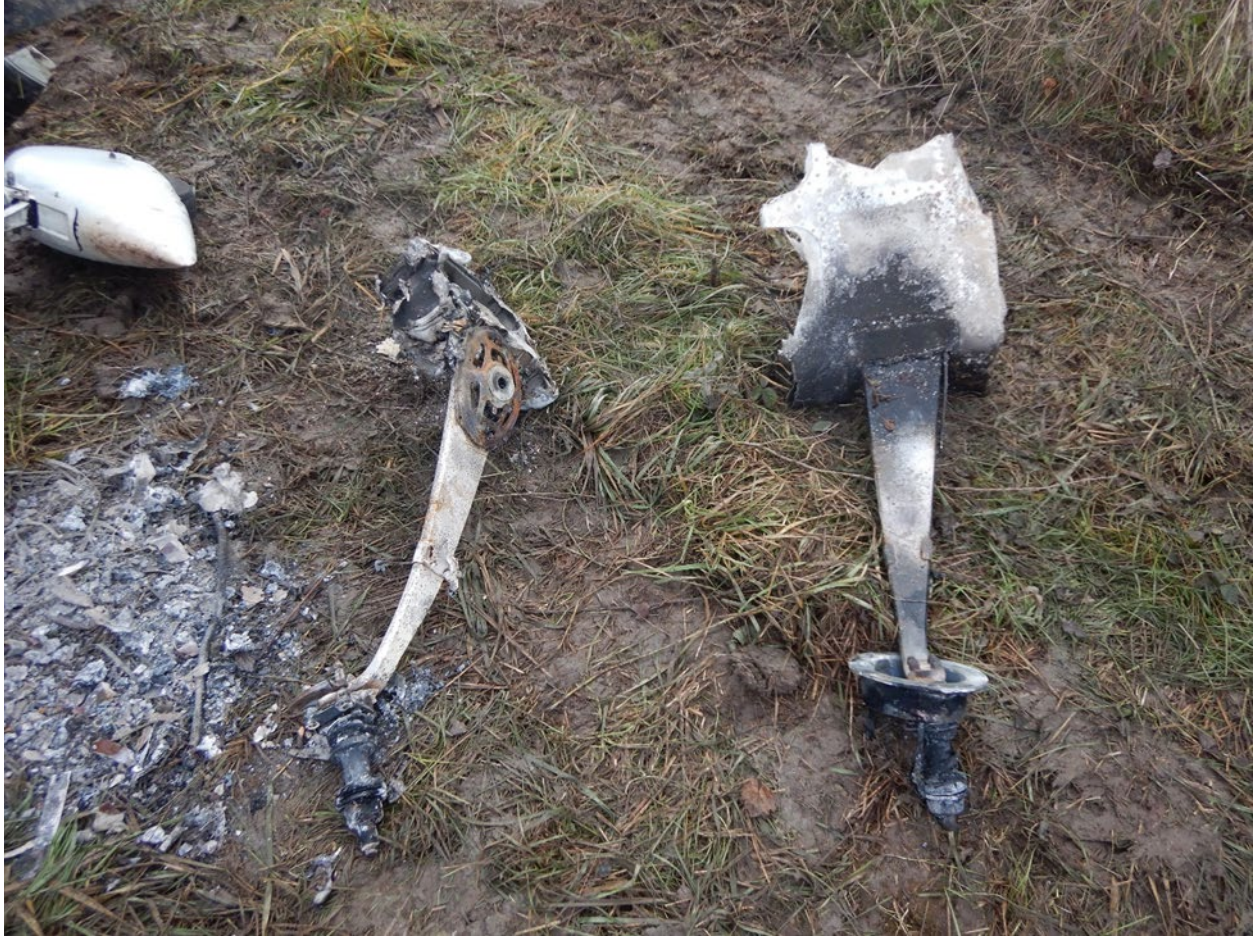
The tricycle landing gear was impact and thermally damaged. The right and left main landing gear separated from the thermally damaged underside of the fuselage but retained sheet metal and mounting hardware to indicate that they were attached at the impact. The nose gear remained attached to the fire wall and exhibited minor damage. The composite wheel cover remained secured to the nose wheel assembly.

Figure 7. Left and right main landing gear.

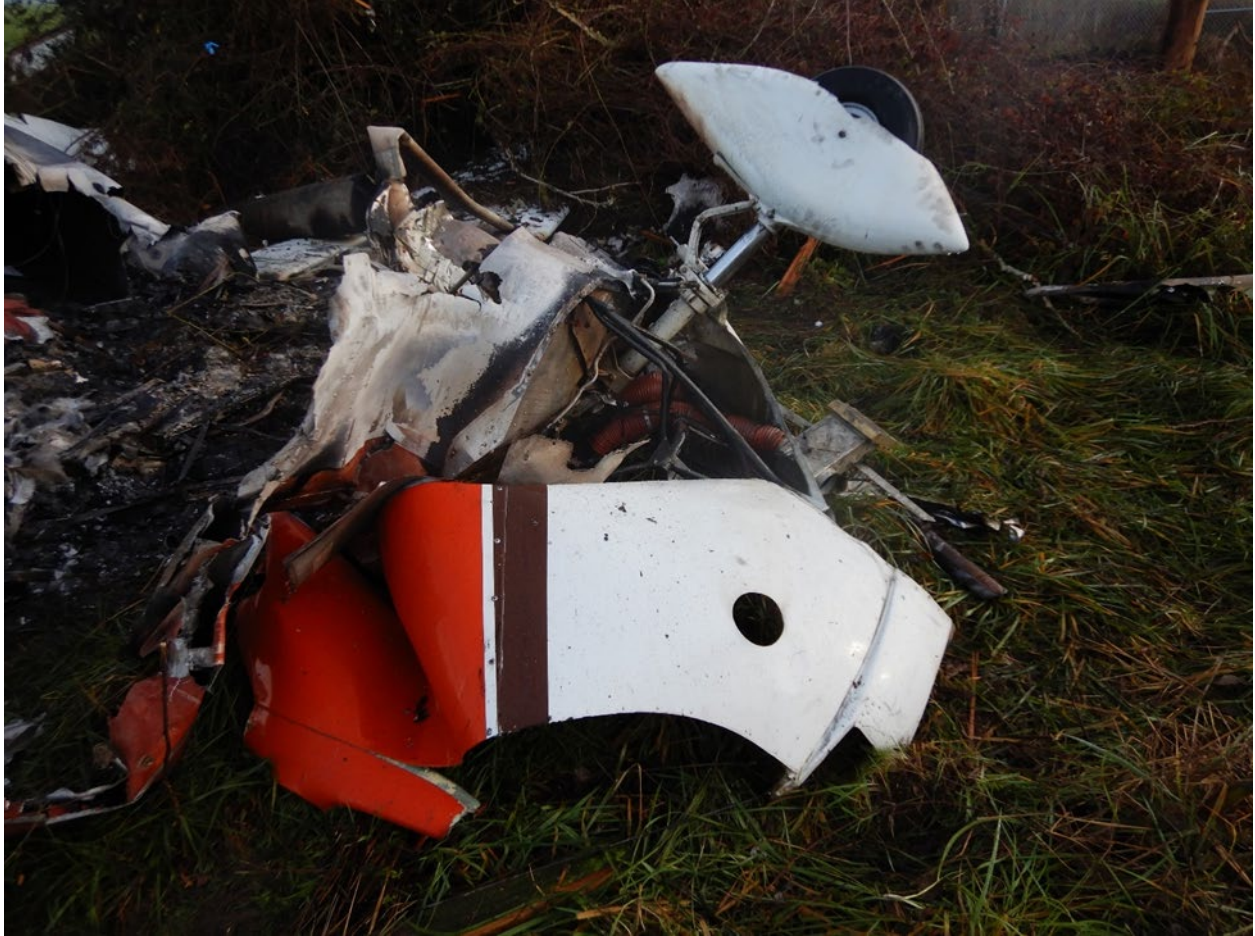
Figure 8. Nose wheel.

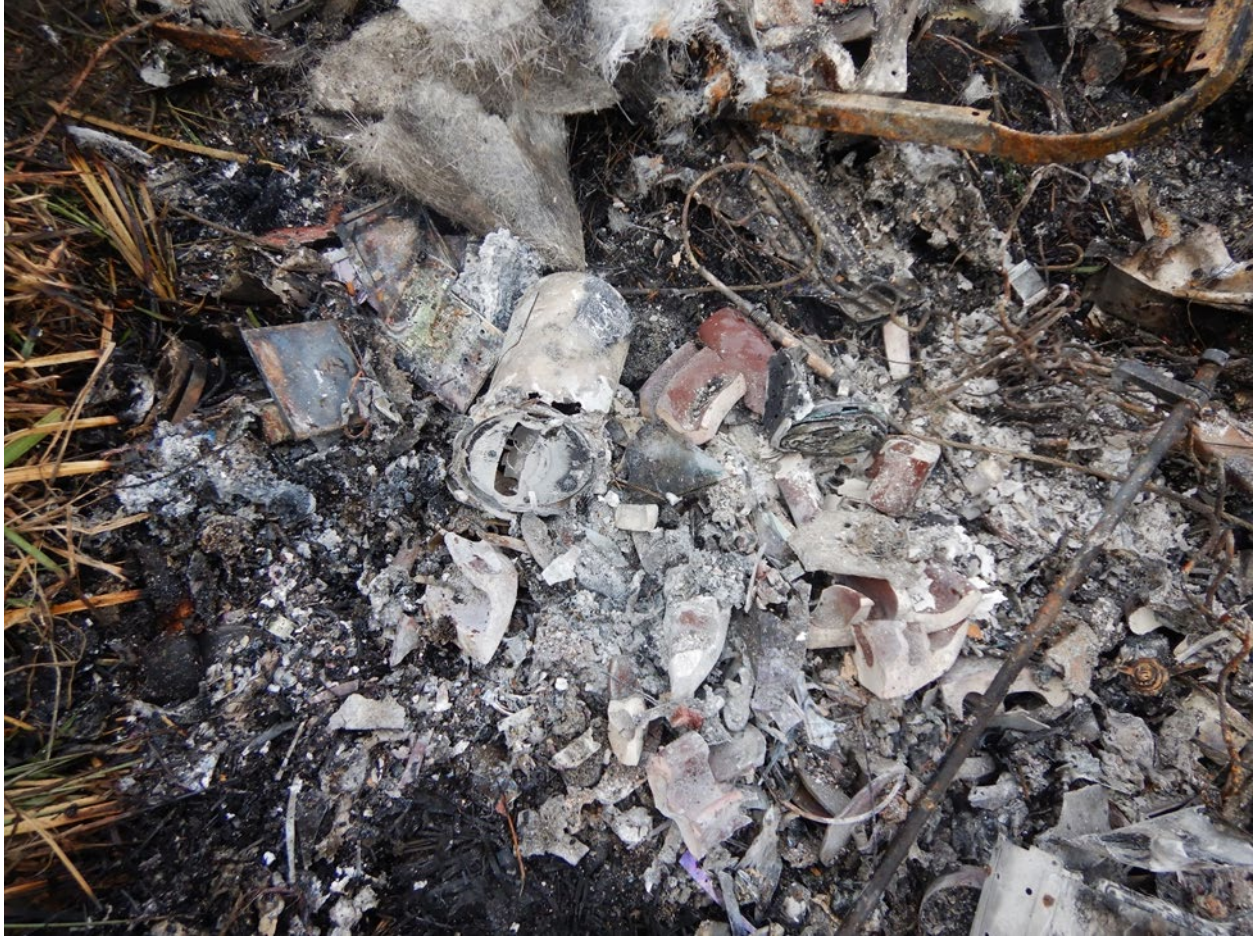
The cockpit, in its entirety, was destroyed by the fire. No instrument, radio, or seat fabric remained. The transponder face was found outside of the wreckage and indicated 1200 code. No other instrument was found that provided useful data.

Figure 9. Cockpit area.

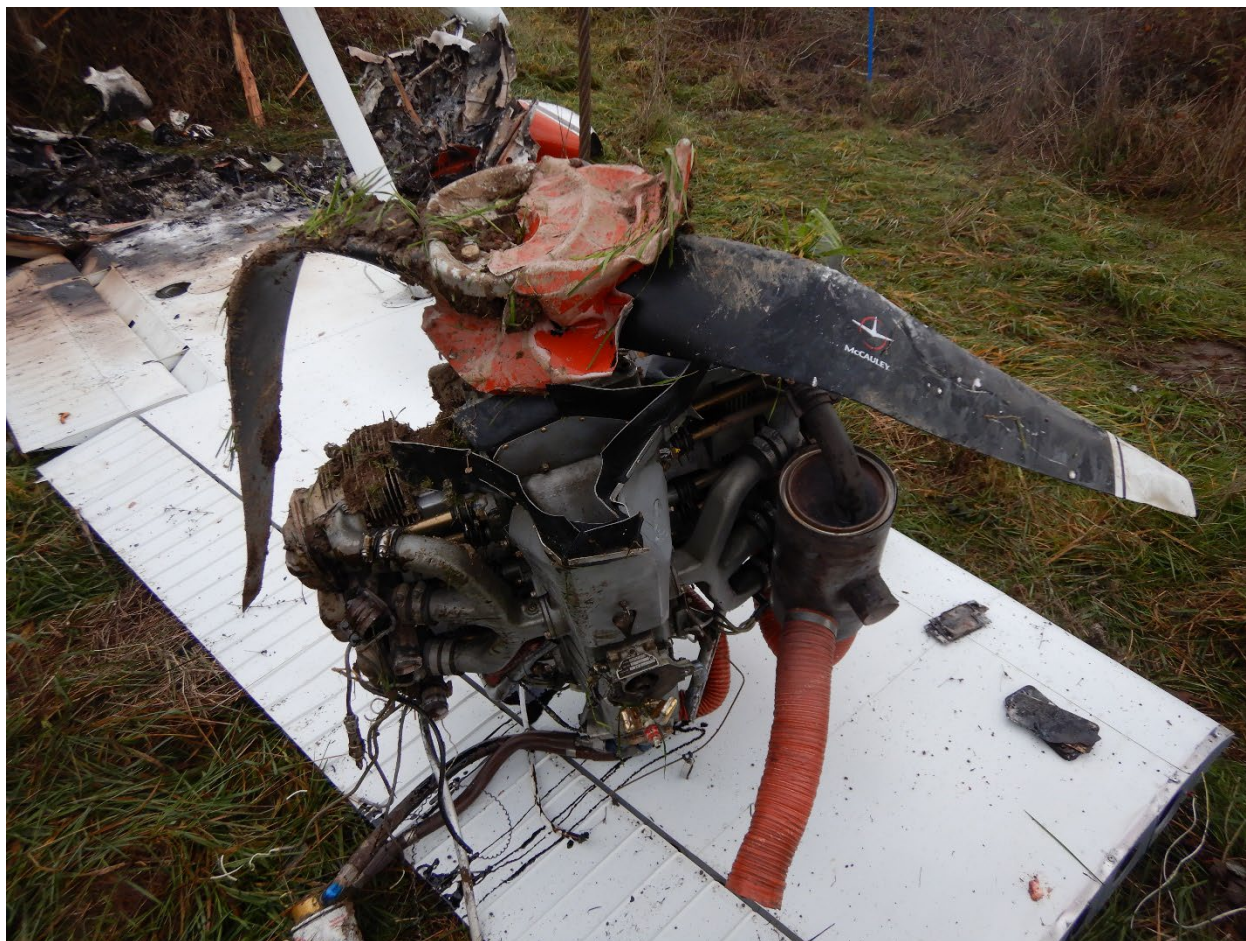
The engine was placed on the underside of the left wing for examination. The engine turned freely. The top sparkplugs were removed and appeared normal. The cylinders were checked for compression. All but the number 5 and number 3 cylinders had compression and vacuum. The number 3 cylinder had no compression and very little vacuum. The number 5 cylinder had no compression nor vacuum. The number 5 push rods were damaged and bent. The valve train continuity was confirmed by the movement of the rocker arms. A borescope examination was conducted of all cylinders, piston tops, and valves. No significant observations were noted.

Figure 10. Engine set on the left wing for examination.

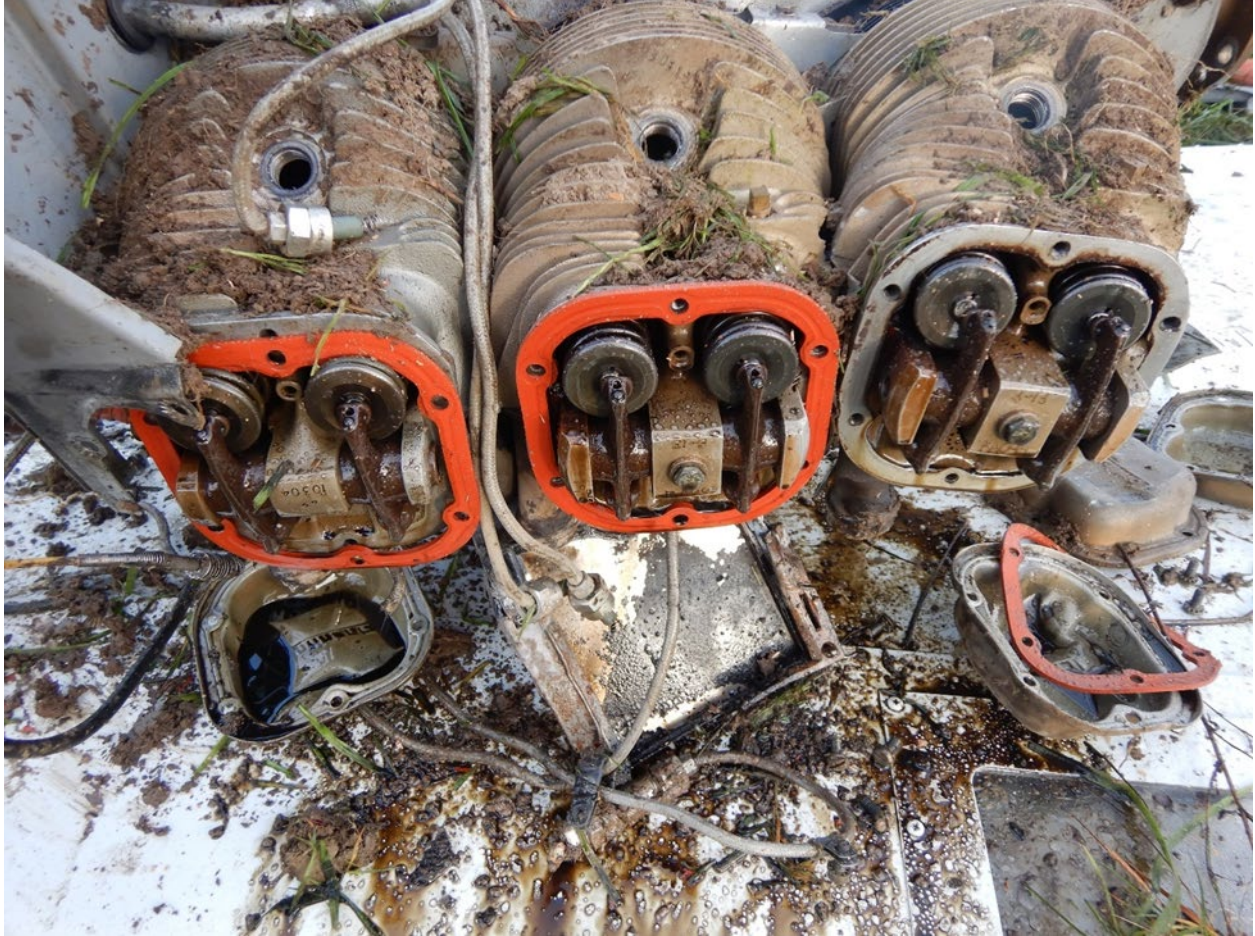
The engine was a Continental O-300D reciprocating six-cylinder engine. The engine was found about 25 ft north of the wreckage. The propeller spinner had been pressed flat against the hub. The number 5 cylinder was pressed aft against the number 3 cylinder. Near the engine there was a large depression in the soft ground. The engine starter and battery were embedded into the depression.

Figure 11. Engine right-side view.

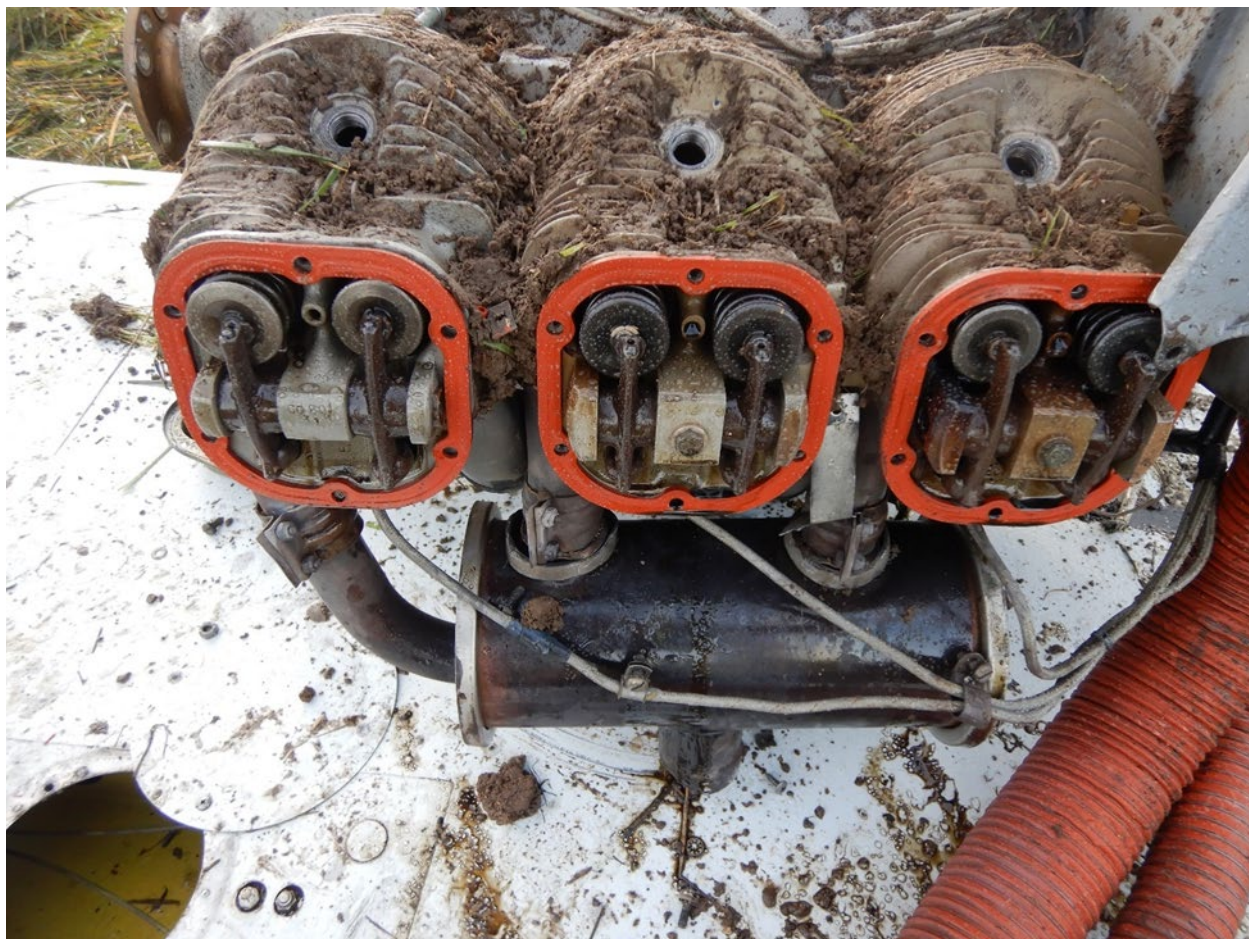
Figure 12. Engine, left-side view.

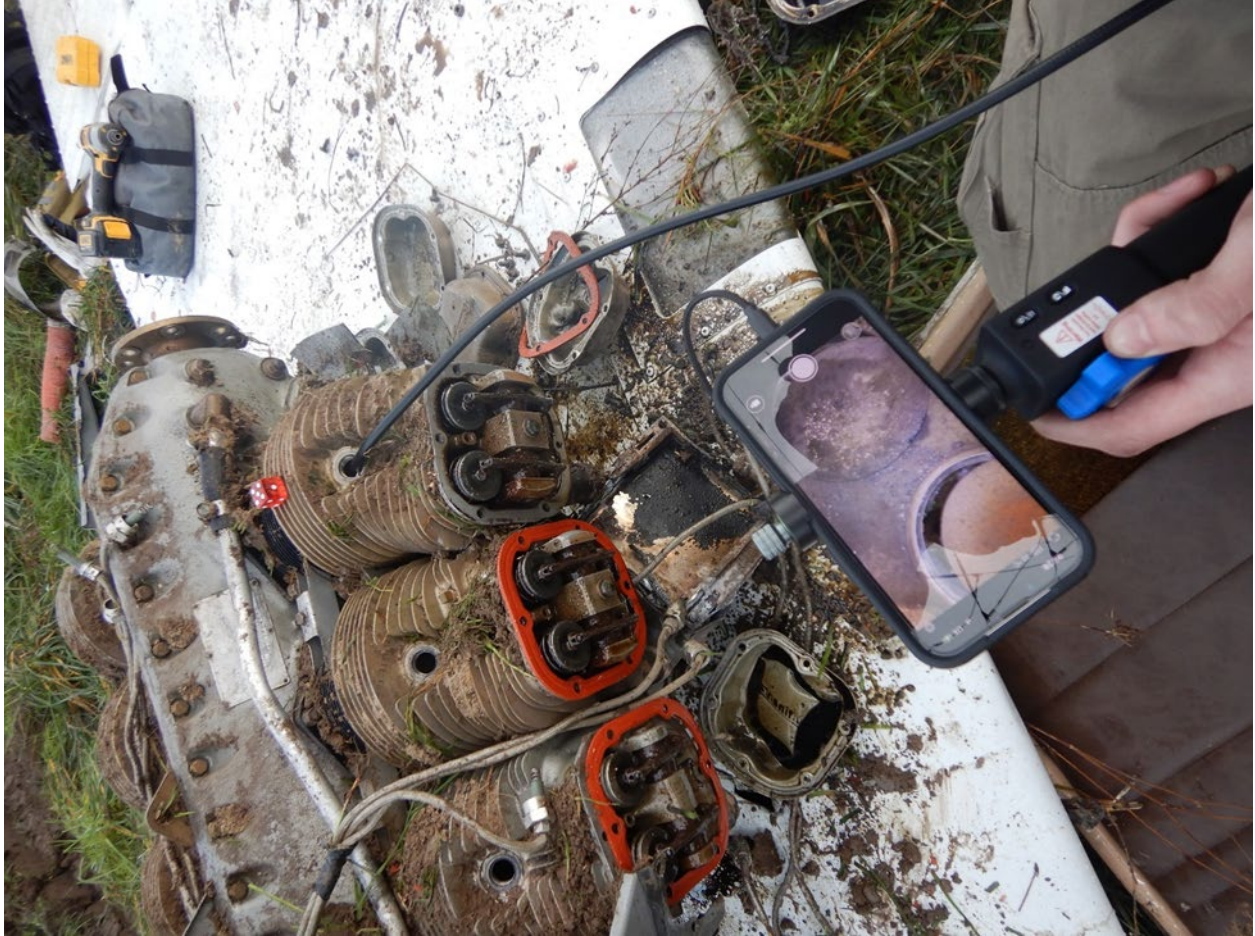
Figure 13. Borescope of the number 5-cylinder.

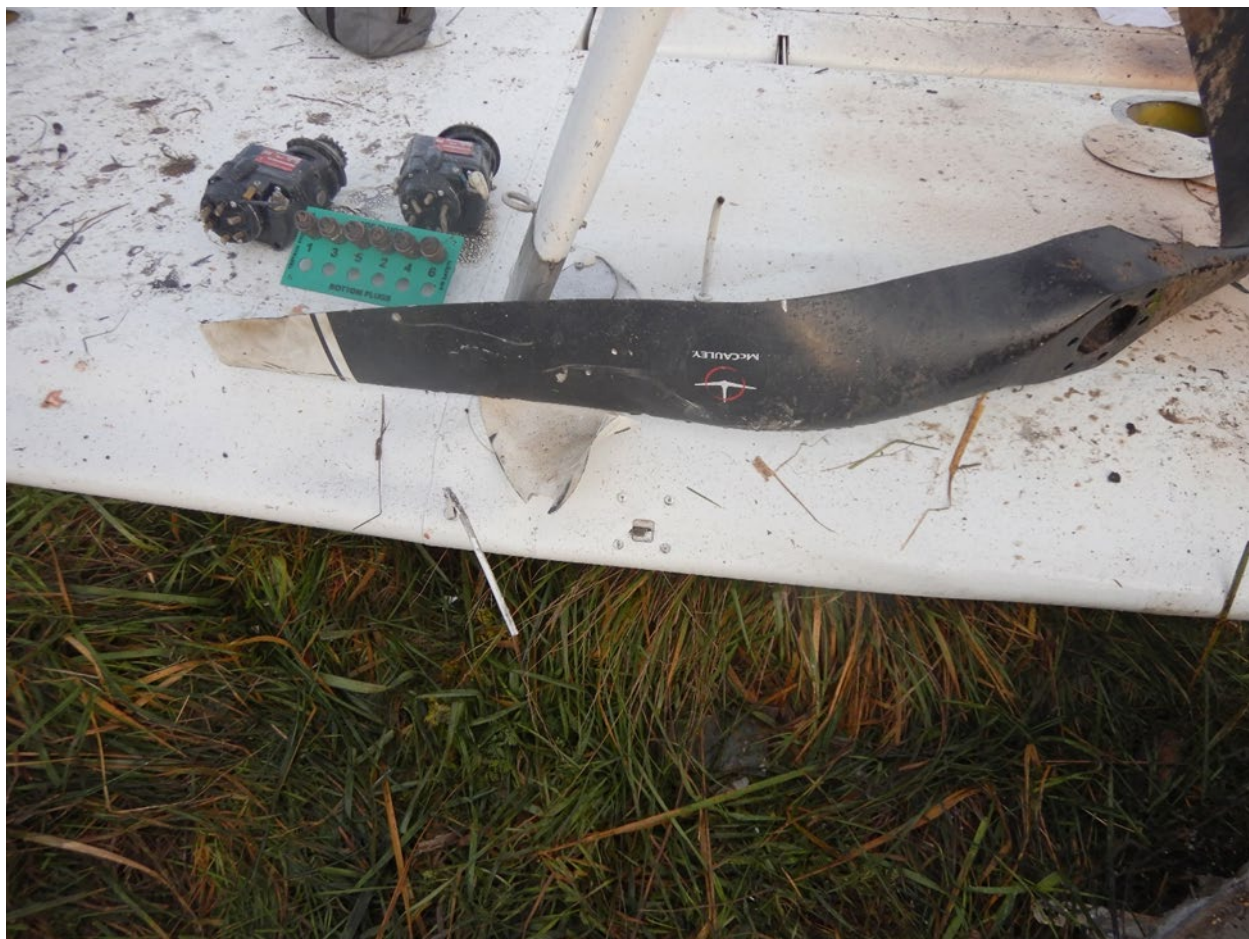
The propeller remained attached to the propeller hub. The fixed pitch two-bladed propeller was damaged. One blade (Blade #1) was bent chordwise about 60° aft and exhibited few chordwise striations. The tip was intact, and the blade exhibited gouges along the leading edge. The other blade (Blade #2) exhibited a near-90° bend but exhibited no gouges on the leading edge.

Figure 14. Propeller blade number 1.

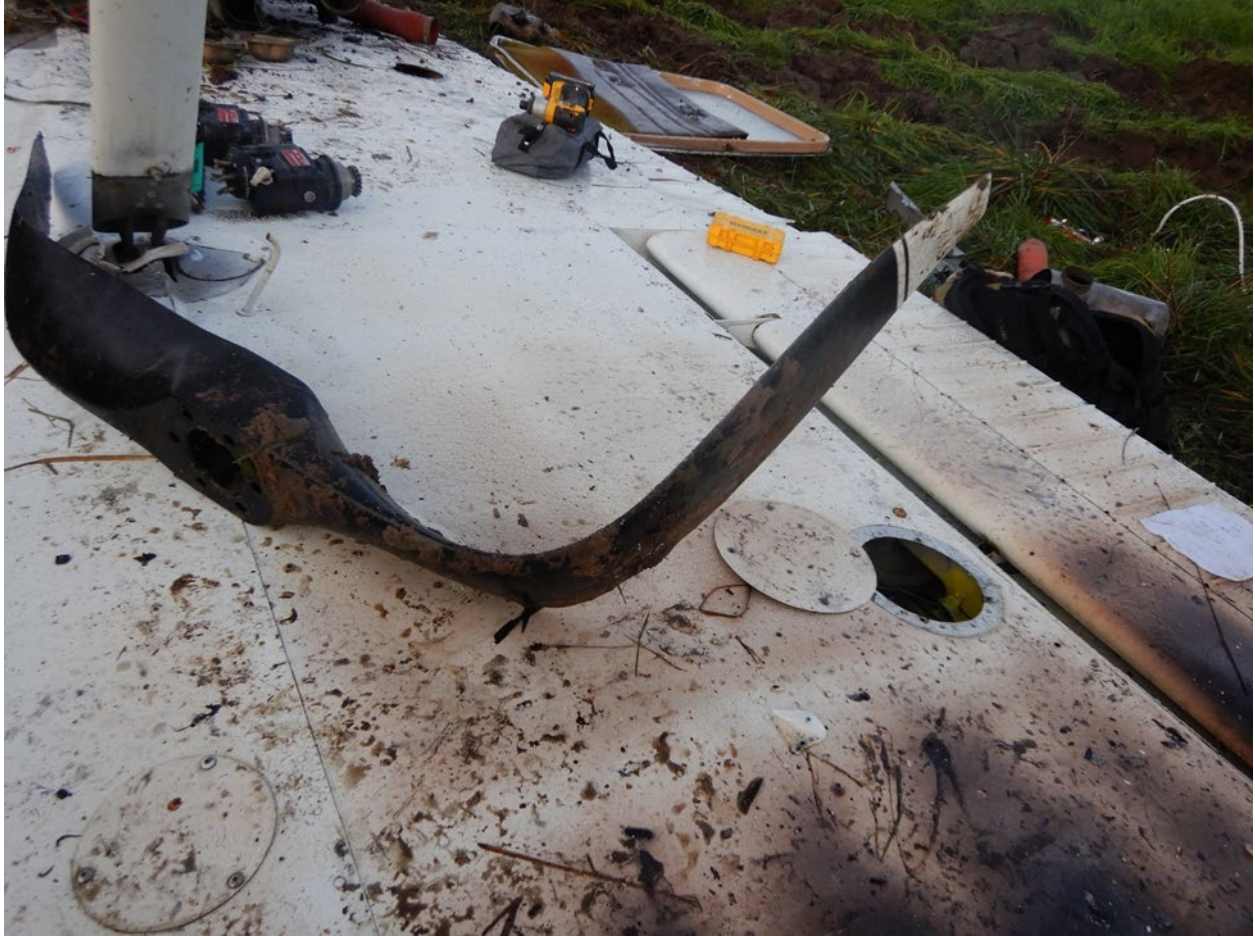
Figure 15. Propeller blade number 2.
