# National Transportation Safety Board

WPR24FA057

## **ACCIDENT SITE SURVEY**

Location: Independence, Oregon  
Date: December 16, 2023  
Time: 1654 PDT  
Airplane: Cessna 172G / N3992L

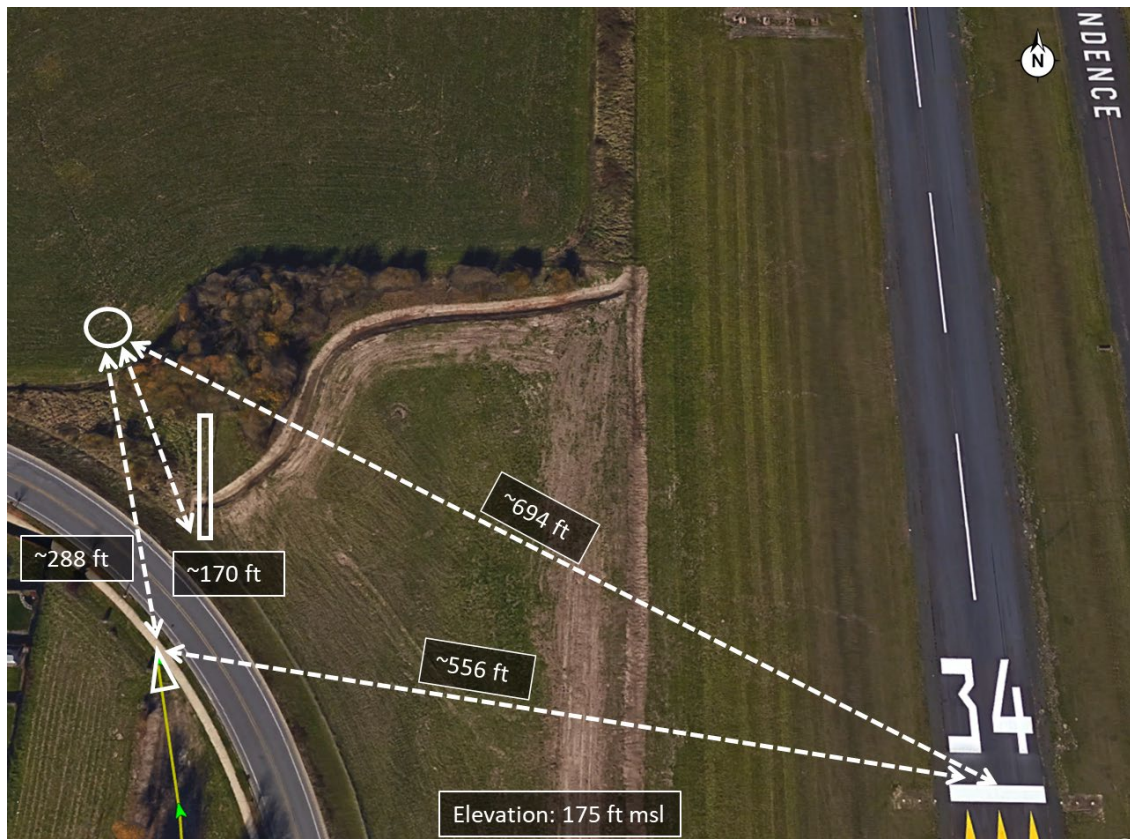
The accident site was in a corner of an open field that bordered the airport's west boundary. The site was located at  $N44^{\circ} 51' 49.6''$   $W123^{\circ} 12' 02.2''$ . The airplane came to rest, inverted on a heading of  $160^{\circ}$  magnetic. The fuselage, from the fire wall aft to the mid-fuselage section just forward of the empennage was consumed by a postaccident fire. The engine separated from the airplane and was about 25 ft north of the fuselage. Shards of acrylic were strewn about the 20 ft debris area around the airplane.

Figure 1. Image showing the last ADS-B point (triangle) open field, the support pole (rectangle) the runway and accident site (circle).

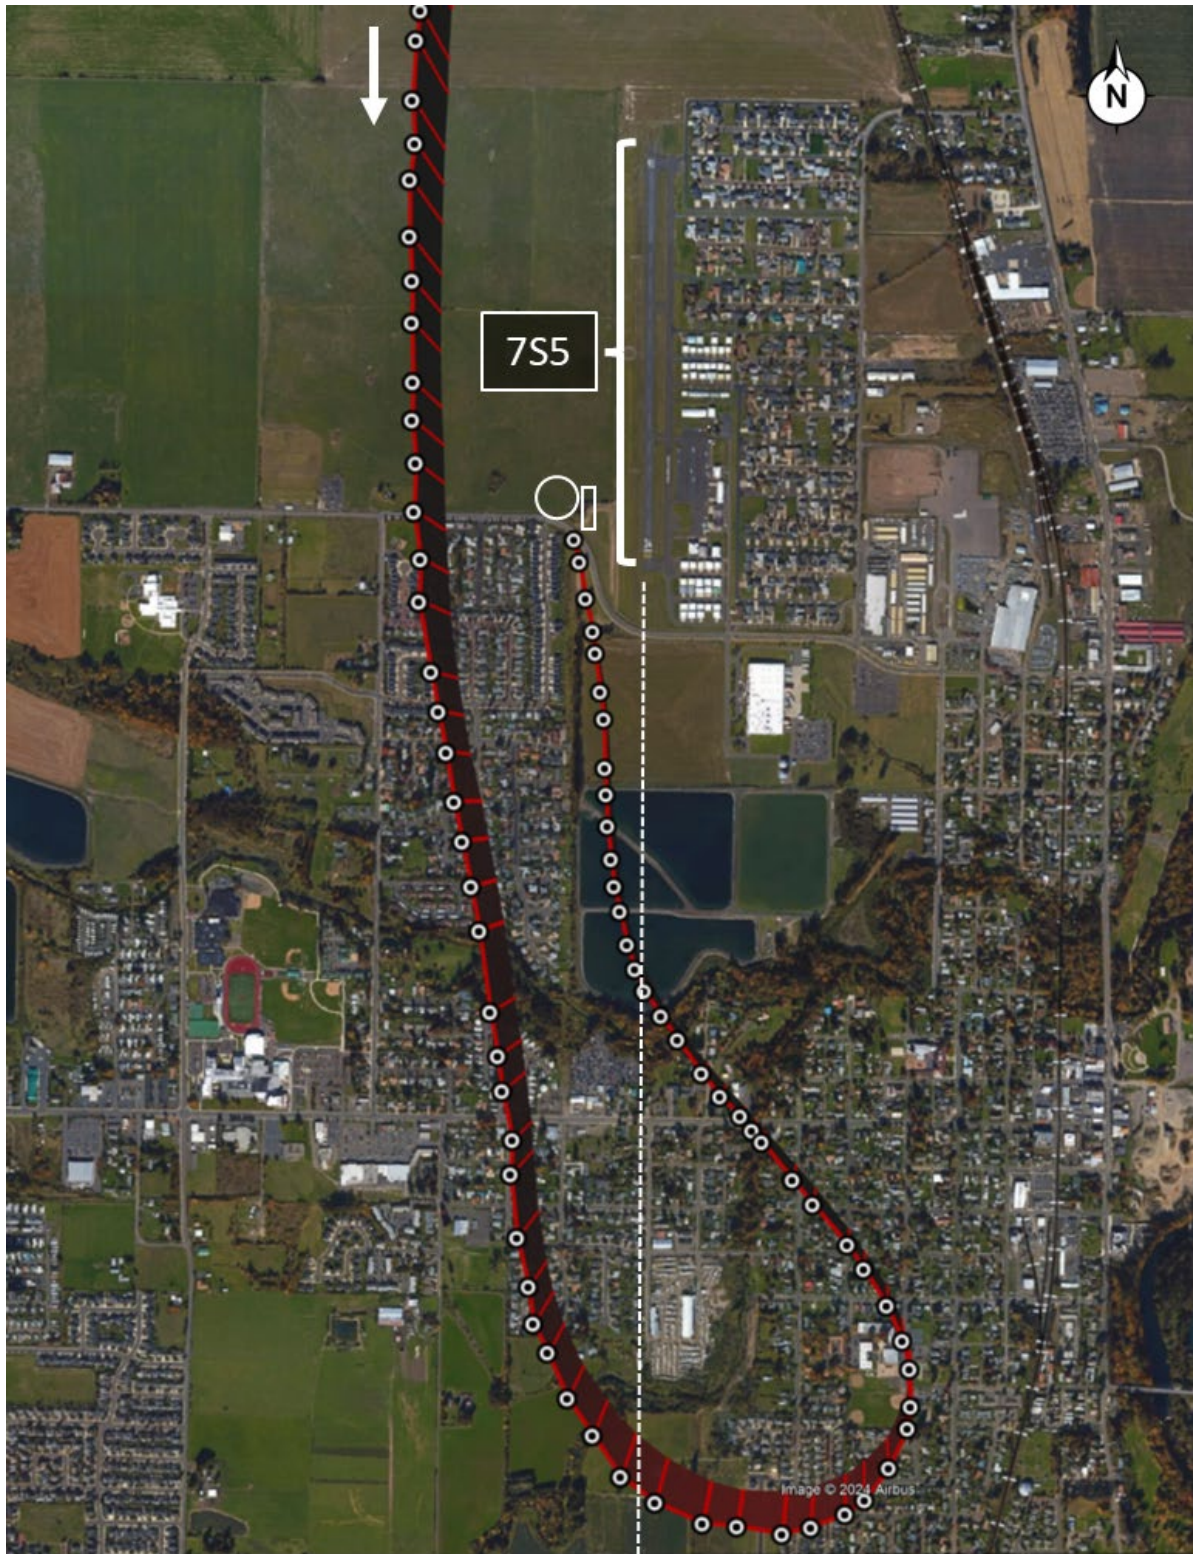
Figure 2. Image of the ADS-B flight track data and the runway centerline (dashed line). Arrow points to the direction of travel.

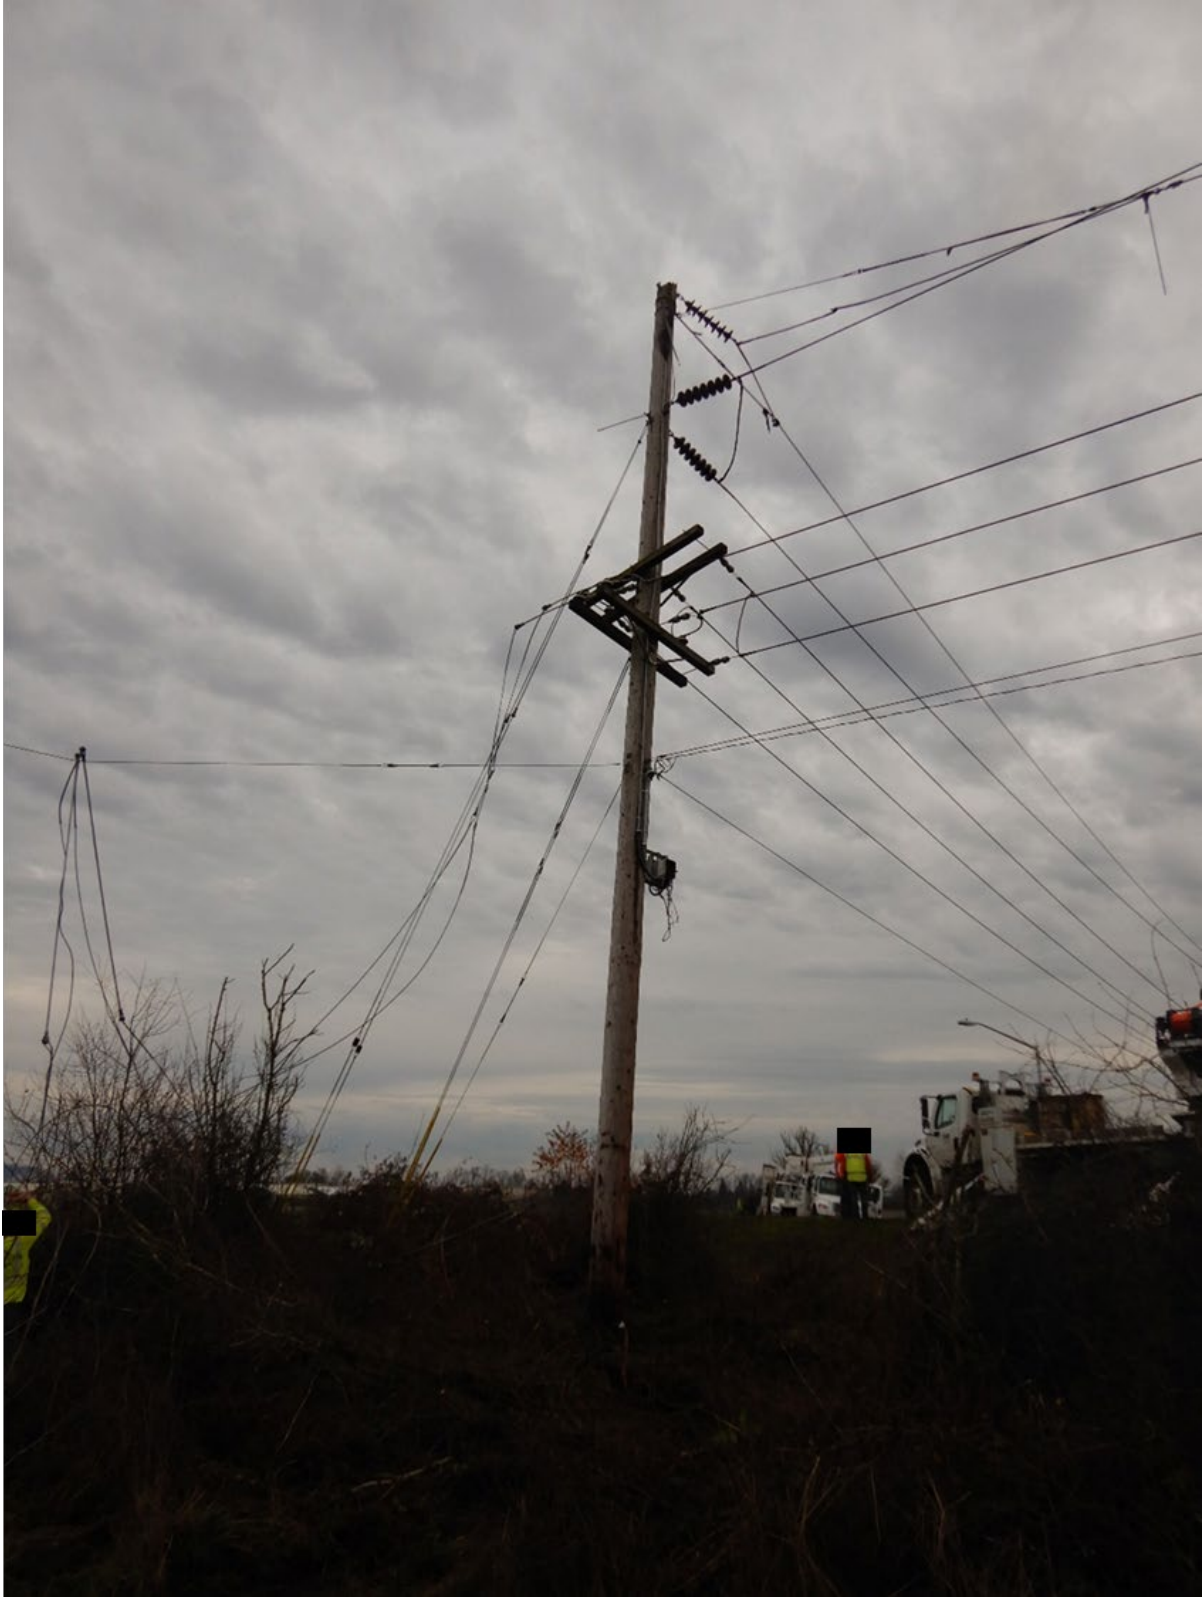
The airplane was near a power line support pole (support pole) about 170 ft southeast of the main wreckage. The top of the support pole and about 4 ft down, fractured into several pieces and was strewn about the wreckage area. The next 12 ft of the support pole (middle section) fractured and fell on top of the underside of the right wing. White paint transfer was observed on this middle section. A dual-light beacon/lamp was attached to the top of the support pole and had fractured and fallen into the wreckage area. The section of support pole that remained installed into the ground was about 69 ft tall.

Figure 3. Support pole that was struck by the airplane.

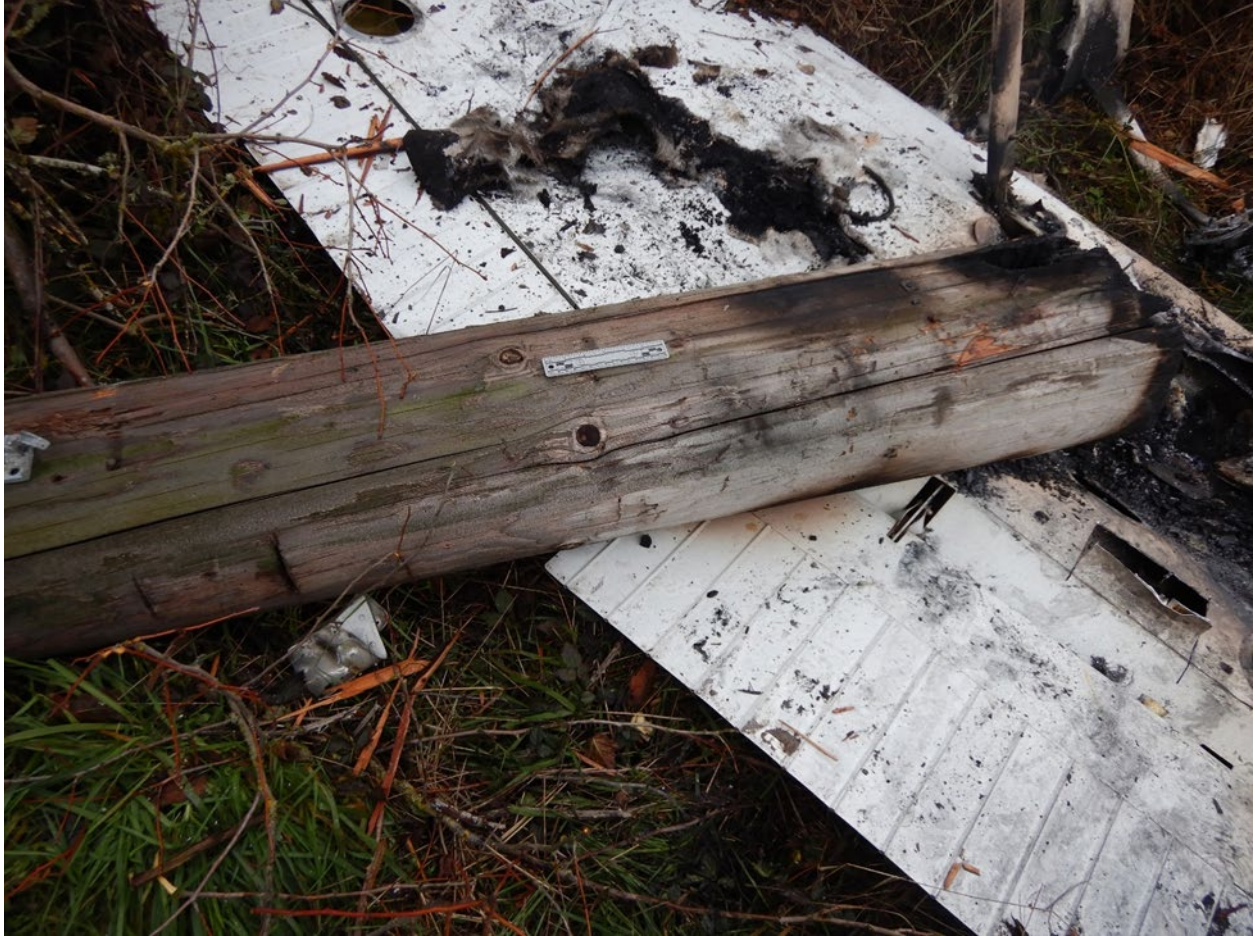
Figure 4. Middle section of the support pole rests on the underside of the right wing.

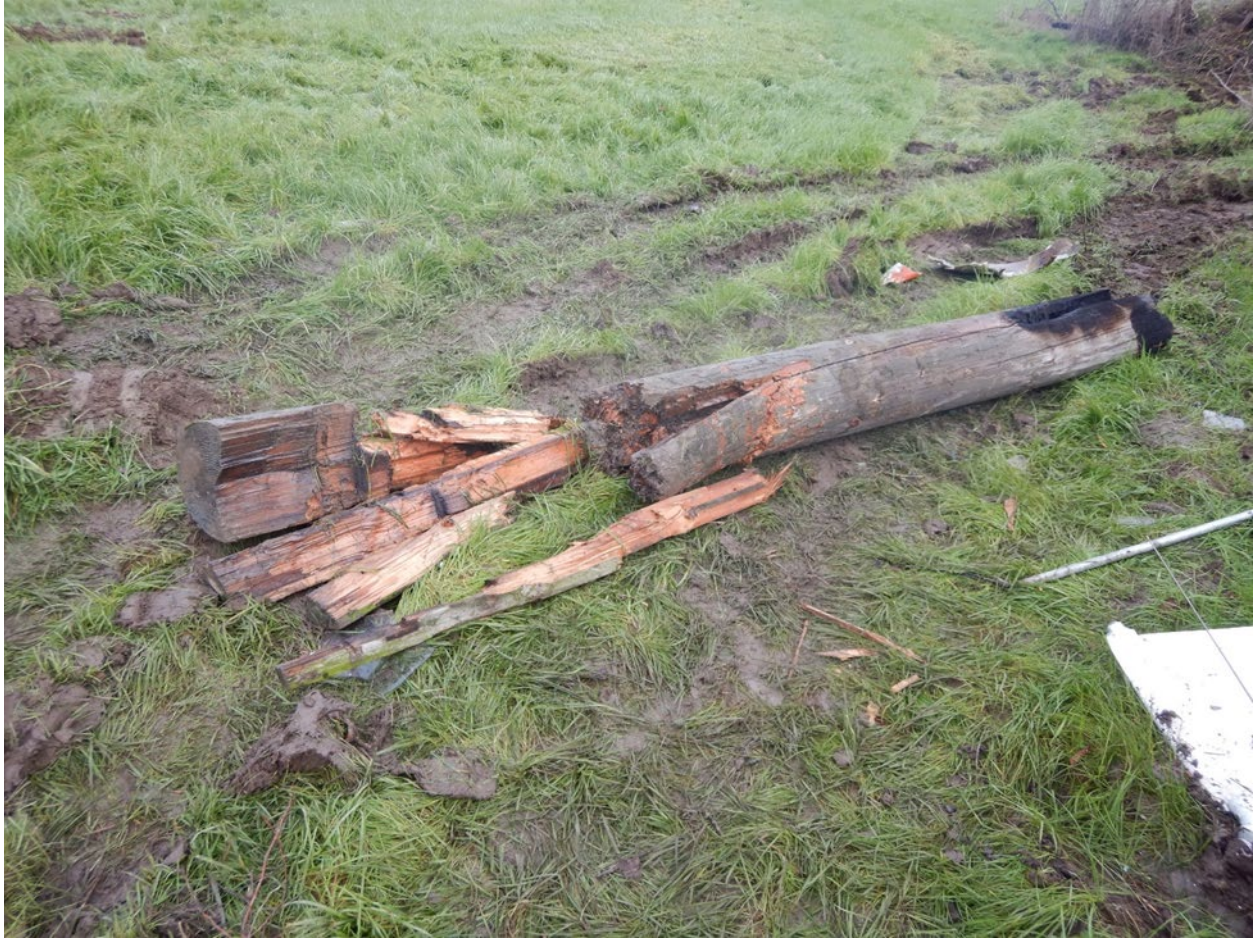
Figure 5. Top and middle section of the support pole.

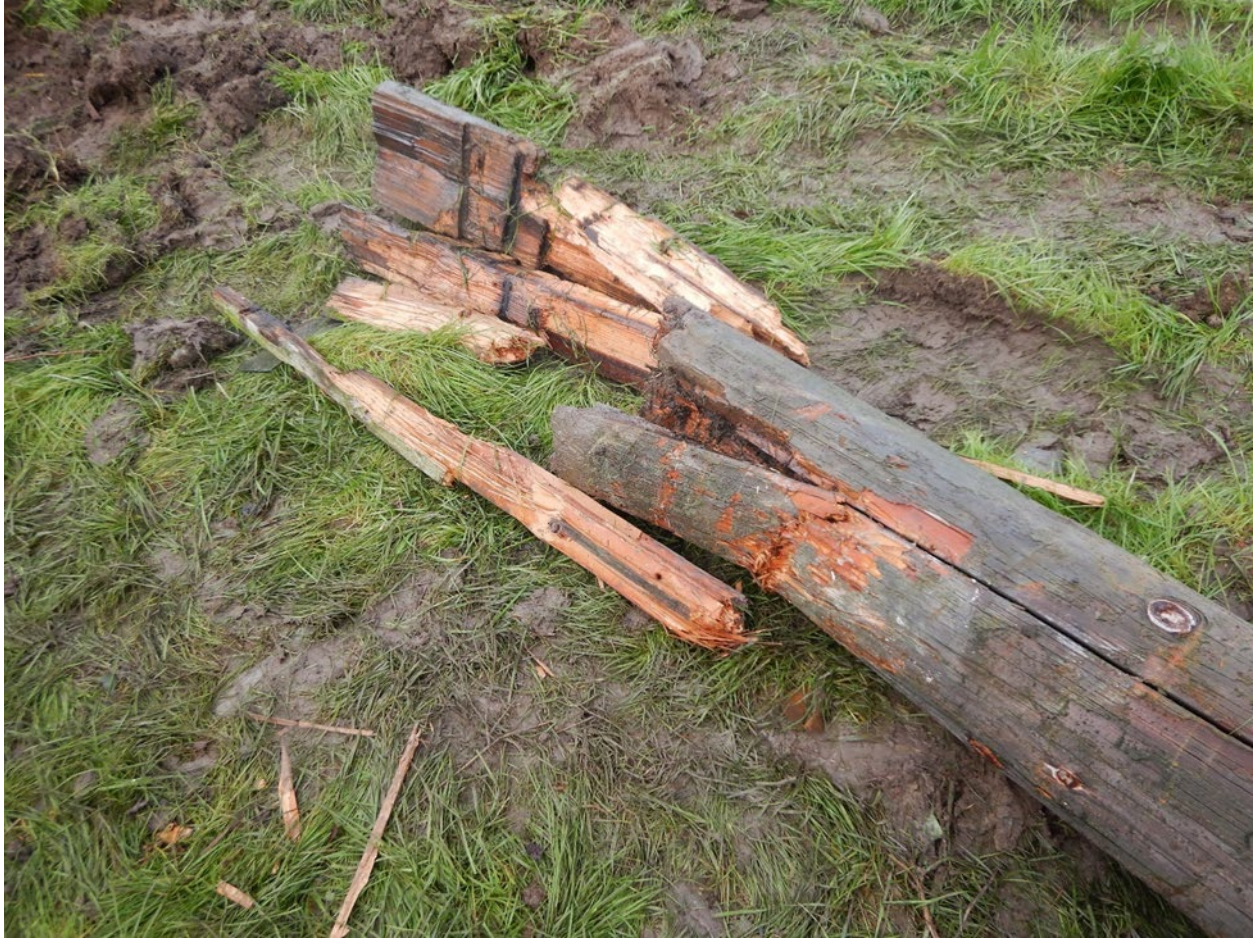
Figure 6. Top and middle section of the support pole showing white color transfer on the middle section.

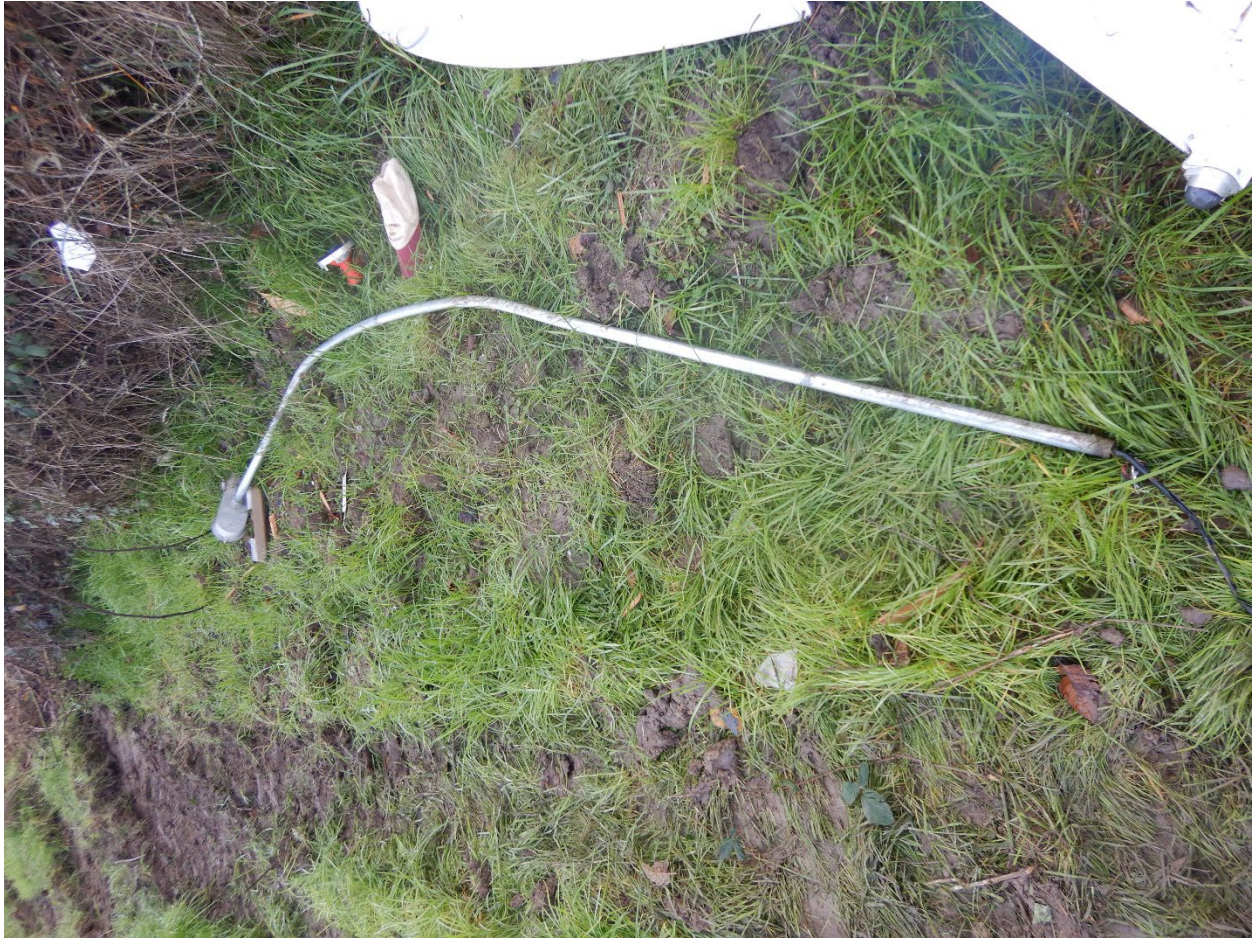
Figure 7. The dual red-light beacon/lamp is on the left end of the support pole.
