# National Transportation Safety Board

WPR22FA072

## **ACCIDENT SITE AND WRECKAGE EXAMINATION REPORT**

Location: Eloy, Arizona  
Date: 01/14/2024  
Time: 0747 mountain standard time  
Aircraft: Kubicek BB85Z

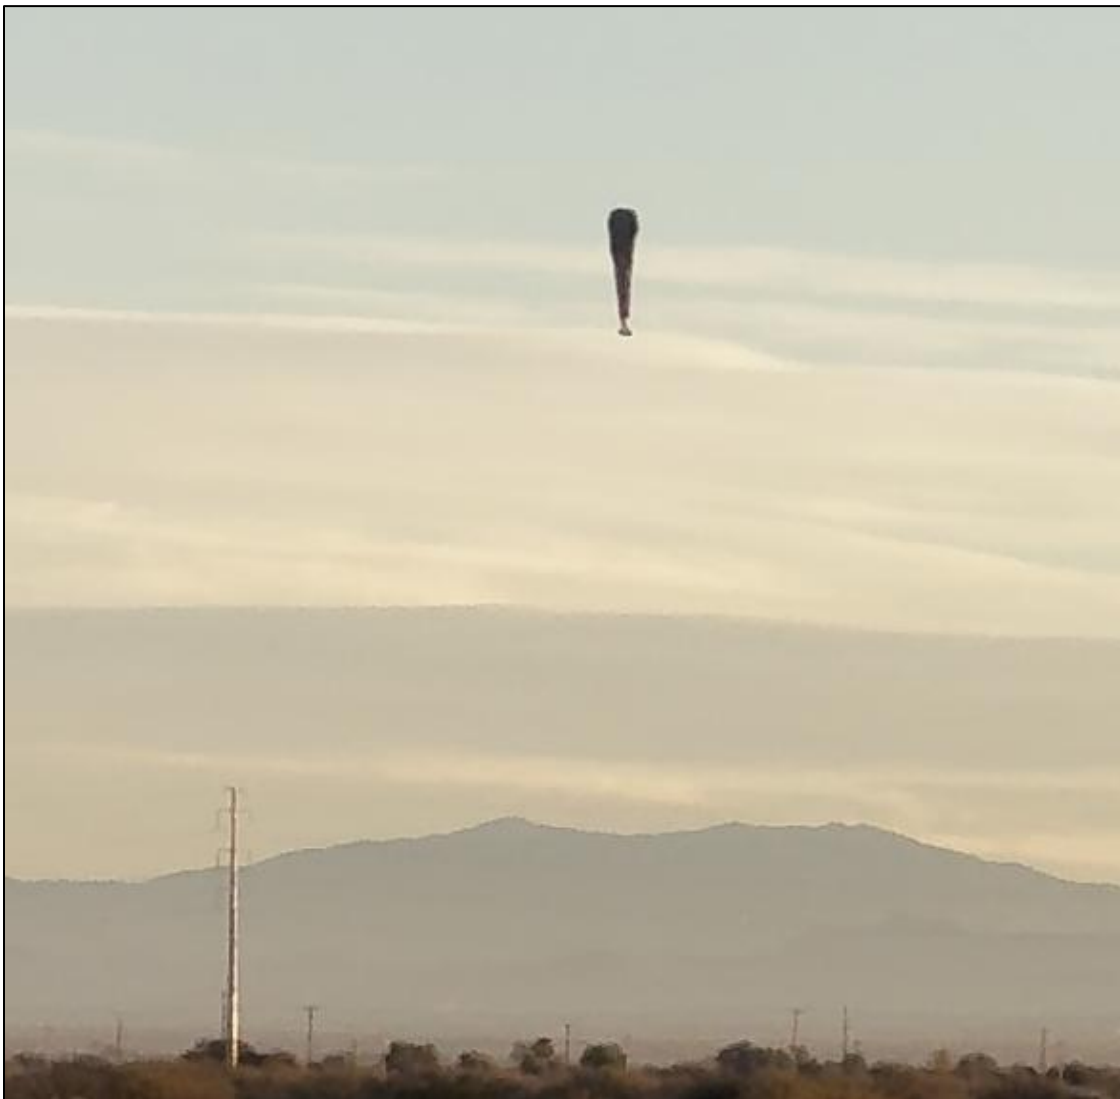
The flight departed near the Francisco Grand Hotel and Golf Resort, near Casa Grande, Arizona, about 17 and 3/4 miles, west-northwest from the accident site. The flight departed before dawn (0703), about 0614. Thirteen occupants boarded the basket and the 8 skydivers departed from the balloon about 28 minutes later at about 10,000 ft mean sea level (msl). Soon after the skydivers departed the balloon, the pilot initiated the descent. Witnesses on the ground captured images of the rapidly descending balloon. (See figure 1.) The balloon impacted the ground about 33 minutes later.

**Figure 1-Witness image of the accident balloon during descent.**

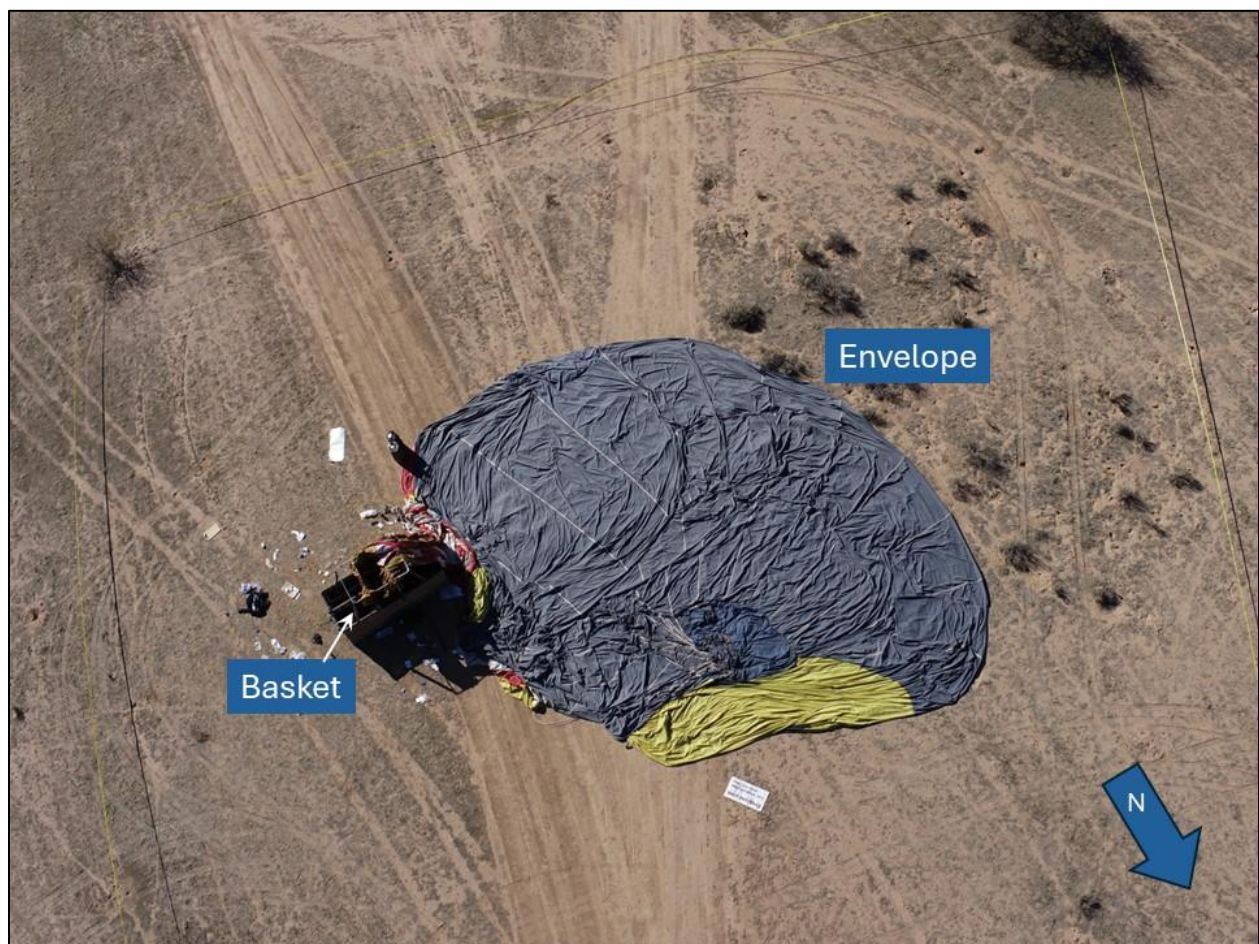
The accident site was about 2 and 1/2 miles northeast of Eloy Municipal Airport (E60), Eloy, Arizona, and located on level desert terrain surrounded by sparse desert and dry brush. The balloon's envelope was located across the ground on the west side of the basket. The envelope remained attached to the basket at all connections. The envelope remained intact, and the vent was found in its relative position to the top opening. Pulleys and lines remained attached to the vent and envelope. The rapid deflation valve line (red) and inflight vent (red and white) remained attached to the basket and envelope. The lower envelope panels and Nomex panels were noted to have thermal damage. The basket remained upright and no movement of the basket across the ground was evident. One propane tank was removed from the basket by first responders. This tank remained attached to the line and burner assembly. The burner support frame had impact damage.

**Figure 2. Accident site aerial view from a drone. (Courtesy of the Eloy Police Department)**

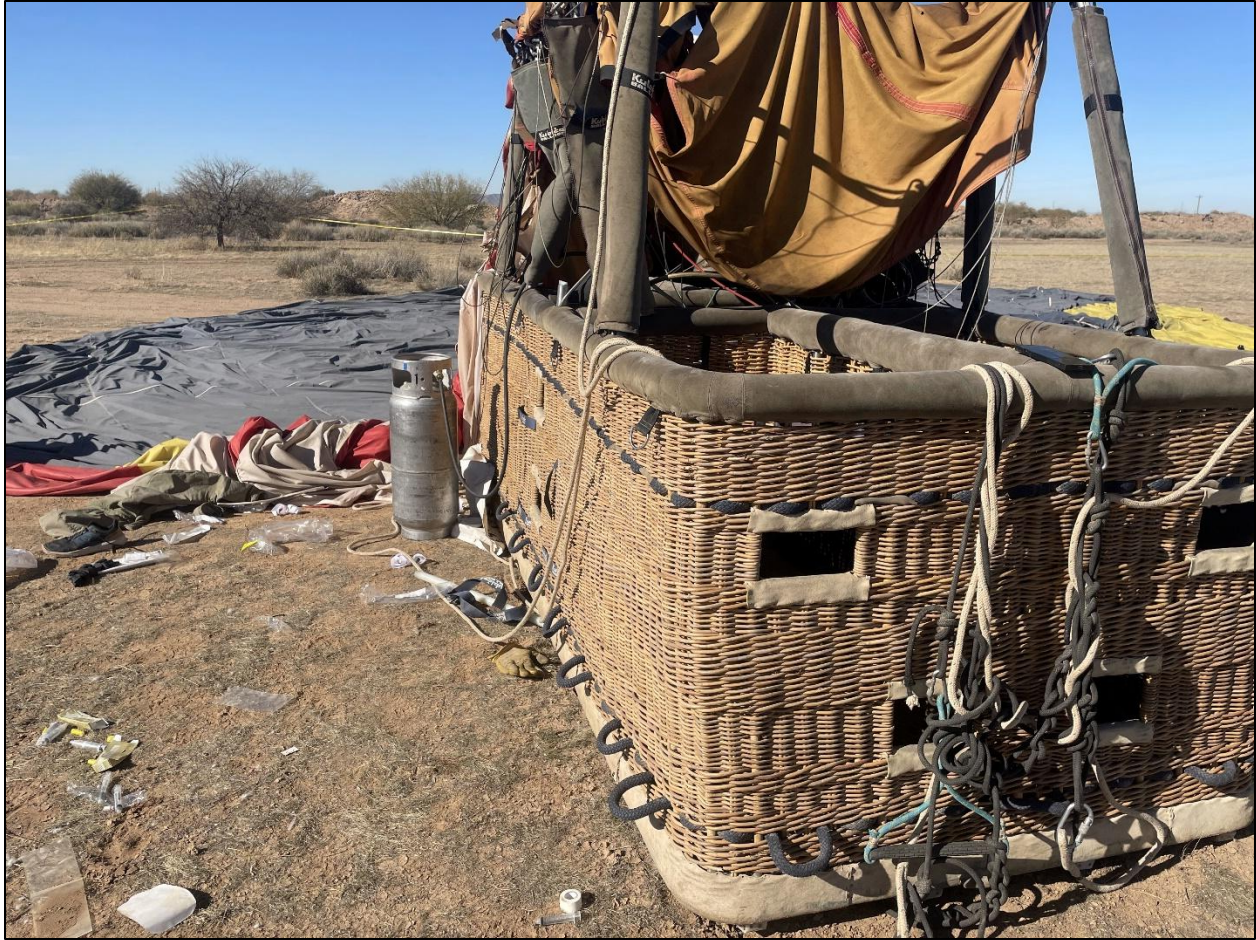
**Figure 3. Accident site, basket and envelope.**

The locking carabiners attaching the envelope to the basket were all found in the locked position and the cables were undamaged. The envelope was removed from the basket during the onsite examination. The burner support frame was damaged and the burner assembly was found dangling above the center of the basket.

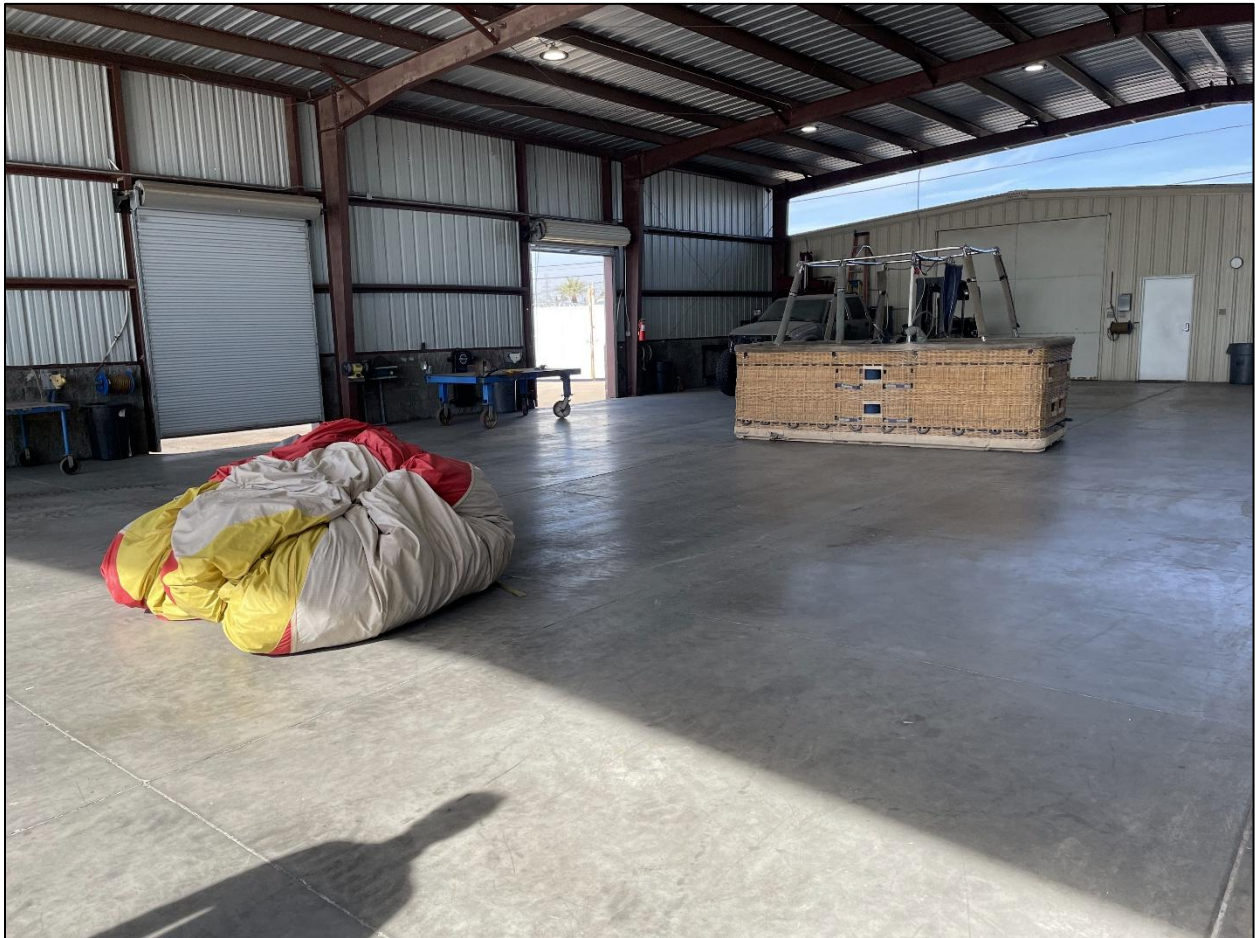
**Figure 4. Wreckage examination layout.**

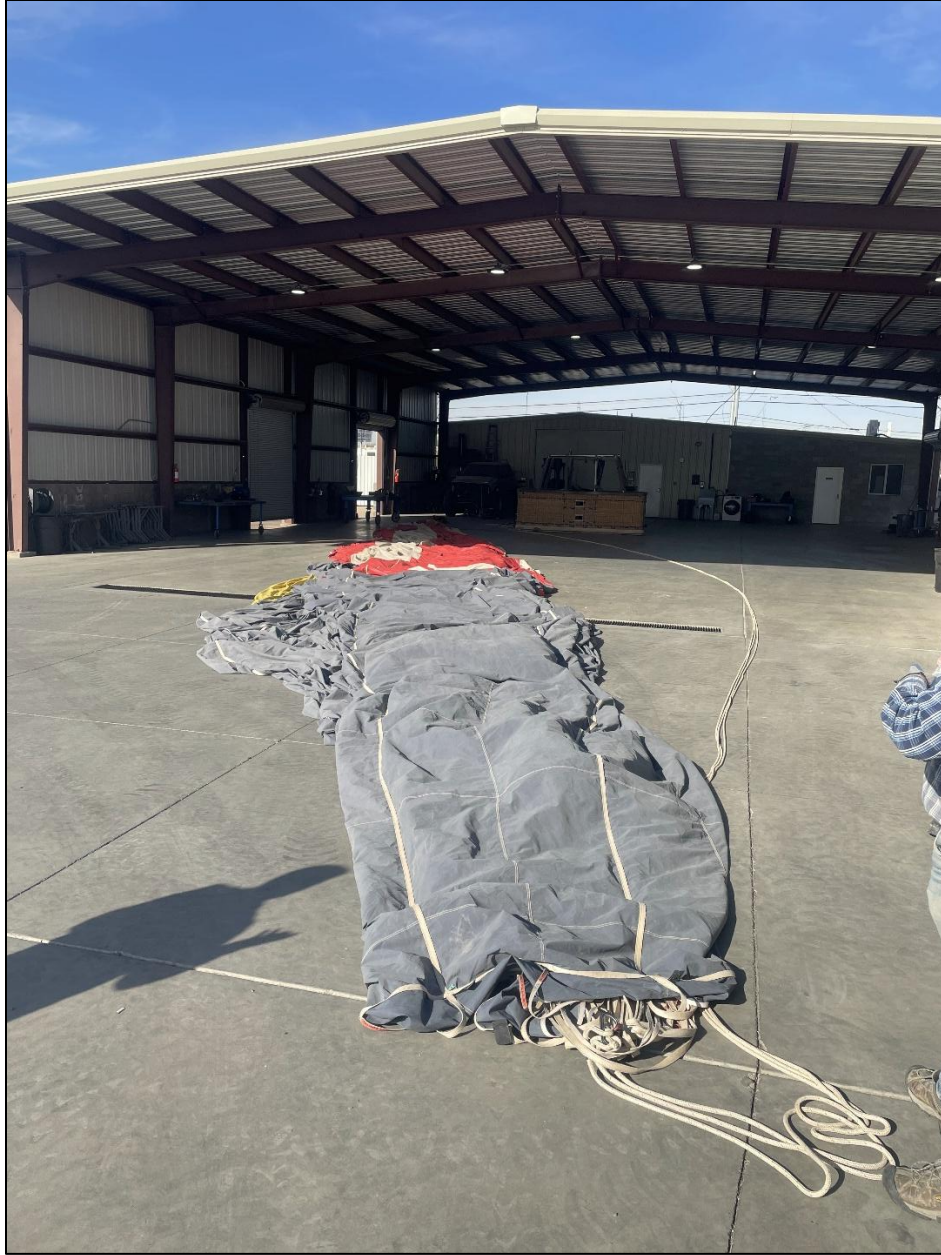
Examination of the rapid deflation vent and turning vents revealed no anomalies. Stitching on the rim tape was frayed in places consistent with whipping and flailing damage. The thermal sensor was not found in the envelope and the thermal sensor Velcro attachment was undamaged.

**Figure 5. Follow-up examination, accident balloon.**

The postaccident examination of the basket and balloon revealed no evidence of any preimpact mechanical malfunctions or failures that would have precluded normal operation.
