# National Transportation Safety Board

WPR24FA072

## VIDEO FILES

Group Chair's Factual Report

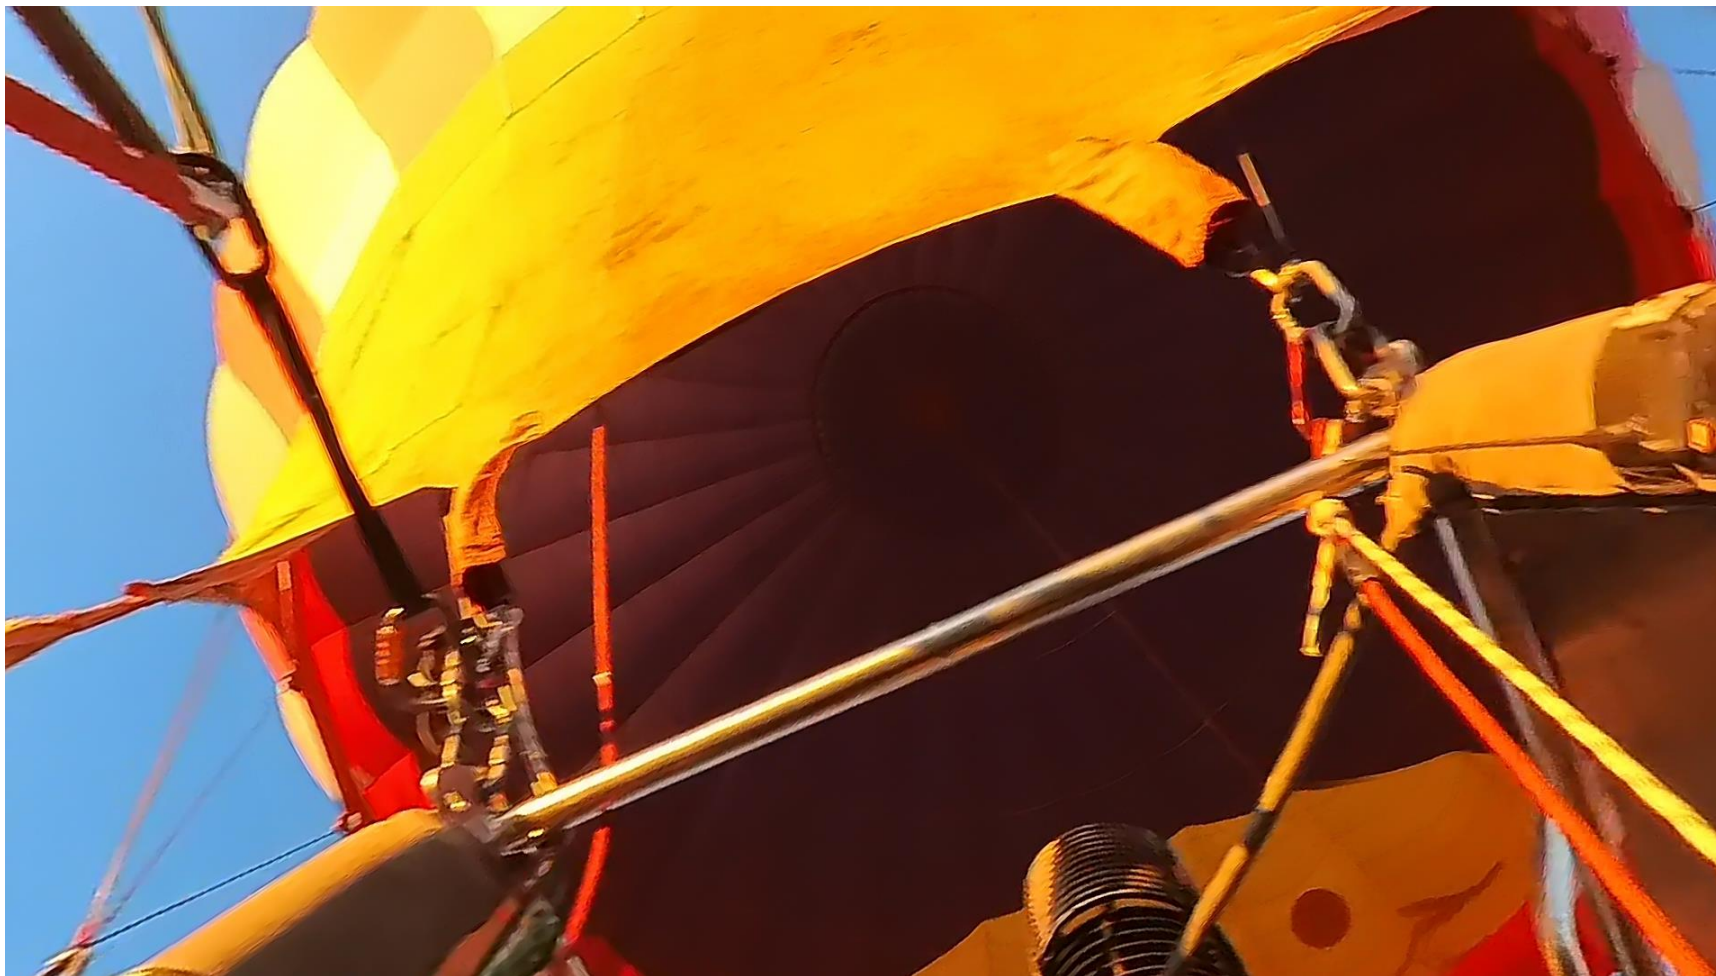
| <b>Time<br/>(mm:ss)</b> | <b>Observation</b> |
|---|---|
| <b>01:54</b> | As the camera moved through the basket, the deflation system vent was visible fully closed. (Figure 1) |

**Figure 1.** View at 01:54 in the second video, as the camera passed through the basket, showing the deflation system vent fully closed.

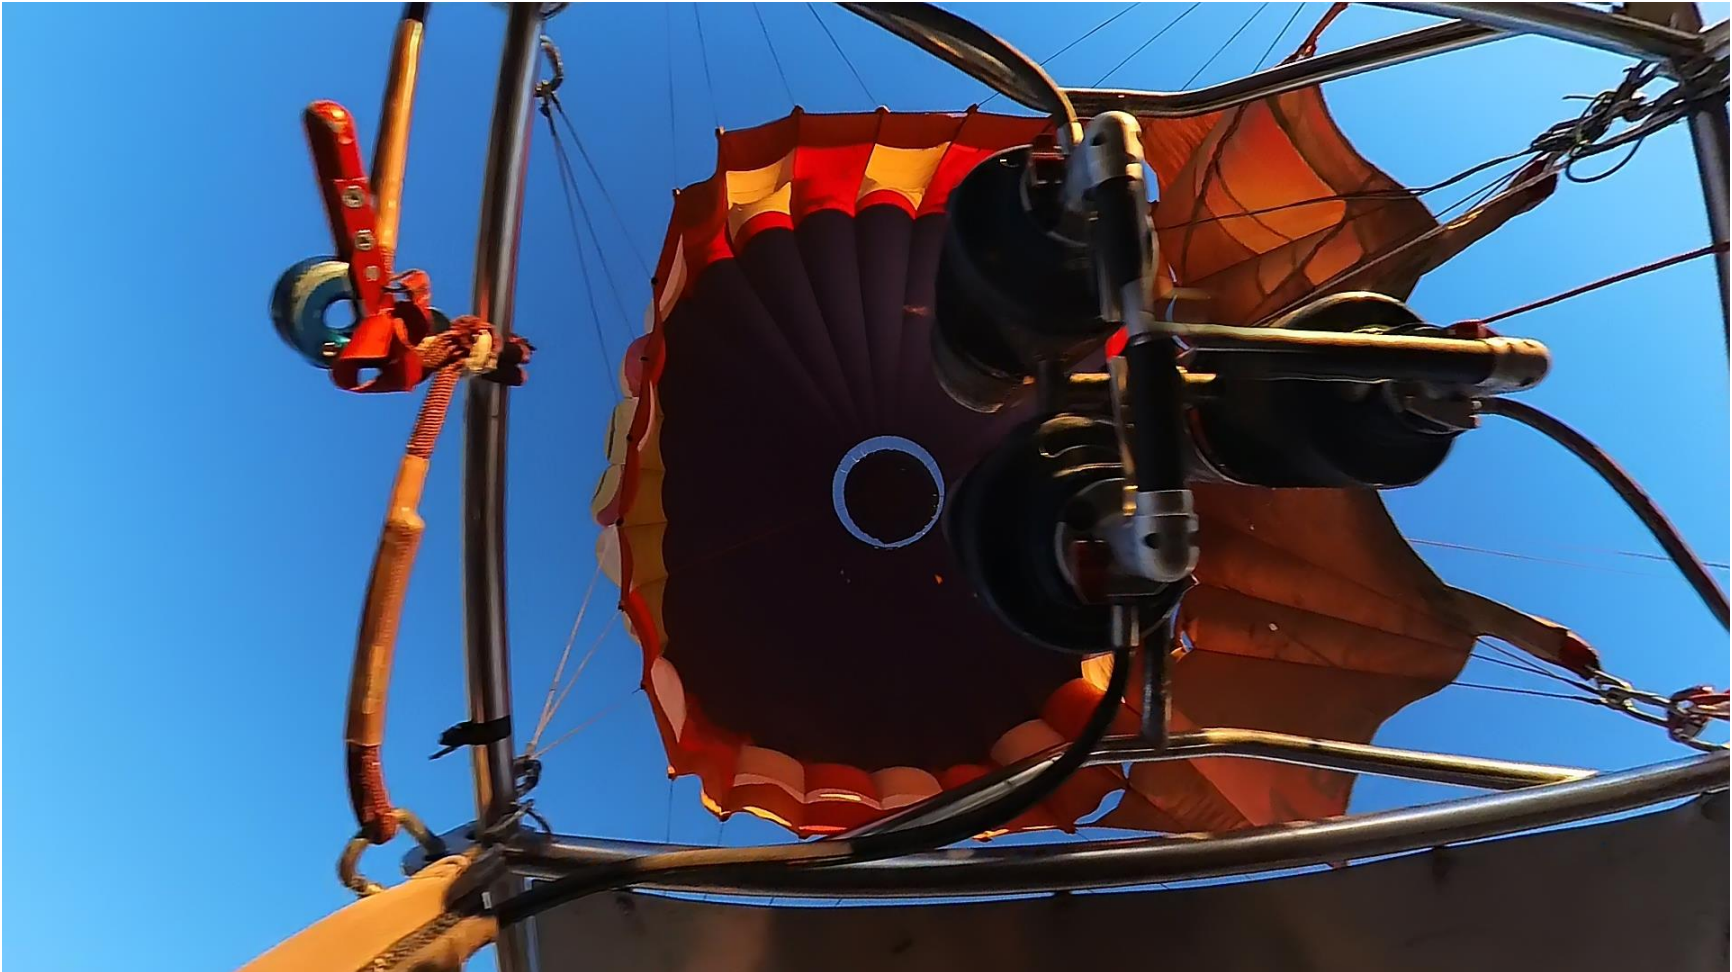
| <b>Time<br/>(mm:ss)</b> | <b>Observation</b> |
|---|---|
| <b>07:52</b> | The pilot looked up and pulled the camera through the basket to the other side. The rapid deflation system vent was observed open (Figure 2). The pilot then began securing the camera pole, while conversing with passengers. The envelope was observed rapidly changing shape as it continued deflating. |

**Figure 2.** View at 07:52 in the second video, as the camera passed through the basket, showing the deflation system vent open.
