# National Transportation Safety Board

WPR24FA073

## **WRECKAGE, AIRFRAME AND ENGINE EXAMINATION**

Location: Half Moon Bay, California  
Date: January 14, 2024  
Time: 1904 Pacific standard time  
Airplane: Cozy MK IV, N656TE

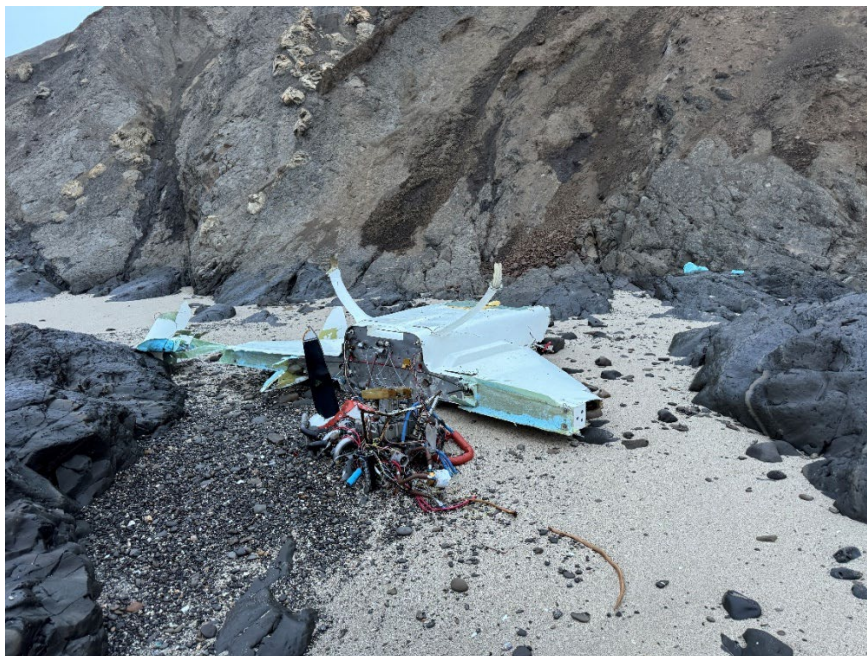
Examination of the wreckage that washed on shore was conducted on January 17, 2024. The center portion of the fuselage, right wing, various fragments of fiberglass, engine, and propeller had washed ashore about 2,130 ft west of HAF.

**Figure 1: View of wreckage and debris washed on shore.**

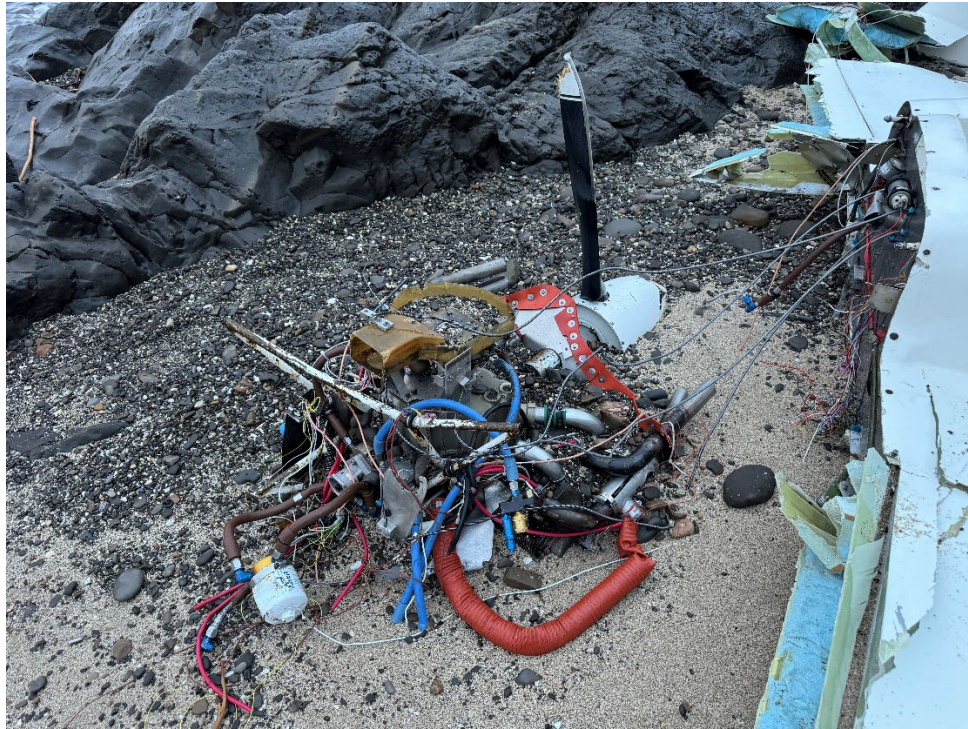
The engine was found upside down, partially embedded within sand and rocks. The engine remained attached to the engine mount, however, the engine mount was separated from the fuselage. A significant amount of rocks and sand was covering the engine. No holes were observed within the crankcase. The induction air box was impact damaged, and the filter element was missing. The fuel supply line from the airframe fuel pump was separated from the engine.

**Figure 2: View of engine as found on the shoreline.**

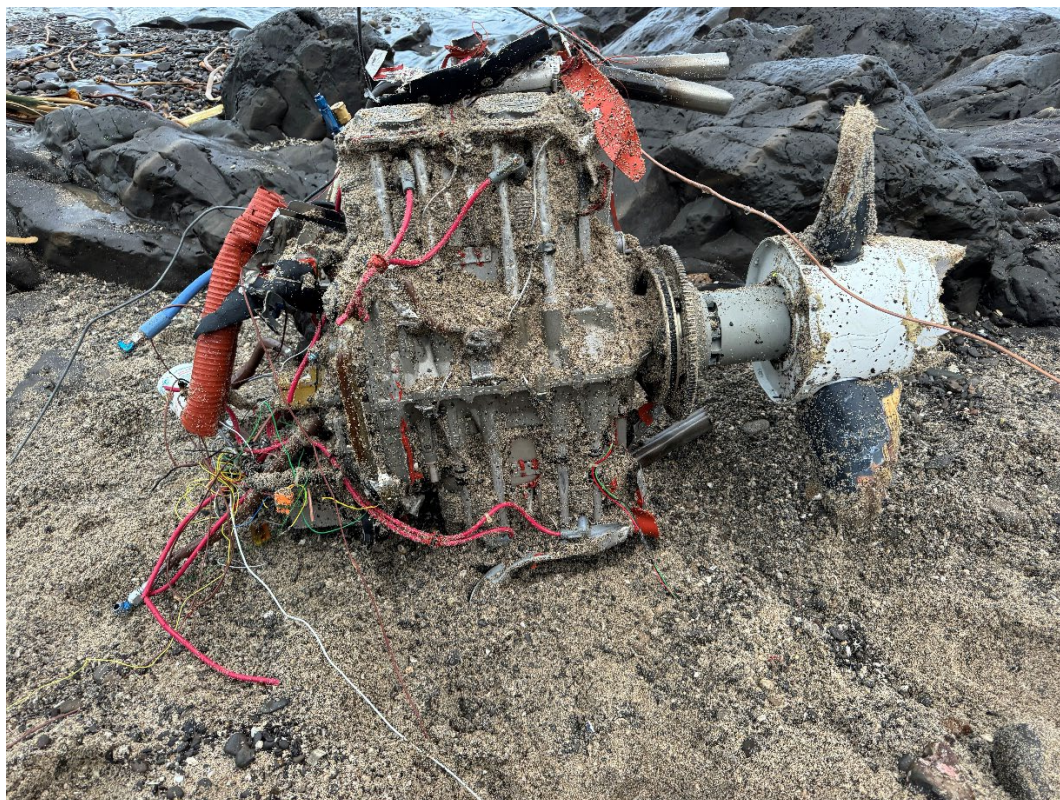
The fuel flow divider, inlet fuel line, and outlet fuel lines remained attached to the engine, however, it was compressed downward against the crankcase. No evidence of any staining or leaks were observed around the inlet fuel line and outlet fuel lines. An FAA inspector removed the fuel flow divider and associated fuel lines from the engine. He stated that while he was removing the inlet fuel line, it was "loose" when using a wrench to remove the "B" nut. Additionally, the inspector noted that the "B nuts" on the 4 outlet ports were loose when removing them utilizing a wrench. All 4 fuel injector lines were impact damaged. Once removed, the NTSB investigator disassembled the fuel flow divider. The 4 screws were tight and had a single strand of

non-twisted safety wire through them, with only one small area twisted, tying both ends together. The internal diaphragm and spring were intact.

**Figure 3: View of the top side of the engine.**

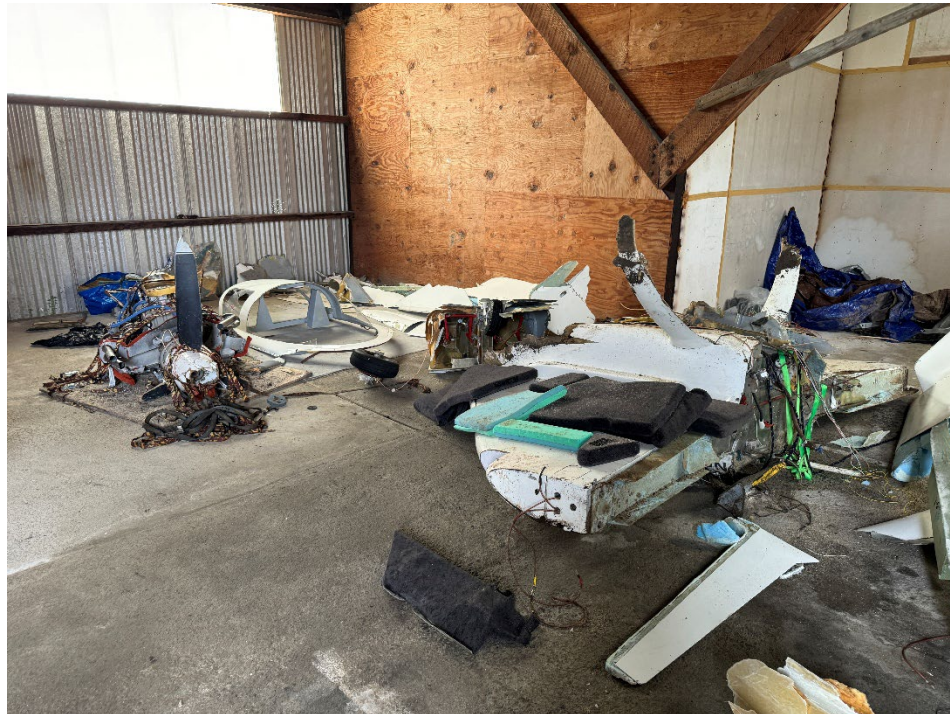
**Figure 4: View of the recovered wreckage.**

Examination of the recovered wreckage revealed that the engine and most of the fuselage, and wing structure were recovered. Remains of the ailerons and canards were observed. The fuel selector was removed and air pressure applied to the outlet line in 3 positions (left, right, and both), with air expelling from the left and right ports. Additionally, air pressure was applied to the left and right fuel lines and the sound of flowing air was heard from the fuel filler ports on each fuel tank. No restrictions in the fuel lines were noted. The airframe fuel pump was impact damaged and exhibited varying degrees of corrosion, consistent with saltwater submersion. The HOBBS meter indicated 906.6 hours. The airframe electrical system was fragmented into multiple sections which precluded functional testing.
