Joshua Cawthra  
Senior Aviation Accident Investigator  
Office of Aviation Safety - Western Pacific Region

**Subject:** WPR24FA073 - Video Camera Footage

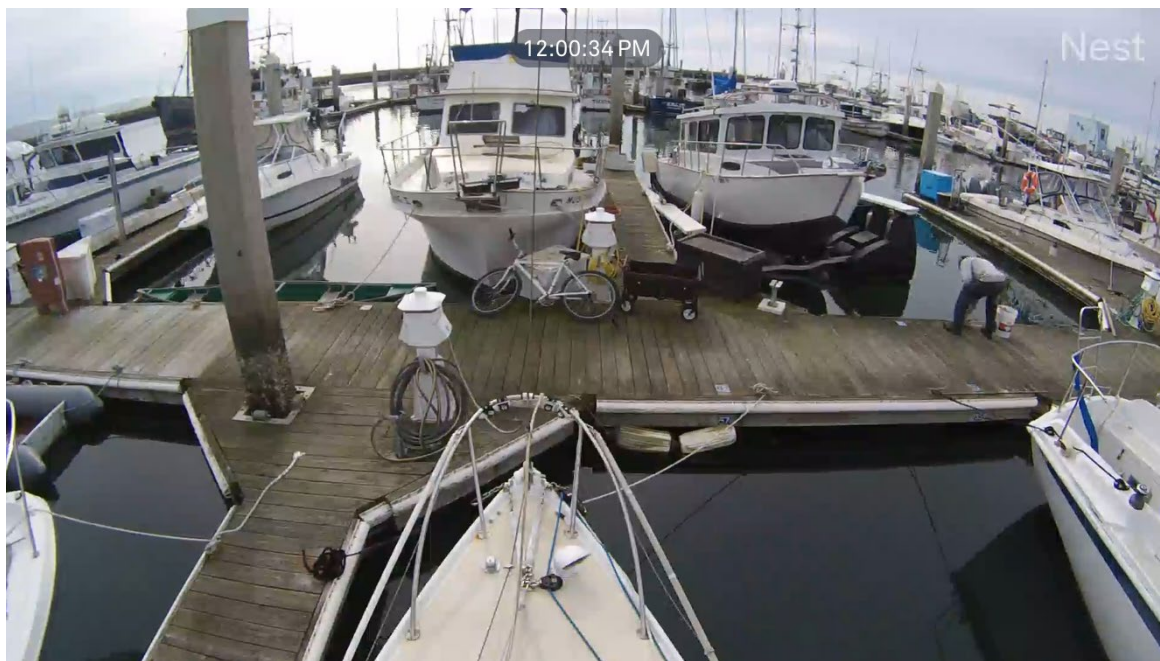
A witness submitted security camera recordings captured from a camera mounted on his boat (see Figure 1), located in a marina about 1 mile southeast of the approach end of runway 30 at Halfmoon Bay Airport. The model of camera had an approximate 130° to 152° horizontal viewing angle.

*Figure 1: Daytime view from the security camera.*

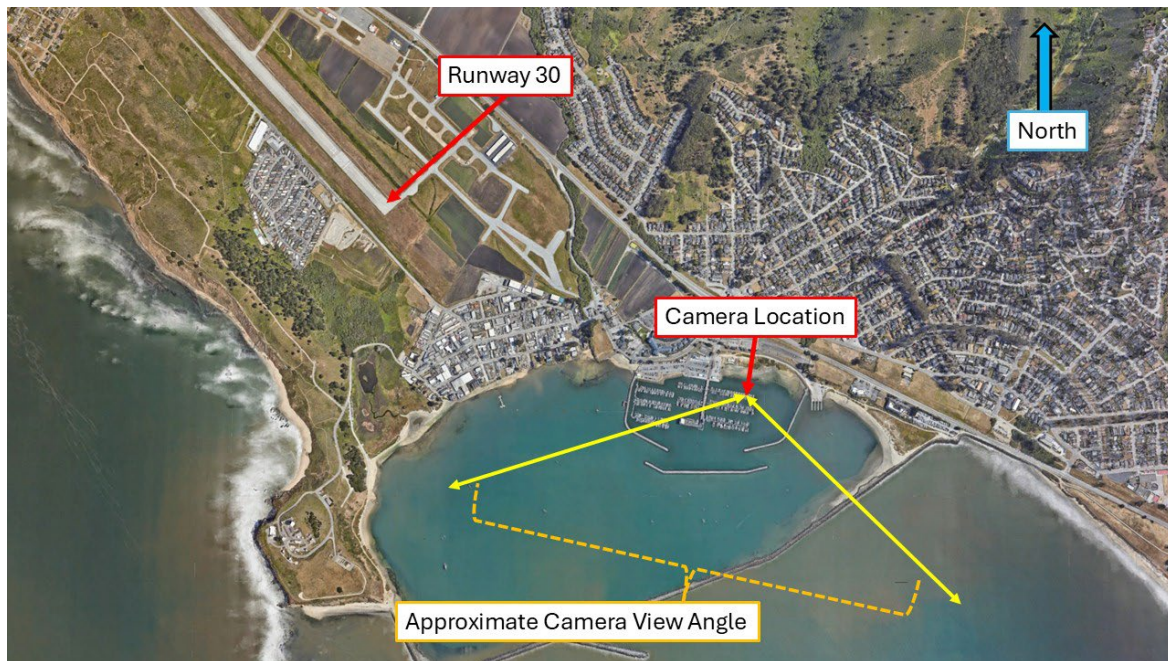
*Figure 2: Camera Location and Approximate Camera View Angles*

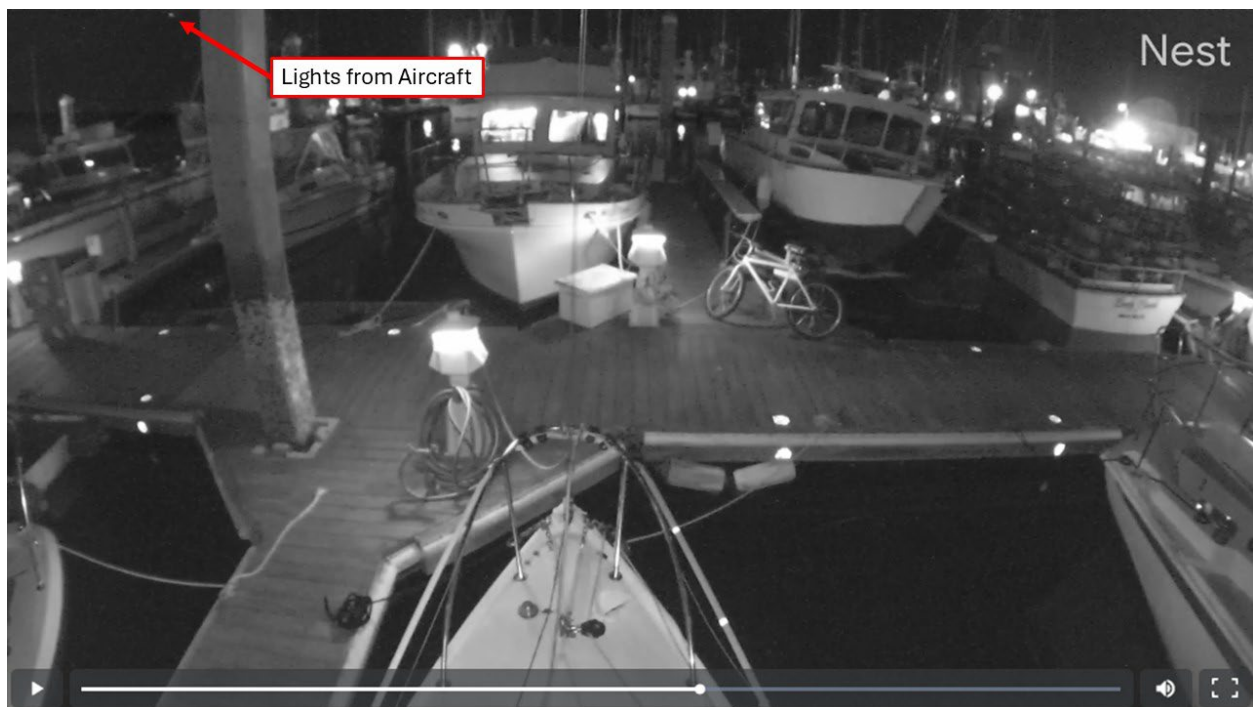
About 1 minute, 27 seconds (about 1904:52 PST), lights from what appears to be from an aircraft enter the upper left area of the frame of video. The lights could be seen transitioning down and to the left side out of the frame of the video 39 seconds (about 1905:32 PST) later as seen in figures 3 and 4.

*Figure 3: Lights from an aircraft come into view of the camera.*

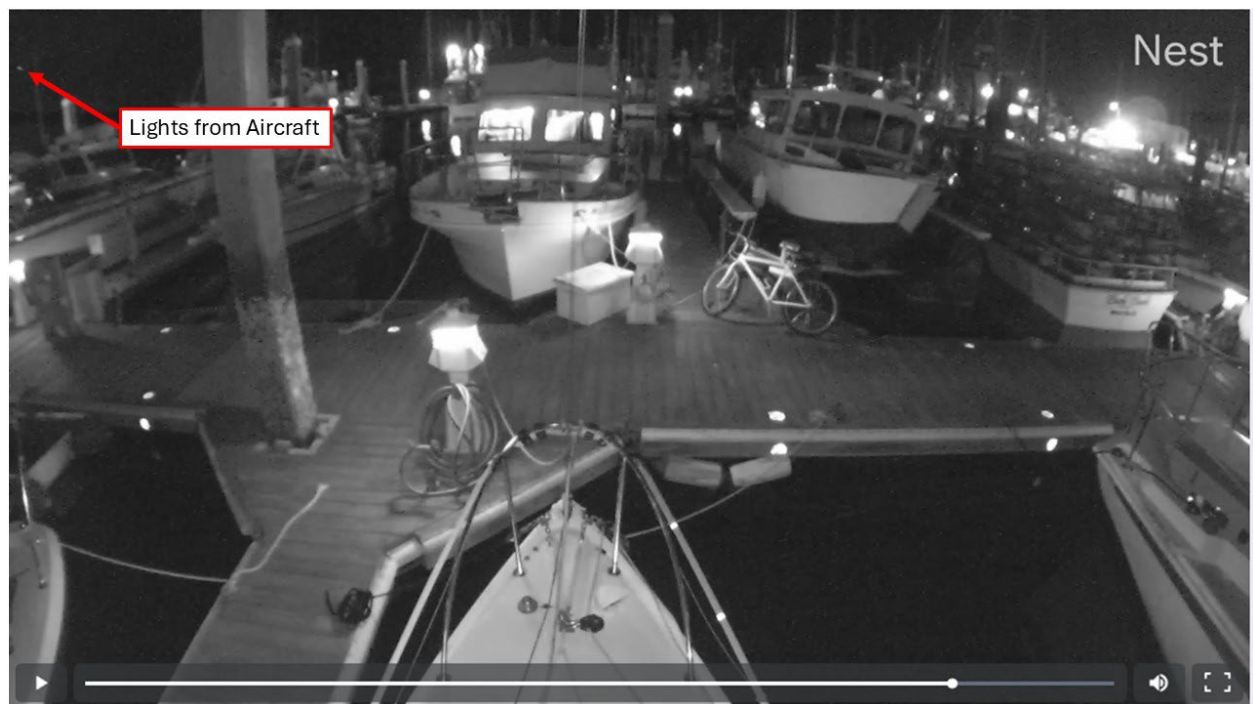
*Figure 4: Lights from an aircraft exit the view of the camera.*
