WPR24FA080

## INVESTIGATION PHOTOGRAPHS

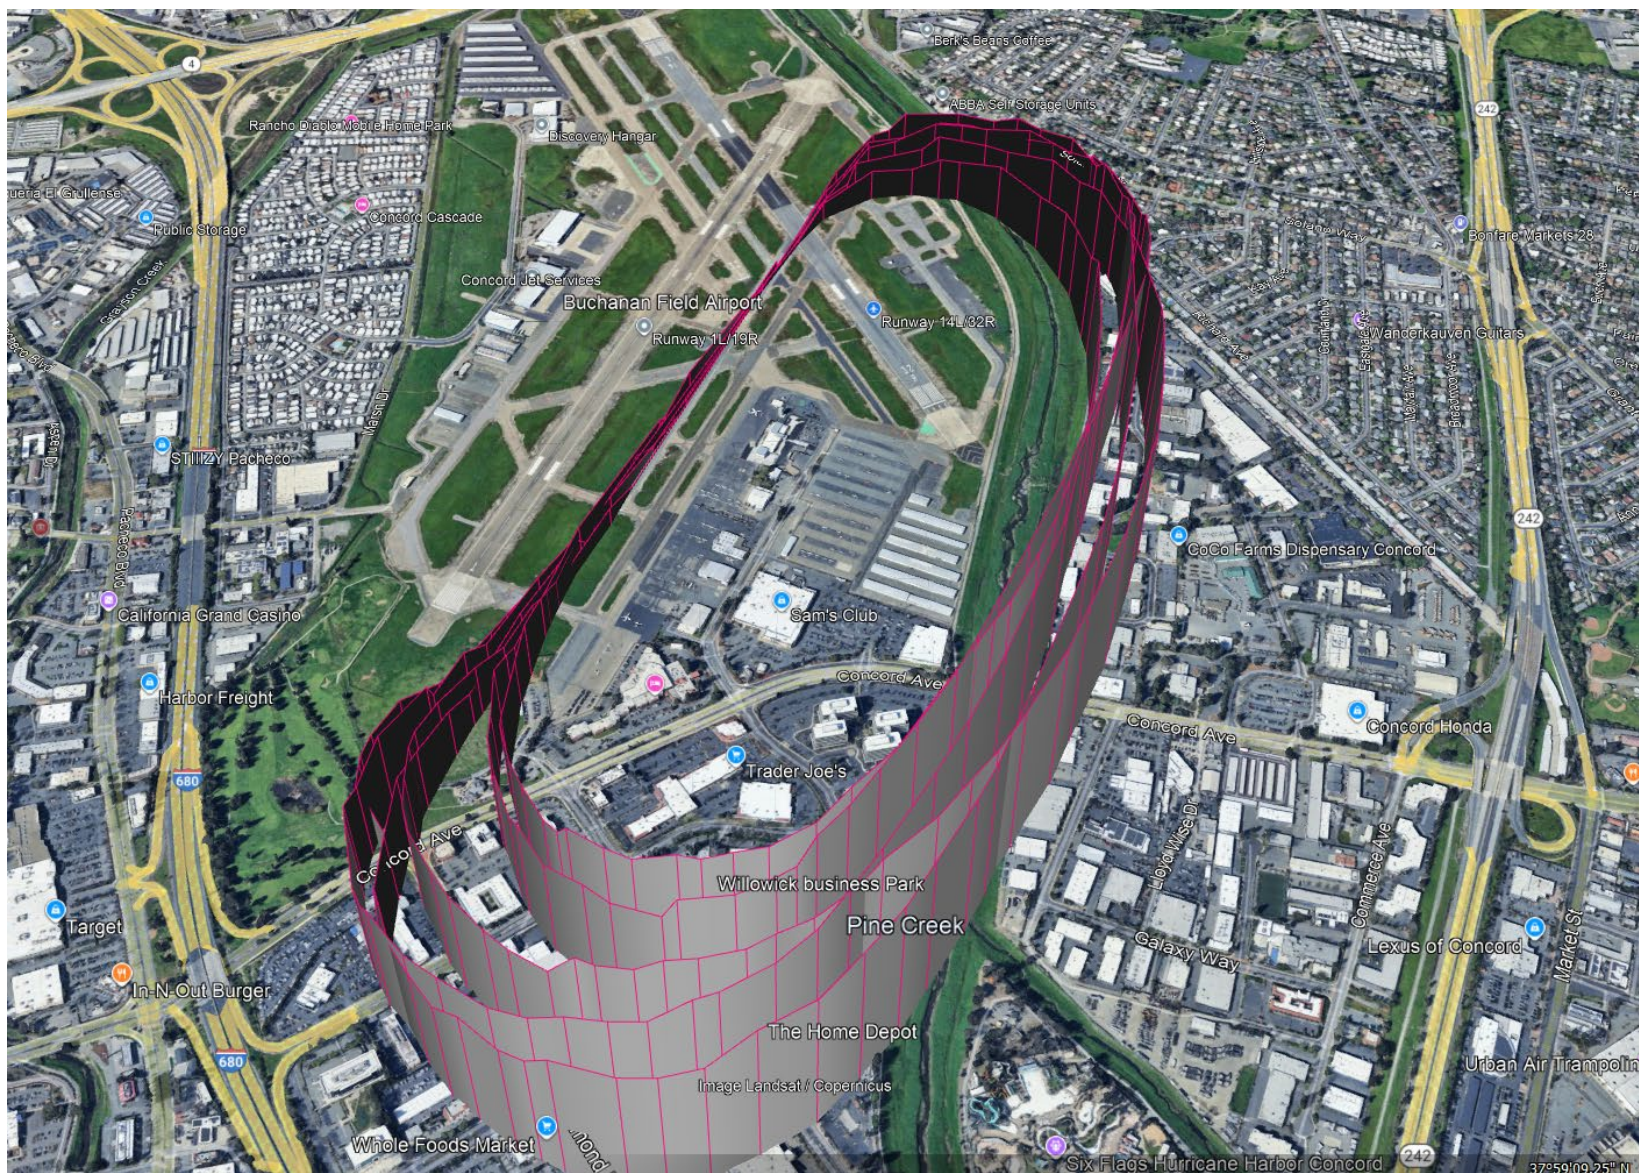
**Photograph 1 - Flight path track photograph**

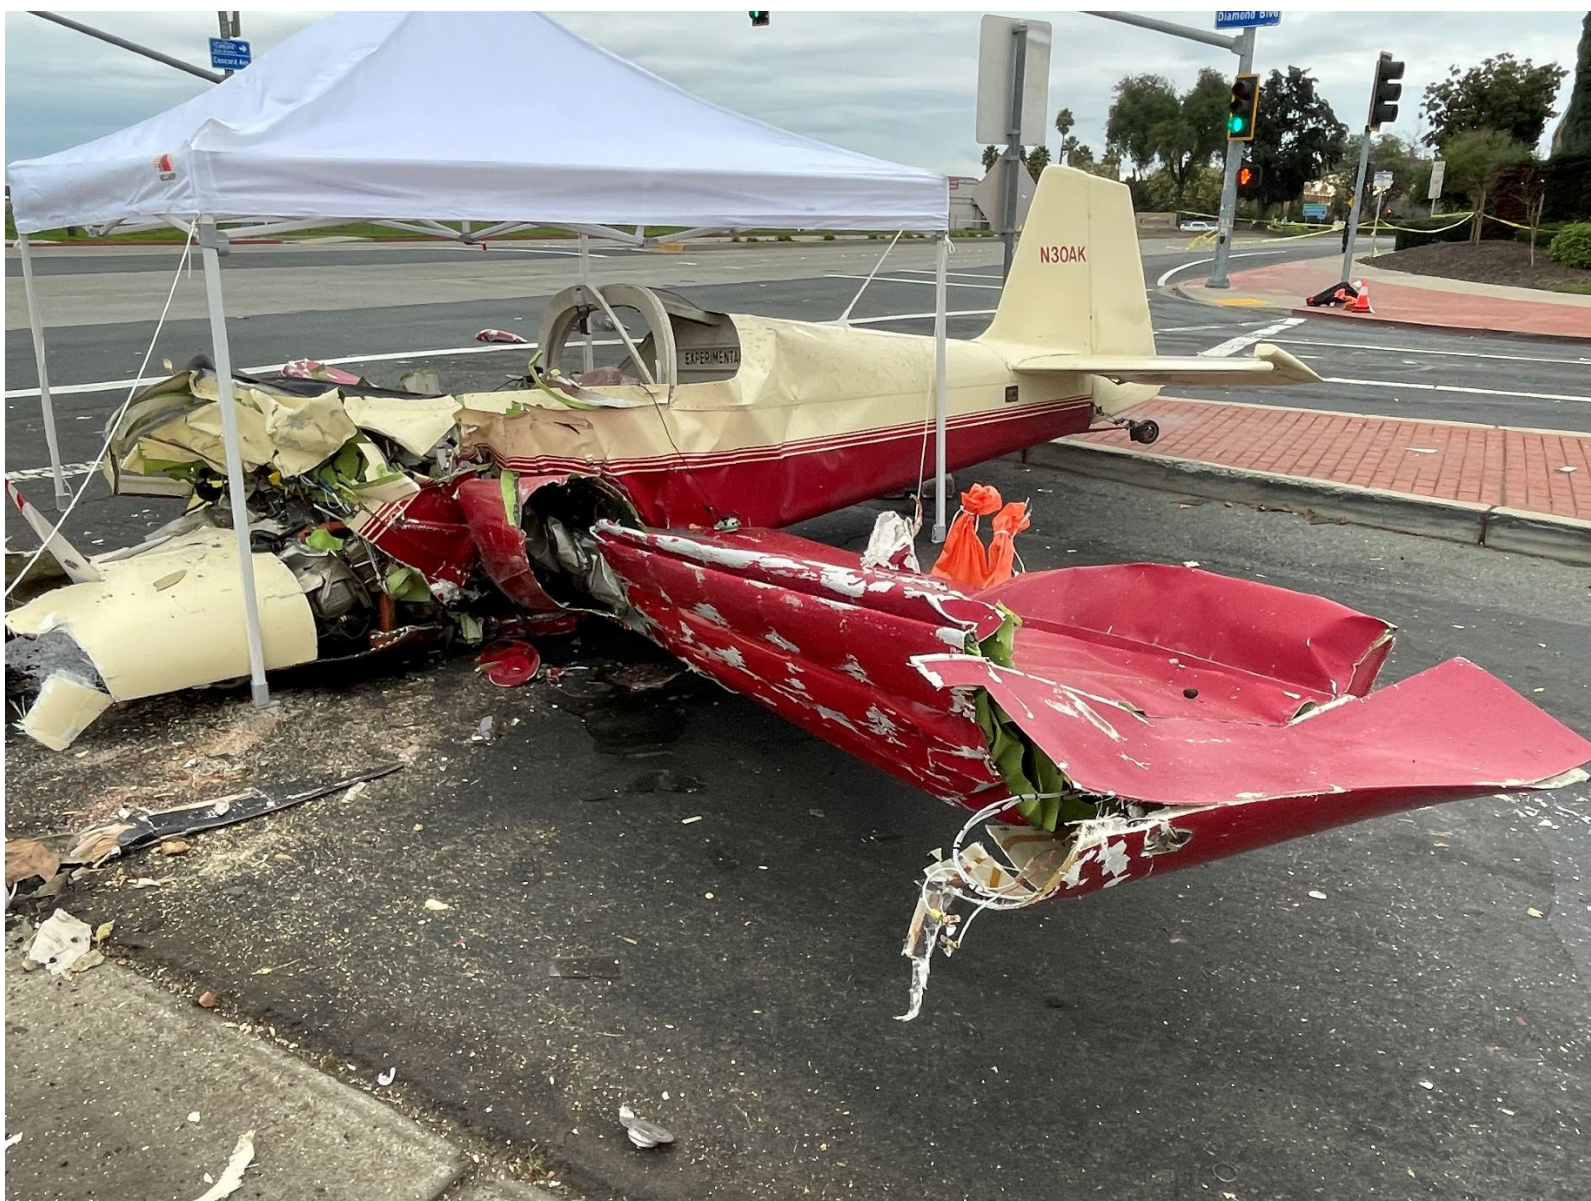
**Photograph 2 - Left side view of airplane at accident site**

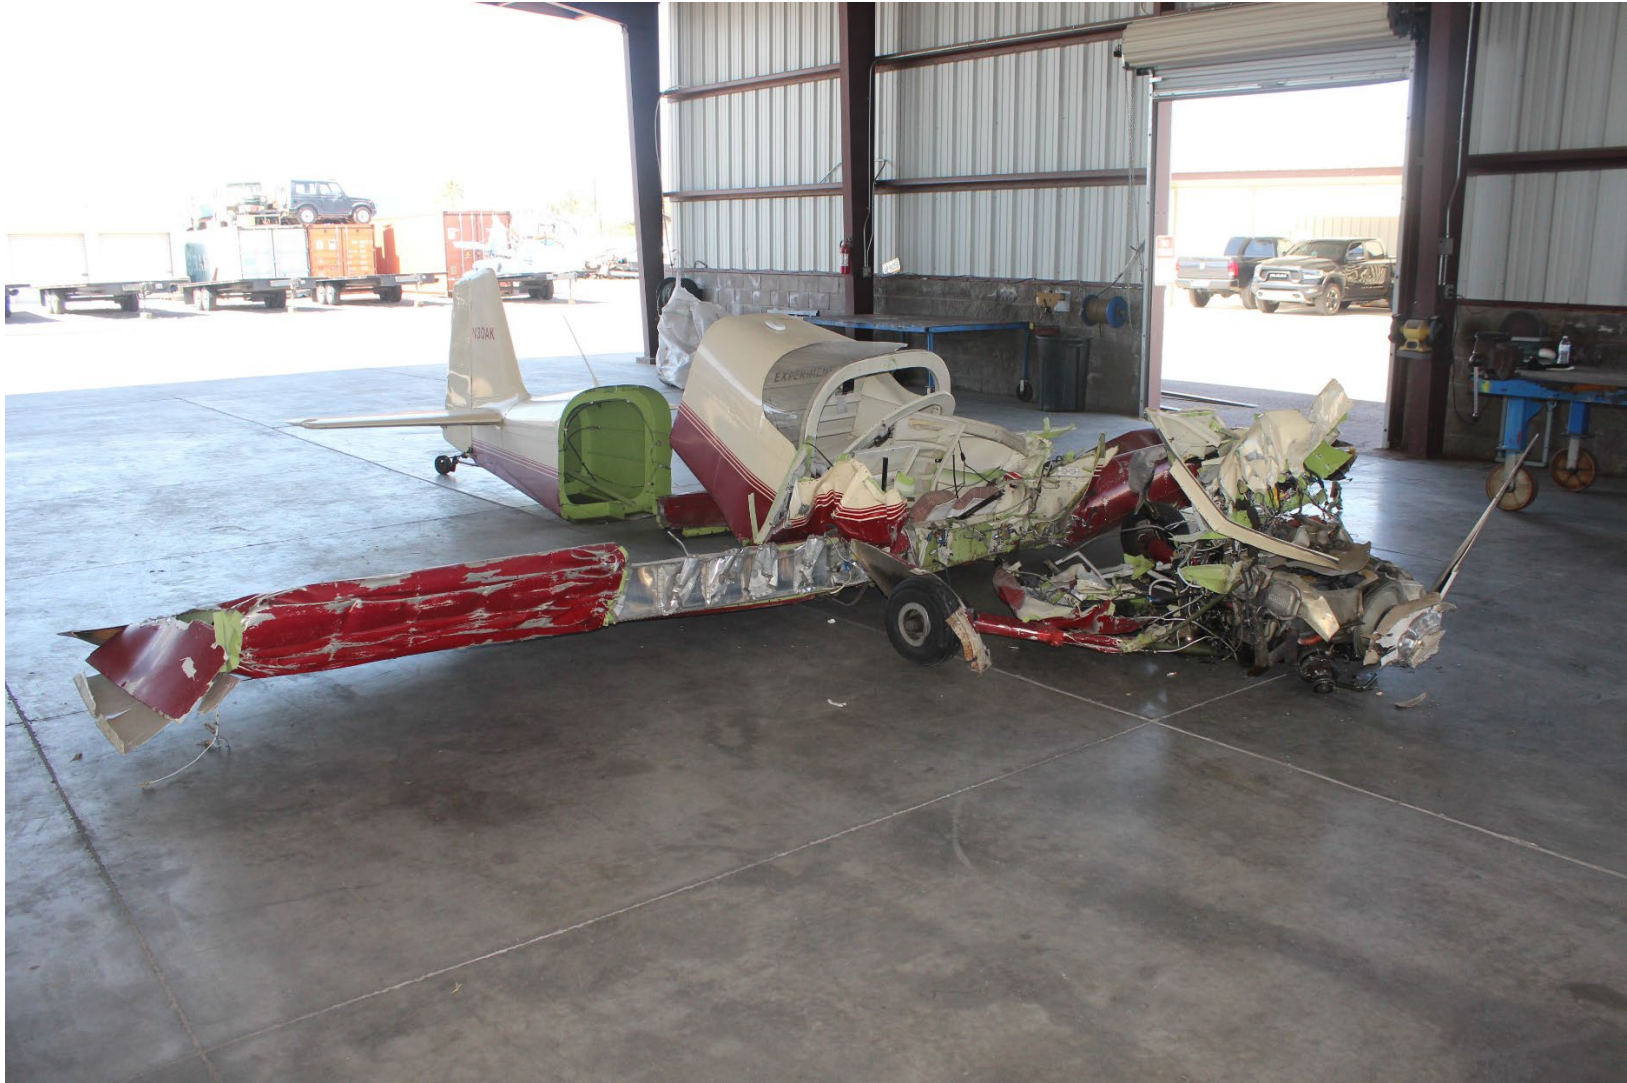
**Photograph 3 - View of airplane at the engine exam.**

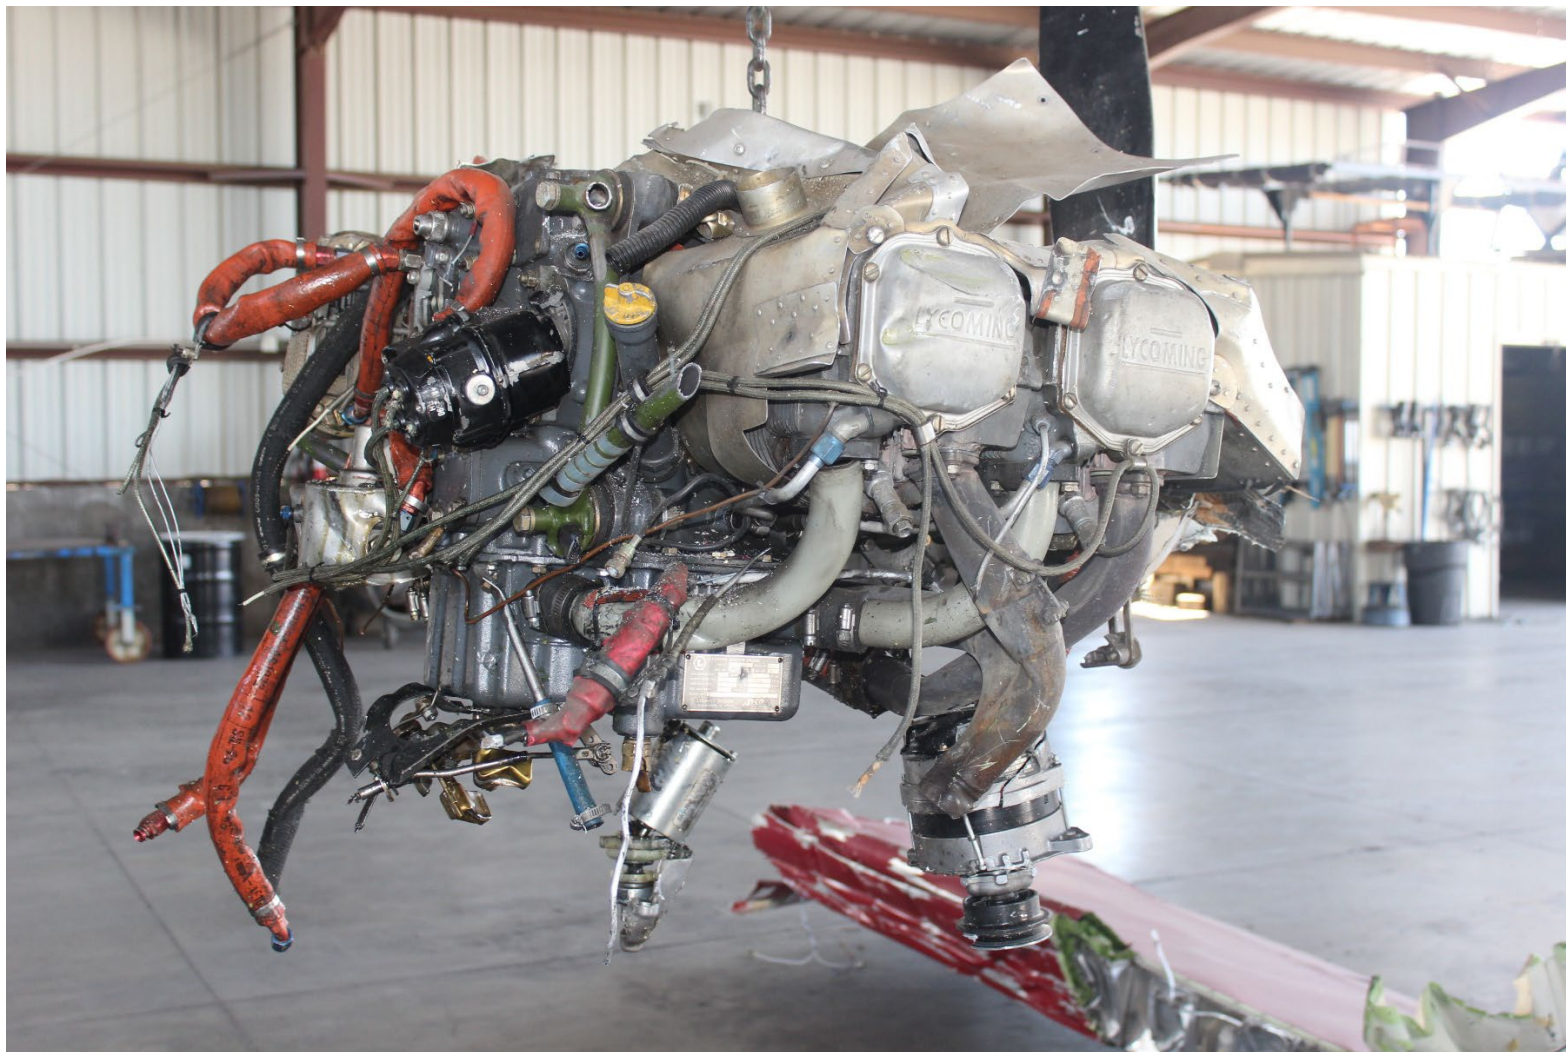
**Photograph 4 - View of engine separated from airframe (Courtesy of Lycoming)**

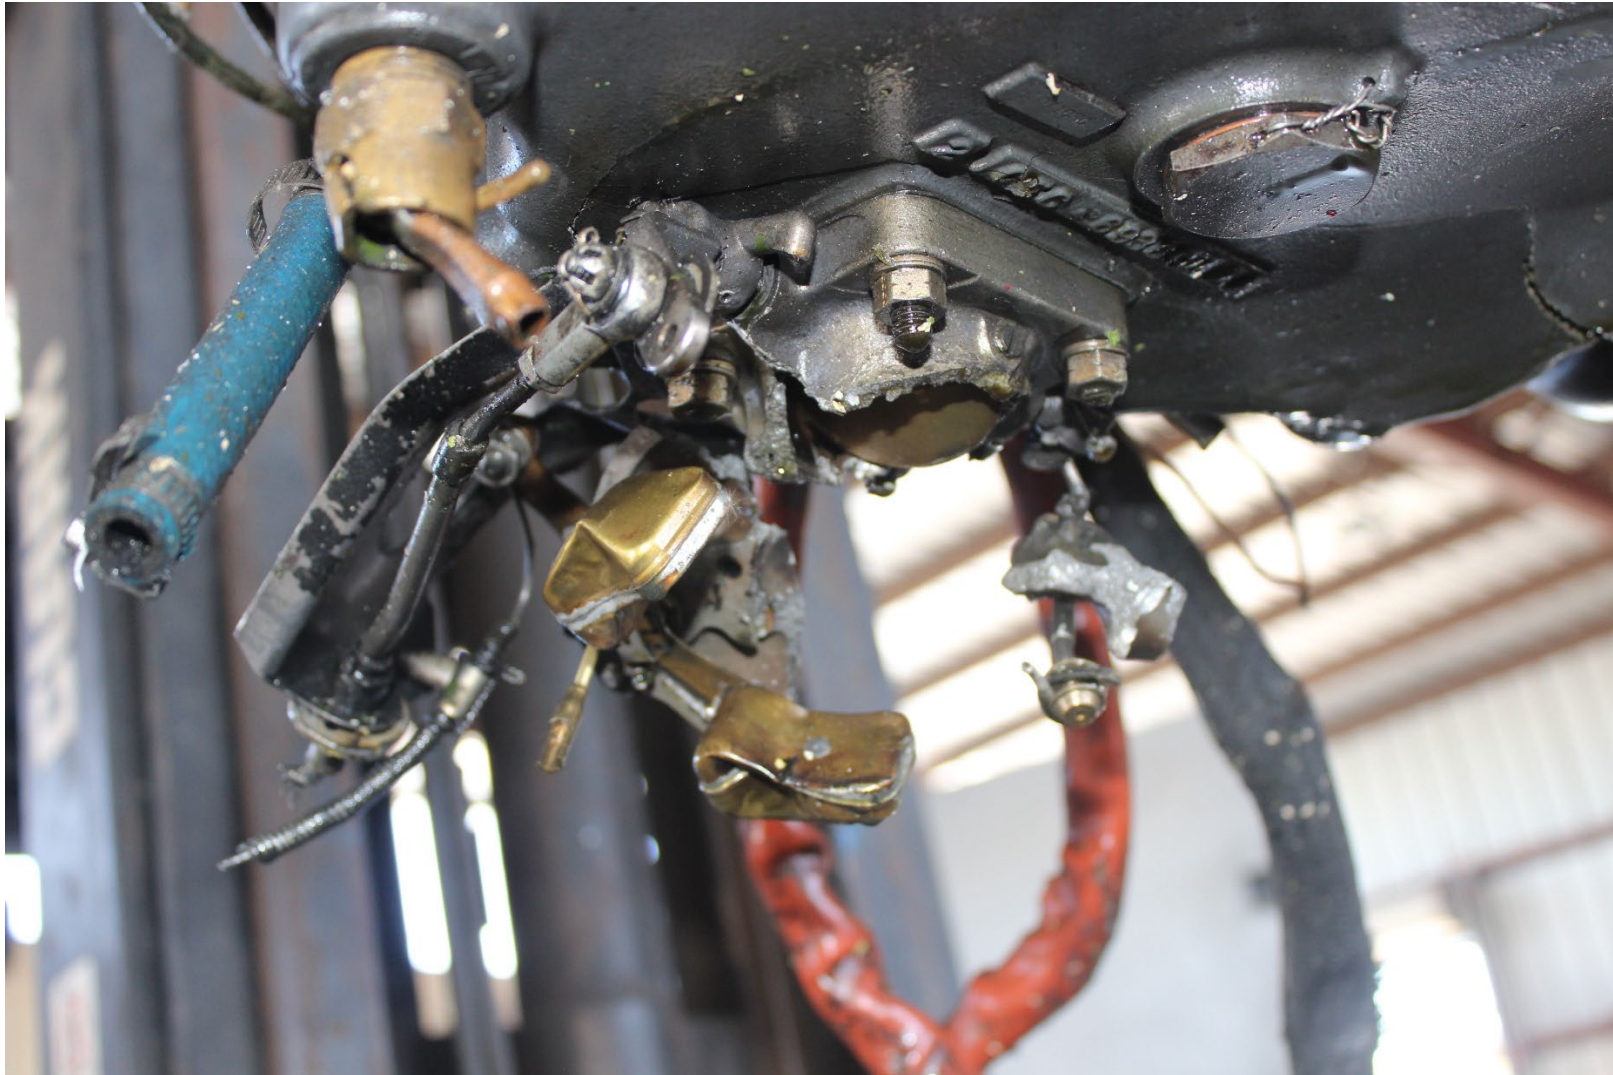
**Photograph 5 - View of carburetor damage (Courtesy of Lycoming)**

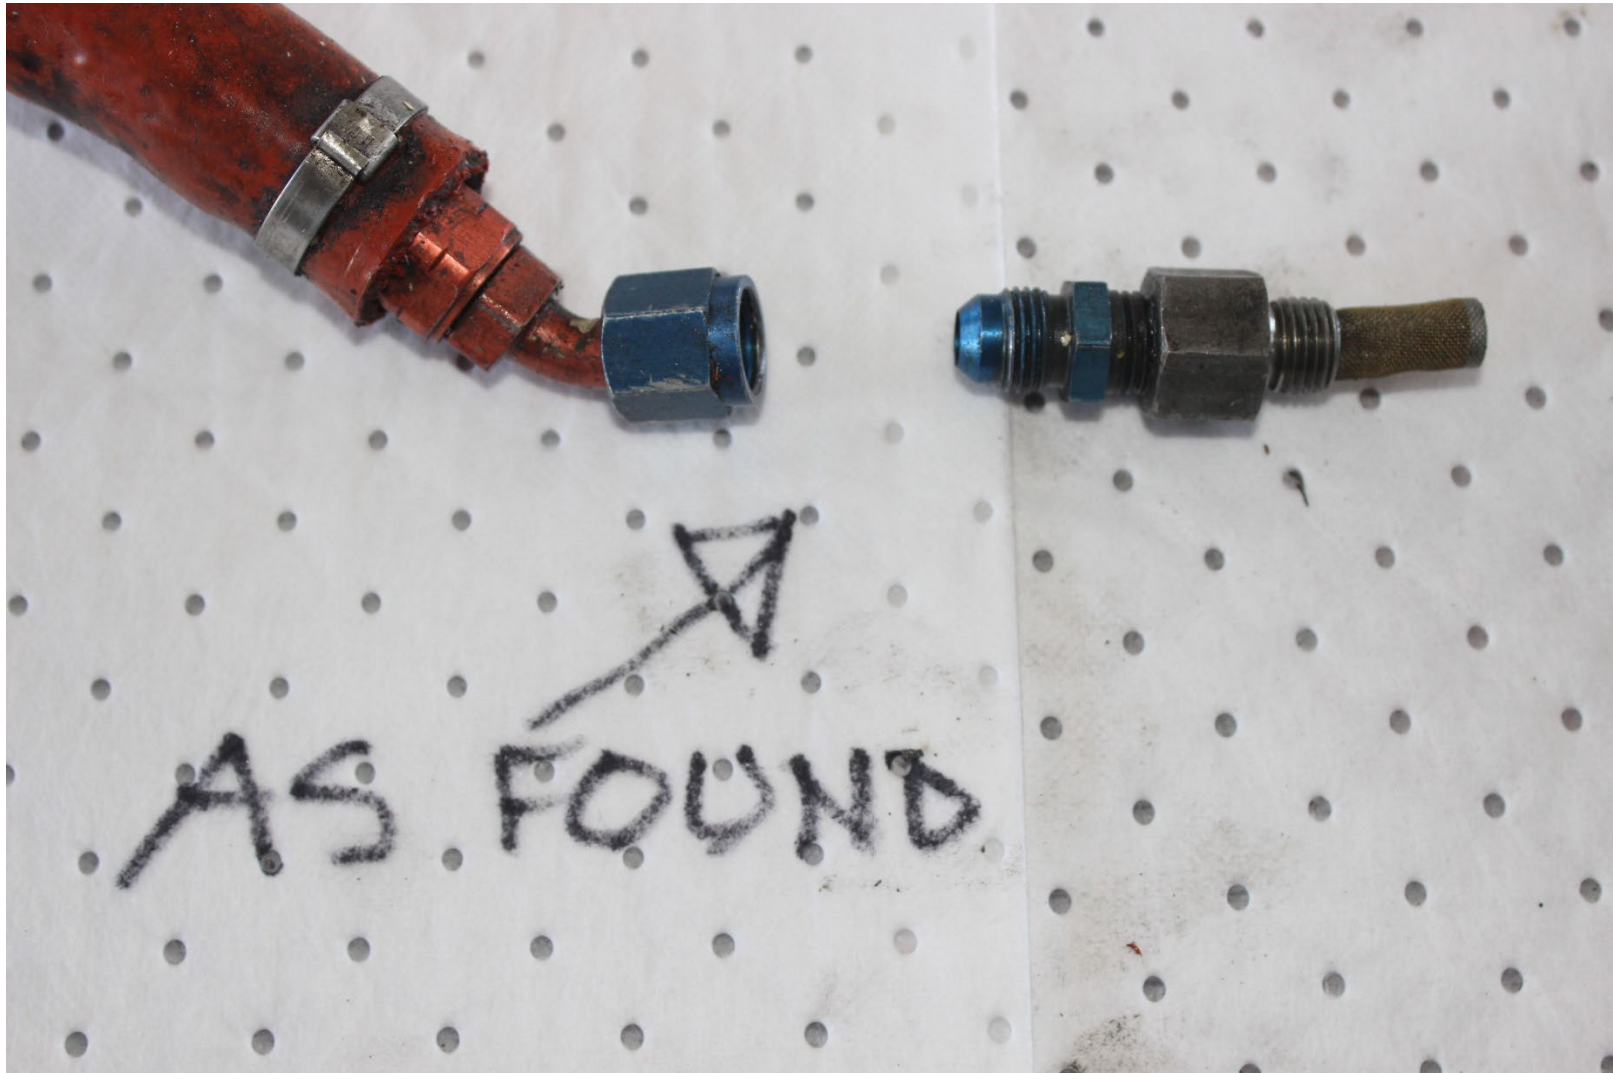
**Photograph 7 - View of detached fuel line**
