# National Transportation Safety Board

WPR24FA080

## **ACCIDENT SITE EXAMINATION**

Location: Concord, California  
Date: January 31, 2024  
Time: 1029 PST  
1829 UTC  
Airplane: Vans RV-6 (N30AK)

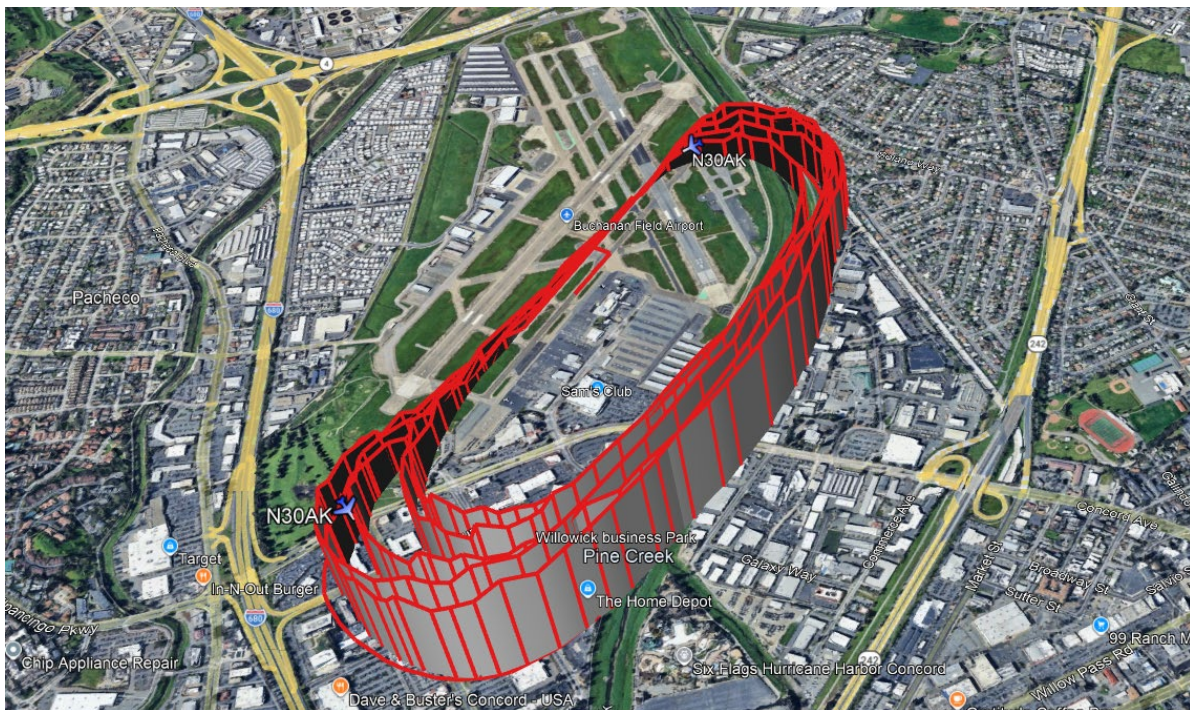
A review of the Federal Aviation Administration (FAA) Automatic Dependent Surveillance Broadcast (ADS-B) data revealed that the airplane departed runway 19L at 1009:21. The airplane continued in the pattern for a series of six touch and go practice take-offs and landings at Buchanan Field Airport, Concord, CA (KCCR). After the 7<sup>th</sup> take off the airplane climbed to approximately 100 ft mean sea level (MSL) and began a shallow decent while making a left turn. The last ADS-B target was at 1029:10 and was located about 100 ft east of the main wreckage.

**Figure 1: ADS-B flight track photograph**

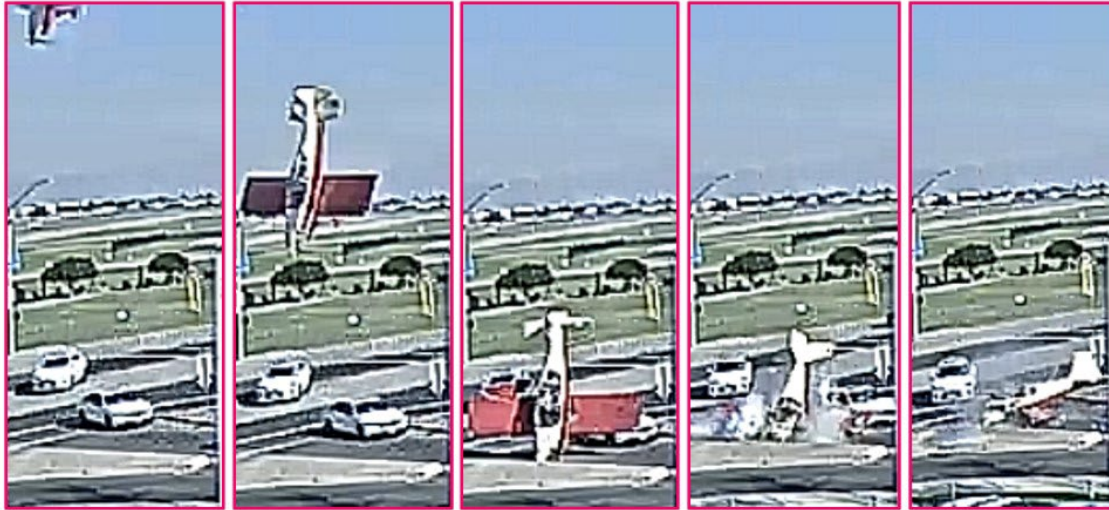
A review of security camera footage revealed that after the final take-off, the airplane entered a near-vertical nose-down decent into the pavement. Numerous witnesses reported that they observed the airplane climbing and then heard the engine suddenly quit. The engine sound momentarily resumed, and the airplane started a brief climb. Seconds later, the engine noise stopped again, and the airplane initiated a left bank, aggressively increasing the steepness of the bank in descent.

**Figure 2: Nose down camera footage**

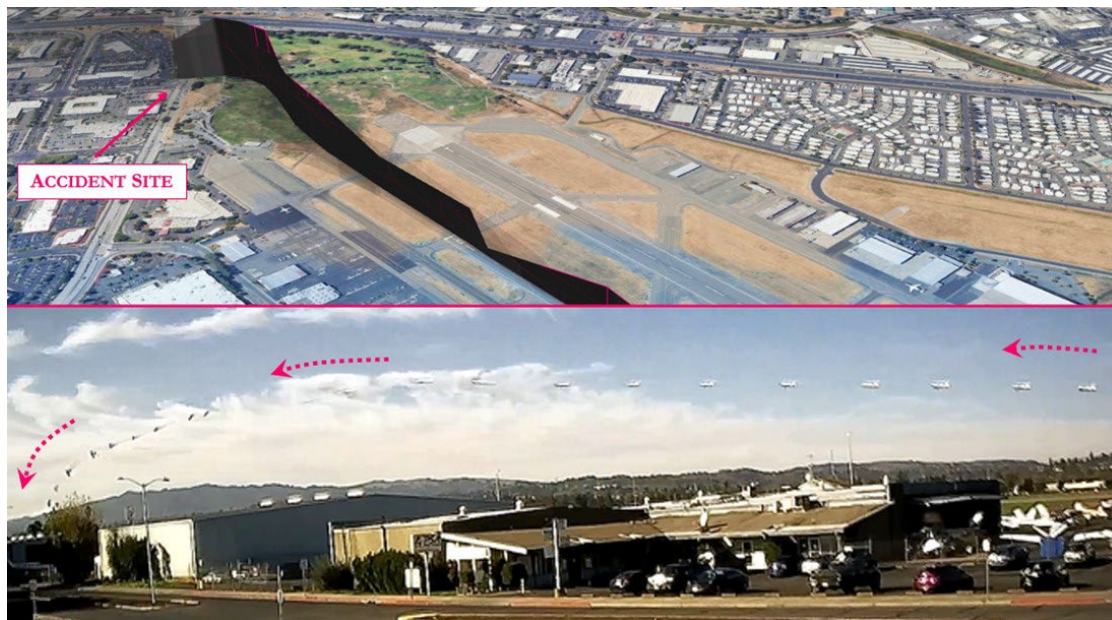
When on the final touch and go on departure, airport video showed the airplane striking the terrain in a vertical nose down attitude.

**Figure 3: View of airplane flight path from video camera**

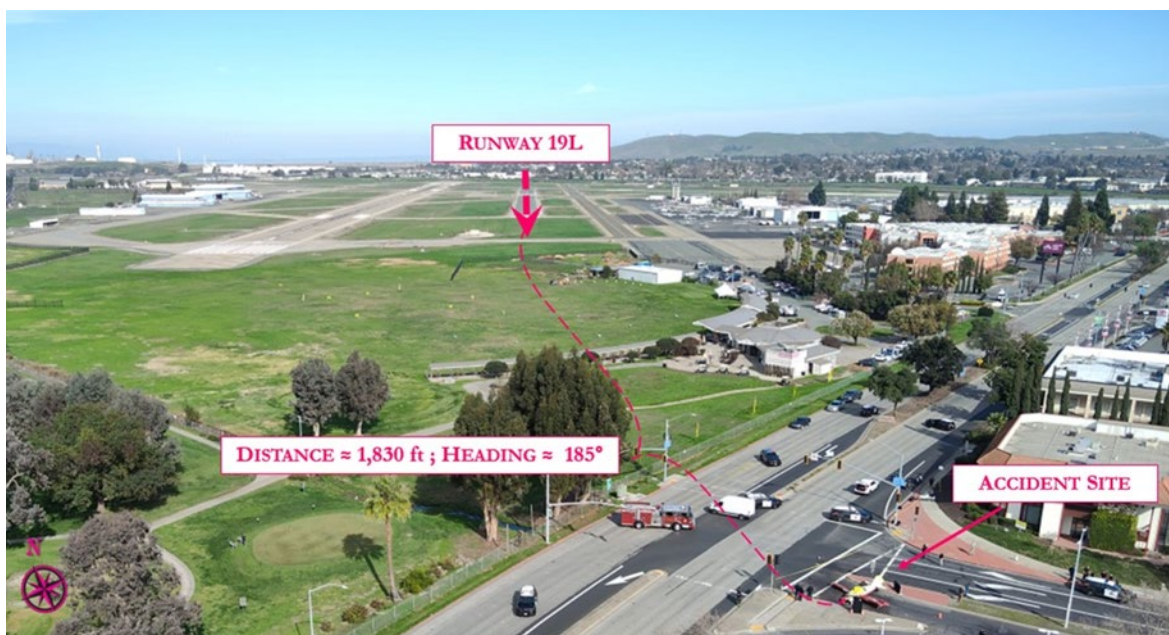
The airplane came to rest about 1,830 ft, southwest of the departure end of 18L and was oriented on a heading of 270°. The debris field was confined to an area within 72 ft. of the wreckage. The airplane struck the pavement at the intersection of Diamond Blvd and Concord Ave just southwest of Buchanan Field airport property at a GPS location of (+037.977762 / -122.061267). The airplane shifted from initial impact about 3.5 feet to the right of centerline of the fuselage which came to rest right side up. A ground scar about 1 ft in diameter was collocated next to the main wreckage where the nose of the airplane made a hole in the pavement and the left wing had struck, leaving a mark and concrete chip of the road shoulder.

Figure 4: View of accident site diagram

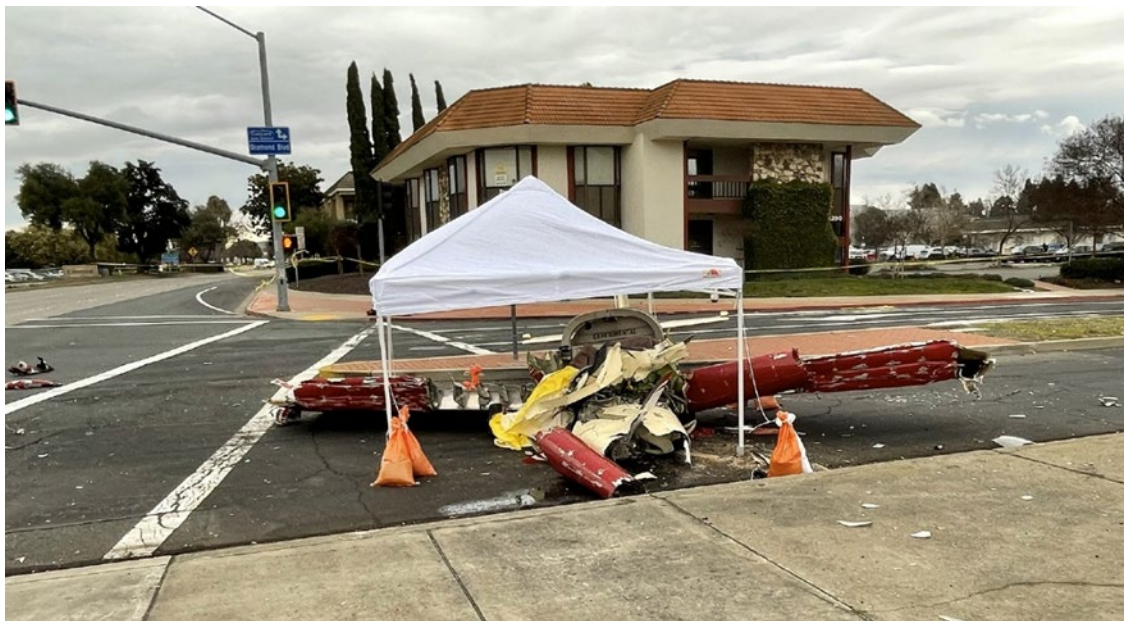
Examination of the wreckage revealed that the airplane came to rest upright. The forward section of the cockpit was impact damaged and crushed aft. The instrument panel was impact damaged with multiple instruments displaced. All of the major structures of the airplane were accounted for at the accident site. Both wings

remained attached to the fuselage at the wing root, the fuel tanks on each wing were breached and the fuel contents expelled.

Flight control continuity was established from all primary flight control surfaces to the left and right cockpit controls. Both flight control assemblies exhibited impact damage. No separations in the control cables were observed.

**Figure 5: Front view of accident airplane.**

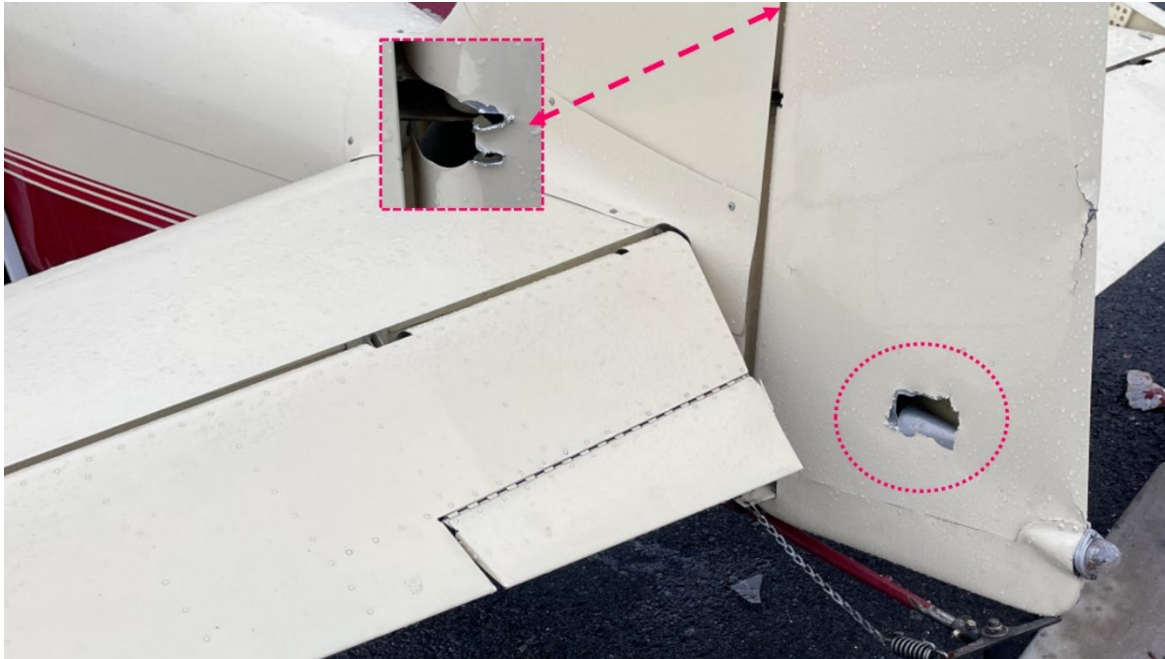
The empennage remained attached to the fuselage and was observed displaced to the left. Both elevators remained attached at their respective horizontal stabilizers and the rudder remained attached to the vertical stabilizer. The left elevator trim tab was in a neutral position and could not be actuated by hand. The rudder had a hole on the left side that when deflected to the left matched where the left trim tab and elevator were positioned in a slightly nose down position at impact.

**Figure 6: Left elevator rudder impact damage**

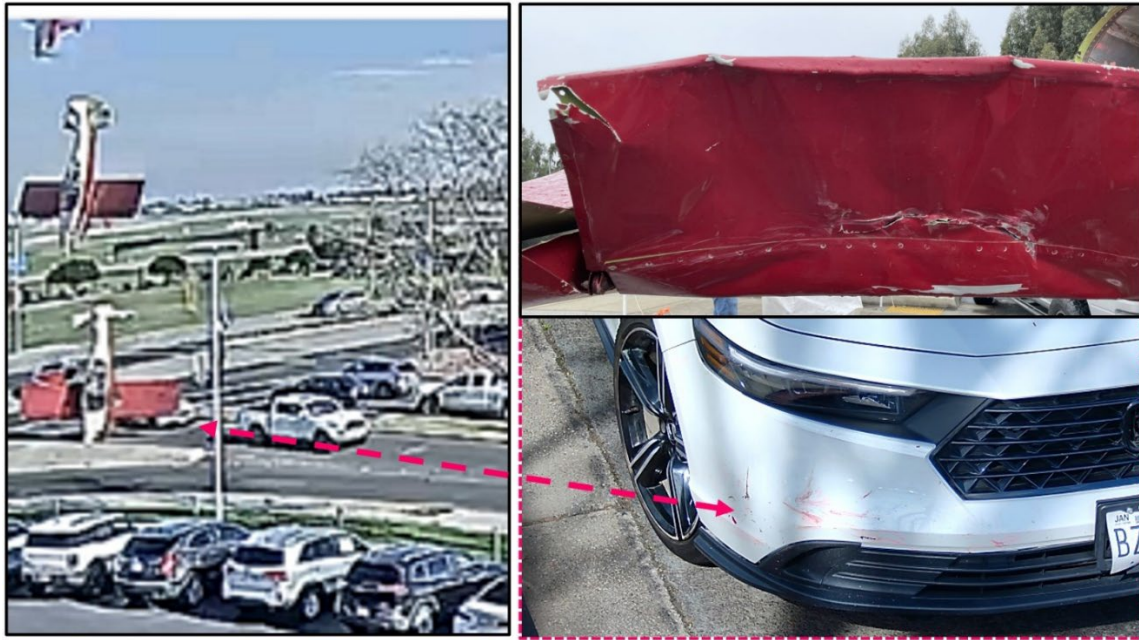
Both wings remained attached to the fuselage at the wing root. Both wings exhibited crushing and bending to the leading edges, from the wing tip to the wing root. Both wings were displaced aft, consistent with impact damage. Both ailerons and flaps remained attached to their respective mounts. The left aileron displayed an upward bend from both end attachment points and was binding and could not be moved. The right aileron exhibited binding and could not be moved.

The damage to the left aileron was consistent to the shape and paint transfer of a forward bumper of a passenger vehicle at the accident site.

**Figure 7: Left aileron vehicle impact damage**

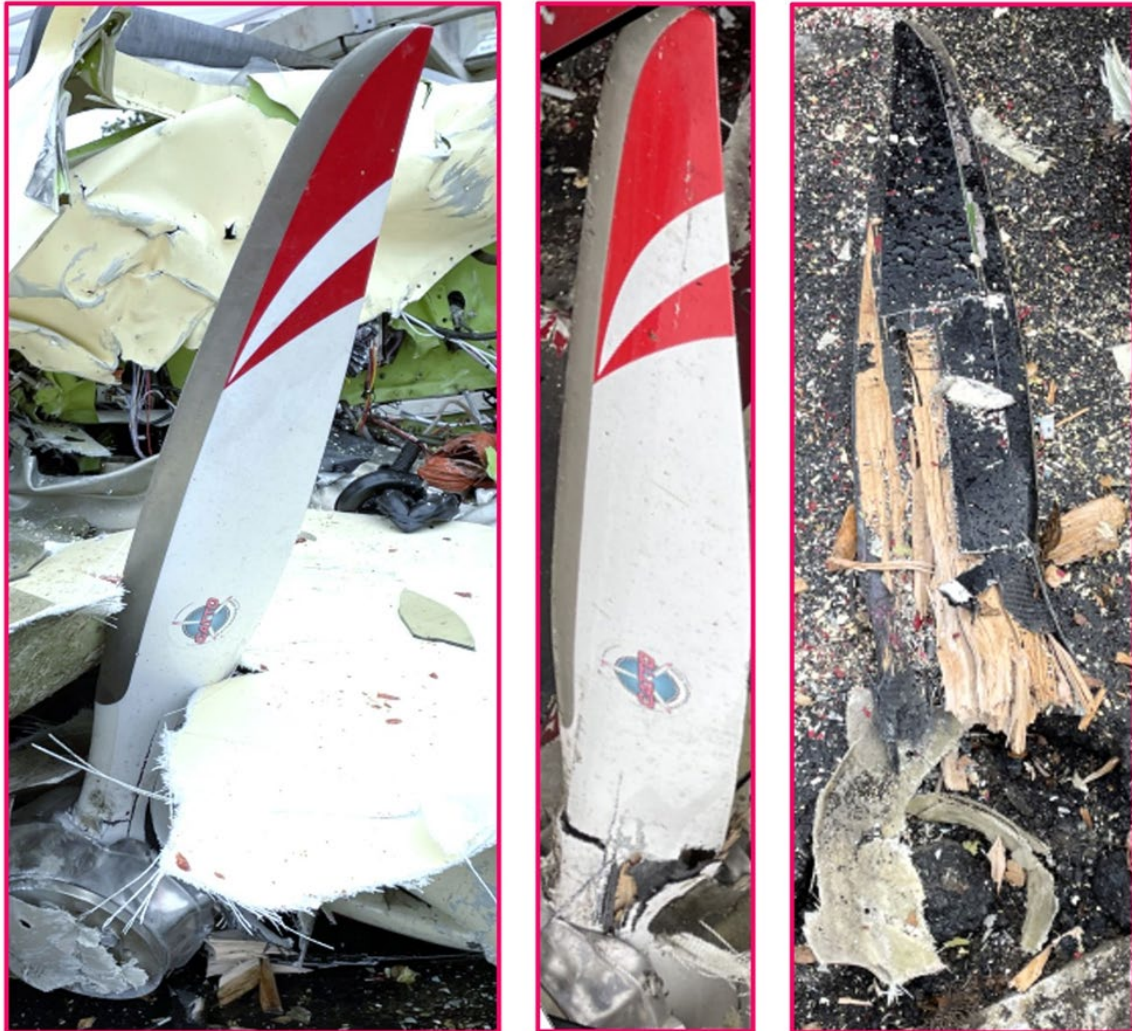
The airplane was equipped with a fixed pitch three blade propeller. One of the three blades of the propellor was fractured, separated and located near the propellor hub, consistent with impact damage. The other two blades remained attached to the propeller hub.

**Figure 8: View of separated propeller blades.**
