# National Transportation Safety Board

WPR24FA080

## ENGINE EXAMINATION

Location: Concord, California  
Date: January 31, 2024  
Time: 1029 PST  
1829 UTC  
Airplane: Swanson R/Swanson S, Vans RV-6 N30AK

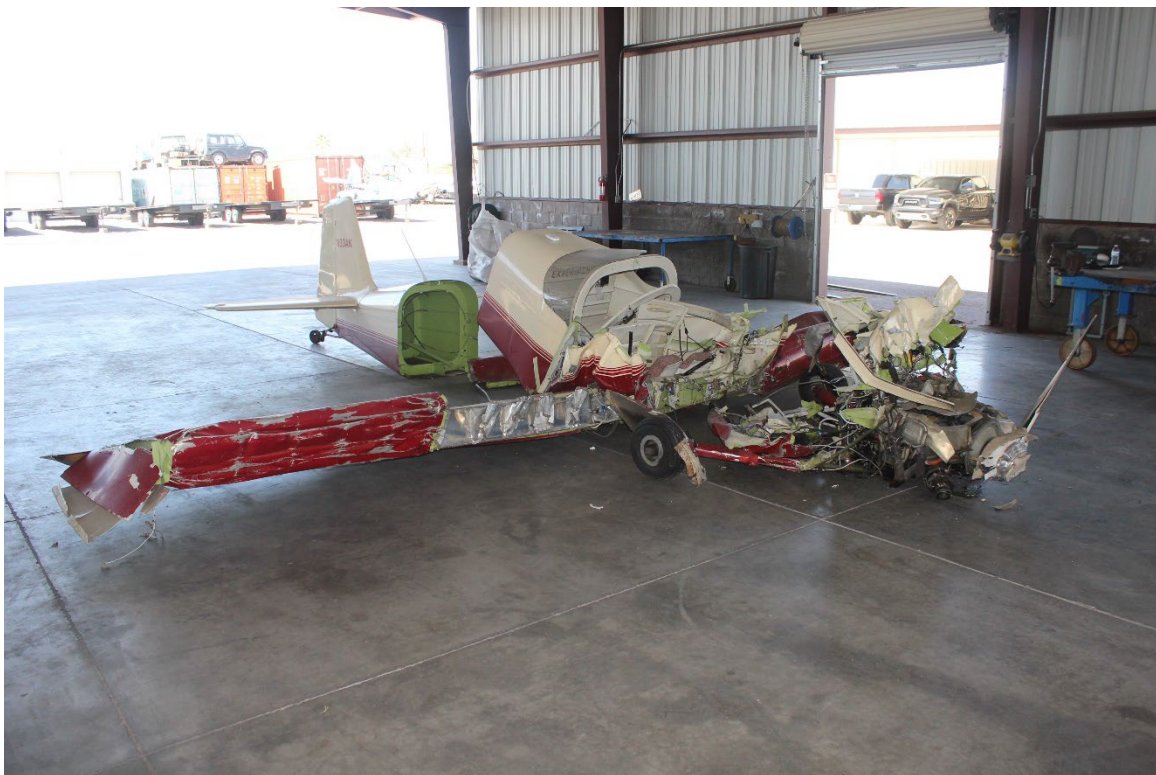
**Figure 1: Front view of accident airplane during examination**

Examination of the recovered wreckage revealed that the engine was impacted damaged and displaced aft. The engine was observed near the pilot seat location in the cockpit. The engine was separated from the wreckage and forward accessories were removed one at a time.

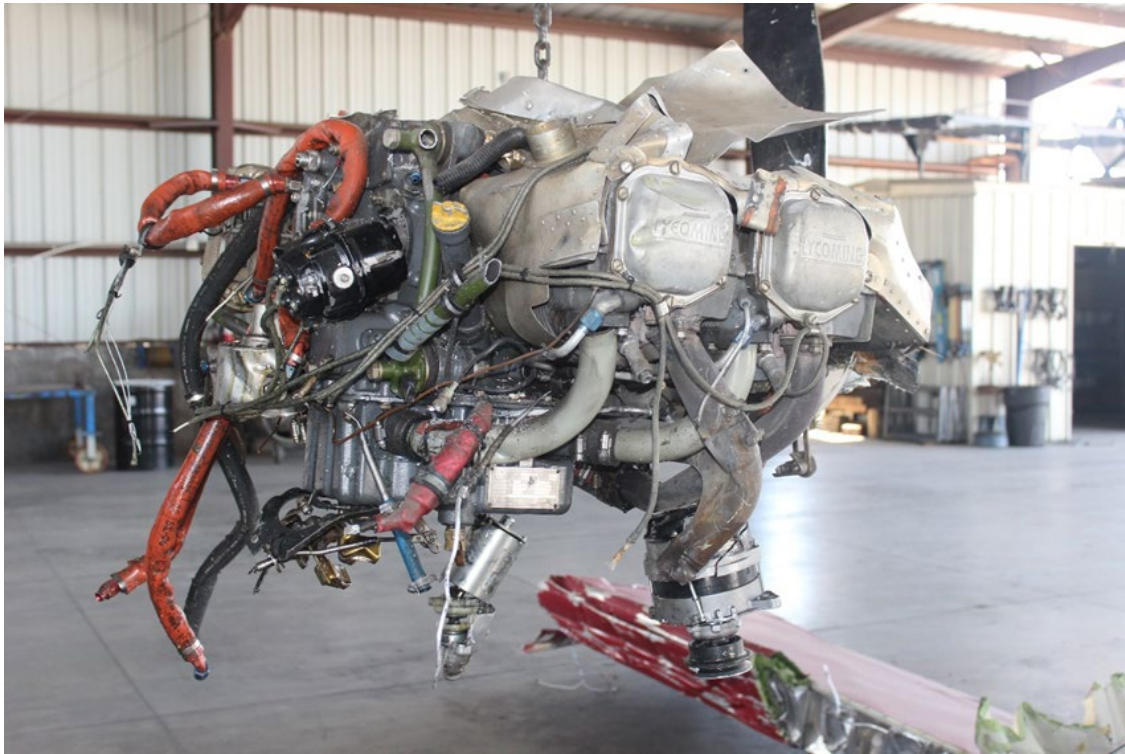
The engine sustained impact damage that precluded engine rotation. Mechanical continuity was established from a partial engine disassembly and borescope examination. Holes were drilled in the crankcase along the rotational plane of each connecting rod. The engine internal components were observed with a lighted borescope. There was no evidence of mechanical malfunction or heat distress at any of the rotating or reciprocating components. The camshaft remained intact, and each of the cam lobes exhibited its characteristic elliptical shape.

**Figure 2: Engine after removal from airplane**

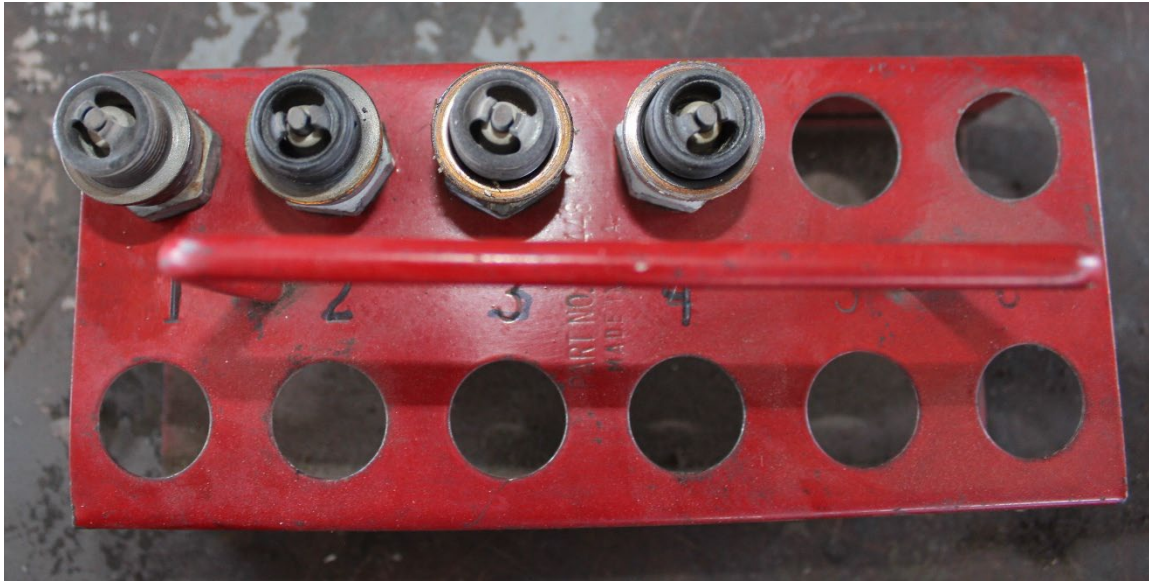
The top spark plugs were the massive electrode type. All spark plugs exhibited gray deposits within the electrode area. All spark plugs exhibited signatures consistent with worn-normal when compared to the Champion Check-A-Plug comparison chart.

**Figure 3: View of spark plugs**

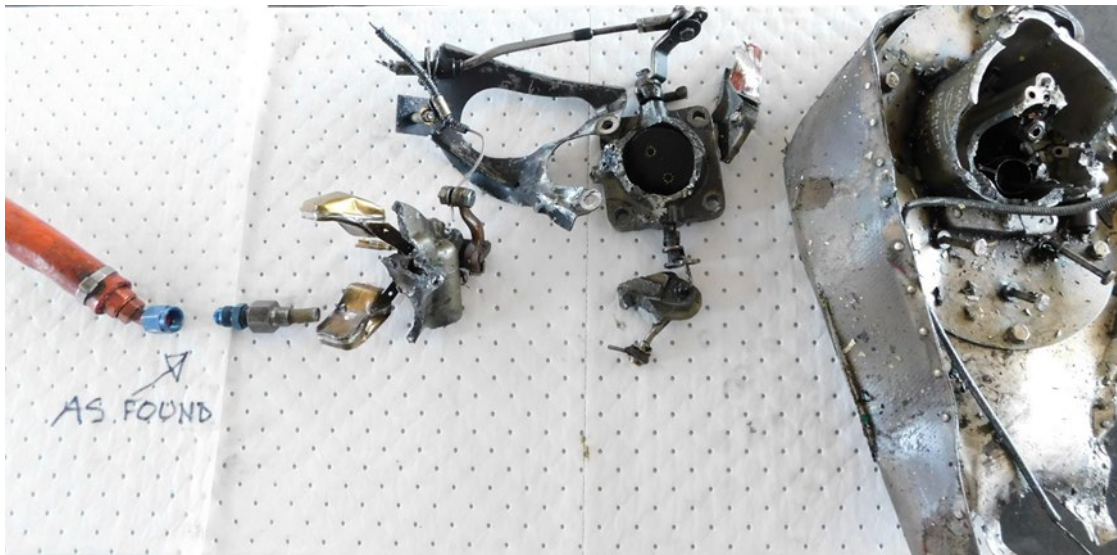
**Figure 4: Output fuel line B-nut as found.**

The fuel pump output fuel line to the carburetor B-nut was detached from the carb fuel inlet filter screen fitting. The B-nut remained free of any impact related damage the threads of the B-nut and the respective fitting remained intact and undamaged.

The engine sustained significant damage during impact. The engine fuel pump outlet hose B-nut was found disconnected at the carburetor fuel inlet filter screen. Both ends of the connection showed no stress damage associated with the accident. The threads of the B-nut and fitting remained intact and free of physical damage.
