# National Transportation Safety Board

WPR24FA083

## **AIRPLANE PERFORMANCE STUDY**

Location: Westwater, Utah  
Date: February 7, 2024  
Time: 1048 MST  
1748 GMT  
Airplane: Hawker 900XP, N900VA

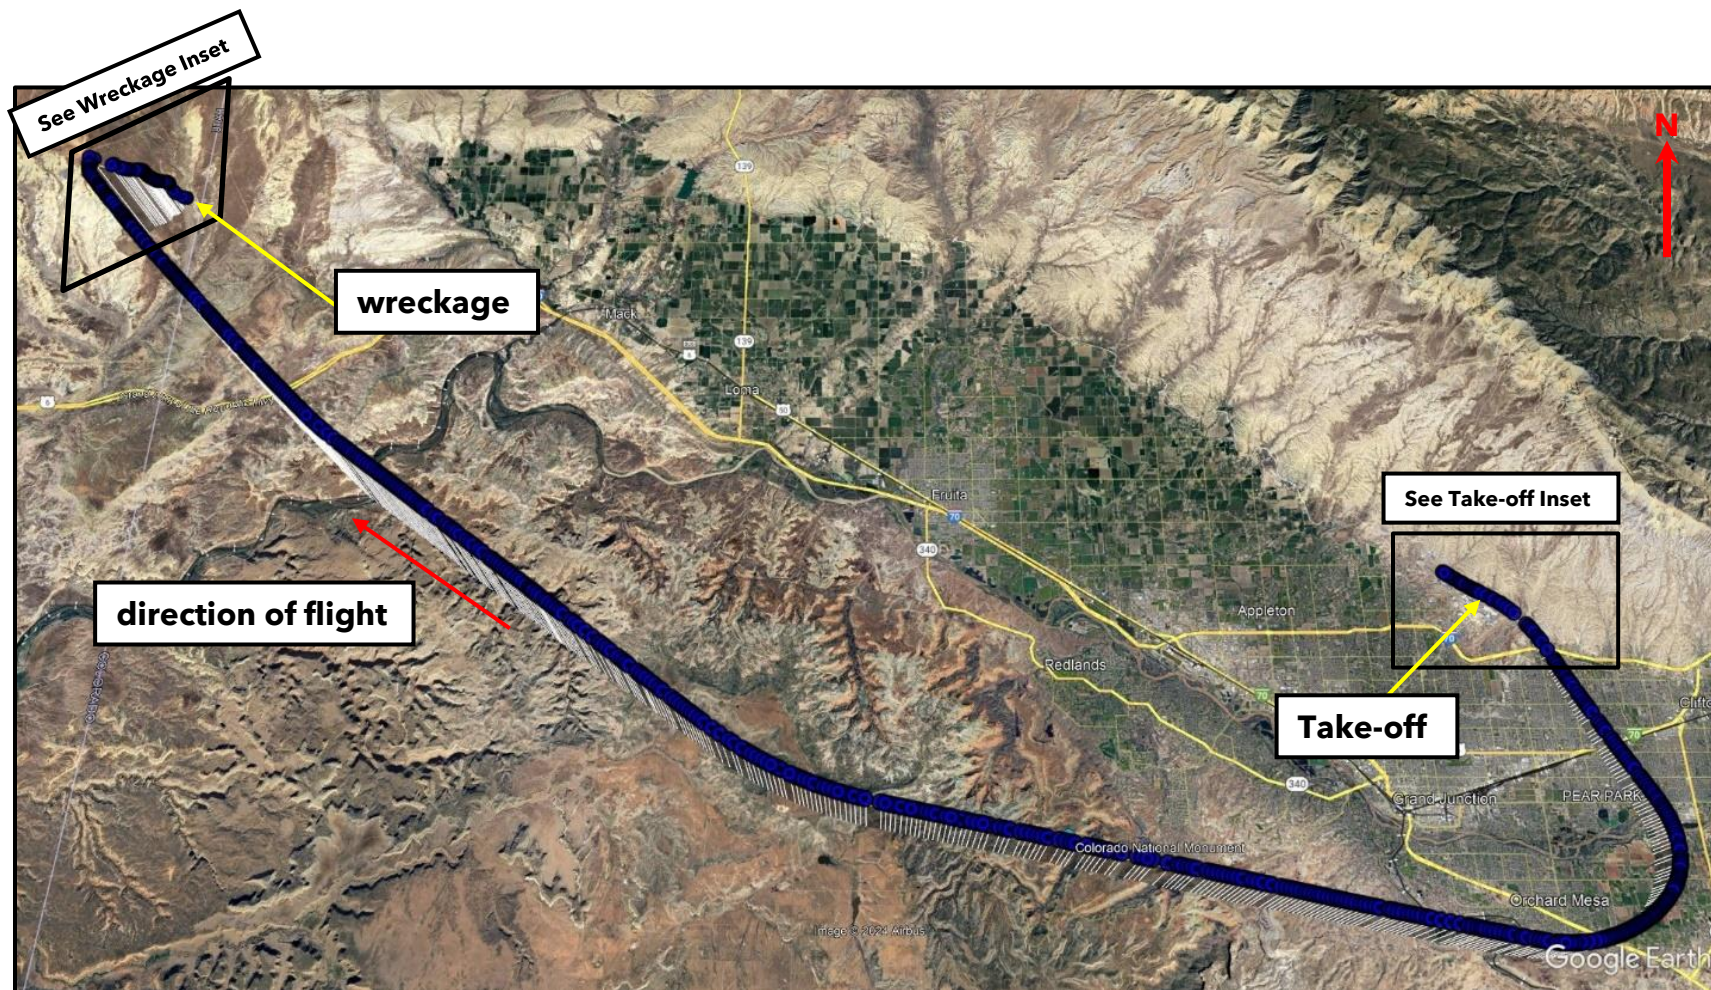
**Figure 1: ADS-B Ground Track for the Eleven Minute Accident Flight**

According to Automatic Dependent Surveillance - Broadcast (ADS-B) data, the airplane departed GJT at 1037 and entered a climb on a southeast heading. The flight crew asked air traffic control (ATC) for a block of altitudes from FL180 to FL200 and ATC approved the request. The airplane circled to the northwest as it continued to climb and subsequently leveled off at 1043:49, near the top of the altitude block. At 1046:47 the flight track data showed the airplane begin a rapid descent in a circular pattern that resembled the shape of a corkscrew. The airplane made multiple rotations before the track ceased at 1047:44. The airplane came to rest in flat, open terrain about 25 nautical miles (NM) northwest of GJT at an elevation of about 4,800 ft mean sea level (msl) and oriented on a west heading. The recorded ADS-B ground track for the eleven-minute flight is shown in Figure 1. A picture of the main wreckage site is shown in Figure 2.

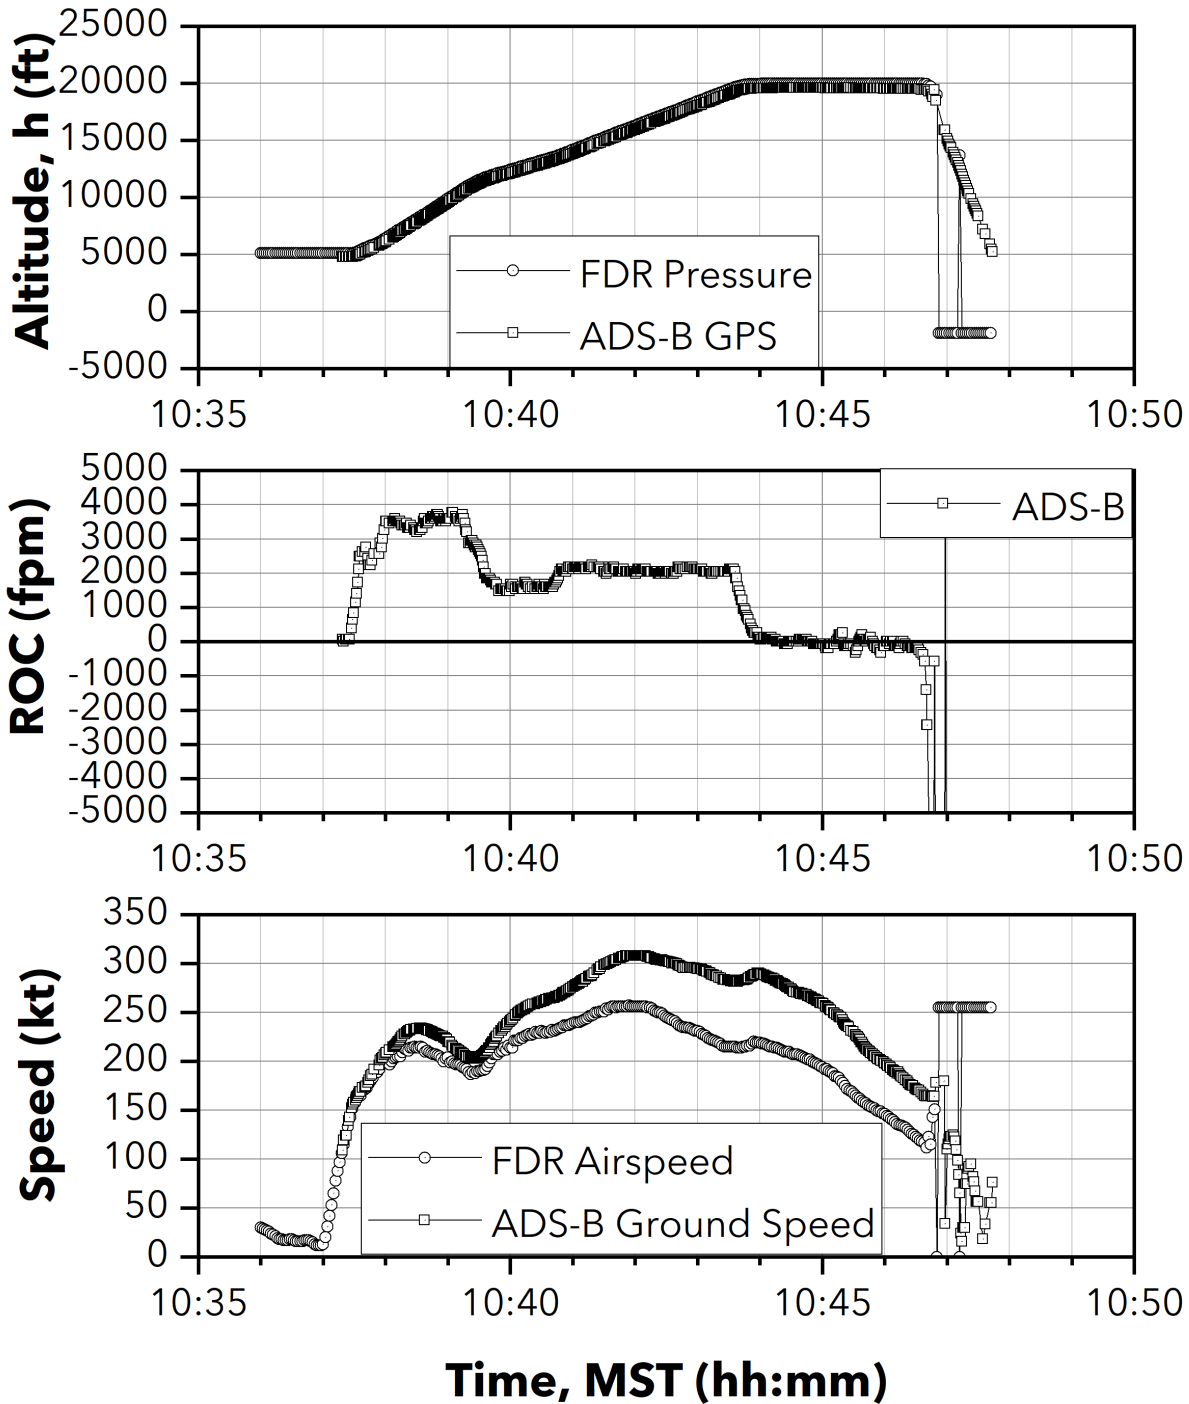
**Figure 4: Altitude, Rate of Climb (ROC), and Speed for Entire Flight**

Figure 4 includes the altitude, vertical speed, airspeed and ground speed from both the FDR and ADS-B data for the entire accident flight. Figure 5 shows the same parameters but highlights approximately the last two minutes of the flight<sup>3</sup>.

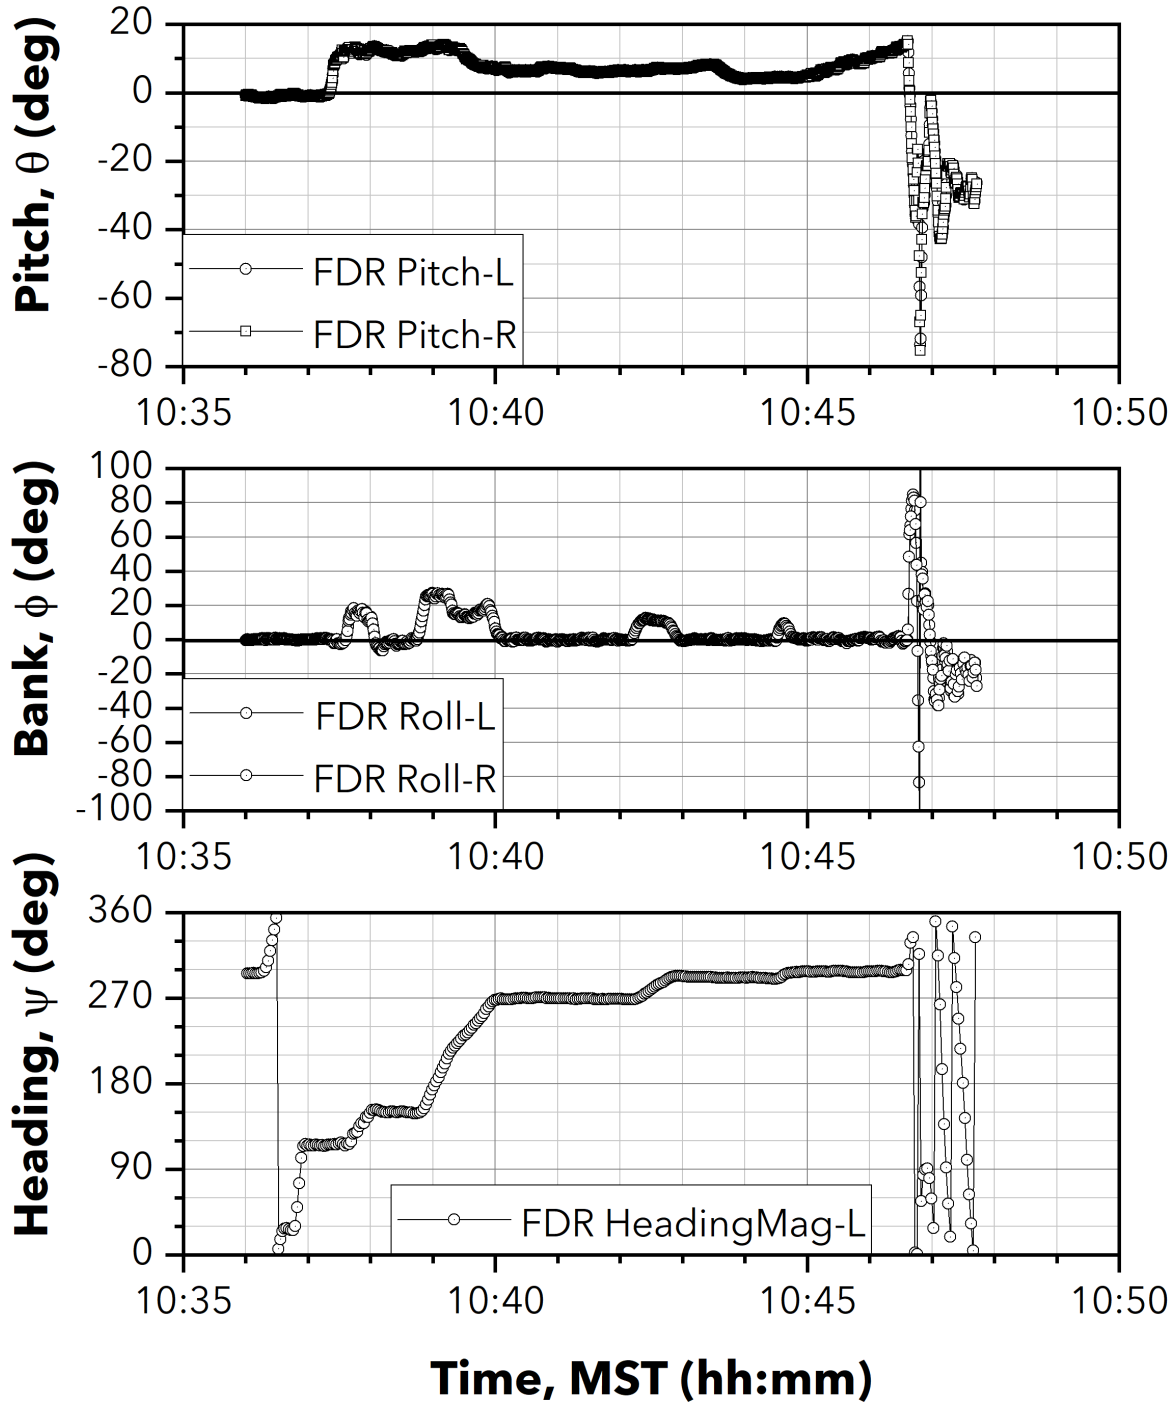
**Figure 6: FDR Pitch, Bank, and Heading Angles for Entire Flight**

FDR pitch, bank, and heading Euler angles for the entire flight are shown in Figure 6, and the last two minutes are highlighted in Figure 7. The pitch was slowly increasing from about 10° airplane-nose-up (ANU) to 15° ANU as the airspeed decreased from 146 kt at 10:46:00 to 118 kt at 10:46:37. At 118 kt, the airplane banked right to 83° in two seconds, despite the flight crew's immediate input of full left-wing-down (LWD) control wheel. Figure 8 includes the elevator, aileron, and rudder deflections associated with the flight crew's input.

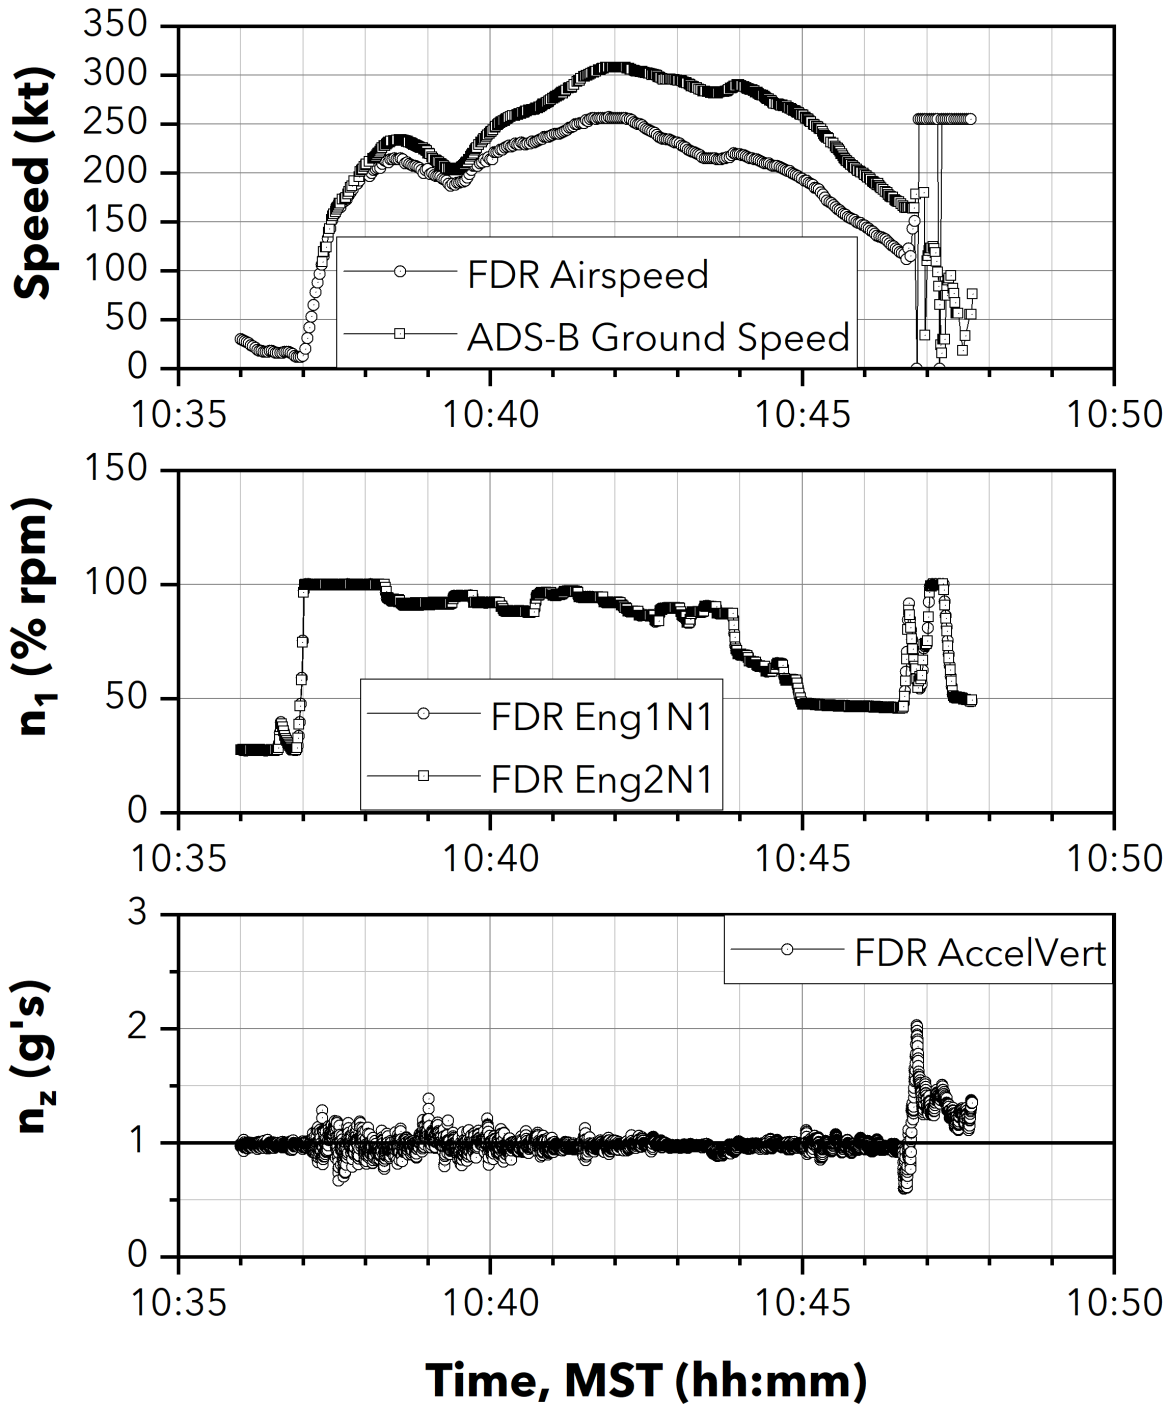
**Figure 9: FDR Engine Fan Speed and Vertical Load Factor for Entire Flight**

Figure 9 shows the recorded engine low pressure compressor fan speeds,  $n_1$ , associated with the flight crew's inputs for the entire flight. Figure 10 includes only the last two minutes. The flight crew first added 89% maximum rpm at 10:46:37 when the airplane banked right to 83° and later reduced engine power to 58% before finally inputting 100% rpm at 10:47:00.

The vertical load factor recorded on the FDR is shown in Figures 9 and 10. About the same time the airplane pitched up to 15° and banked right to 83°, the vertical load factor went from 1g to about 0.6g. Similarly, the recorded angle-of-attack or AOA (as a percentage of maximum lift<sup>4</sup>) shown in Figure 11 went from approaching 90% to less than 80% and finally up to 100%.

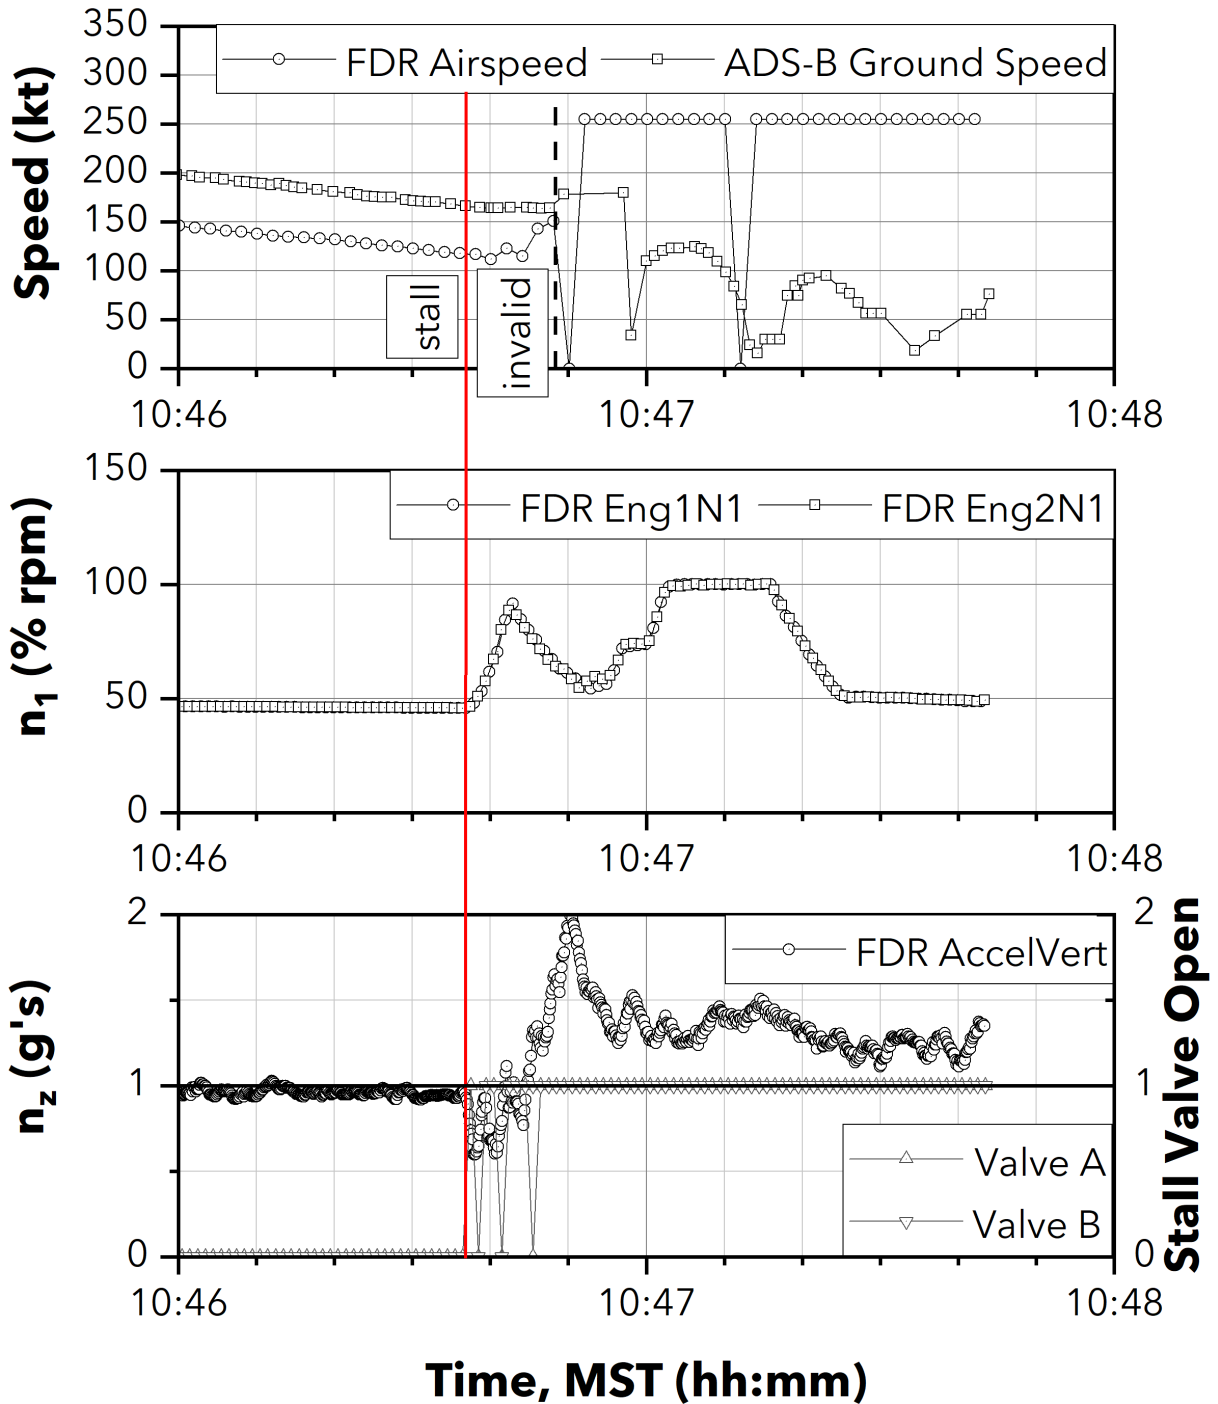
**Figure 10: FDR Fan Speed and Vertical Load Factor for Final Minutes of Flight**

Figure 10 shows an abrupt change or “break” in vertical load factor at 10:46:37 as the airspeed slowed to about 117.5 kt during the first system check. Such a break in load factor is often the result of a stall when one or both wings reach the critical AOA, and the air flow over the wing becomes separated<sup>6</sup>. As a result of the separation, the stalled wing can no longer generate necessary lift and the airplane descends, often rapidly. If the airplane is uncoordinated<sup>7</sup> at stall, a spin may result. N900VA’s final descent was in a circular pattern that resembled a spin or “corkscrew”. See Figure 12.

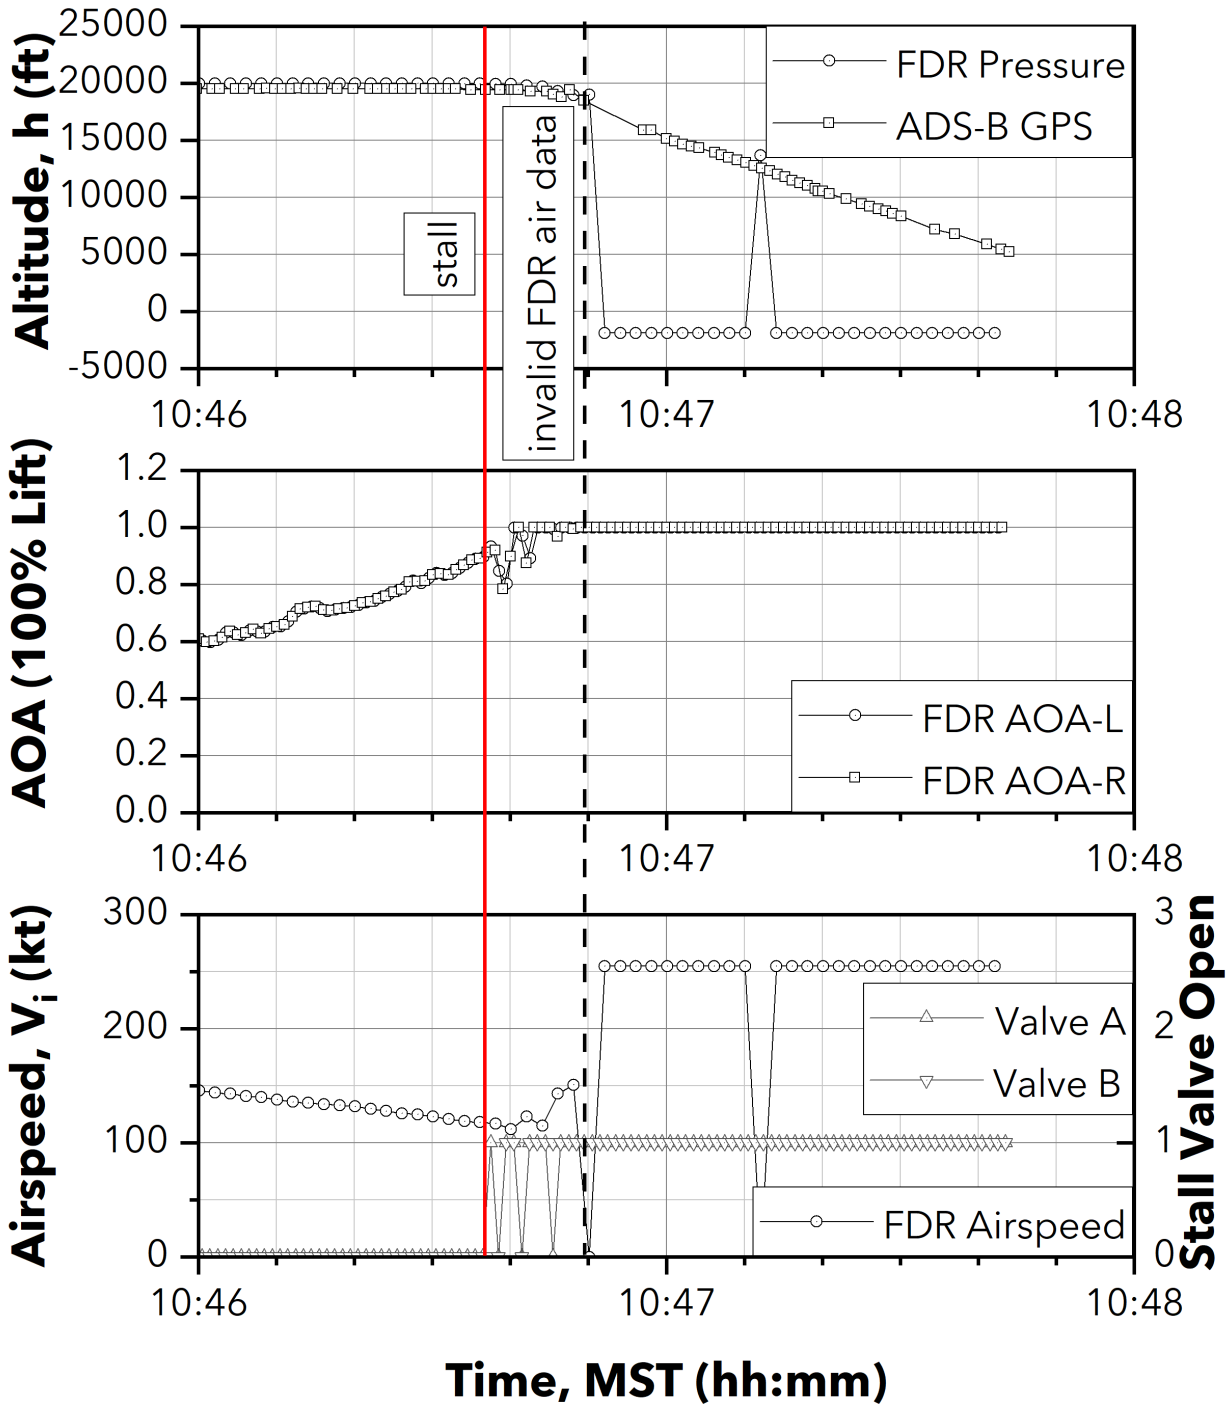
**Figure 11: FDR Angle-of-Attack for Final Minutes of Flight**

<sup>4</sup> At slow stall entry rates or less than 1 kt/sec in the case of the accident, the stick shaker activates at 23° vane AOA or about 15° body AOA. This is approximately 90% maximum lift as shown in Figure 11.

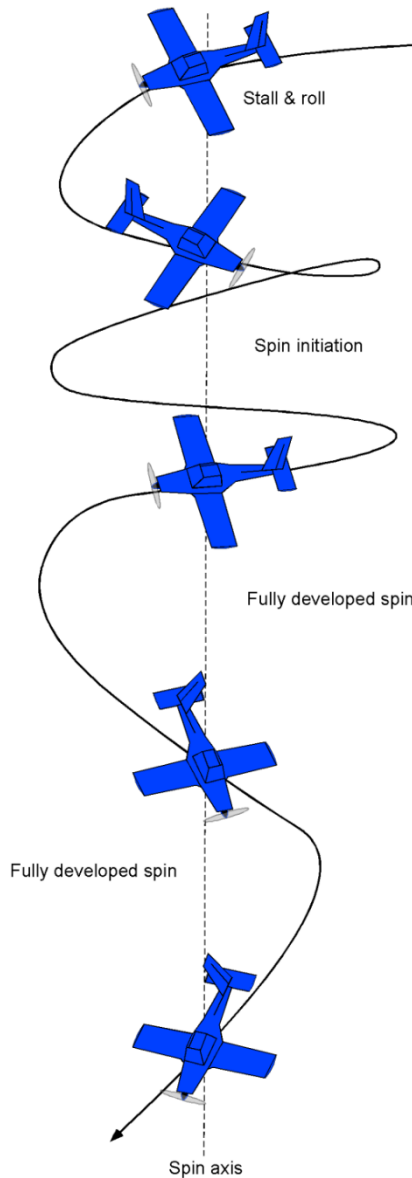
**Figure 12: A Spin can result During an Uncoordinated Stall and Cause the Airplane to Develop into a Steep, Spiraling Downward Path that Resembles a Corkscrew**

A generic recovery technique<sup>8</sup> for a spin is to reduce the power, neutralize the aileron input, apply full opposite rudder to arrest the yaw rate, and input forward control column to reduce the AOA with elevator. However, the flight crew of N900VA immediately input full LWD aileron when the airplane abruptly banked right and ultimately applied full power and full aft control column, likely aggravating a stall/spin<sup>9</sup>.
