# National Transportation Safety Board

WPR24FA083

## **NTSB ONSCENE EXAMINATION REPORT**

Location: Westwater, Utah  
Date: February 7, 2024  
Time: 1048 mountain standard time  
1748 UTC  
Airplane: Hawker 900XP (N900VA)

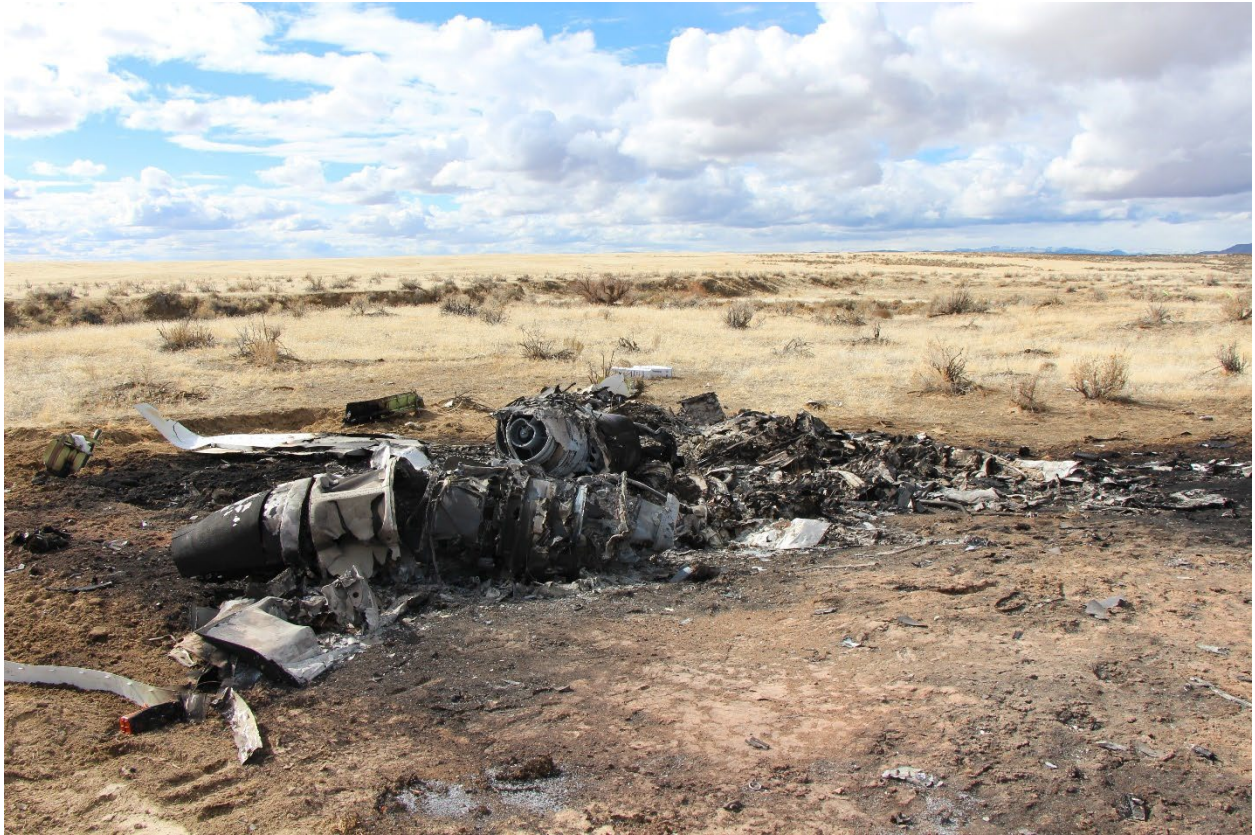
The airplane came to rest in flat open terrain about 25 nm northwest of Grand Junction Regional Airport (GJT), Grand Junction, Colorado at a field elevation of about 4,800 ft mean sea level and oriented on a west heading. The airplane's major

structures were all accounted for at the accident site. A debris path was traced from the main wreckage to the end of a burn area that was about 200 ft long and 175 ft wide at the widest point, oriented on a magnetic heading of 345°. A silhouette of the left wing, fuselage and both engines was located about 10 ft south of the main wreckage.

**Figure 2: Accident site main wreckage**

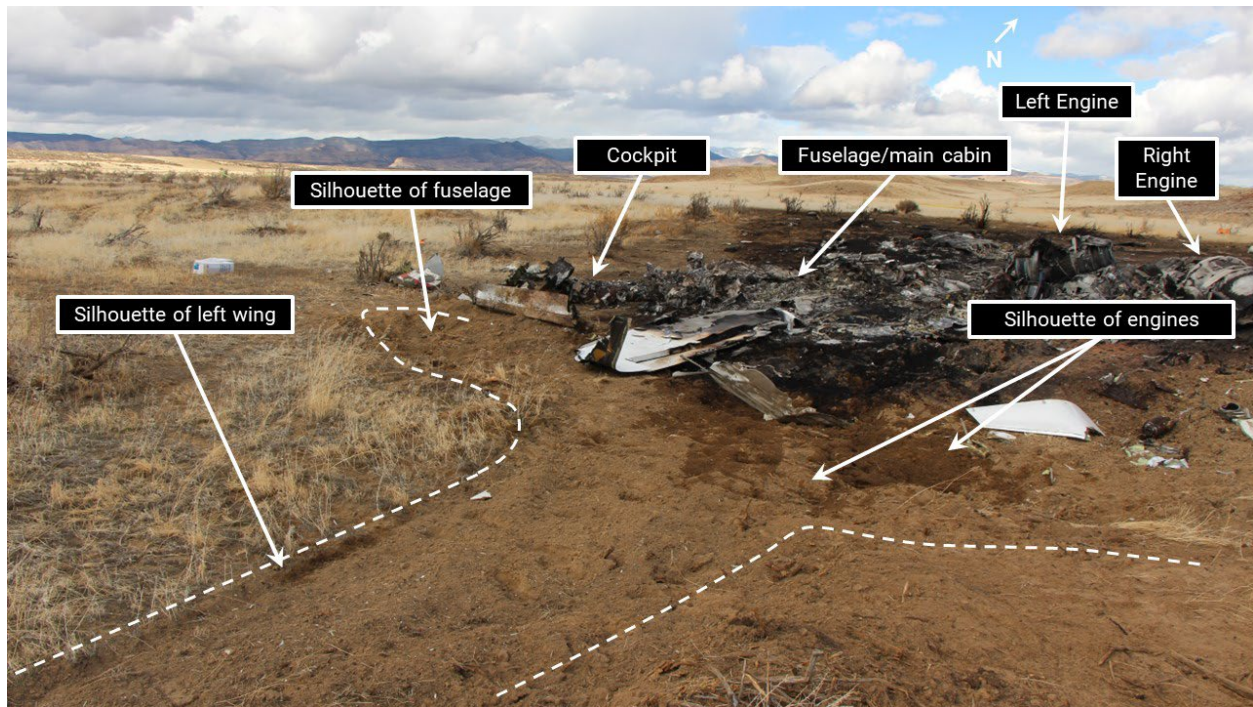
**Figure 3: Accident site with ground signatures**

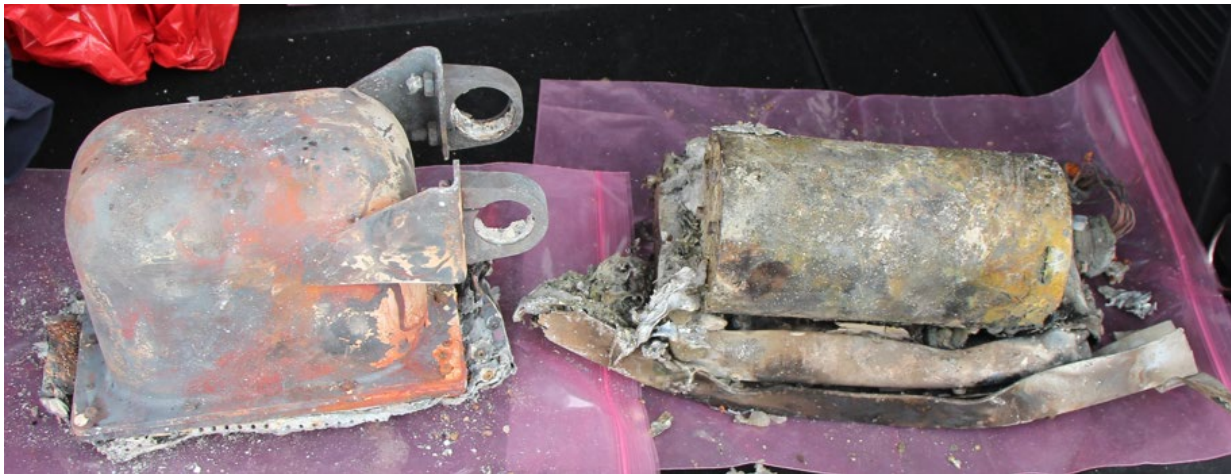
The airplane cockpit voice recorder and flight data recorder were found in the fuselage wreckage collocated with both engines. Both units were thermally damaged and retained for further examination.

**Figure 4: Cockpit voice recorder (left) and flight data recorder (right)**
