# National Transportation Safety Board

WPR24FA083

## **NTSB WRECKAGE EXAMINATION REPORT**

Location: Westwater, Utah  
Date: February 7, 2024  
Time: 1048 mountain standard time  
1748 UTC  
Airplane: Hawker 900XP (N900VA)

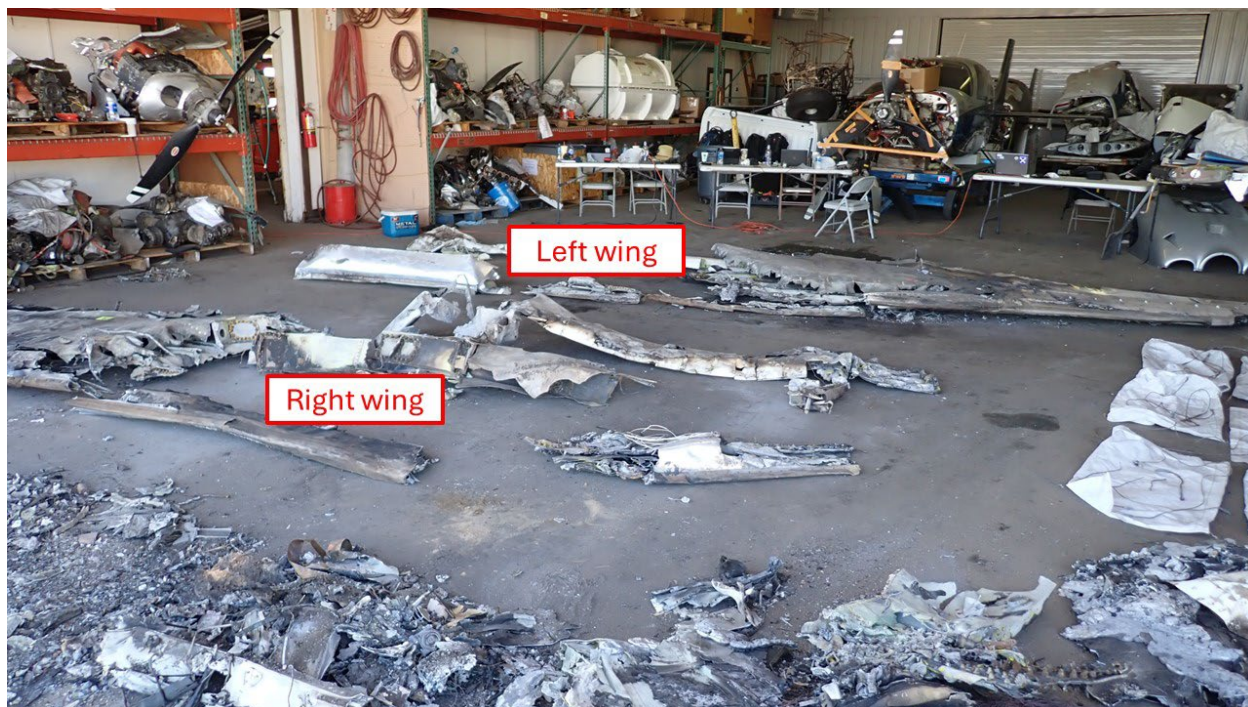
A wreckage examination was performed at Beegles Aircraft in Greeley, Colorado on June 11, 2024. As most of the wreckage was consumed by postcrash fire, the purpose of the examination was to capture remnants of the flight control system. The wreckage fragments and smaller pieces had been recovered into approximately 20 canvas bags. Each bag was emptied onto a tarp and the contents were examined to locate remnants of the flight control cables and fragments of the flight control assembly and systems.

**Figure 1: Wreckage layout**

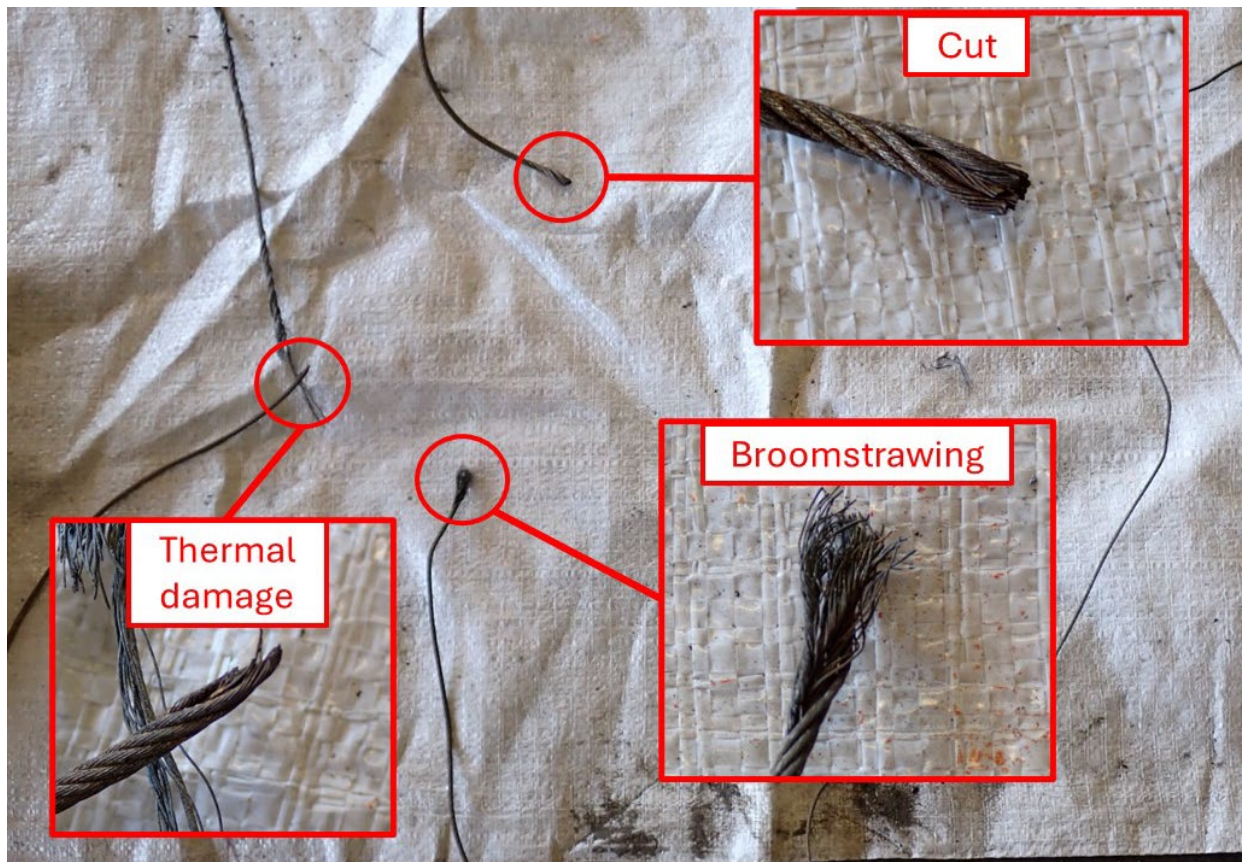
Approximately 16 strands of flight control cable sections were recovered. None of the strands could be traced back to their installation (elevator, rudder, trim, flap). Aileron and rudder/elevator continuity were accounted for onsite. The cable ends either exhibited broomstrawing consistent with overload separation, thermal damage, or had been cut by recovery personnel.

**Figure 2: Cable fragments recovered from wreckage with damage from overload separation, postcrash fire, and to facilitate recovery**

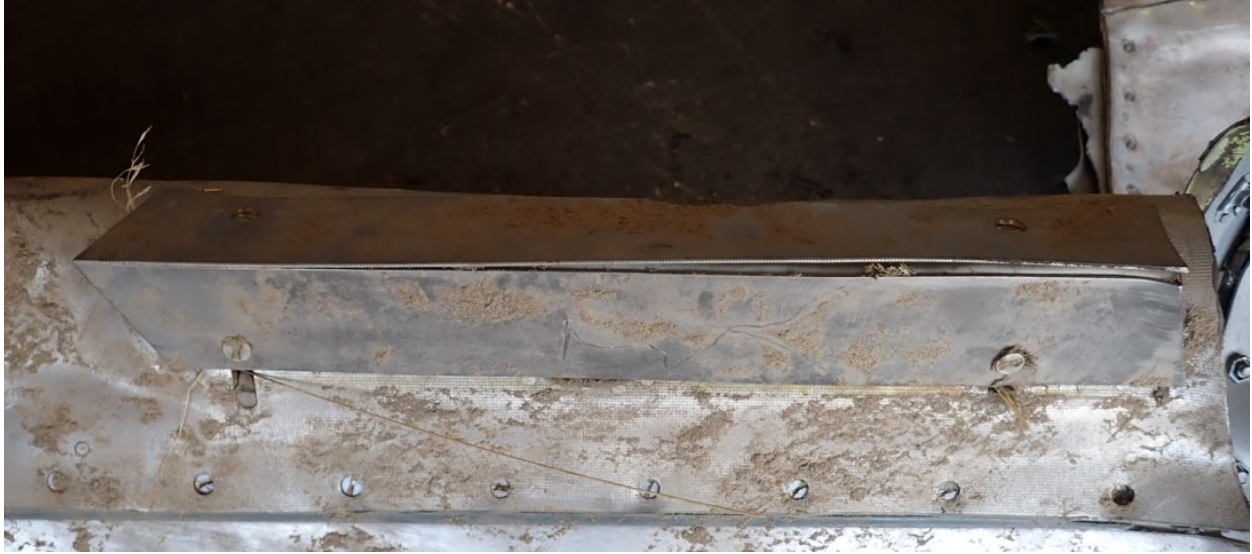
The outboard right wing remained intact with the lower aileron still attached, and the winglet had separated. The right wing flap had separated from the wing and was damaged by postcrash fire. The flap skin was punctured and exhibited upward bending. The stall spoiler (stall strip) was still attached at the inboard right wing leading edge. The flap actuator remained intact. Approximately 3-4 TKS panels were identified within the recovered wreckage.

**Figure 3: Stall spoiler (stall strip) at right wing leading edge**
