# National Transportation Safety Board

WPR24FA083

## **OPERATIONAL FACTORS/HUMAN PERFORMANCE**

Specialists' Factual Report

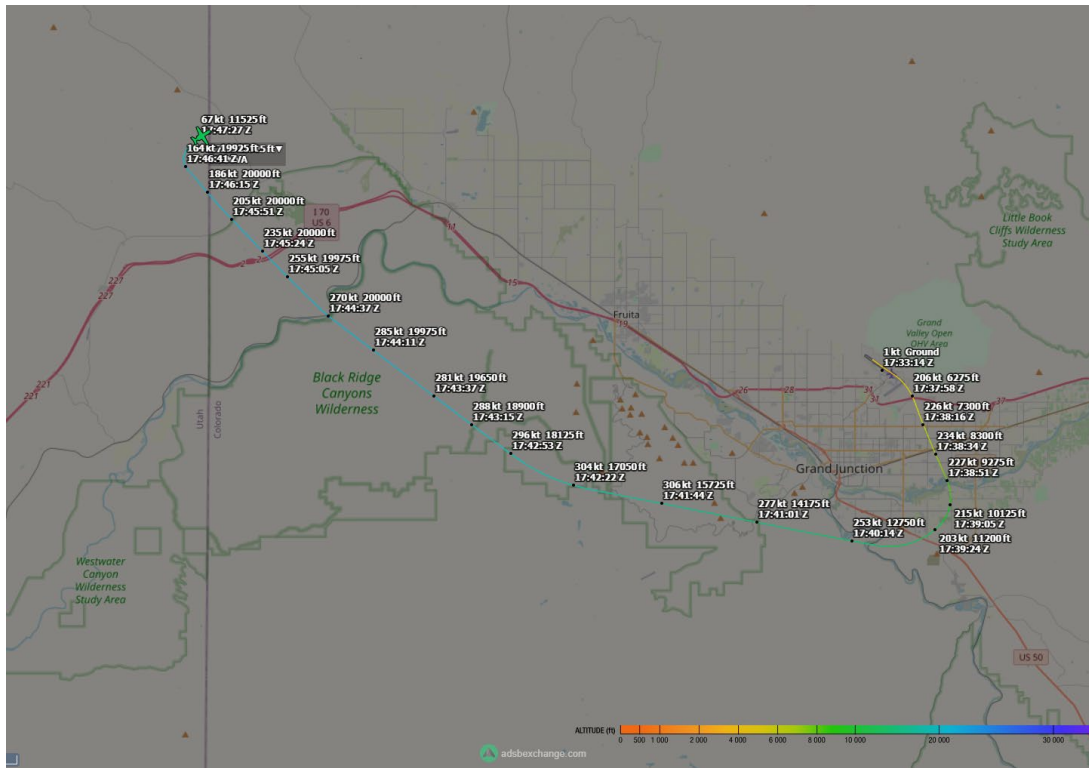
**Figure 1:** Overhead View of Entire Accident Flight (Source: ADSBExchange.com)

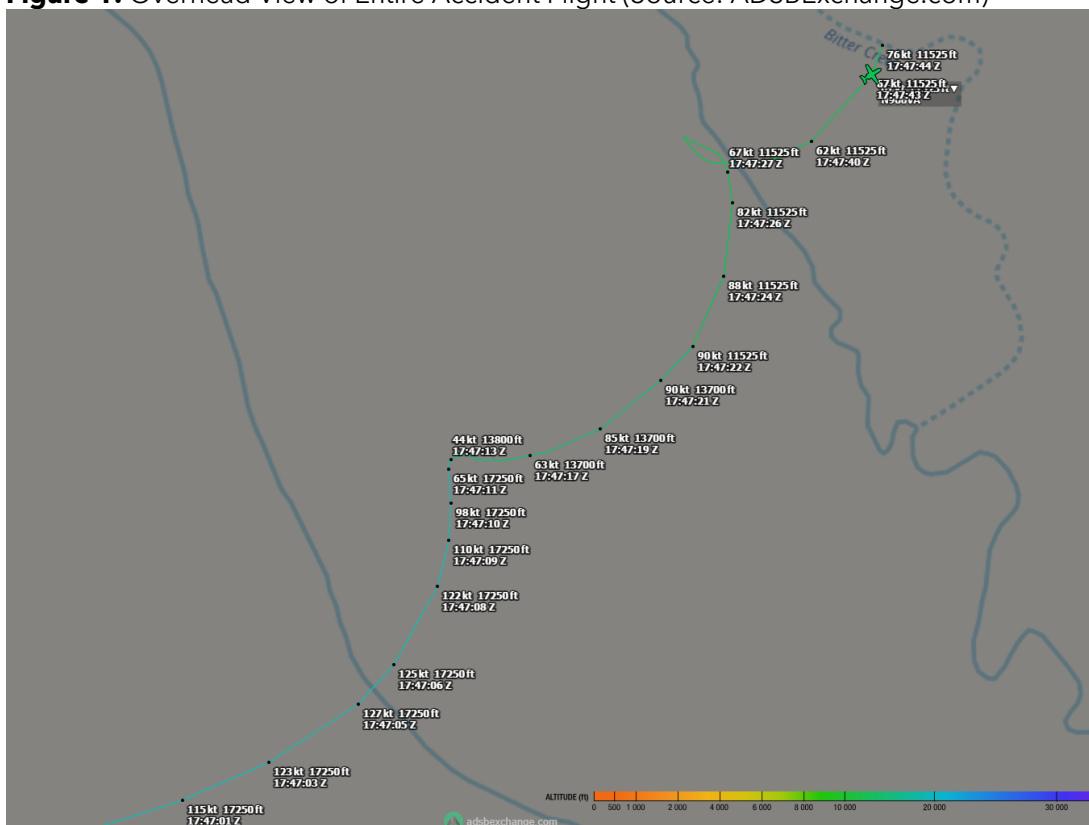
Approximately 1046:46, the airplane indicated 19,475 ft msl, 164 kts, and a ground track of about 355°. For about the next minute the airplane continued on a northeasterly ground track. During that minute the ground track varied and the ground speed indicated various speeds below 122kts.

At 1047:44 the last recorded data of the accident flight indicated 11,525 ft msl and a ground speed of 76 kts.

**Figure 2:** Expanded View of Last Approximate Minute of the Accident Flight (Source: ADSBExchange.com)
