# National Transportation Safety Board

WPR24FA083

## COCKPIT VOICE RECORDER

Group Chair's Factual Report

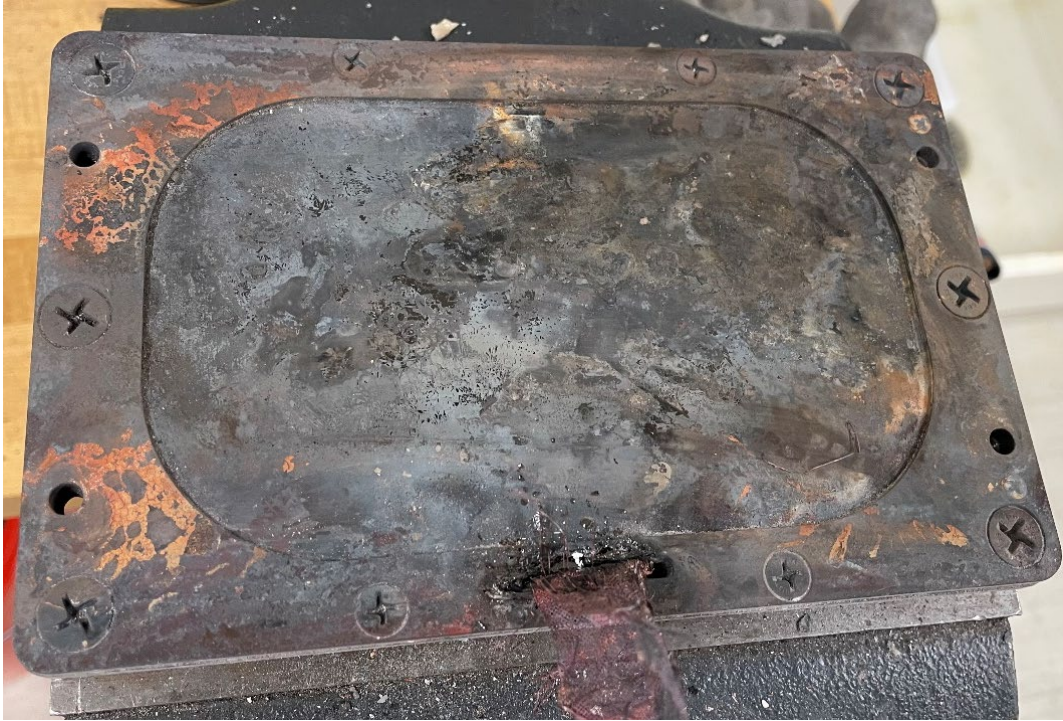
Upon arrival at the laboratory, it was evident that the exterior of the CVR crash case had sustained extreme heat exposure as shown in figure 1. The remainder of the CVR, if it was found, was not shipped to the recorder lab. The crash survivable memory module showed extreme signs of heat-induced structural damage including warping, delamination, and carbonization of the printed circuit board (PCB) and flex cable material, as well as solder reflow across the entire module (see figures 2 through 7).

**Figure 1.** Heat damaged crash case of the CVR (view of bottom).

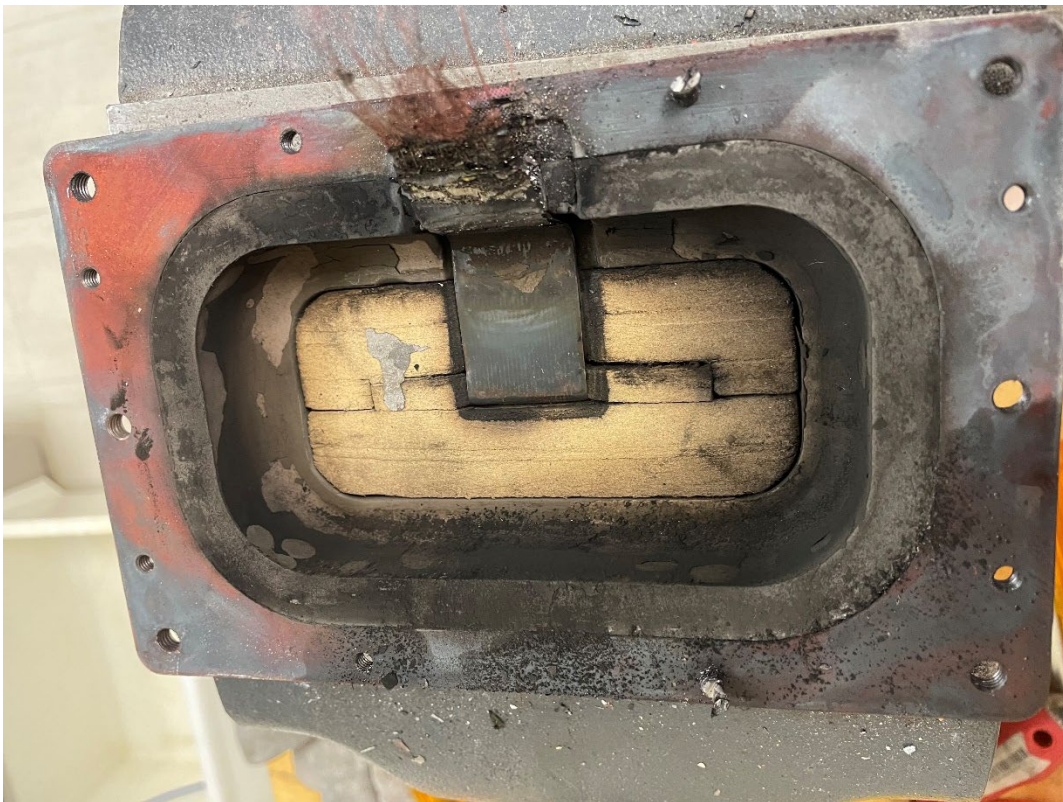
**Figure 2.** View of crash case opened to reveal heat insulation material and ribbon cable.

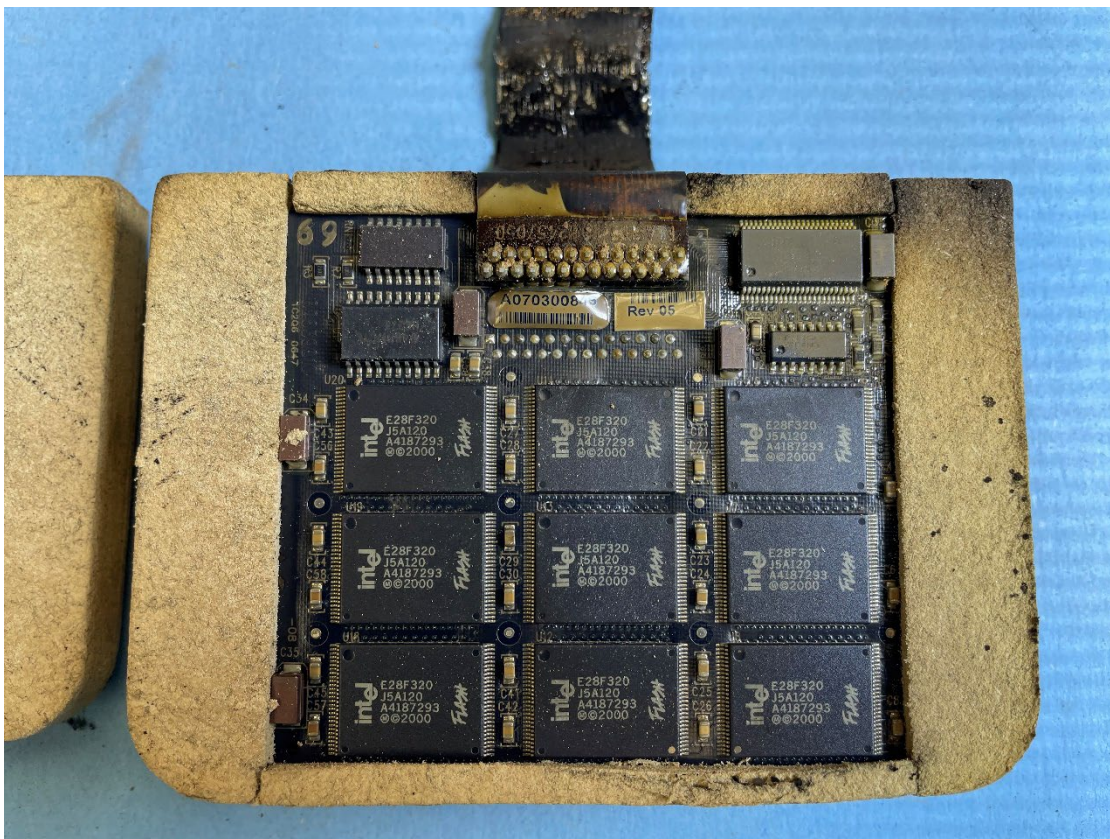
**Figure 3.** Memory module (within heat insulation material) showing signs of extreme heat damage.

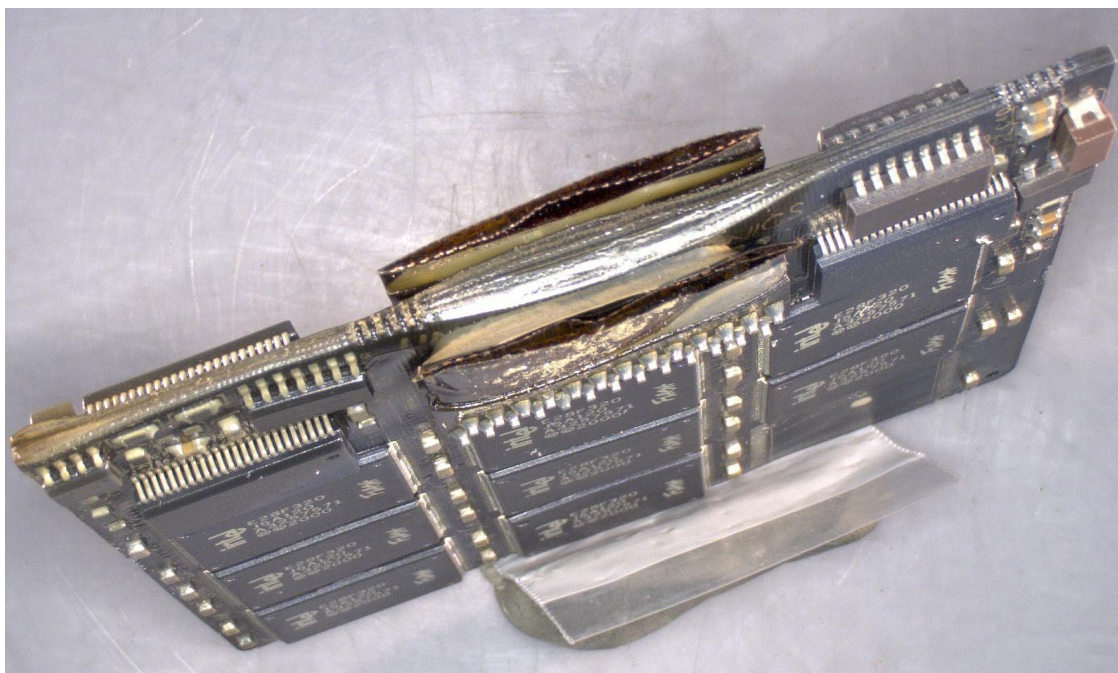
**Figure 4.** Memory module showing severe delamination and warping at the flex cable entry.

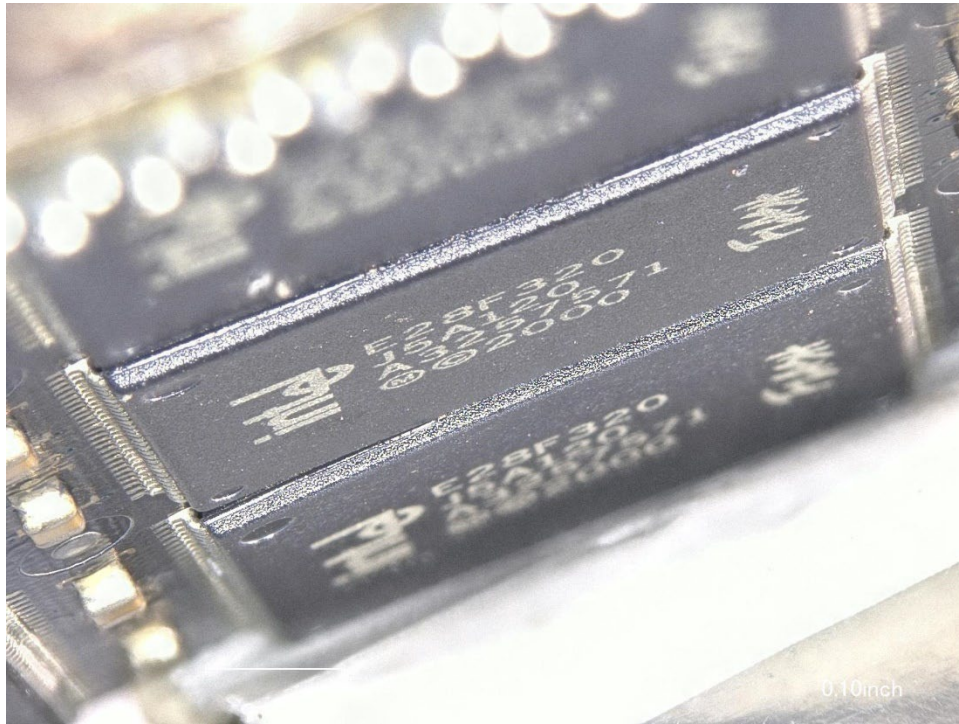
**Figure 5.** Memory module signs of delamination and warping.

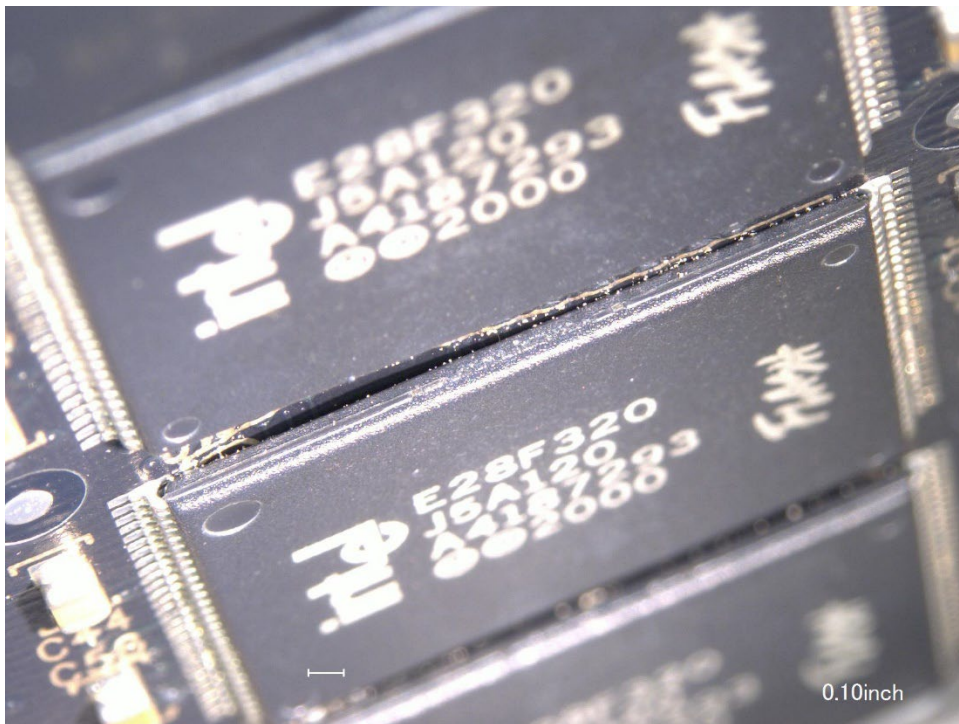
**Figure 6.** Memory module signs of delamination and warping.

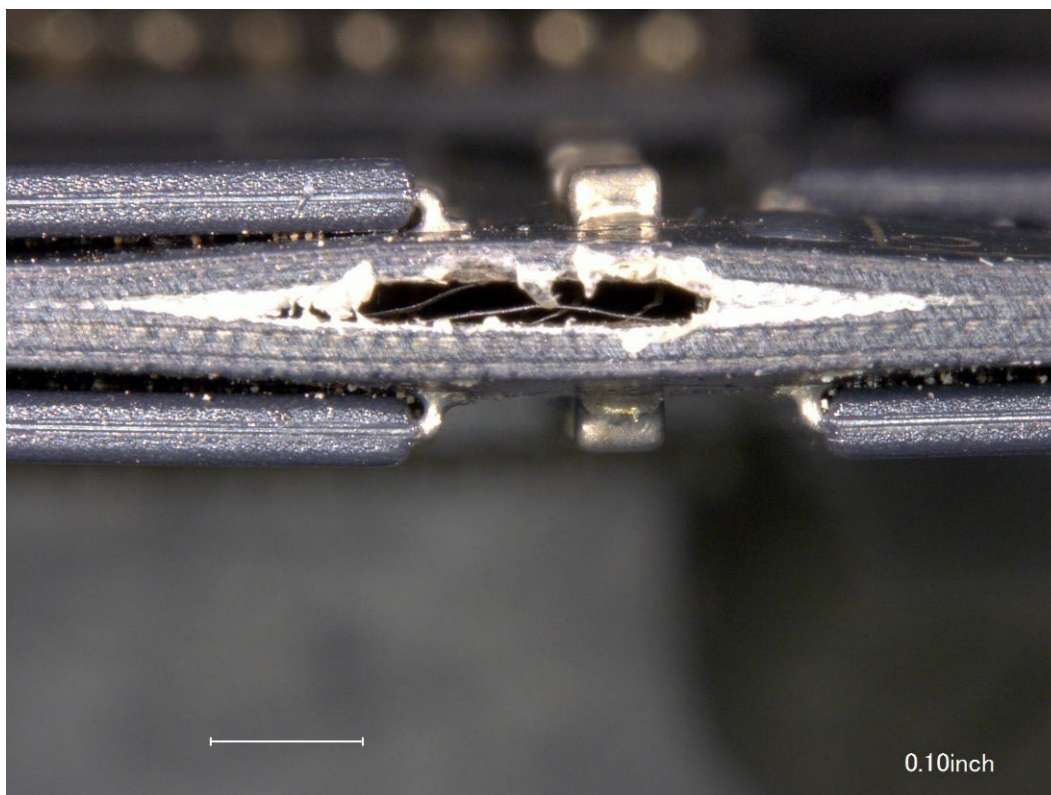
**Figure 7.** Memory module signs of delamination and warping at the opposite end from the flex cable.

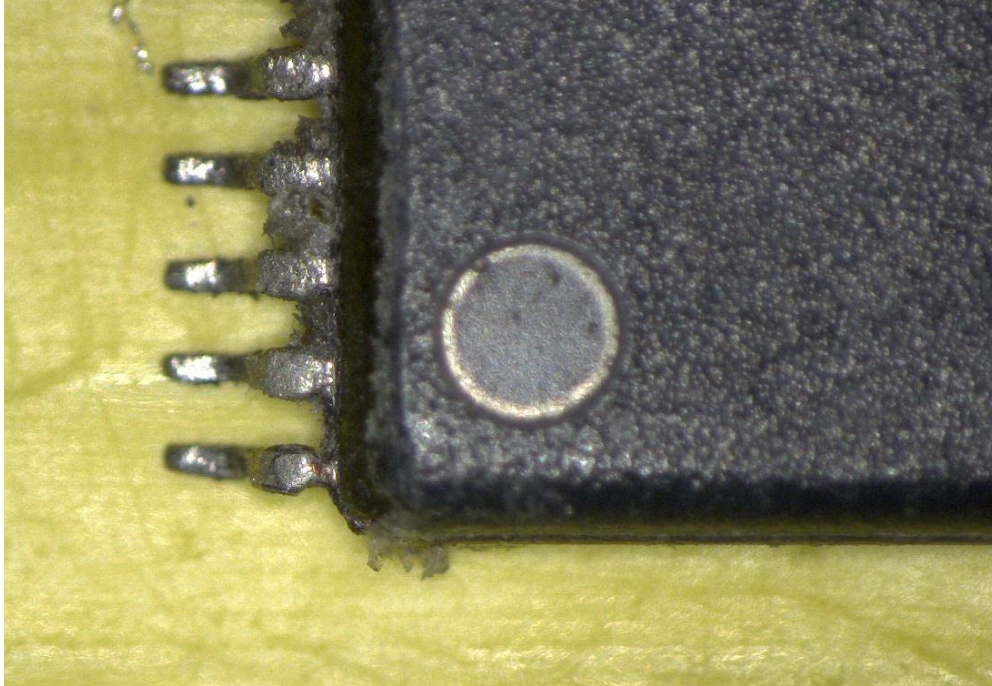
Due to what appeared to be a heat-induced chemical interaction between the original solder and the metallization of chip leads, there was metal loss and weakening of many pins on various chips. To prevent loss, some pins required careful repair via partial removal of the black packaging material to expose the internal lead frame. The area was then silver-soldered to provide a reliable electrical connection and mitigate against mechanical breakage (see figures 13 and 14). This was also done by-hand under microscopy using specialized tools.

**Figure 13.** FLASH memory device showing severe metal loss at root of bottom pin.

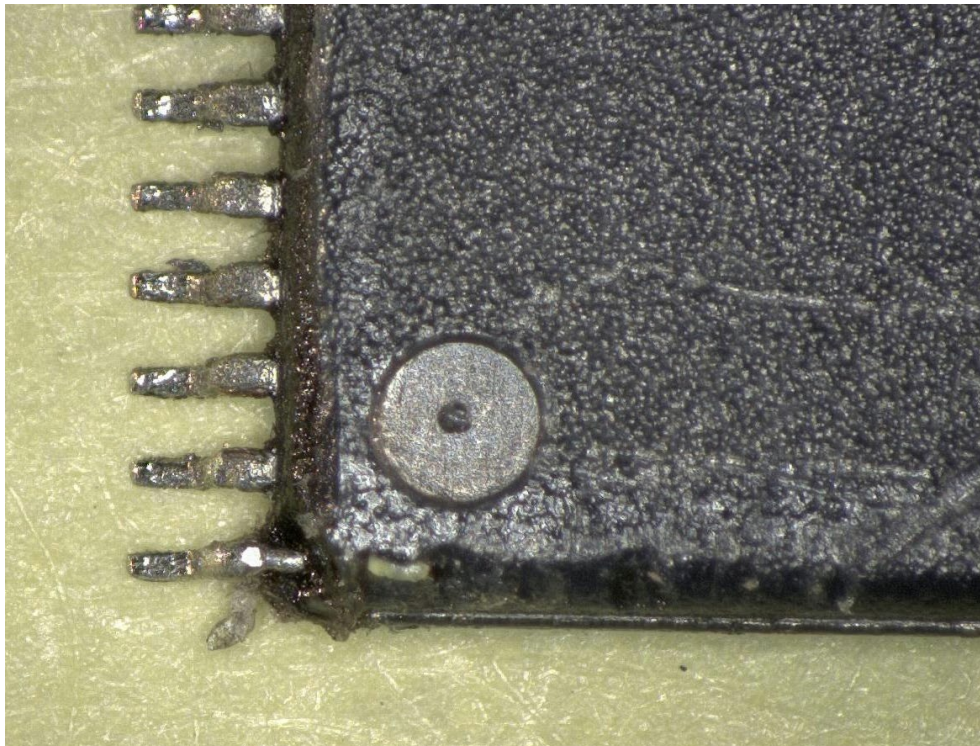
**Figure 14.** FLASH memory device showing silver-solder repair at root of bottom pin.

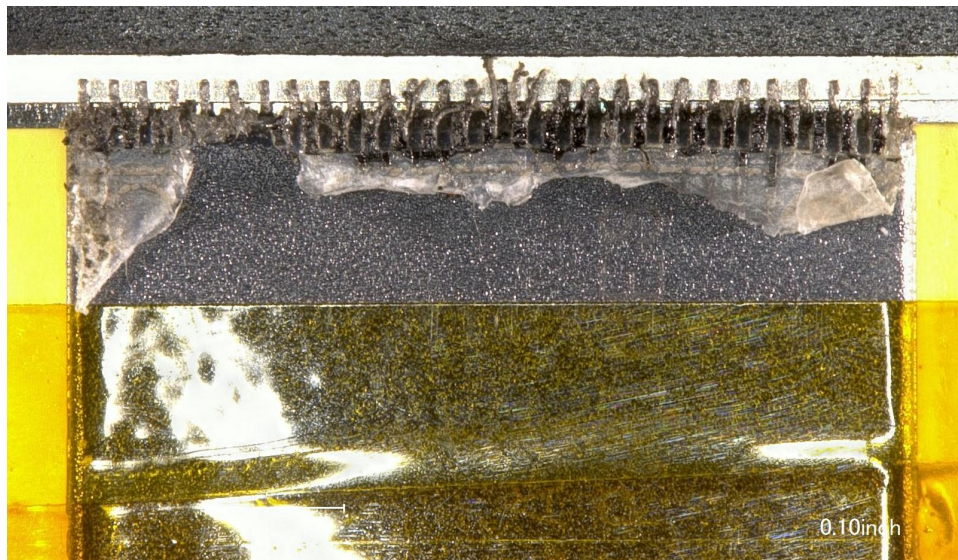
**Figure 15.** FLASH memory device showing underpin contamination before cleaning.
