# National Transportation Safety Board

WPR24FA104

## **AIRCRAFT AND ENGINE ON-SCENE EXAMINATION SUMMARY NOTES**

Location: Cave Junction, Oregon  
Date: March 7, 2024  
Time: 1124 Pacific standard time (PST)  
1824 coordinated universal time (UTC)  
Airplane: N4443G

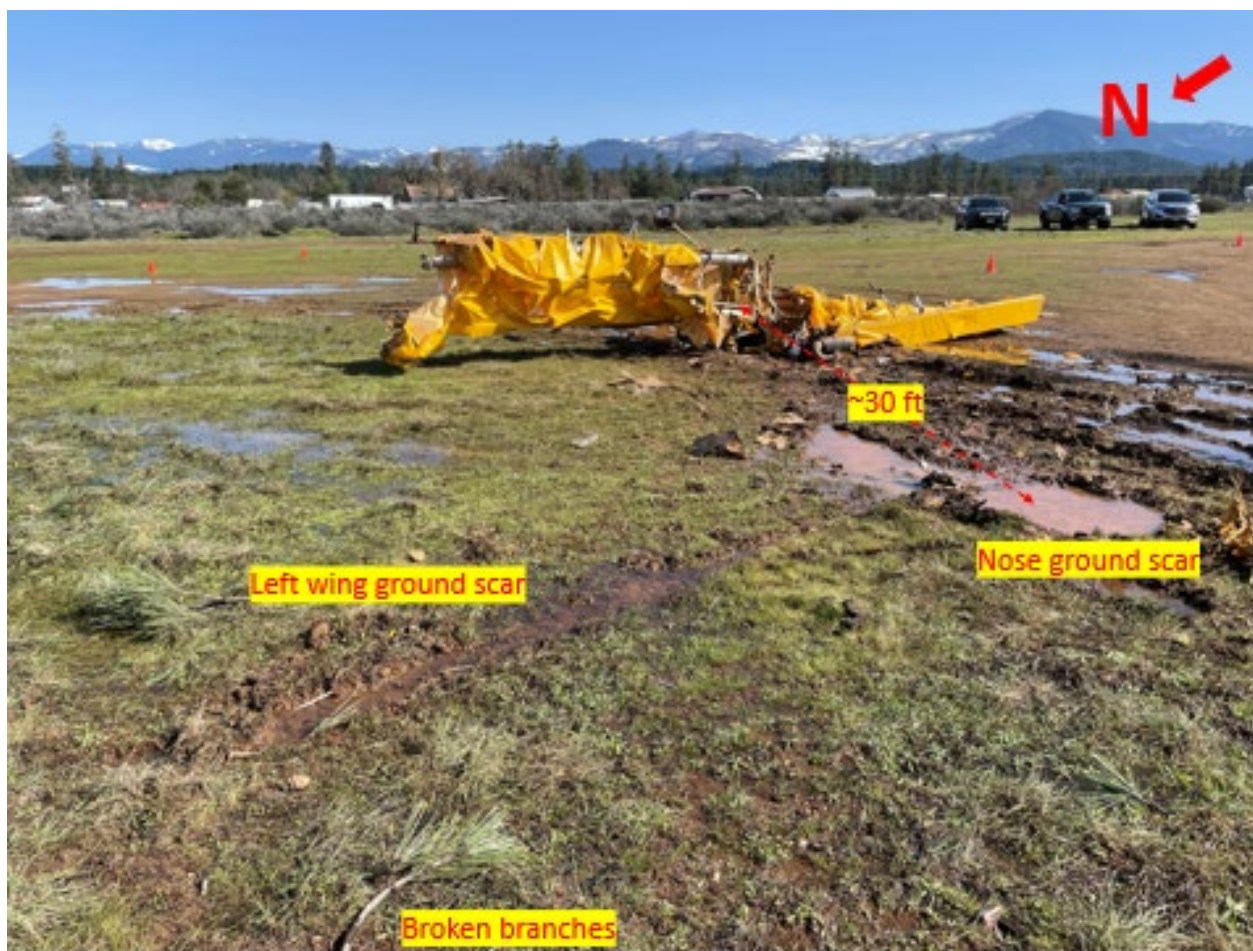
**Figure 2. View of main wreckage**

The main wreckage is located about 0.14 nm northwest from the end of runway 36. The airplane came to rest in an open, muddy field with a directional heading about 125°. The first identified point of contact (FIPC) was a tree with broken branches about 40 ft northwest of the main wreckage; the branches were found adjacent to the tree. The airplane's left wing and nose section contacted the ground first, followed by the right-wing leading edge, as evidenced by ground scars; the airplane impacted terrain in about a 40° angle. Shortly after impact, the airplane slid about 30 ft and came to rest oriented in about a 100° heading. The two blade sections that were recovered were the furthest identifiable components, coming to rest about 50- and 60-feet northeast of the main wreckage, respectively. All major structures required for flight were accounted for at the main wreckage. See figure 2.

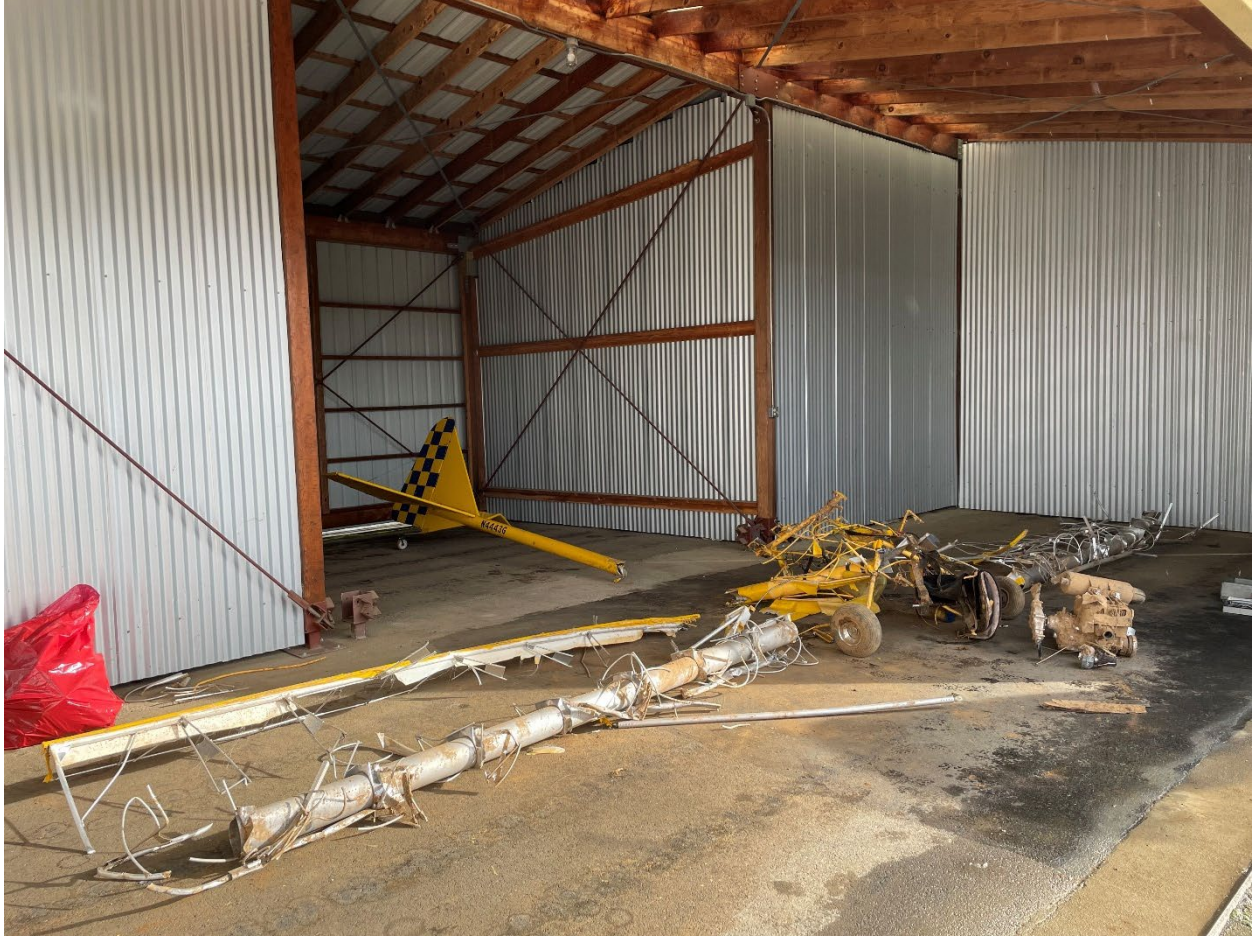
**Figure 3. View of airplane layout in hangar.**

The airplane and engine examination took place on November 8, 2024, at a local hanger. See figure 3.

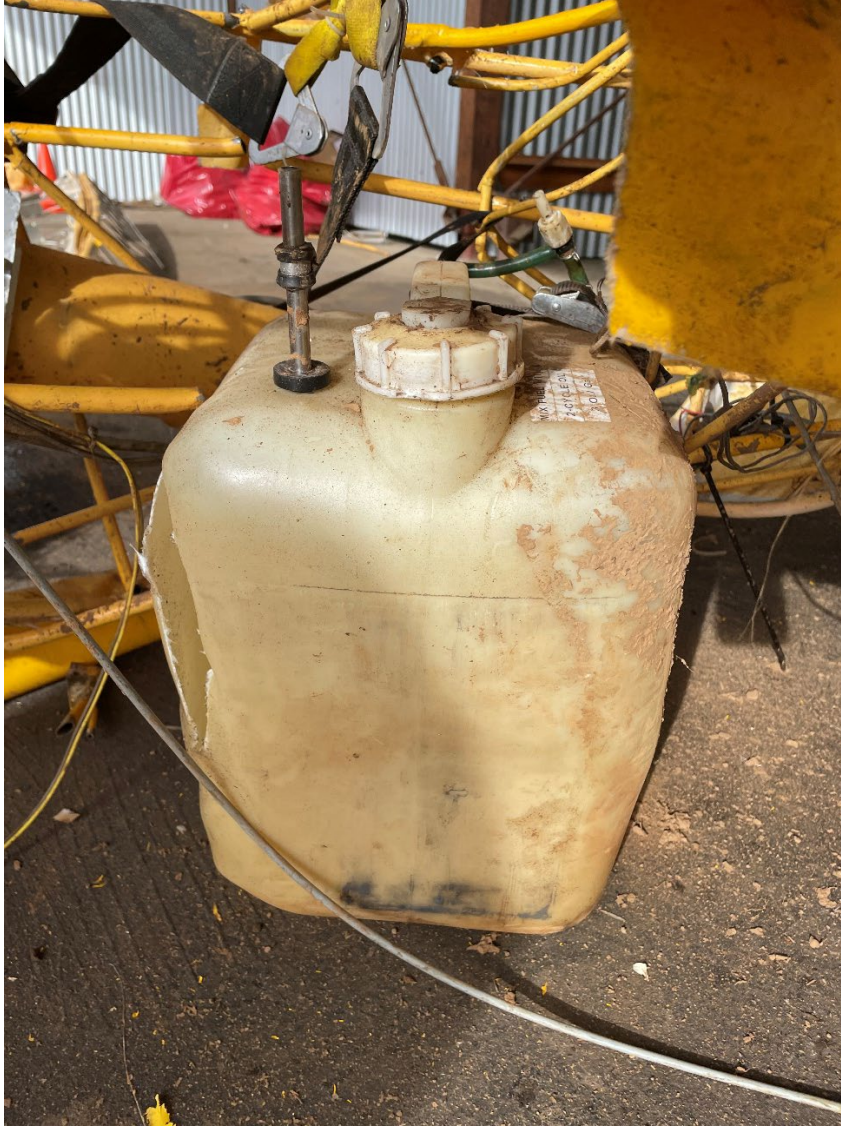
**Figure 4. View of fuel tank.**

Fuel odor was present at the main wreckage site. The fuel tank was void of fuel and was breached on its side wall. See figure 4. The external mounted fuel filter was intact and connected to the fuel tank by fuel hoses.

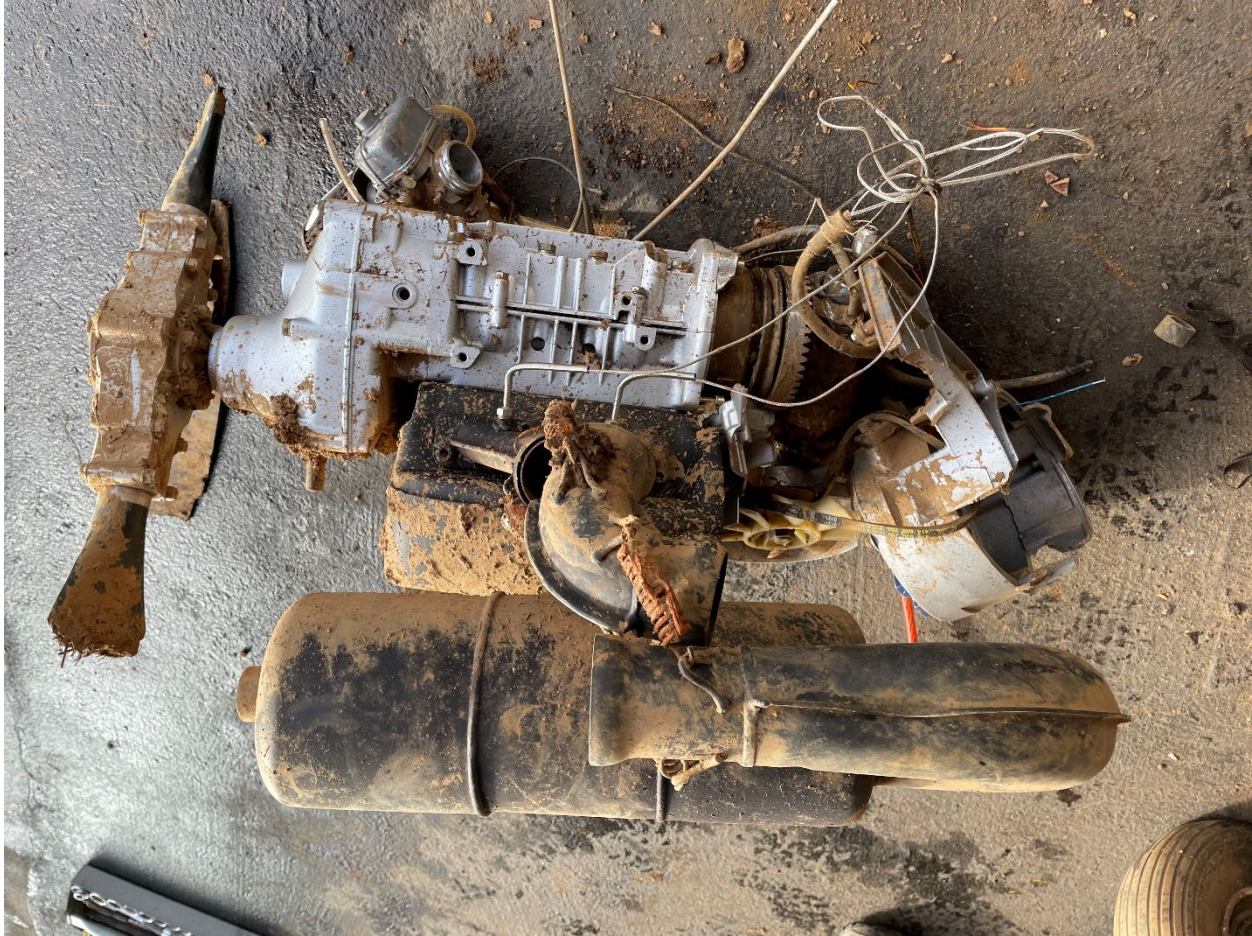
**Figure 5. View of engine at examination.**

The engine was separated from its engine mounts and found adjacent the main wreckage. The engine case was found with minor damage. The voltage regulator was impact damaged and was separated from its mounting pad. The CDI ignition system and carburetor remained attached to its mounting pads with minor damage. The exhaust was impact damaged and remained partially attached to the engine.

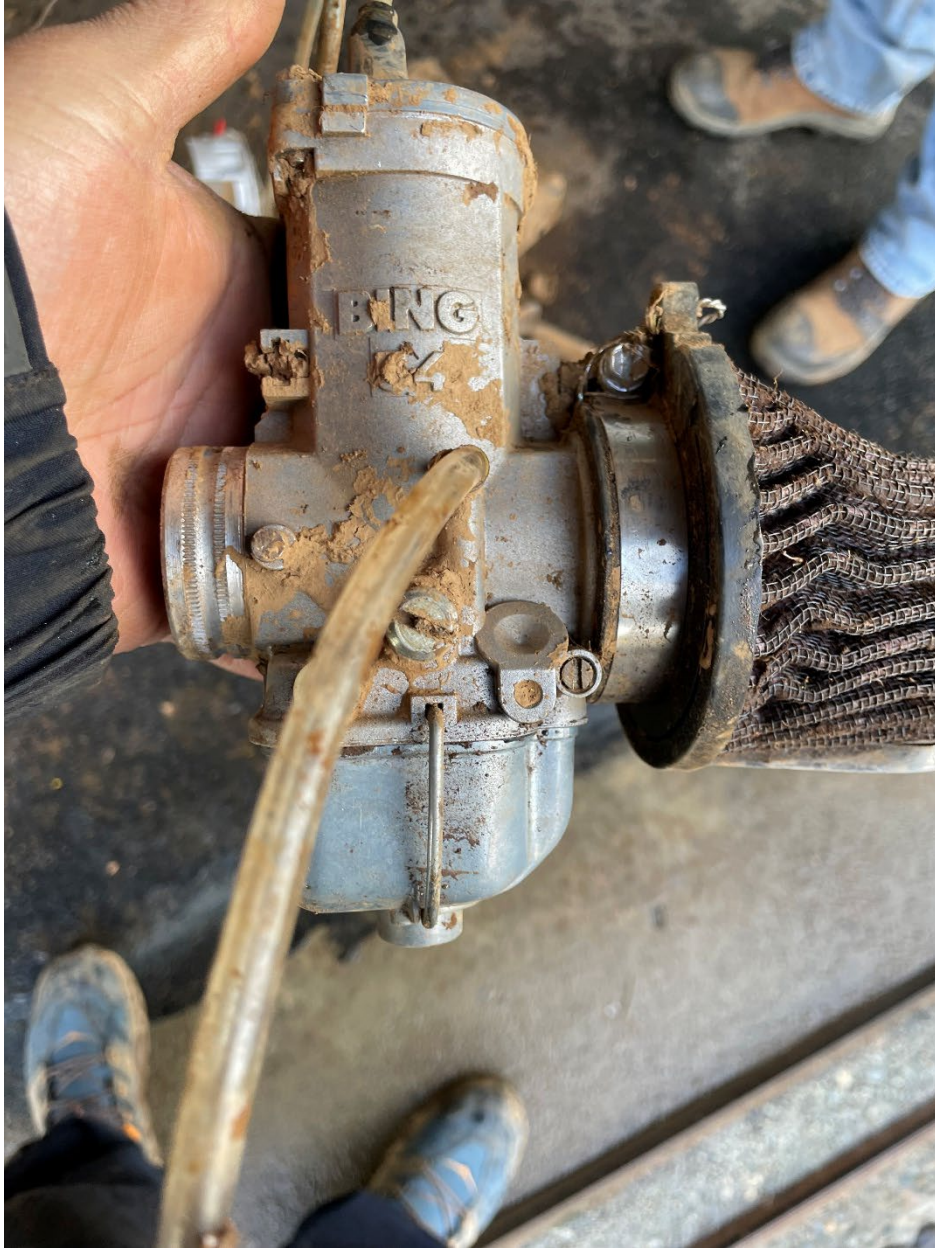
**Figure 6. View of carburetor and air filter.**

The BING carburetor was separated from its mounting pad and remained intact. The carburetor fuel filter was found unremarkable. The air filter was impact damaged and remained attached to the carburetor. The filter internally was found unremarkable.

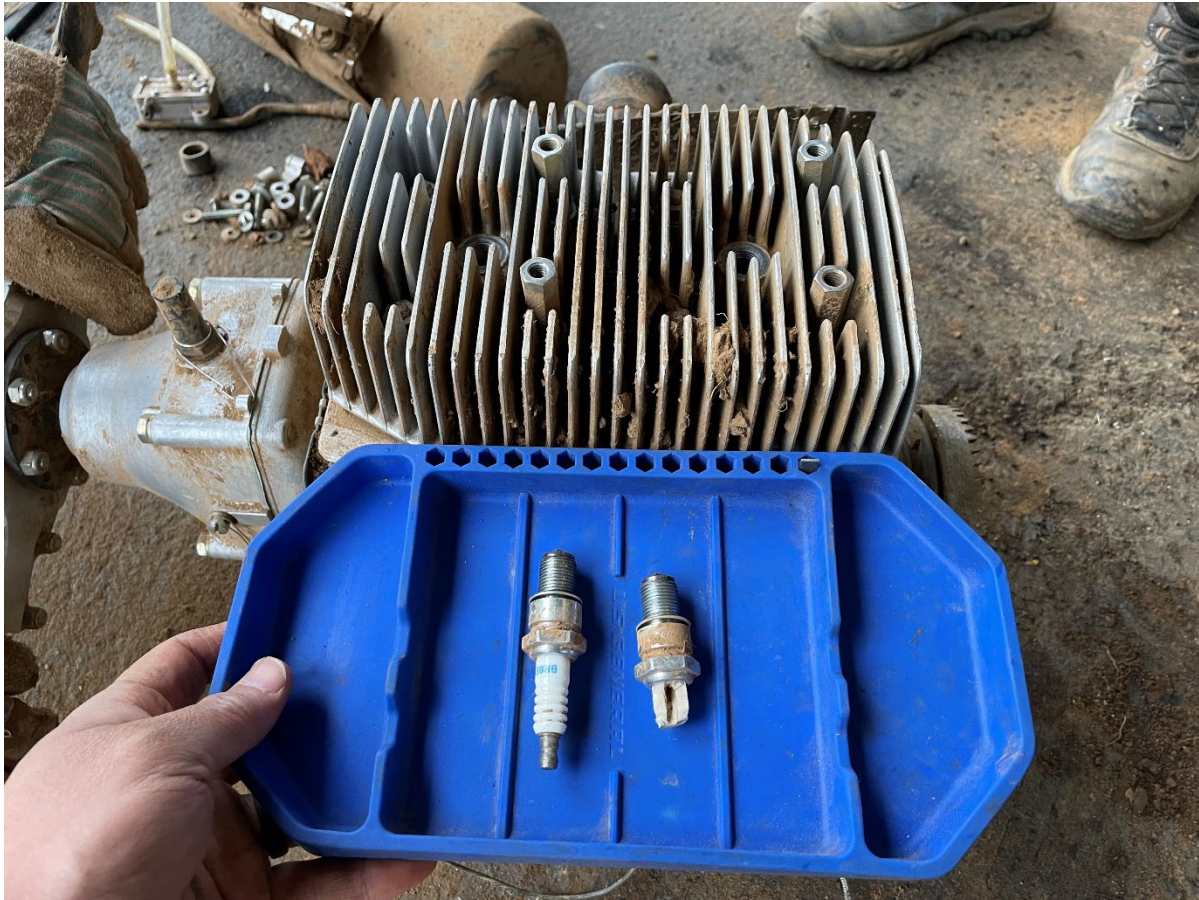
**Figure 7. View of cylinders and corresponding spark plugs**

Two spark plugs remained attached to it corresponding cylinder. See figure The aft spark plug was impact damage. Examination of the spark plugs revealed no anomalies and carbon found was consistent with normal operations. Valve control continuity was established by manually rotating the propeller.
