WPR24FA104

## INVESTIGATION PHOTOGRAPHS

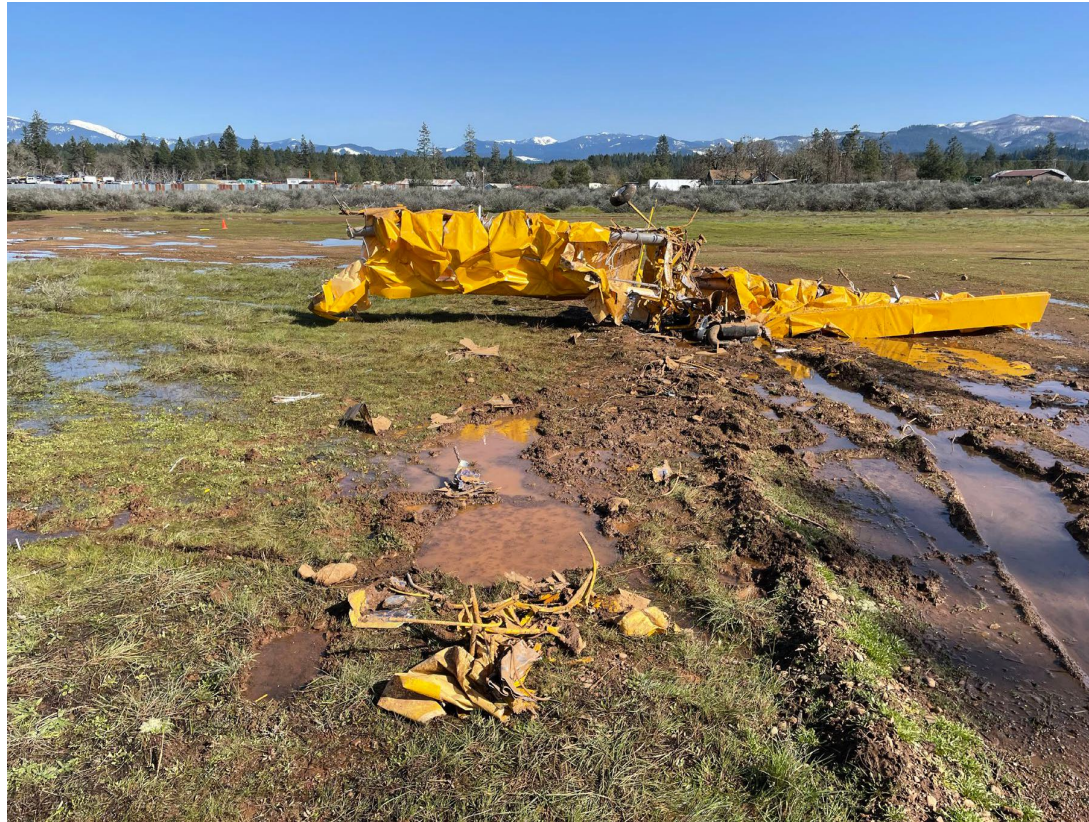
**Photograph 1 - View of accident airplane in an open field**

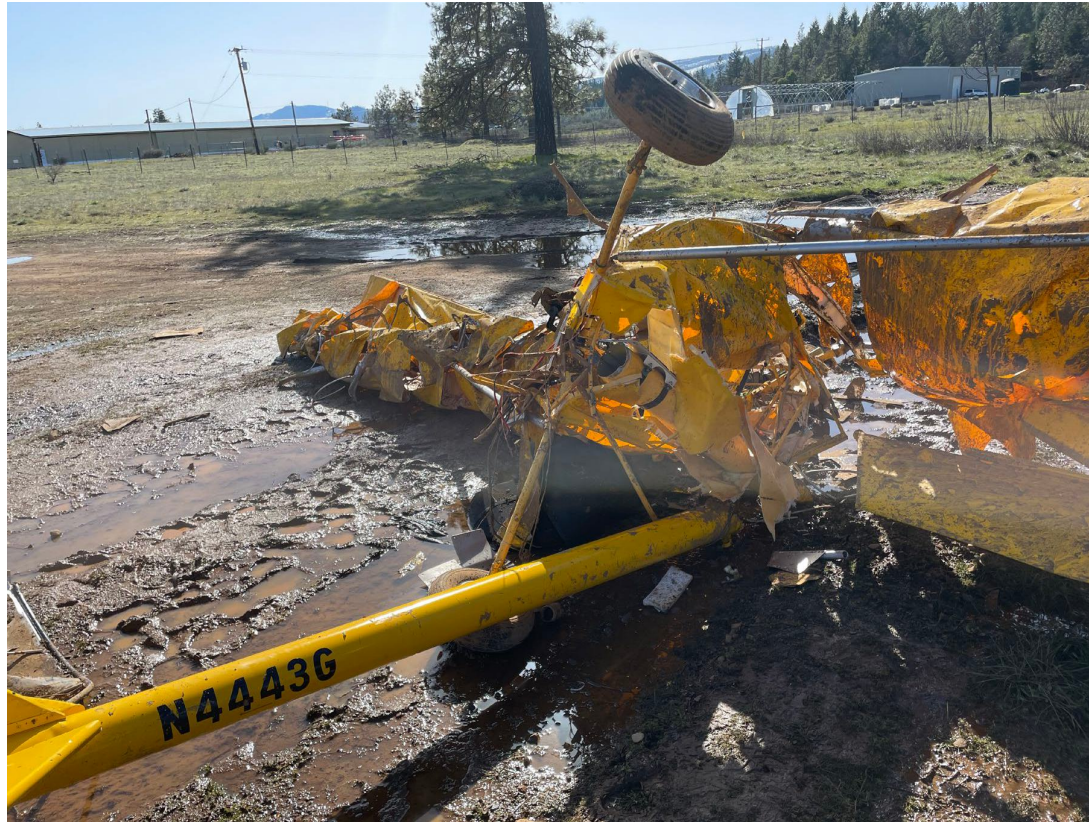
**Photograph 2 - View of damaged fuselage, wings and tailcone**

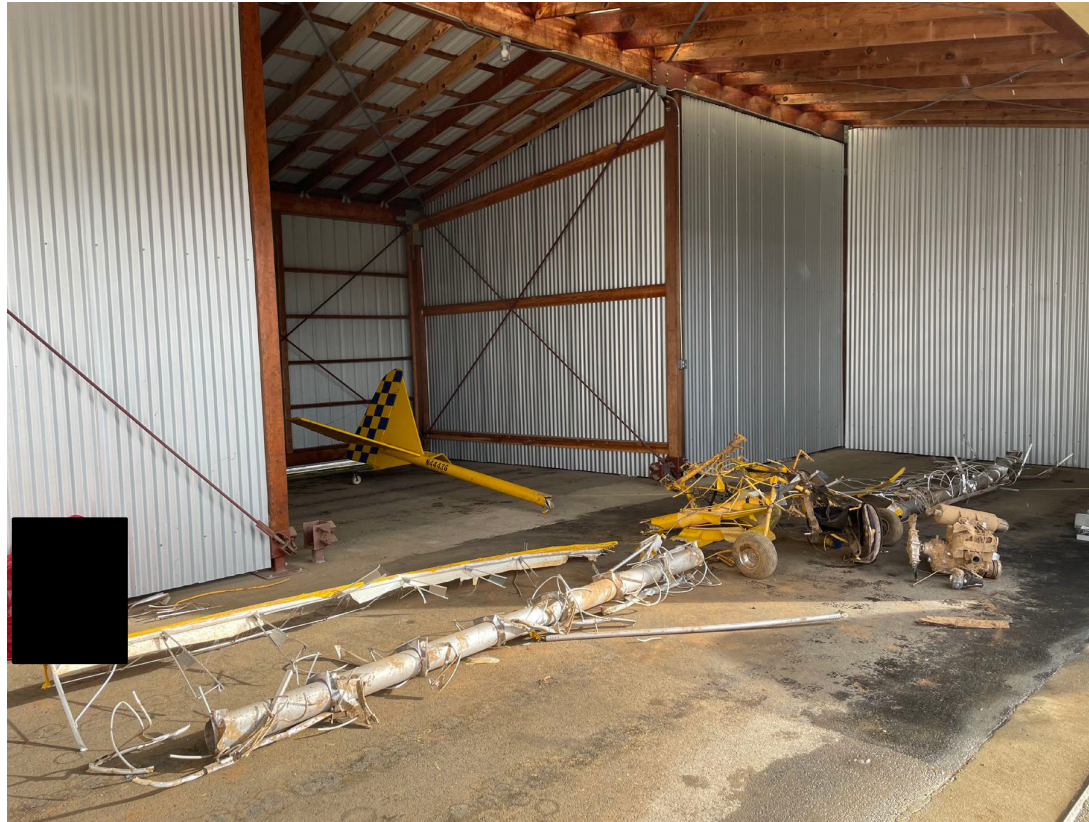
**Photograph 3 - View of recovered airplane in hangar for examination**

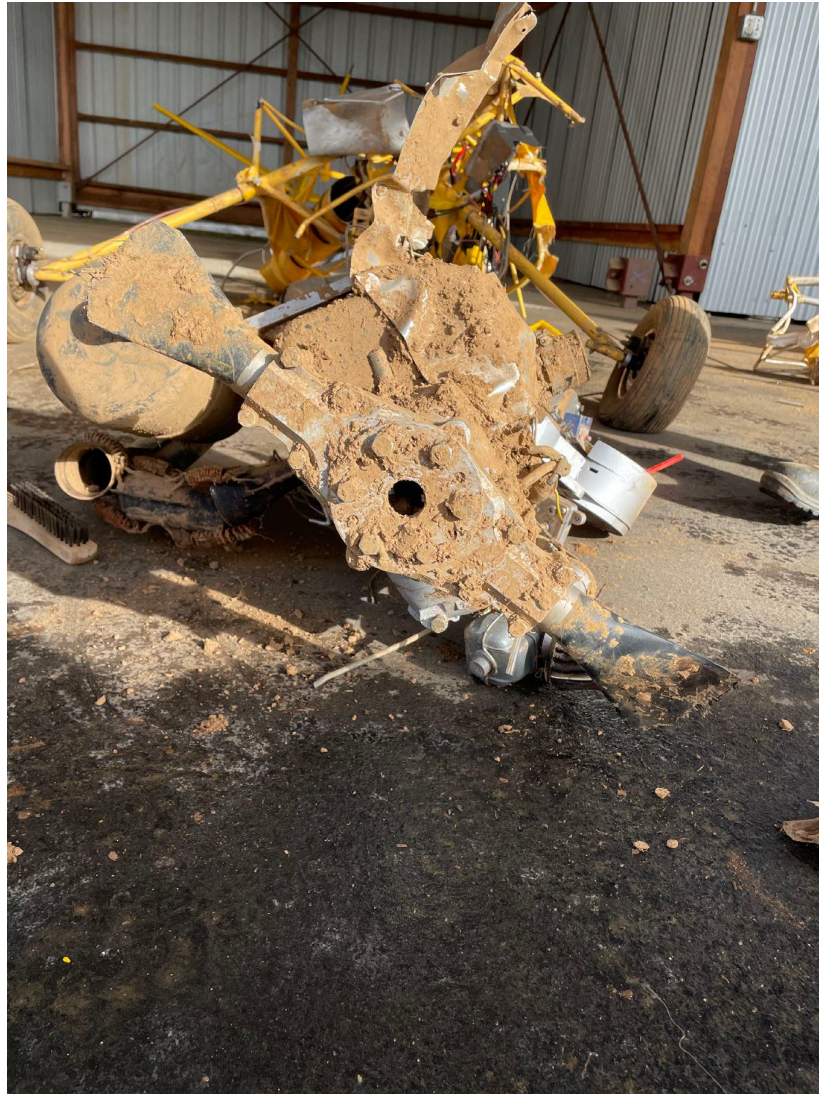
**Photograph 4 - View of damaged propeller assembly**

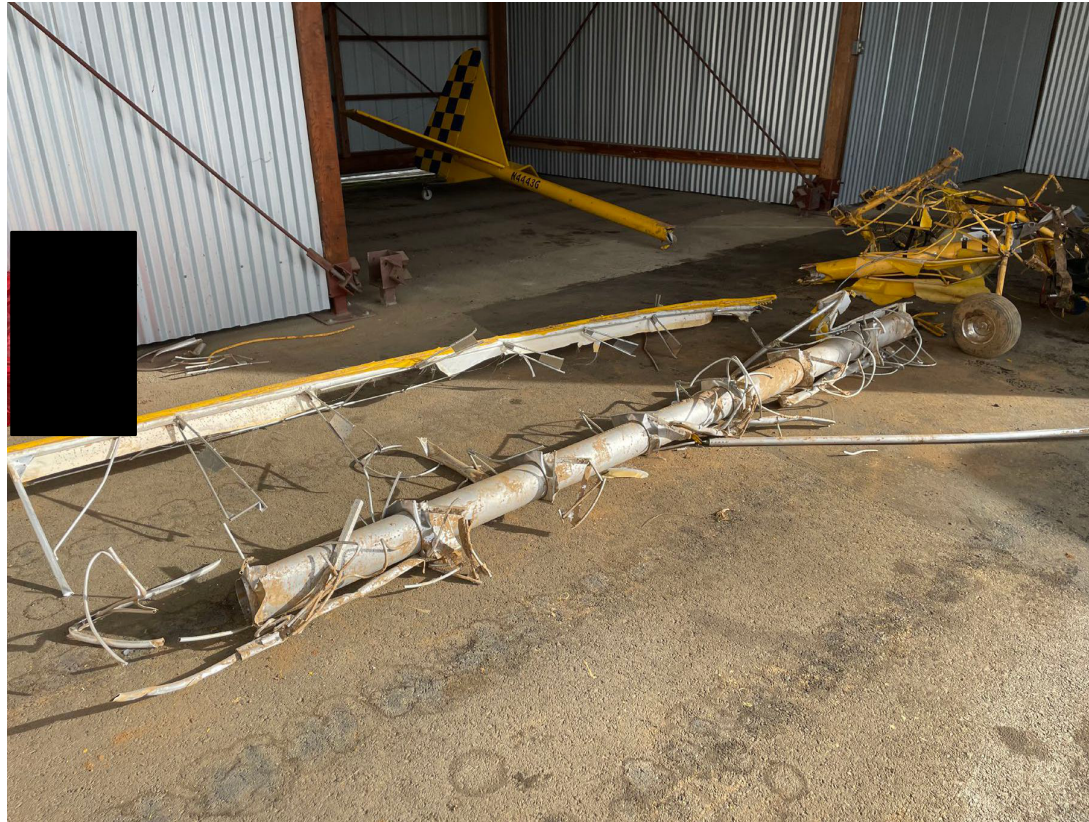
**Photograph 5 - View of right-wing during examination**

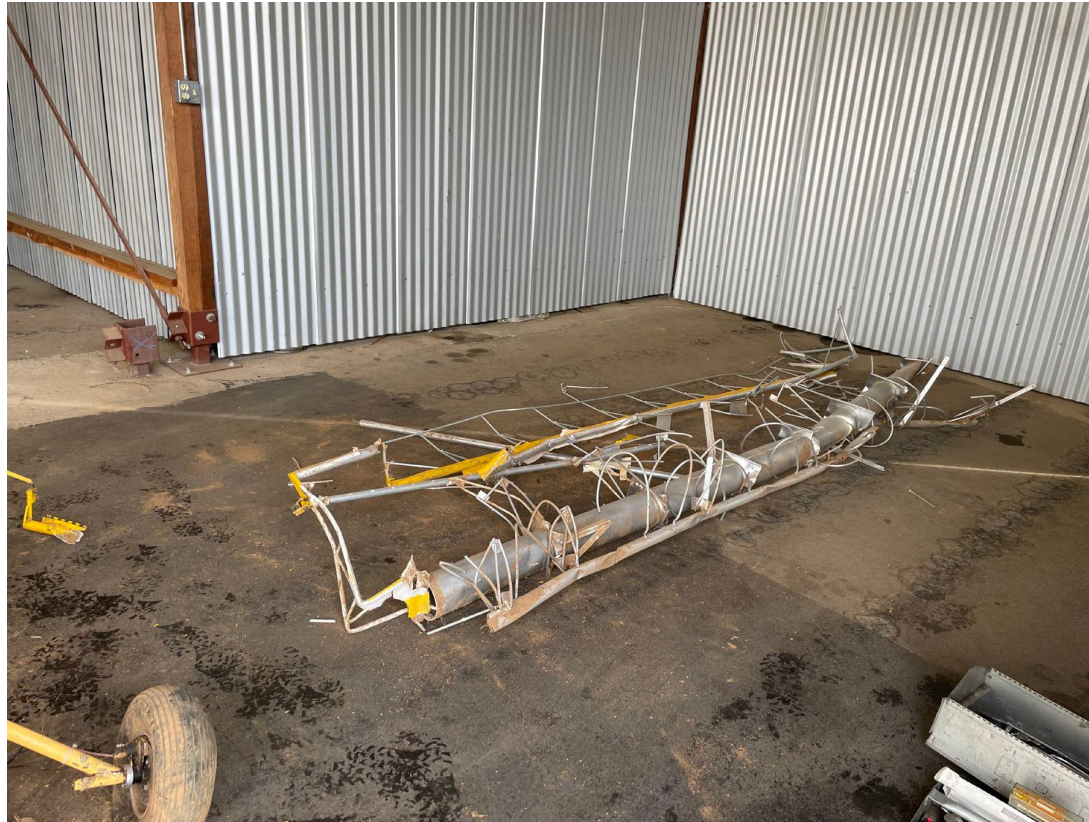
**Photograph 6 - View of left-wing during examination**

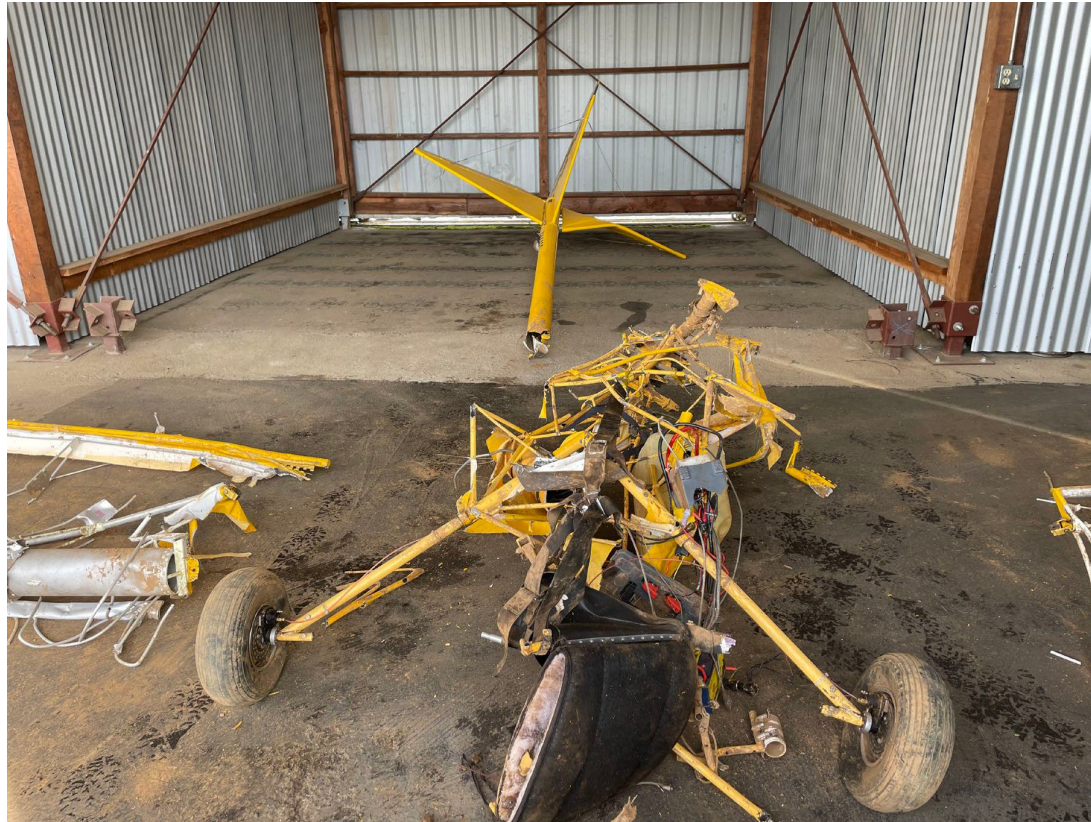
**Photograph 7 - View of fuselage, empennage, and tailcone during examination**

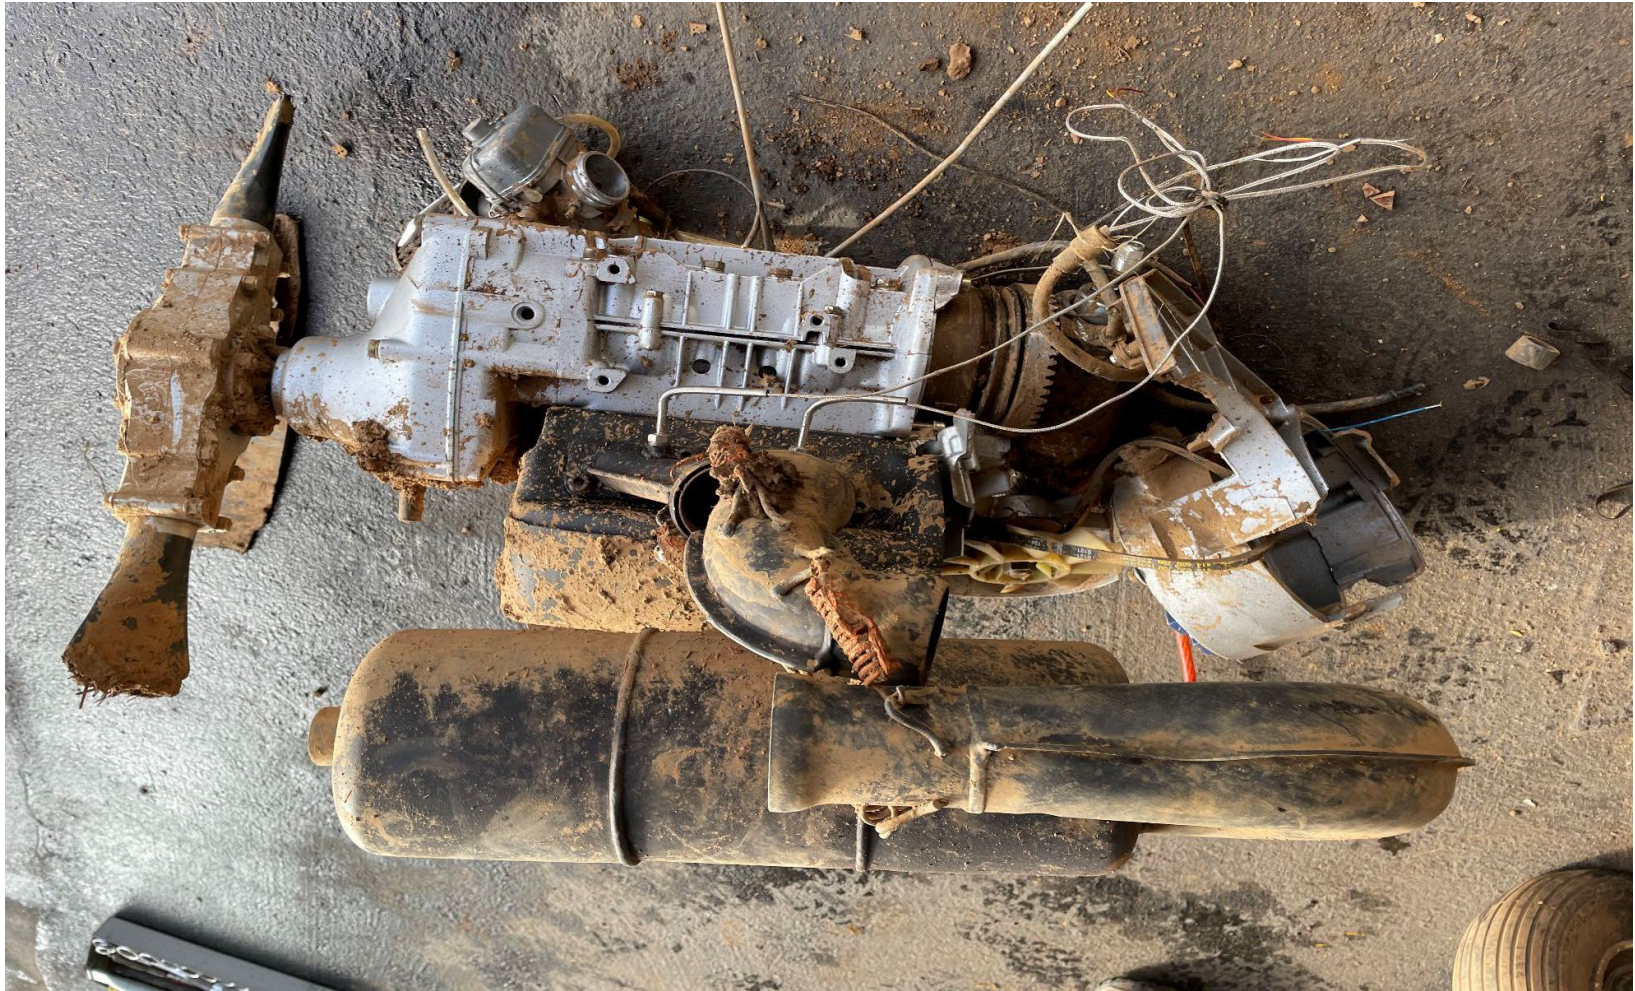
**Photograph 8 - View of engine during examination**
