WPR24FA105

## INVESTIGATION PHOTOGRAPHS

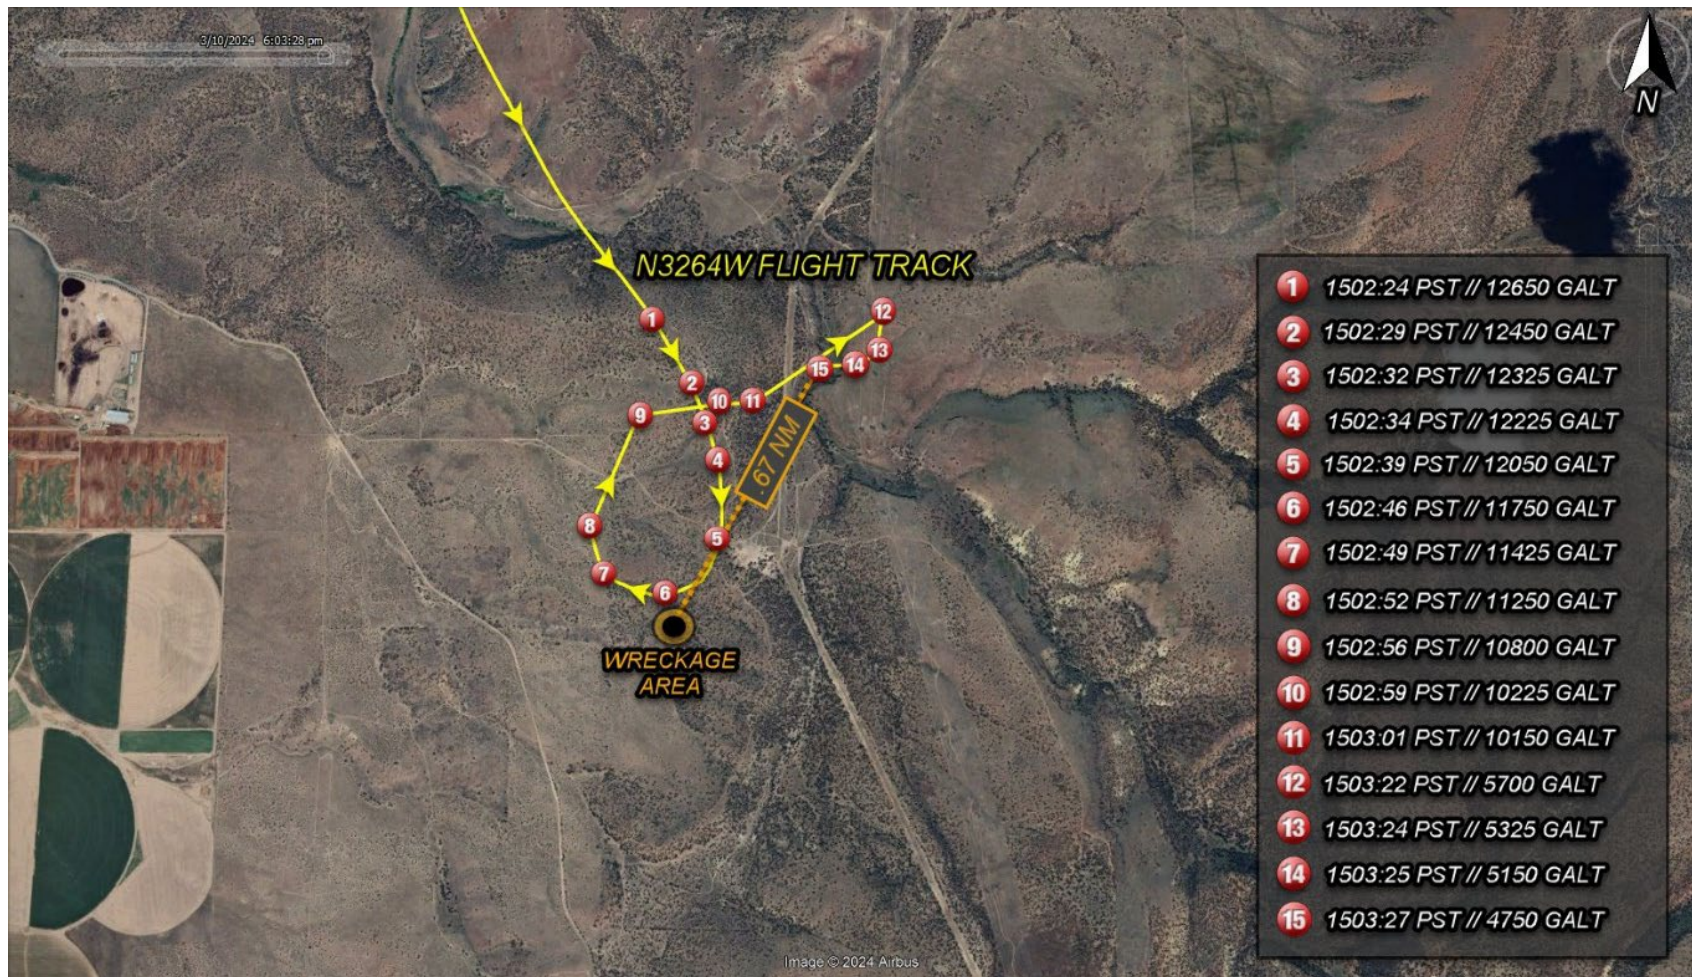
**Photograph 1 - Southeast flight track to accident site**

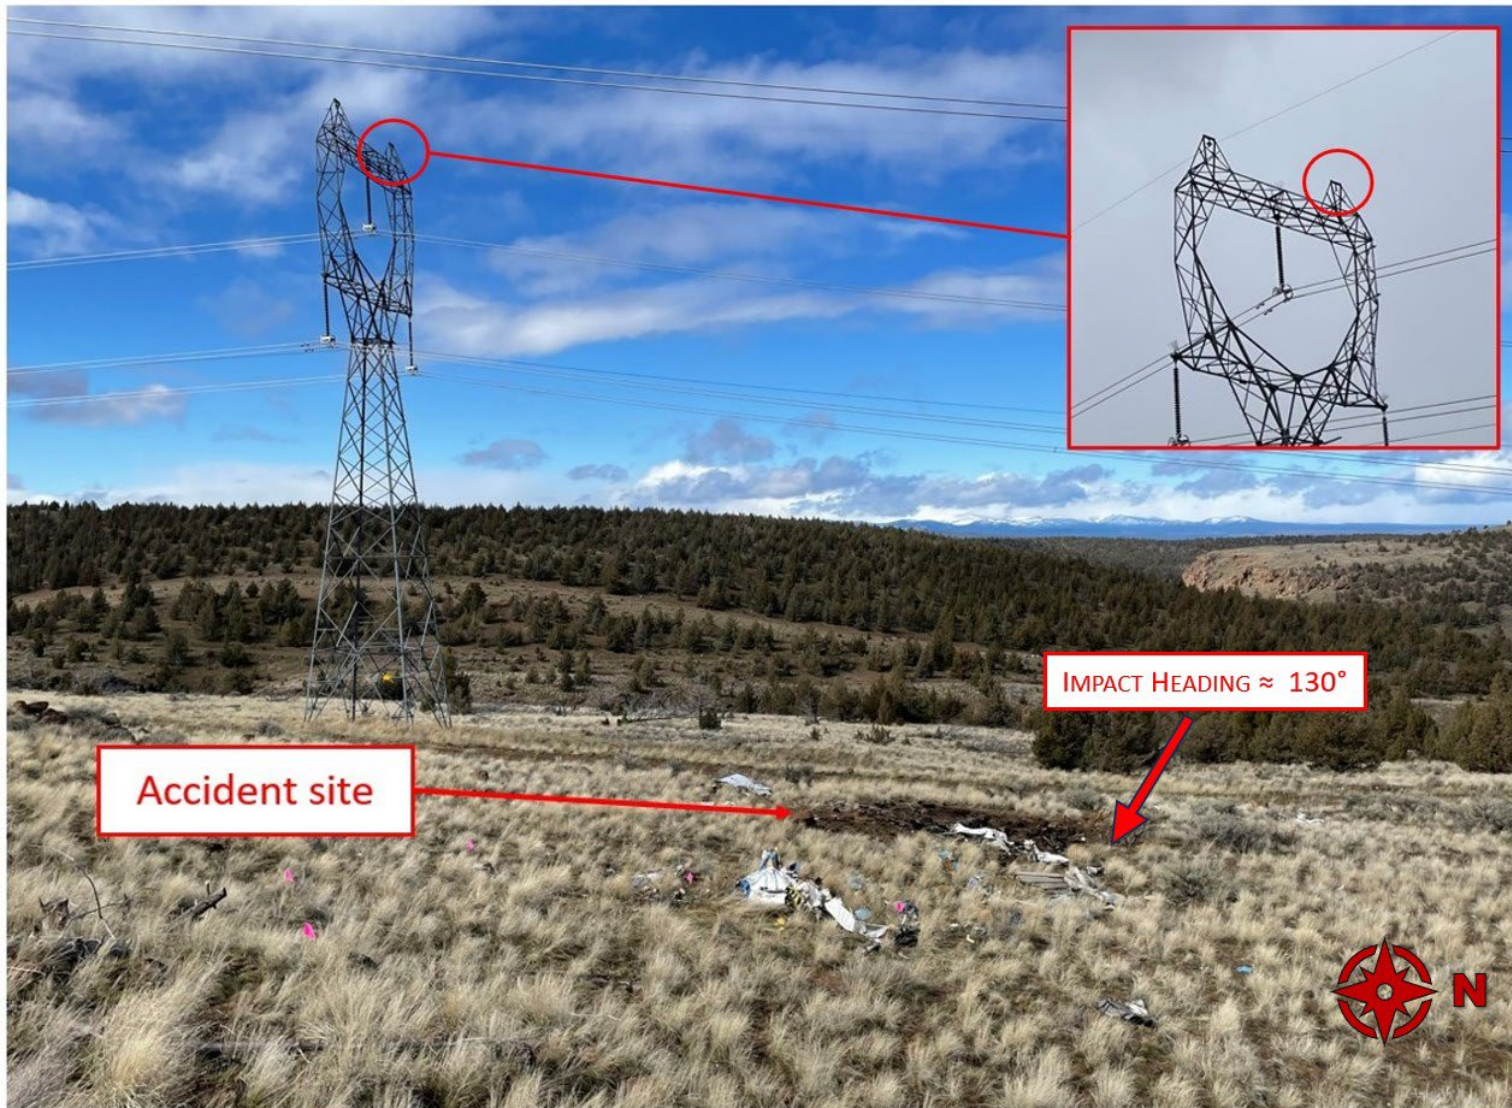
**Photograph 2 - View of cut static high-tension line between towers**

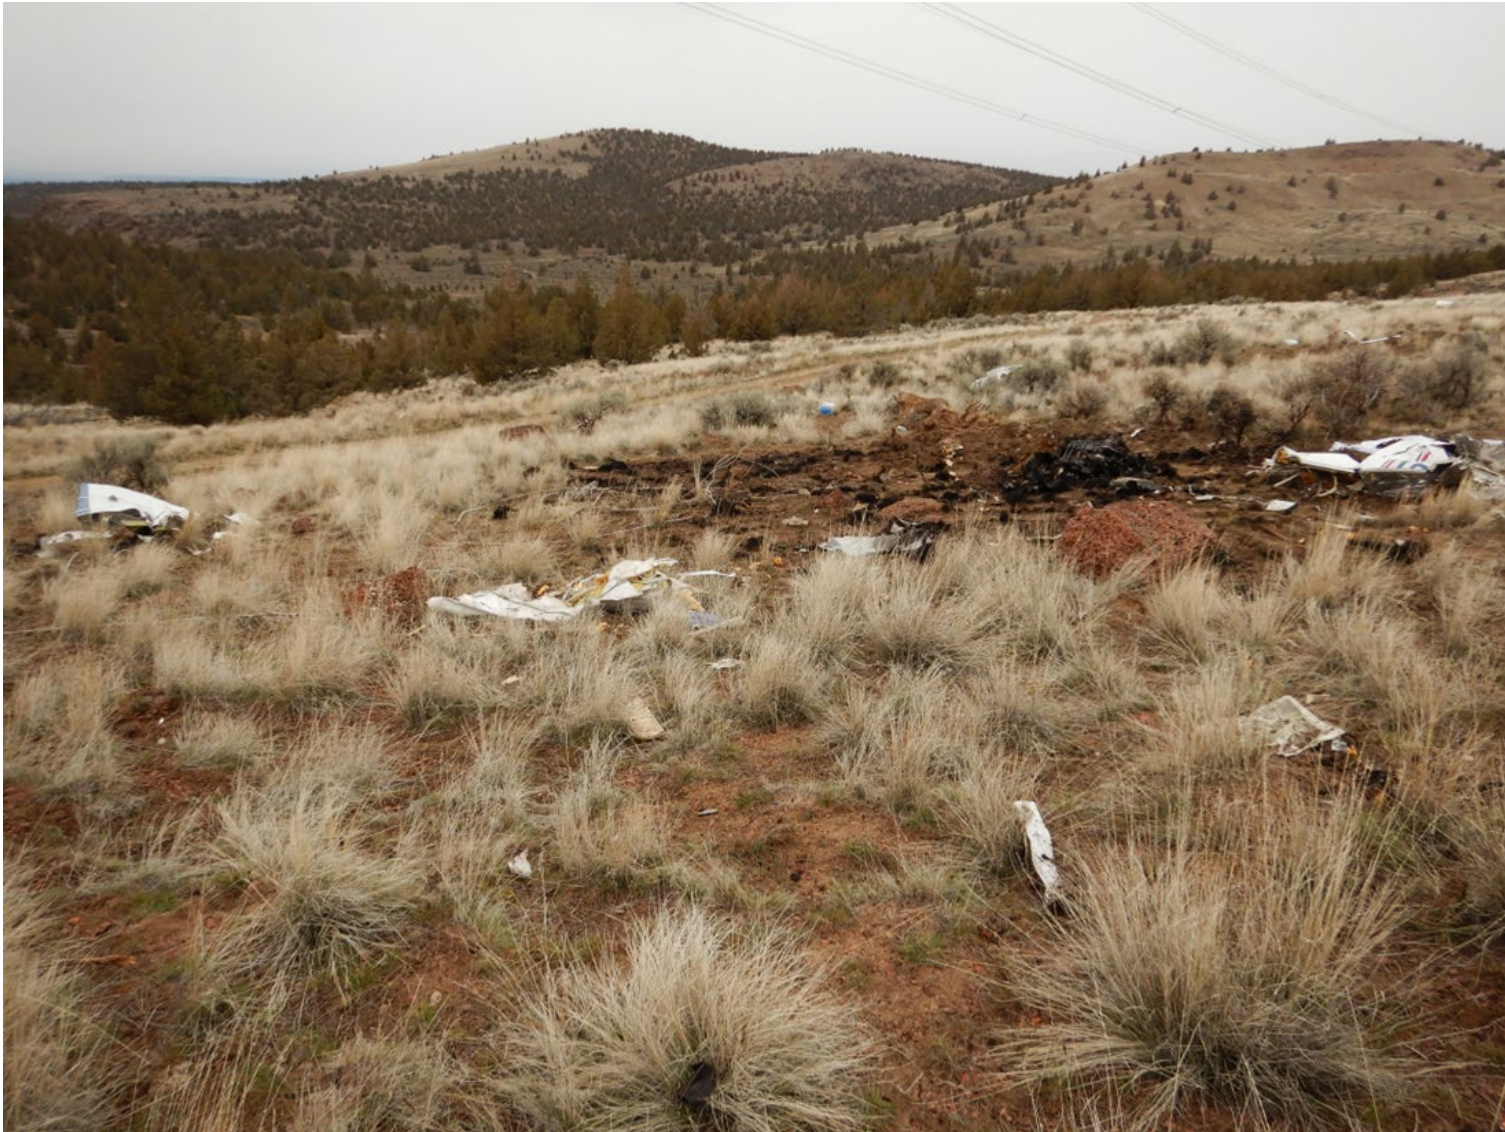
**Photograph 3 - View of accident site between high-tension towers**

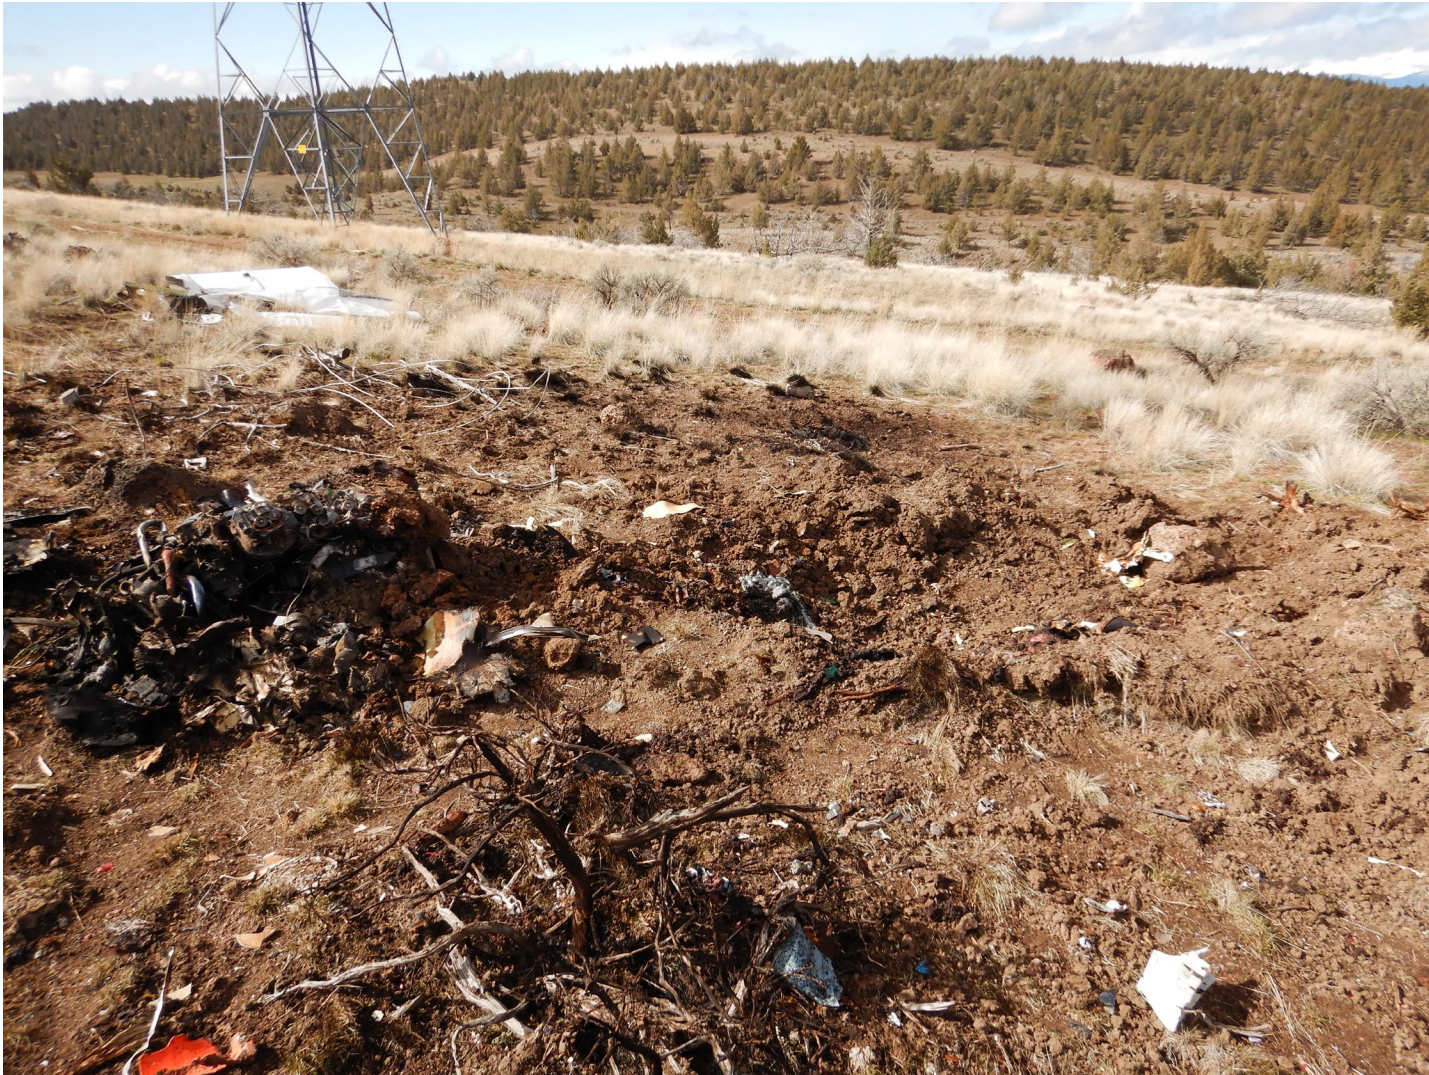
**Photograph 4 - View of engine at end of accident trench**

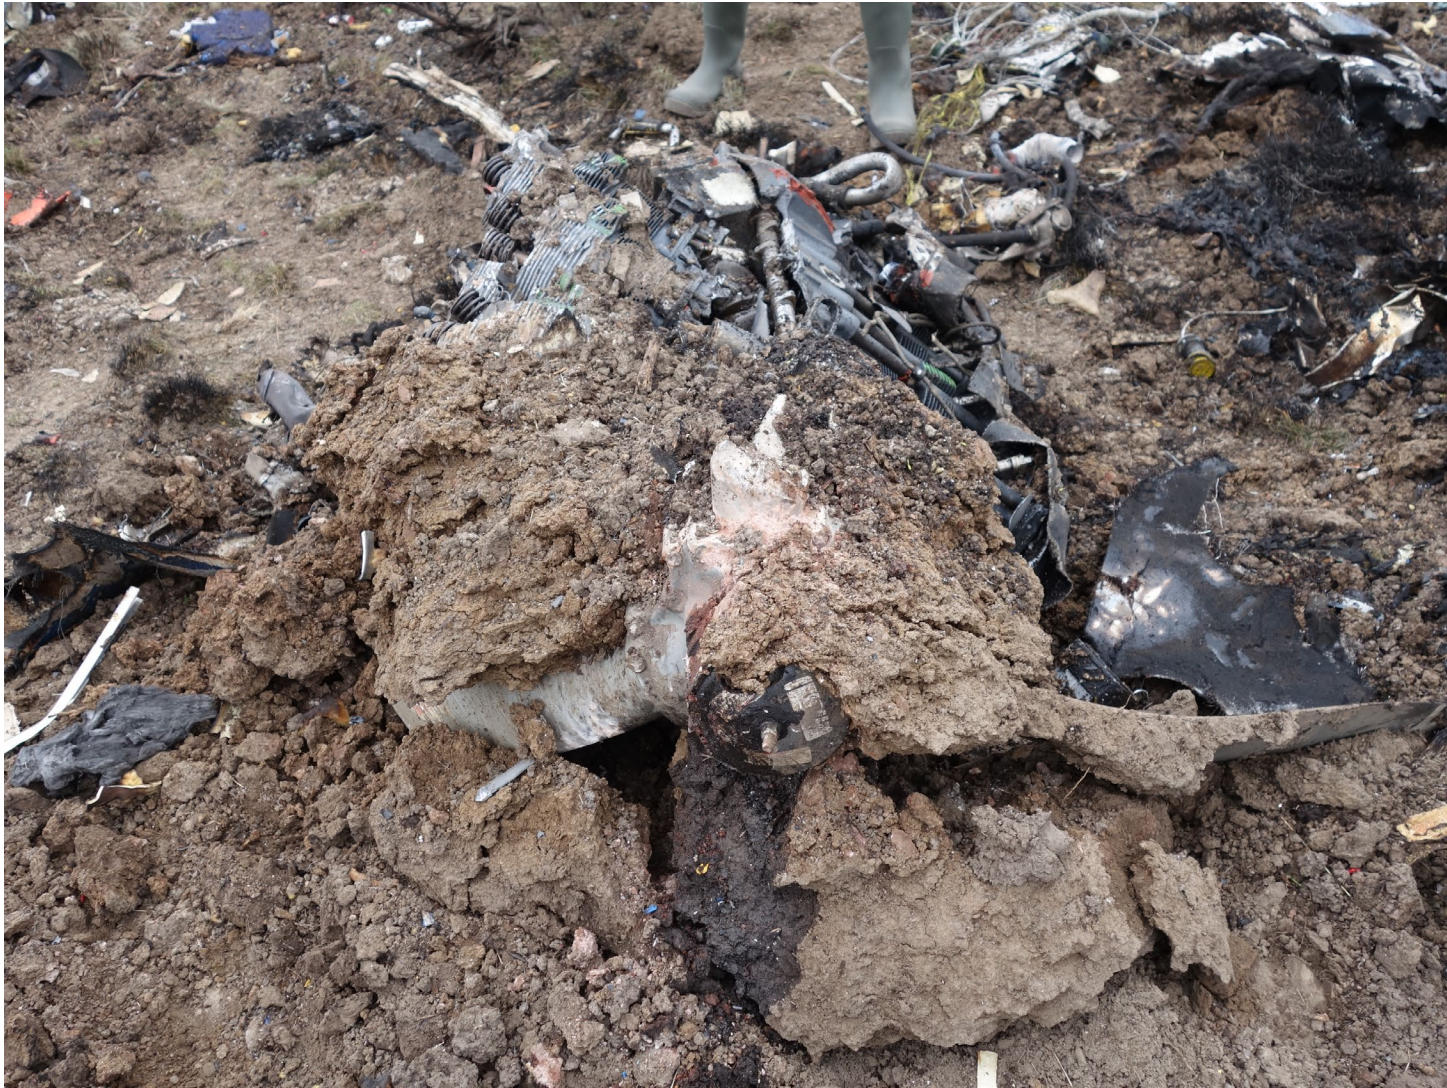
**Photograph 5 - View of engine at accident site**

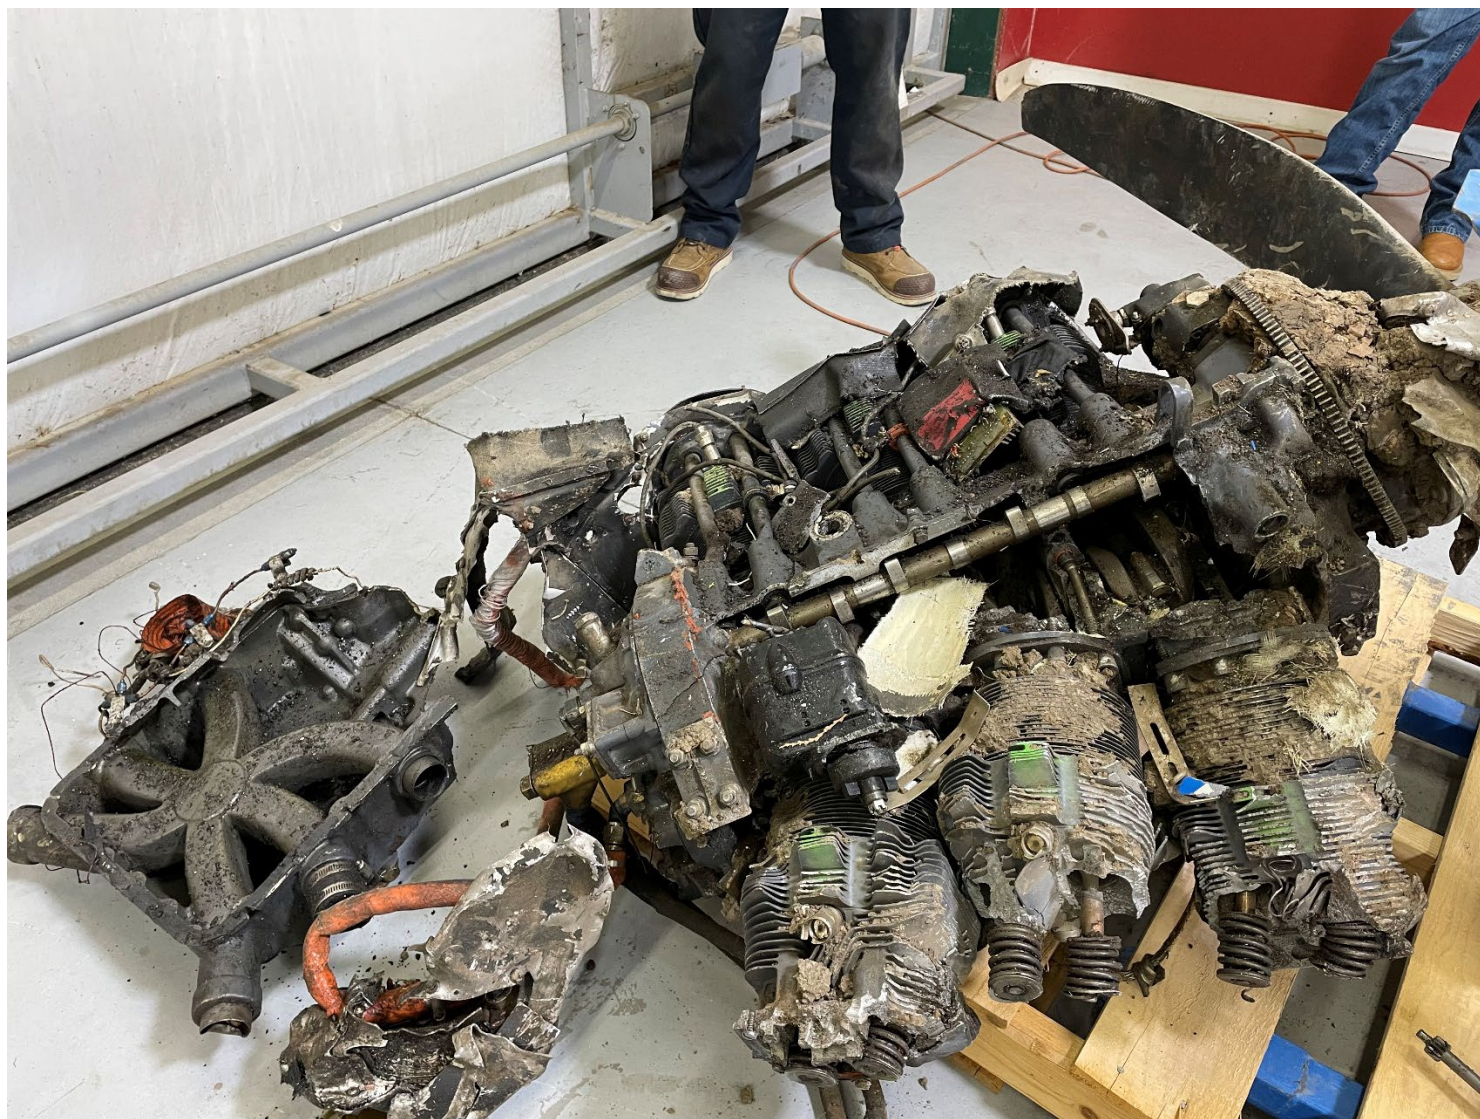
**Photograph 6 - View of engine prior to engine examination**
