# National Transportation Safety Board

WPR24FA105

## **ACCIDENT SITE EXAMINATION**

Location: Madras, Oregon  
Date: March 10, 2024  
Time: 15:03 PDT  
2203 UTC  
Airplane: Piper PA -32-260 (N3264W)

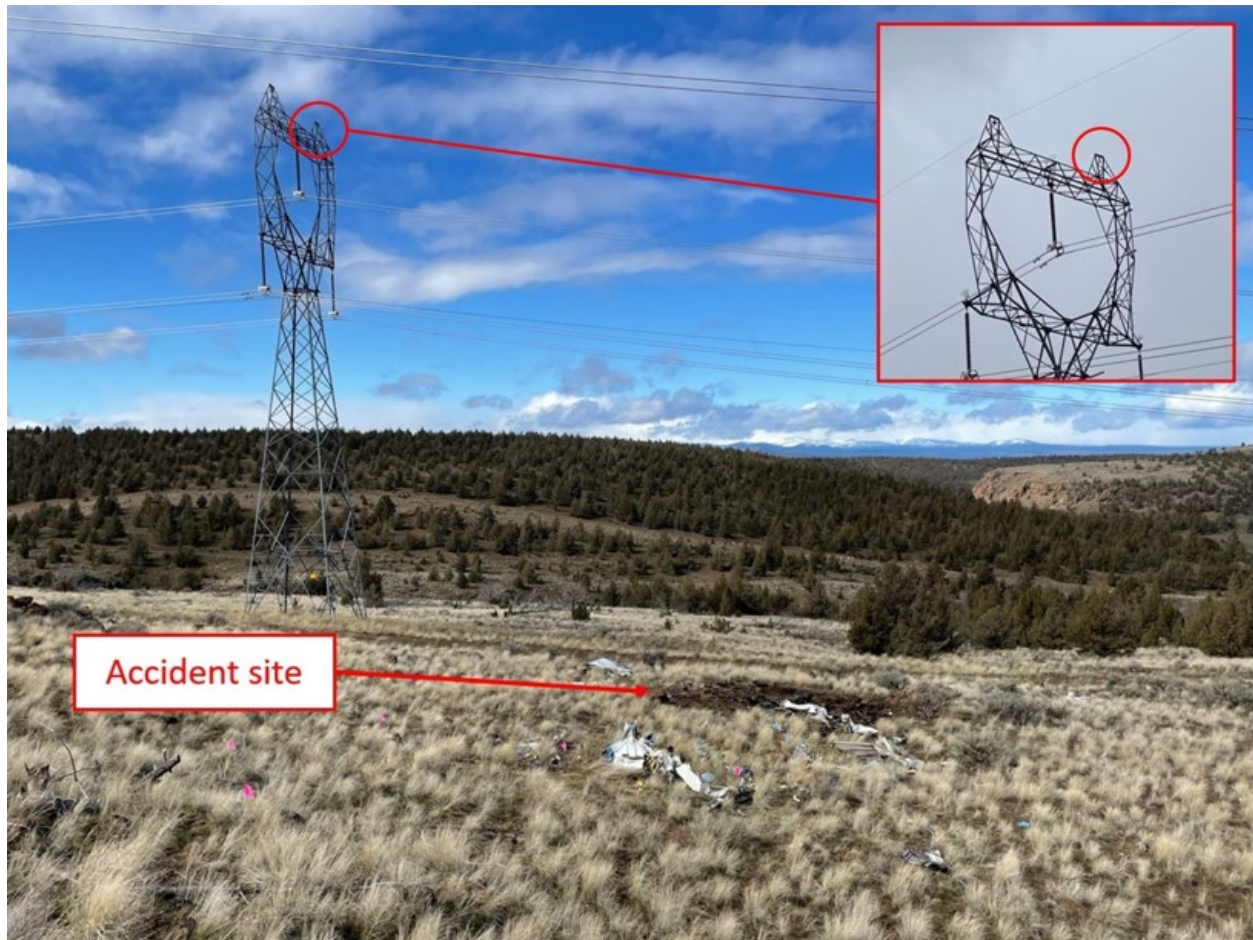
**Figure 1: Wreckage site with static wire strike**

Observed on scene, the airplane struck and cut one of the high-tension static lines off the top of nearby north-south powerline towers. The first identified point of contact (FIPC) with sloping terrain was a ground scar/impression approximately 5 feet deep, 12 feet wide and 20 feet long into terrain at a heading of 130 °magnetic and spread out 300 ft debris path. A small post-crash fire ensued but extinguished itself quickly due to recent rains.

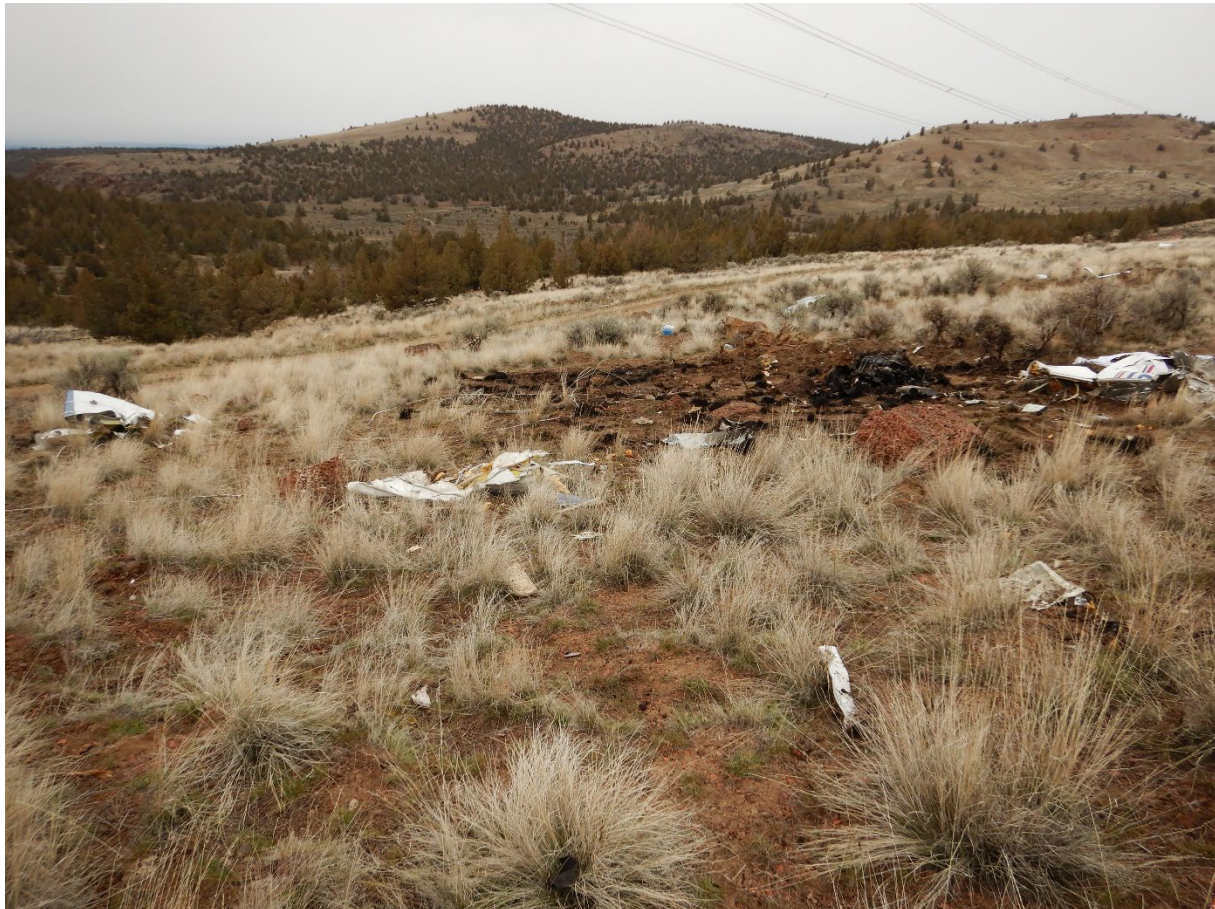
**Figure 2: Northwest view of impact site with ground fire marks**

Examination of the wreckage area revealed heavy fragmentation of the airplane structure. All four corners on the airplane were accounted for. Primary and secondary flight surfaces, both sides of the stabilator and the vertical stabilizer with rudder attached were found. Both rudder cables were attached to the rudder.

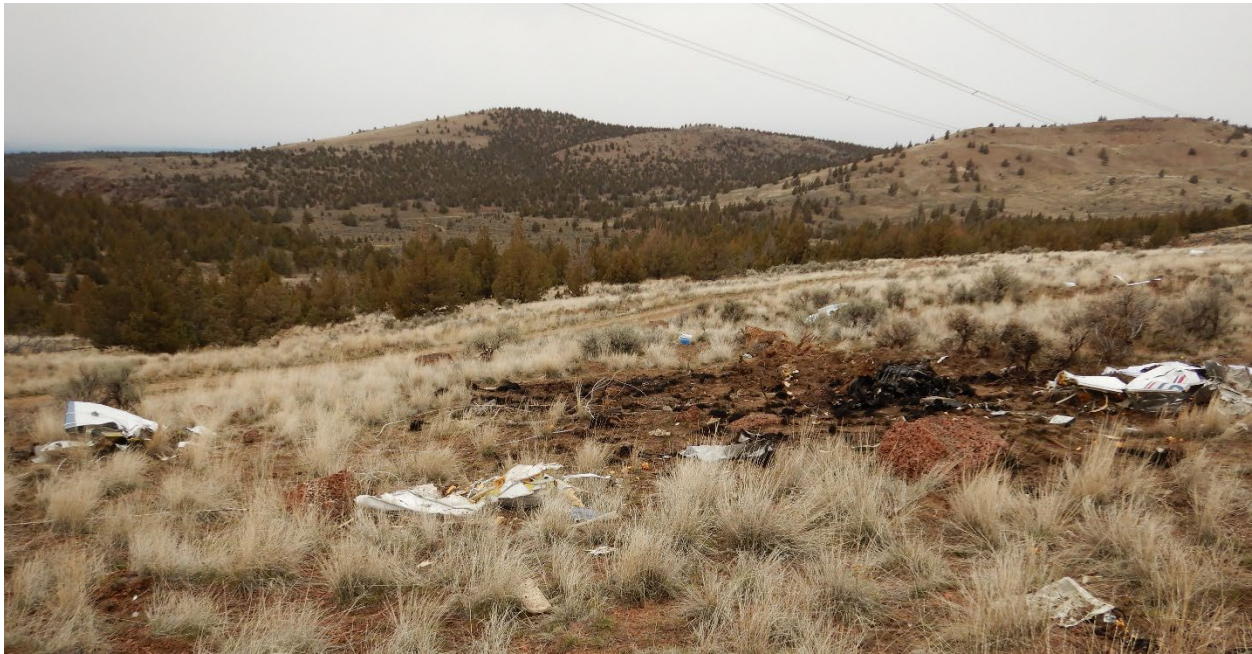
**Figure 3: Right wing with high-tension static line**

The right wing was separated from the fuselage with the main portion located in the debris field south of the main impact crater. The wing was further separated into three sections with a portion of the leading edge, forward of the main spar and inboard of the main fuel tank, located in the debris field north of the main impact crater. A third section, also located north of the main impact crater, consisted of the outboard portion of the wing, less the auxiliary/tip tank.

The main right fuel tank remained attached to the wing and the fuel cap remained intact in the fuel filler neck opening. The tip tank was destroyed and a loose fuel filler cap, consistent with the tip tank, was in the debris field near the main portion of the right wing.

The flap was separated from the wing and further separated chordwise into two pieces, both of which were located beneath the main portion of the wing. The aileron was separated from the wing and located in the debris field. The aileron and balance cables were continuous to the wing root/fuselage and exhibited broomstraw

separations at the ends. The main landing gear remained partially attached to the right wing.

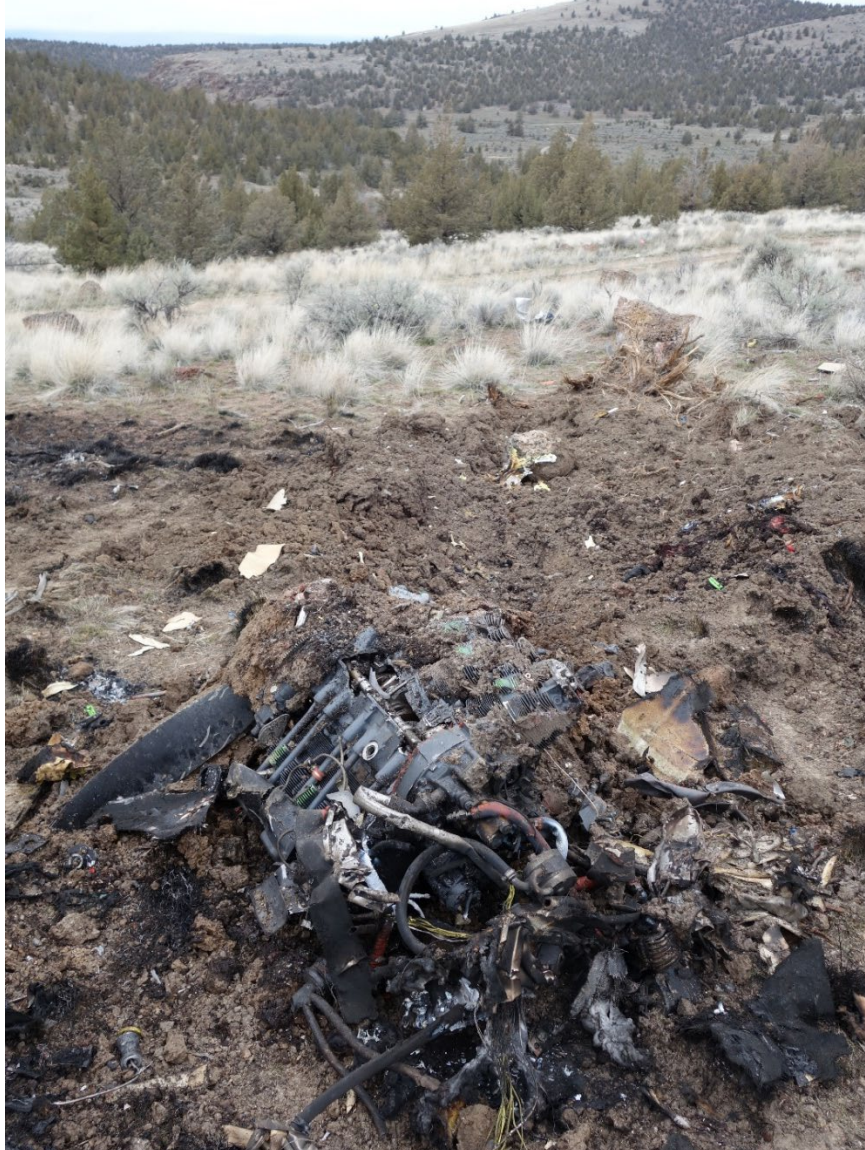
**Figure 4: Engine at top of impact trench**

The engine was separated from the engine mount and located right side up on the ground just beyond the main impact crater and facing the opposite direction of the aircraft's direction of travel. All three cylinders on the right side of the engine were impact damaged and displaced. The right side of the crankcase was broken and fragmented. The cylinders and crankcase on the left side remained largely intact. The engine was rolled over on the ground to facilitate further examination which revealed that the oil sump was fractured and separated from the crankcase. An undetermined quantity of oil was observed in the bottom of the sump. The carburetor was separated from its mount and remained attached by a cable to the cockpit portion of the fuselage. Carburetor bowl exhibited dark/black discoloration on internal throat and a portion of the exterior of the float bowl. The color resembled soot or thermal discoloration. Similar dark color/soot signatures were visible on the carburetor heat airbox assembly which was separated and located in the debris field.

The left magneto remained attached to its mount on the accessory housing. The right magneto and vacuum pump were separated from their mounts and located adjacent to the engine.

The Hartzell three-blade aluminum constant speed propeller remained attached to the crankshaft propeller flange. The first blade, which remained captured in the hub, was intact from the hub to the blade tip and exhibited slight aft bending and some chordwise scratches. The second blade also remained captured in the hub and was separated chordwise about mid span. The outer portion of this blade was not located. The inner portion exhibited significant chordwise scratches and gouging of the leading edge. The third blade remained captured in the hub but was fractured and separated just outboard of the hub. The remainder of this blade was not located.
