# National Transportation Safety Board

WPR24FA105

## **ENGINE EXAMINATION**

Location: Madras, Oregon  
Date: March 10, 2024  
Time: 1503 Pacific standard time  
2303 UTC  
Airplane: Piper PA-32-360 (N3264W)

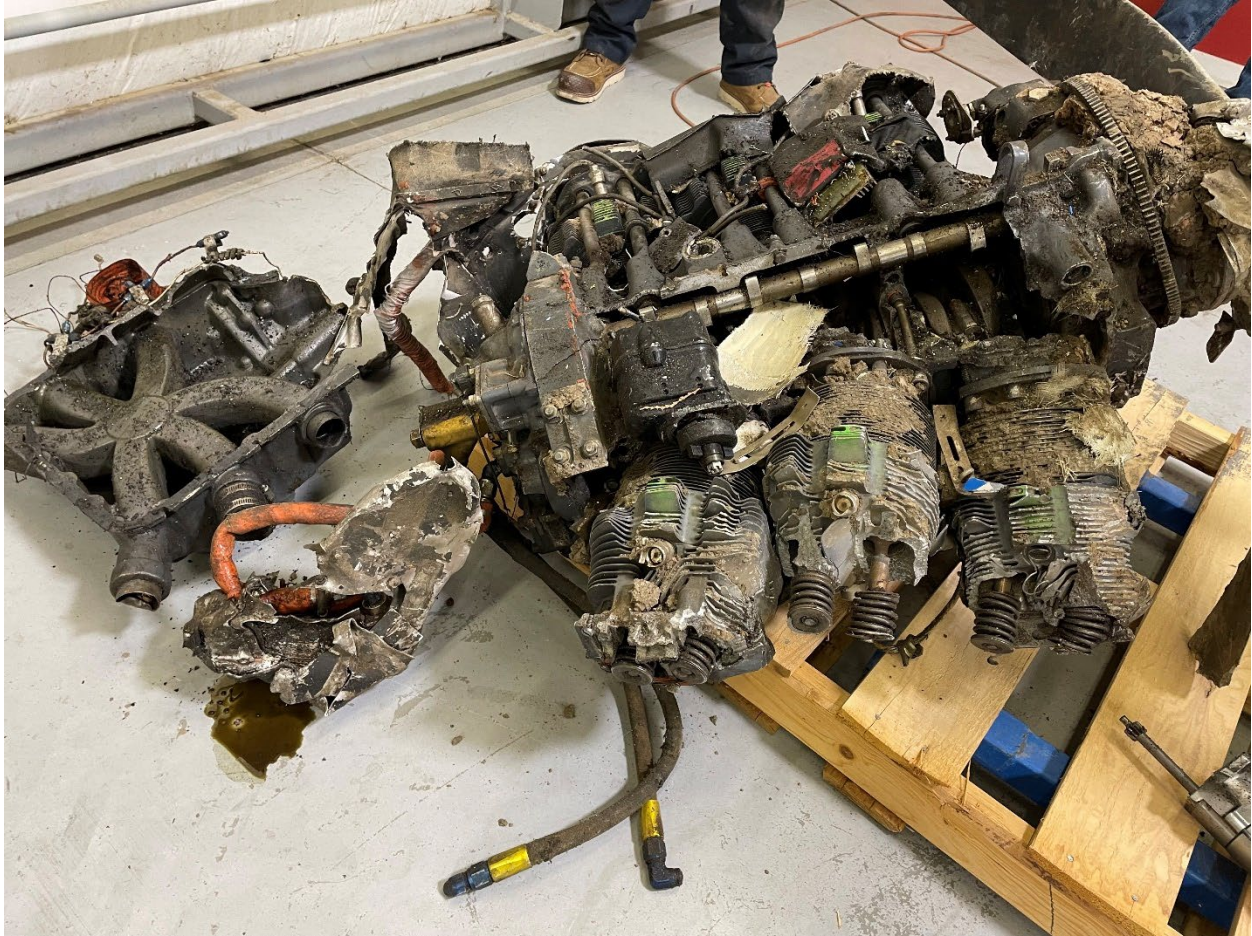
Examination of the recovered engine revealed that the engine was separated from the engine mount and crushed consistent with impact damage on the right side. The damage to the engine precluded engine rotation.

**Figure 1: View of right side of engine.**

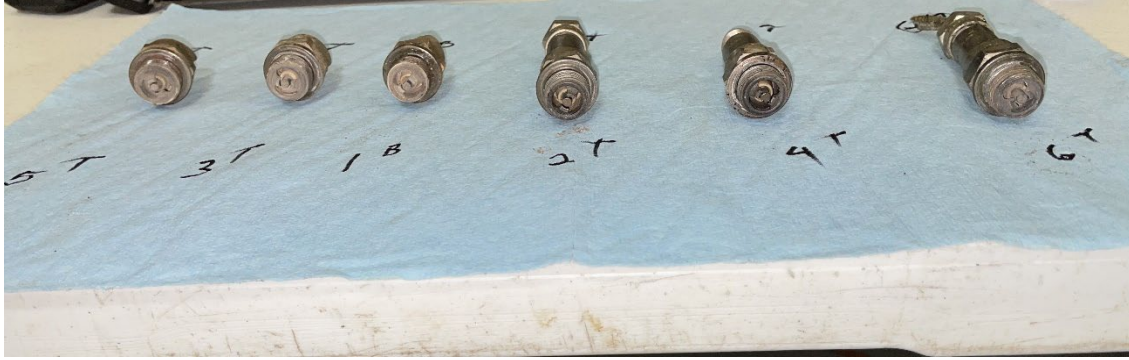
The camshaft remained intact, and each of the cam lobes exhibited characteristics consistent with an elliptical shape. The top and one of the bottom spark plugs were removed, and the electrodes remained undamaged and exhibited normal depositing, reference the Champion spark plug chart - AV-27.

**Figure 2: Removed spark plugs.**

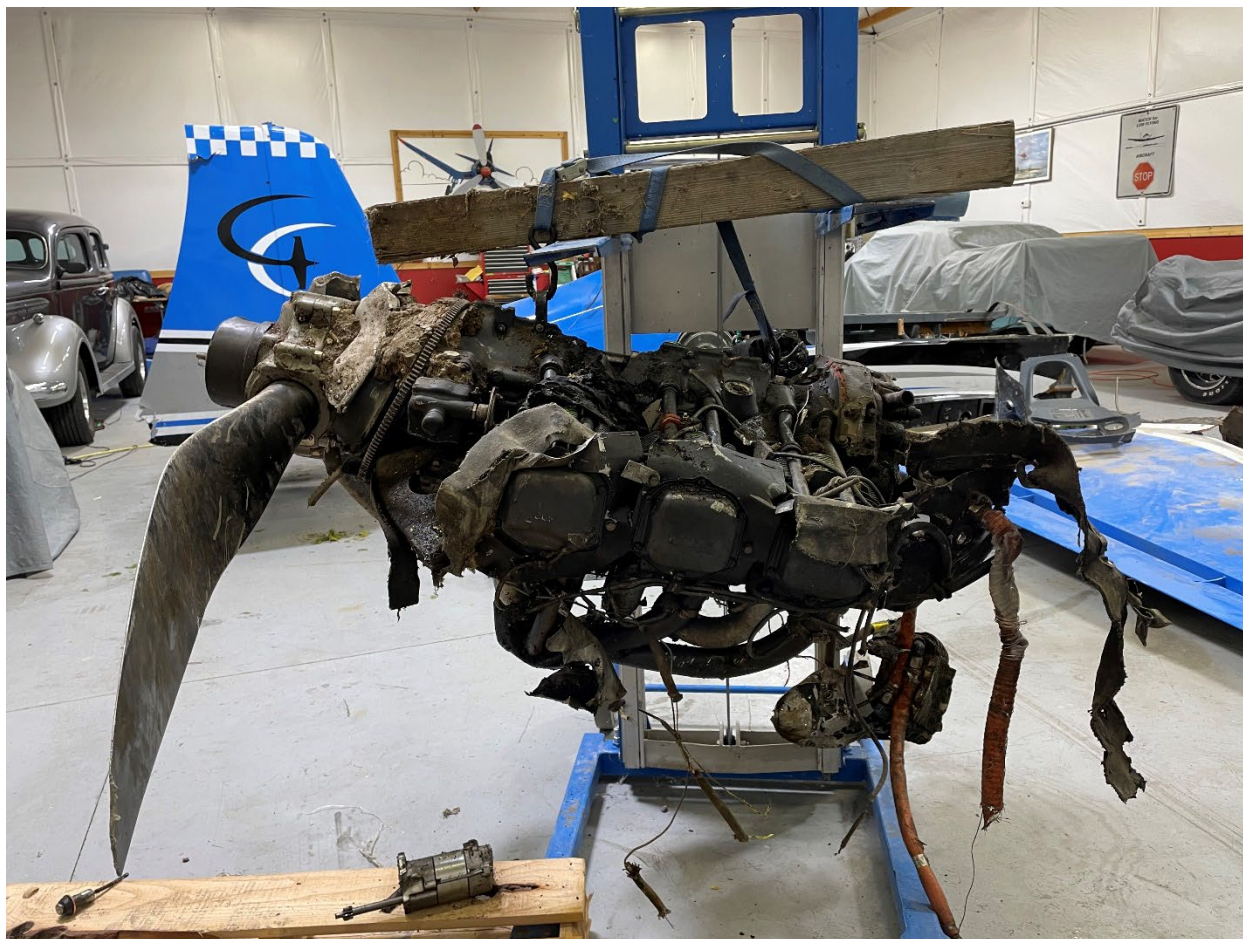
The cylinder combustion chambers were examined with a lighted borescope. All exhibited normal operational carbon deposits. Cylinders 2, 4, and 6 remained attached to the left half of the crank case with no evidence of foreign object damage observed. The right side of the engine case was mostly crushed, and the cylinders remained attached to the crankshaft via their respective connecting rods. Cylinders 1, 3, and 5 were crushed into the crankcase. Most of the right side of the crankcase was crushed and/or missing. The rocker boxes on the left side of the engine looked normal and intact. The right-side rocker boxes were heavily crushed due to impact damage. Cylinder intake and exhaust valves on the right-side rocker boxes of the engine were loosely surrounded by their crushed cylinder head. The pushrods and tubes were either bent or missing and the camshaft sustained minimal impact damage.

**Figure 3: View of left side of engine.**
