WPR24FA112

## INVESTIGATION PHOTOGRAPHS

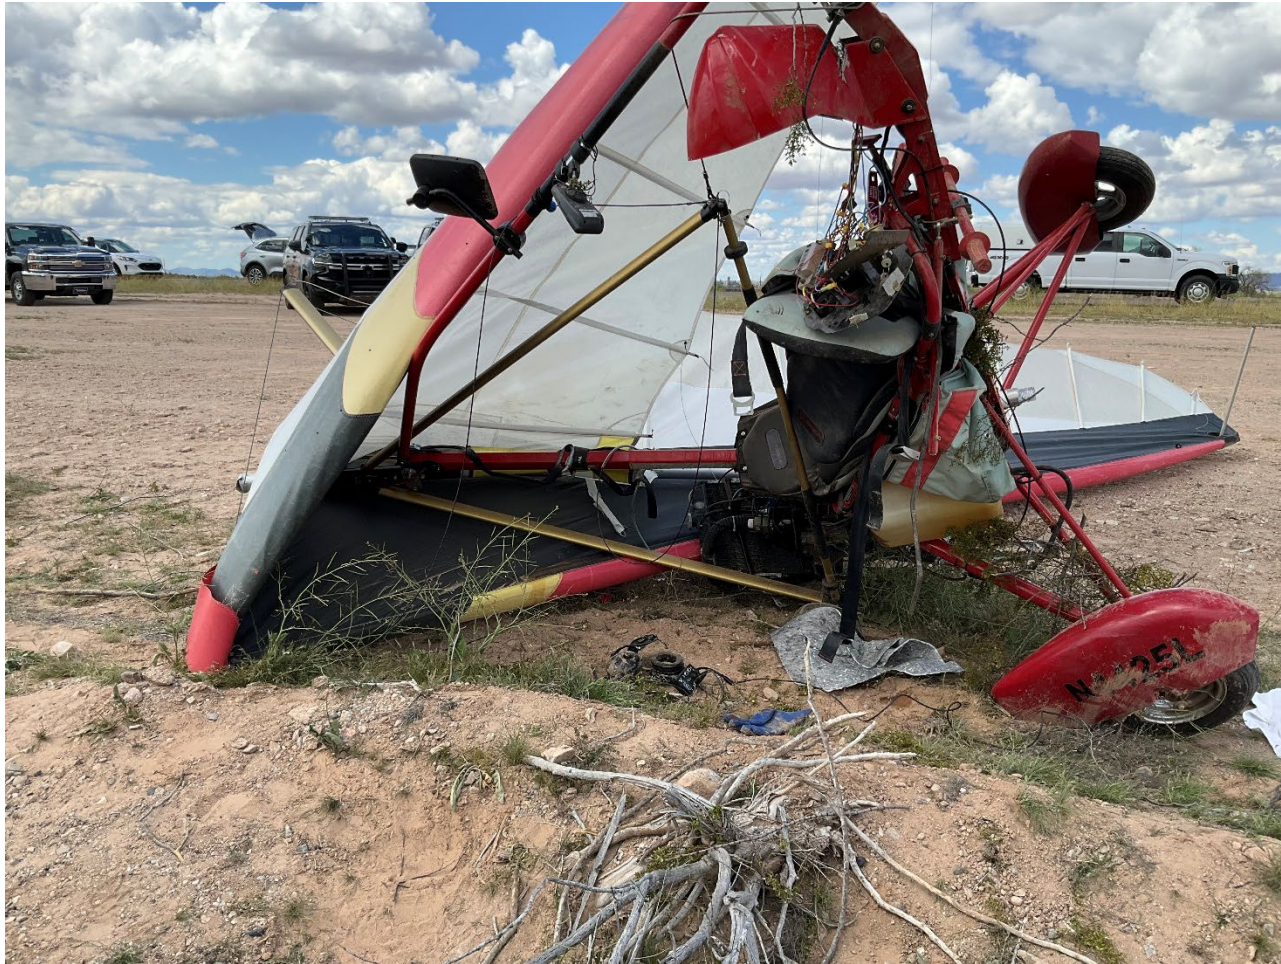
**Photograph 1 - Forward to aft view of aircraft with mesquite tree attached to lower carriage  
(Courtesy of LEA)**

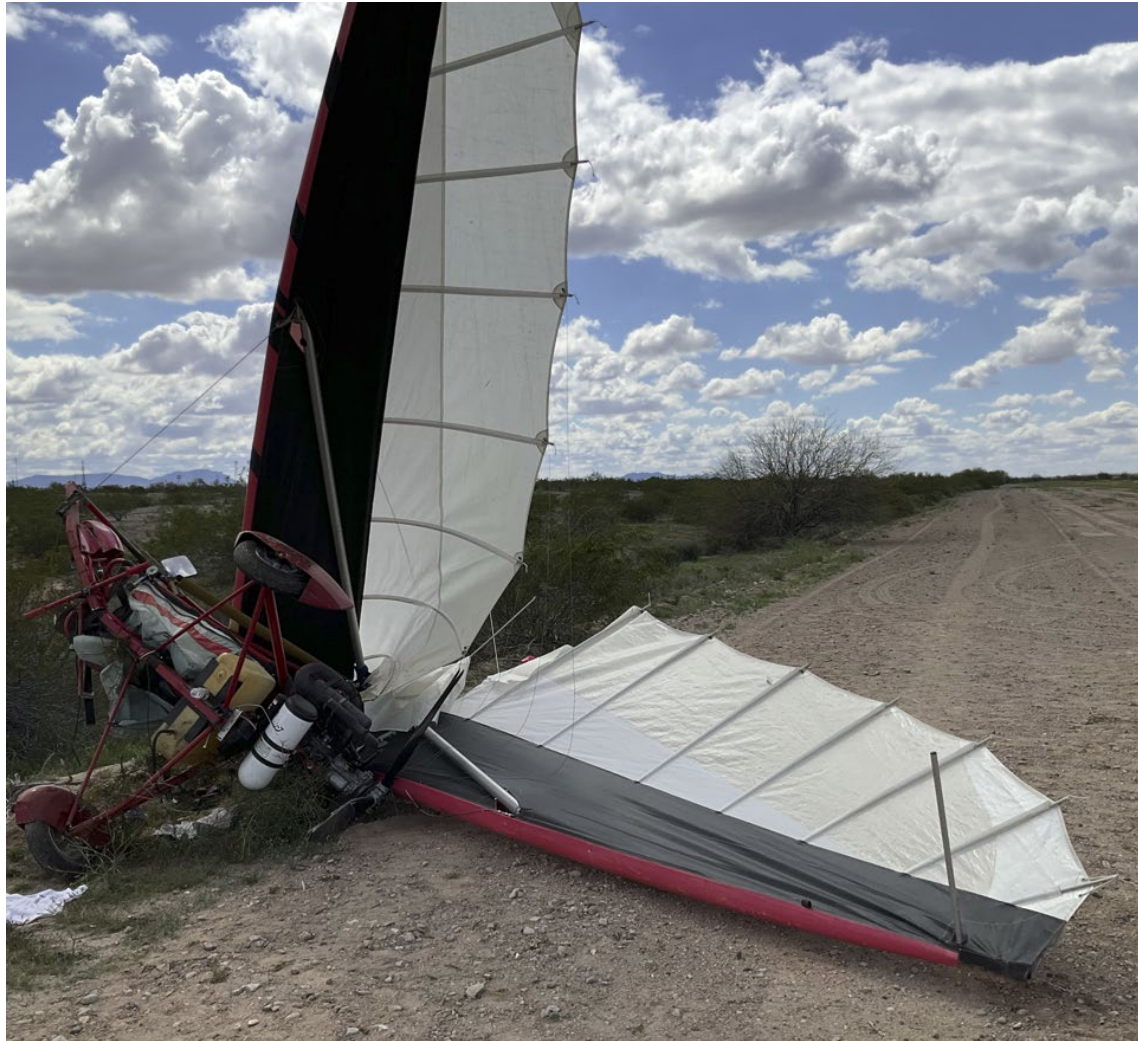
**Photograph 2 - Bottom view of inverted aircraft with damage to inboard sail and carriage keel  
(Courtesy of FAA)**

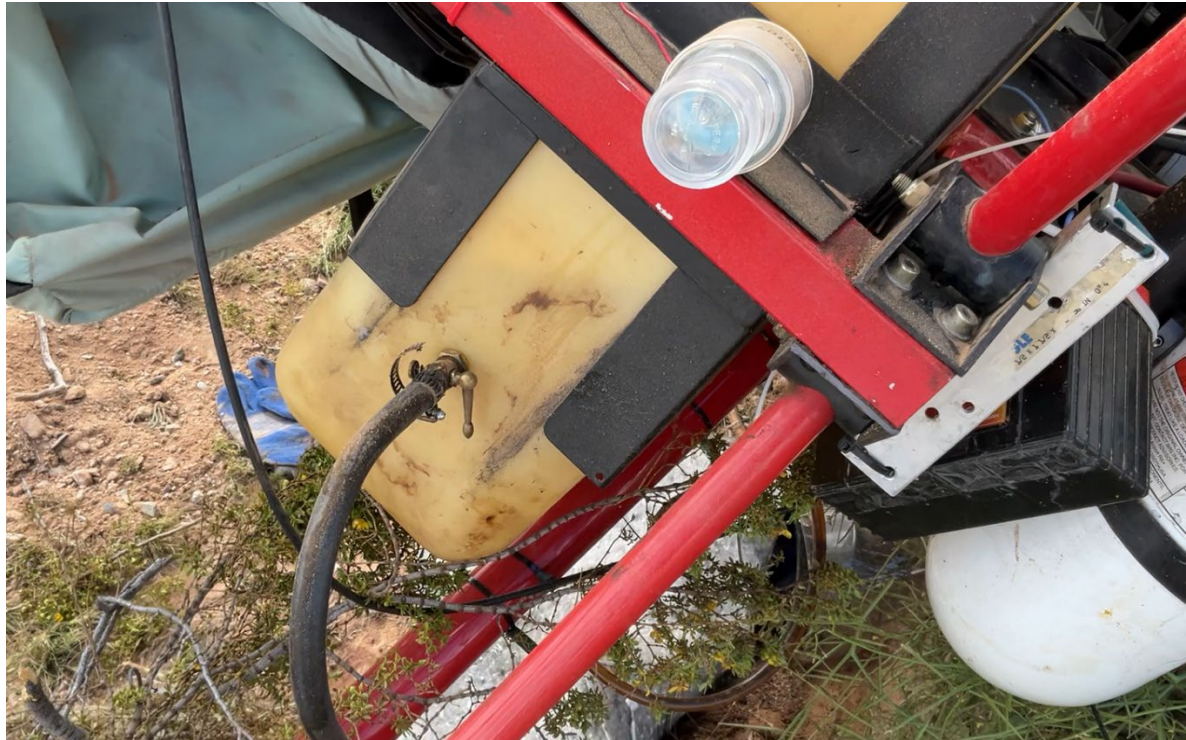
**Photograph 3 - View of fuel selector in the open position (Courtesy of LEA)**

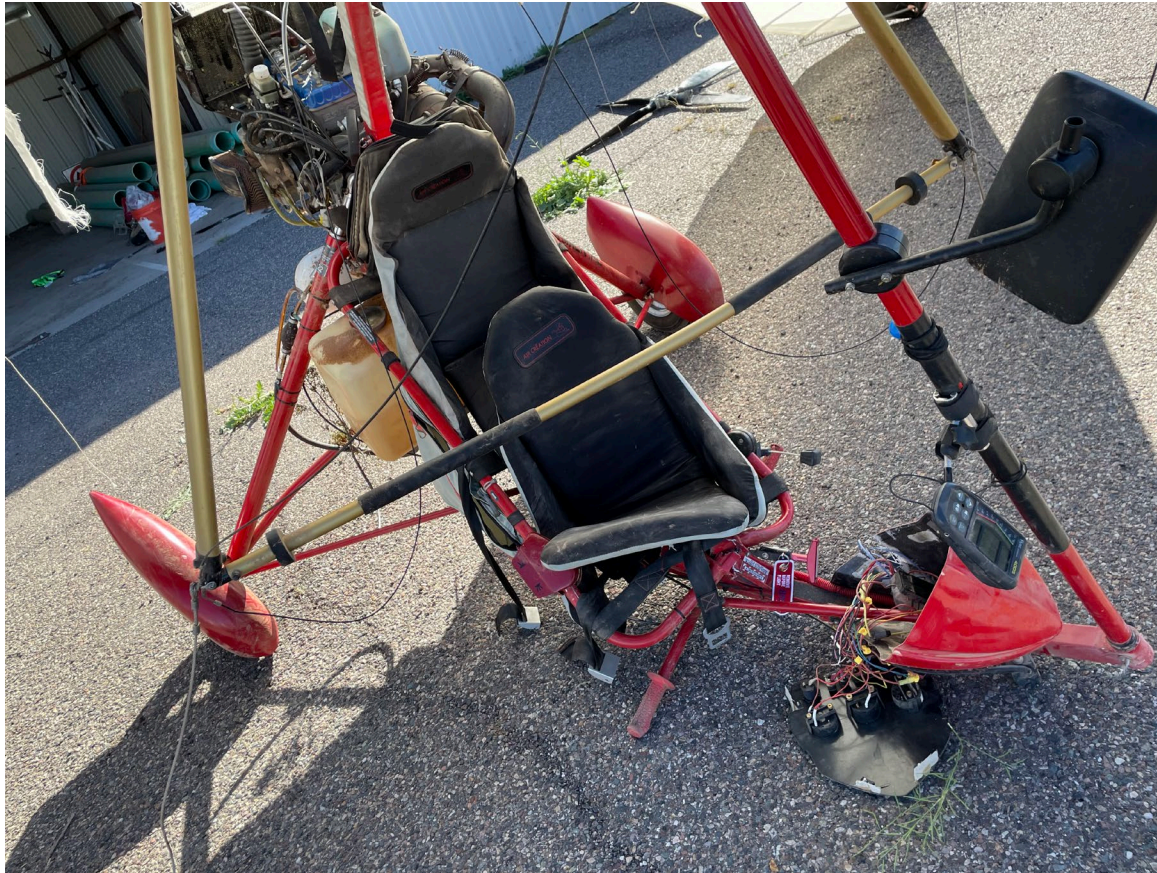
**Photograph 4 - Front to aft view of the impact damage to carriage keel forward seat frame**

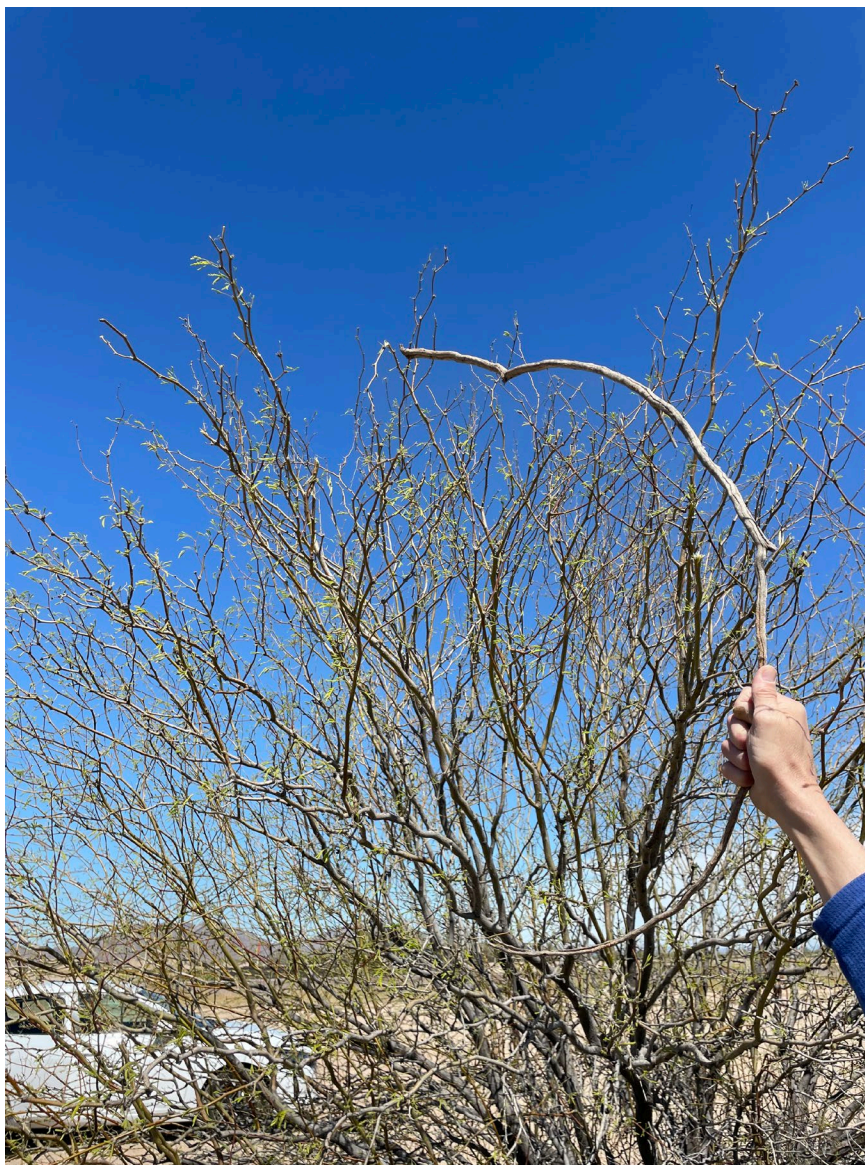
**Photograph 5 - View of initial point of contact impact signatures on mesquite tree**

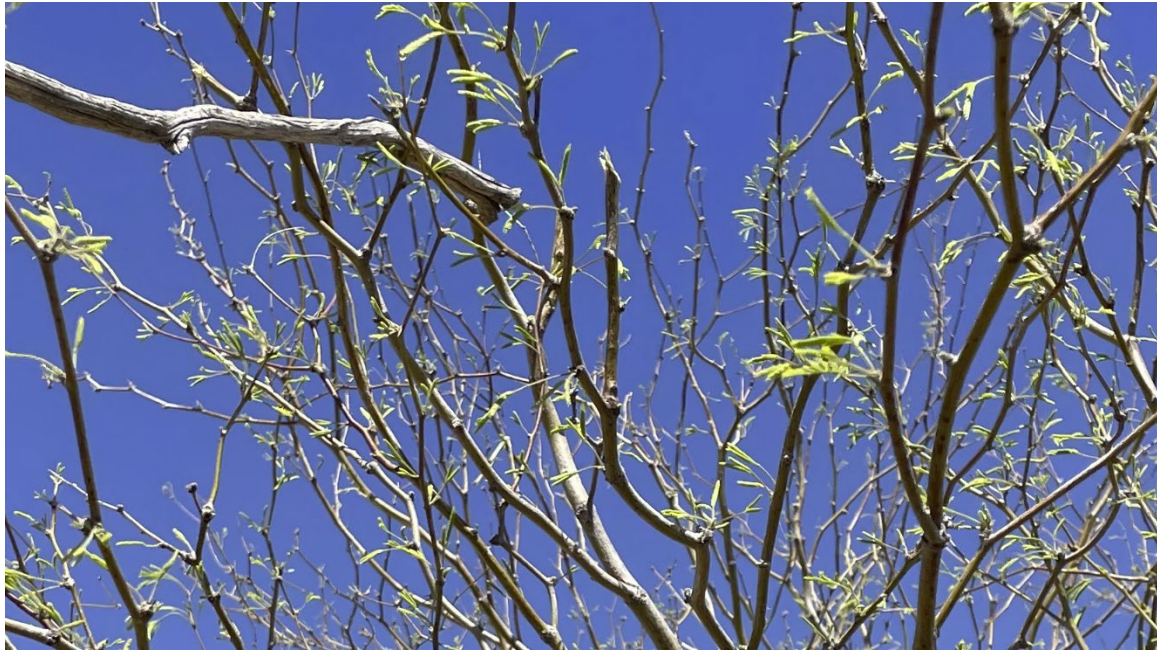
**Photograph 6 - View of 45° tree branch separation signatures**
