# National Transportation Safety Board

WPR24FA185

## EXAMINATION

Location: Gila Bend, Arizona  
Date: March 17, 2024  
Time: 0942L  
1642Z  
Airplane: N4425L

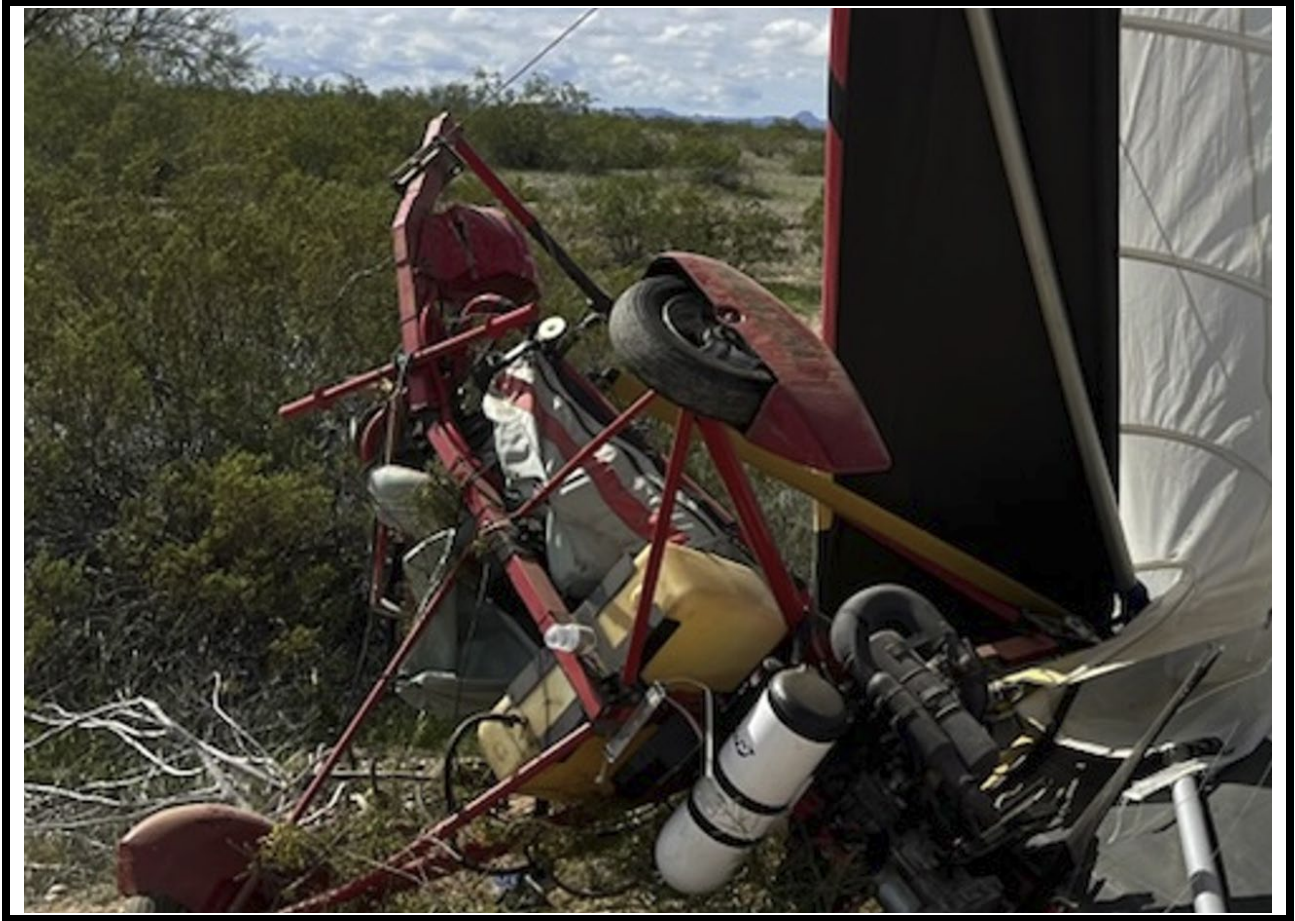
The carriage consisted of tandem seats. The engine mounts remained attached with no visible deformation. The nose wheel and front seat floor control pedals separated from the carriage keel at their attachment points. As viewed from the front of the aircraft, the front tube bowed to the right but remained attached to the carriage wing attachment (hang point) and carriage keel attachment point. The carriage keel was fracture-separated midpoint, just aft of the seat frame attachment point (Figure 1). The carriage mast remained attached to the hang point and aft carriage keel.

**Figure 1:** View from aft to forward, of the carriage keel left bending impact signature

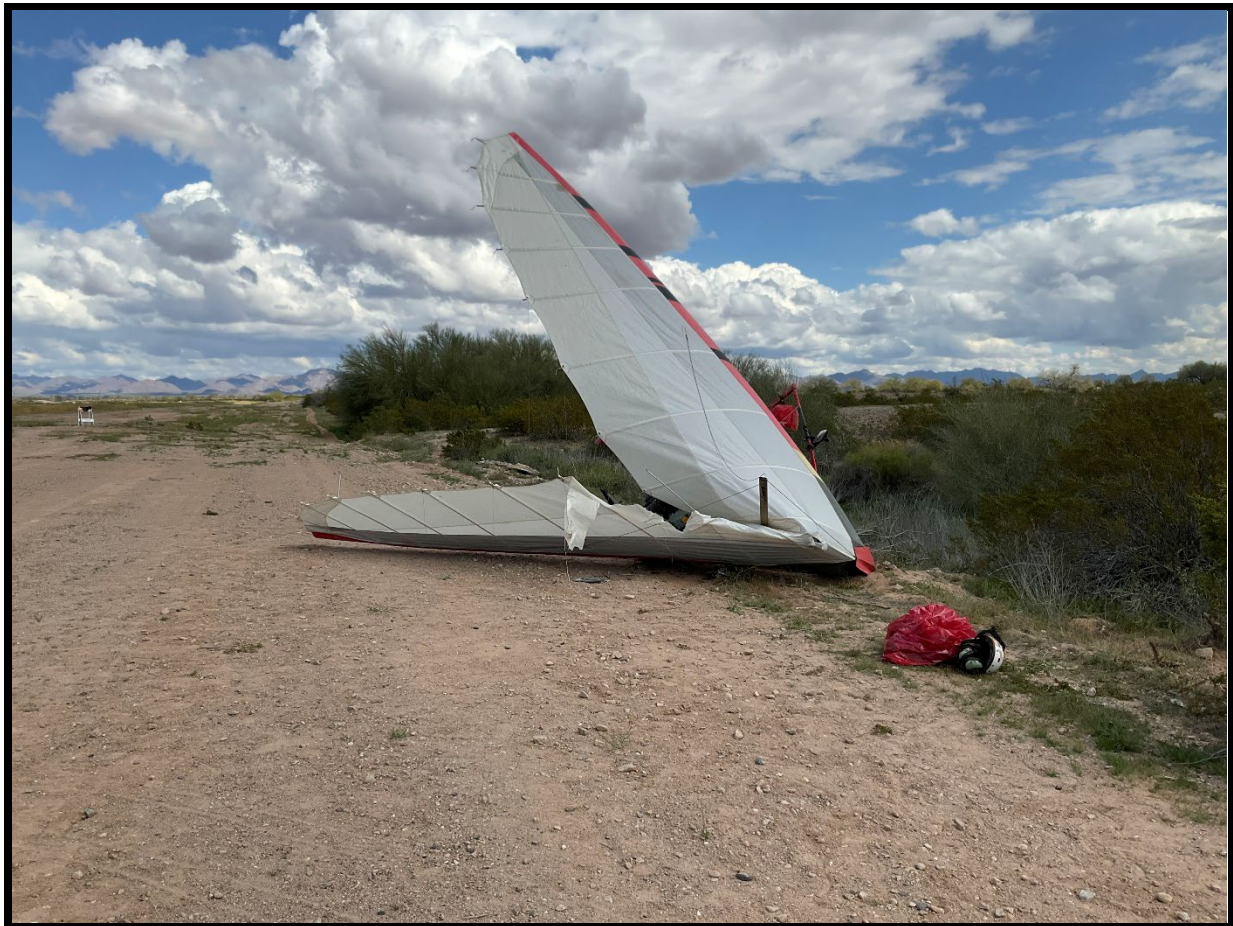
The right wing reflex cables, battens, pockets and leading-edge stiffeners were present and unremarkable. The washout strut was present, secure, and unremarkable. The sail remained intact and unremarkable, up to the inboard second batten pocket. The No. 3 inboard batten and pocket were unremarkable, but the sail, revealed damage with forward, aft, and lateral tears near the aft section and separated the reflex cable (Figure 3). The resulting damage liberated the inboard No. 2 batten from its pocket, and trailing edge of the sail.

**Figure 3:** Top view of the delta wing damage to the inboard aft right section above the engine

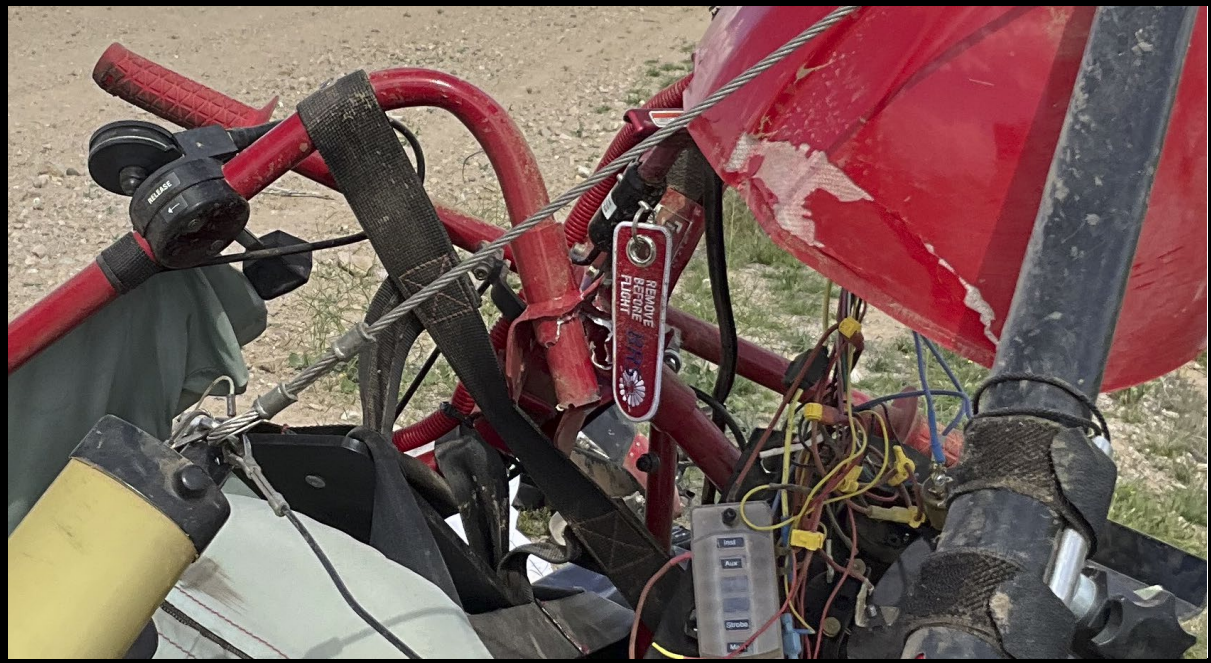
The seat frame was separated above the carriage keel. The ballistic recovery system (BRS) parachute was not deployed, and the pin remained in its orifice, albeit placarded with a tag stating, "Remove Before Flight." The seatbelts were not cut, severed, and appeared functional.

**Figure 4:** BRS pin still inserted in its orifice

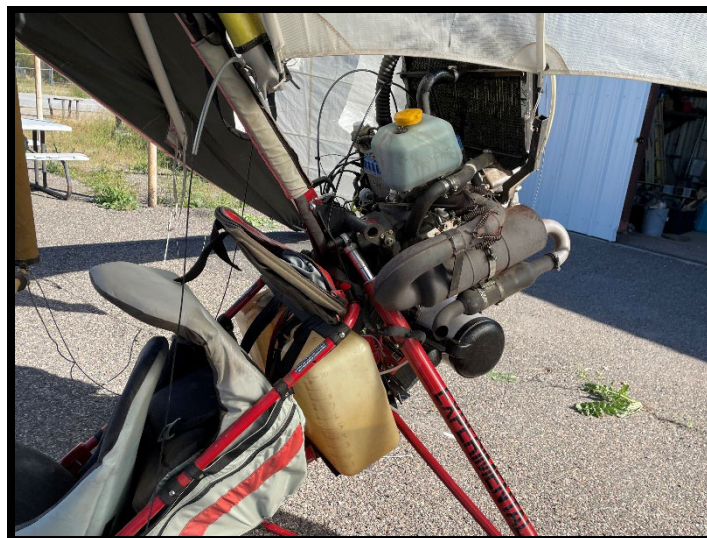
The fuel system remained intact from the pedal throttle control to the hand throttle, through the carburetor control lever. The choke remained attached, the fuel cell was not breached, and the fuel intake lines were unremarkable. The manual on/off fuel selector located behind the pilot's seat and underneath the fuel tank, was found in the off position and believed to be manipulated by first responders. The fuel sump hose remained secure and was not leaking. The fuel pump remained sealed intact, and unremarkable. The fuel cell contained fuel greater than 1/3 tank (Figure 5).

**Figure 5:** Fuel in the fuel cell is greater than 1/3 full

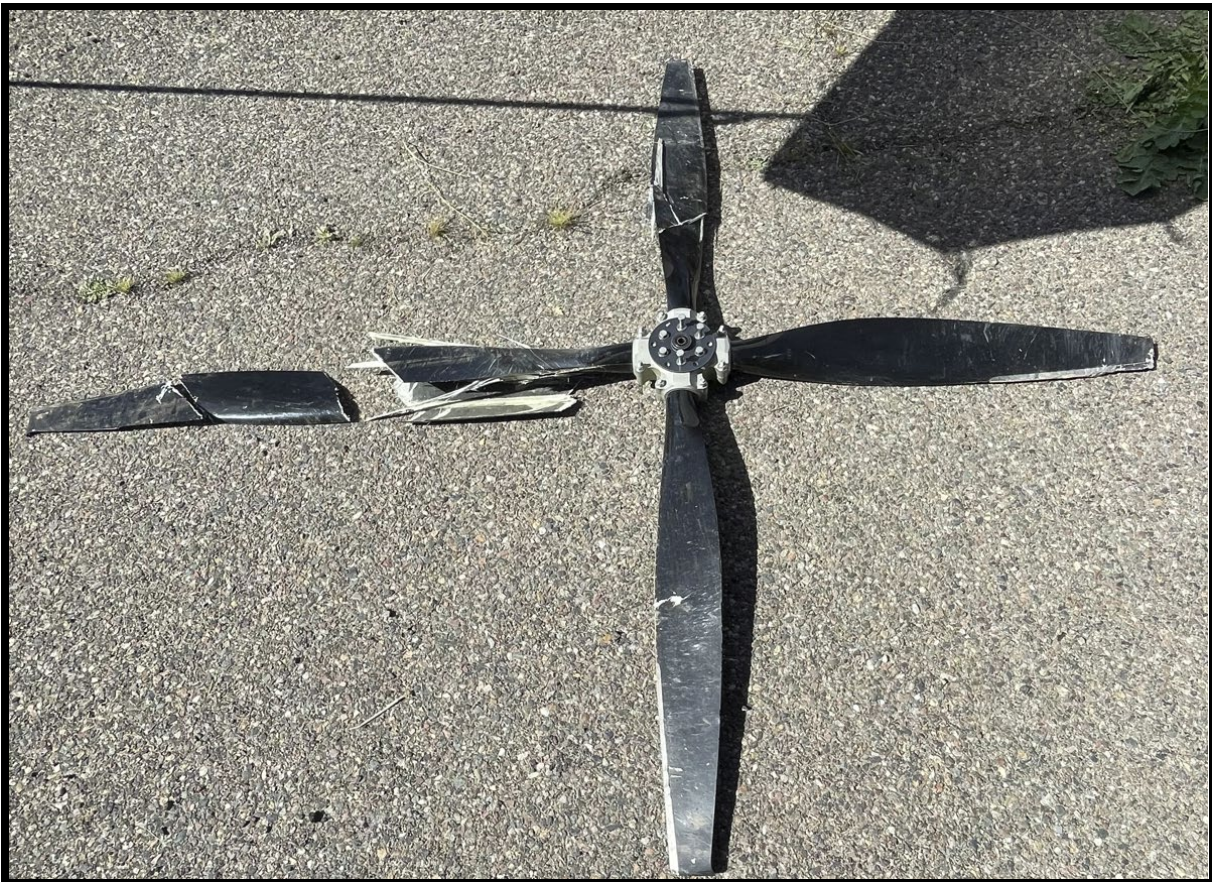
Two of the four-blade pusher propeller blades revealed uniform 45° separations, about mid span emanating from the leading edge through the trailing edge (Figure 6). A third blade revealed a 90° separation about mid span, that stopped about the mid-chord. The fourth blade revealed blade tip damage with chordwise striations. The propeller hub remained intact and unremarkable. The propeller flange appeared to have seized resulting from the right-side rear flying wire attached to the right crossbar and right downtube being taught and wrapped twice around the flange. The blade manufacture was not observed, however, a serial number for each blade was stamped on the blade hub.

**Figure 6:** View of damage to the propeller blades
