# National Transportation Safety Board

WPR24FA123

## **WRECKAGE EXAMINATION REPORT**

Airplane: Ayres Corporation S2R-G10

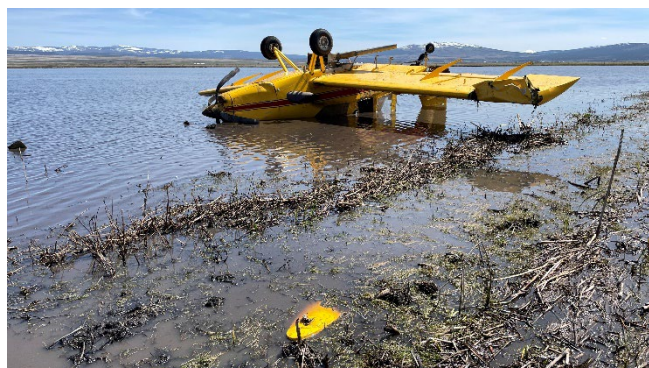
The airplane was found inverted on the western edge of a two feet deep water filled rice field within an open valley at an elevation 4374ft MSL.

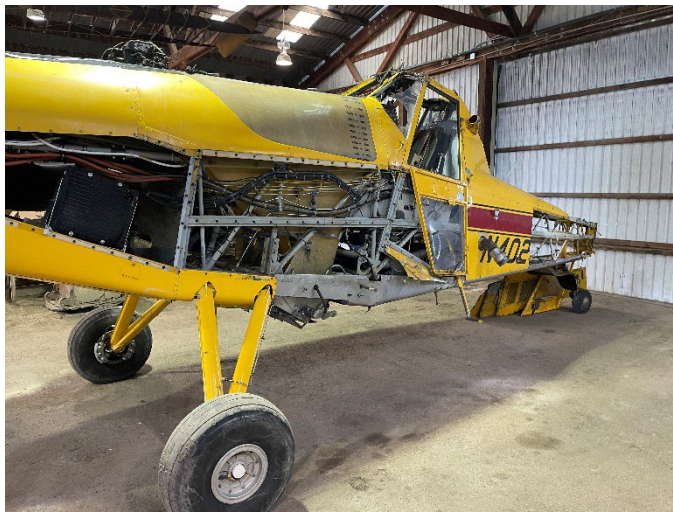
The upper portion of the cabin structure and empennage were partially submerged in water. The airframe was intact. A 3ft outboard section of the right wing leading edge was crushed. The upper section of the rudder was crushed approx. 6 inches. All control and trim surfaces were attached. Aileron and elevator control travel was smooth and unobstructed in all directions. Both rudder cable connection was continuous from the surface to the pedals.

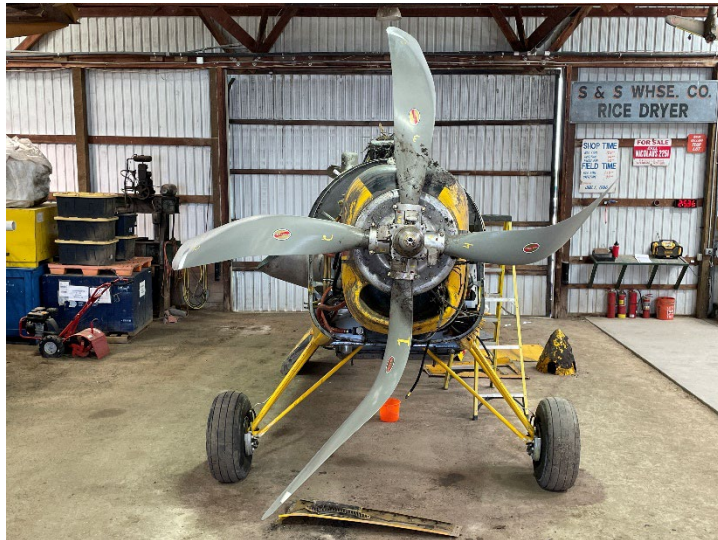
The propeller hub was intact with all blades. 3 of 4 propellers were bent uniformly aft. The 4<sup>th</sup> propeller was bent in a forward orientation. Blade pitch was consistent with positive pitch angle.
