# National Transportation Safety Board

WPR24FA124

## ON SCENE SUMMARY REPORT

Location: San Bernardino, CA  
Date: April 13, 2024  
Time: 20:41 Pacific daylight time  
Airplane: N965BC, Gulfstream Corp 695A Twin Commander

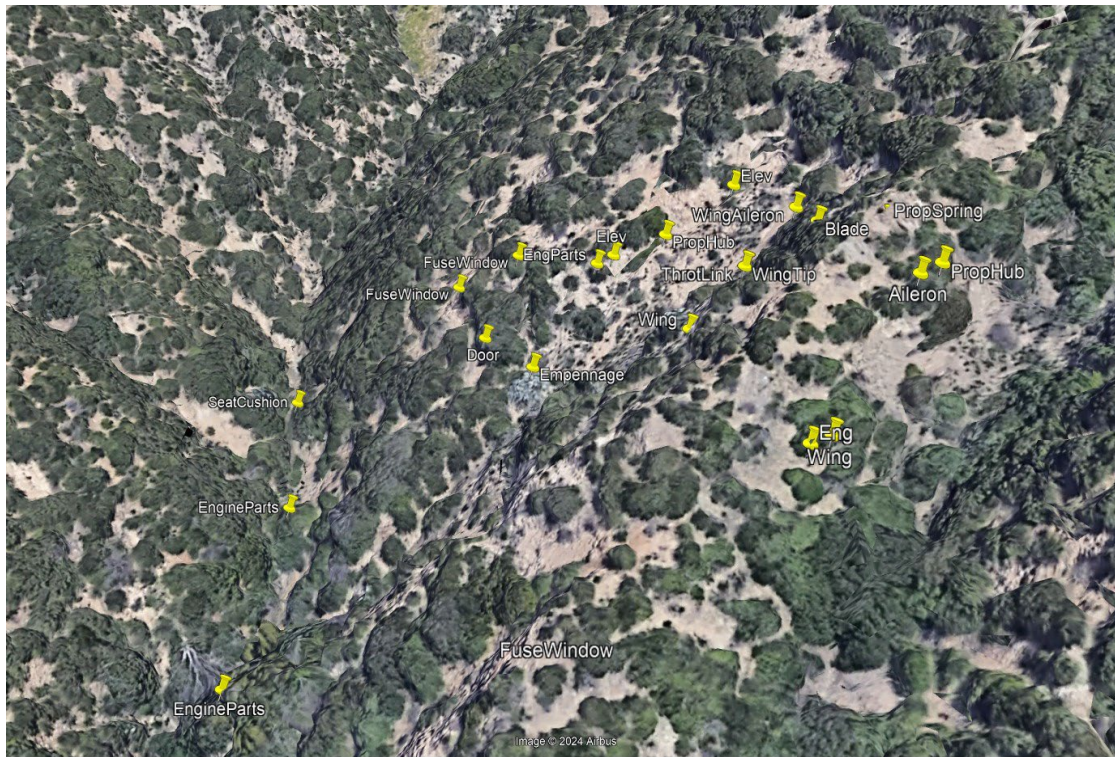
Examination of the accident site revealed that the airplane impacted mountainous terrain near the top of a 45° sloping ridgeline within a south facing ravine. Debris was dispersed along both sides of the sloping ridgeline. The first identified point of contact (FIPC) with the ground was near the top of the sloping ridgeline.

The debris field along the south facing slope was about 260 ft in length from the FIPC and was oriented on a magnetic heading of 236°.

The debris field along the north facing slope was about 190 ft in length from the FIPC and was oriented on a magnetic heading of 286°.

The main wreckage came to rest upright, about 109 ft from the FIPC, and was oriented on an approximate heading of 108° magnetic, at an elevation of 2,541 ft msl. (see figure 1)

Figure 1. Debris field

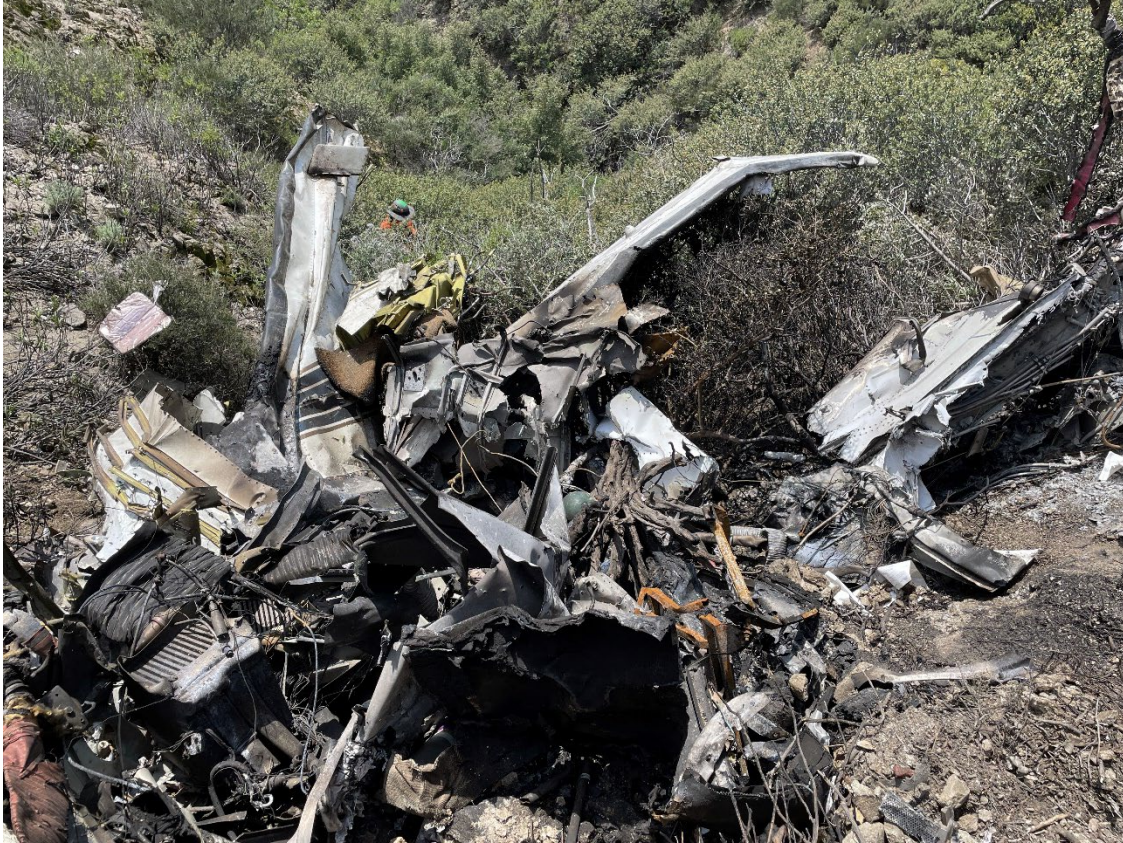
The fuselage was highly fragmented and found throughout the debris field. The largest portion of the fuselage was found with the empennage section, accordion crushed aft and thermally damaged. (see figure 2)

Figure 2. Main wreckage – largest portion of fuselage and the empennage

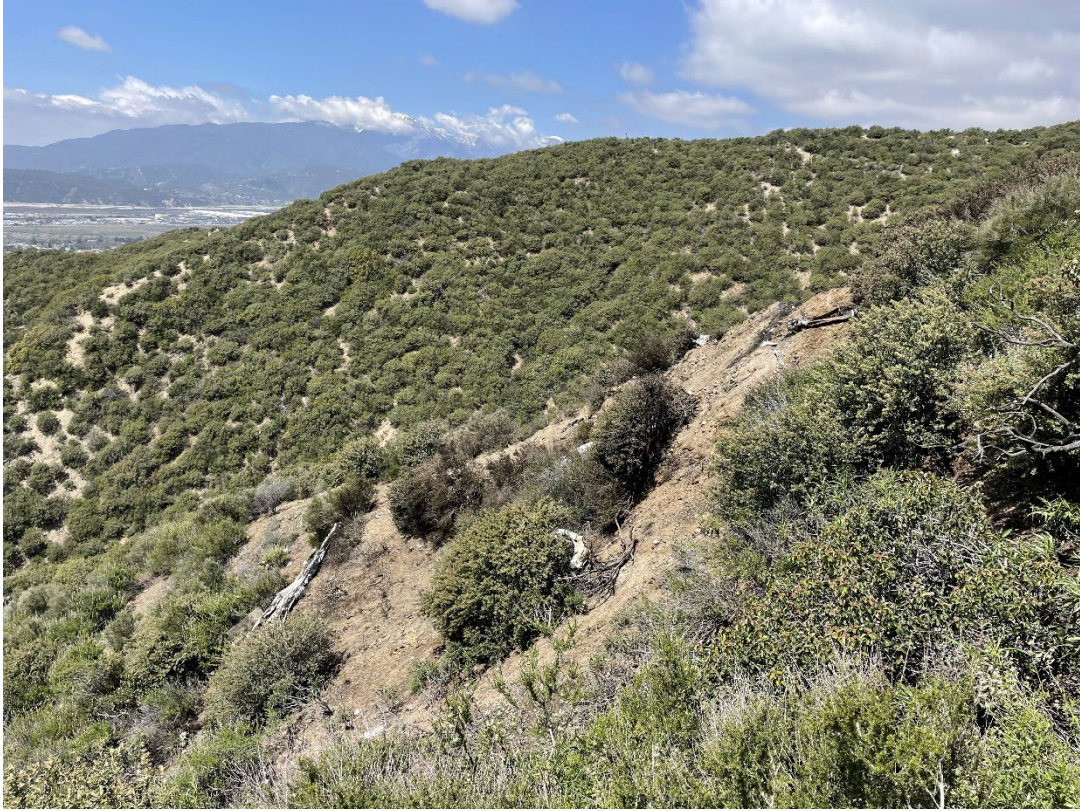
The wing on the south facing slope, outboard of the engine nacelle, was located along the south facing slope of the ridgeline. It was accordion compressed along the length of the leading edge through to the trailing edge. The wing's outboard section of flap remained attached at its attachment points. The wing's aileron was located near the FIPC. (see figure 3)

Figure 3. Wing and other debris on south facing slope

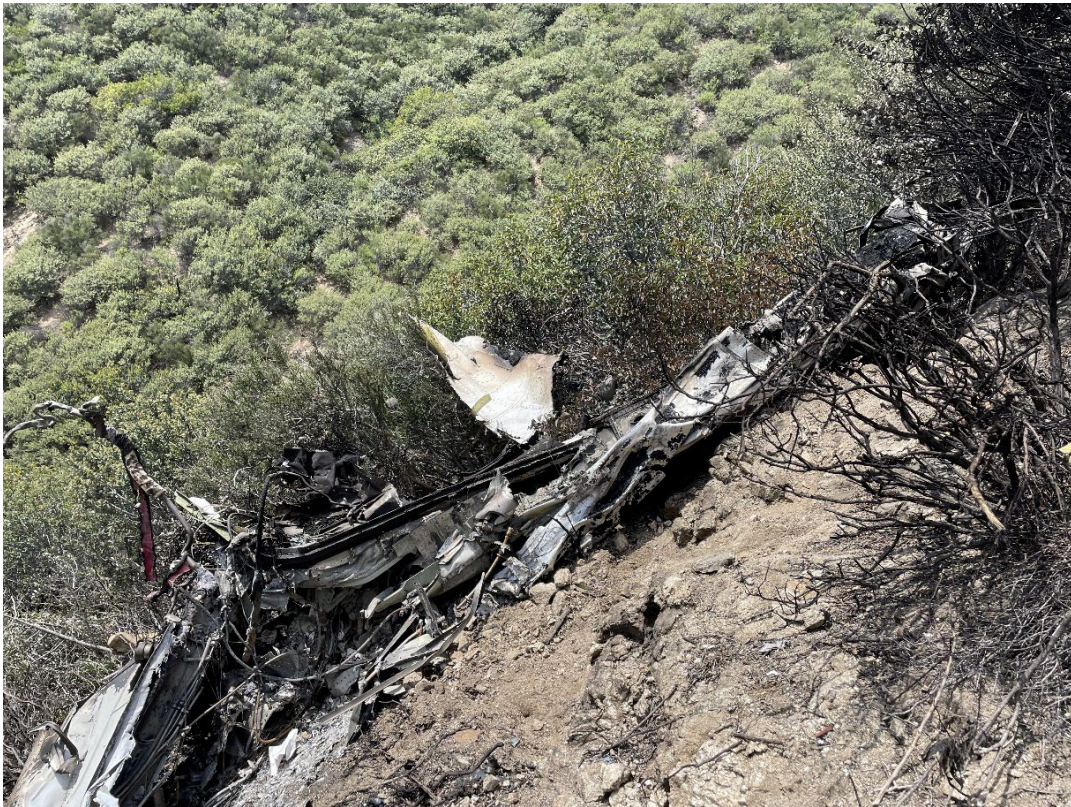
The wing on the north facing slope was located near the main wreckage. It was accordion compressed along the length of the leading edge through to the trailing edge. The wing's aileron was located near the FIPC. (see figure 4)

Figure 4. Wing on north facing slope

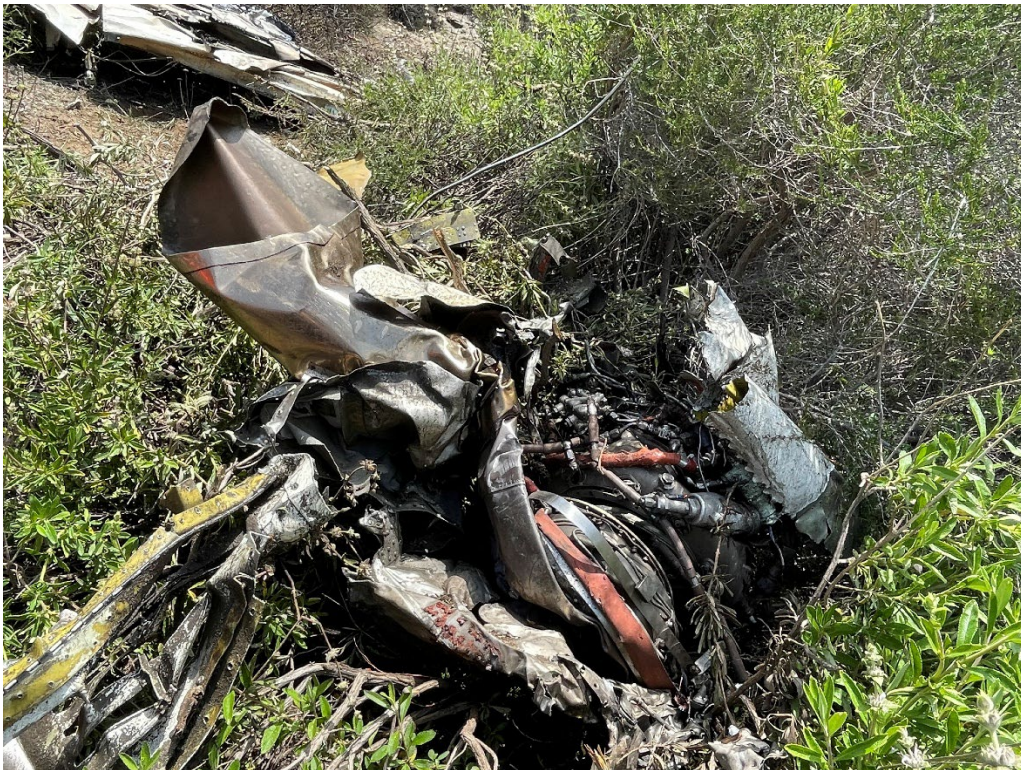
One engine was separated from its wing and was found within the debris on the south facing slope of the above referenced ridgeline. The power section was separated from the gear box assembly. Fragments of the gear box casting, various reduction gears and remaining engine components were observed throughout the debris field. (see figure 5)

Figure 5. Engine power section located on south slope

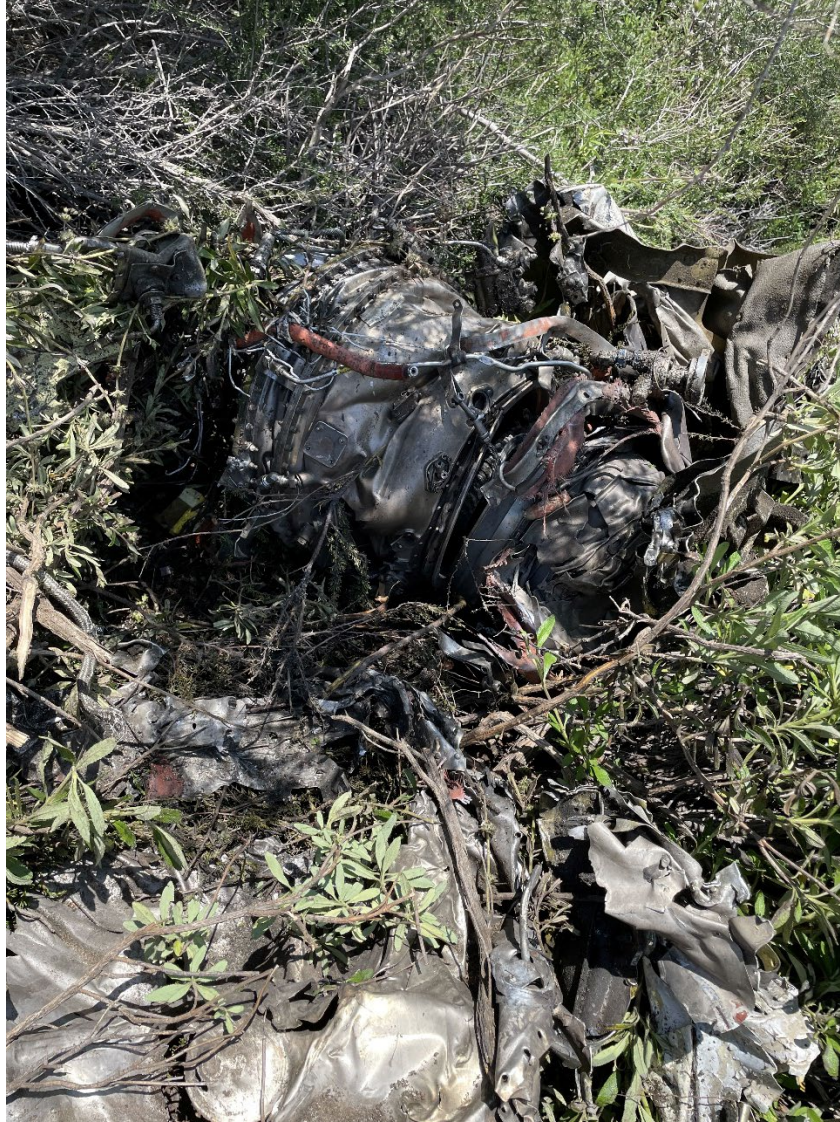
The other engine was also separated from its wing and found within the debris on the north facing slope of the above referenced ridgeline. The power section was separated from the gear box assembly. Fragments of the gear box casting, various reduction gears and remaining engine components were observed throughout the debris field. (see figure 6)

Figure 6. Engine power section located on north slope

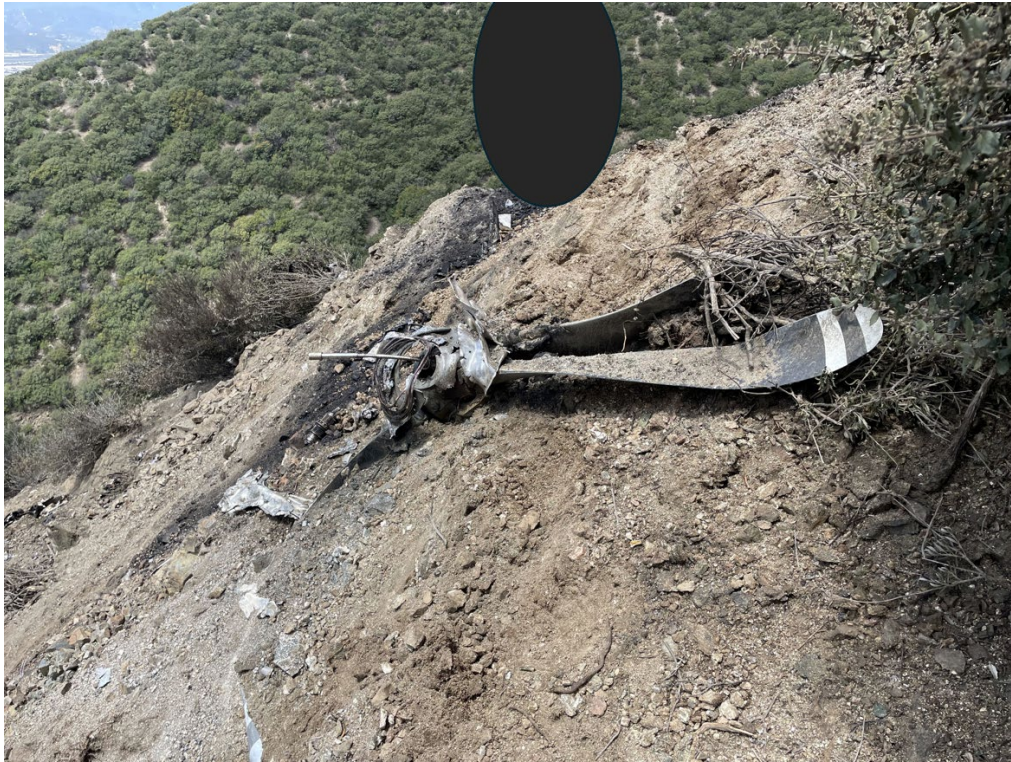
One propeller assembly was located near the FIPC. Two propeller blades remained attached to the hub. The third propeller blade separated at the hub and was located

adjacent to the hub. Each propeller blade displayed leading edge gouging and chordwise scuffing. (see figure 7)

Figure 7. Propeller assembly

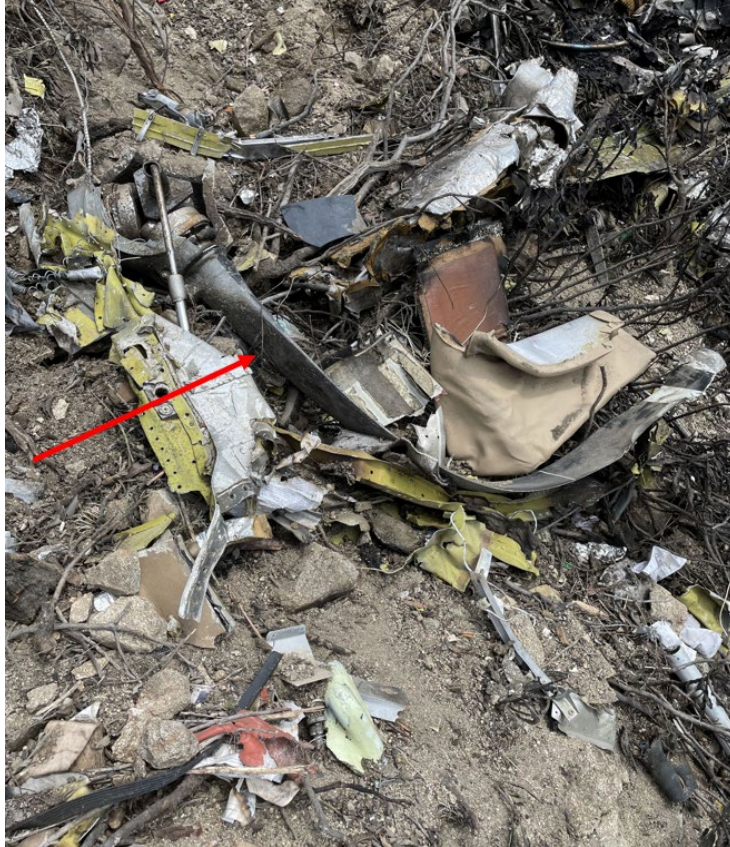
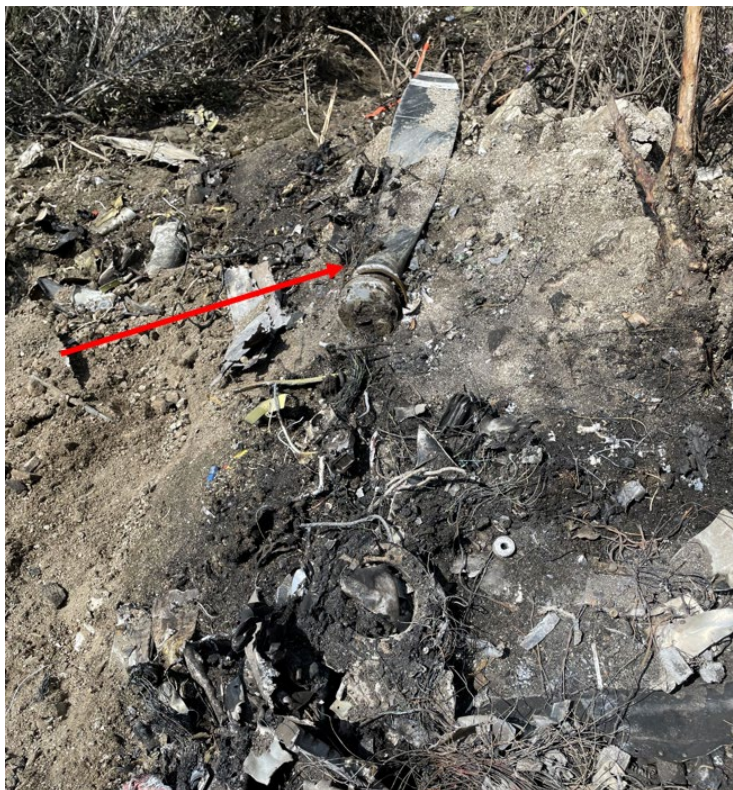
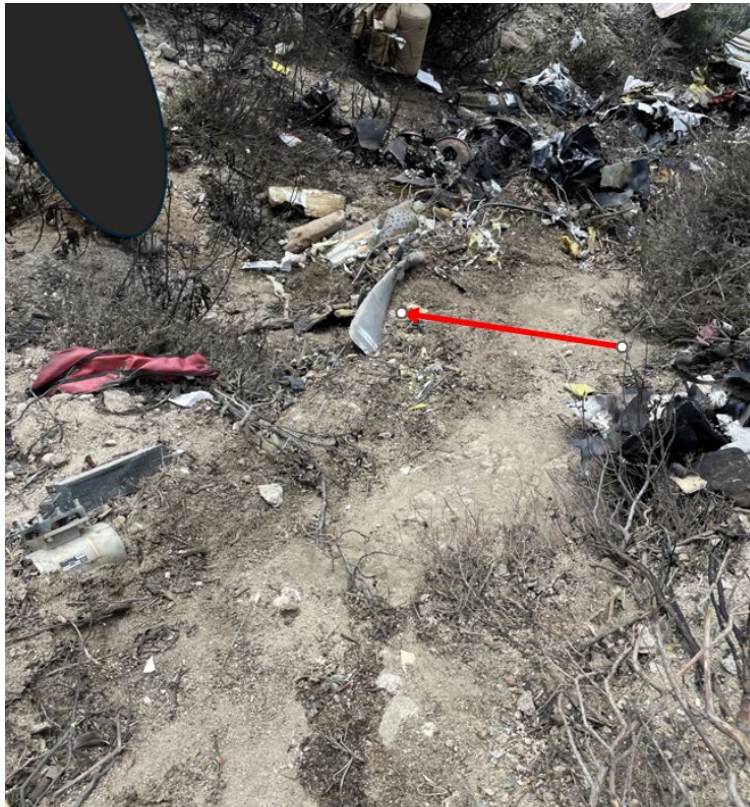
One propeller assembly was located dispersed throughout the debris field on the north facing slope of the ridgeline. One propeller blade remained attached to the propeller hub. The two remaining propeller blades were separated from the hub and found within the debris field. Each propeller blade displayed leading edge gouging and chordwise scuffing. (see figures 8, 9, 10)

Figure 8. Propeller blade in hub, in debris field

Figure 9. Propeller blade in debris field

Figure 10. Propeller blade in debris field
