# National Transportation Safety Board

WPR24FA124

## **AIRFRAME & ENGINE EXAM SUMMARY REPORT**

Location: San Bernardino, CA  
Date: April 13, 2024  
Time: 20:41 Pacific daylight time  
Airplane: N965BC, Gulfstream Corp 695A Twin Commander

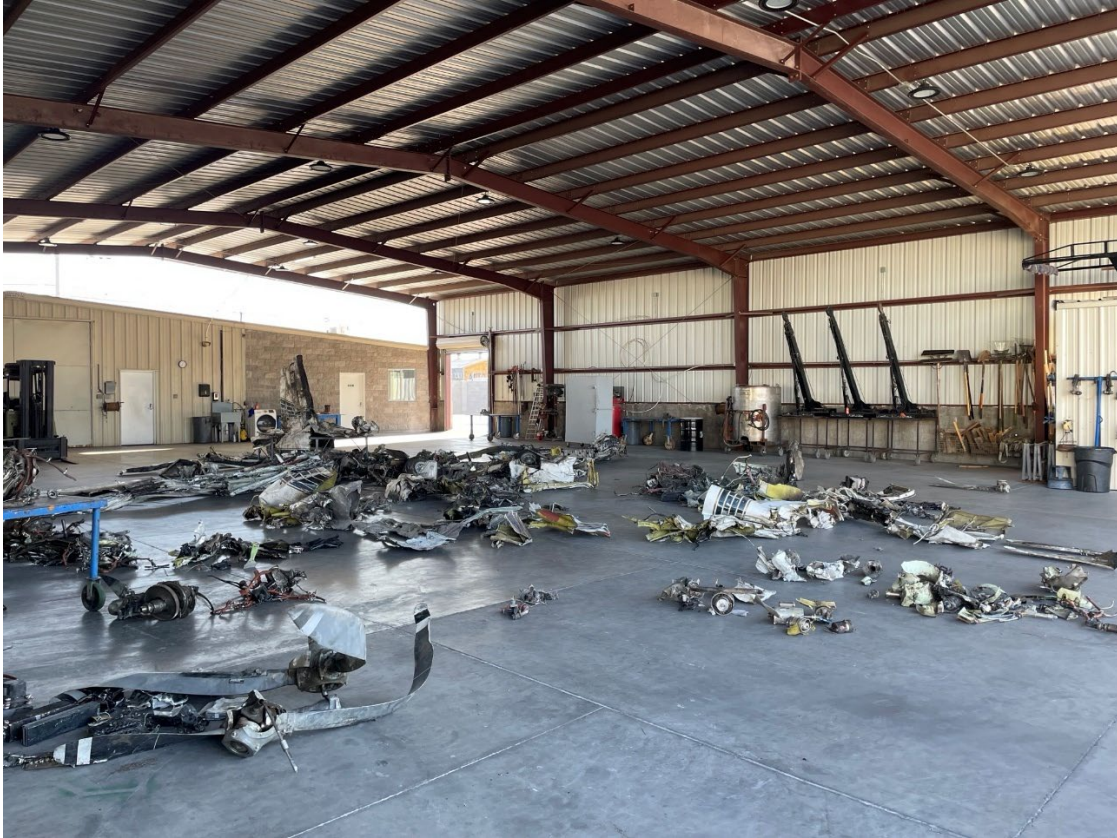
The fuselage was highly fragmented and displayed evidence of post impact fire. The instrument panel and cabin controls were destroyed by impact and thermal damage. (see figure 1)

Figure 1. Fragmented wreckage

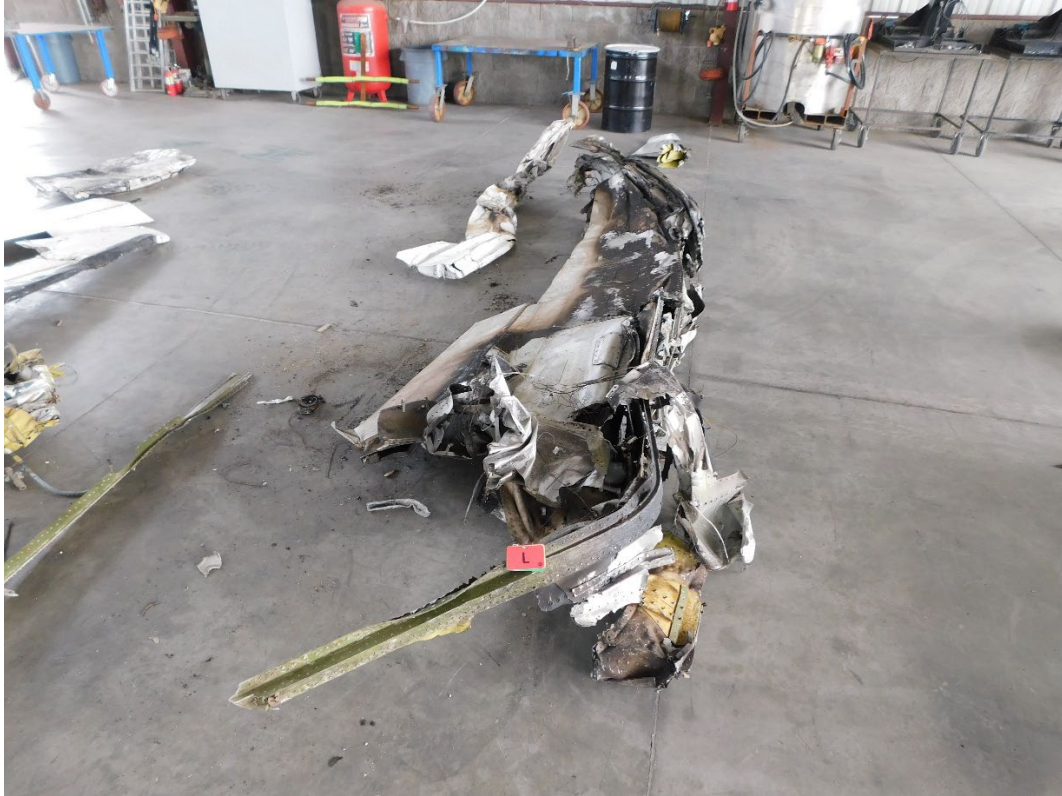
The left wing separated at the engine nacelle. It displayed crushing and thermal damage along the length of its span, from the leading edge, aft, to its trailing edge. The pneumatic de-ice boot displayed thermal damage throughout the leading edge. The outboard section of the left flap remained partially attached. The left wing's aileron was separated at its wing attachment points. (see figure 2)

Figure 2. Left wing, aileron, outboard flap

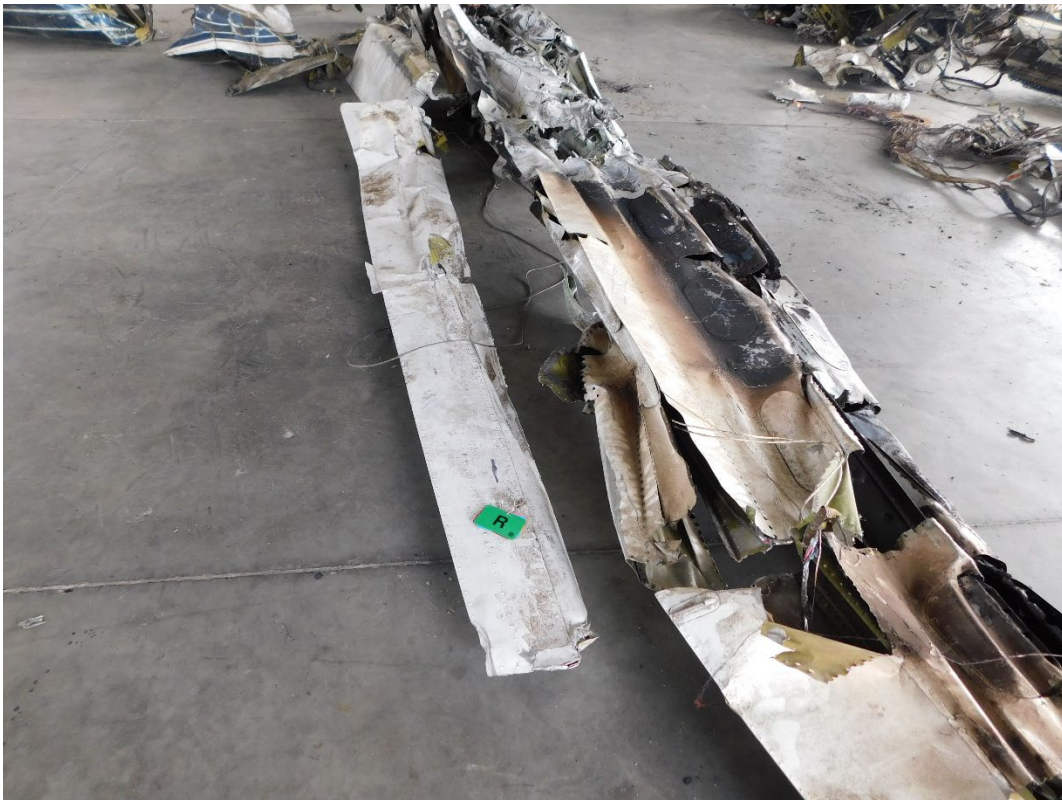
The right wing separated at the engine nacelle. It displayed crushing and thermal damage along the length of its span, from the leading edge, aft, to the trailing edge. The pneumatic de-ice boot displayed thermal damage throughout the leading edge. The outboard section of the right flap remained partially attached. The right wing's aileron was separated at its wing attachment points. (see figure 3)

Figure 3. Right wing, aileron, outboard flap

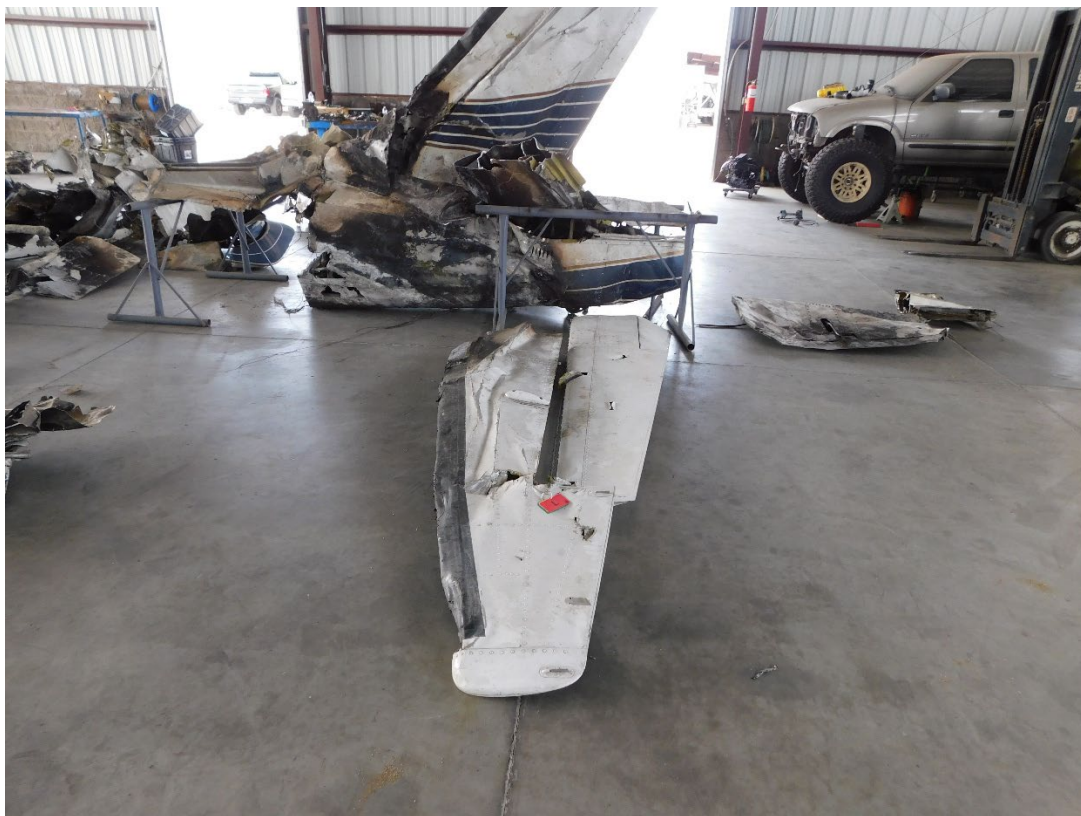
The left horizontal stabilizer remained attached at the root, to the empennage and displayed crushing and denting along the leading edge. It was cut by wreckage recovery near the root. The pneumatic de-ice boot remained attached and displayed ripping and tearing. The left side of the elevator was separated at its attachment points, from the horizontal stabilizer. It had multiple punctures in the upper and lower skin. The left elevator trim tab remained attached at its hinge and control arm. (see figure 4)

Figure 4. Left horizontal stabilizer and elevator

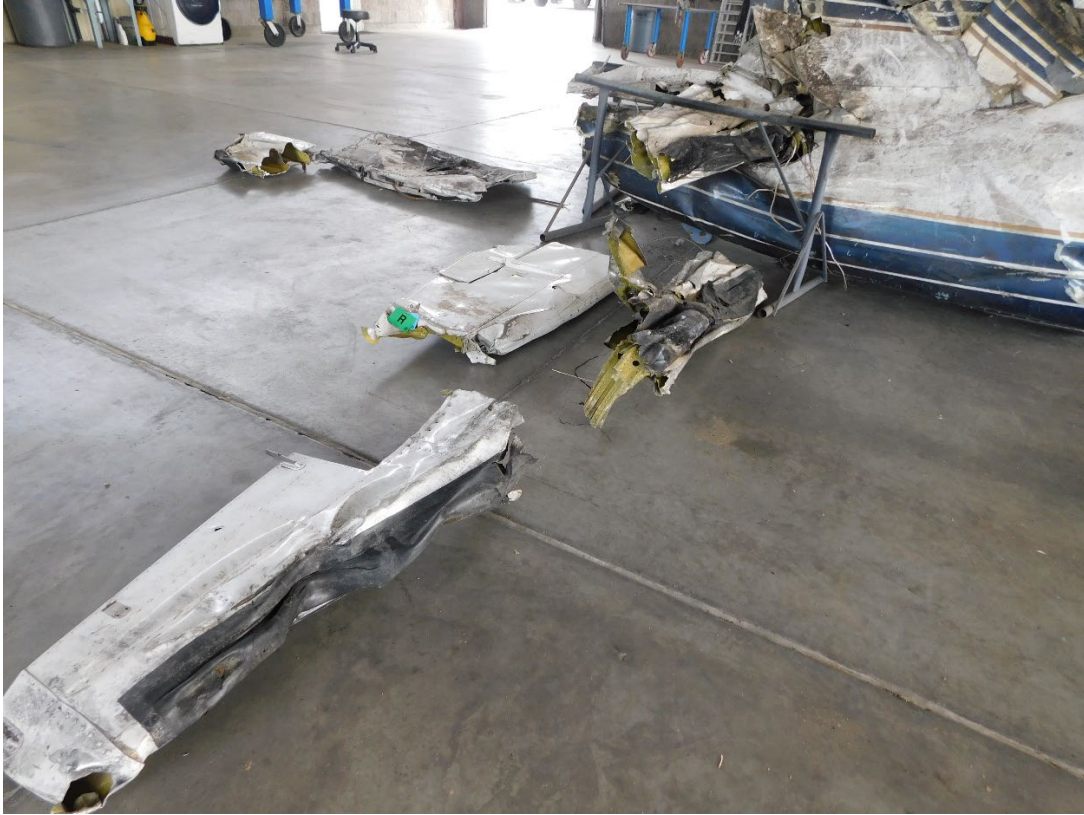
The right horizontal stabilizer was observed in two sections, separated about mid span, but remained attached at the root, to the empennage and displayed crushing and denting along the leading edge. It was cut by wreckage recovery near the root. The pneumatic de-ice boot remained attached and displayed ripping and tearing. The right side of the elevator was separated at its attachment points, from the horizontal stabilizer. It had multiple punctures in the upper and lower skin. The right elevator trim tab remained attached at its hinge and control arm. (see figure 5)

Figure 5. Right horizontal stabilizer and elevator

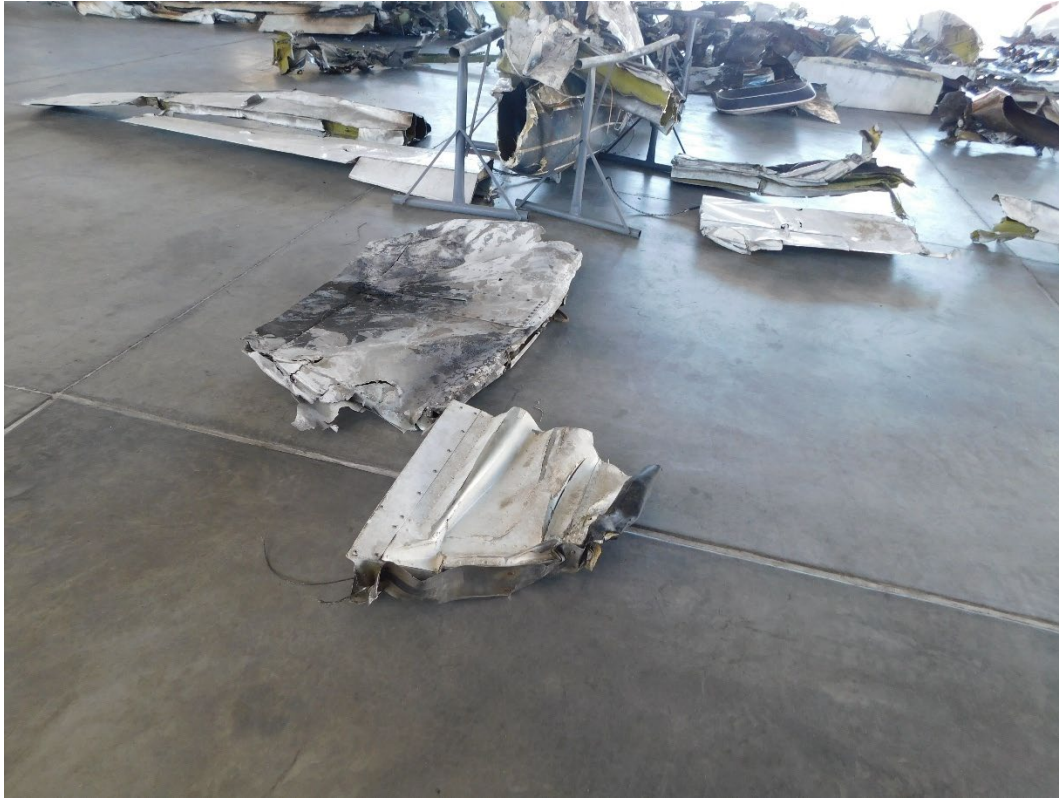
The vertical stabilizer remained attached to the empennage and displayed crushing from the leading edge, aft, to the trailing edge. The upper portion of the vertical stabilizer was cut by wreckage recovery. The rudder horn anti-icer remained mounted to the vertical stabilizer. The rudder was separated from the vertical stabilizer at its attachment points and displayed crushing and thermal damage throughout. (see figure 6)

Figure 6. Rudder and upper section of vertical stabilizer

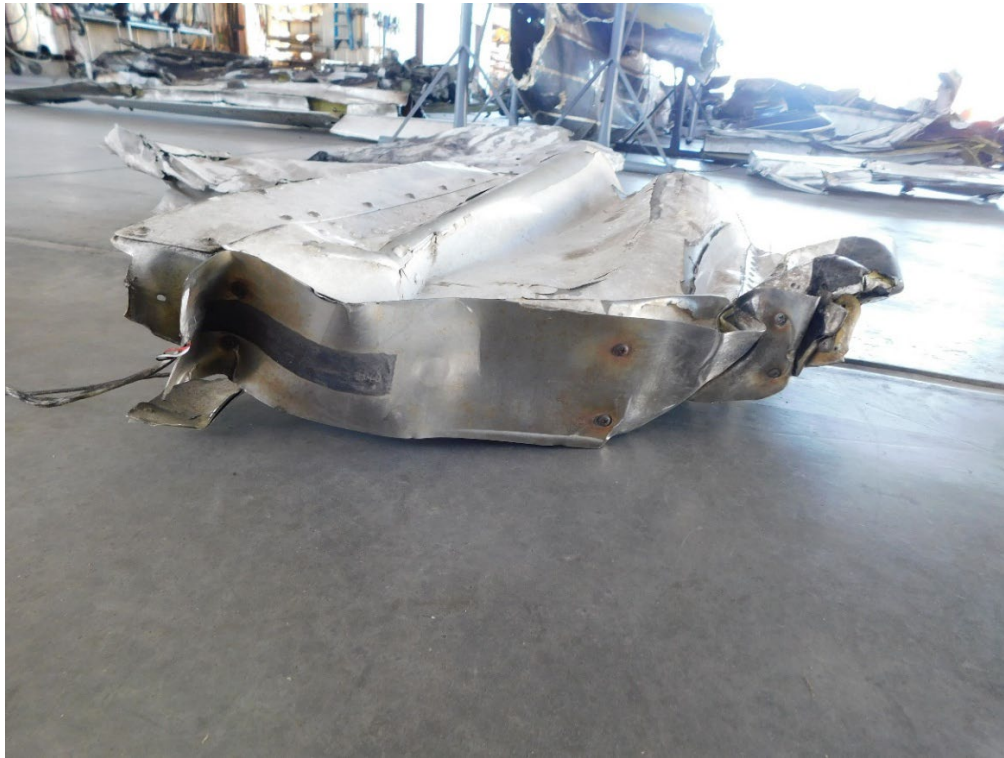
The upper rudder horn anti-icer remained mounted to the vertical stabilizer. (see figure 7)

Figure 7. Rudder horn anti-icer

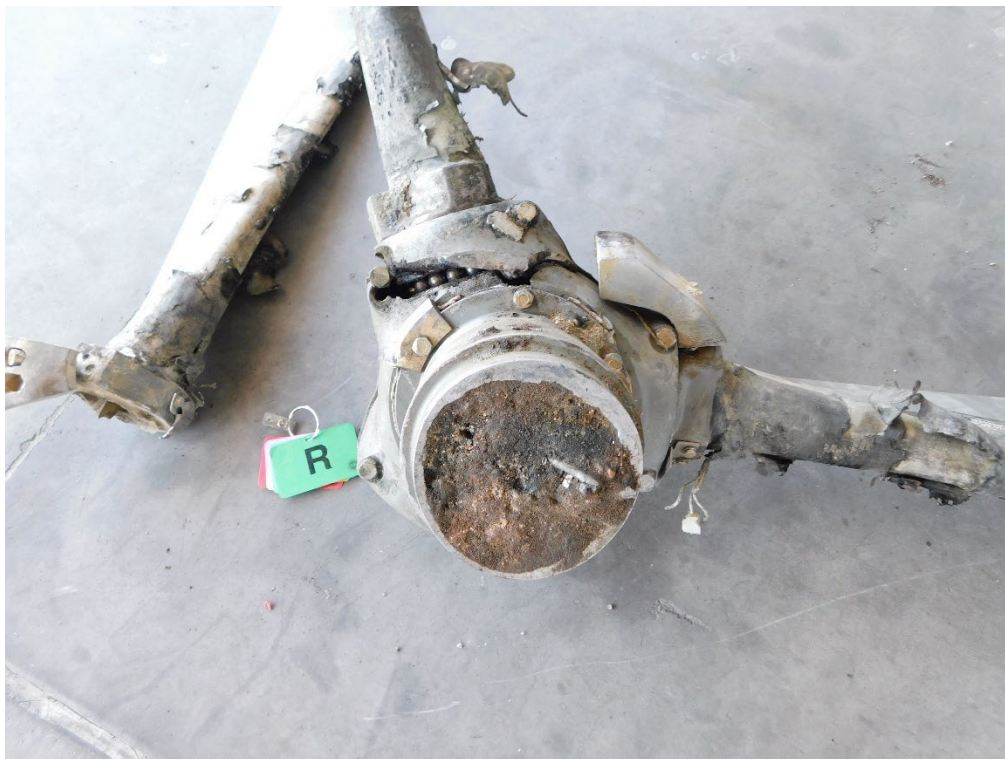
De-ice boots on three of the six total propeller blades were intact and electrical wiring was noted and present. (see figure 8) The de-ice boots on the remaining three

total propeller blades displayed ripping and tearing damage. None of the associated electrical wiring for them was observed.

Figure 8. Wiring observed present with two propeller blade de-ice boots

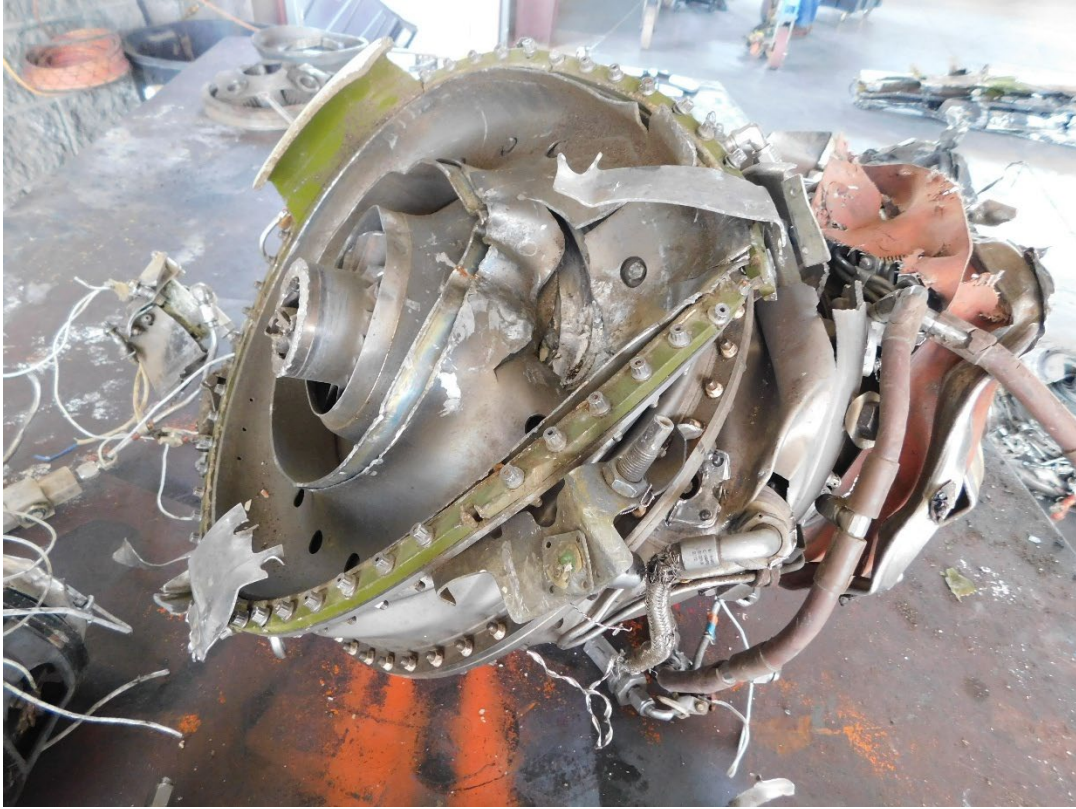
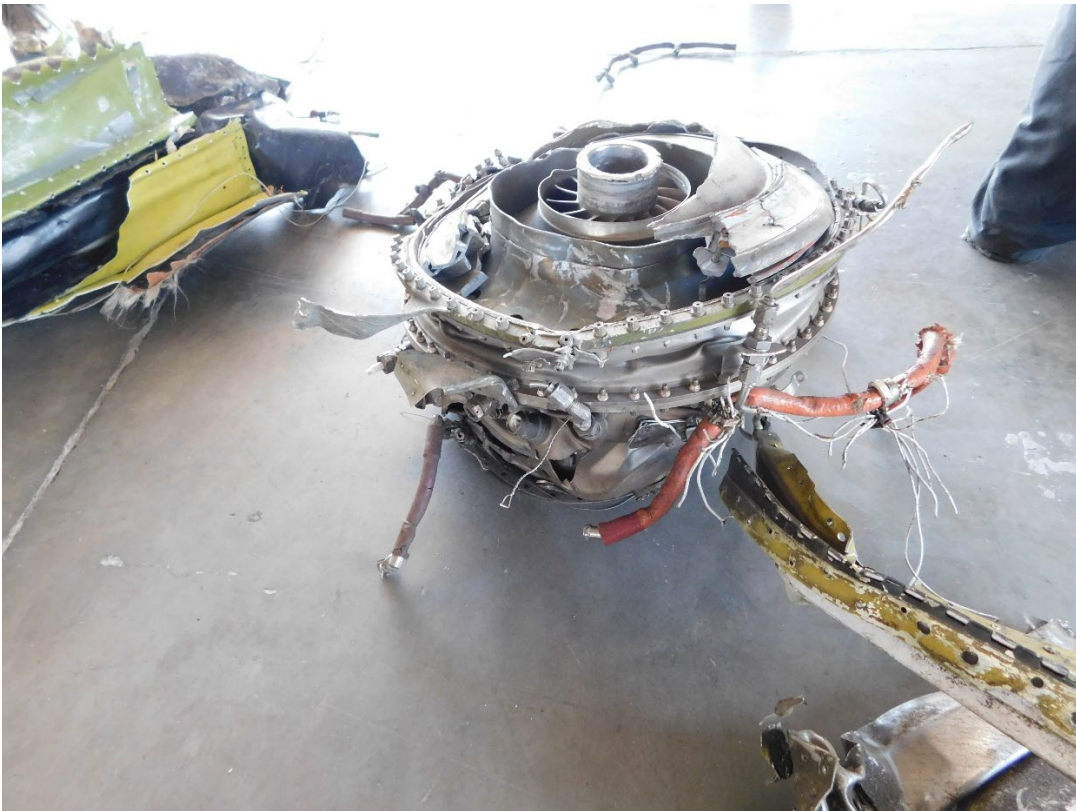
The power sections from each engine were separated from their accessory gear boxes, consistent with impact. (see figures 9 and 10) Both power sections were separated aft of the first stage impellers, which were located loose among the debris. The blades on both first stage impellers were missing at the hub lines. The aft curvics of the first stage impeller and the forward curvics of the second stage impeller were smeared, consistent with operation at the time of impact. Both power sections showed compression damage. The second and third stage turbine rotors were separated from one of the two power sections. Rotational scoring was present throughout both power sections. Both turbines showed evidence metal spray deposits on the third stage stator vanes.

Figure 9. Engine power section

Figure 10. Engine power section

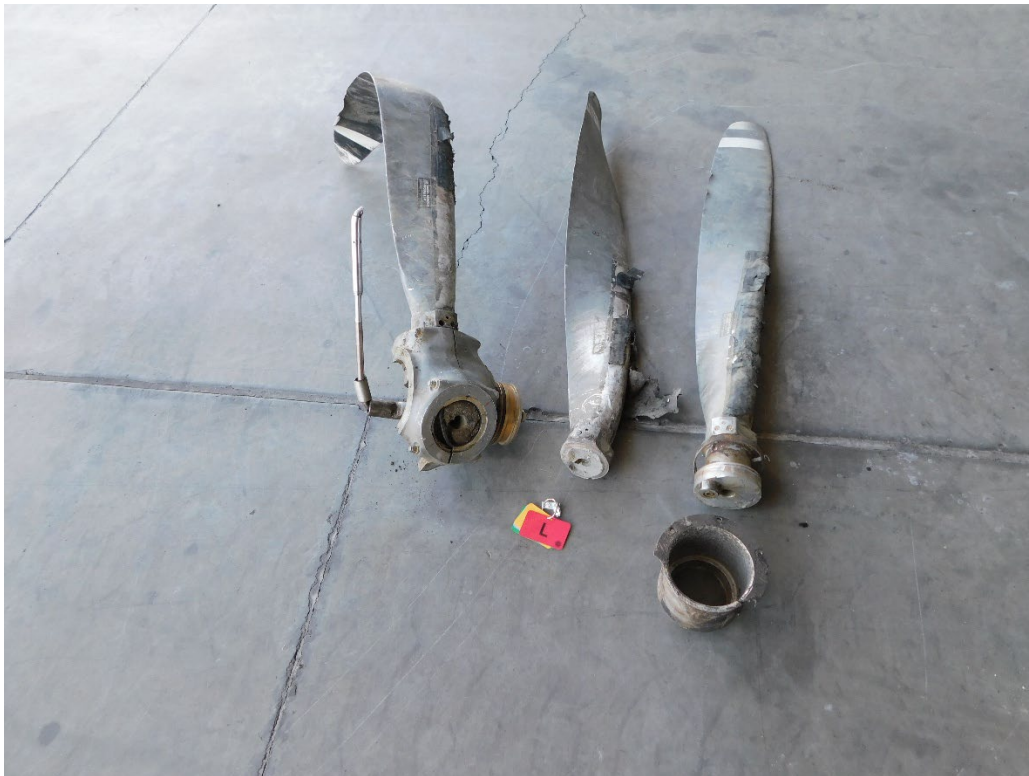
The left engine's propeller assembly was a three bladed, constant speed assembly. One propeller blade remained attached to the propeller hub. The two remaining propeller blades were separated from the hub. Two of the three blades displayed bending or twisting, and each propeller blade displayed gouging and chordwise scuffing. (see figure 11)

Figure 11. Left propeller assembly

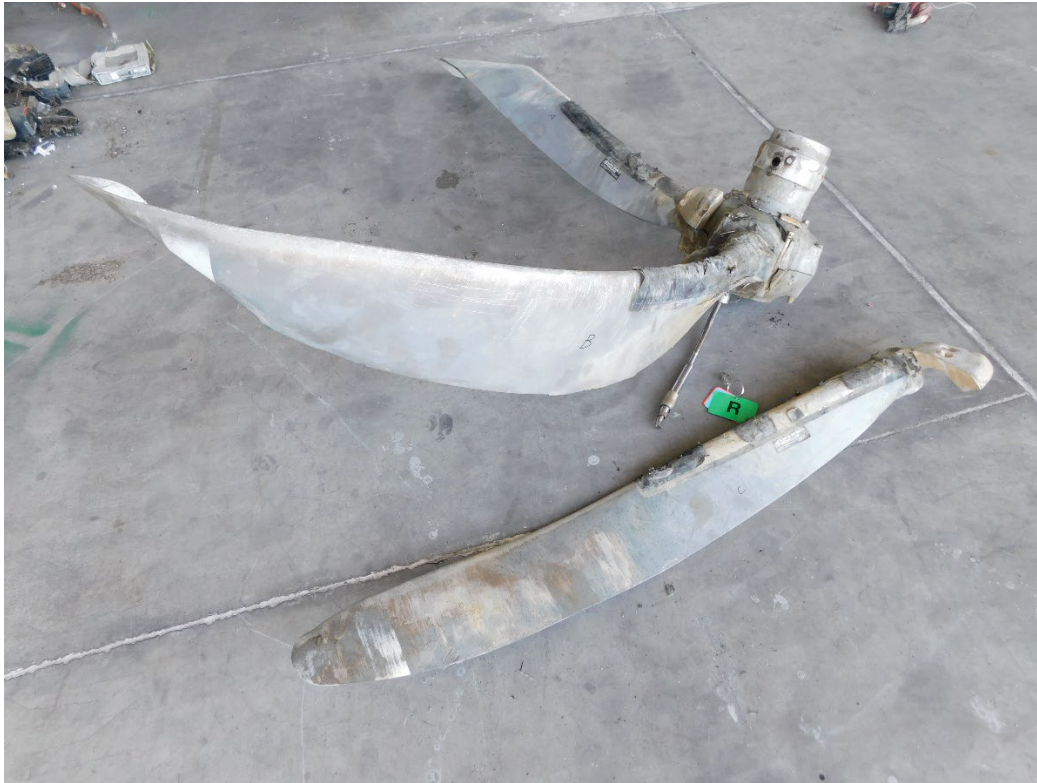
The right engine's propeller assembly was a three bladed, constant speed assembly. Two propeller blades remained attached to the hub. The third propeller blade

separated at the hub. Each propeller blade displayed varying amounts of bending, gouging and chordwise scuffing. (see figure 12)

Figure 12. Right propeller assembly
