| <b>Rolls-Royce</b> | Rolls-Royce Corporation<br>450 S. Meridian Street<br>Indianapolis, Indiana<br>46225-1103, USA | <b>REPORT NO.</b><br>24FAE-061-PR | <b>REV.</b><br>Initial | <b>PAGES</b><br>1 of 54 |
| <b>TITLE</b><br><b>METALLURGICAL INVESTIGATION OF A TURBINE TO COMPRESSOR COUPLING, P/N 23032345, INSTALLED IN AN M250-C30P ENGINE, S/N CAE895785, OPERATED BY HELIWORKS FLIGHT SERVICES</b> | | <b>PREPARED</b><br>Signatures on File | | |

| Part Name: | Turbine to Compressor Coupling |
| Engine Model: | M250-C30P |

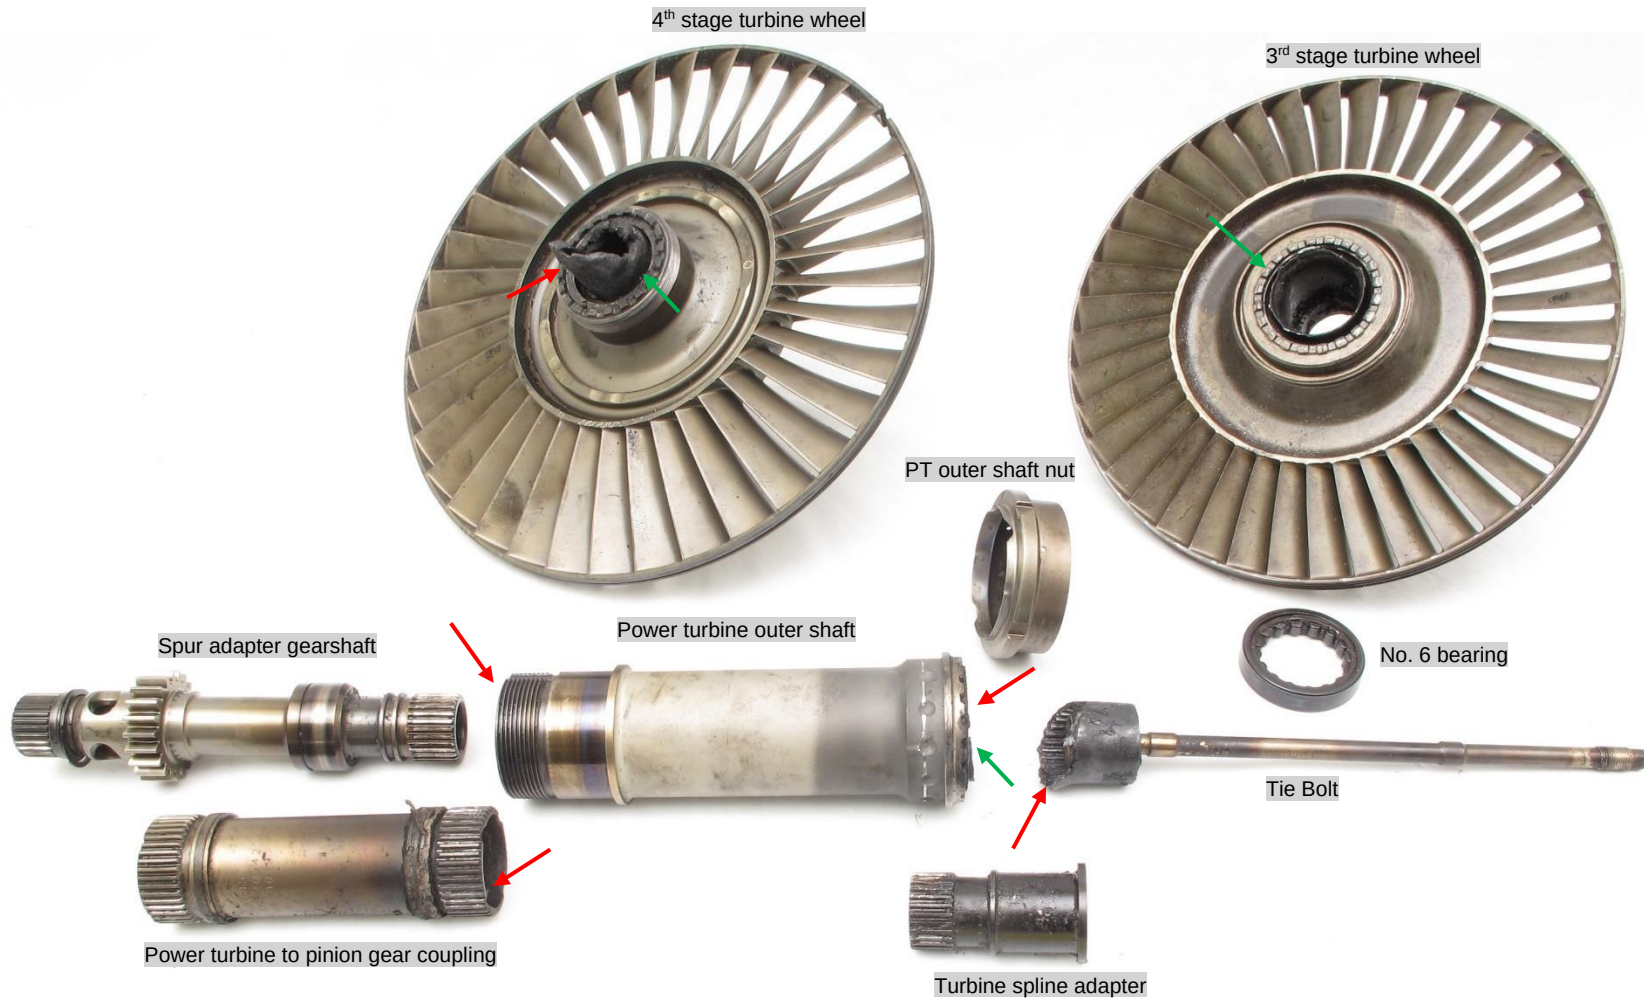
A partial engine schematic that illustrates the layout of components submitted for evaluation is shown in Figure 1. An overall view of the turbine and shaft components submitted for investigation are shown in Figure 2. The turbine to compressor coupling was fractured in several places and was found embedded in the power turbine (PT) outer shaft, 4<sup>th</sup> stage turbine wheel, and power turbine to pinion gear coupling. The PT inner shaft was fractured in several places and was found embedded in the PT outer shaft, 4<sup>th</sup> stage turbine wheel, and 3<sup>rd</sup> stage turbine wheel.

**Figure 2.** Overall view of the components submitted for investigation in the as-received condition. The red and green arrows indicate locations where the turbine to compressor coupling and PT inner shaft, respectively, were fractured and retained within the surrounding components.

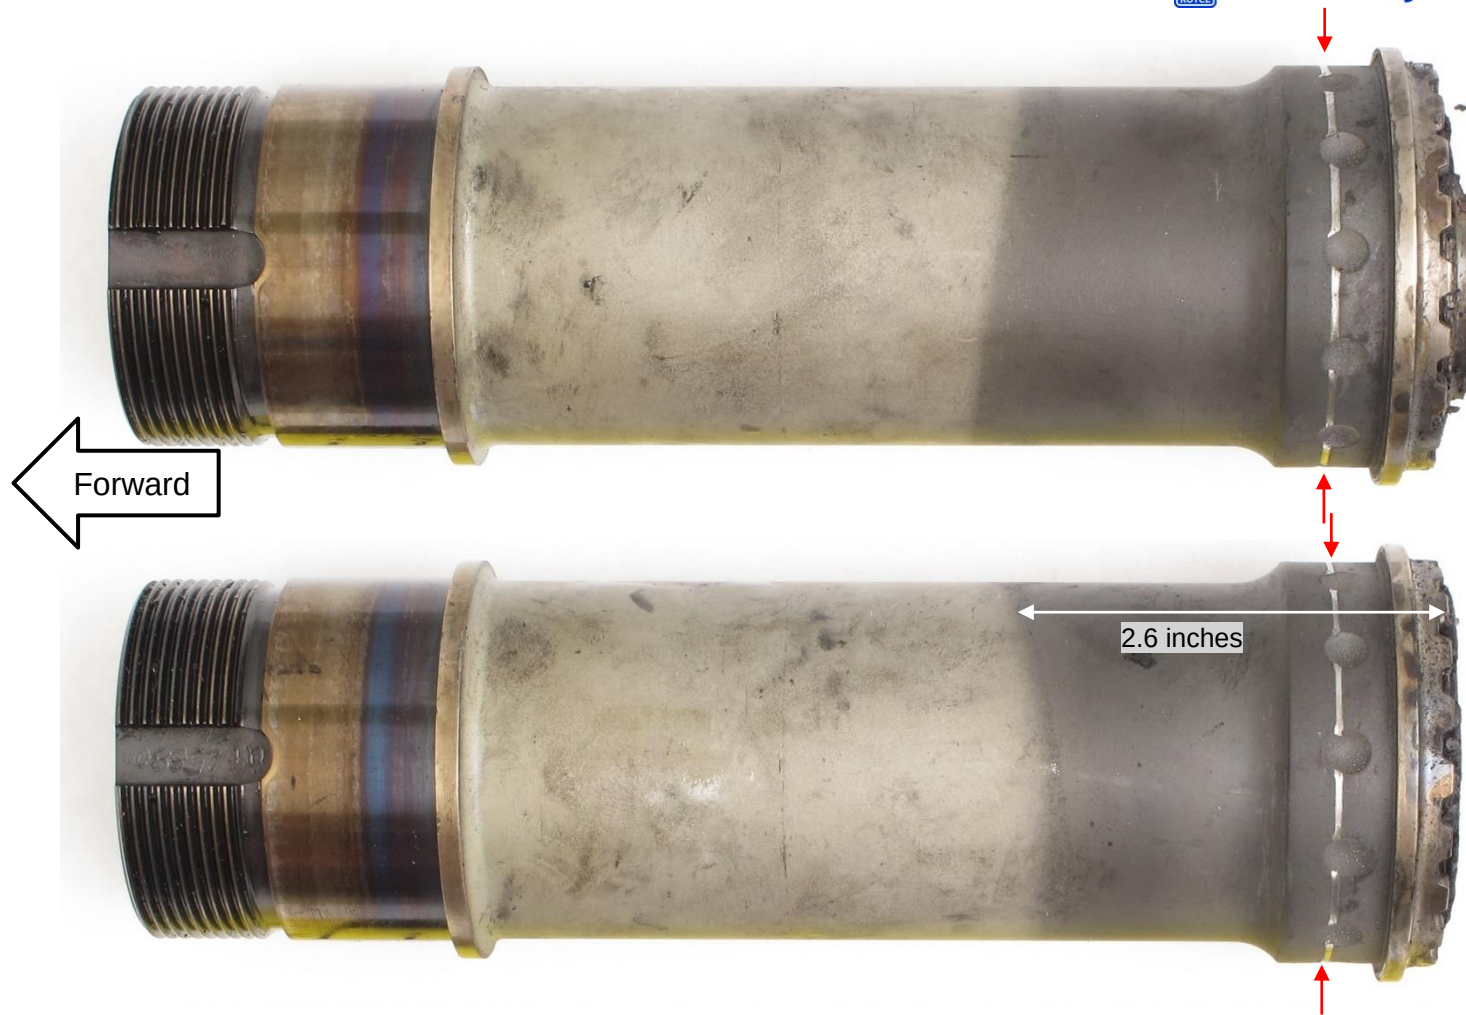
Overall views of the PT outer shaft are shown in Figure 3 in the as-received condition. The outer surface exhibited a darker grey discoloration that spanned up to approximately 2.6 inches forward of the Curvic teeth. Circumferential score marks were observed on the dimples, which was consistent with disassembly damage from the deformed dimples on the coupling nut. An overall aft looking forward view of the Curvic teeth and fractured and embedded portions of the PT inner tube, turbine to compressor coupling, and PT inner coupling nut is shown in Figure 4. The PT outer shaft walls were sectioned at two diametrically opposed locations and the resulting internal views are shown in Figure 5. The turbine to compressor coupling exhibited outboard deformation where it overlapped the PT inner shaft. The turbine to compressor coupling exhibited a spiral fracture forward of the PT outer shaft Curvic teeth. The PT inner shaft exhibited several fractures and deformed material between the turbine to compressor coupling and PT outer shaft. Dark deposits consistent with coked

**Figure 3.** Overall outboard looking inboard views of the power turbine outer shaft in the as-received condition. Each image is rotated approximately 180° from the previous. The red arrows indicate circumferential score marks consistent with disassembly damage from the PT coupling nut.

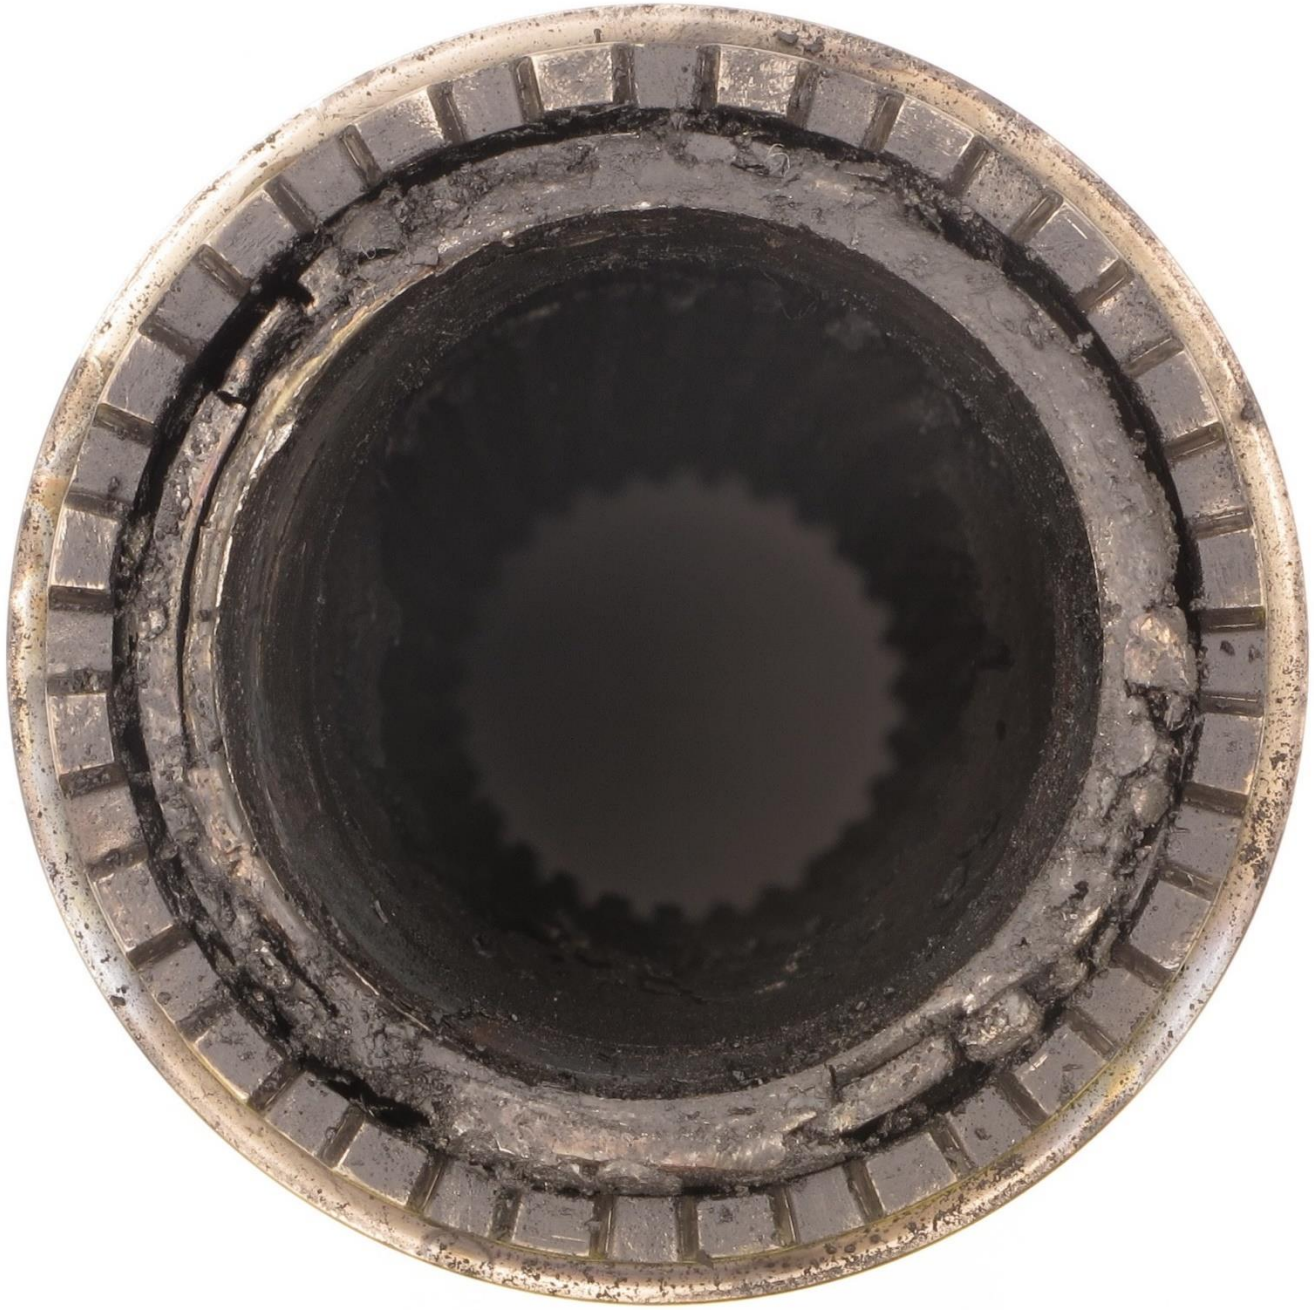
**Figure 4.** Overall aft looking forward views of the power turbine outer shaft in the as-received condition. Smeared PT inner shaft, PT inner coupling nut, and turbine to compressor coupling material was observed on the aft end along with coked oil.

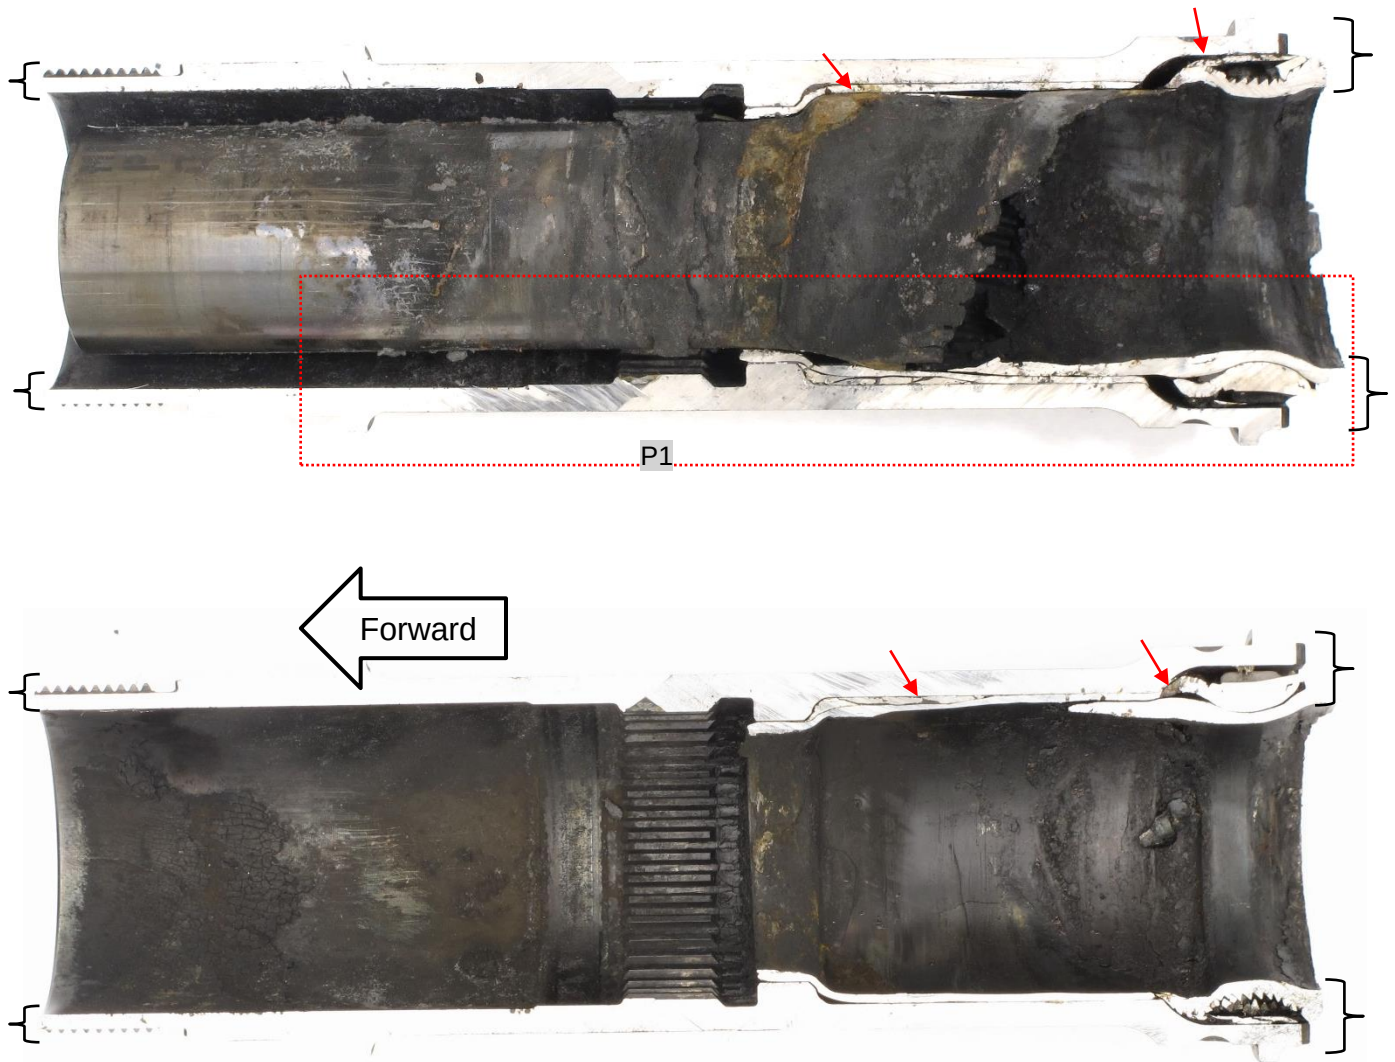
**Figure 5.** Overall views of the two halves of the PT outer shaft following laboratory cuts (black braces), showing fracture and deformed material from the PT inner shaft, PT inner coupling nut, and turbine to compressor coupling. Coked oil product was observed throughout the inboard surfaces of the PT outer shaft and outboard surfaces of the turbine to compressor coupling. Rust product on the laboratory cut surfaces from exposure to tool coolant is indicated by the red arrows (not all are noted). The plane (P1) indicated by the red box was selected for metallographic examination shown in Figure 10.

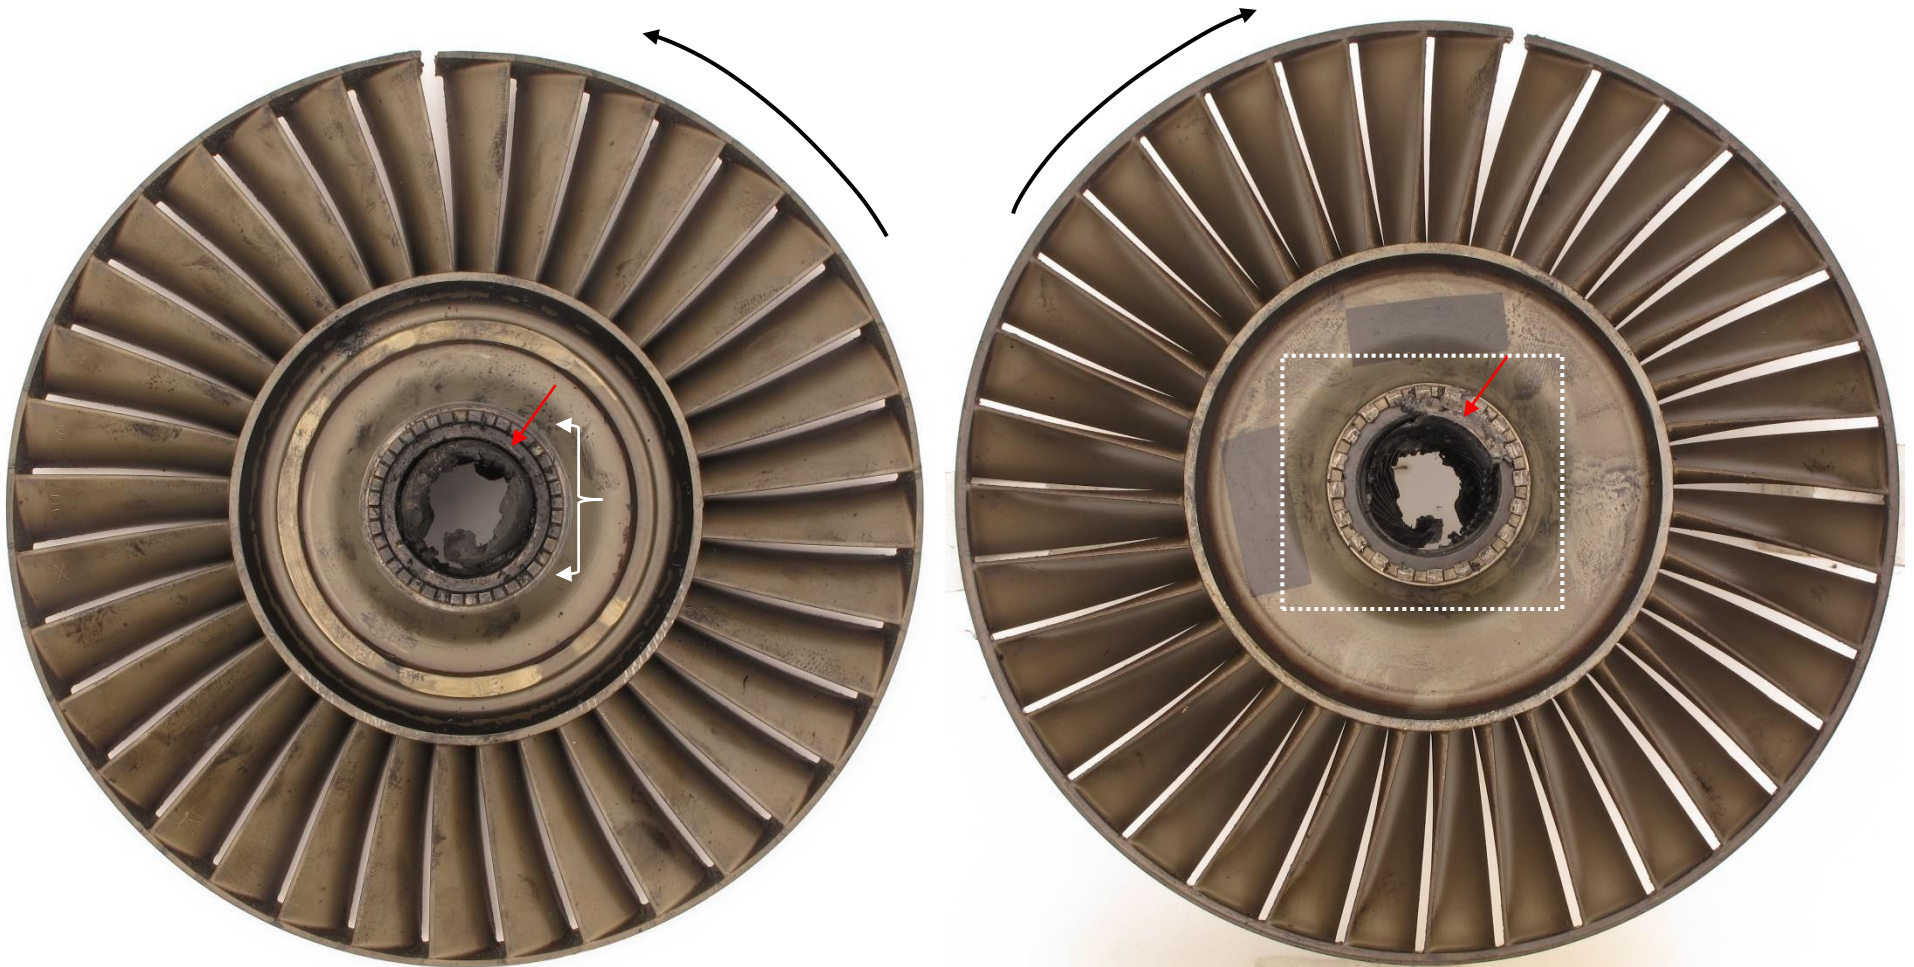
Overall views of the 4<sup>th</sup> stage turbine wheel are shown in Figure 6 in the as-received condition. A span of the fractured turbine to compressor coupling was embedded in the wheel bore along with PT inner shaft material. A detailed aft looking forward view of the 4<sup>th</sup> stage turbine wheel aft Curvic teeth, embedded PT inner shaft material, and embedded turbine to compressor coupling is shown in Figure 7. The aft portion of the turbine to compressor coupling was deformed outboard and onto the 4<sup>th</sup> stage turbine wheel aft Curvic teeth. The turbine to compressor coupling internal splines were deformed in a spiral in the direction of engine rotation from forward to aft. PT inner shaft material was observed between the turbine to compressor coupling material and the 4<sup>th</sup> stage turbine wheel bore. The turbine to compressor coupling material extended forward from the forward face of the Curvic teeth approximately 1.03 inches as shown in Figure 7.

**Figure 6.** Overall forward looking aft (left) and aft looking forward (right) views of the 4<sup>th</sup> stage turbine wheel. Turbine to compressor coupling material is indicated by the red arrows. The black arrows indicate the direction of engine rotation. The areas indicated by the white box and brace are shown in more detail in Figure 7.

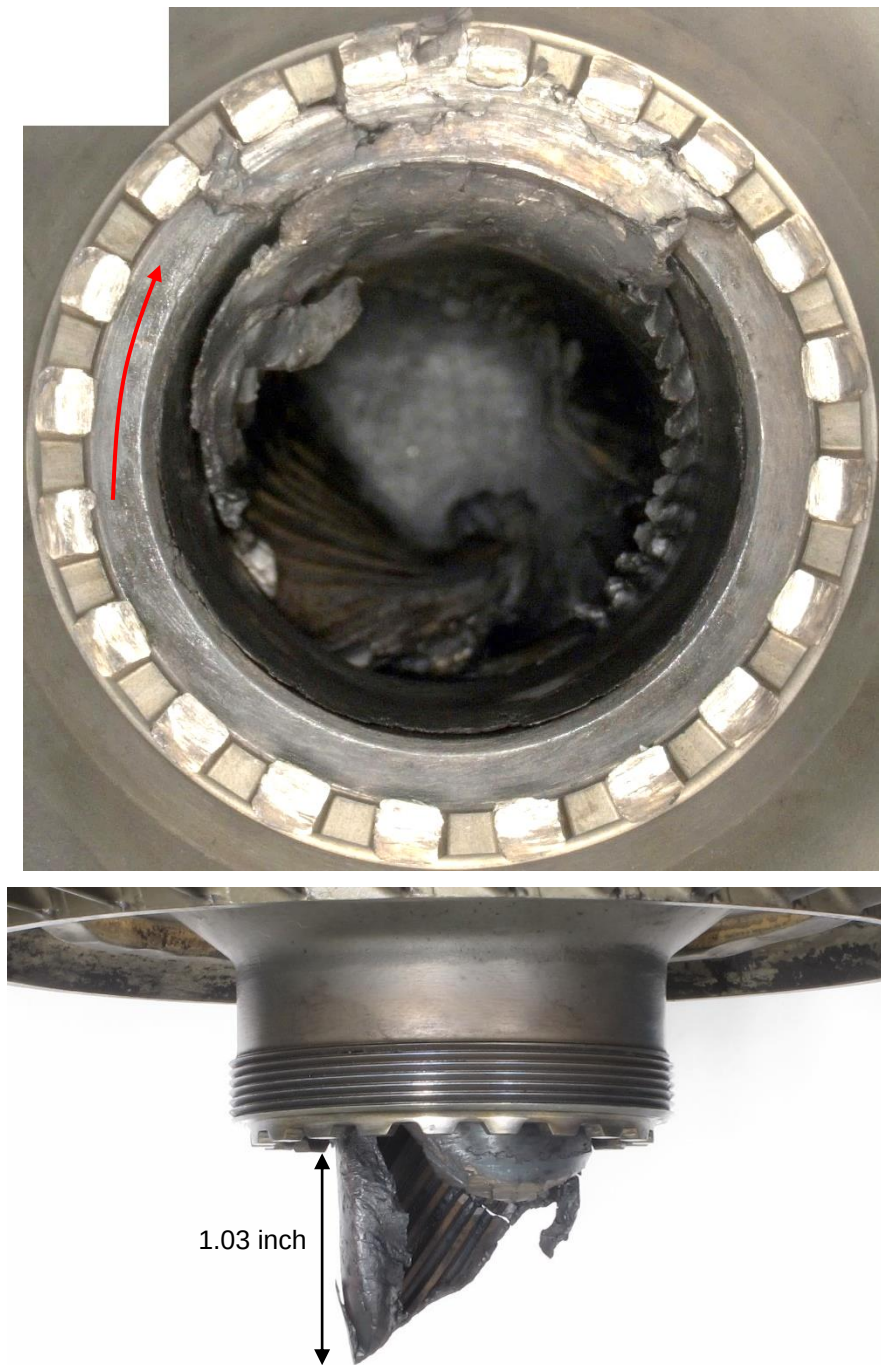
**Figure 7.** Top: Detailed aft looking forward view of the 4<sup>th</sup> stage turbine wheel showing rub on the Curvic teeth and fractured and deformed turbine to compressor coupling and PT inner shaft material. The red arrow indicates the direction of engine rotation.  
Bottom: Outboard looking inboard view of the forward Curvic coupling showing the turbine to compressor coupling material.

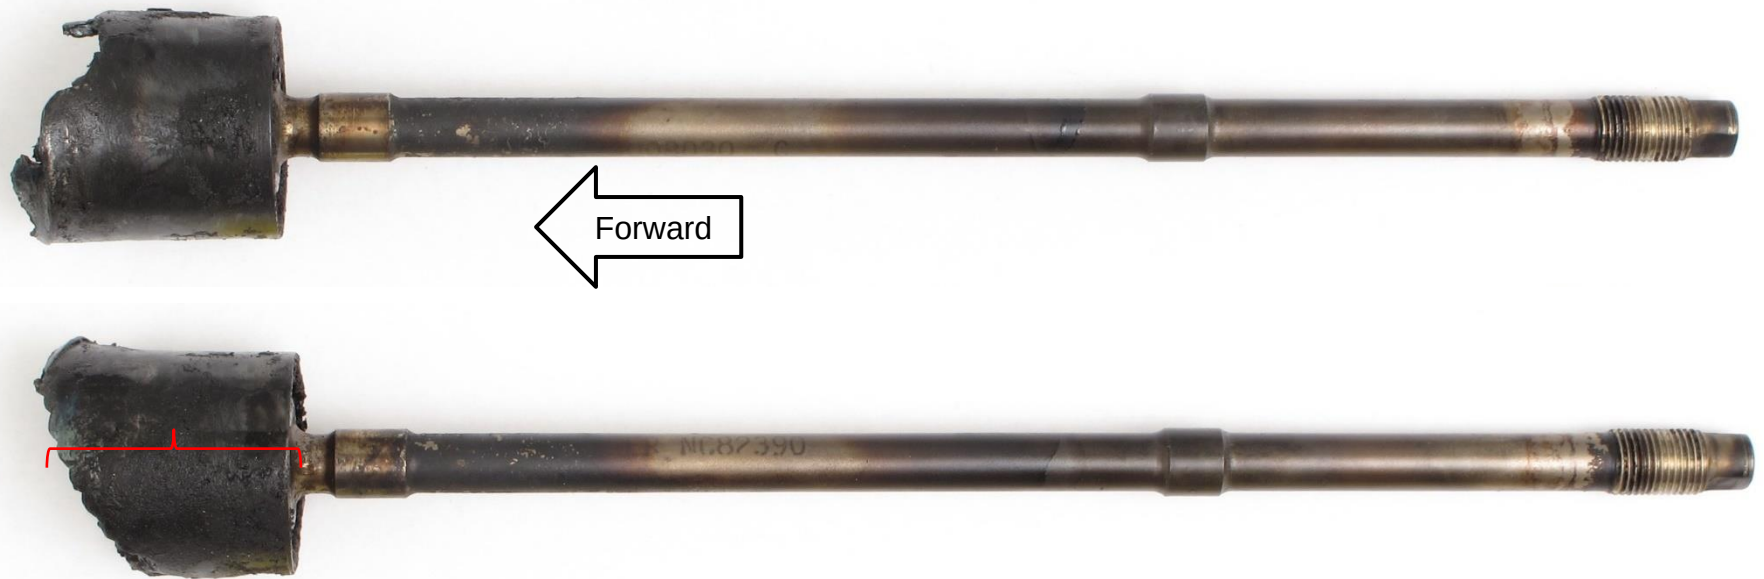
Overall views of the tie bolt are and aft-most portion of the turbine to compressor coupling, assembled by the tie bolt nut, are shown in Figure 8. The fractured portion of the turbine to compressor coupling exhibited deformation and rub damage and was coated with dark deposits consistent with coked oil.

**Figure 8.** Overall outboard looking inboard views of the tie bolt in the as-received condition. Each image is rotated approximately 180° from the previous. The portion of the turbine to compressor coupling is indicated by red braces.

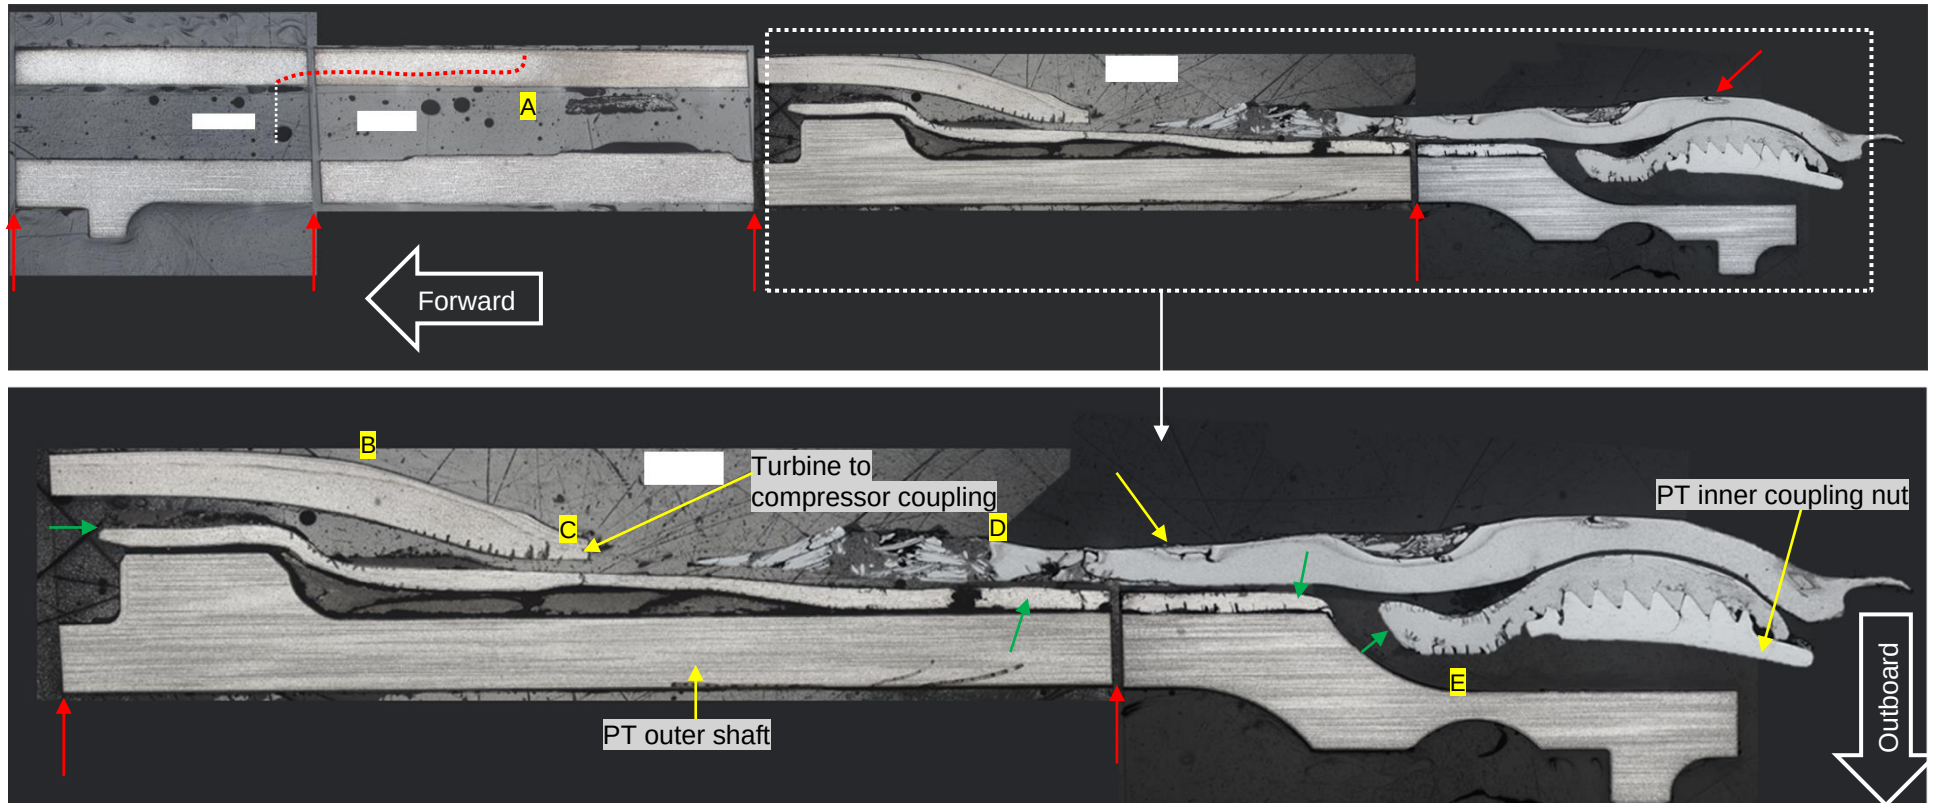
A metallographic cross-section was performed on the PT outer shaft that included the fractured turbine to compressor coupling, PT inner shaft, and the PT inner coupling at the approximate plane shown in Figure 5. Montaged metallographic images of the turbine to compressor coupling, PT inner shaft, PT outer shaft, and PT inner coupling nut are shown in Figure 10. The turbine to compressor coupling exhibited melted, deformed, cracked, and thermally distressed material. The PT inner shaft exhibited several fractures, areas of melted material, and cracking. Figure 11 shows a detailed view of the turbine to compressor coupling outer diameter surface at the extent of thermal distress, which was located approximately 1.37 inch forward of the PT outer shaft internal retaining feature for the power turbine to pinion gear coupling. Figure 12 shows detailed, representative thermally distressed material in the turbine to compressor coupling. Figure 13 shows local areas of thermal distress in the turbine to compressor coupling outer diameter adjacent to melted and re-solidified material from the PT inner shaft. Figure 14 shows detailed views of a span of melted and re-solidified material in the turbine to compressor coupling, which was melted through the wall thickness.

**Figure 10.** Montaged metallographic images of the cross-section (P1, see Figure 5) of the PT outer shaft, PT inner shaft (green arrows, bottom image), turbine to compressor coupling, and PT inner coupling nut showing the extent of thermally distressed material in the turbine to compressor coupling (red border, top image). The extent of thermal distress is shown by the white double arrows, measured forward of the pinion gear coupling retaining arm. The red arrows indicate laboratory cuts. Locations A through E are shown in more detail in the following figures. Etchant: Nital.

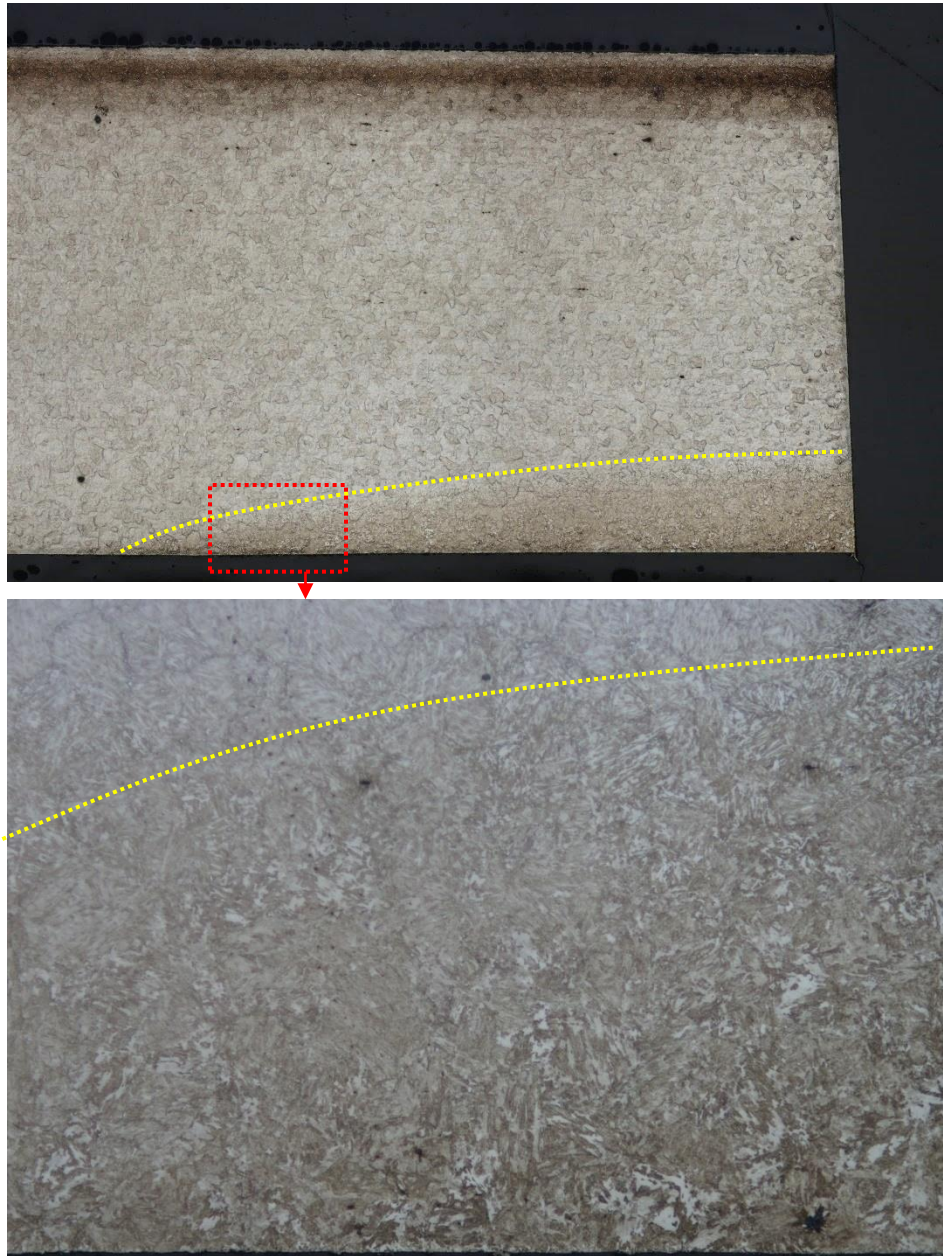
**Figure 11.** Detailed metallographic images of the turbine to compressor coupling at the forward extent of thermal distress (location A from Figure 10). The yellow dashed line indicates the extent of thermal distress. Etchant: Nital.

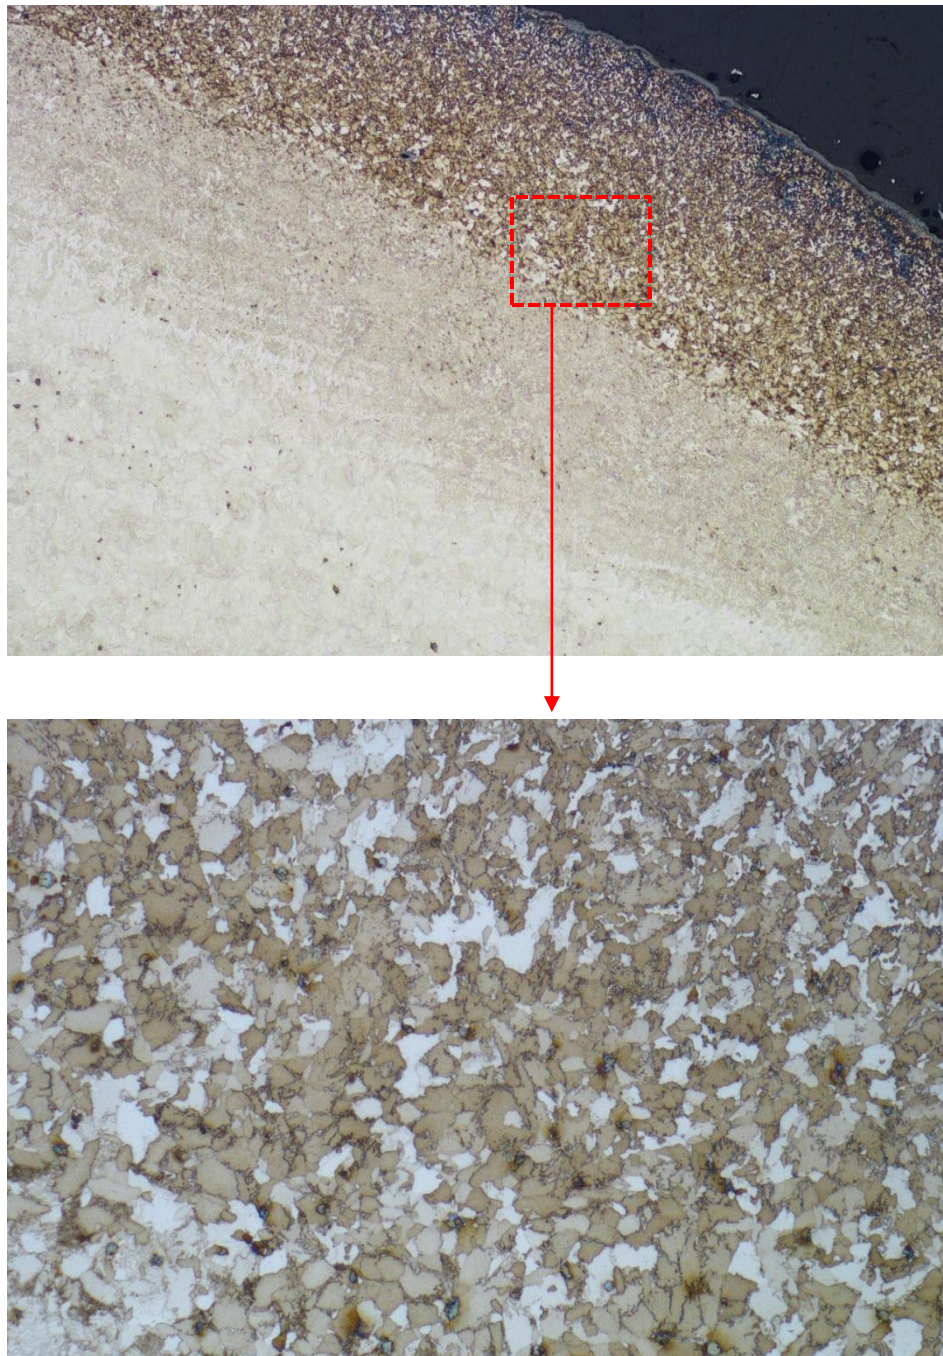
**Figure 12. Detailed metallographic images of the turbine to compressor coupling (location B from Figure 10) showing thermally distressed nitride case microstructure. Etchant: Nital.**

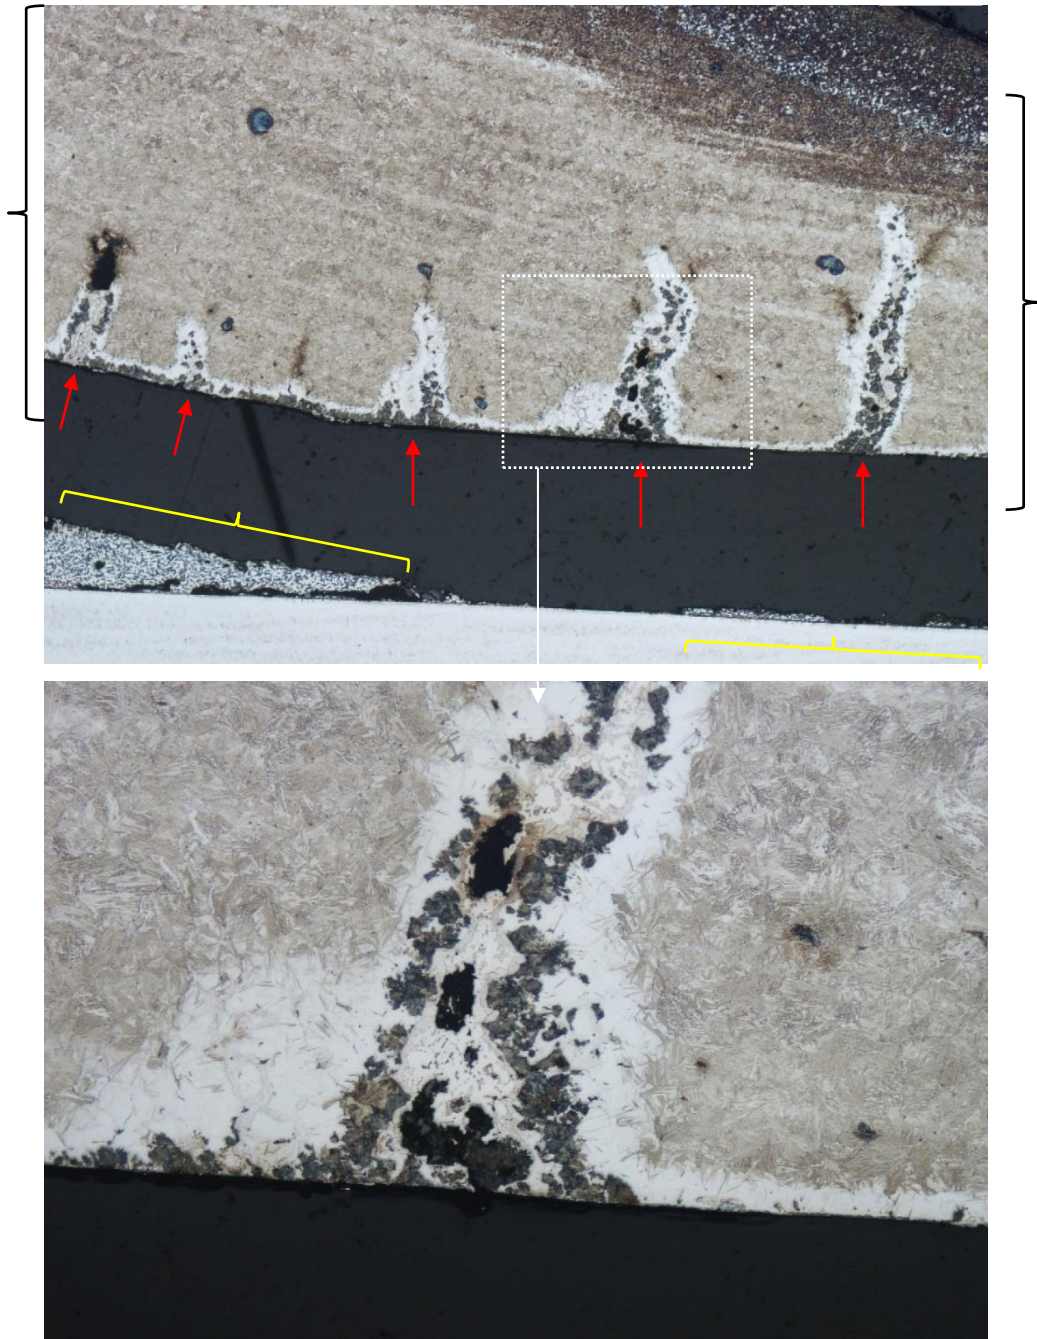
**Figure 13.** Detailed metallographic images of the turbine to compressor coupling (black braces) and PT inner shaft material (yellow braces) (location C from Figure 10) showing localized areas of transformed material (red arrows). Melted PT inner shaft material is indicated by the yellow braces. Etchant: Nital.

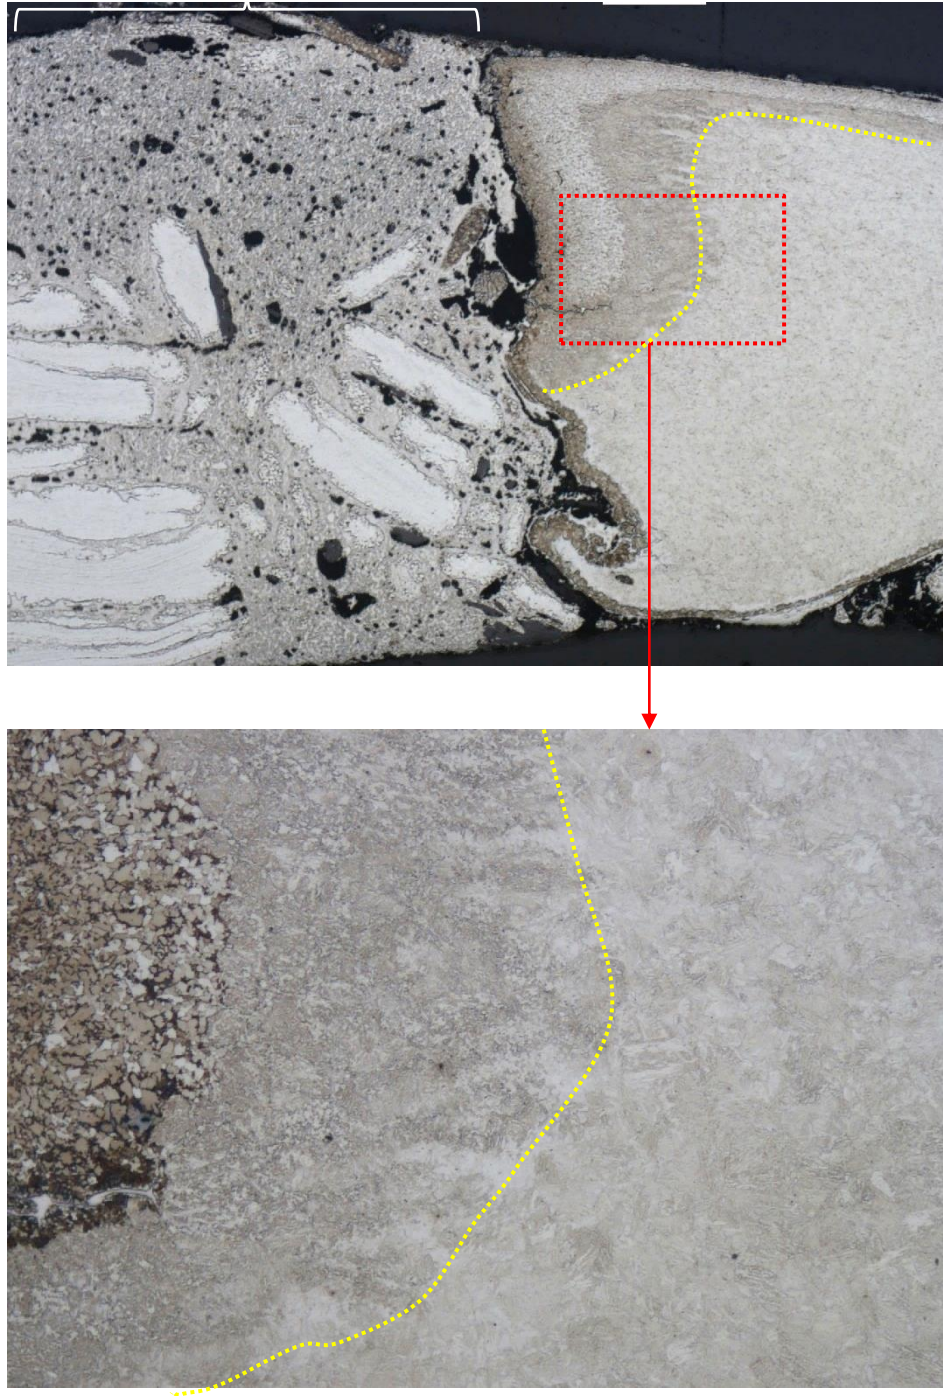
**Figure 14.** Detailed metallographic images of the turbine to compressor coupling at location D from Figure 10 showing resolidified material (white brace) and deformed and thermally distressed nitride case (yellow border) and core material. Etchant: Nital.

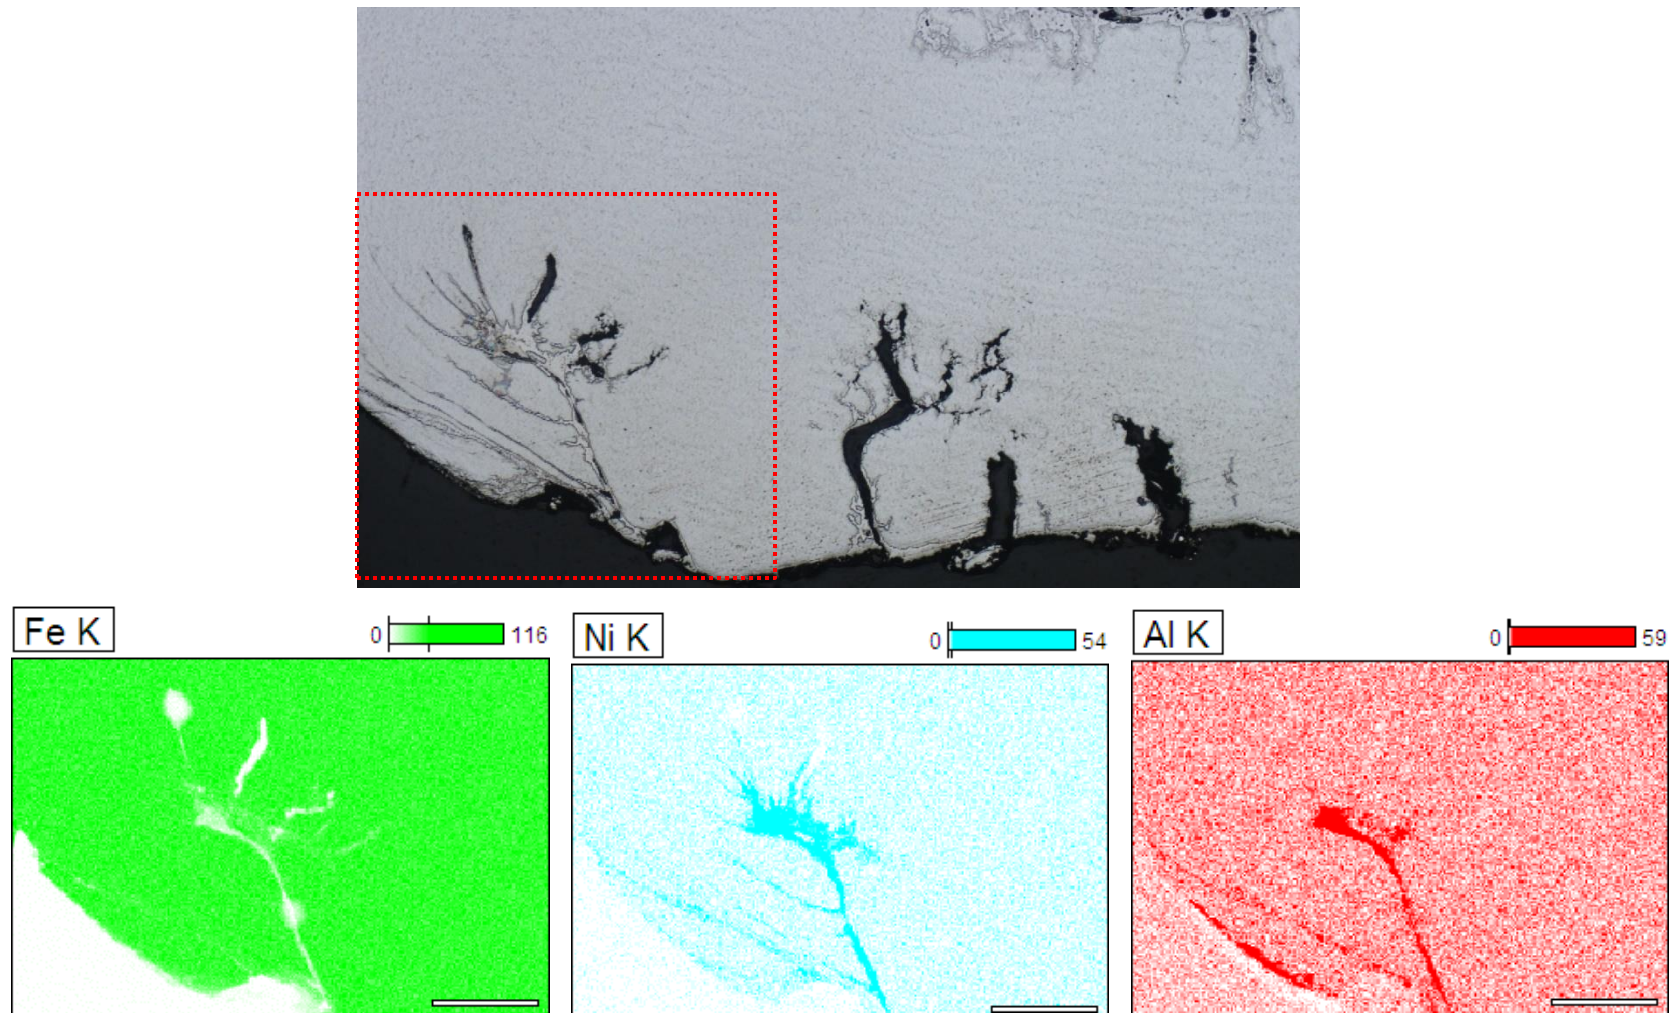
Figure 15 shows detailed views of the PT inner shaft material at the PT inner coupling nut. The outer diameter surface exhibited thermally distressed material diffused into the base material. Energy dispersive X-ray spectroscopy (EDS) of the diffused material revealed higher concentrations of nickel and aluminum.

**Figure 15.** Top: Detailed metallographic image (top) and EDS maps (bottom) of the PT inner shaft outer diameter surface at location E from Figure 10. Etchant: Nital.  
Bottom: EDS element maps showing spatial concentrations of iron (left), nickel (center), and aluminum (right), which show diffusion of the nickel plate and aluminum coating into the base material.
