| <b>Rolls-Royce</b> | Rolls-Royce Corporation<br>450 S. Meridian Street<br>Indianapolis, Indiana<br>46225-1103, USA | <b>REPORT NO.</b><br>24FAE-061-PR | <b>REV.</b><br>Initial | <b>PAGES</b><br>1 of 54 |
| <b>TITLE</b><br><b>METALLURGICAL INVESTIGATION OF A TURBINE TO COMPRESSOR COUPLING, P/N 23032345, INSTALLED IN AN M250-C30P ENGINE, S/N CAE895785, OPERATED BY HELIWORKS FLIGHT SERVICES</b> | | <b>PREPARED</b><br>Signatures on File | | |

| Part Name: | Turbine to Compressor Coupling |
| Engine Model: | M250-C30P |

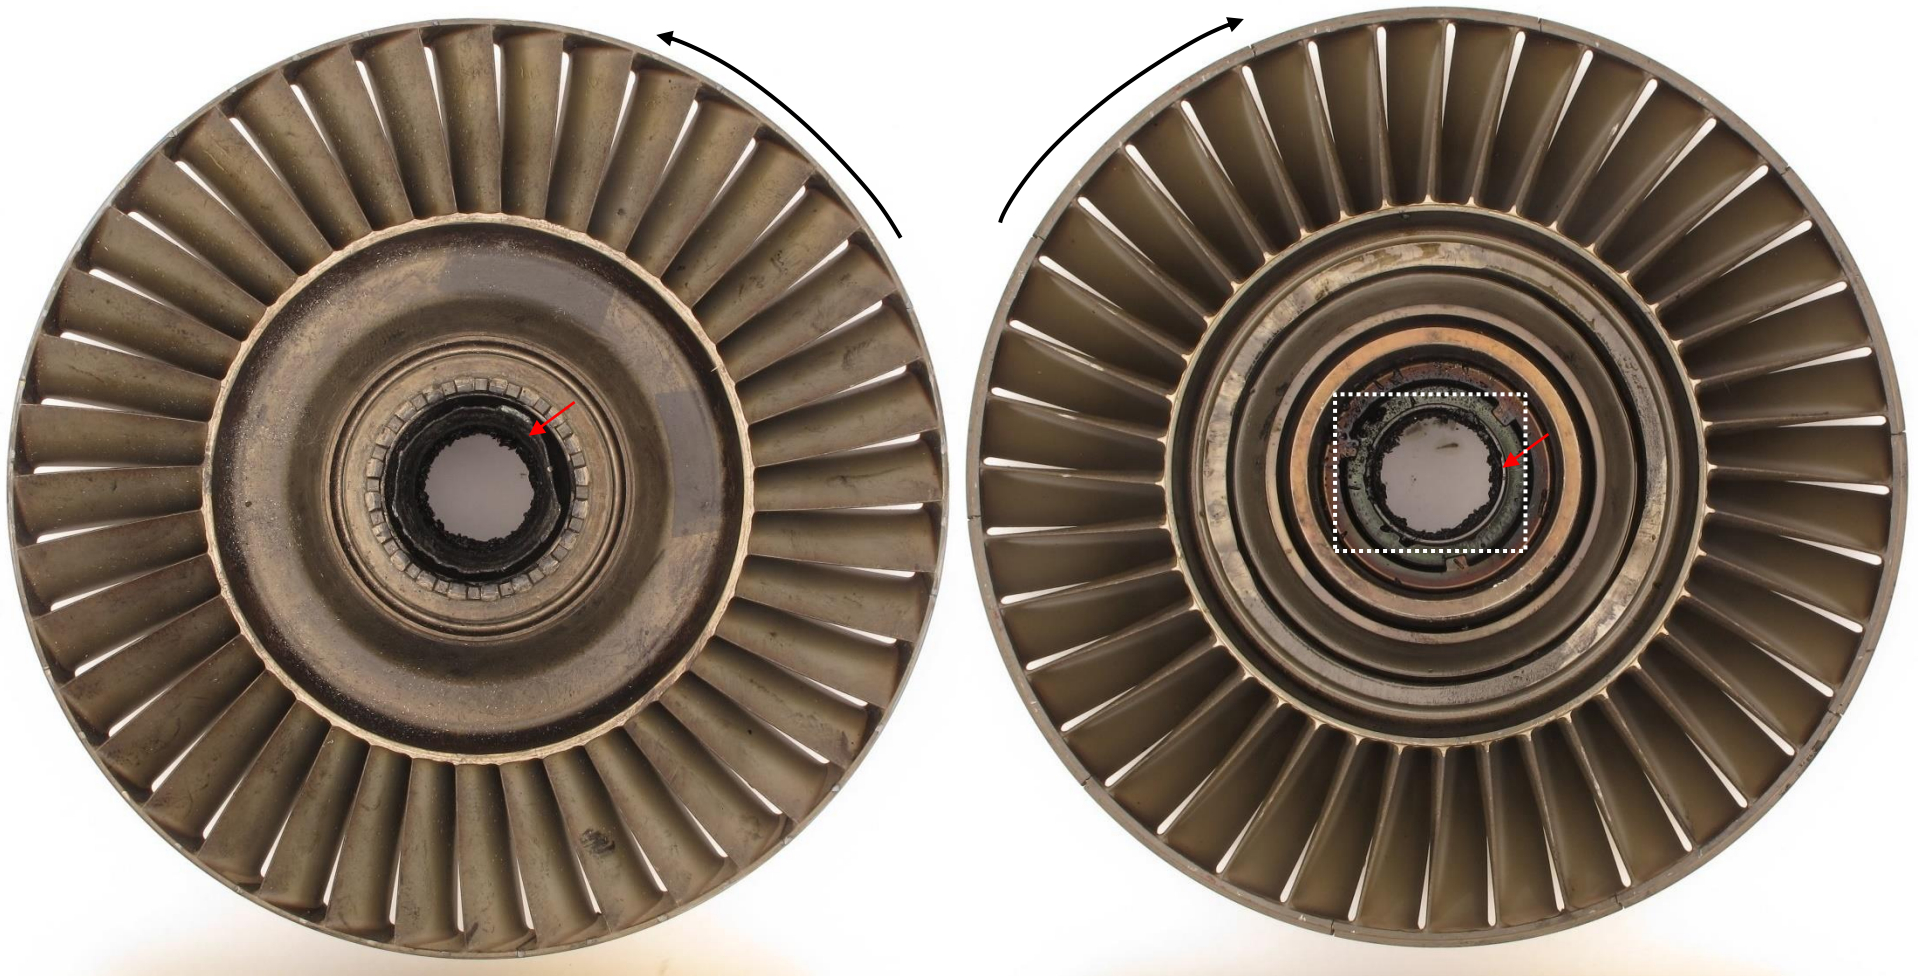
Overall views of the 3<sup>rd</sup> stage turbine wheel and the fractured and embedded portion of the PT inner shaft are shown in Figure 19. The approximately 1.75 inch aft span of the PT inner shaft was retained in the 3<sup>rd</sup> stage turbine wheel bore. The forward fracture of the PT inner shaft was flared outboard and smeared. Dark deposits consistent with coked oil were observed in the aft side of the 3<sup>rd</sup> stage turbine wheel bore and inside the PT inner shaft. A detailed aft looking forward view of the PT inner shaft embedded in the 3<sup>rd</sup> stage turbine wheel is shown in Figure 20. The PT inner shaft was removed from the 3<sup>rd</sup> stage turbine wheel and is shown in Figure 21.

**Figure 19. Overall forward looking aft (left) and aft looking forward (right) views of the 3<sup>rd</sup> stage turbine wheel and PT inner shaft remnants (red arrows). The area indicated by the white box is shown in more detail in the following figure.**

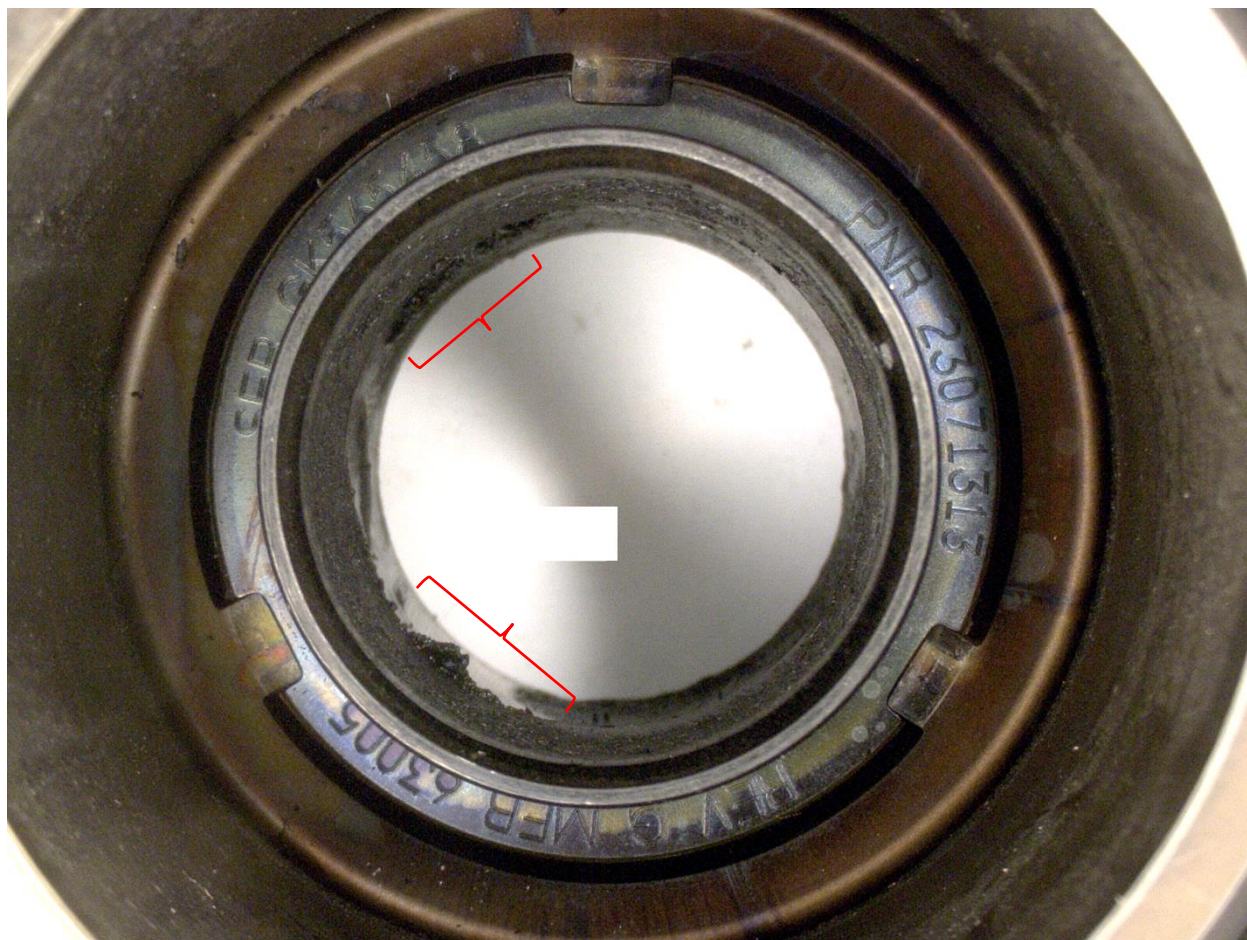
**Figure 20.** Detailed view of the PT inner shaft aft end as assembled in the 3<sup>rd</sup> stage turbine wheel. The red braces indicate dark deposits on the PT inner shaft inner diameter consistent with coked oil.

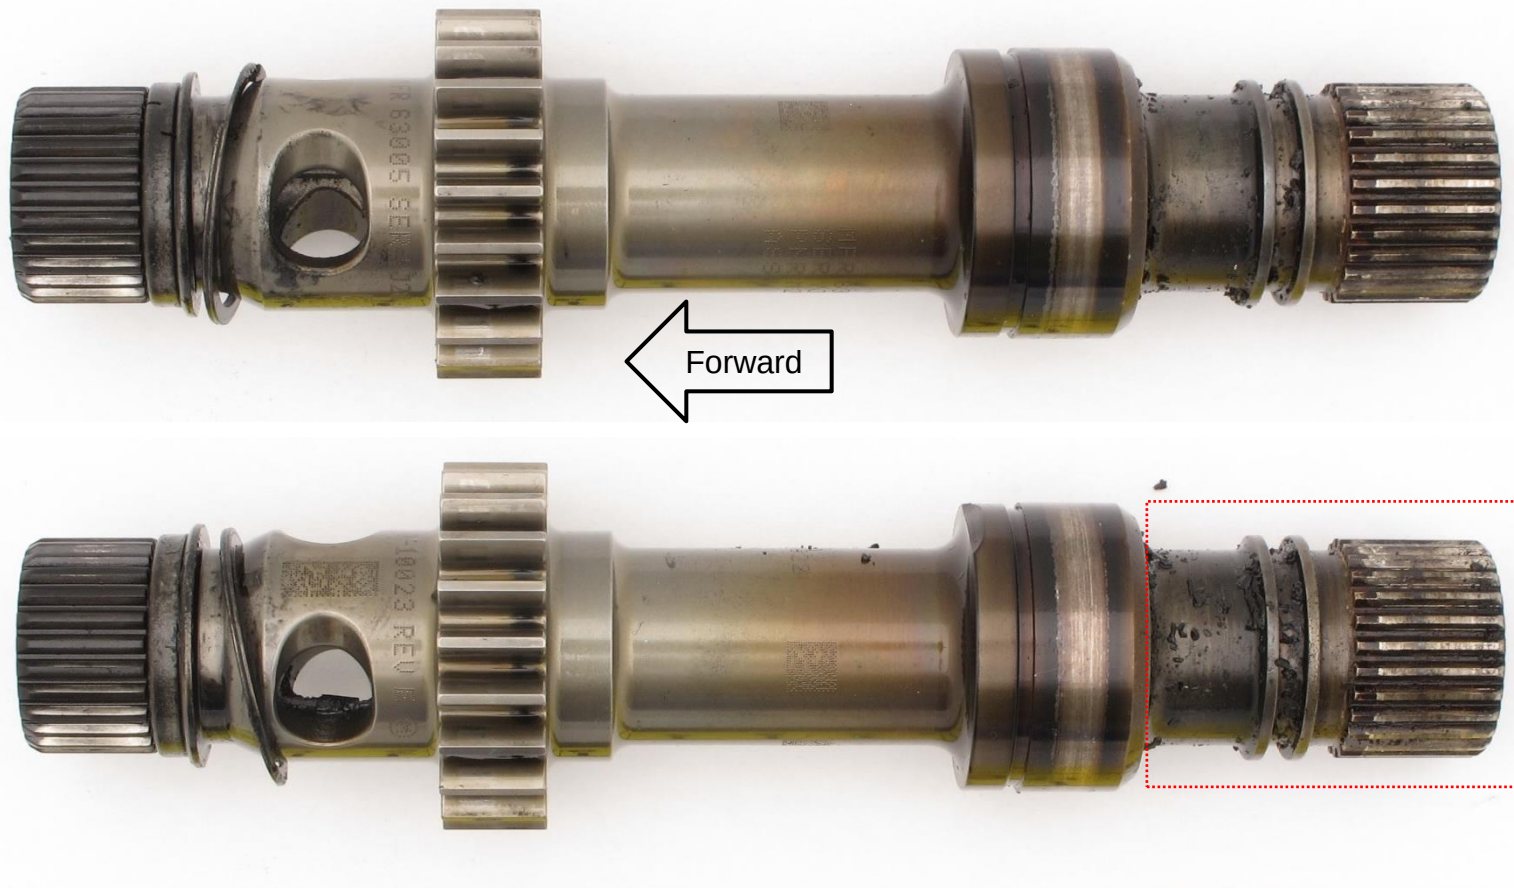
Overall views of the spur adapter gearshaft in the as-received condition are shown in Figure 25. Loosely adhered dark deposits were observed aft of the No.2.5 bearing race. Detailed views of O-ring grooves and aft splines are shown in Figure 26. A layer of oil stain was observed in the spline teeth that spanned into the O-ring groove approximately 0.023 inch forward of the spline teeth face. The span of the aft O-ring groove that did not exhibit oil stain was approximately 0.118 inch. The oil stain was observed on the spline tooth tips from the tooth face and on the tooth flanks near the aft face.

**Figure 25. Overall outboard looking inboard views of the spur adapter gearshaft in the as-received condition. Each image is rotated approximately 180° from the previous. The red boxed area is shown in more detail in the following figure.**

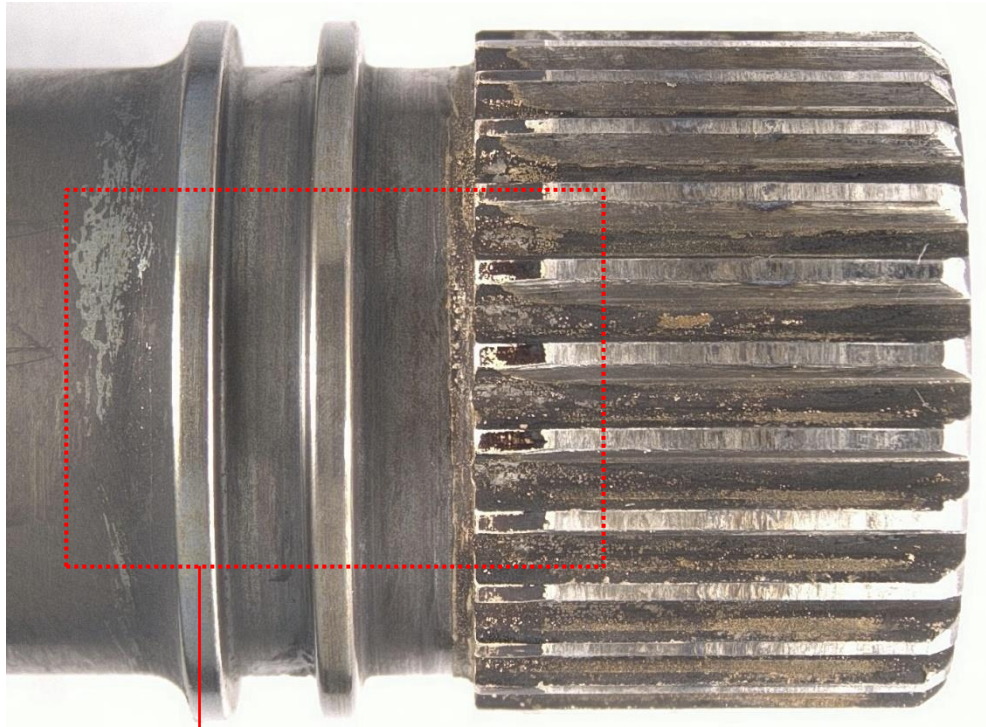
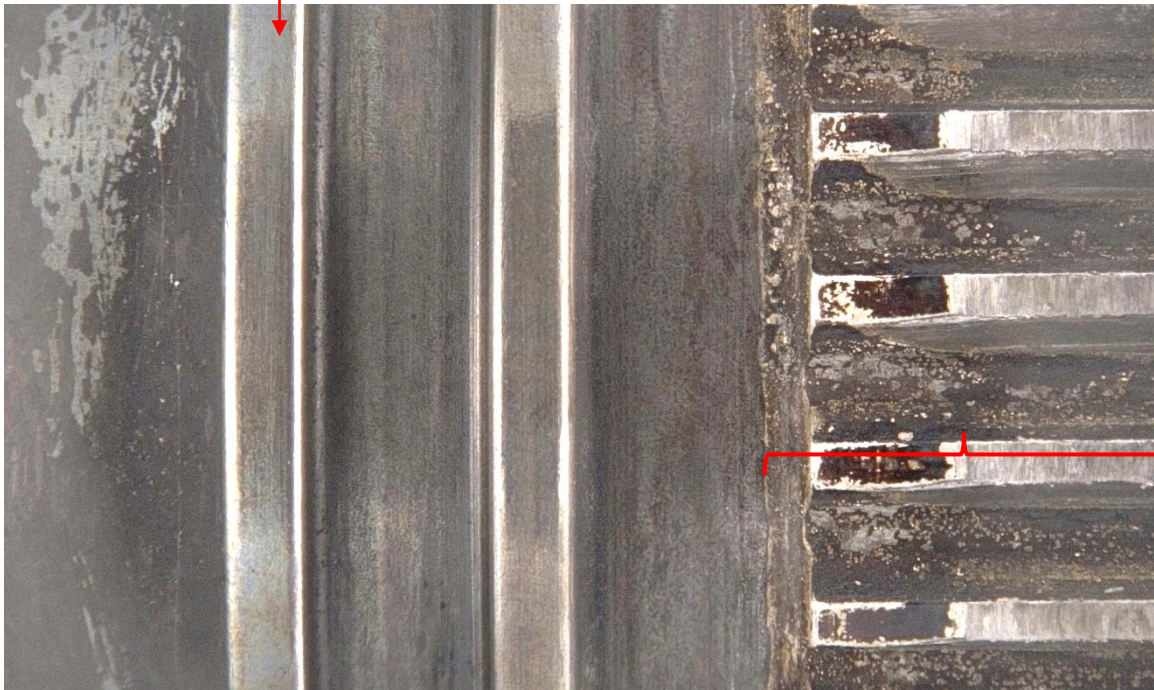
**Figure 26.** Detailed outboard looking inboard views of the spur adapter gearshaft O-ring grooves (black braces) and aft spline. The axial span of coked oil is indicated by the red braces and was observed in the spline roots, tooth tips, and forward into the O-ring groove. No evidence of coked oil was observed in the forward O-ring groove.

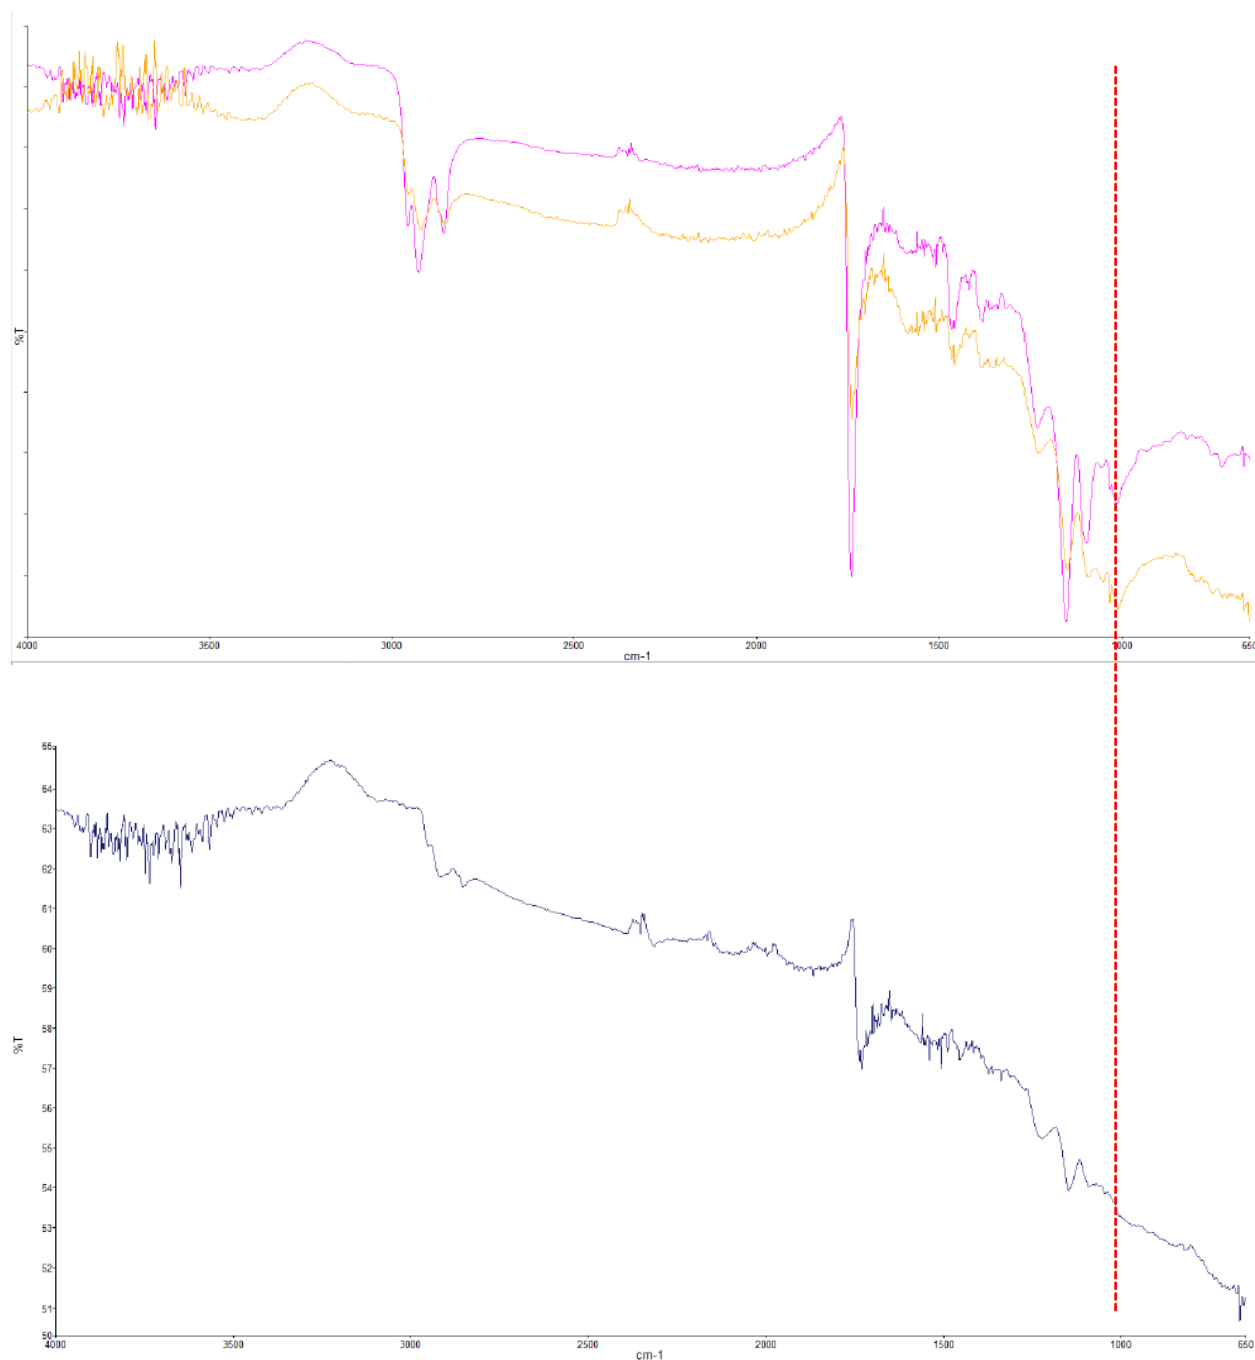
Solid dark deposits were collected from the spur adapter gearshaft, turbine to compressor coupling, the PT outer shaft, and the 4<sup>th</sup> stage turbine wheel bore and subjected to Fourier transform infrared (FTIR) spectroscopy at the Rolls-Royce Chemical Laboratory in Indianapolis, IN. The resultant spectra from FTIR are shown in Figure 27. FTIR revealed two samples of deposits collected from the spur adapter gearshaft exhibited a signal at 1050 cm<sup>-1</sup>, which was consistent with a signal from a fluorocarbon type material, along with carbon material consistent with coked oil. A representative spectrum from the dark deposits collected from components aft of the spur adapter gearshaft did not exhibit the signal at 1050 cm<sup>-1</sup>, which was consistent with a coked oil type material.

**Figure 27. FTIR results showing spectra from coked oil material recovered from the spur adapter gearshaft (top) and the 4<sup>th</sup> stage turbine wheel (bottom). The red dashed line indicates the C-F stretch at 1050 cm<sup>-1</sup> that was observed in the spur adapter gearshaft material and not observed in the 4<sup>th</sup> stage turbine wheel material. This signal is associated with a fluorocarbon rubber consistent with O-ring material installed on the spur adapter gearshaft.**

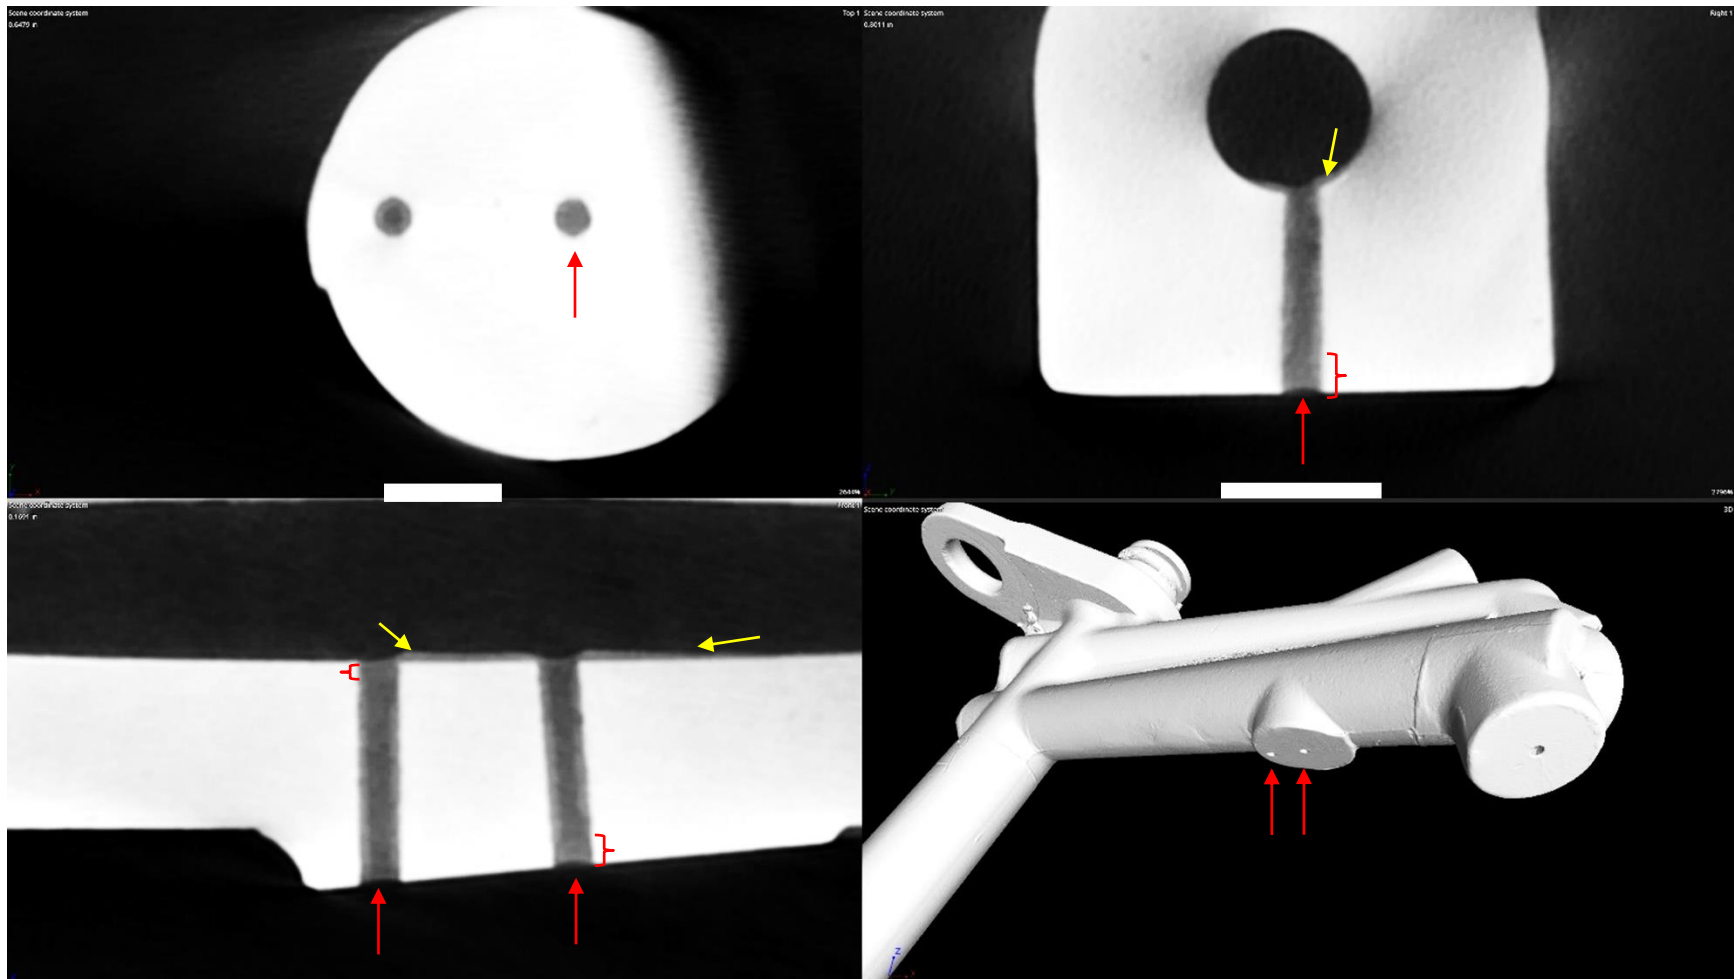
Overall views of oil delivery tube are shown in Figure 28 in the as-received condition. The oil delivery tube was subjected to the computed topography (CT) examination at the Rolls-Royce Corporation Non-destructive Testing Department in Indianapolis, IN. CT revealed a blocked passage in the No. 3 bearing oil jet as shown in Figure 29. The blockage exhibited a relatively denser material compared to the residual oil that remained in the passageways. The denser material was also observed built up on the internal cavity walls. No other oil jets exhibited evidence of complete blockages.

**Figure 29.** CT radiograph of the oil jet to the No. 3 bearing (red box in previous figure) showing a blocked passage (red arrows), which exhibited higher density material in the blockage and the inner cavity walls (yellow arrows) and spanned the entire diameter at the passage exit (red braces).

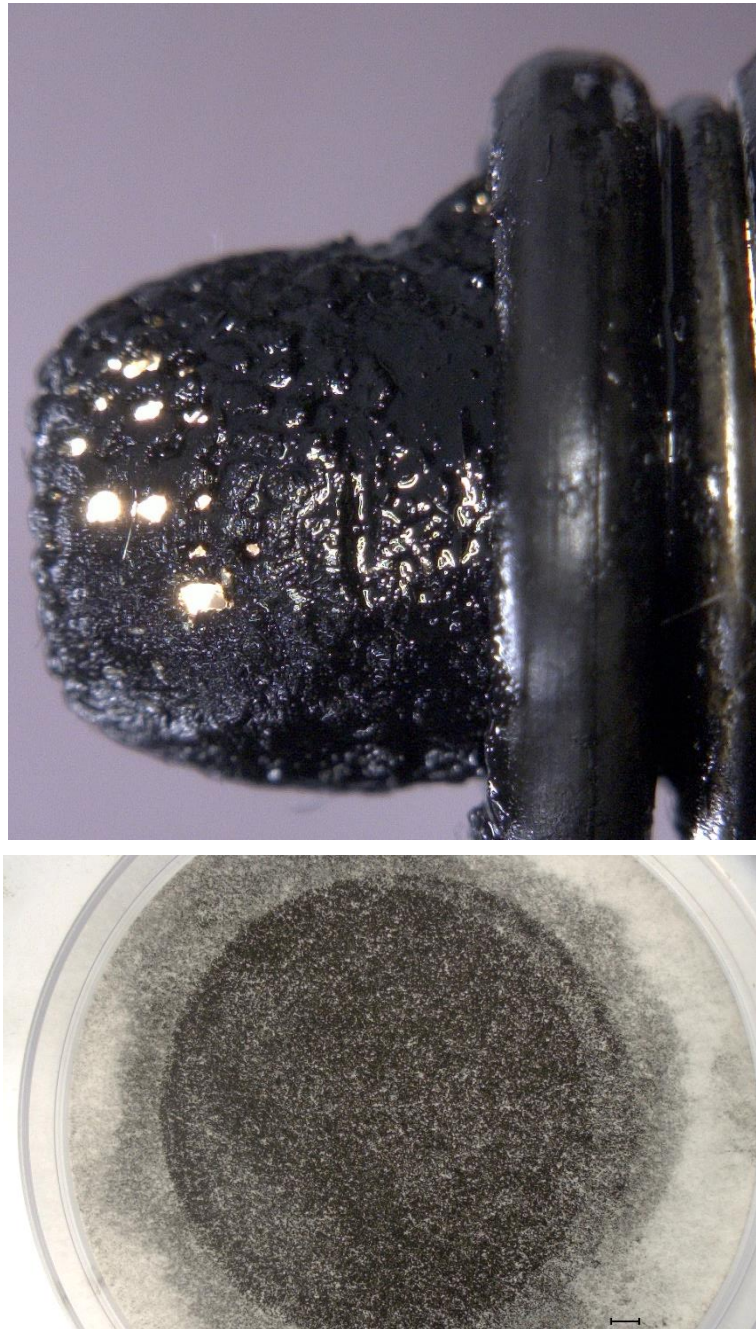
A detailed view of the oil screen is shown in Figure 30, which exhibited buildup of dark, viscous, oil material that occluded the oil screen surface. The oil sludge material was removed with laboratory solvents and collected onto a filter paper and is shown in Figure 30. The collected deposits were a dark, fine powdery material.

**Figure 30. Top: Detailed view of the oil screen back lit from the aft end. Dark deposits consistent with coked oil product were observed around a majority of the screen surface. Bottom: overall view of filtered product from the oil screen. The product consisted of a black powder type material consistent with coked oil.**

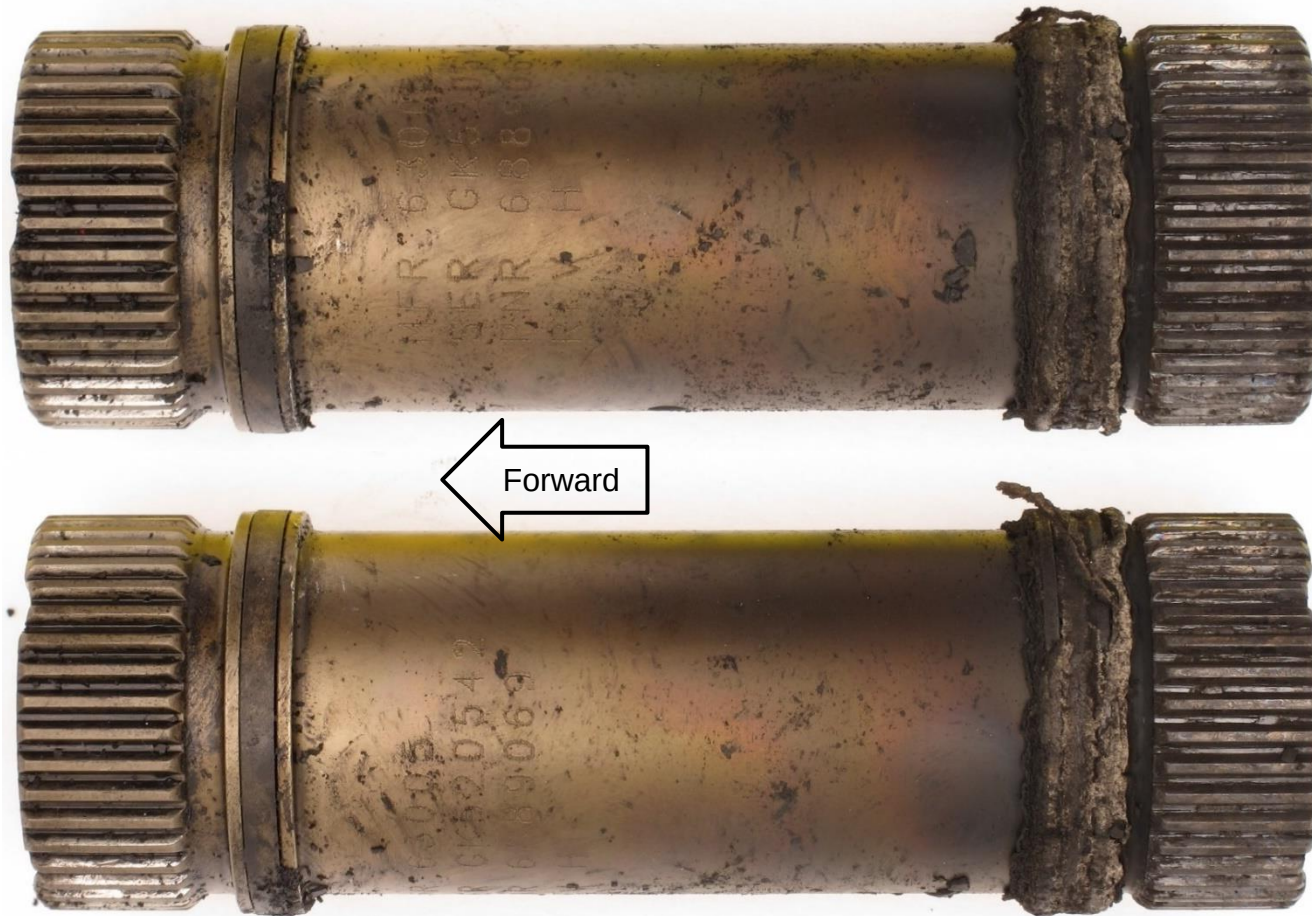
Overall views of the power turbine to pinion gear coupling, hereafter pinion gear coupling, are shown in Figure 31 in the as-received condition. Dark deposits consistent with coked oil were observed on the inner and outer diameter surfaces and embedded in the spline teeth. The aft Teflon seal was damaged and frayed. Discoloration was observed on the forward half of the pinion gear coupling. Detailed views of the forward and aft Teflon seals are shown in Figure 32. A detailed view of the pinion gear coupling aft side and internal features are shown in Figure 33. The inner diameter exhibited a thin layer of adhered turbine to compressor coupling material.

**Figure 31.** Overall outboard looking inboard views of the power turbine to pinion gear coupling in the as-received condition. Each image is rotated approximately 180° from the previous. Dark deposits consistent with coked oil were observed throughout the surface. The aft side exhibited discoloration consistent with heat tint.

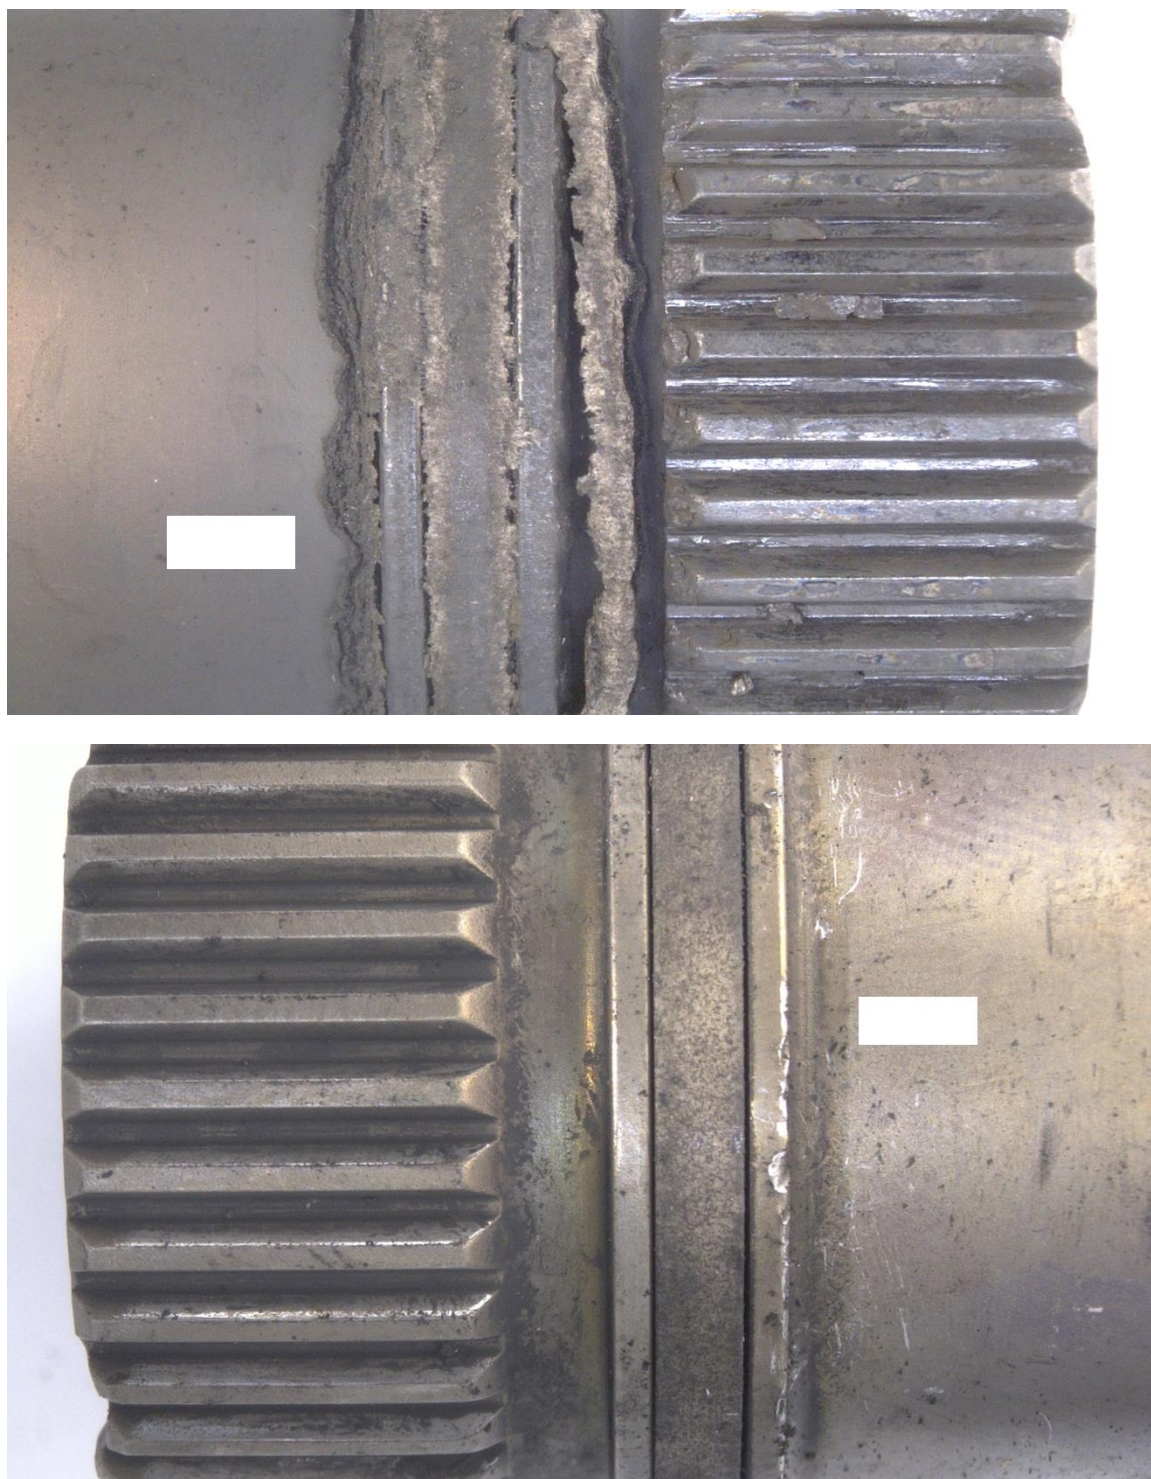
**Figure 32. Detailed views of the aft (top) and forward (bottom) splines and Teflon seals on the pinion gear coupling. The aft Teflon seal exhibited damage.**

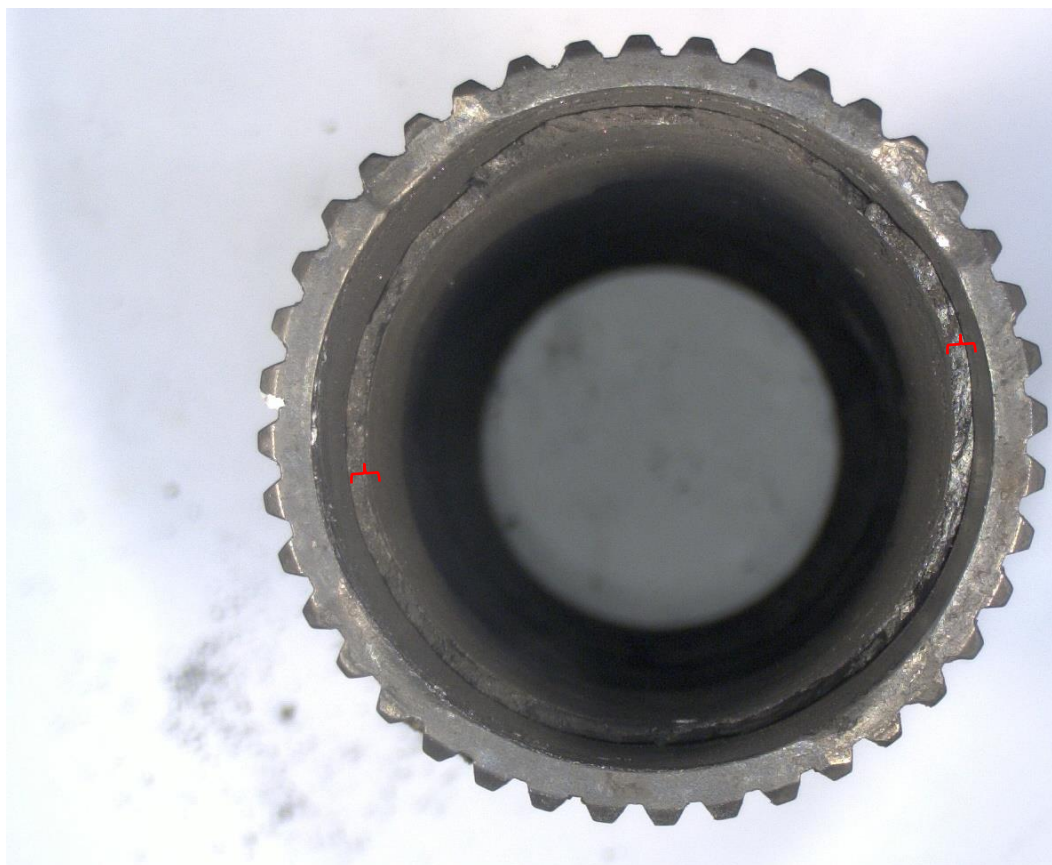
**Figure 33. Overall aft looking forward view of the pinion gear coupling showing turbine to compressor coupling material (red braces) in the inner diameter.**

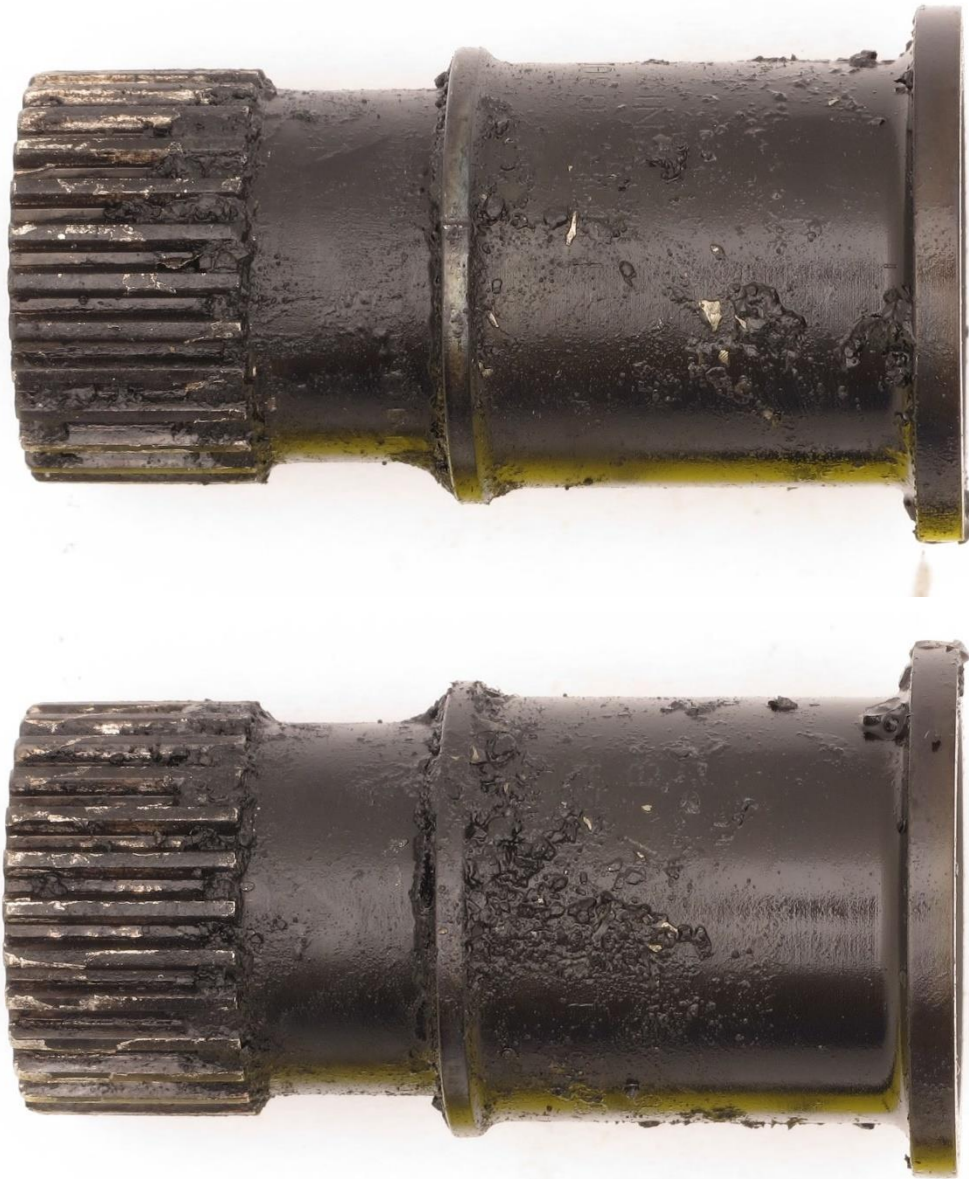
Overall views of the turbine spline adapter are shown in Figure 34 in the as-received condition. Dark deposits consistent with coked oil were observed in the spline teeth and inner and outer diameter surfaces.

**Figure 34. Overall outboard looking inboard views of the turbine spline adapter in the as-received condition. Each image is rotated approximately 180° from the previous. Dark deposits consistent with coked oil were observed throughout the part.**

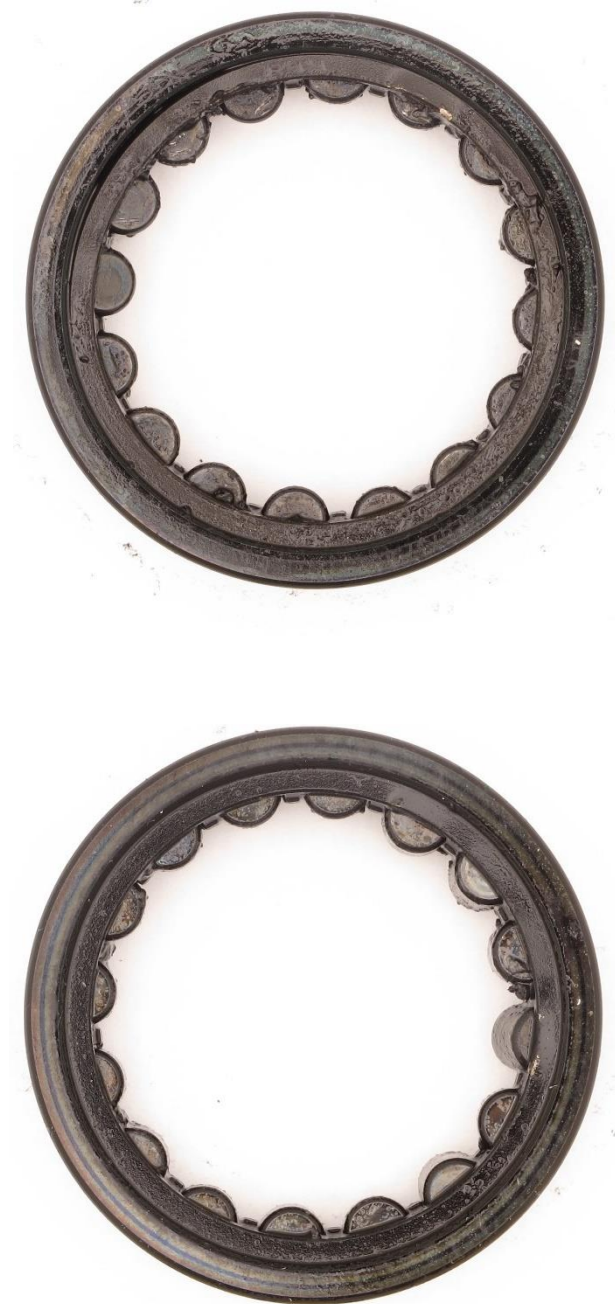
Overall views of the No. 6 roller bearing are shown in Figure 35 in the as-received condition. The bearing surfaces and rollers exhibited dark deposits consistent with coked oil. The bearing exhibited resistance when turned.

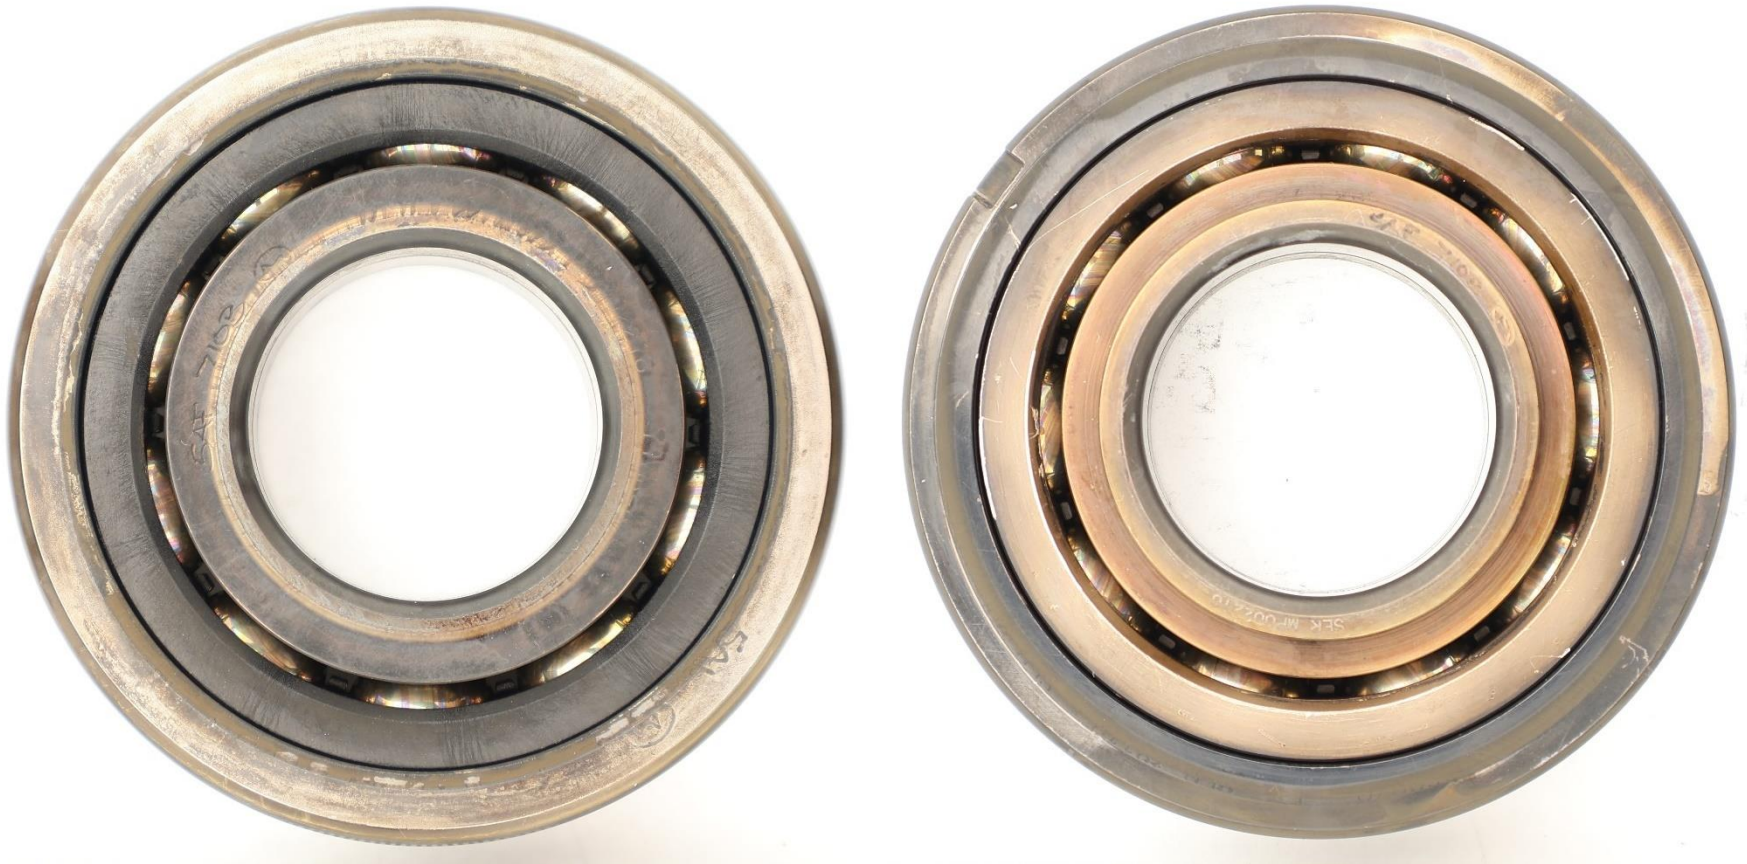
Overall views of the No. 2 bearing are shown in Figure 36 in the as-received condition. The forward side exhibited a darker discoloration in the inner ring and separator. Detailed views of the separator inner diameter and balls are shown in Figure 37. The separator exhibited a dark discoloration that was flaked off in areas consistent with a layer of coked oil material. The coked oil layer spanned from the approximate axial mid-span onto the forward face. The separator forward face at each ball pocket exhibited radially oriented banded features in the coked oil layer. The outer ring forward face exhibited a darker layer of material located approximately 0.13 inch inboard of the outer diameter chamfer. Detailed views of the separator outer diameter are shown in Figure 38. Detailed views of the separator forward and aft rails are shown in Figure 39. The separator outer diameter exhibited a dark discoloration. Detailed views of the outer ring raceway are shown in Figure 40. Detailed views of the forward inner race are shown in Figure 41. A dark discoloration was observed on the forward portion of the raceway and onto the forward shoulder. Detailed views of the aft inner race are shown in Figure 42.

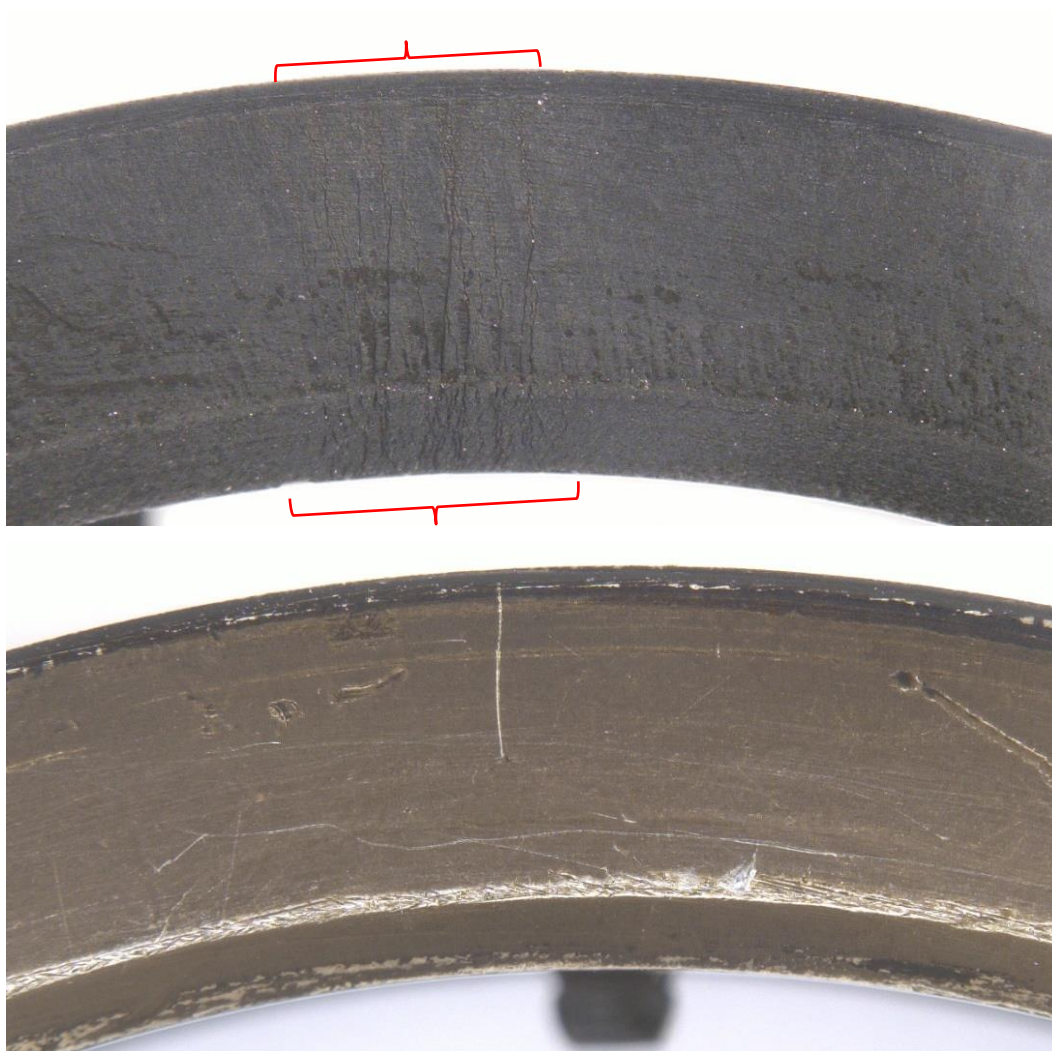
**Figure 39.** Detailed views of the No. 2 bearing separator forward (top) and aft (bottom) rail. The forward rail exhibited a dark discoloration and linear features (red braces).

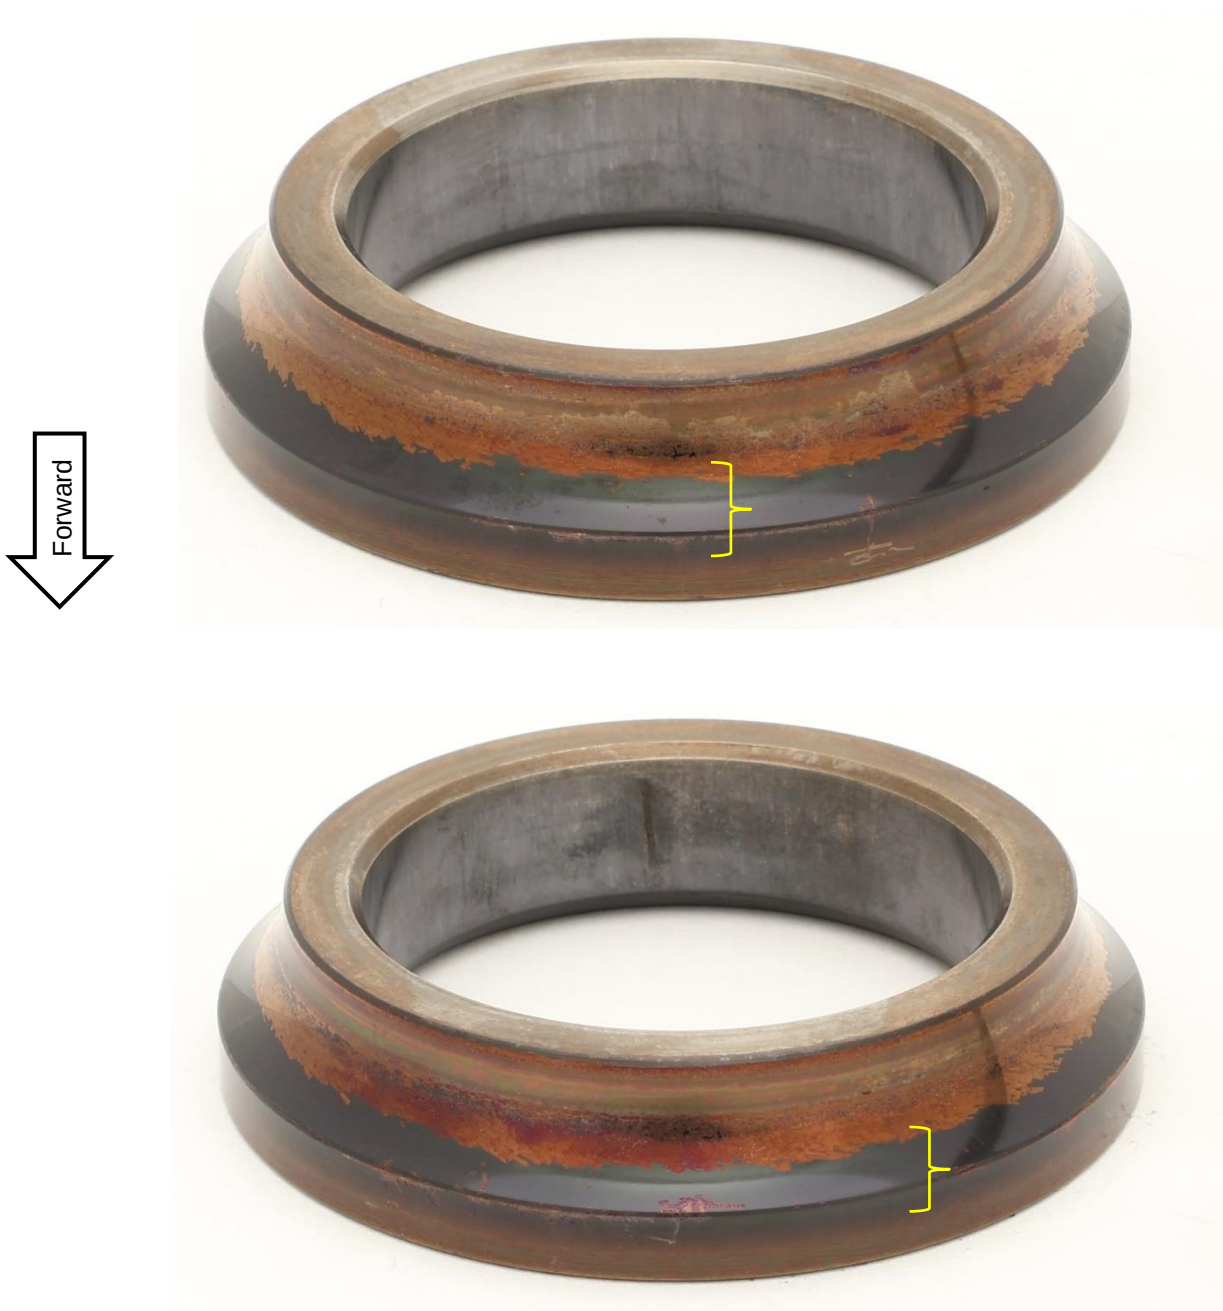
**Figure 41. Detailed views of the No. 2 bearing forward inner race. Each image is rotated approximately 180° from the previous. The forward portion of the raceway and adjacent shoulder exhibited a layer of dark discoloration (yellow braces).**
