| <b>Rolls-Royce</b> | Rolls-Royce Corporation<br>450 S. Meridian Street<br>Indianapolis, Indiana<br>46225-1103, USA | <b>REPORT NO.</b><br>24FAE-061-PR | <b>REV.</b><br>Initial | <b>PAGES</b><br>1 of 54 |
| <b>TITLE</b><br><b>METALLURGICAL INVESTIGATION OF A TURBINE TO COMPRESSOR COUPLING, P/N 23032345, INSTALLED IN AN M250-C30P ENGINE, S/N CAE895785, OPERATED BY HELIWORKS FLIGHT SERVICES</b> | | <b>PREPARED</b><br>Signatures on File | | |

| Part Name: | Turbine to Compressor Coupling |
| Engine Model: | M250-C30P |

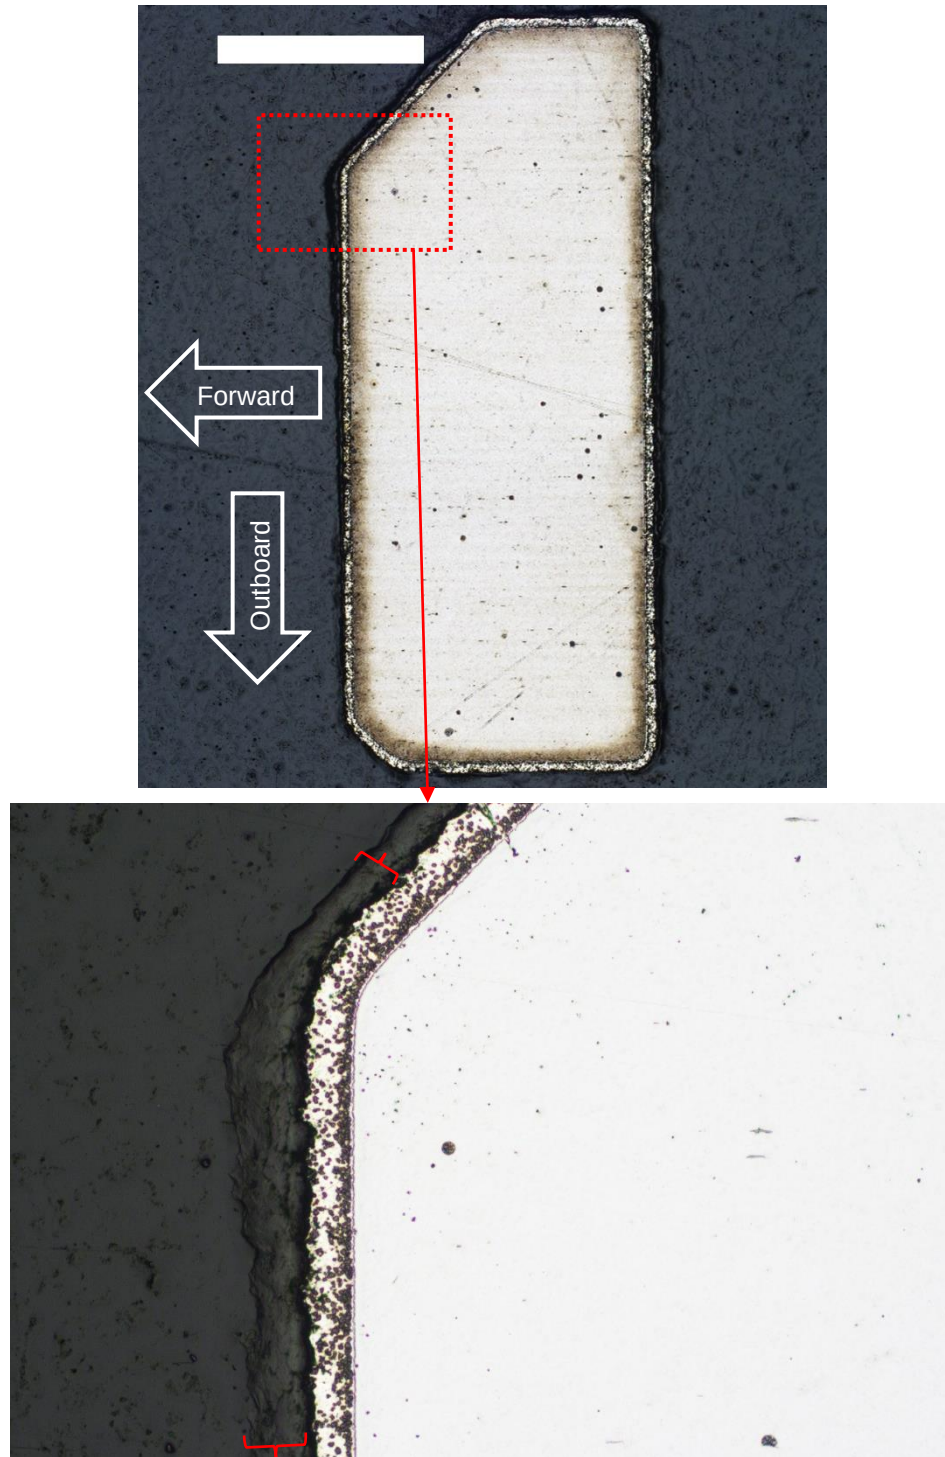
Metallographic cross-sections of the No. 2 bearing separator and outer ring were performed at plane P4 as shown in Figure 37. Metallographic images of the separator forward rail are shown in Figure 43. The forward face and adjacent inboard chamfer exhibited a layer of dark, flaky material consistent with coked oil up to approximately 0.004 inch thick. Metallographic images of the outer ring are shown in Figure 44. The forward face and shoulder exhibited a layer of dark, flaky material consistent with coked oil up to approximately 0.003 inch.

**Figure 43. Montaged (top) and detailed (bottom) micrographs showing cross-section P4 (see Figure 37) through the separator forward rail. A layer of dark, flaky material consistent with coked oil is indicated by the red braces. No evidence of thermal distress was observed.  
Etchant: Top: Nital; Bottom: None.**

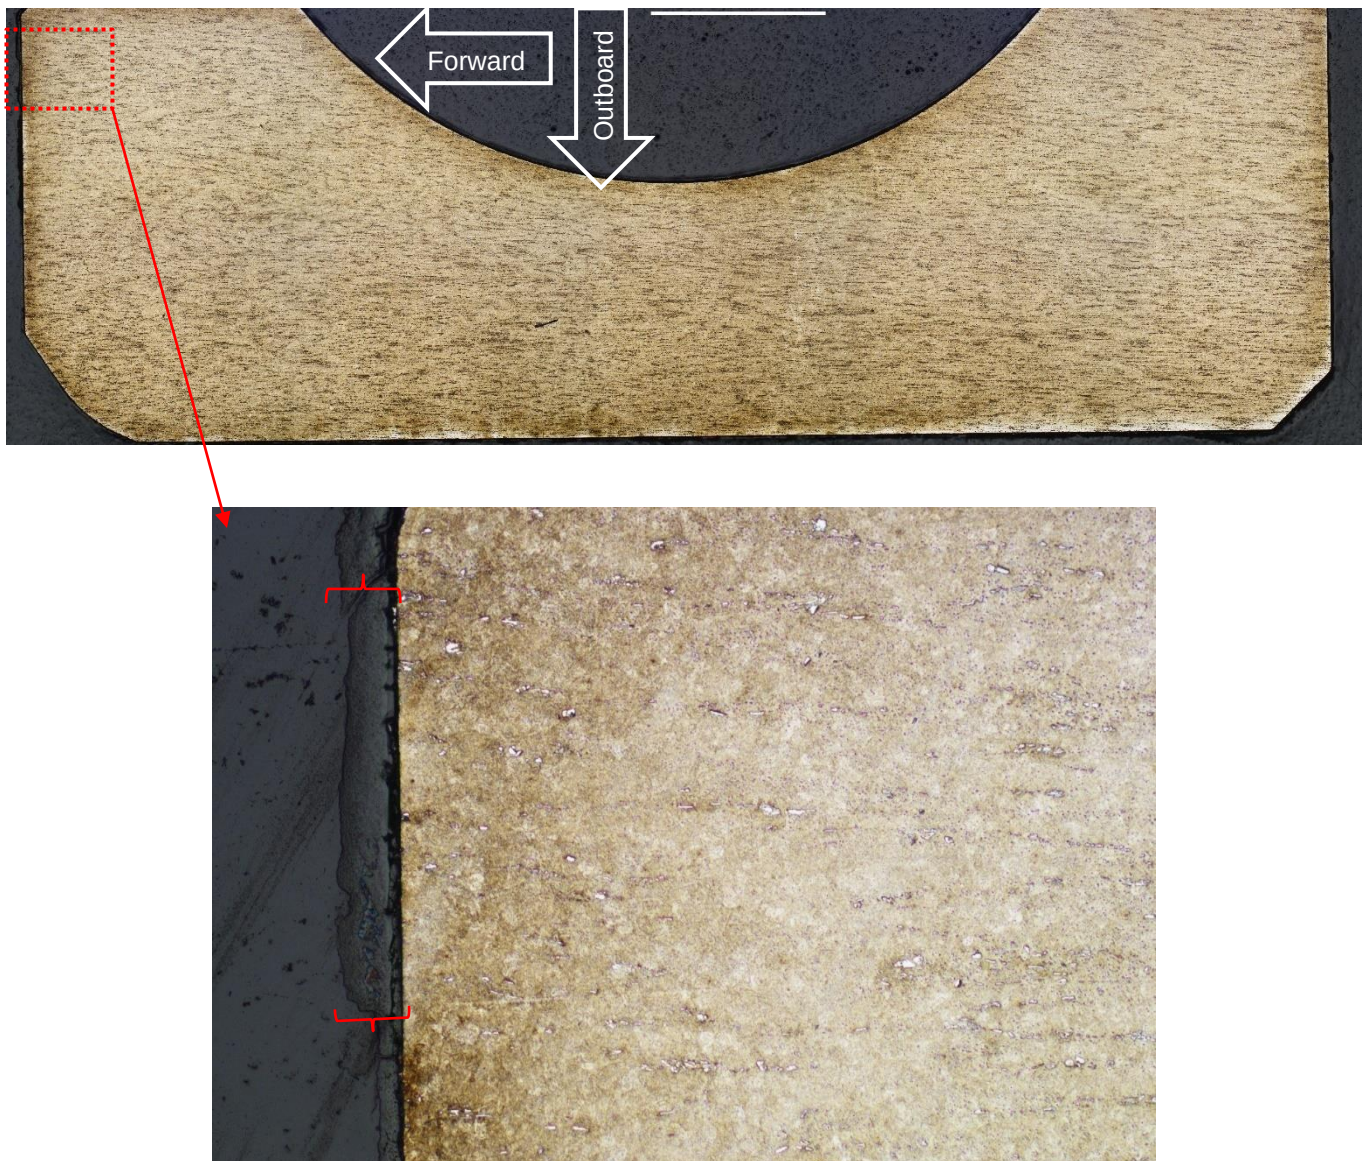
**Figure 44.** Montaged (top) and detailed (bottom) micrographs showing cross-section P4 through the outer ring. A layer of dark, flaky material consistent with coked oil is indicated by the red braces. No evidence of thermal distress was observed. Etchant: Vilellas

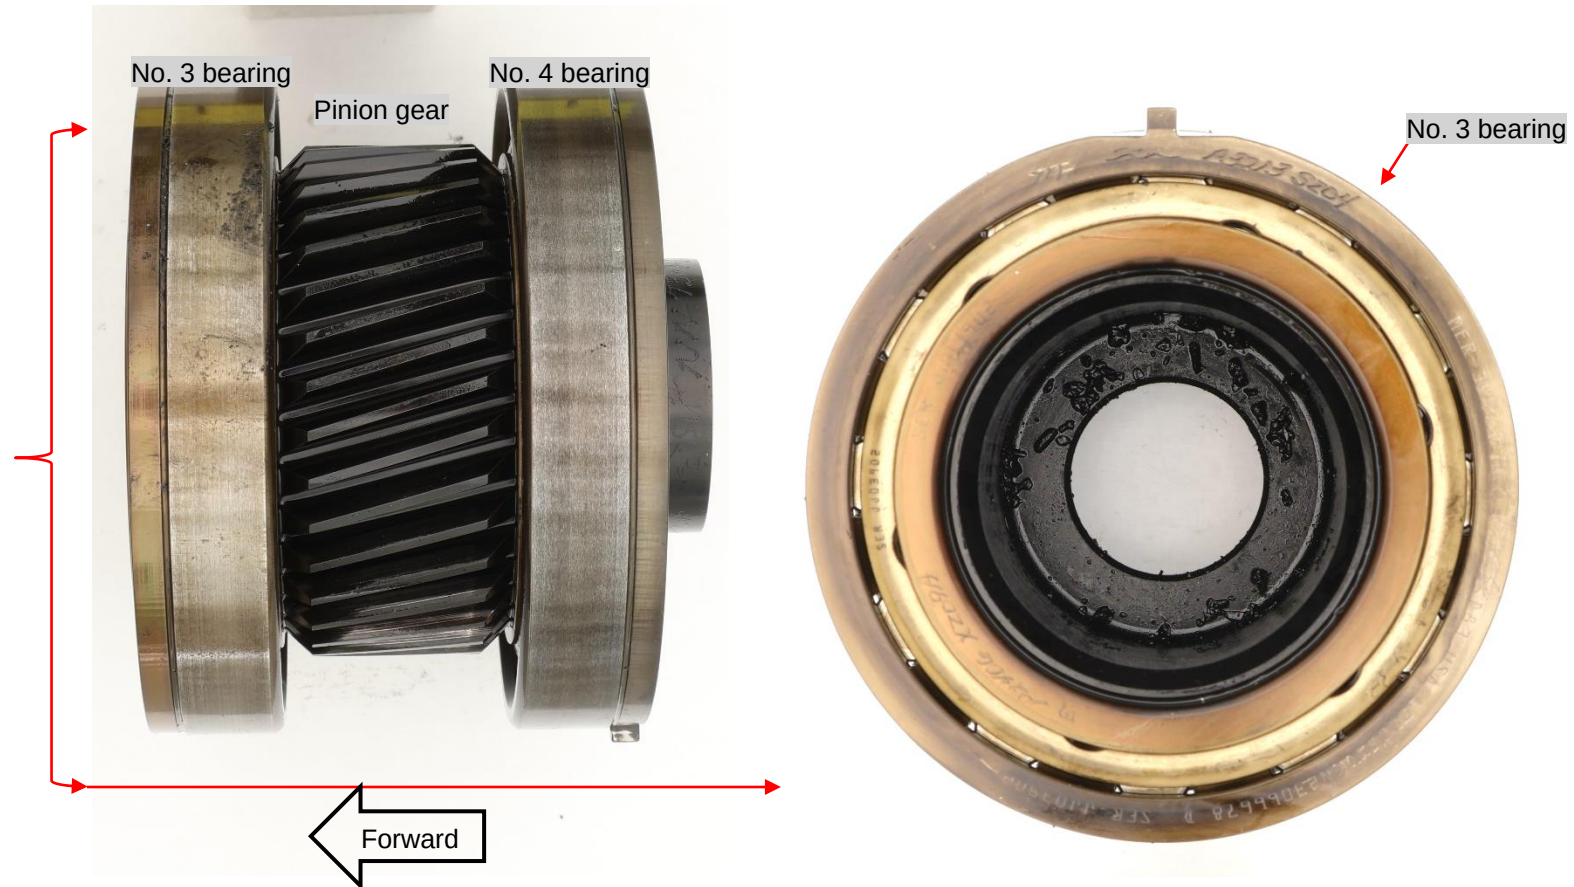
Overall views of the No. 3 bearing, No. 4 bearing, and pinion gear assembly are shown in Figure 45. Dark deposits consistent with coked oil were observed on the internal surfaces of the pinion gear. The No. 3 and No. 4 bearings rotated freely.

**Figure 45. Overall outboard looking inboard (Left) and forward looking aft (right) views of the No. 3 and No. 4 roller bearing and pinion gear assembly. Dark deposits consistent with coked oil were observed on the pinion gear internal surfaces.**

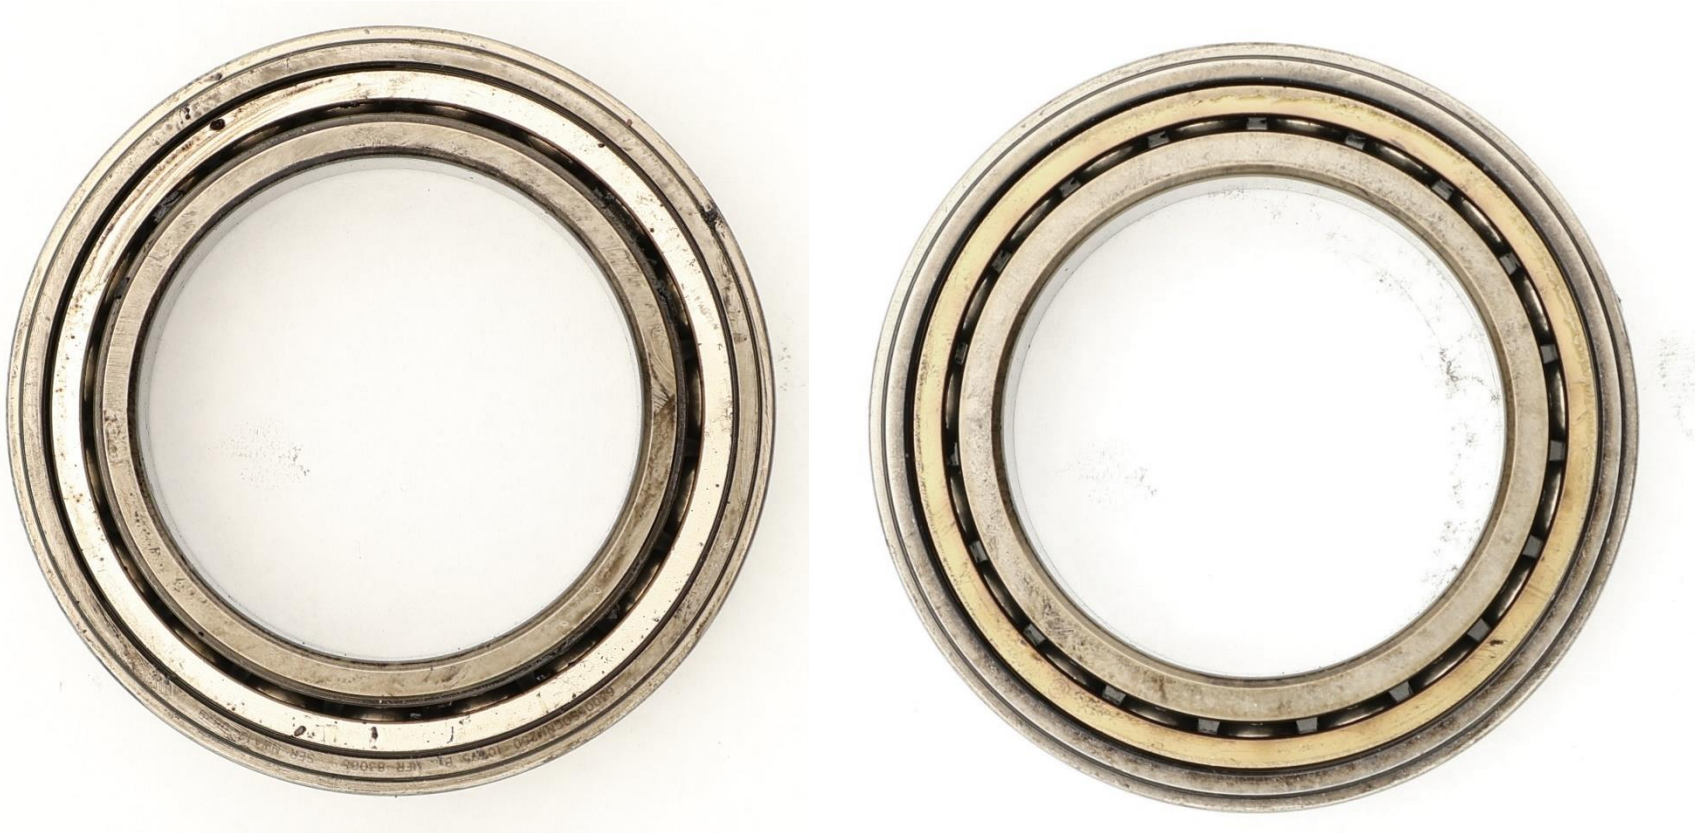
Overall views of the No. 5 bearing are shown in Figure 46 in the as-received condition. Dark deposits consistent with coked oil were observed on the outer race, separator, and in the ball assembly. The No. 5 bearing rotated freely.
