# National Transportation Safety Board

WPR24FA132

## **POWERPLANTS FACTUAL REPORT**

Location: Anaconda, Montana  
Date: April 26, 2024  
Time: 06:59 local time  
Helicopter: Bell B206L-4, Registration Number N988B

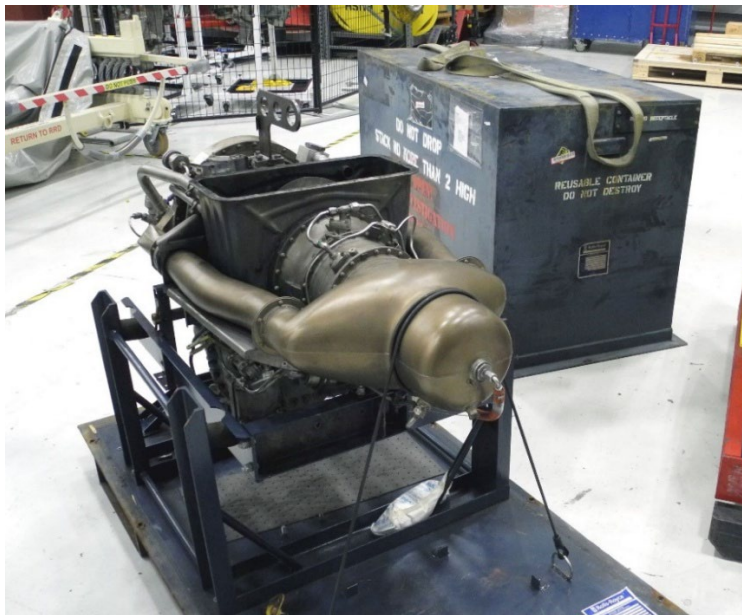
The engine was in a metal shipping container which was opened in the presence of the NTSB (**Photo 1**). It was externally clean and intact (**Photo 2**). There was no evidence of an un-containment or external impact or fire.

**Photo 1** - RR M250-C30P S/N CAE-895742 - As Received

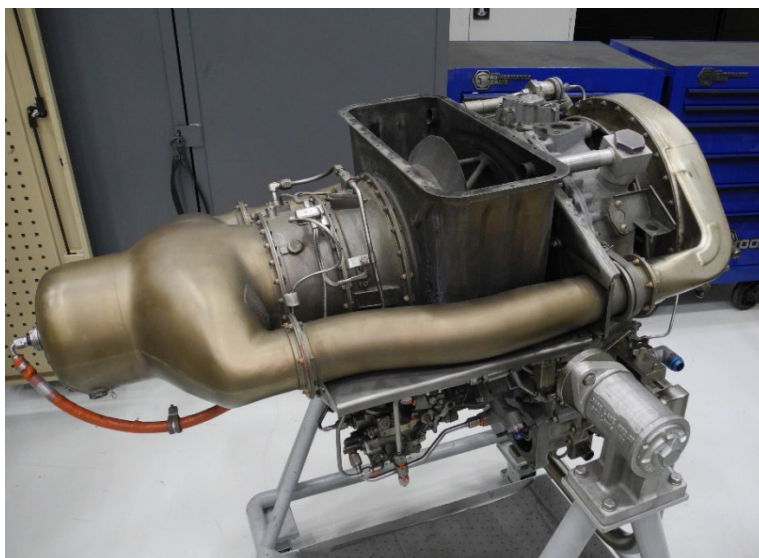
**Photo 2** - Externally Generally Clean and Intact

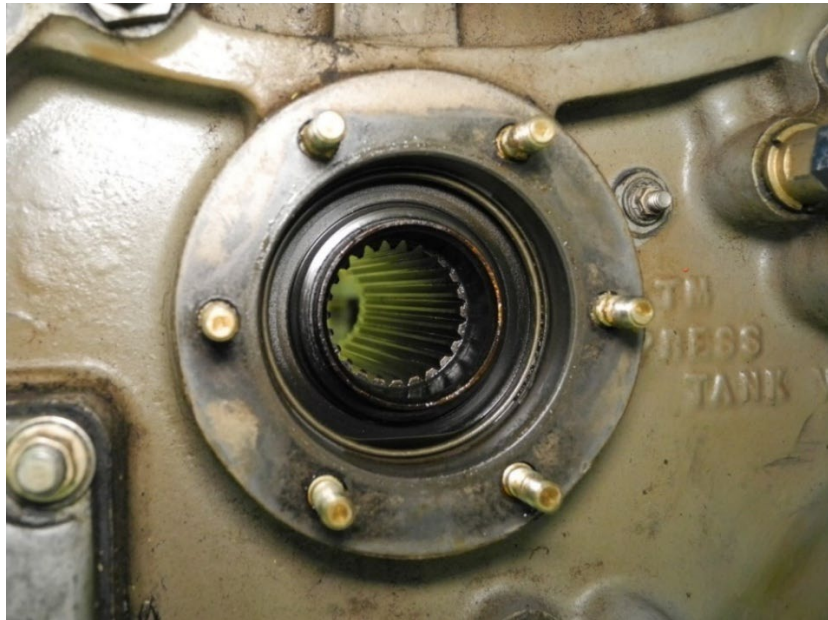
The power takeoff (PTO) spline of the AGB (**Photo 3**) and starter/generator inner spline were intact and undamaged.

**Photo 3** - AGB Power Takeoff (PTO) Spline - Undamaged

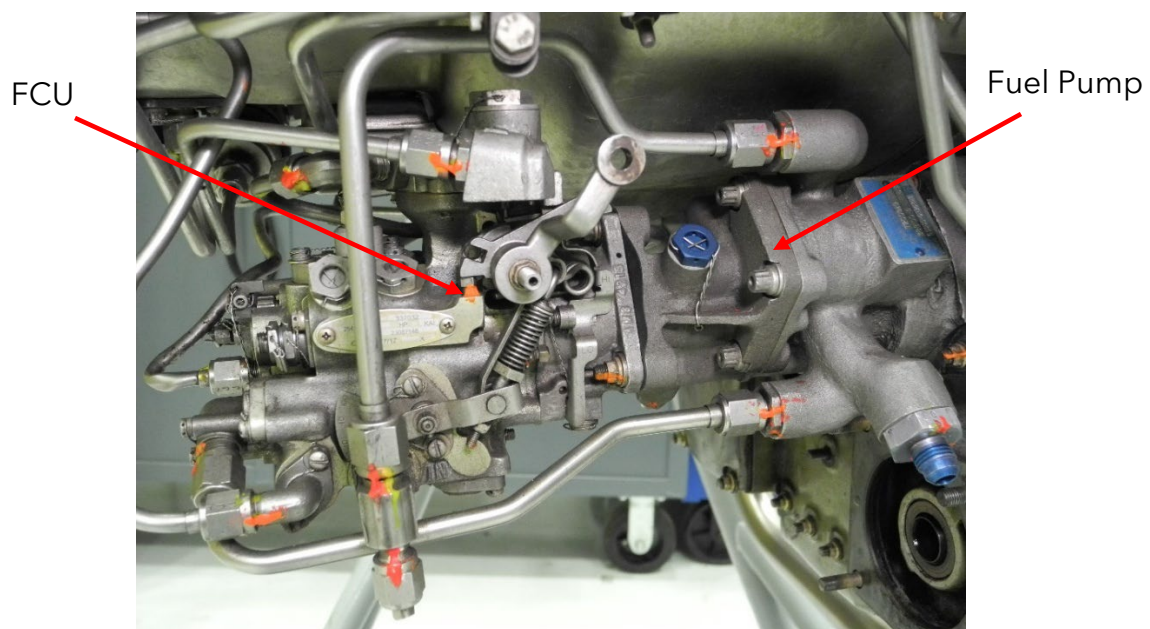
**Photo 4** - FCU/Fuel Pump Assembly - Undamaged

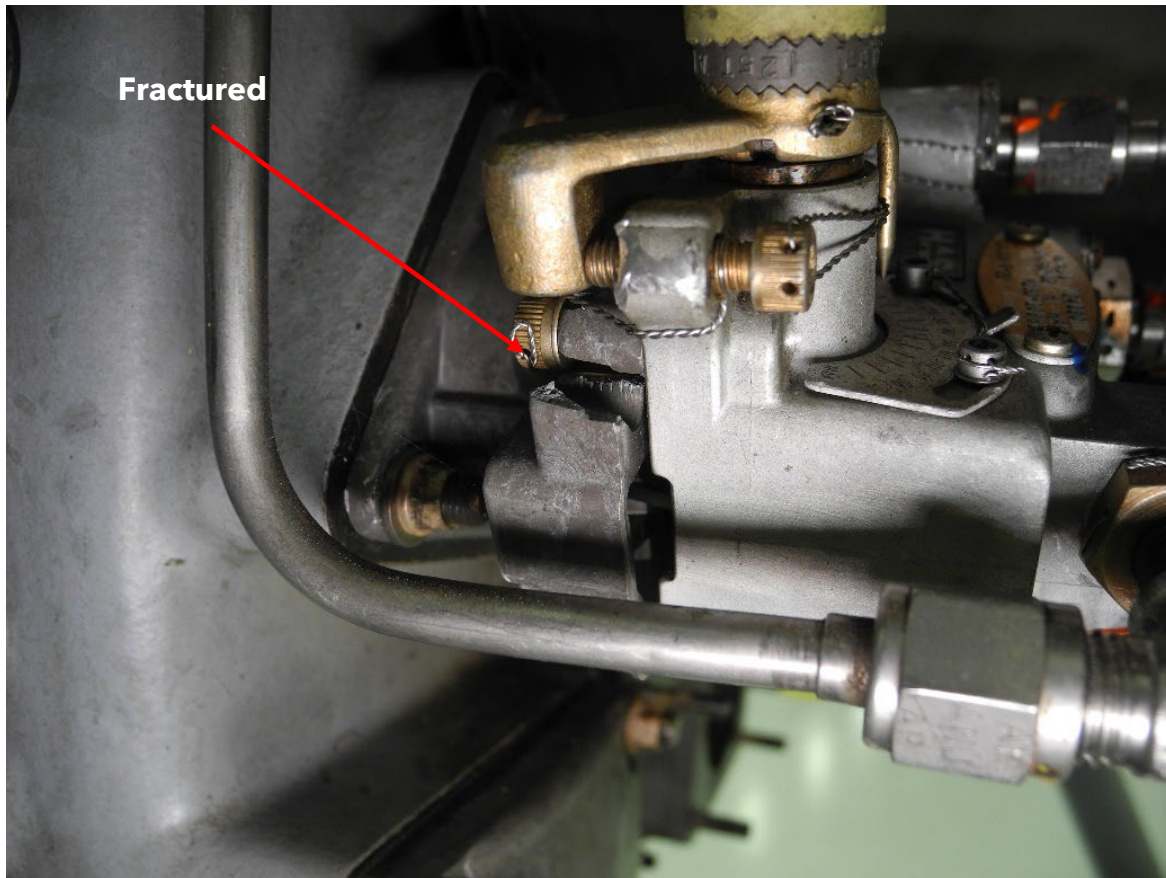
The FCU/fuel pump assembly (**Photo 4**) was intact, undamaged, and secured to the AGB. The power turbine governor (PTG) housing was fractured at the assembly split line, exposing the internal components; however, its mount flange was still attached to the AGB (**Photo 5**).

**Photo 5** - PTG - Fractured Housing

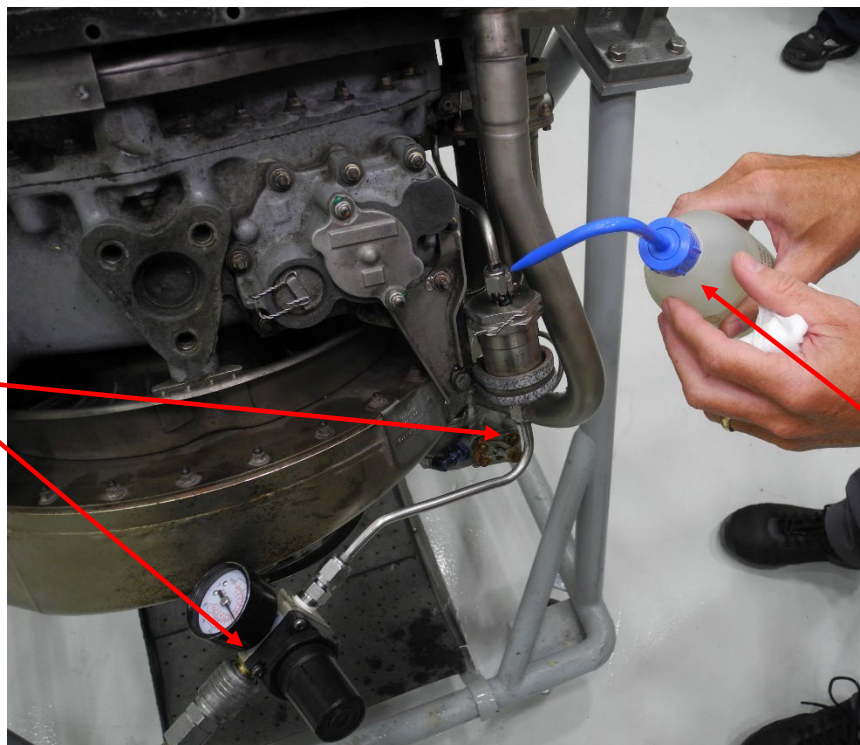
All the Pc<sup>3</sup> tubes between the Pc filter, PTG, and FCU and the were intact; however, some tubes were deformed, consistent with impact. The Pc system tubes and fittings were tested for integrity and leaks by introducing an 80 pounds per square inch (psi) air source into the Pc filter and spraying a special leak detector fluid on all the tubes and fittings (**Photo 6**) and observing for the presence of air bubbles. No leaks were found.

**Photo 6** - Pc Leak Test Being Performed

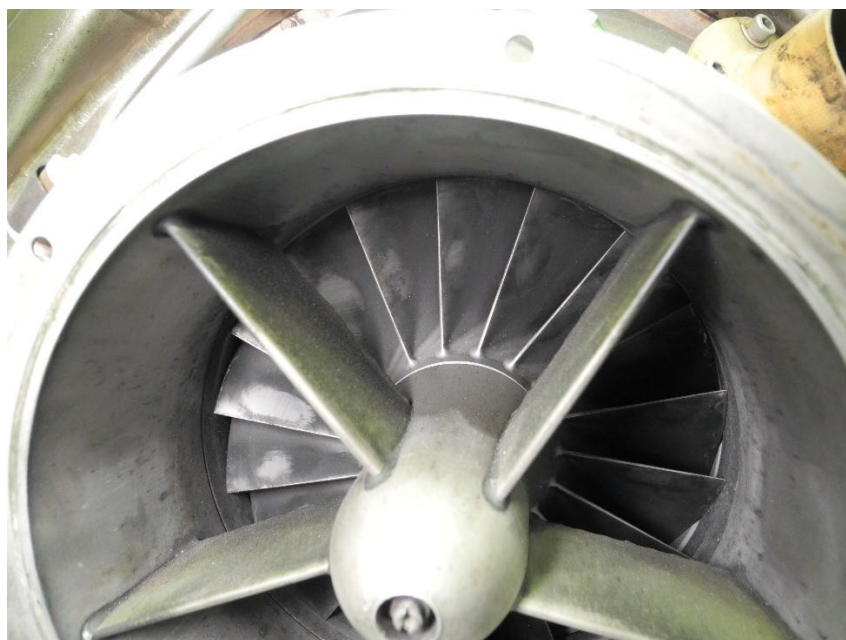
The inlet was free of debris and the leading edges of the impeller vanes (**Photo 7**) were undamaged.

**Photo 7** - Impeller - Undamaged

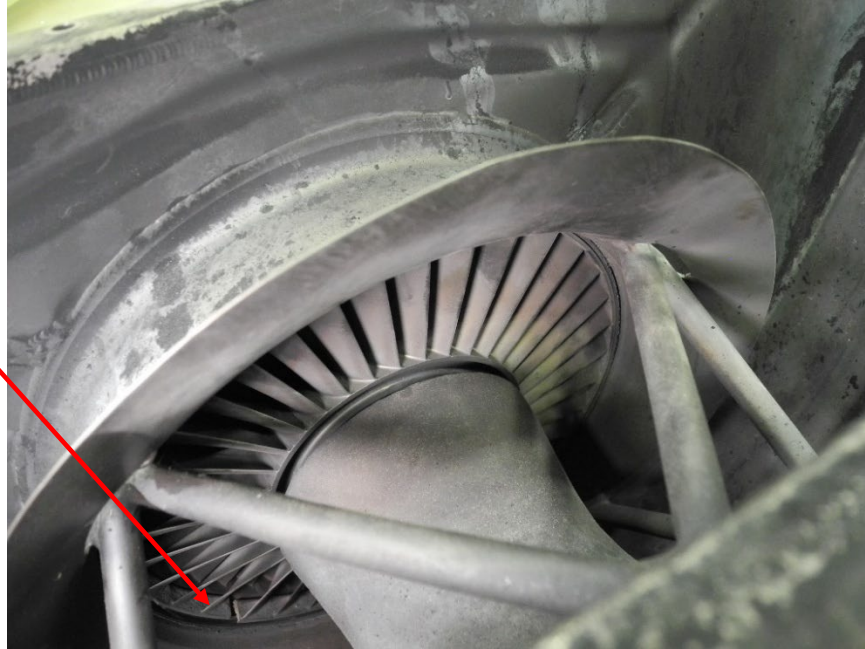
The exhaust collector was intact. All the blades of the 4<sup>th</sup> stage turbine wheel (2<sup>nd</sup> stage power turbine) were intact (**Photo 8**); however, most of the blade shrouds were rotationally scored, consistent with contact against 4<sup>th</sup> stage wheel seal. The outer rim was fractured in one location.

Outer  
Shroud  
Fractured  
in One  
Location

**Photo 8** - 4<sup>th</sup> Stage Turbine Wheel

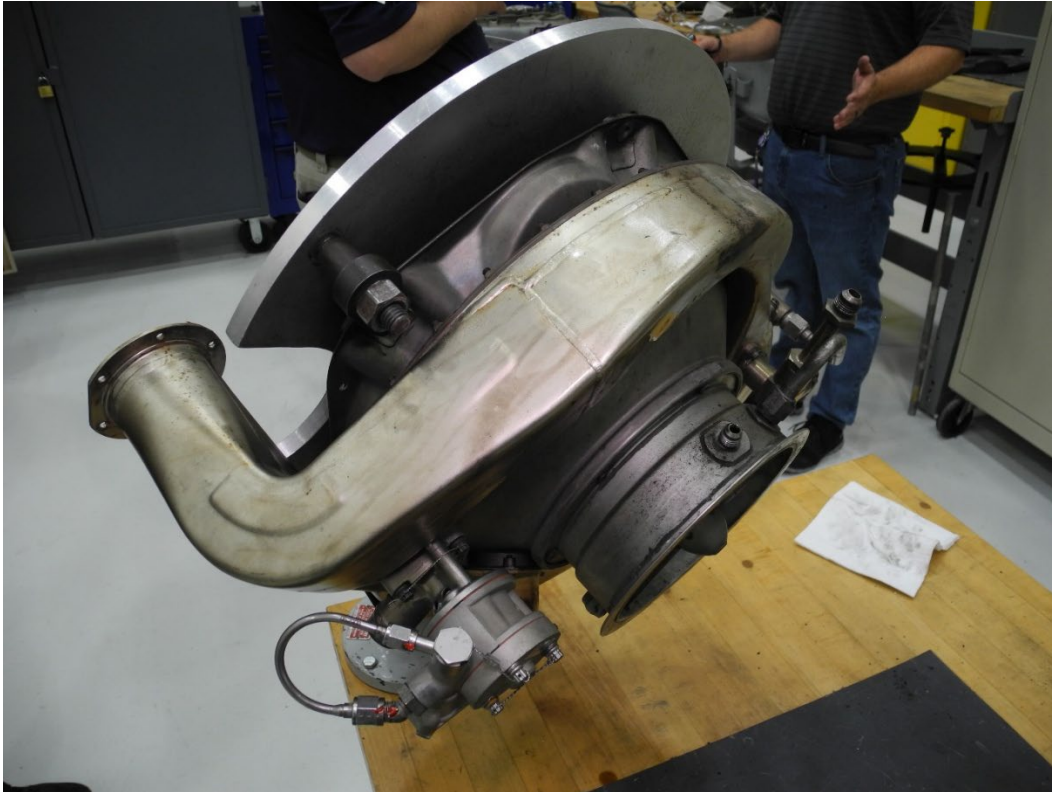
The compressor module (**Photo 9**) was intact and undamaged and the compressor impeller turned freely and smoothly, consistent with the No. 1 and No. 2 bearings being undamaged so the assembly was not further disassembled.

**Photo 9** - Compressor Module - Undamaged

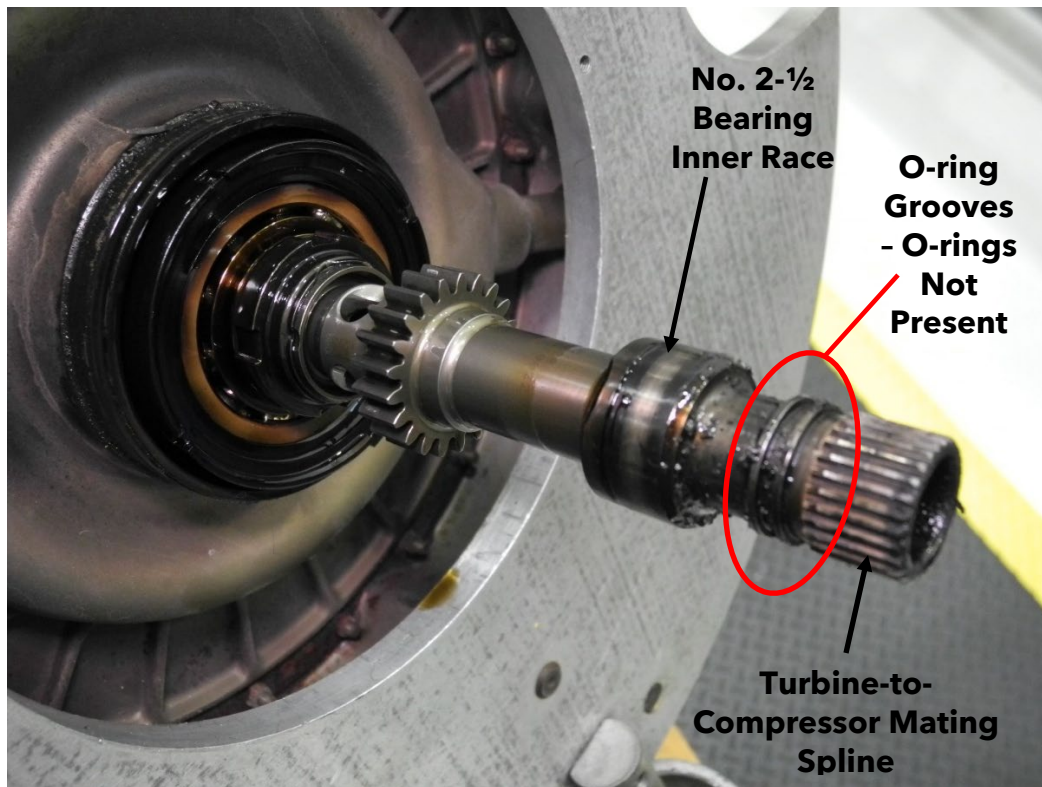
The spur adapter gearshaft (SAG) (**Photo 10**) was intact and undamaged. The No. 2-½ bearing inner race land of the SAG was intact and displayed minor witness marks, consistent with normal operation. The turbine-to-compressor coupling mating spline on the SAG was intact. The two O-ring grooves were undamaged; however, no visible evidence of either O-ring was found in the grooves (**Photo 11**). Small black granular particles were found still adhering to the SAG.

**Photo 10** - Spur Adapter Gearshaft (SAG) - No O-rings Present

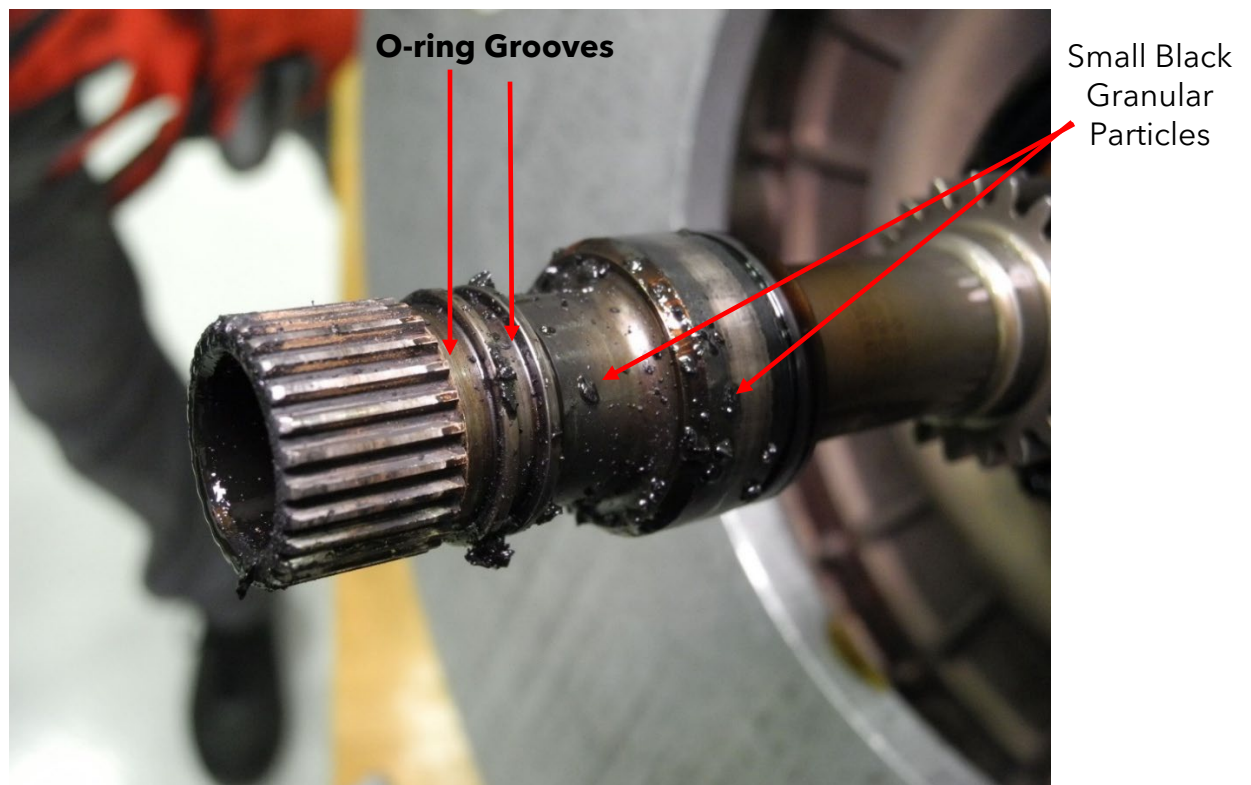
**Photo 11** - SAG - Detail of O-ring Grooves - No O-rings Present

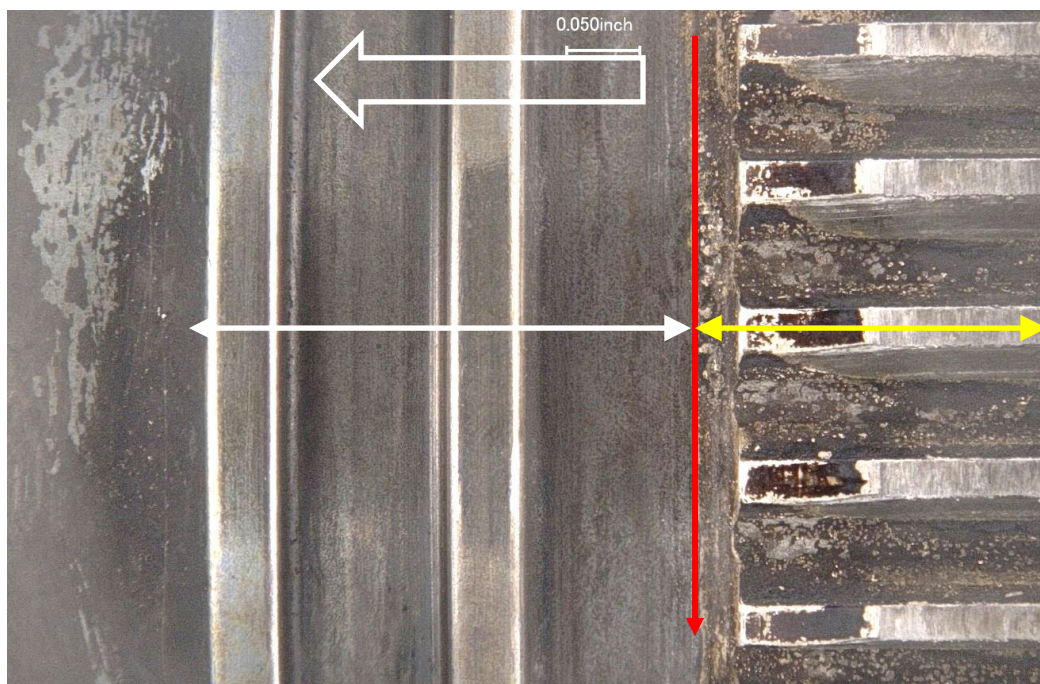
The SAG was sent to the RR materials laboratory which performed a microscopic examination of the O-ring grooves as well as a Fourier Transform Infrared Spectroscopy (FTIR) analysis of the black granular particles that were found adhered to the SAG (**Photo 12**). The findings were:

- 1) The axial span of deposited coked oil is indicated by the yellow dimension and was observed in the turbine-to-compressor spline roots, tooth tips, and just forward into the O-ring groove.
- 2) No evidence of coked oil was observed in the forward O-ring groove is indicated by the white dimension.
- 3) The FTIR analysis of the black granular particles collected from the SAG sleeve revealed minor fluorocarbon rubber signatures consistent with O-ring material.

This FTIR analysis and laboratory microscopic findings indicate that at least one O-ring was installed in a groove during the last assembly; however, it had completely disintegrated and no longer in the groove. According to RR technical representatives, the complete disintegration of an O-ring, leaving no remaining material within the grooves, has not previously been observed.

**Photo 12** - Detailed view of the SAG O-ring Grooves and Turbine-to-Compressor Mating Spline - Image Taken After Cleaning - Courtesy RR

According to RR, there have been two failures of C30 model engines that were attributed to damaged or missing SAG O-rings. Because the previous engine failures occurred at less than 700 hours without the SAG O-rings being present, the question of when they escaped the O-ring grooves in this event was considered.

If the O-rings had disintegrated at some time before the turbine-to-compressor coupling failure, then the black granular particles that were found adhering to the SAG would have been centrifuged off the shaft because of the high rotational speed of the SAG during normal operation. It is therefore likely that the O-rings were still in the grooves at the time of the engine failure and that they were extruded due to the whirling of the non-parallel shafts after the turbine-to-compressor coupling failure.

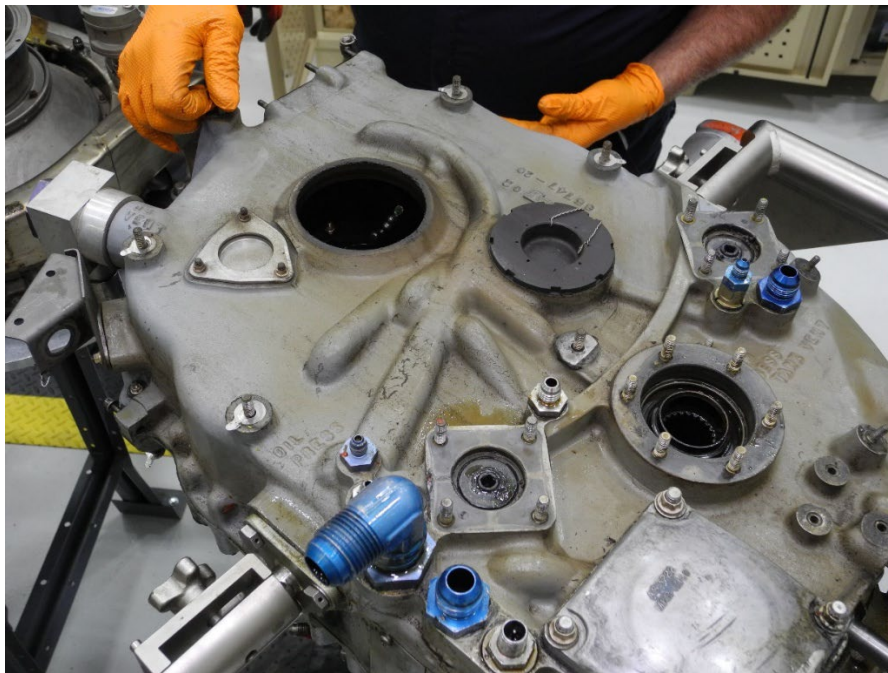
The AGB was externally intact and undamaged (**Photo 13**). The internal components were oil wetted and rotated normally.

**Photo 13** - AGB - Undamaged

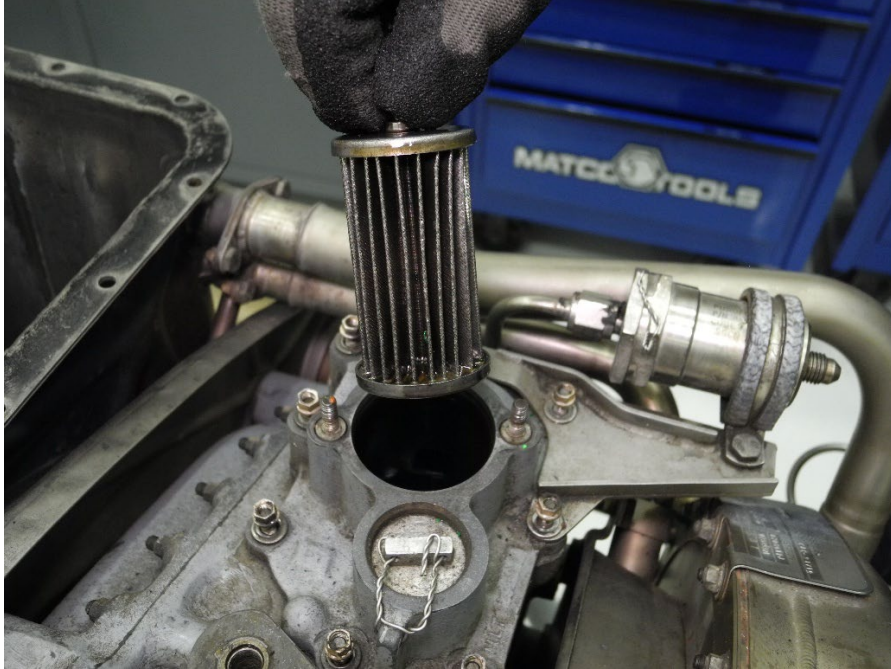
The oil filter was removed and found to be clear of debris, oil wetted; however, carbon or coke stained (**Photo 14**).

**Photo 14** - Engine Oil Filter - Clean

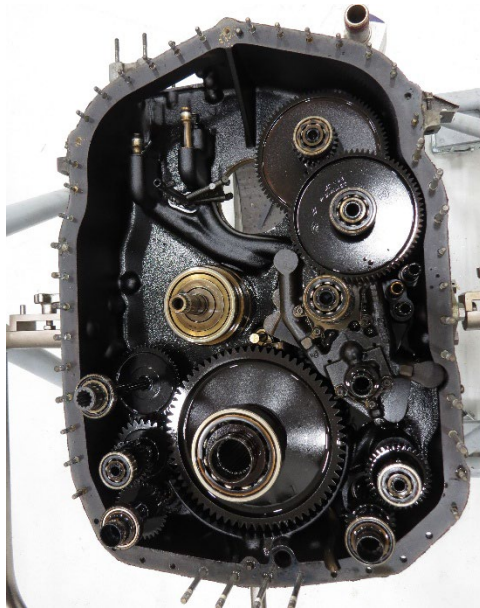
The pressure oil filter housing was removed from the gearbox to visually assess the oil delivery (piccolo) tube and surrounding gear components. The engine gearbox was opened to facilitate inspection of the internal components, gears, bearings, torquemeter, & oil pump (**Photo 15**). All the components were in position and visually free of abnormal wear indications.

**Photo 15** - Gearbox - Opened to Inspect Internal Components

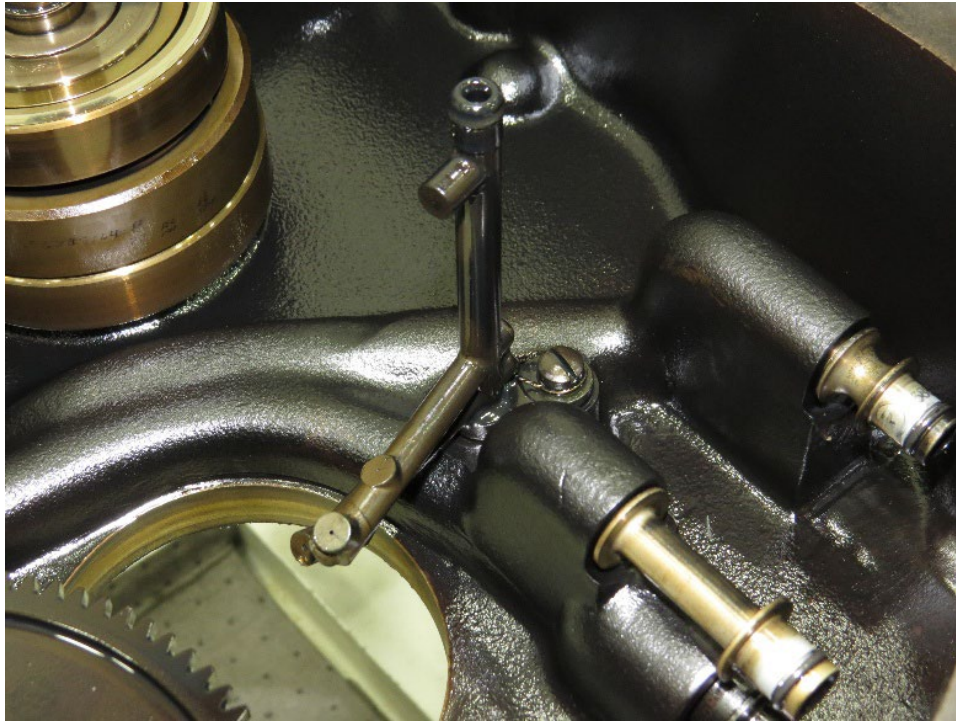
The piccolo tube ([See Figure 3](#)) was installed correctly in the AGB ([Photo 16](#)) and the nozzles were externally clean. The piccolo tube features an inlet screen and five nozzles which direct oil to (1) No.2 bearing, (2) 1<sup>st</sup> stage N2 reduction gears (3) No. 3 bearing, (4) SAG holes which lubricate the turbine to compressor coupling splines and (5) No. 2-½ bearing.

**Photo 16** - Piccolo Tube - Installed Correctly

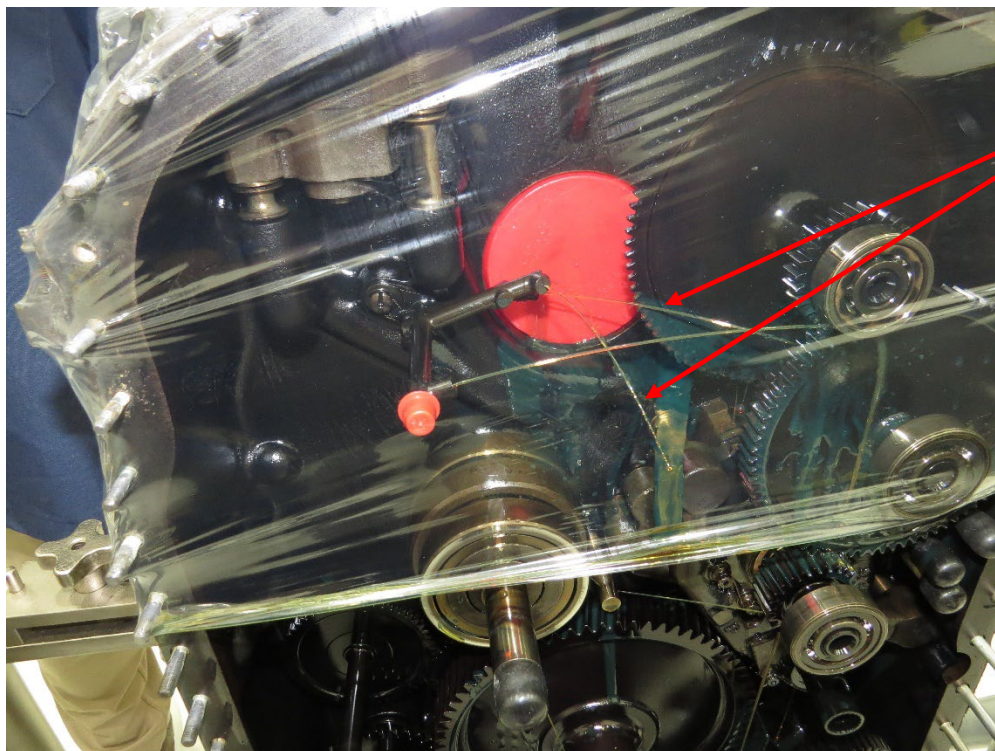
To test the flow from the piccolo tube oil jets, the gearbox housing was mounted in the engine stand and positioned vertically in the engine's normal operating configuration. The oil pump was rotated with an electric motor, and an oil supply was connected to the pump inlet ([Photo 17](#)). Oil flow through all oil supply and scavenge fittings on the gearbox that go to and from the compressor and turbine bearings were confirmed. Oil flowed through only three jets on the piccolo tube, with the oil streams aimed at the No. 3 bearing blocked ([Photo 18](#)).

**Photo 17** - Oil Distribution Flow Check

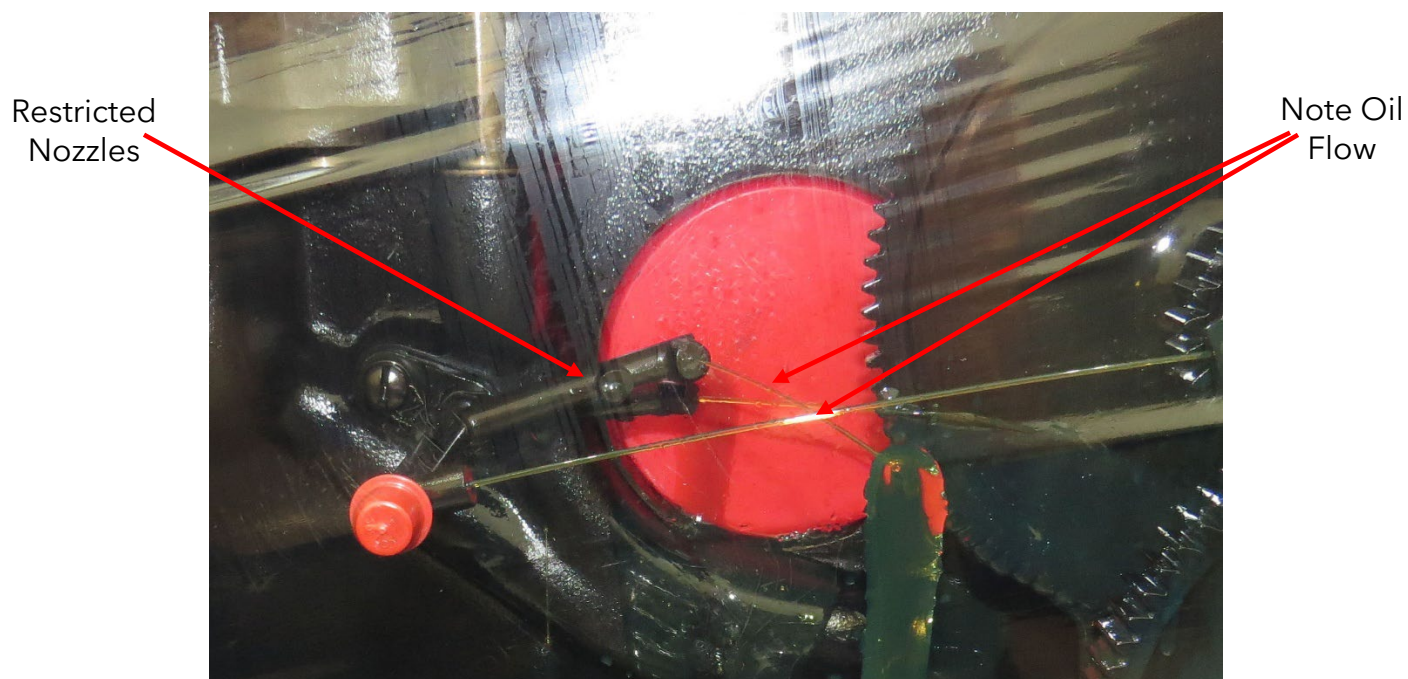
**Photo 18** - Piccolo Tube - Nozzle Restrictions

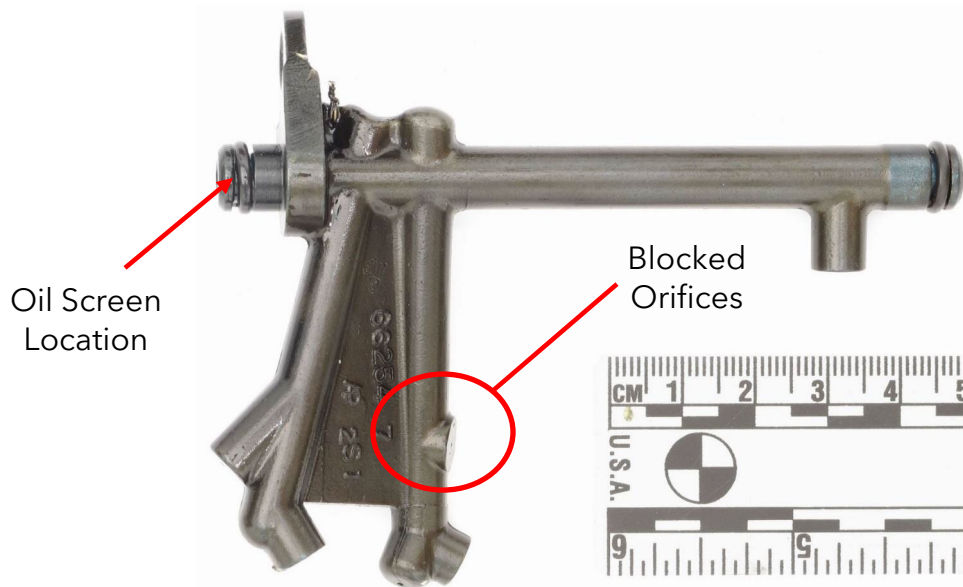
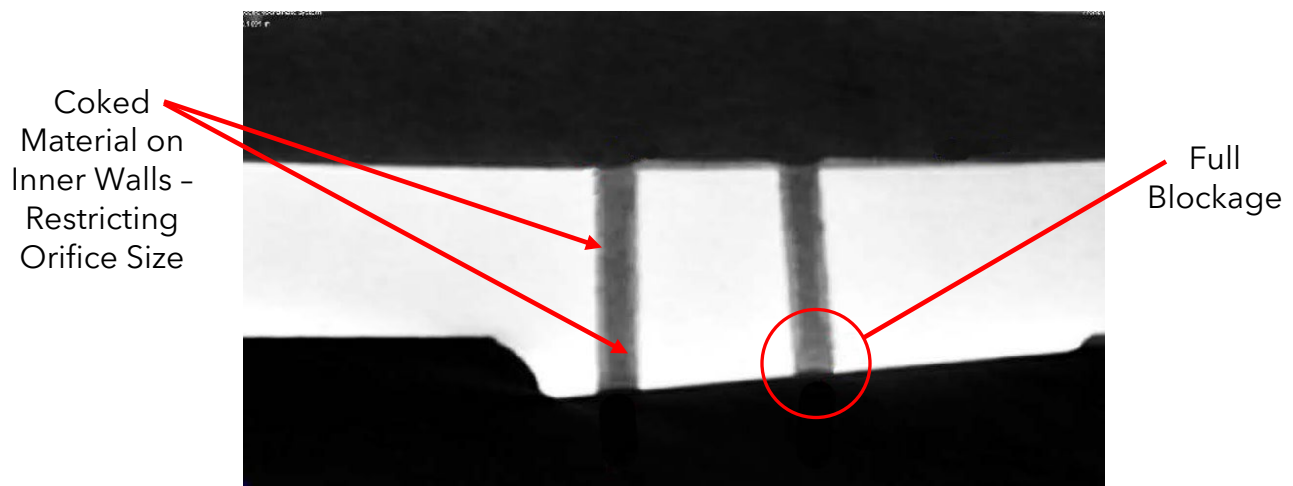
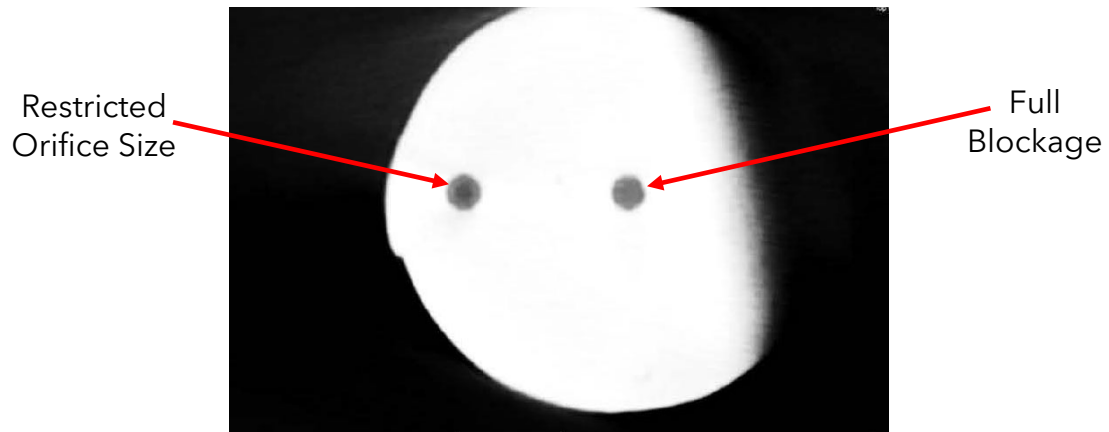
The piccolo tube was therefore sent to the RR materials laboratory where a computer tomography (CT) scan of the part was made, revealing restricted orifices and a fully blocked No. 3 bearing oil jet (**Photo 19**, **Photo 20** and **Photo 21**).

**Photo 20** -Restricted Oil Jet Orifices in Piccolo Tube - Side View - Courtesy RR

**Photo 21** - Restricted Oil Jet Orifices in Piccolo Tube - Direct View - Courtesy RR

It is possible that the reduced oil flow from the piccolo tube screen and the nozzles reduced the cooling effect in the shafting and resulting in the carbon or coke buildup between the shafts.

The PT pressure oil nozzle flow check does not give any indication of the condition of the other areas of the oil system, such as the piccolo tube. There is no procedure available for testing the condition of the piccolo tube oil supply to the SAG and shafting.

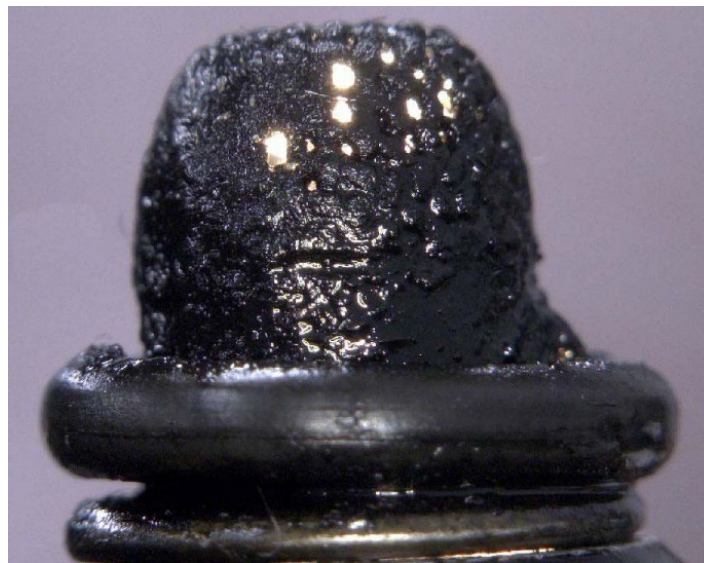
The oil screen at the piccolo inlet was removed and examined, revealing oily coke deposits that covered much of the surface (**Photo 23**). Although oil test confirmed that some oil flowed through the piccolo tube oil screen, the amount of restriction it presented to the oil flow could not be determined.

**Photo 22** - Piccolo Tube Oil Screen - Courtesy RR

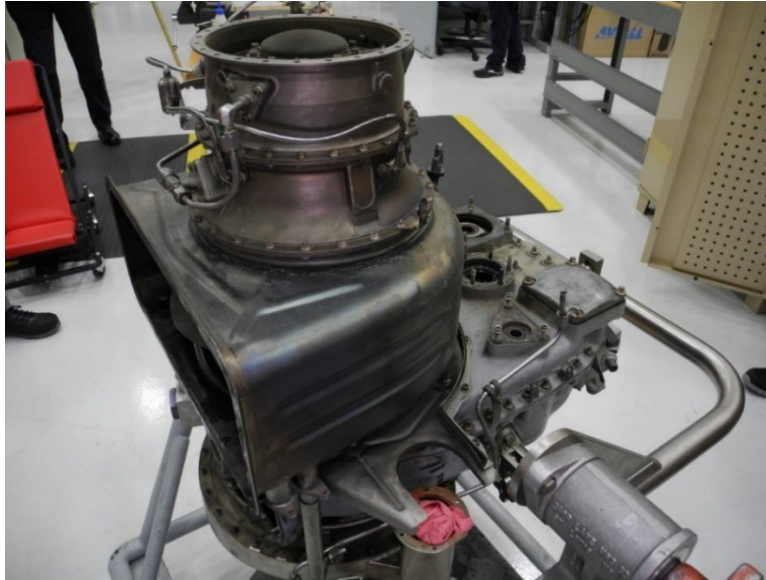
The exhaust collector support housing was intact and undamaged (**Photo 20**).

**Photo 23** - Exhaust Collector Support Housing - Intact

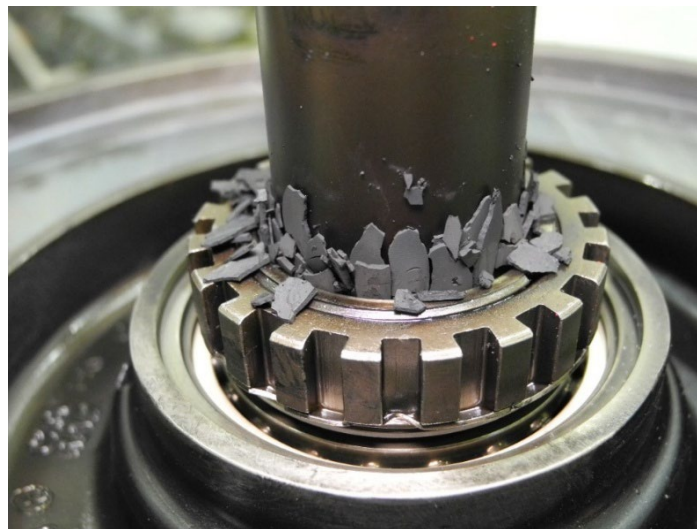
When AGB module was being separated from the exhaust collector support housing, the PT-to-pinion gear coupling remained attached to the PT outer shaft. As it was being separated from the PT outer shaft, a large amount of carbon deposits was drawn out of the mating spline (**Photo 21** & **Photo 22**).

**Photo 24** - PT-To-Pinion Gear Coupling - Note Grey Coke Flakes

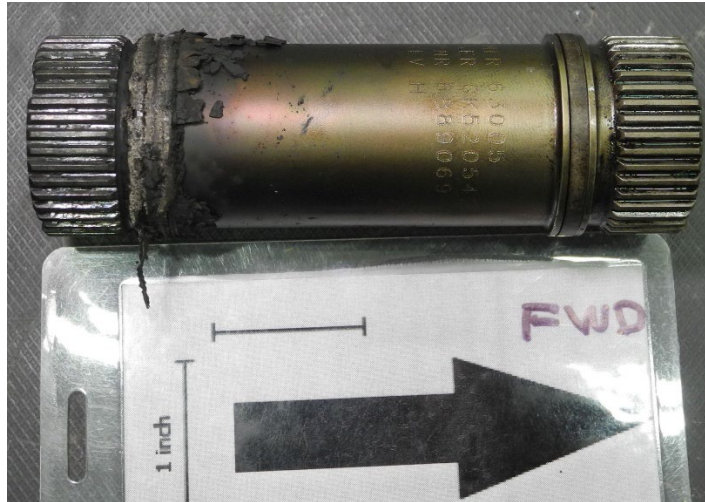
**Photo 25** - PT-To-Pinion Gear Coupling - Note Thermal Distress

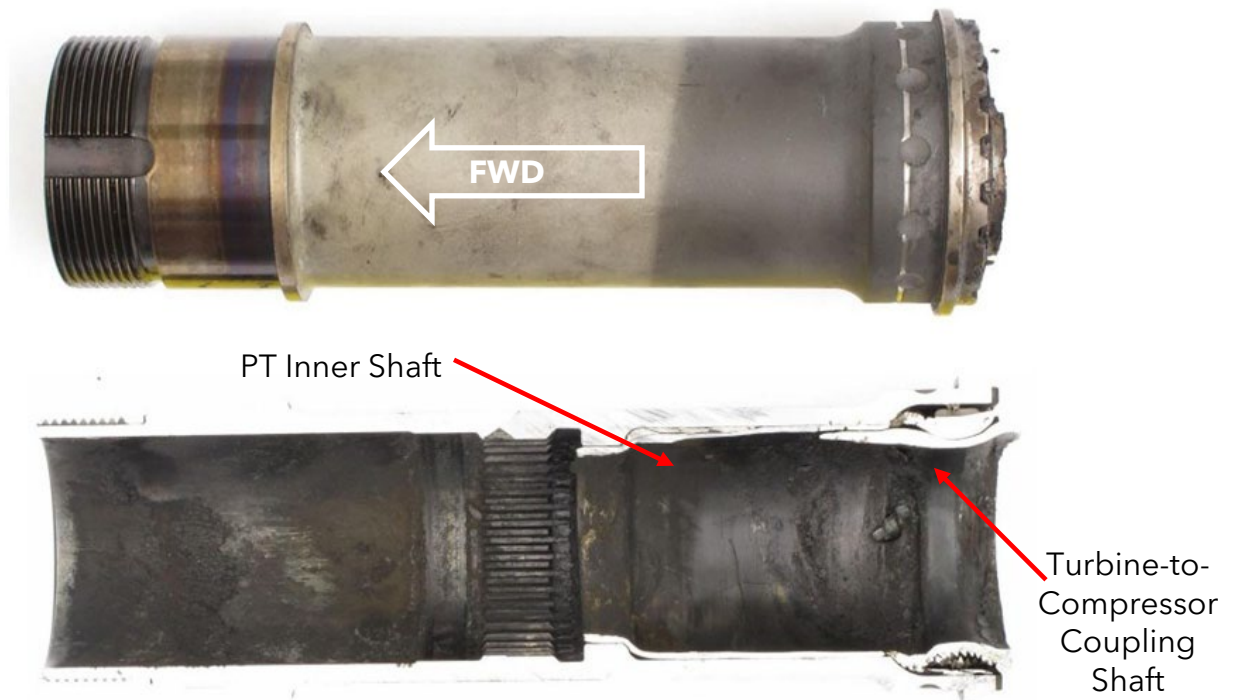
The PT outer shaft could not be withdrawn from the assembly using normal procedures and was separated from the assembly in the RR materials lab.

The PT outer shaft was sectioned (**Photo 23**), revealing fractured and deformed material from the PT inner shaft, PT inner coupling nut, and turbine-to-compressor coupling on the inner diameter. Coke was present in the turbine-to-compressor coupling, PT inner shaft, PT outer shaft, spur adapter gearshaft, power turbine-to-pinion gear coupling, 4<sup>th</sup> stage turbine wheel, 3<sup>rd</sup> stage turbine wheel, turbine spline adapter, and No. 6 bearing.

**Photo 26** - PT Outer Shaft (Top) and Sectioned (Bottom) - Courtesy RR

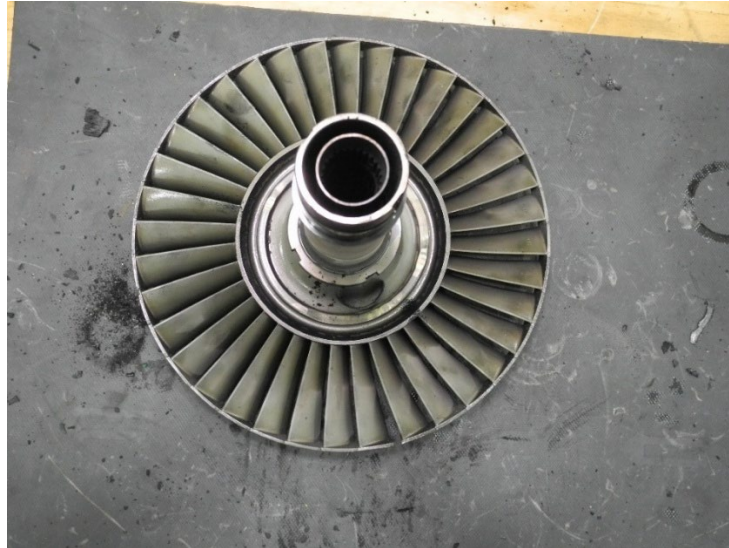
The 4<sup>th</sup> stage turbine wheel (2<sup>nd</sup> stage PT) (**Photo 24**) was intact; however, all the blade shrouds were rotationally scored, consistent with contact against the 4<sup>th</sup> stage wheel shroud. The rim was fractured in one location. The curvic coupling was rotationally sheared and smeared, consistent with rotation against the 3<sup>rd</sup> stage wheel curvic coupling.

**Photo 27** - 4<sup>th</sup> Stage Turbine Wheel - Intact

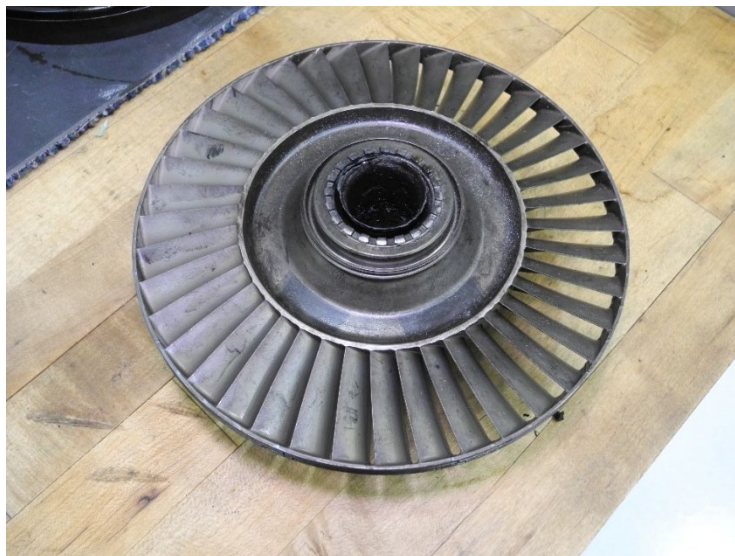
The 3<sup>rd</sup> stage turbine wheel (1<sup>st</sup> stage PT) (**Photo 25**) was intact, however, the leading-edge platforms of the blades were rotationally scored. The aft end of the fractured PT inner shaft was seized in the bore. The rotating labyrinth seal could not be removed. The curvic coupling was rotationally sheared and smeared (**Photo 26**), consistent with contact against the 4<sup>th</sup> stage wheel curvic coupling. The No. 6 bearing was undamaged.

**Photo 28** - 3<sup>rd</sup> Stage Turbine Wheel

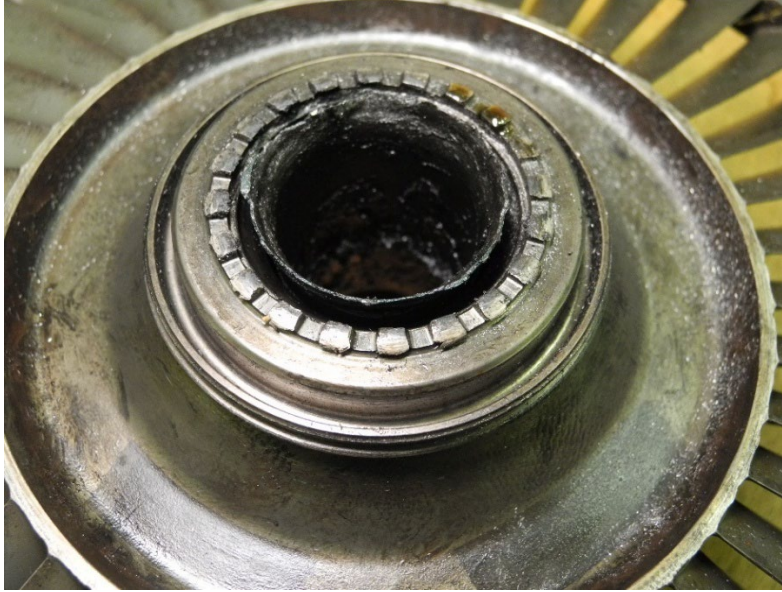
**Photo 29** - 3<sup>rd</sup> Stage Turbine Wheel Curvic Coupling - Rotationally Smeared

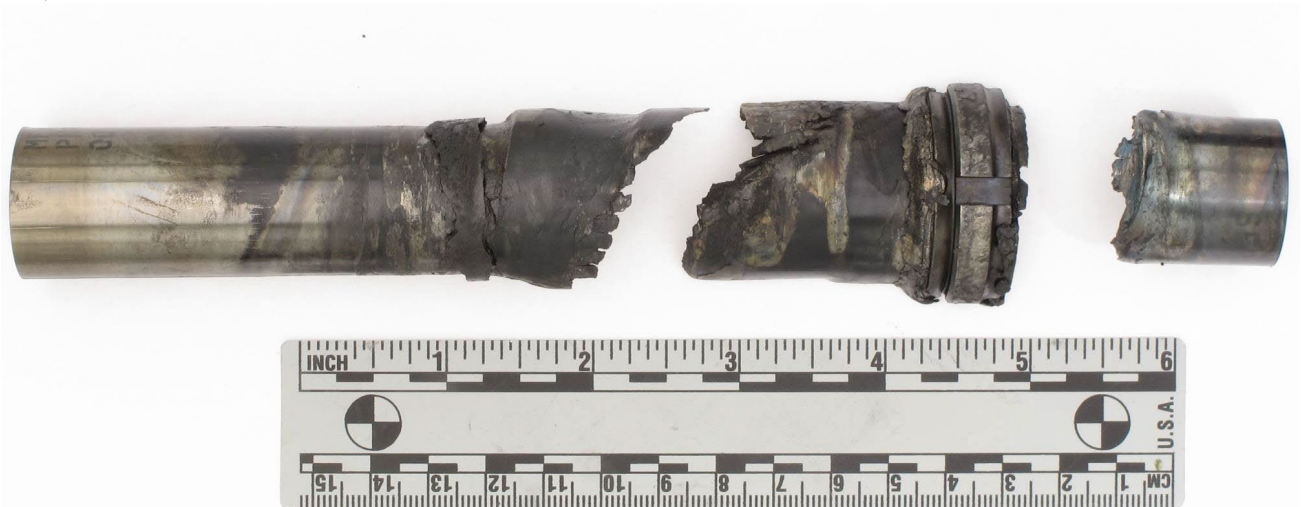
The turbine-to-compressor coupling shaft ([See Figure 2](#)) was deformed, twisted, and fractured in three locations ([Photo 27](#)). One of the three fragments was lodged in the 4<sup>th</sup> stage PT wheel ([Photo 28](#)), the second was deformed over the end of the tie bolt ([Photo 29](#)), and the third, was seized in the PT outer shaft ([See Photo 23](#)).

**Photo 30** - Turbine-to-Compressor Coupling Shaft - Fractured - Courtesy RR

The phenomenon of carbon build-up (coking) between the turbine-to-compressor coupling and turbine inner shaft (Refer to **Figure 2** and **Figure 3**) is due

to shaft temperatures higher than the carboning or coking limits of the oil. Generally, the two conditions leading to excessive temperatures in the shafting area are higher cavity temperatures or reduced oil flow through the shafting. The interference between the shafting caused by coke build-up results in localized heating, which can lead to weakened material properties of the components to the point of failure.

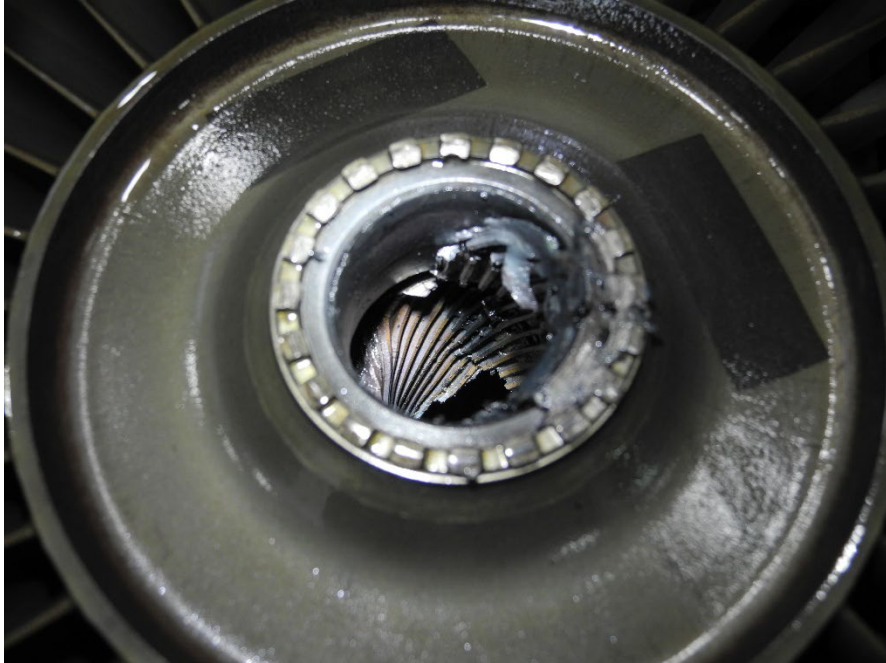
**Photo 31** - 4<sup>th</sup> Stage Wheel with Portion of the Deformed and Seized Turbine-to-Compressor Coupling Shaft

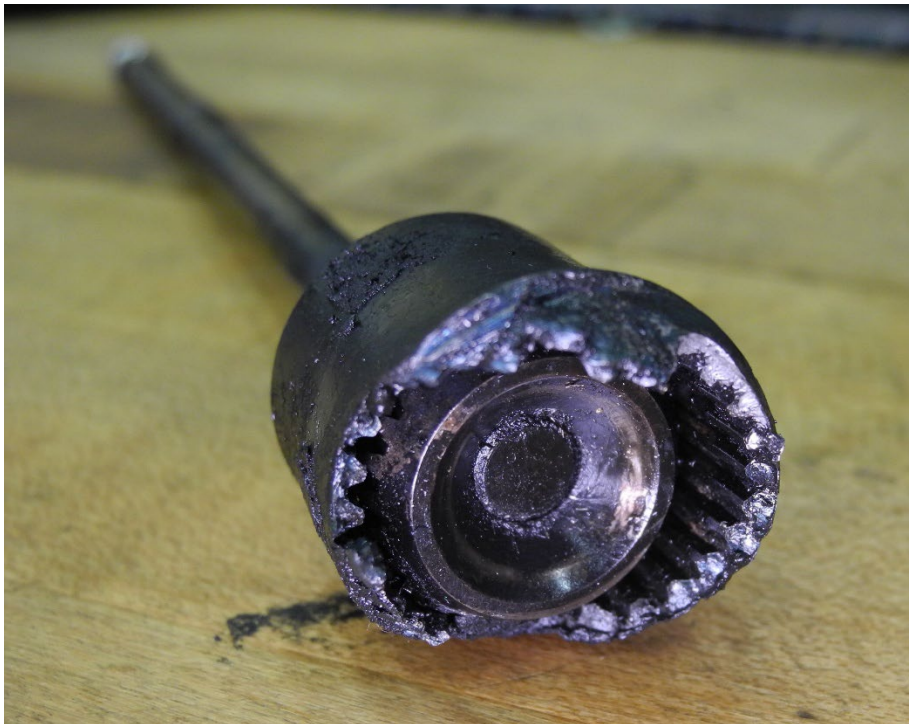
**Photo 32** - Turbine-to-Compressor Coupling Shaft Was Deformed Over Tie Bolt Nut
