# National Transportation Safety Board

WPR24FA132

## **POWERPLANTS FACTUAL REPORT**

Location: Anaconda, Montana  
Date: April 26, 2024  
Time: 06:59 local time  
Helicopter: Bell B206L-4, Registration Number N988B

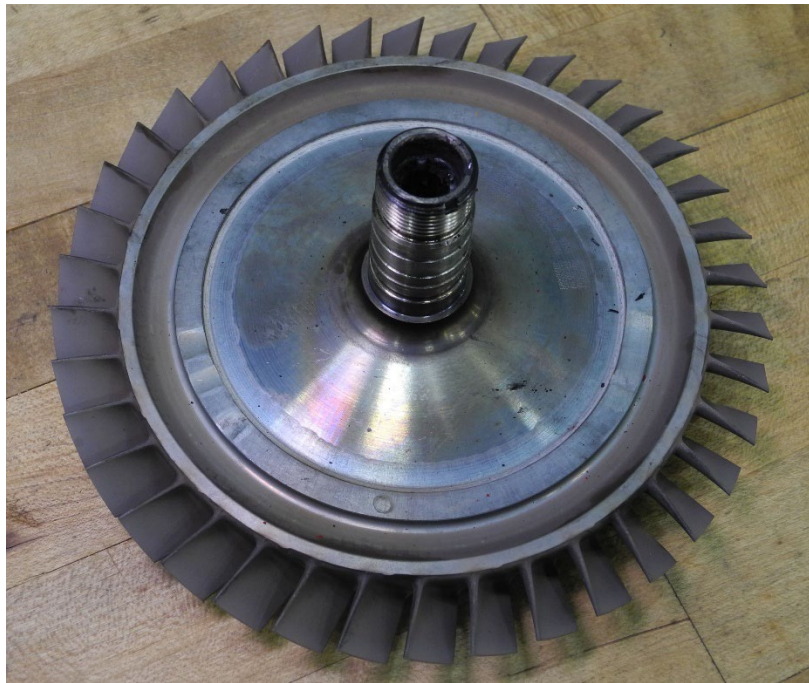
The 1<sup>st</sup> stage turbine wheel was intact and undamaged (**Photo 30**).

**Photo 33** - 1<sup>st</sup> Stage Turbine Wheel - Undamaged

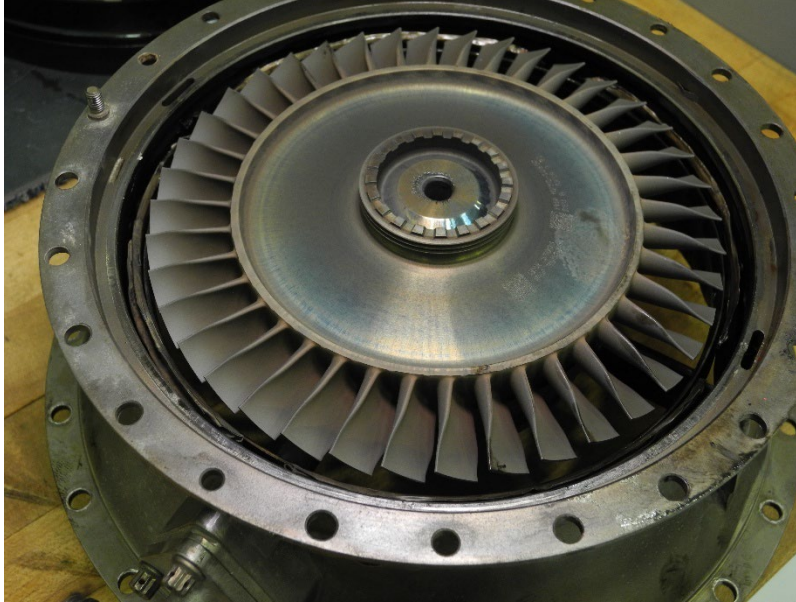
The 2<sup>nd</sup> stage turbine wheel was intact. The spline adapter was still secured to the 2<sup>nd</sup> stage wheel hub (**Photo 31**). The splines and the undercut area of the spline adapter were coated with thick layer of oily coke (**Photo 32**).

**Photo 34** - 2<sup>nd</sup> Stage Turbine Wheel - Intact

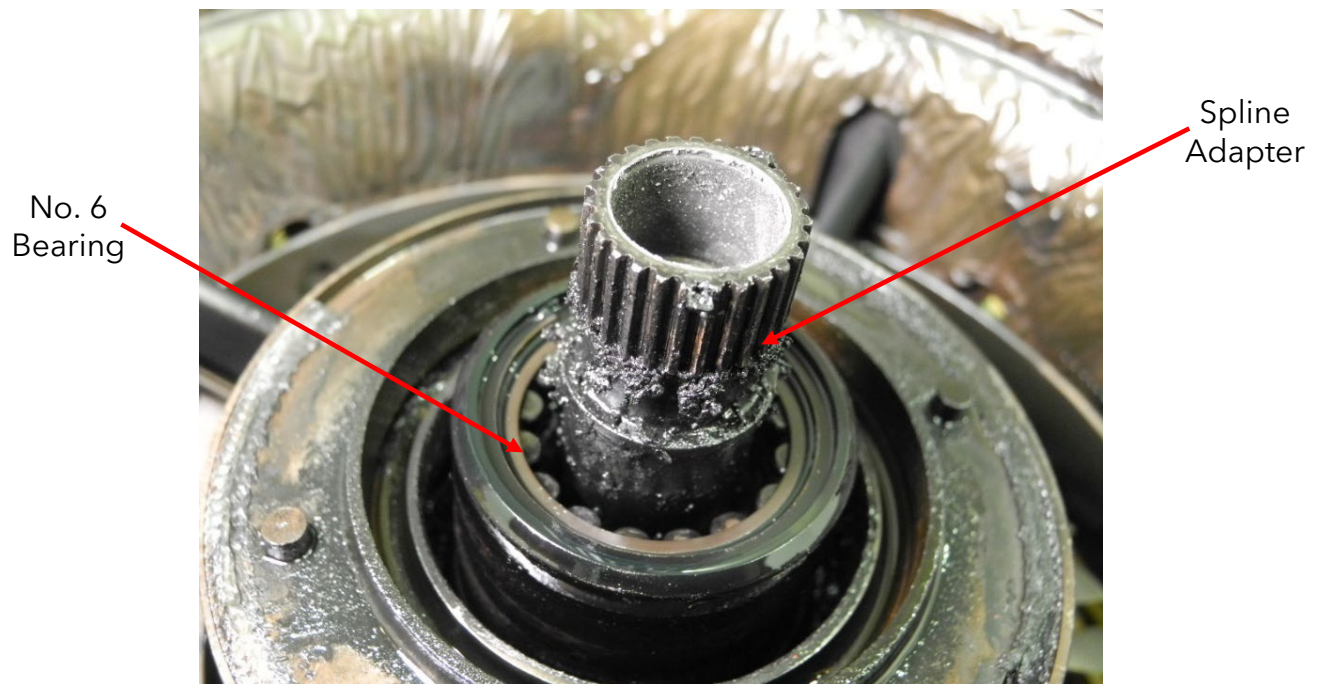
**Photo 35** - Detail of 2<sup>nd</sup> Stage Turbine Spline Adapter - Heavy Carbon Deposits

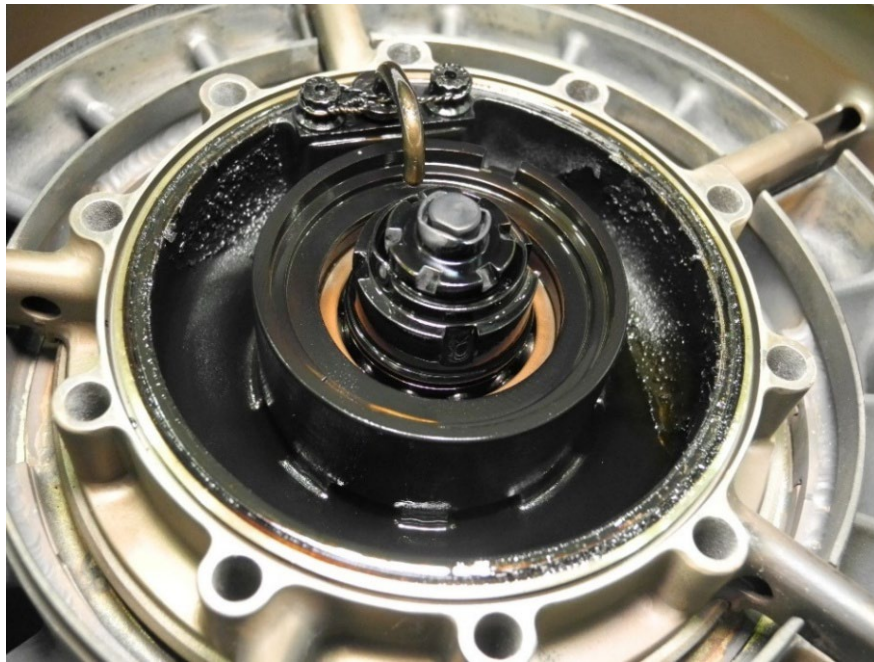
The No. 8 bearing cavity and bearing were oil wetted (**Photo 33**). The No. 8 bearing was intact and undamaged.

**Photo 36** - No. 8 Bearing Cavity

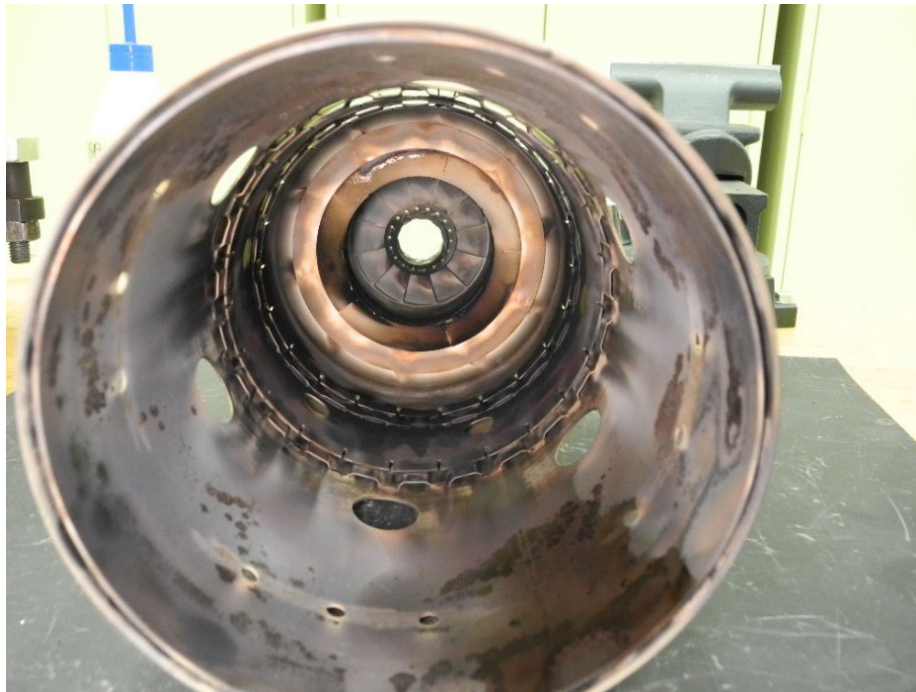
The outer combustor case (OCC) was intact and undamaged. The combustor liner was intact and undamaged. The fuel nozzle was intact and undamaged (**Photo 34**).

**Photo 37** - Combustor Liner - Undamaged
