# National Transportation Safety Board

WPR24FA150

## **ACCIDENT SITE SURVEY**

Location: Thurlow, Montana  
Date: May 14, 2024  
Time: 0715 MDT  
Airplane: Piper PA-18 / N14323

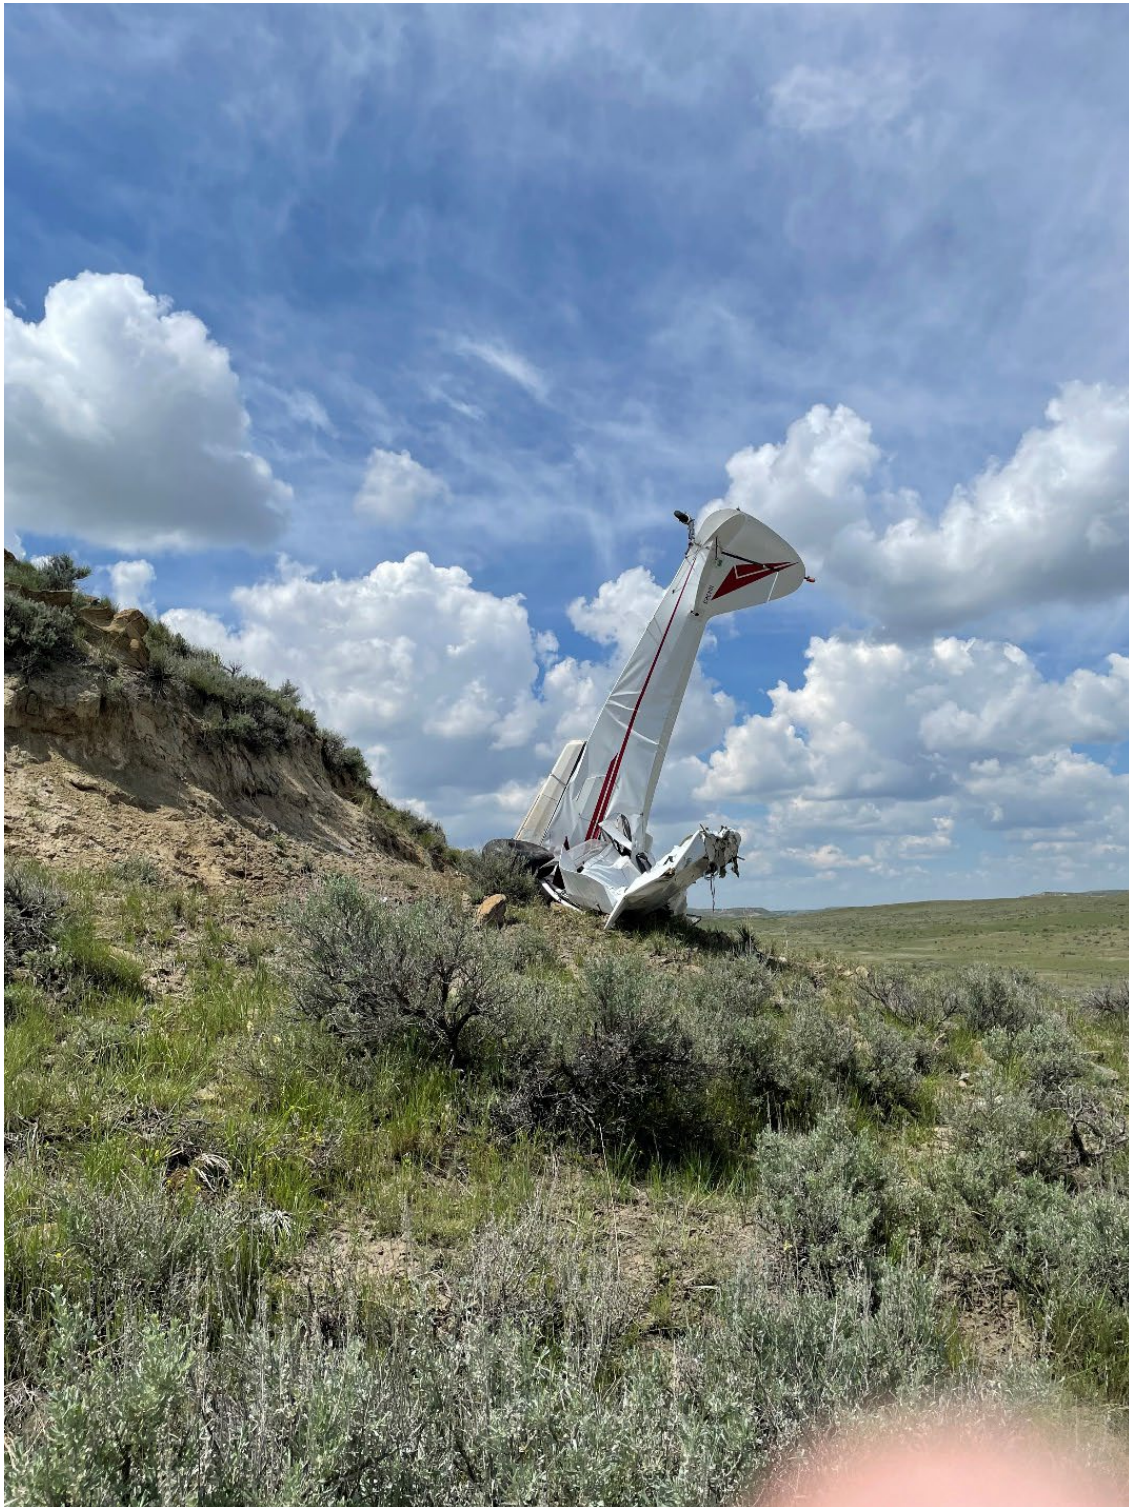
The airplane came to rest on the engine nacelle that was displaced upward significantly, which resulted in the empennage oriented straight up. The heading was about 040° magnetic. Fragments of the red and green navigation lights were

discovered imbedded in the terrain and aided in determining that the heading at impact was about 310° magnetic. The airplane then rotated clockwise about 90°.

Figure 1. N14323, at rest on a heading of about 040°. The image is looking 310° magnetic, the impact heading.

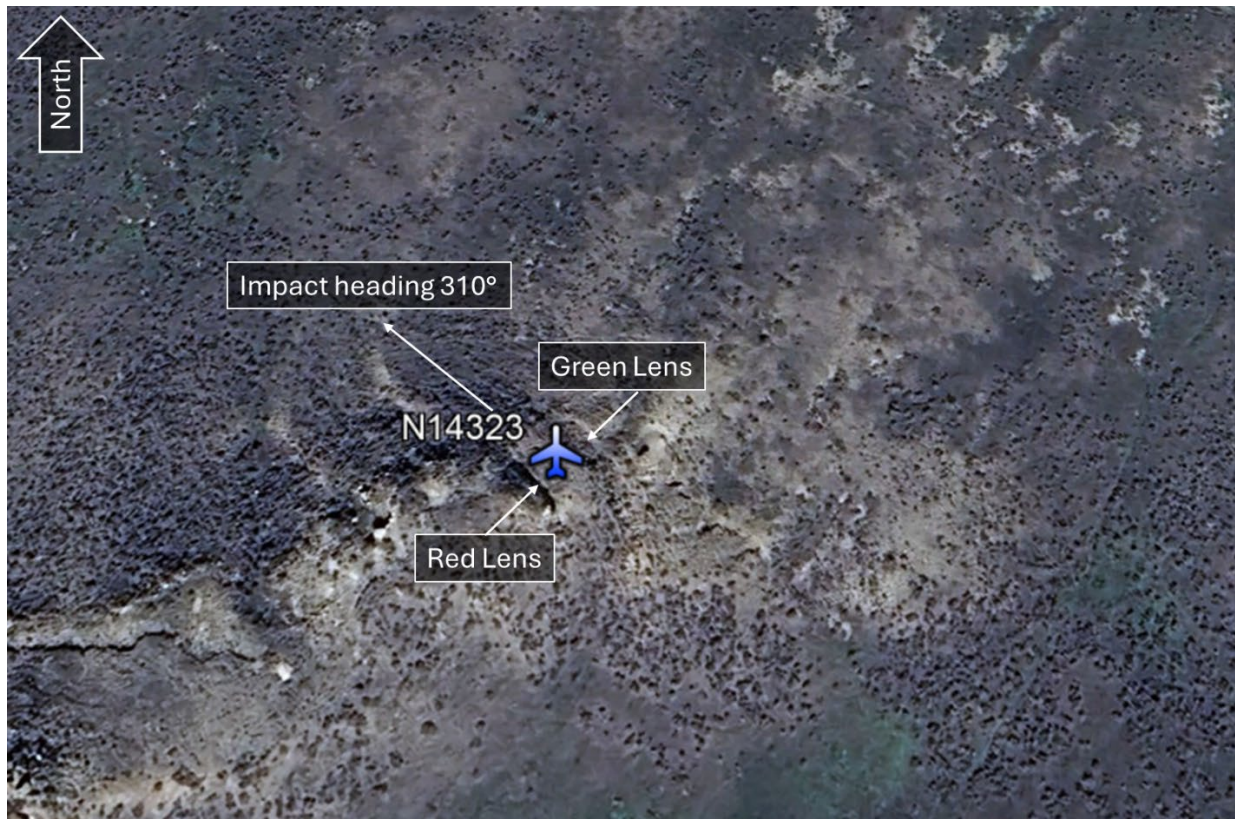
Figure 2. Google Earth image showing the impact heading and the estimated location of the navigation light fragments.

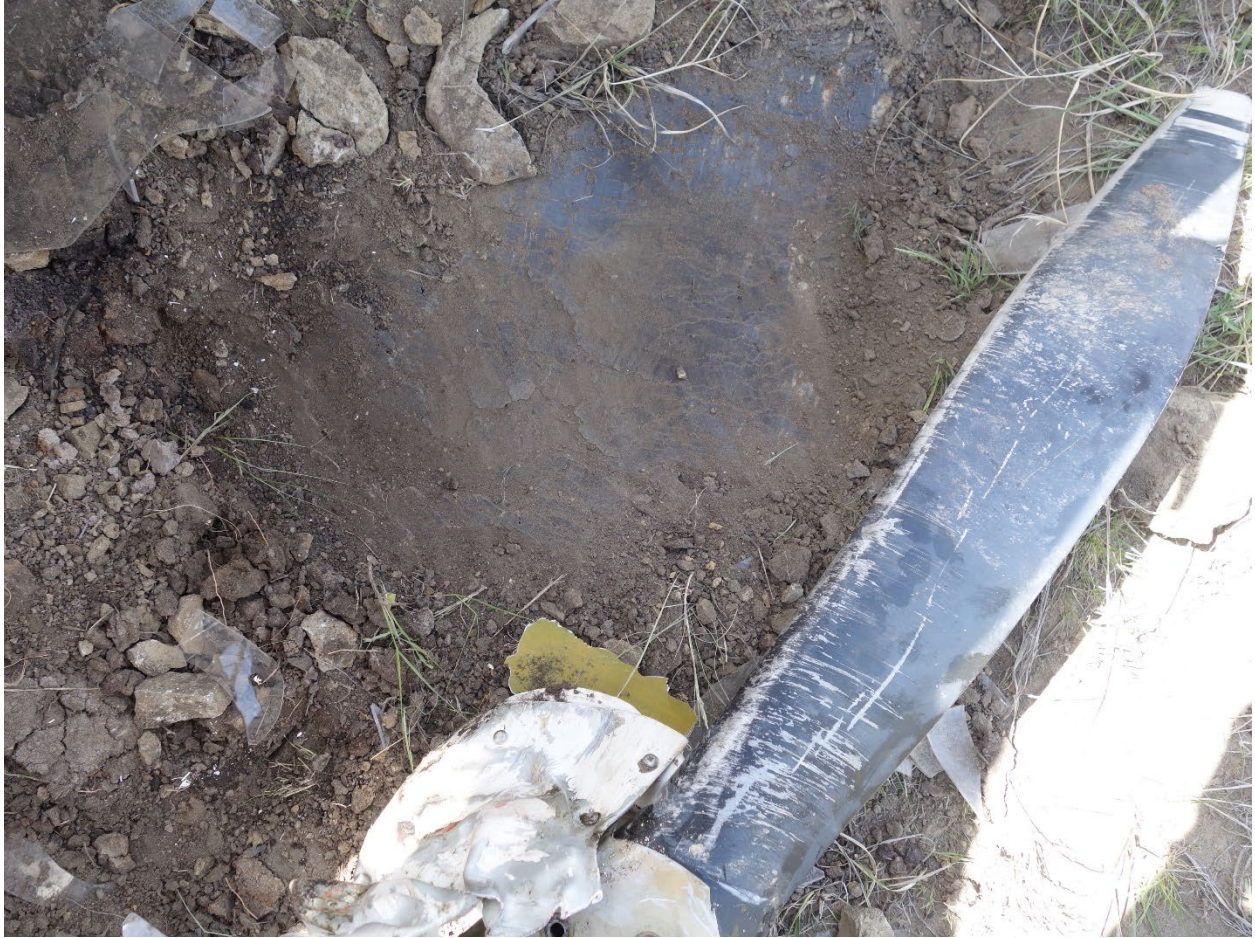
The first point of probable impact was a gouge in the terrain directly underneath the wreckage. The gouge was consistent with one propeller blade cutting smoothly into the soil.

Figure 3. Image showing the first point of probable impact. The propeller is positioned for scale.

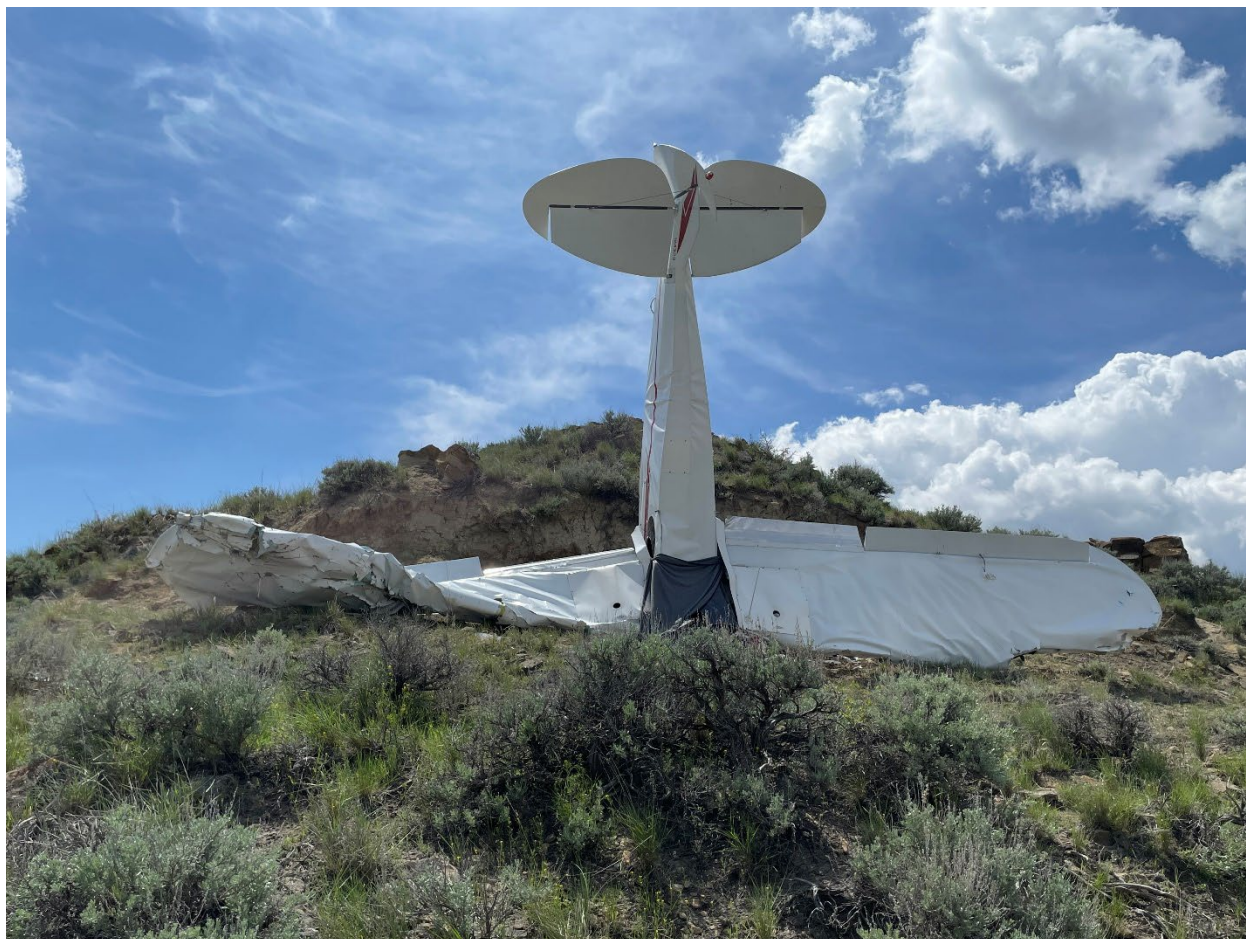
The airplane came to rest near the top of a hill. There were no indications that the airplane travelled in any direction after impact, other than rotating about 90° clockwise.

Figure 4. Image showing the top of the hill.

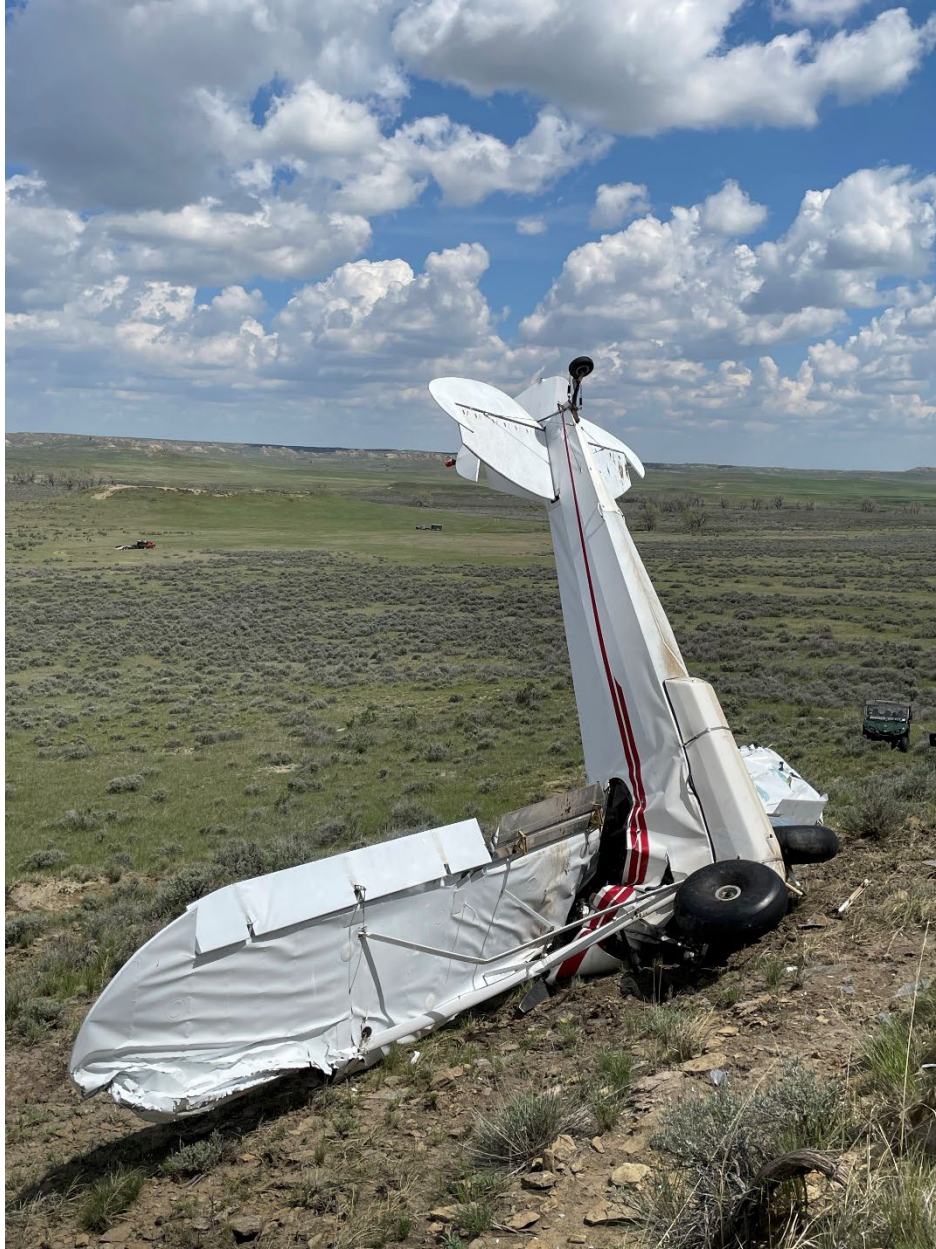
Figure 5. Image showing the airplane and the hilly terrain.

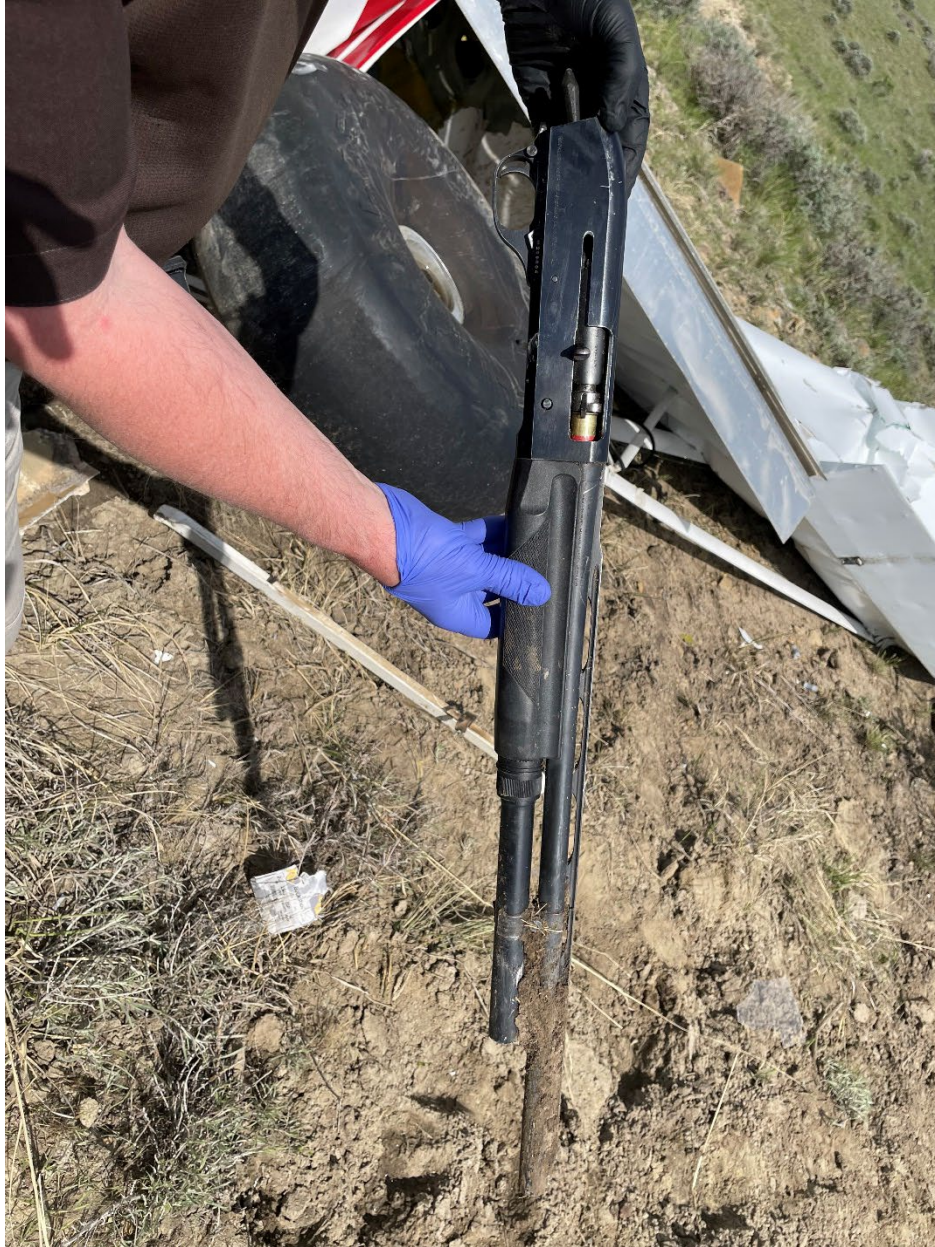
Figure 6. Semi-automatic H&K shotgun recovered from cabin. Note the red shotgun shell in the chamber.

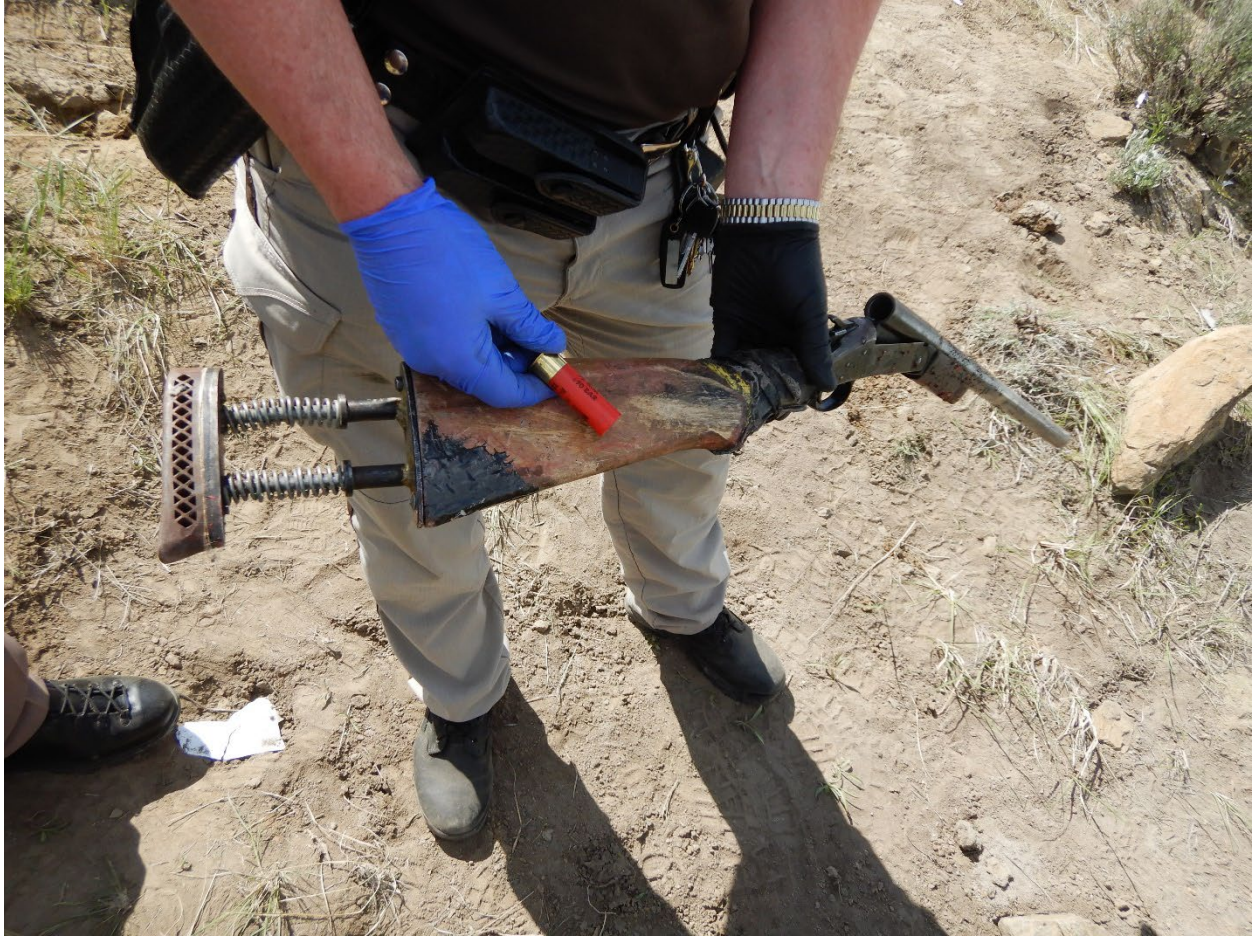
Figure 7. Single-shot H&R shotgun recovered from the cabin. The red shotgun shell was removed from the chamber.

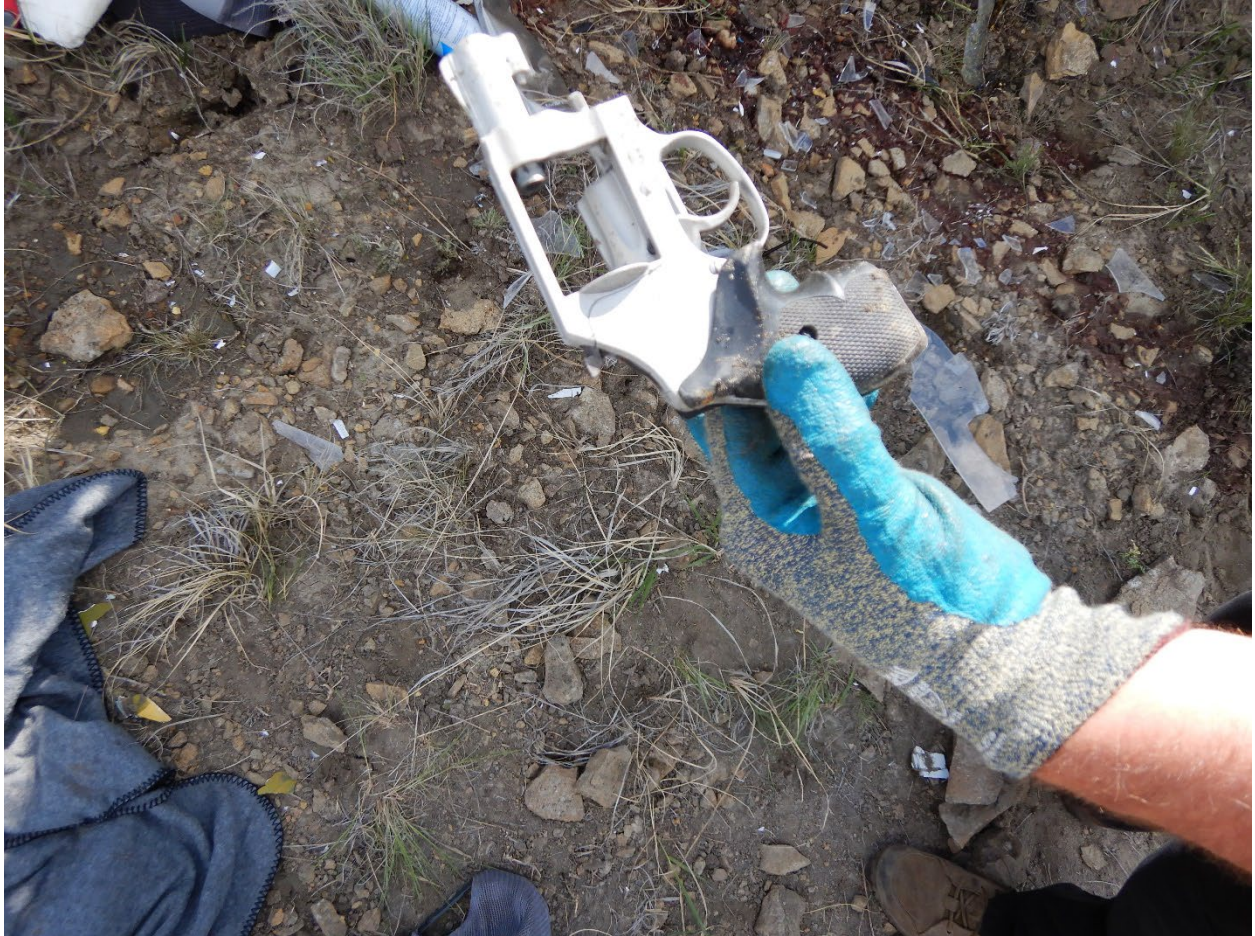
Figure 8. .22-caliber pistol recovered from the cabin.

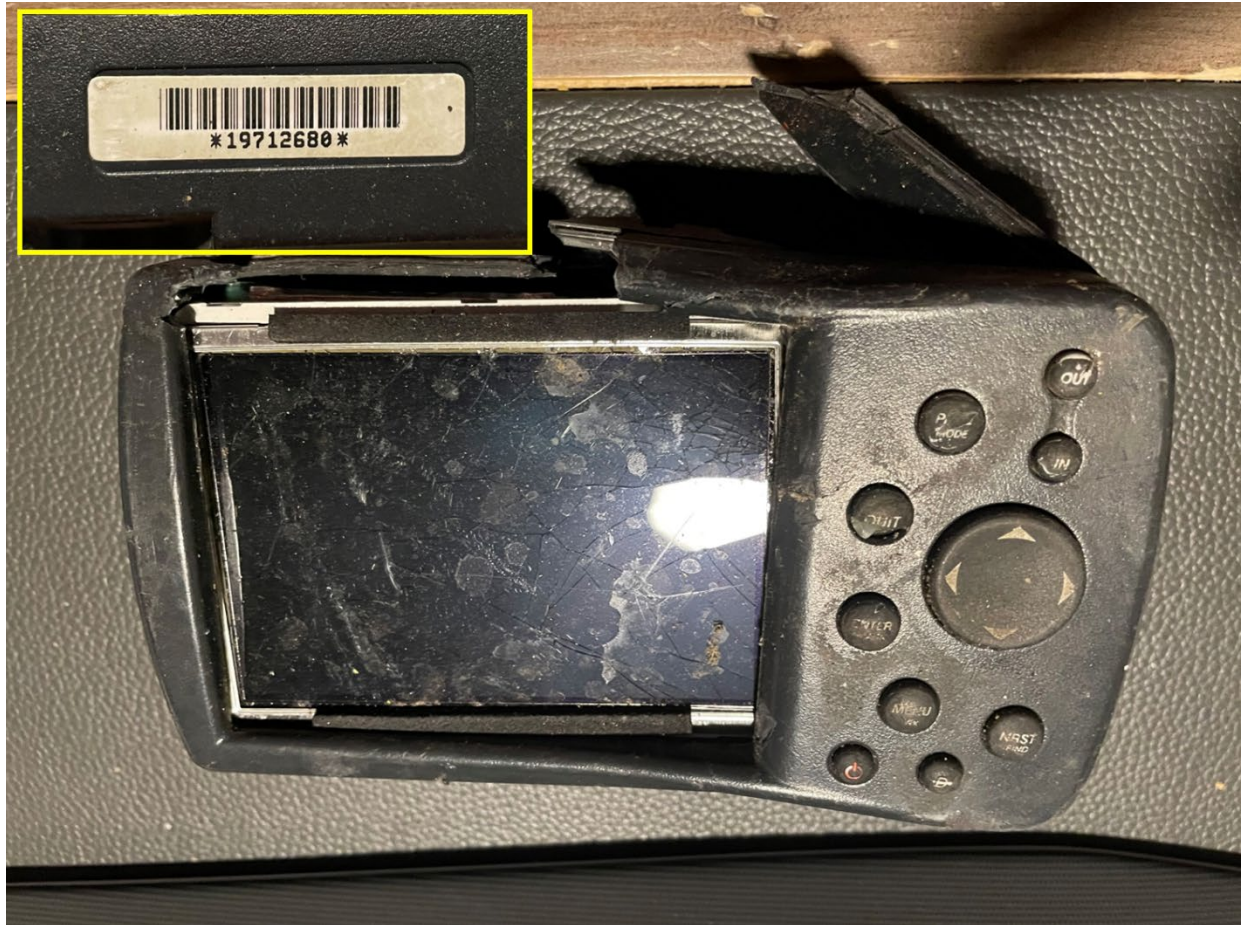
A Garmin 496 GPS, serial number: 19712680, was recovered from the cabin. The GPS was retained for further examination.

Figure 9. Garmin 496 GPS unit.
