# National Transportation Safety Board

WPR24FA150

## **AIRFRAME AND ENGINE EXAMINATION REPORT**

Location: Thurlow, Montana  
Date: May 14, 2024  
Time: 0715  
Airplane: Piper PA-18-150 / N14323

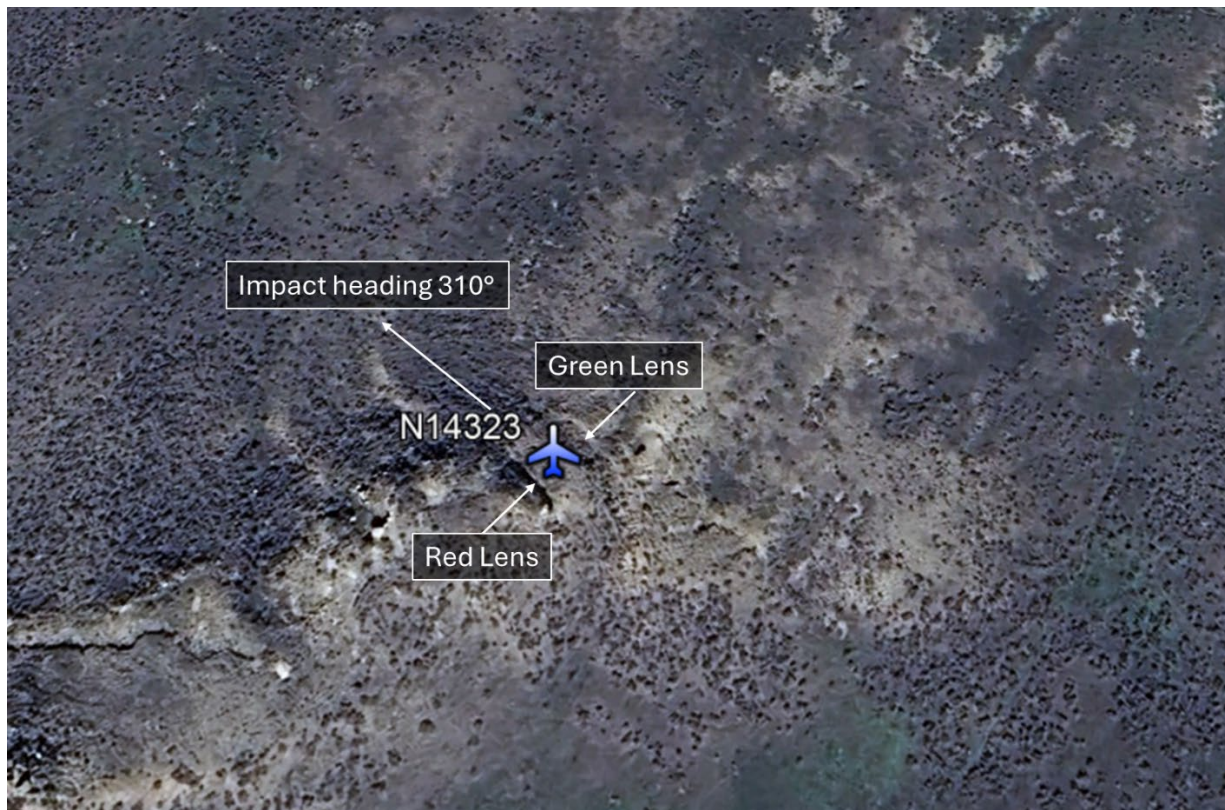
The airplane came to rest next to a hill at 46°.328928 -106°.37472, at an elevation of about 2,618 ft mean sea level (msl), with the fuselage nose down and the empennage nearly vertical, as shown in figure 1. The fuselage was substantially damaged from the firewall aft to the empennage. The engine cowling and engine were displaced upwards and aft.

**Figure 1. Google Earth image showing the location of the accident airplane and the location of the fragments of the position lights.**

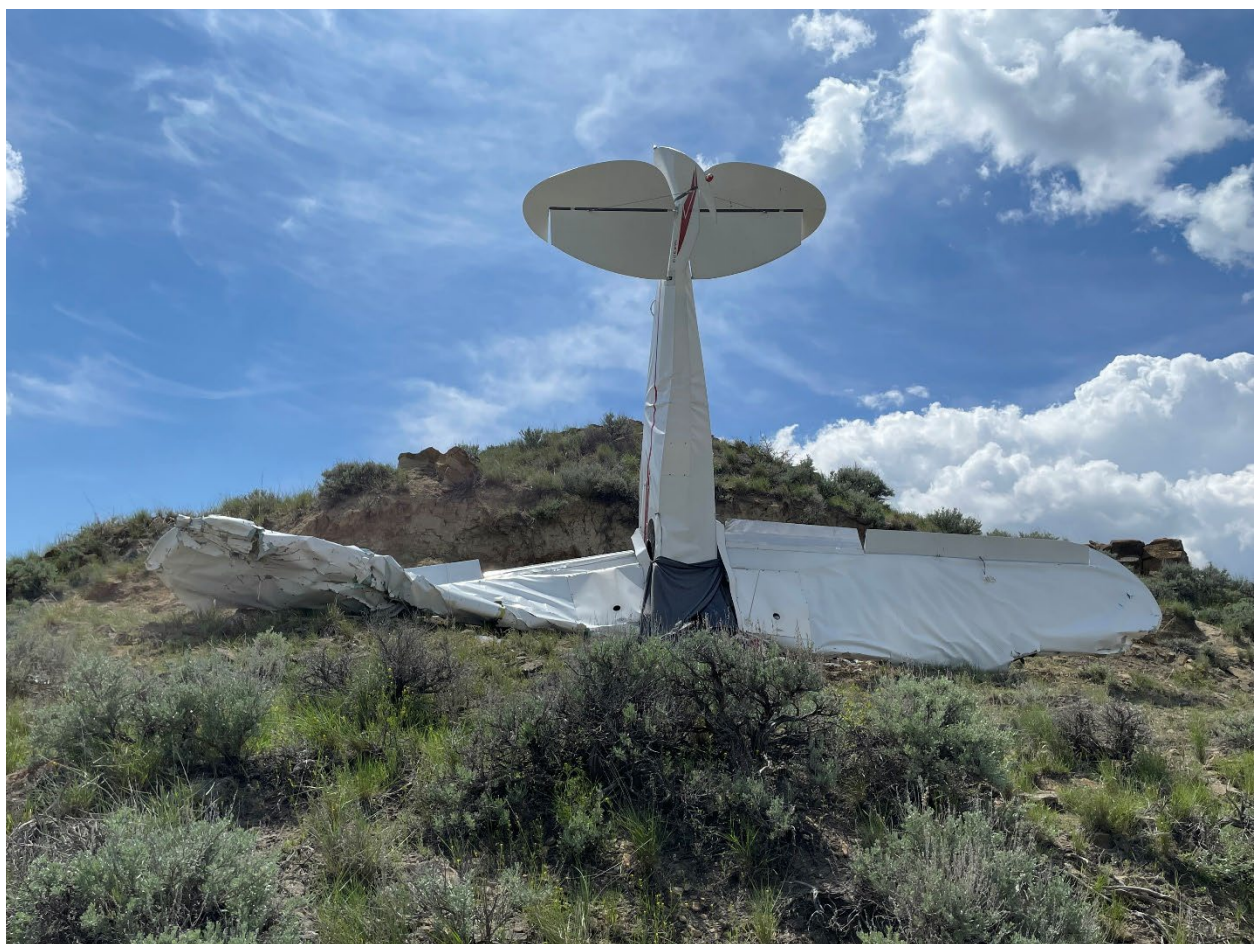
Both wings exhibited substantial damage to the leading edges.

The right wing remained attached to the fuselage and exhibited significantly more damage than the left. The right wing was twisted upwards from the tip to the root. The right aileron and right split flaps remained attached to the aft end of the wing. The struts remained attached to the wing and fuselage. The majority of the green navigation light was found shattered and embedded in the dirt, oriented toward the top of the airplane.

The left wing remained attached to the fuselage. Areas of the leading edge were flattened and displaced aft. The left aileron and left split flaps remained attached to the aft end of the wing. The struts remained attached to the wing and fuselage. Fragments of the red navigation light were found resting in the dirt, oriented toward the belly of the airplane.

**Figure 2. Image showing wings, fuselage, and empennage.**

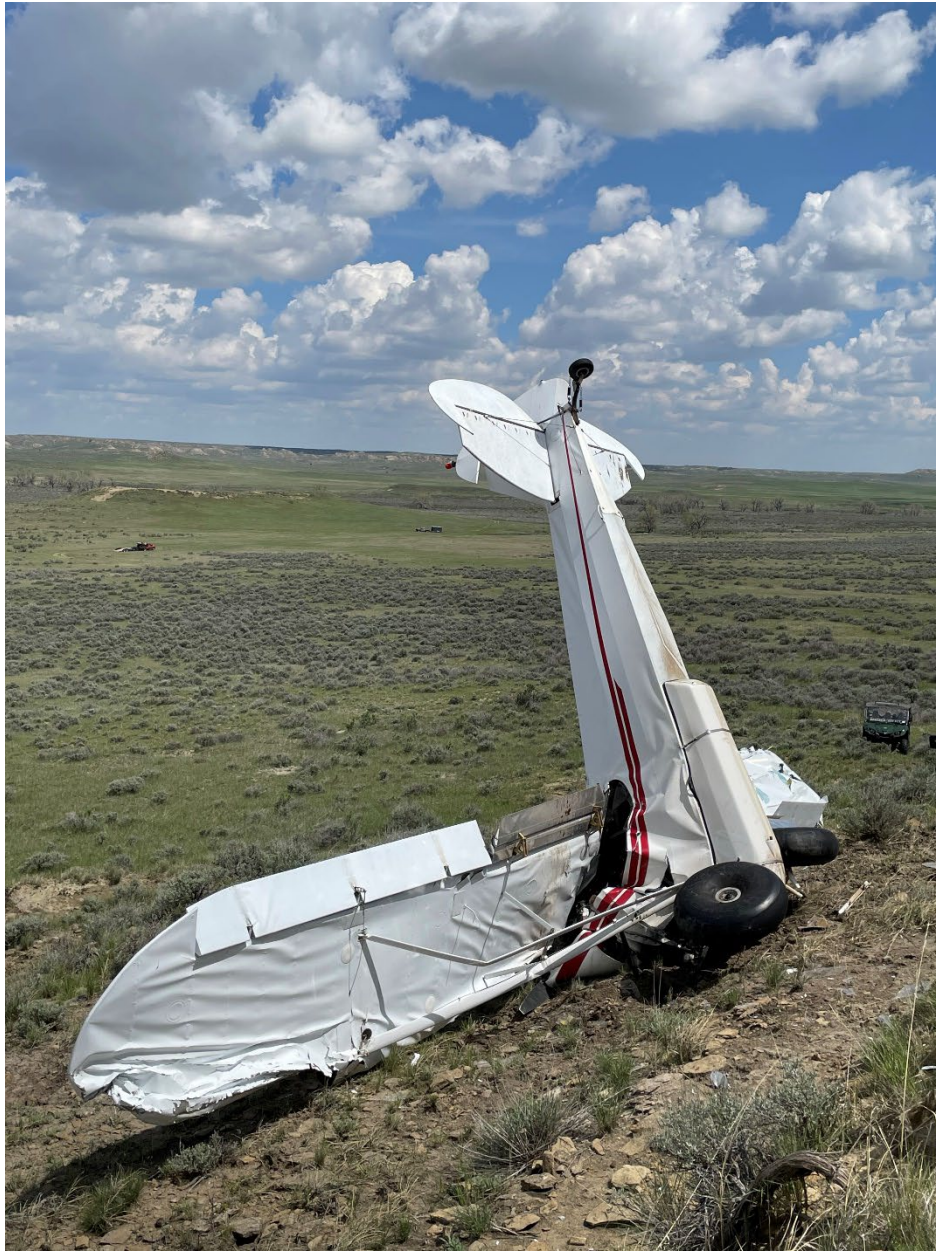
The airplane was tail wheel equipped with the tail wheel exhibiting no damage. The main landing gear was equipped with over-sized "tundra tires." Both main landing gear struts exhibited buckling and bending failures.

**Figure 3. Image showing the underside and landing gear**

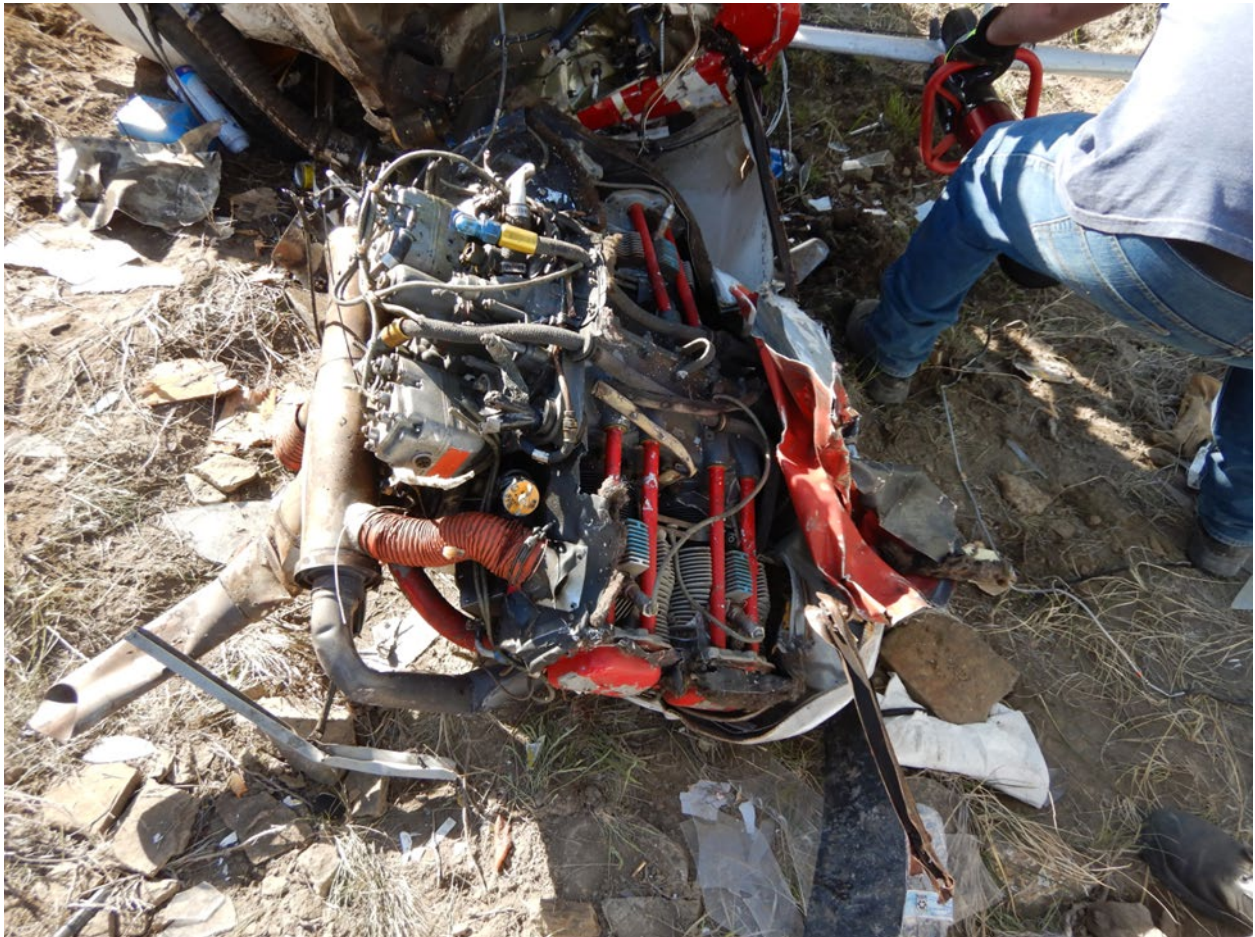
The engine remained secured to the damaged firewall by the engine mounts. The engine was separated from the engine mounts with mechanical cutters and set up on pallets for examination. The top spark plugs were removed, and all appeared a dry grayish color, consistent with running lean.

**Figure 4. Image showing the engine after it was separated for examination.**

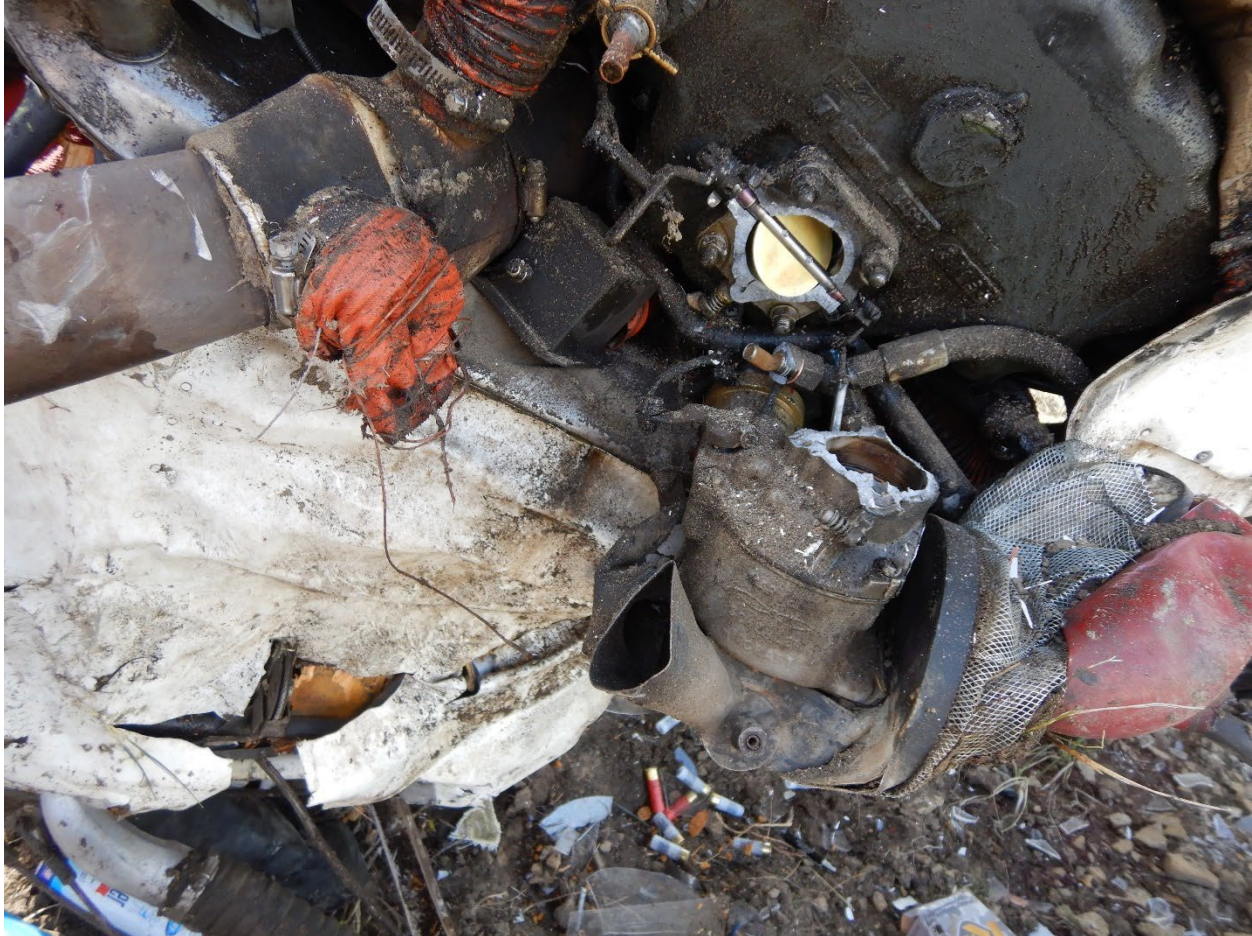
The carburetor had fractured and separated from the intake plenum at the neck. The butterfly valve remained secure and appeared undamaged. The bowl was removed, exposing two undamaged plastic floats. The needle separated and was found in the carburetor. The throttle and mixture control cables remained secured to the carburetor. The air filter remained attached to the carburetor but was crushed.

**Figure 5. Image showing the underside and the carburetor**

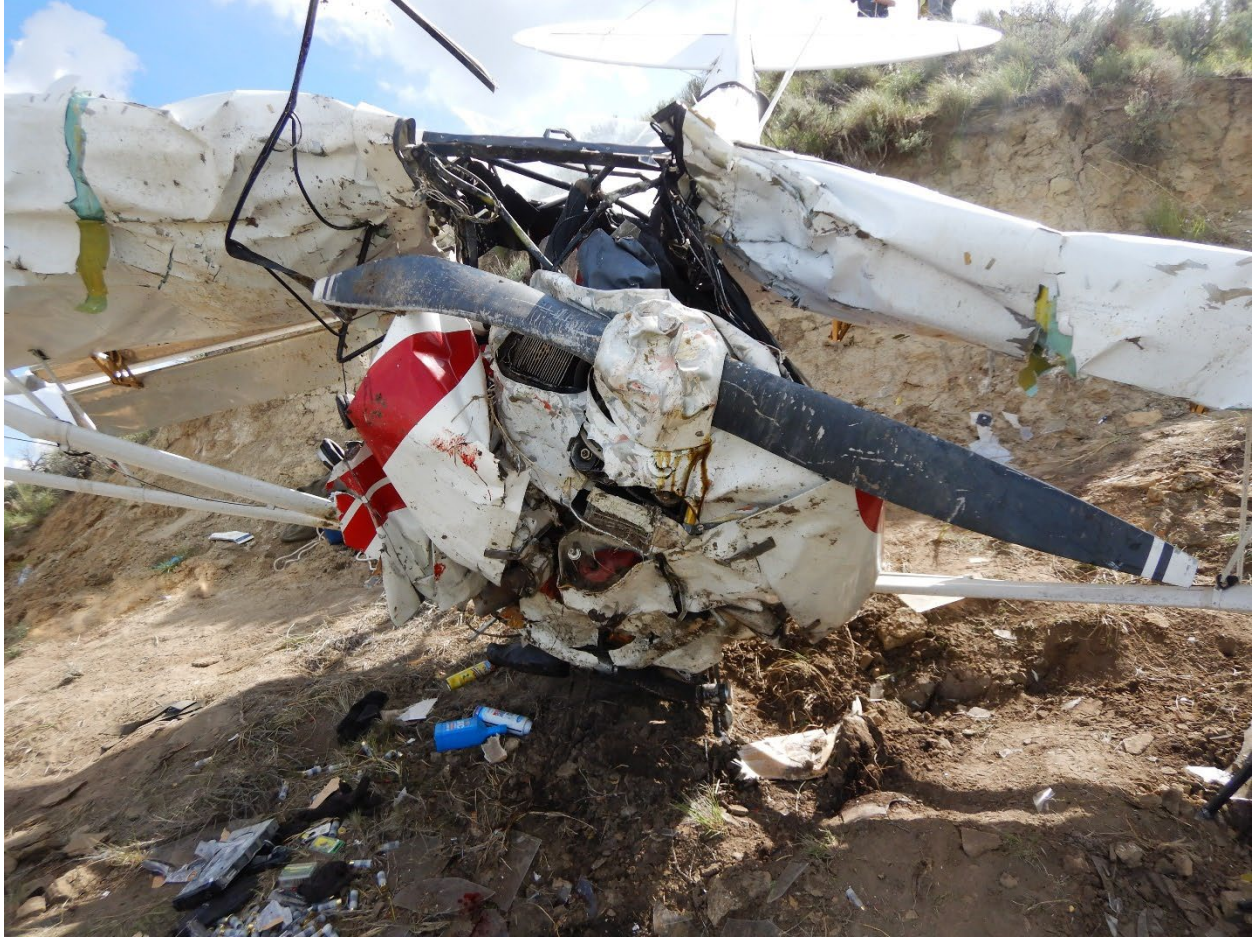
The propeller remained attached to the engine at the propeller flange. The fixed pitched aluminum propeller exhibited minimal damage to one propeller blade and a near 90° bend to the other propeller blade. A significant gouge was found in the dirt consistent with a propeller strike. One blade exhibited chord-wise striations. Neither propeller blades exhibited evidence of high-power rotation.

**Figure 6. Image showing the underside of the engine and the propeller**

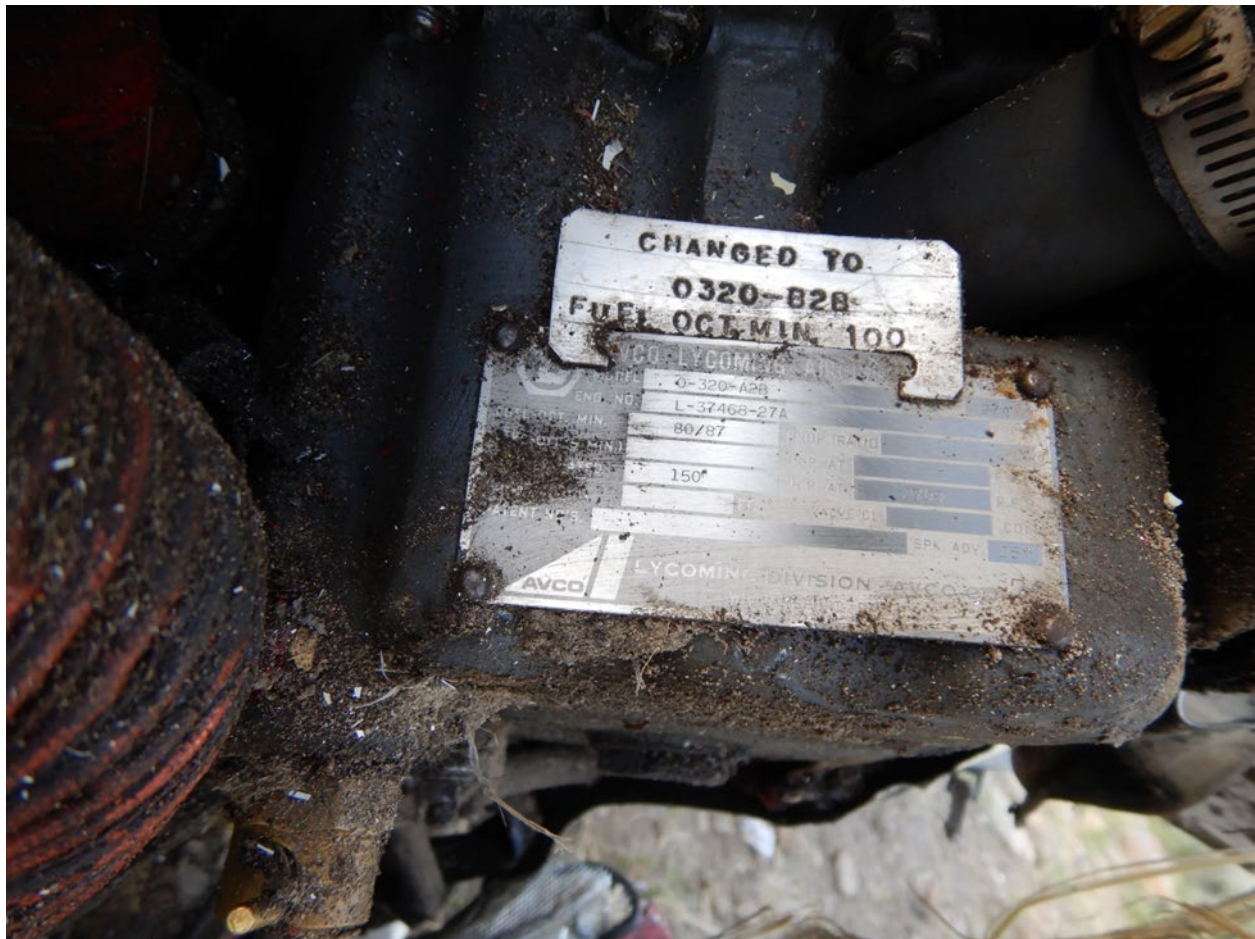
The airplane was a Piper PA-18-150, Serial number: 18-7409083 equipped with a Lycoming 4-cylinder engine. A placard identified the engine model as O-320-A2B. A second tag was permanently attached to the original tag that stated the engine was "changed to a O-320-B2B." The engine serial number remained L-37468-27A.

**Figure 7. Engine data plate with second data plate, permanently attached.**
