# National Transportation Safety Board

WPR24FA182

## **FLIGHT CONTROL EXAMINATION**

Airplane: Vans RV-12 N412JN

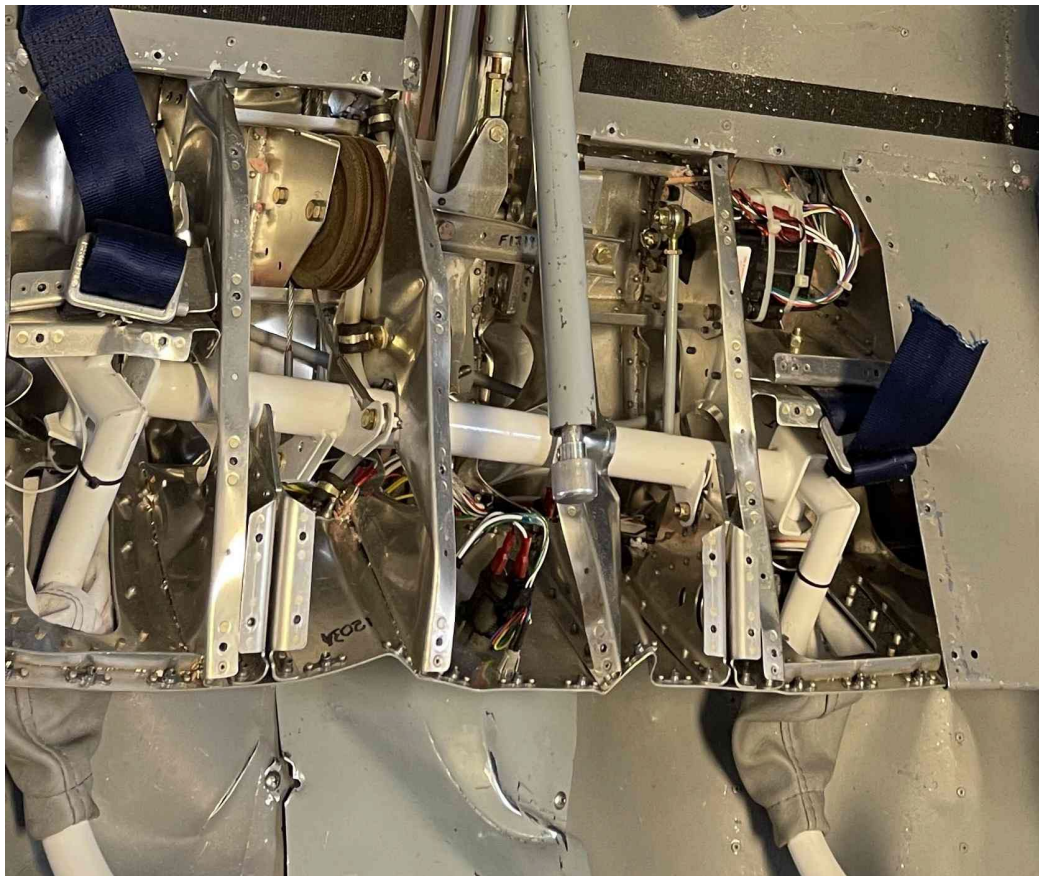
Both control sticks were intact and straight, with no obvious deformation, and both were equipped with protective boots at their bases. Each stick remained attached to the control column. The column remained attached to bulkhead by its bearings (see figure 1).

**Figure 1 - Control stick assembly.**

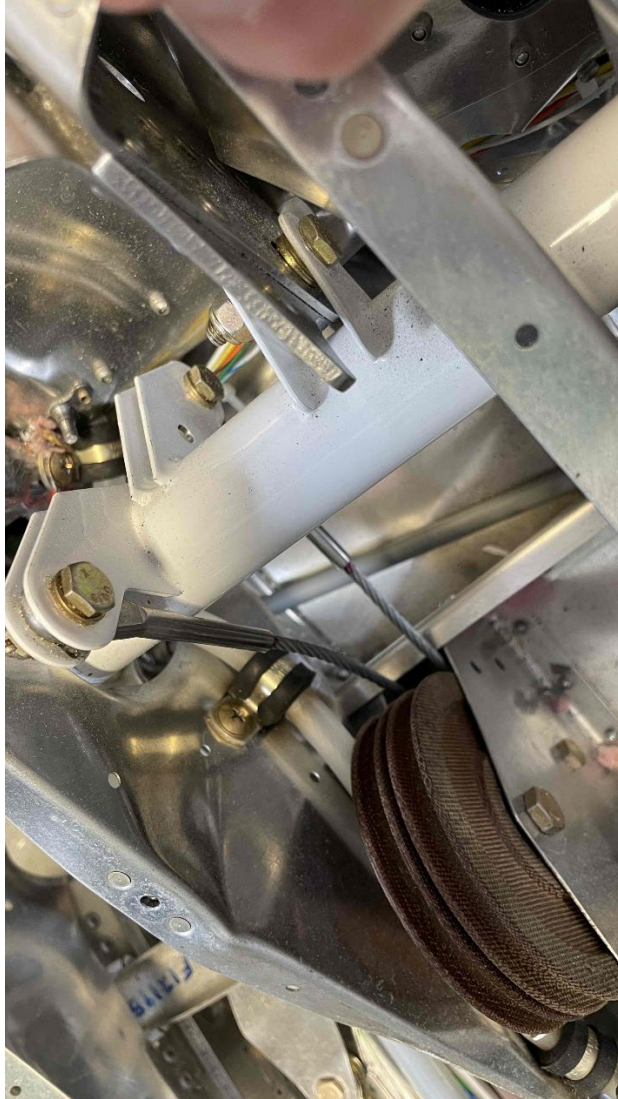
The pitch control cables remained attached to their respective control column arms (see figure 2). Both cables were routed correctly through their respective guide pulleys and were continuous through the fuselage to the stabilator upper and lower horns. The cable turnbuckles were intact and fitted with their locking clips.

**Figure 2 - Pitch control cables.**

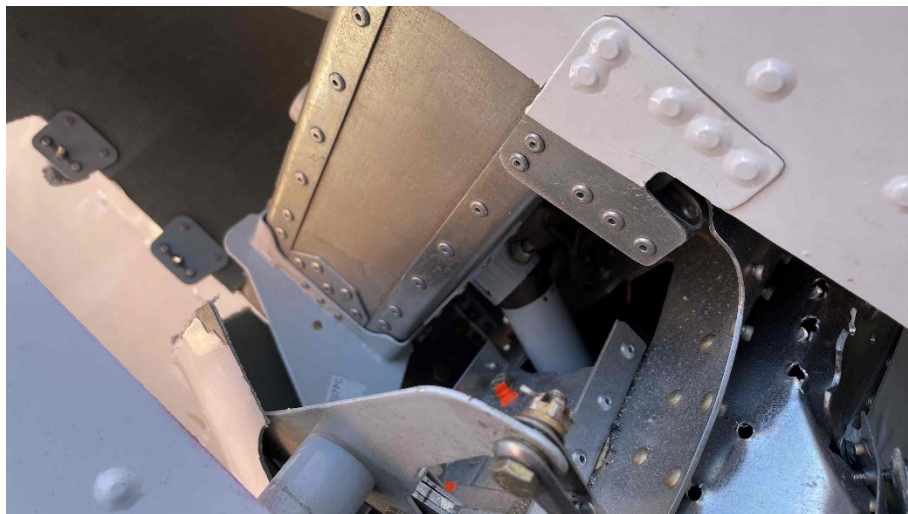
The counterbalance weight had an appropriate strap installed in accordance with Safety Bulletin SB-00067. The arm had broken off at the base of the assembly. The arm was still partially connected to the base at the accident site (see figure 3). but had dropped down during recover. There was no evidence that the counterbalance assembly had scratched or contacted the tail areas in flight, and the arm separation area exhibited 45° lips and bright surface features consistent with overload failure.

**Figure 3 - Counterbalance weight arm.**

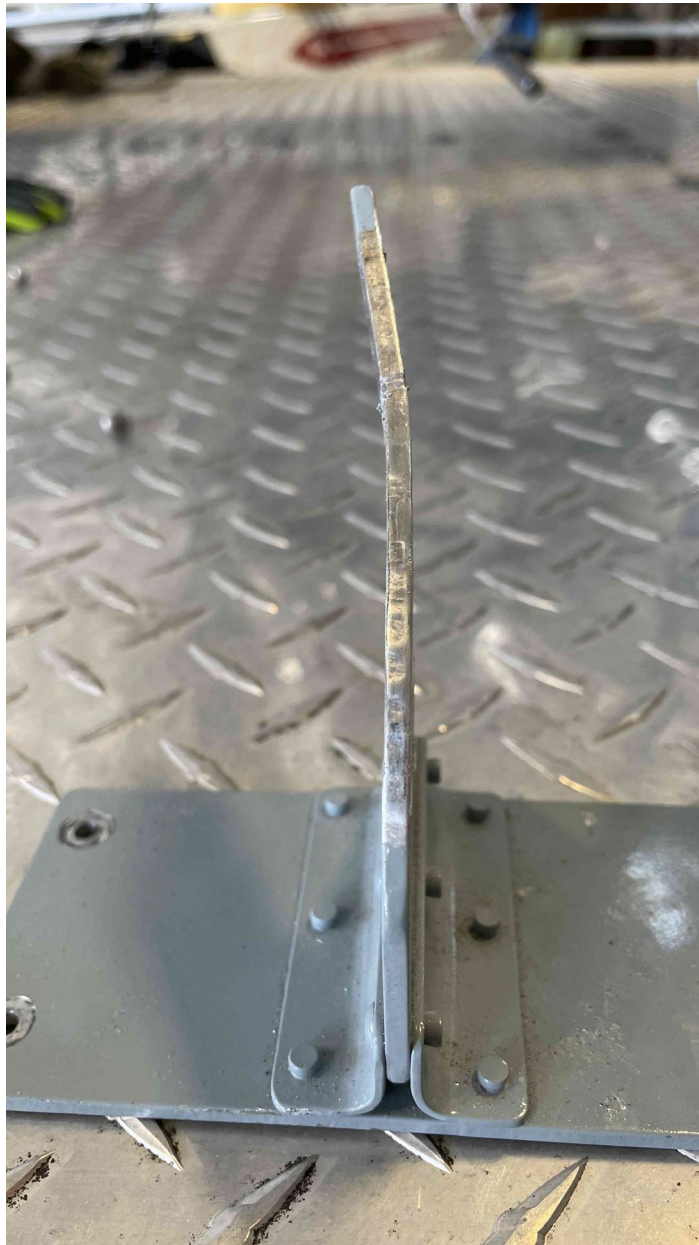
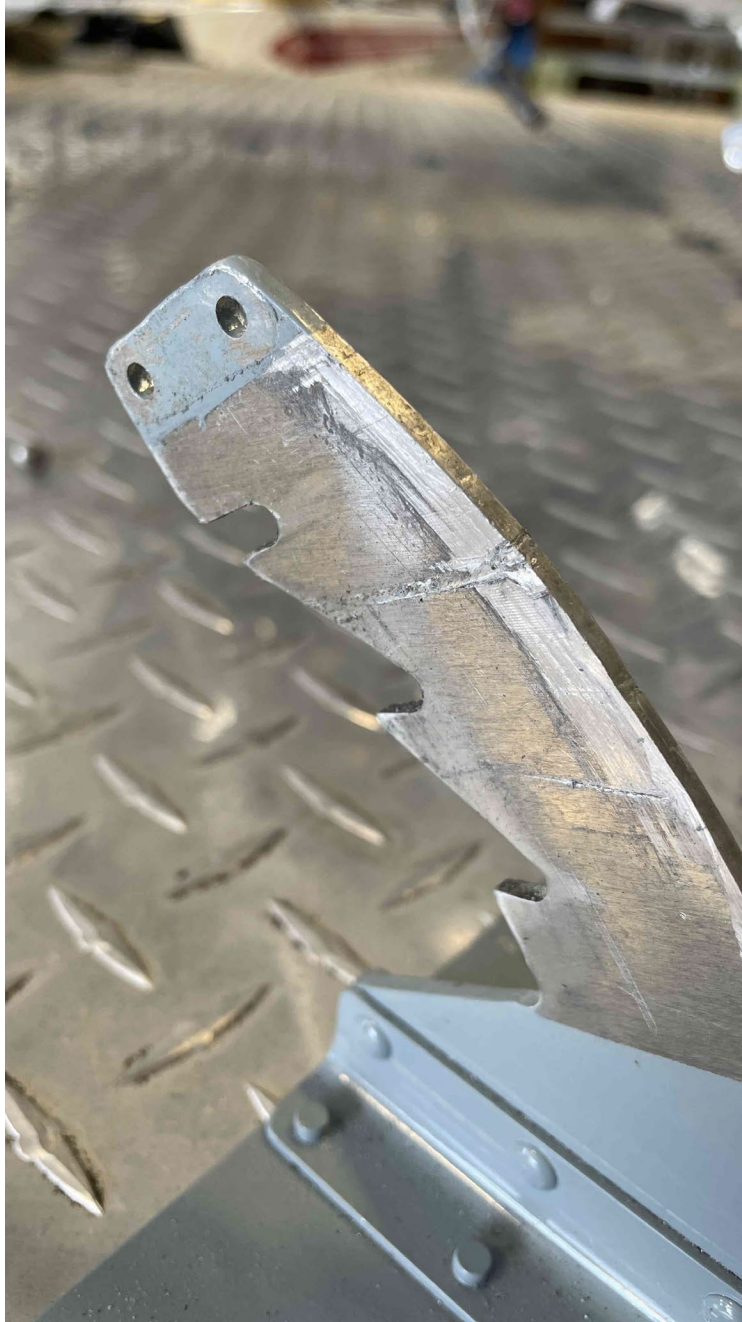
The flap handle remained attached to its Delrin mounting blocks on the structure. The handle was in the full up position (flaps full down), and its control button assembly was locked into the top pawl of the detent bracket/stop. The base of the flap handle structure (WD-1223) was compressed and buckled to the left. The F226A flap detent bracket was bent to the left at the top detent position. The bracket exhibited a defined gouge at the bend, in a location that would correspond to the full flaps position (see figures 4, 5).

**Figure 4 - Flap handle bracket.**

**Figure 5 - Flap handle bracket.**

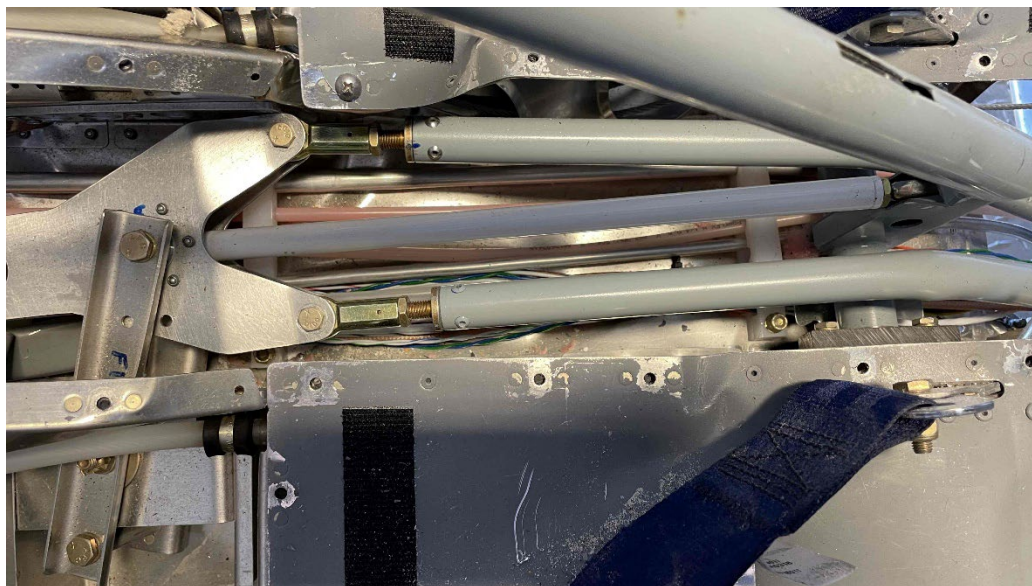
The flap actuator rod remained attached to the flap handle and the F1263 Flaperon Mixer Bellcrank assembly (see figure 6). The bellcrank assembly was at the aft end of its travel, which corresponded to the flaps deployed position.

**Figure 6 - Flaperon mixer bellcrank and pushrods.**

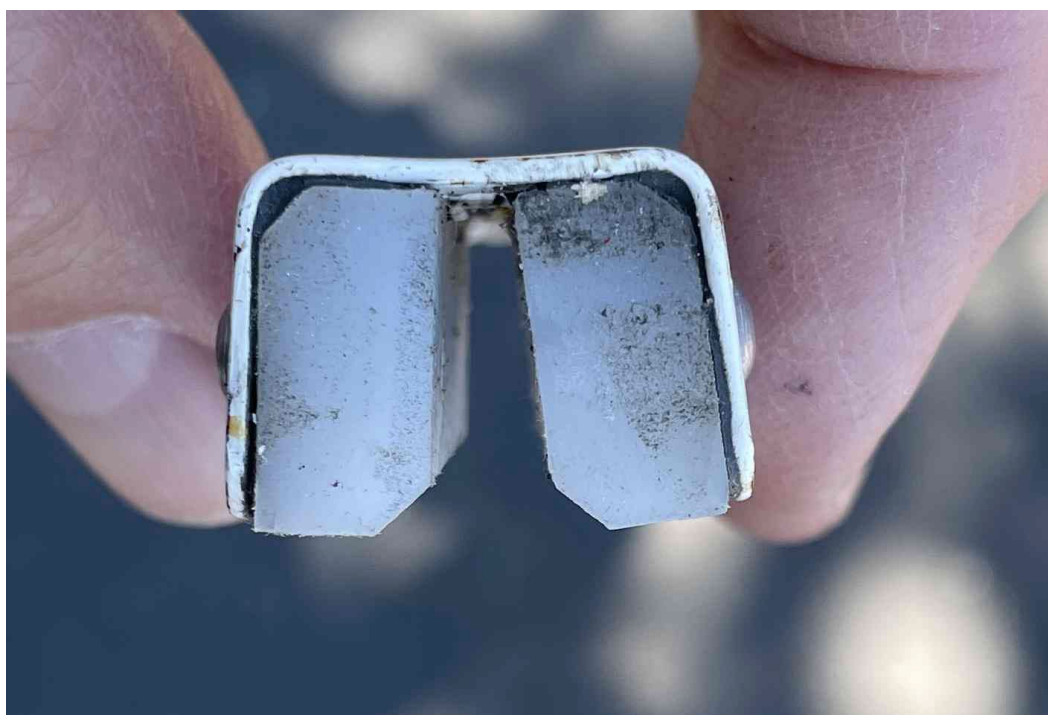
The left flaperon torque tube was in place, and its clevis was attached with both F-1261 spacers intact. The right clevis had broken away from the torque tube at its weld and had opened about 5° with both F-1261 spacers intact (see figure 7). There were no indications of corrosion or signatures associated with fatigue such as beach marks. The failure surface was serrated and ratcheted consistent with impact damage overload, and it appeared the detachment area had torn through the fusion area of weld, rather than the body of the clevis or torque tube (see figure 8).

**Figure 7 - Right flaperon clevis.**

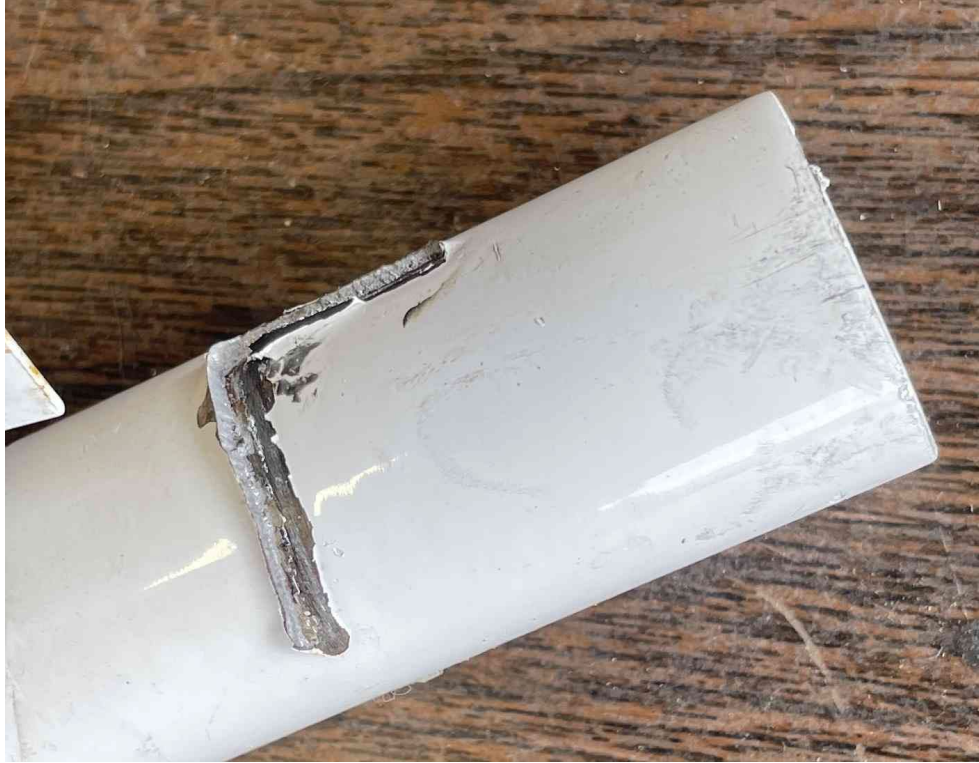
**Figure 8 - Right flaperon torque tube clevis attach point.**

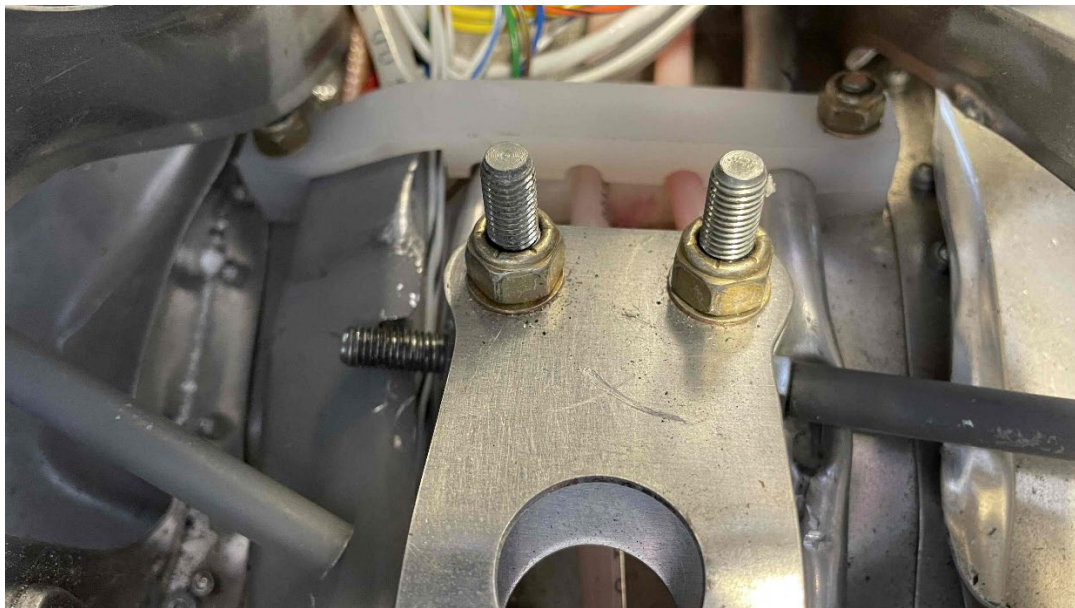
The left control stick pushrod had disconnected from the inboard eyebolt at the mixer bellcrank. The pushrod eyebolts were incorrectly installed, such that the eyebolt stud was connected to the pushrod, and its body to the mixing bellcrank, rather than the other way around. Under this condition, the stud end of the eyebolt was free to rotate within the threaded inboard section of pushrod. With the pushrod disconnected, the pilot would have had no roll control from the left seat.

Review of the roll control system within the footwell indicated that the F1264 control stick pushrod on the left side was bent about 40° midspan, and not connected to the inboard CM-4MS eyebolt at the flaperon mixer bellcrank (see figures 9, 10). The right eyebolt was loose and had backed about 1/16 inch away from the pushrod end (see figures 10.11). Both pushrods were about 7 ¾ inches long as required by the plans, however, the outboard M3414M eyebolts although tight and equipped with jam nuts (AN316-4R), were not fully engaged with the pushrod, and exhibiting about 1/2 inches of exposed thread rather than being snug against the pushrod as indicated in the plans (see figures 10). There were no jam nuts on the eyebolt end of the rod, as required by the plans.

**Figure 9 - Left control stick pushrod disconnected from the inboard eyebolt at the flaperon mixer bellcrank.**

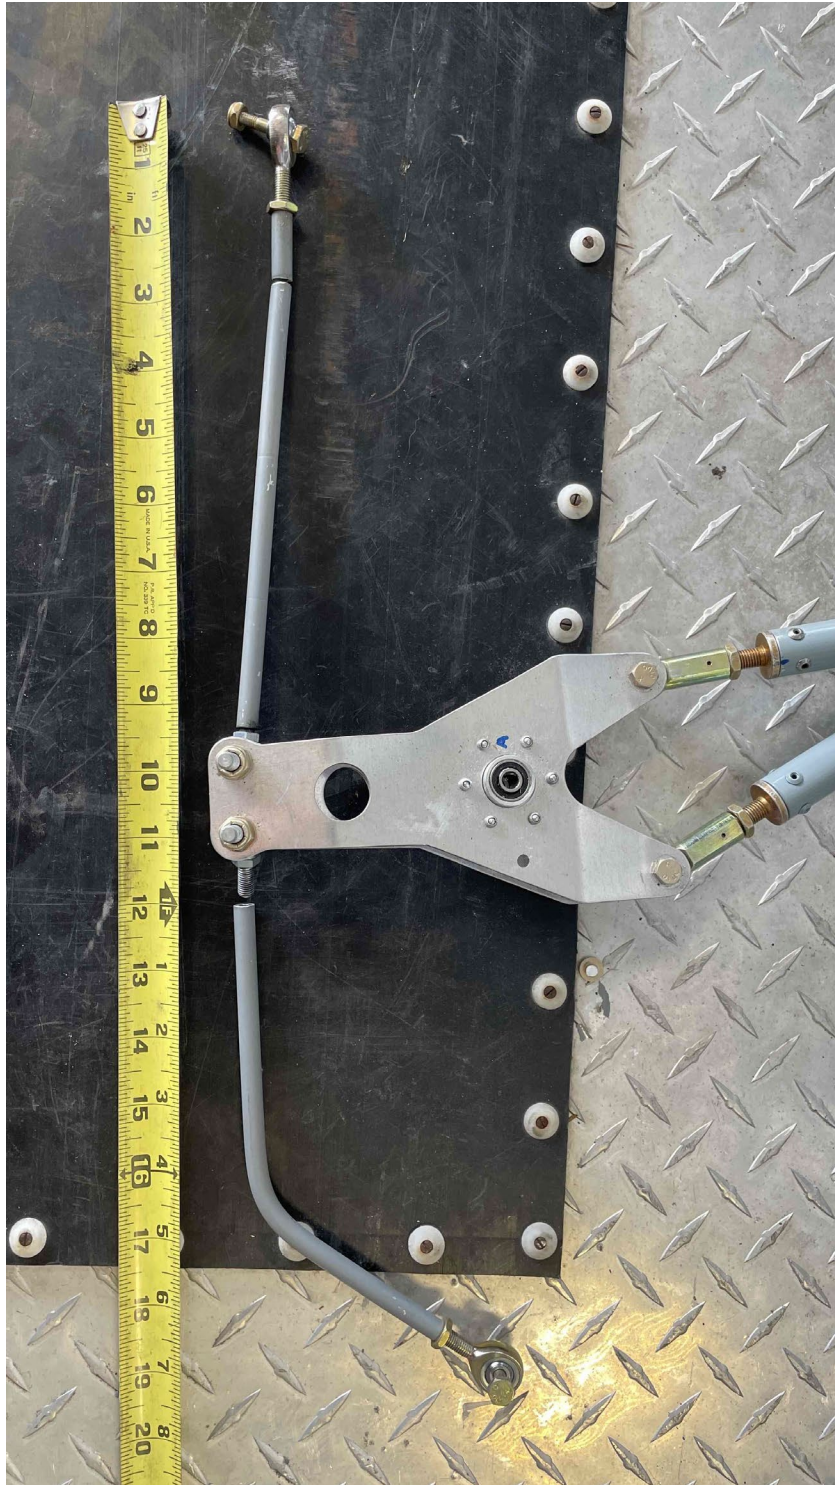
**Figure 10 - Pushrods and flaperon mixer bellcrank assembly.**

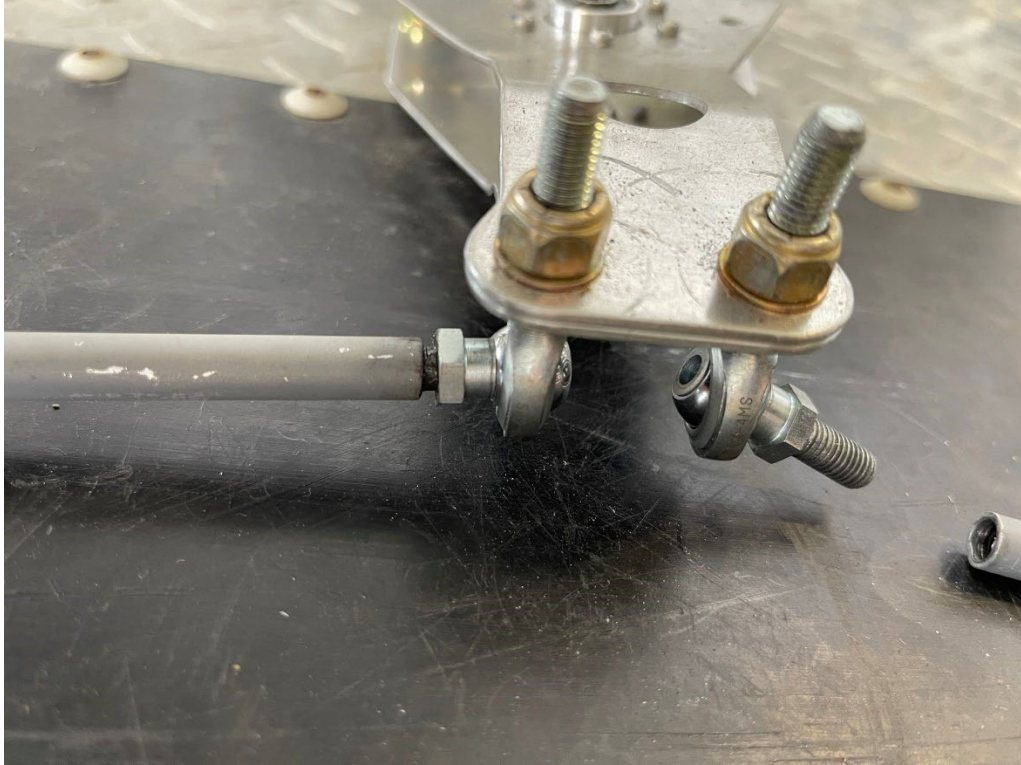
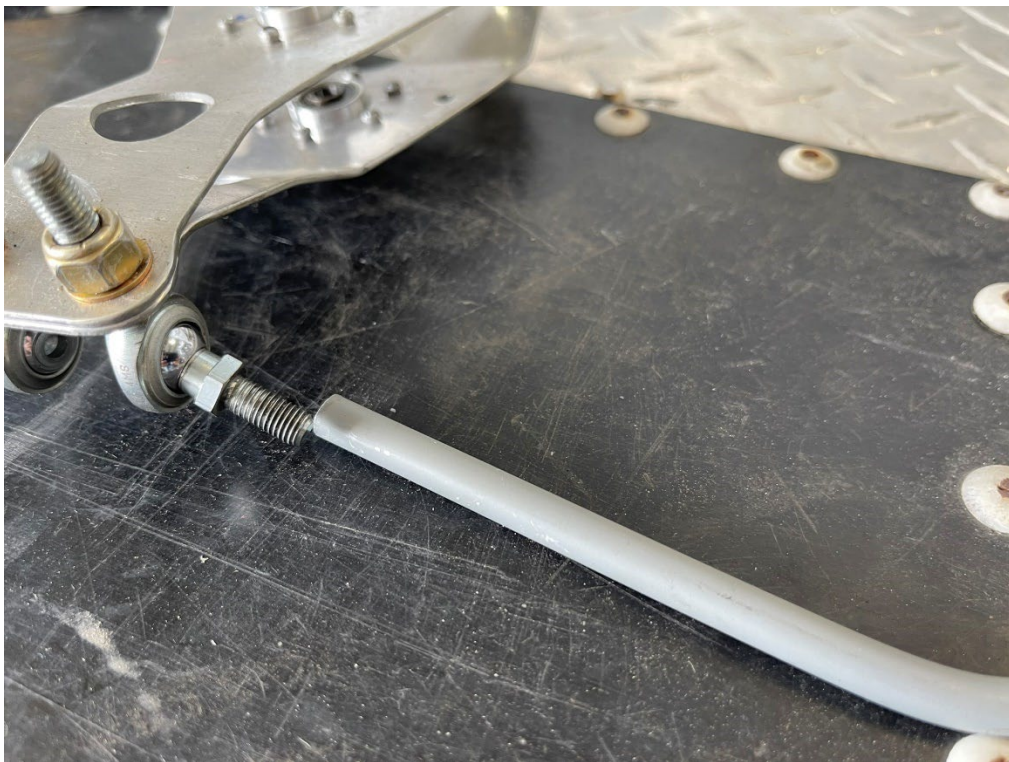
Further examination revealed that the inboard CM-4MS eyebolts on both sides had been installed reversed such that the stud was connected to the pushrod, and the body to the mixer bellcrank, instead of the other way around. Under this condition, and with no jam nut, the stud end of the CM-4MS eyebolt was free to rotate within the pushrod (see figures 11, 12).

**Figure 11 - Inboard CM-4MS eyebolts installed reversed. Left pushrod disconnected.**

**Figure 12 - Inboard CM-4MS eyebolts installed reversed. Left pushrod disconnected.**

**"CAUTION: Ensure the CM-4MS body, and NOT the stud, is threaded into the pushrod as shown."**

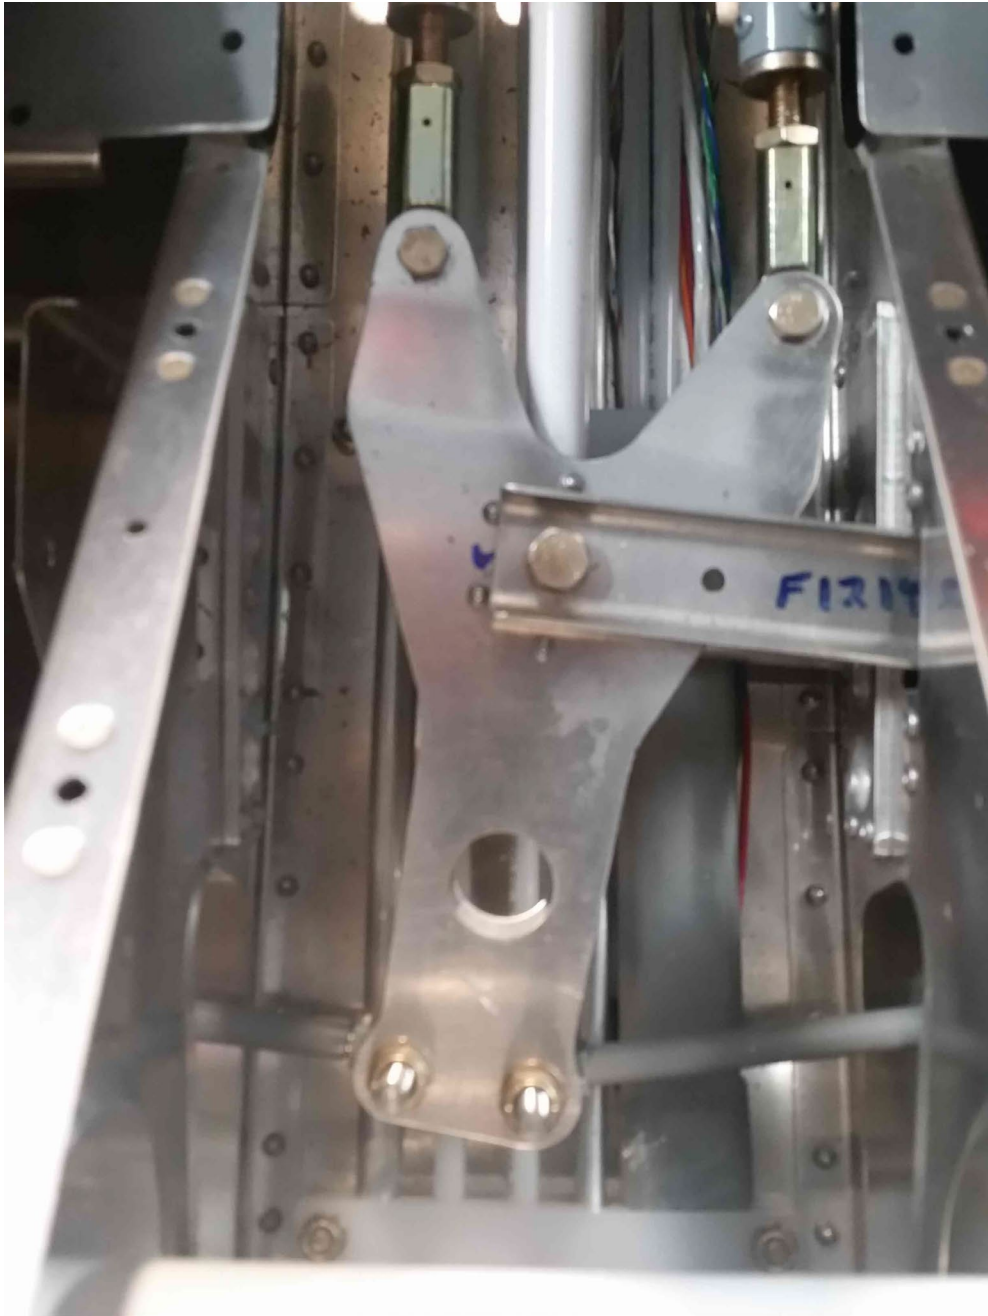
Review of the airplane builders log indicated that this construction error had been present in a photo dated August 5, 2019 (see figure 13).

**Figure 13 - Mixer bellcrank and eyebolts as shown in pilots build logs.**

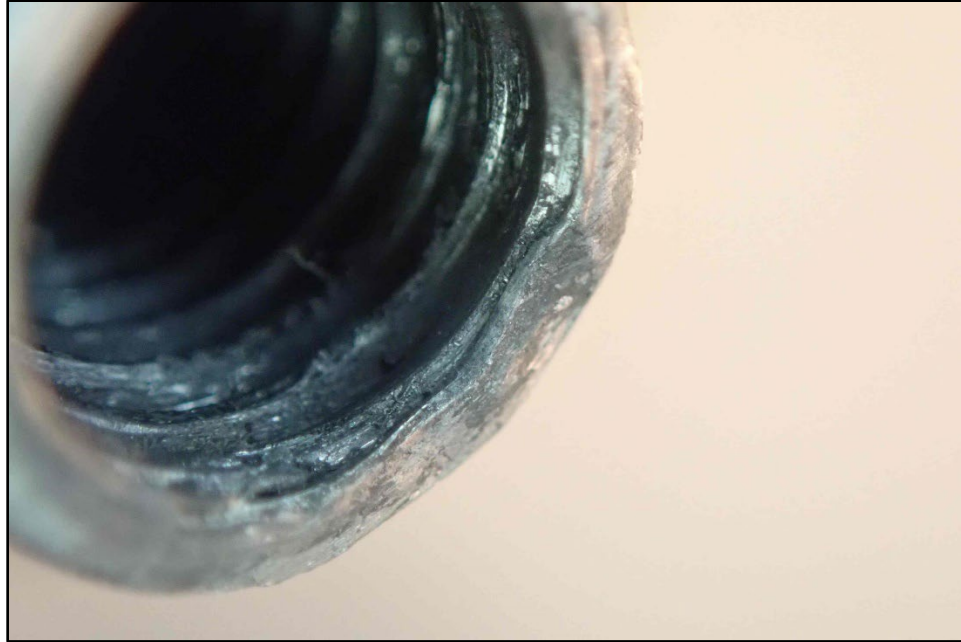
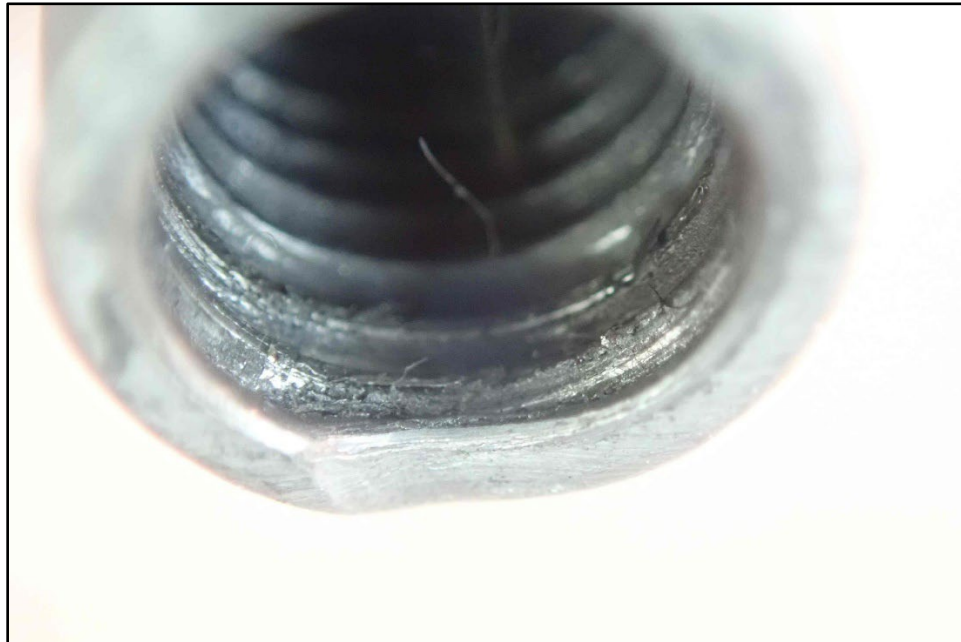
Closer examination of the inboard end of the left pushrod revealed that the internal threads were intact and undamaged, and the threads of the eyebolt stud did not exhibit any evidence of cross threading such as aluminum shards or debris. The outer crest of the pushrod thread exhibited inward bending deformation around its radius (see figure 14, 15).

**Figure 14 - Inboard end of the left pushrod.**

**Figure 15 - Inboard end of the left pushrod.**
