# National Transportation Safety Board

WPR24FA185

## EXAMINATION SUMMARY

Location: Picacho Peak State Park, Arizona  
Date: June 8, 2024  
Time: 0721MST  
0221UTC  
Airplane: N518D

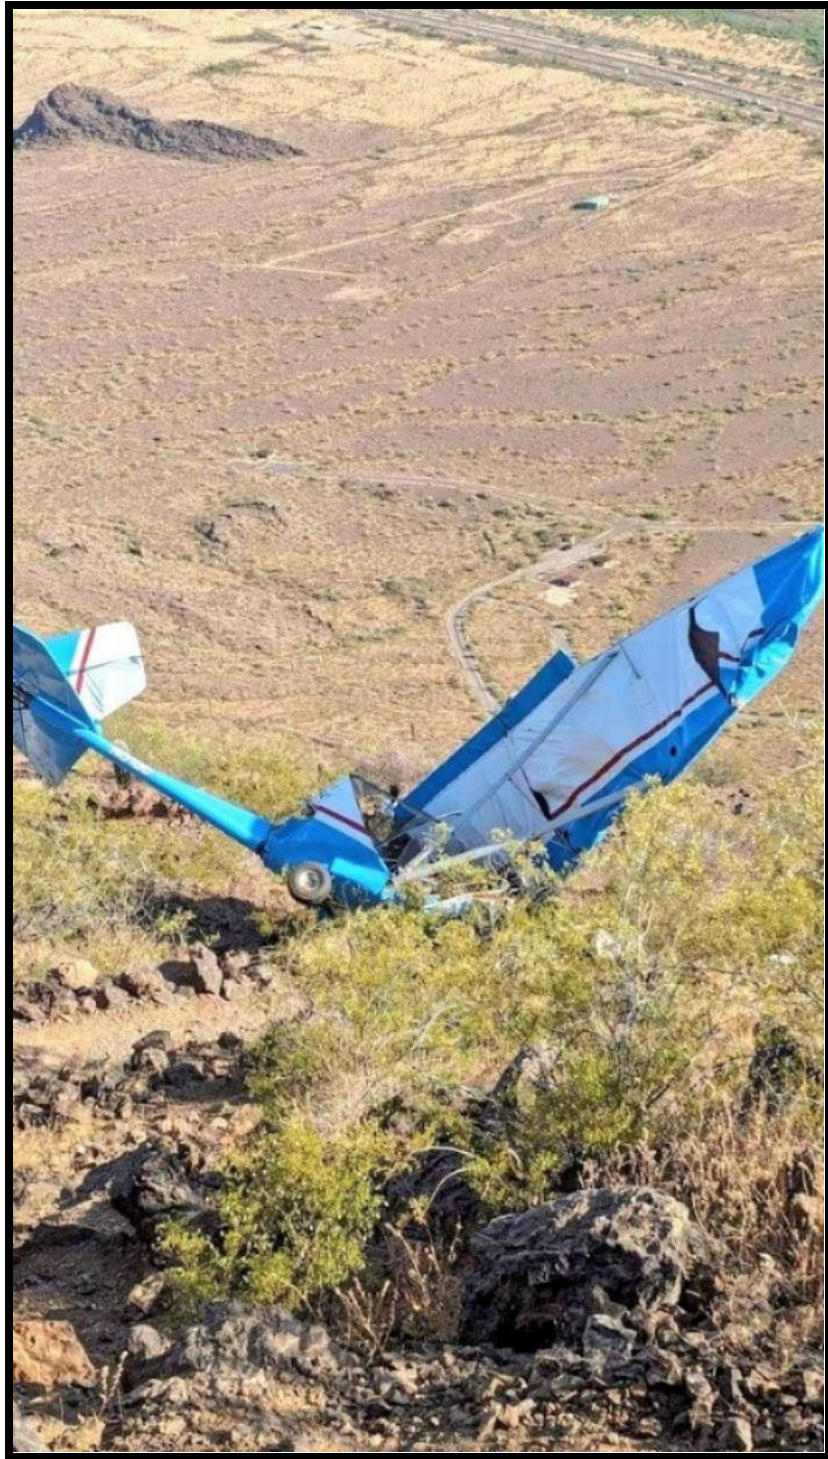
Observation of the wreckage was accomplished June 9, 2024, after first responders manipulated the airframe to extricate the occupant (Figure 1 & Figure 2). The wreckage site terrain was steep, unstable, and merely allowed for confirmation of flight control continuity. Examination of the engine was accomplished after the airplane was transported to a secure facility, to ensure investigator's safety. Examination of the airframe and engine revealed no preimpact mechanical anomalies or malfunctions that would have prevented normal operation.

**Figure 1:** View of the airplane in the initial impact position, prior to first responder aircraft manipulation to facilitate extrication (Courtesy of social media).

Both wings remained attached to the upper fuselage and the wing lift struts. The left (Figure 1) and right wing lift strut sustained impact damage about midspan. The right wing exhibited impact damage to the forward outboard section and showed accordion-like folding signatures from the outboard flap attachment, through the wing root. The right flap and aileron remained attached to the wing and control continuity was confirmed to the left and right control stick.

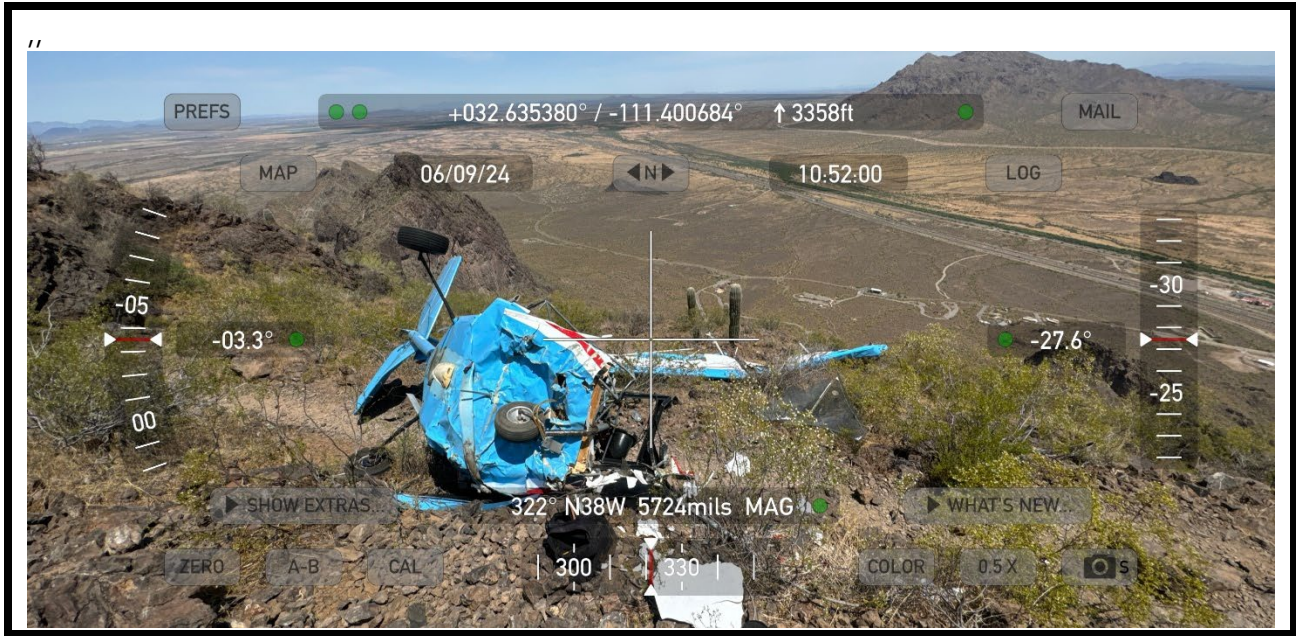
**Figure 2:** View of the airplane onsite, after first responder occupant extrication, showing damage to the nose section and forward fuselage due to initial impact.

The airplane came to rest on the left side forward fuselage with the nose oriented to the south, toward the summit, and conversely, the tail was oriented to the north. The horizontal axis of the airframe was observed in left wing low (left bank) attitude. The nose section of the airplane was crushed upward and aft. The cabin exhibited uninhabitable space encroachment as the forward fuselage sustained the brunt of the impact damage. Flight control continuity was visually and physically observed from the left and right control stick to left and right aileron surfaces, as well as to the elevator, and the flaps were retracted. Control cable continuity was observed from the rudder pedals to the rudder control surface.

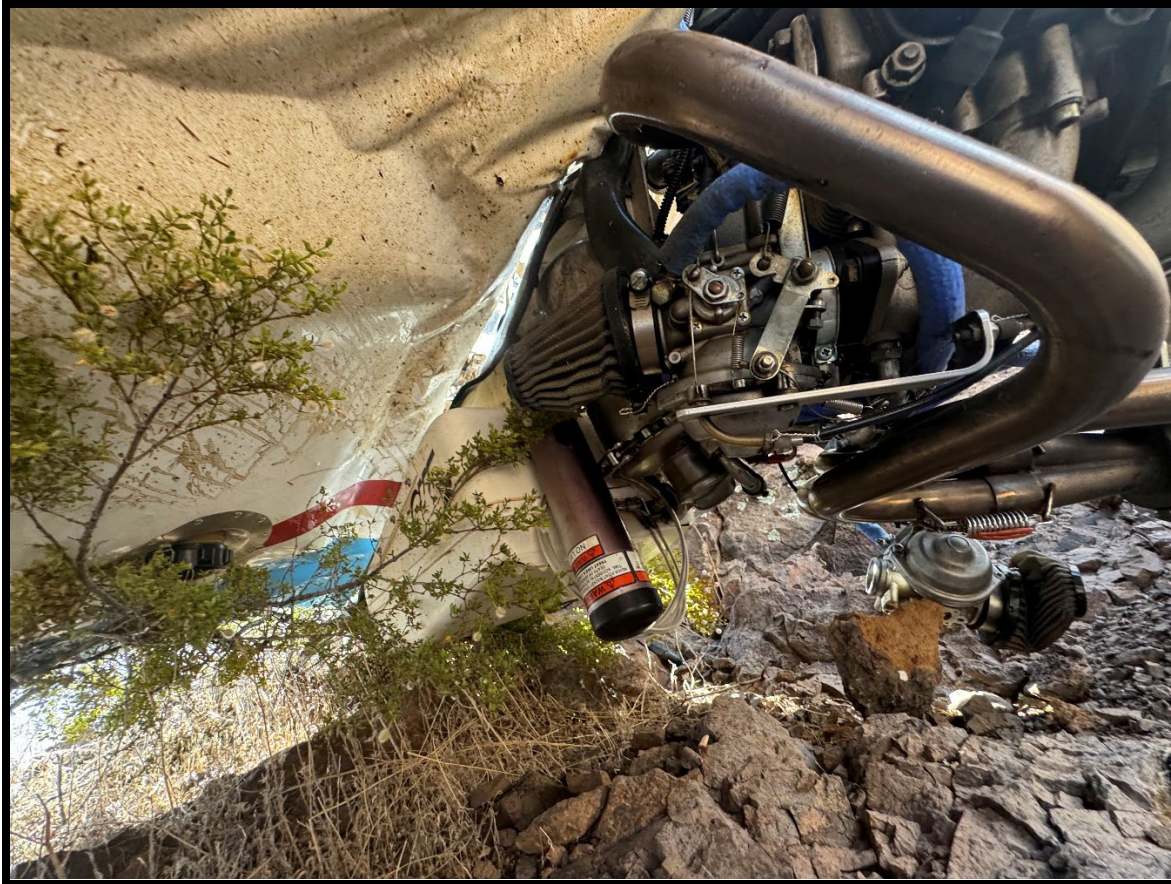
On-site the fuel lines appeared intact. The wing tank was breached, and the faint odor of fuel was observed. The fuel cap was present and unremarkable. The engine driven and auxiliary fuel pumps remained intact, as did the fuel filter. The fuel selector was manipulated by first responders and found in the off position. The 1/3 carburetor sustained impact damage and the 2/4 carburetor remained intact (Figure 3).

**Figure 3:** View of the inverted engine and damage to the 1/3 carburetor.

The #1/3 carburetor was found displaced from its respective intake manifold, and the carburetor socket clamp that secured the carburetor to the intake socket was missing. The #1/3 carburetor was reattached to the intake manifold in preparation for the engine test run. The air filter attached to the carburetor was removed, and the piston slide was inspected. No anomalies were

observed with the piston slide or the bore of the carburetor. The throttle lever arm sustained impact damage and was found bent inwards towards the carburetor body. The throttle lever arm spring was found configured in the spring close position, in the event of a throttle cable breakage. Although this setup differs from the standard Rotax factory configuration, the RANS installation manual provided instructions for connecting the throttle arm spring in this manner. Slight fuel staining was observed on the outside of the carburetor body. The #1/3 carburetor was function tested during the engine test run and performed correctly.

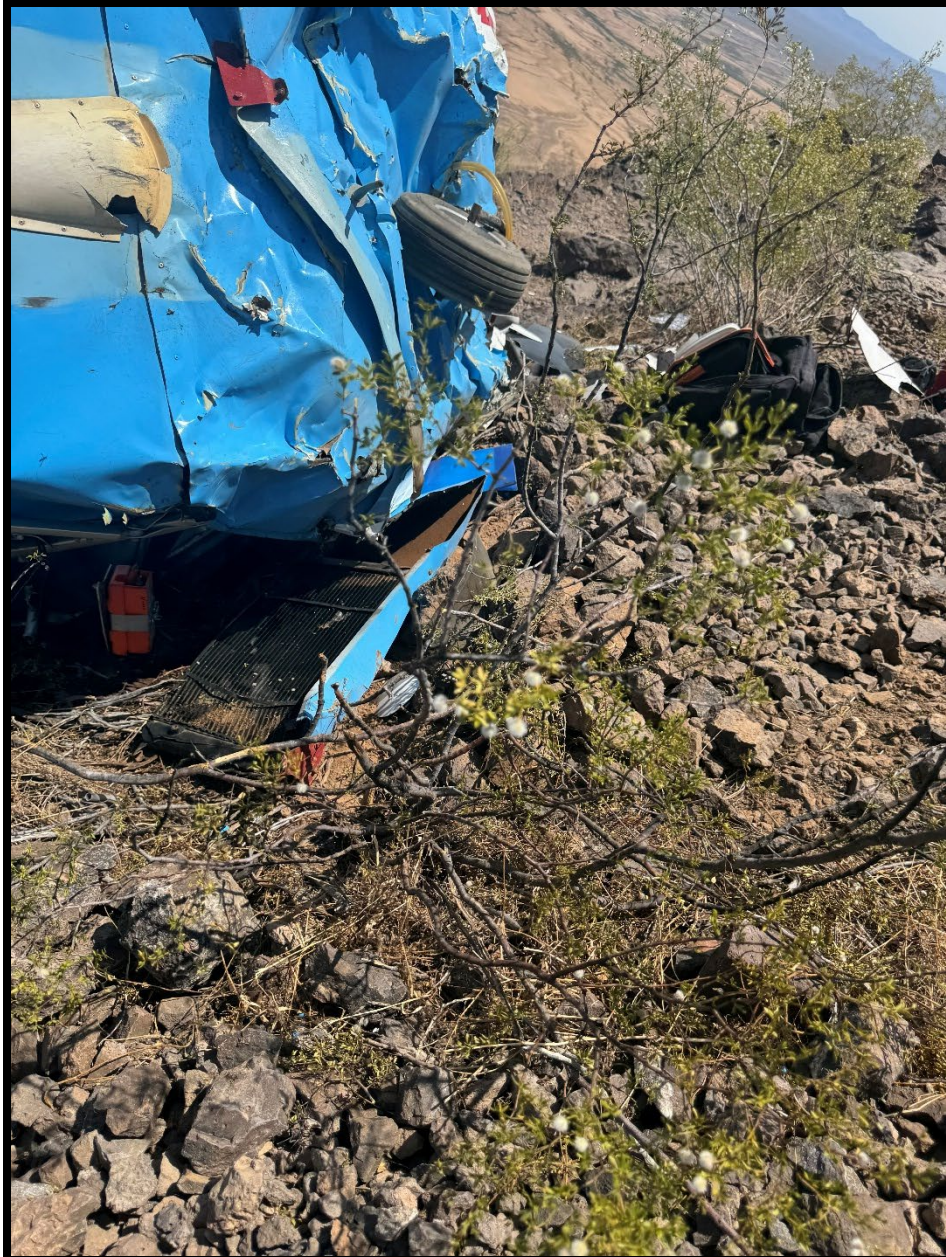
- The #1/3 carburetor was displaced from the intake manifold due to impact damage.
- The coolant radiator was not present for examination, and the coolant system was breached (Figure 4).
- All three propeller blades were broken off approximately 4 to 6 inches from the hub.

**Figure 4:** On-site view of damage to the engine coolant system radiator.

The coolant system was damaged, and the coolant radiator was not present for examination. The engine was test run without the coolant radiator or coolant in the system.

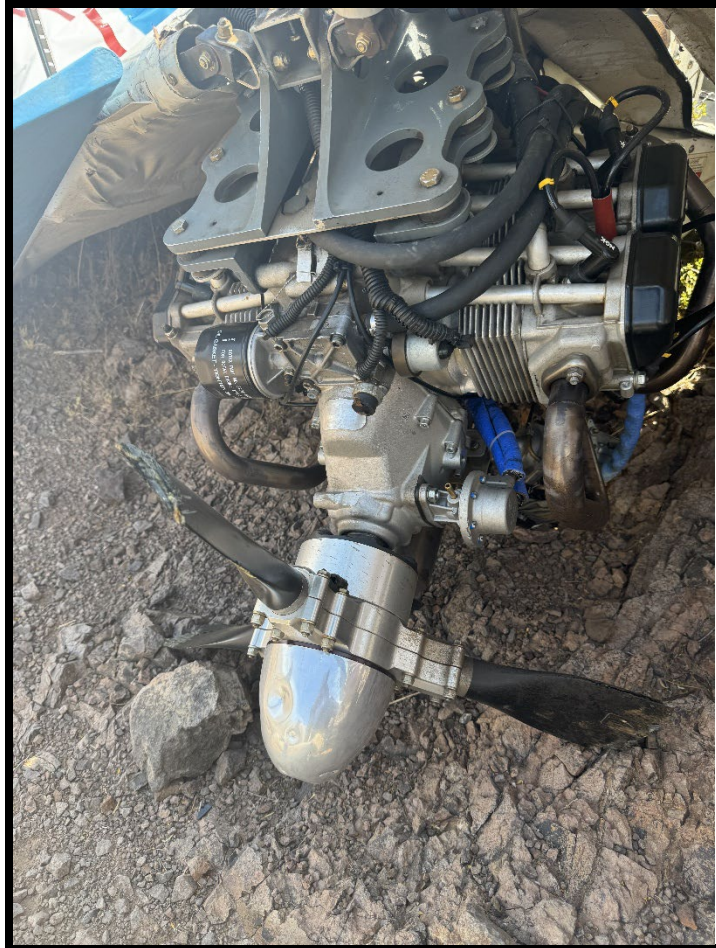
The propeller hub was configured with a Saber propeller extension. The Powerfin Inc. propeller hub was unremarkable, and the propeller hub

contained the base of three carbon fiber propeller blades (Figure 5). Each of the blades were fracture-separated evenly about 6 inches from the hub. The spinner sustained minor impact damage.

**Figure 5:** View of the inverted engine with unremarkable propeller hub extension, hub, damaged propeller blade and minor damage sustained to the spinner.
