# National Transportation Safety Board

WPR24FA190

## **AIRFRAME AND ENGINE EXAM SUMMARY REPORT**

Location: Elk River, Idaho  
Date: June 12, 2024  
Time: 10:06 Pacific daylight time  
Airplane: N34903, Cessna 177B

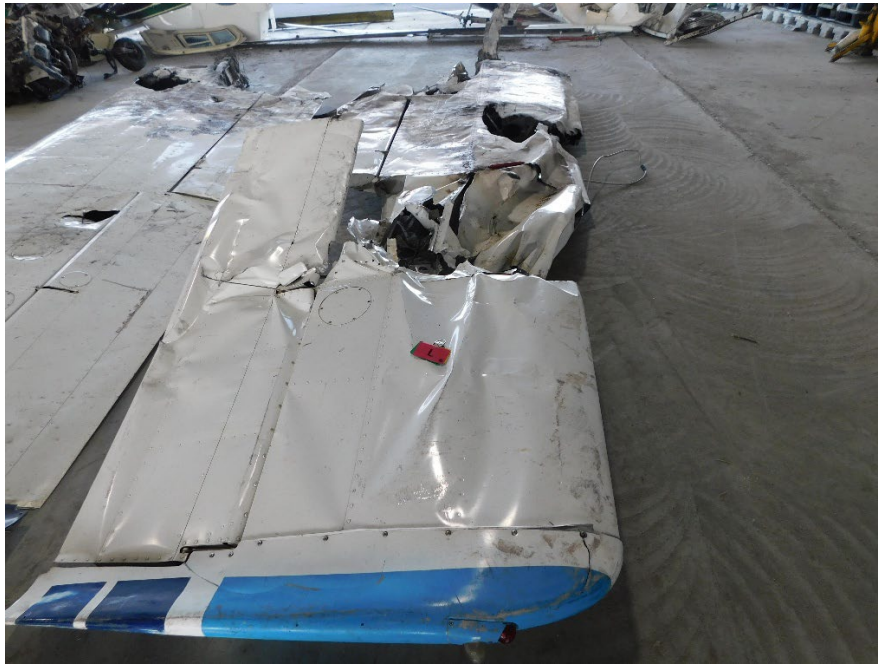
The inboard 6 ft of the left wing was thermally damaged. It displayed bending and crushing throughout. The outboard 3 ft of the left wing, and the left aileron were

separated from the wing, consistent with a tree strike. The left aileron remained attached to the separated outboard section of left wing, and displayed bending, midspan. The left flap remained attached to the wing at its attachment points and displayed trailing edge bending and crushing. (see figure 1)

Figure 1. Left wing.

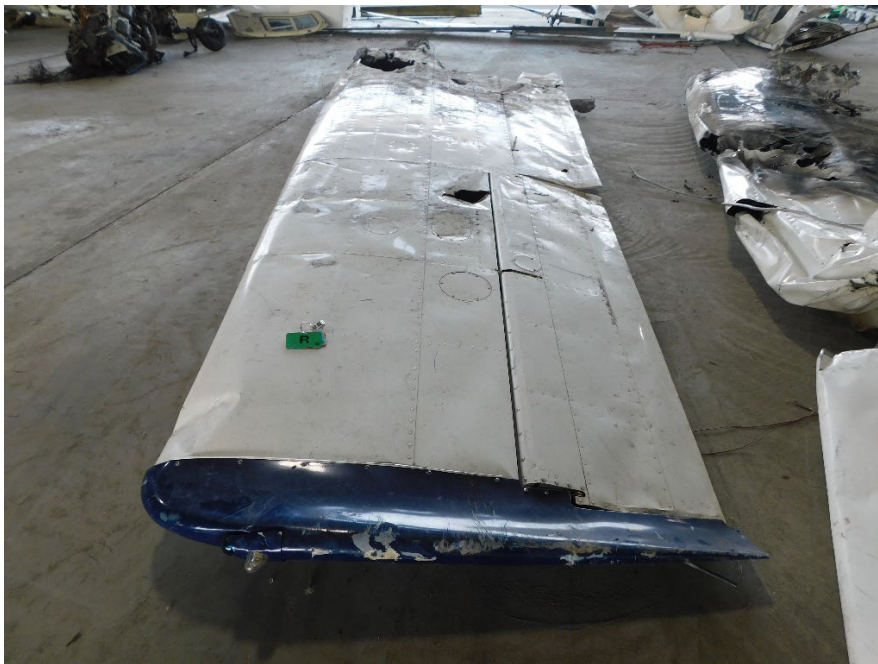
The inboard half of the right wing was thermally damaged. It displayed various dents, and areas of crushing, throughout. The right aileron and flap remained attached at their attachment points. (see figure 2)

Figure 2. Right wing.

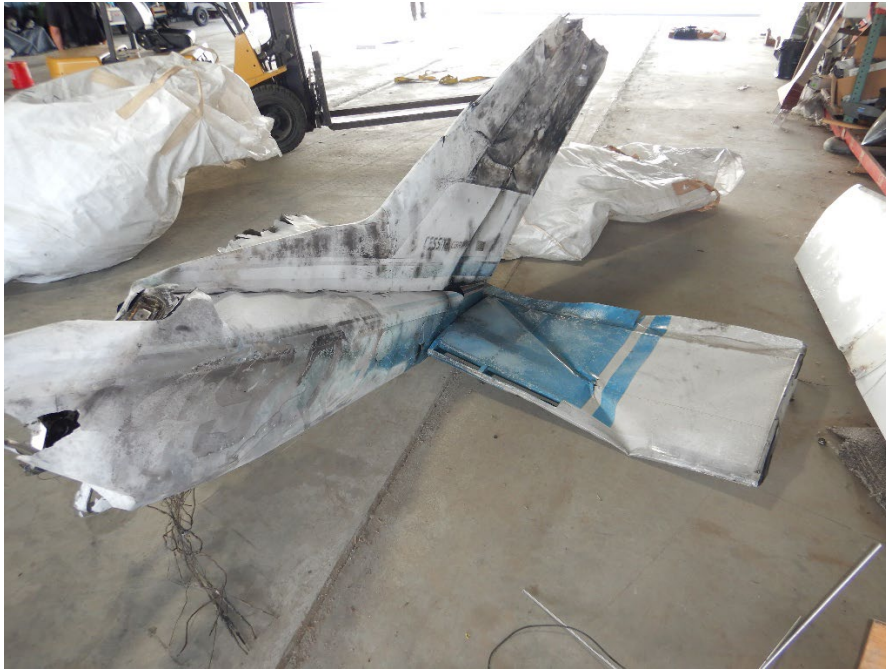
The empennage displayed thermal damage. The vertical stabilizer, rudder, and horizontal stabilator, remained attached to the empennage; all displayed denting, crushing and buckling throughout. The left side of the horizontal stabilator displayed upward bending and crushing, midspan. The outboard 12 inches of the right side of the horizontal stabilator displayed thermal erosion. The stabilator trim tab remained attached to the horizontal stabilator. (see figure 3)

Figure 3. Empennage.

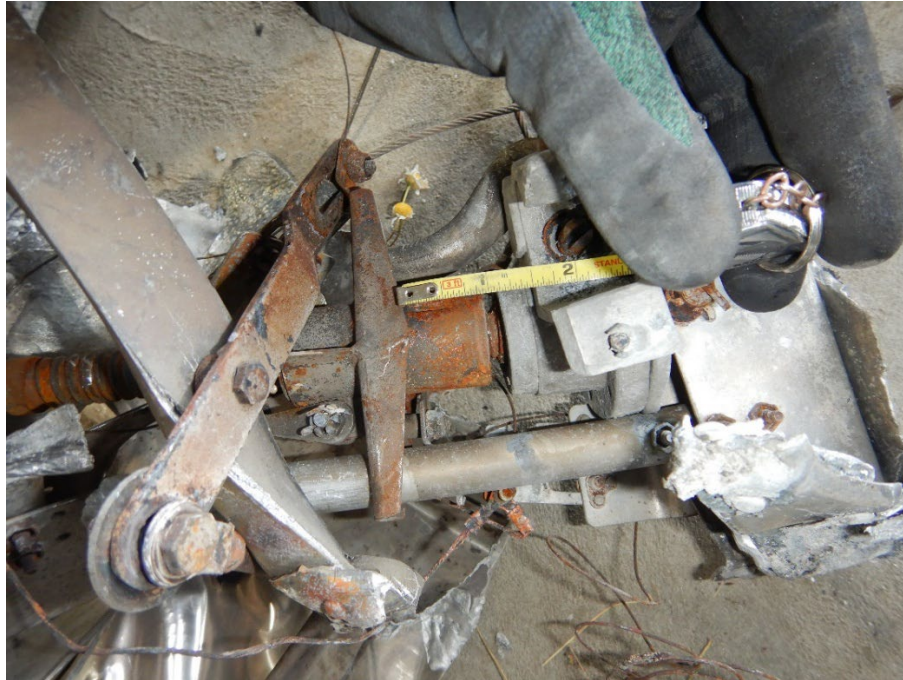
The flap actuator mechanism screw drive extension dimension indicated that the flaps were extended to approximately 30° based on the measurement of approximately .30 in. from the jackscrew motor to the jackscrew carrier. (see figure 4)

Figure 4. Measurement between the jackscrew motor and jackscrew carrier (Courtesy of Textron)

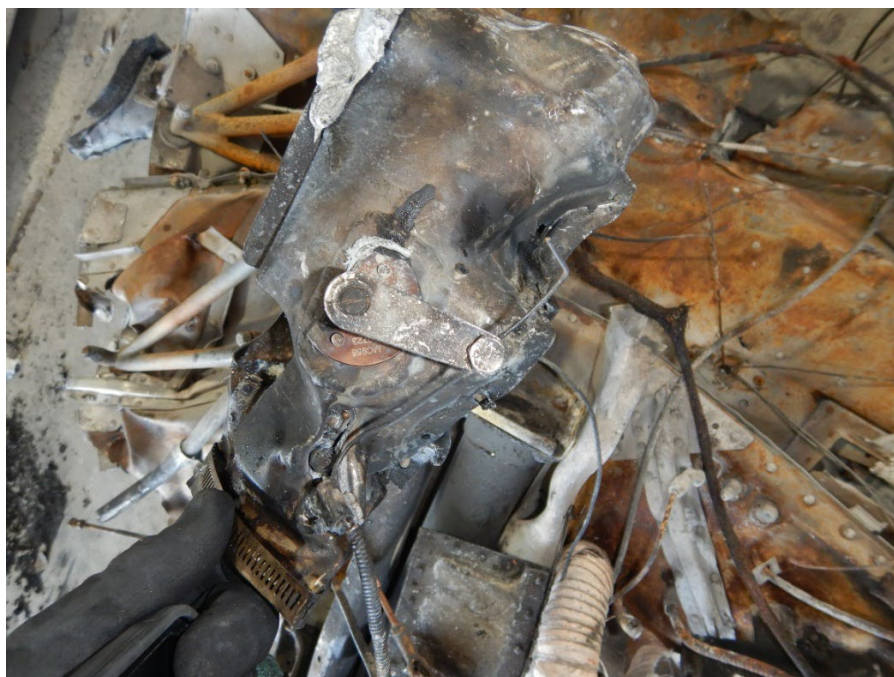
The carburetor heat control arm was found attached to the airbox, and the heat door was observed in the open position. The carburetor heat control cable was attached to the control arm. The airbox displayed crush damage. (see figure 5)

Figure 5. Carburetor heat control arm and airbox (Courtesy of Textron)

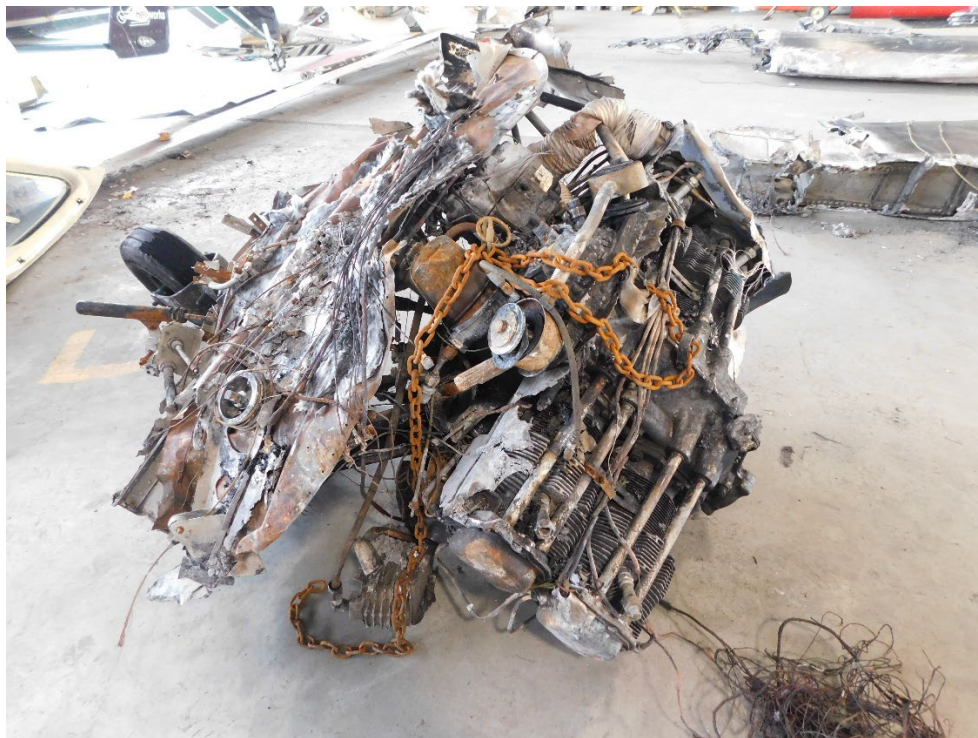
The engine was thermally damaged and remained attached to the firewall. The firewall was thermally separated from the fuselage. (see figure 6)

Figure 6. View of engine.

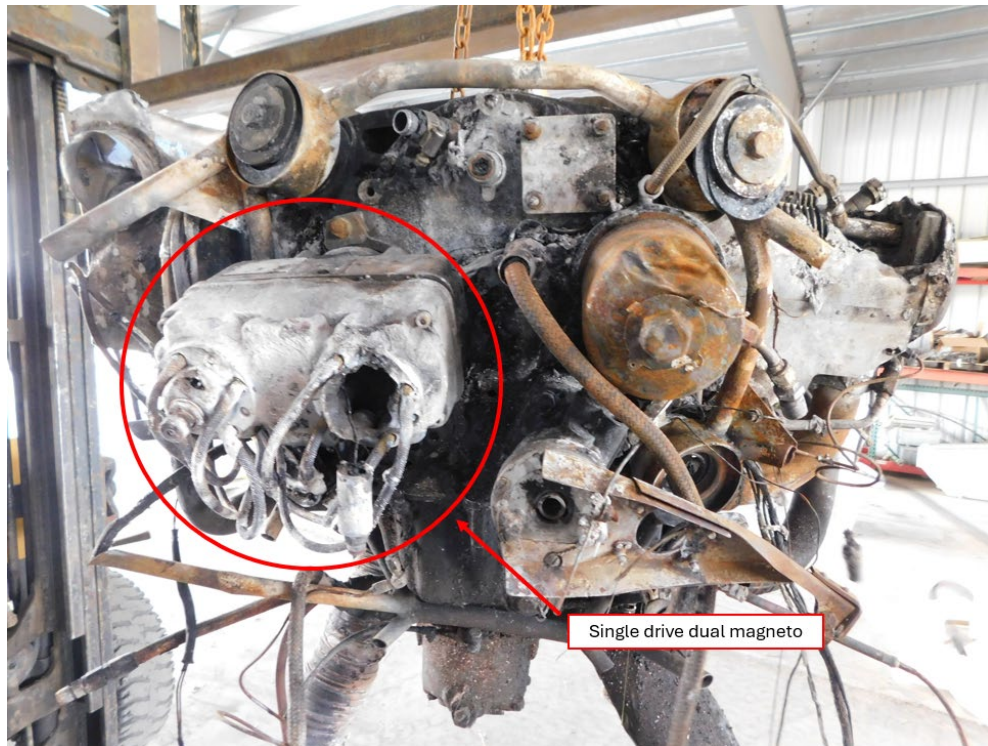
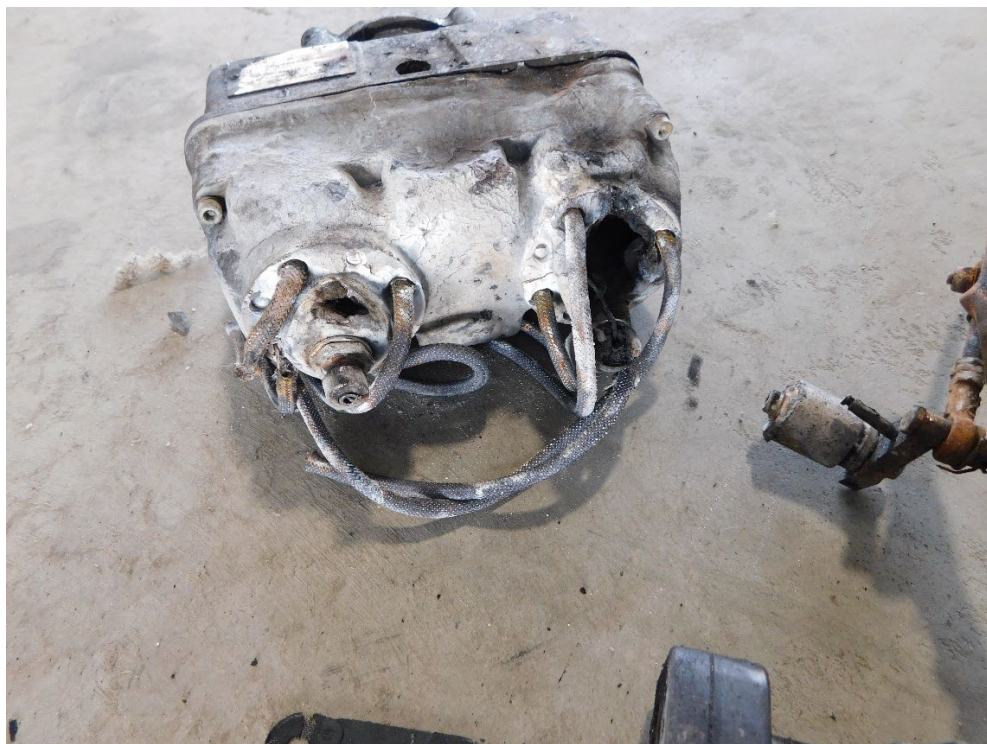
The single drive, dual magneto displayed thermal damage. Due to the damage, it was unable to be tested or rotated. (see figures 7 and 8)

Figure 7. Single drive dual magneto before removal from engine.

Figure 8. Single drive dual magneto after removal from engine.

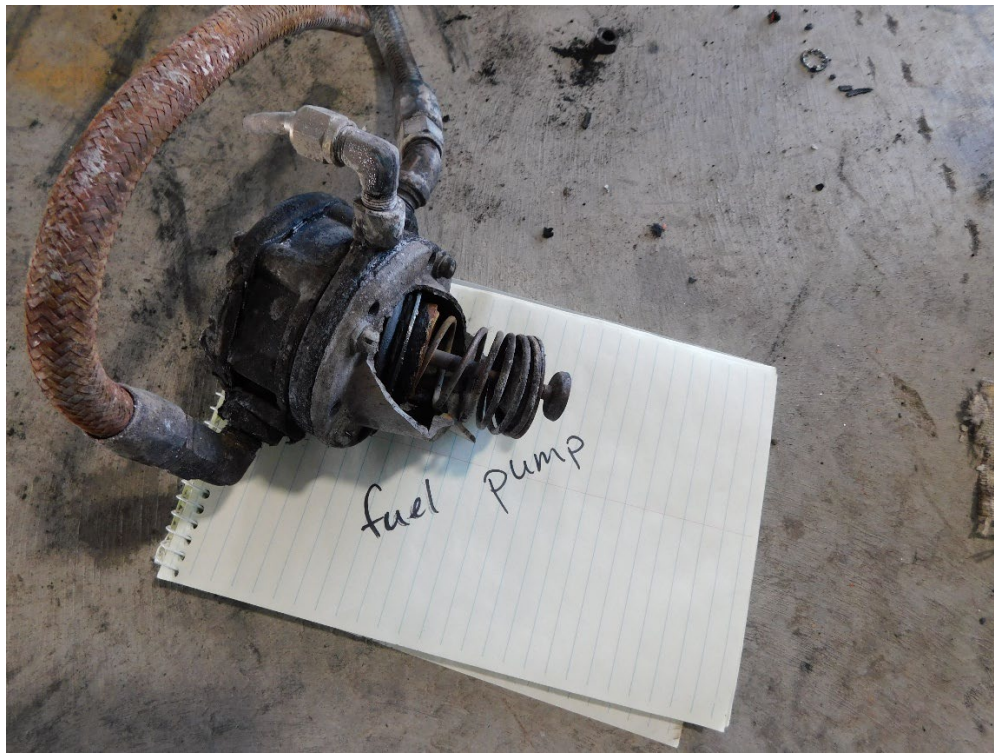
The fuel pump was separated from the flange and was thermally damaged. Due to impact and thermal damage, the fuel pump was unable to be tested. (see figure 9)

Figure 9. Fuel pump.

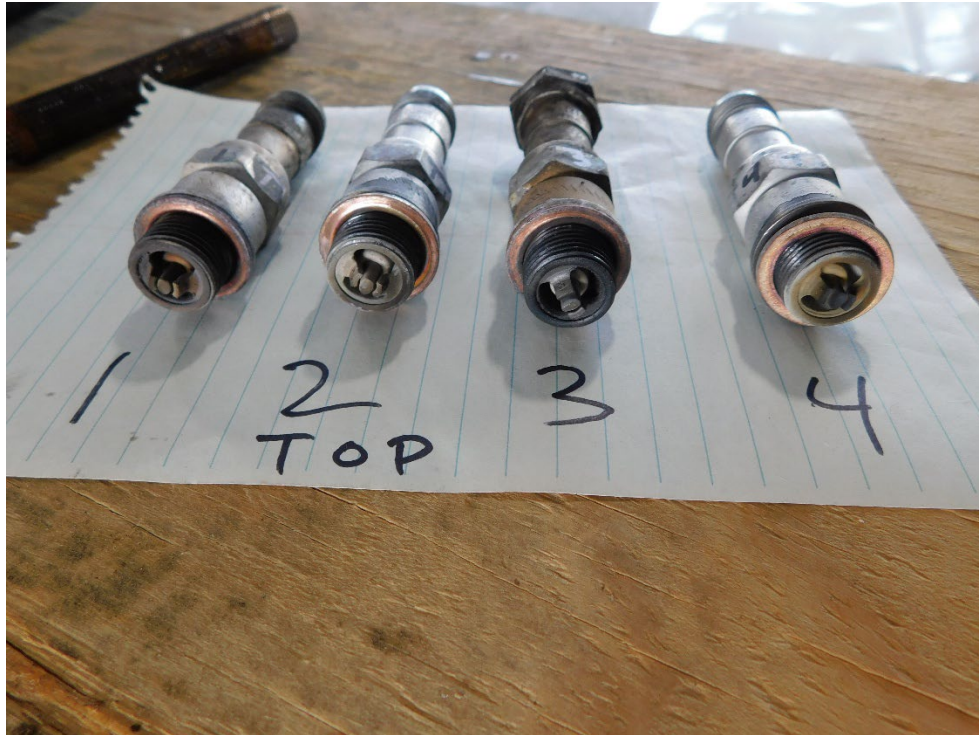
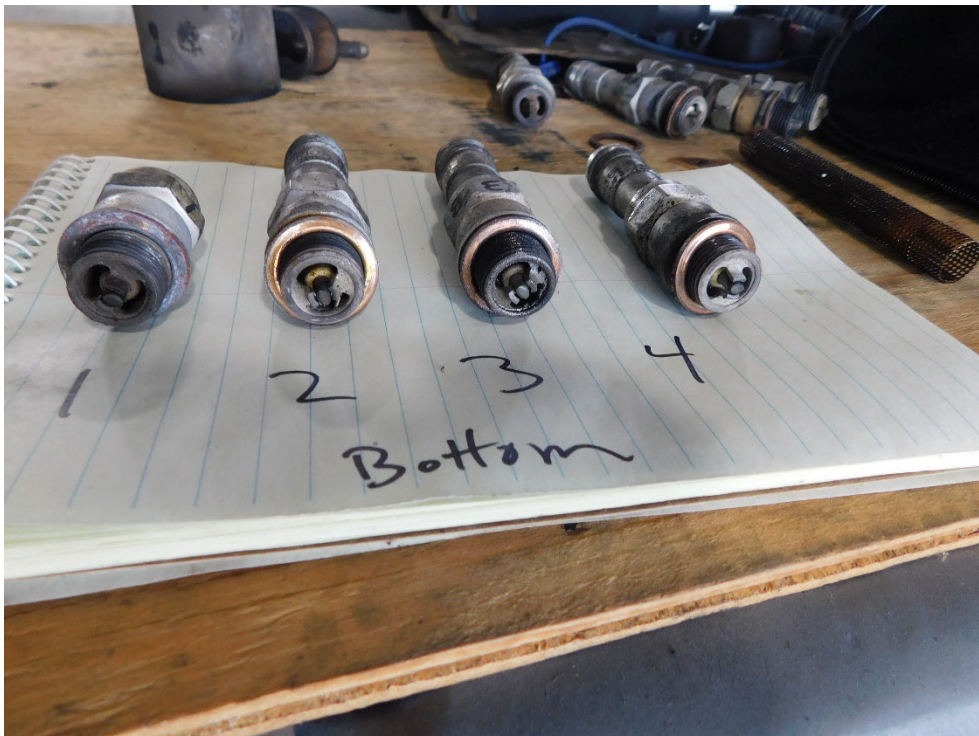
The top and bottom spark plugs were removed. All of the spark plugs were observed to be consistent with "worn severe", when referencing the Champion Aviation Check-A-Plug Chart AV-27. (see figures 10 and 11)

Figure 10. Top spark plugs.

Figure 11. Bottom spark plugs.

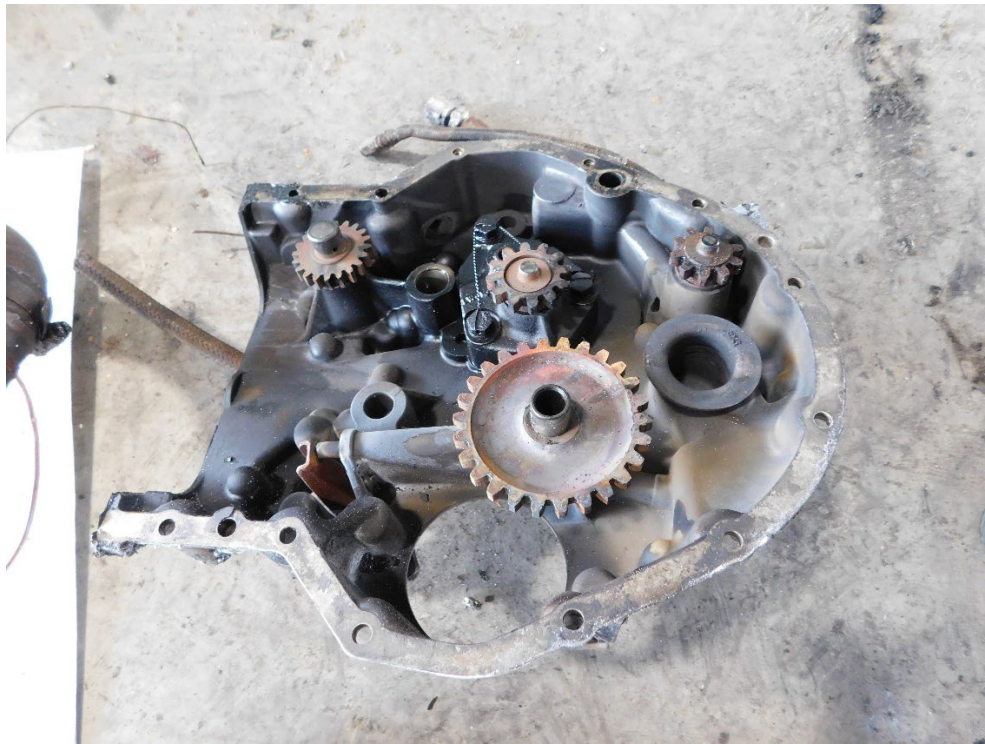
The crankshaft was unable to be rotated by hand and thumb compression could not be confirmed. The cylinders were removed, and no anomalies were noted. The connecting rods could be individually rotated. The camshaft could be manually rotated. The accessory case was disassembled. (see figure 12) The oil pump could be manually rotated. The engine case was disassembled. The flange was separated from the forward end of the crankshaft. No other anomalies were noted.

Figure 12. Accessory case.

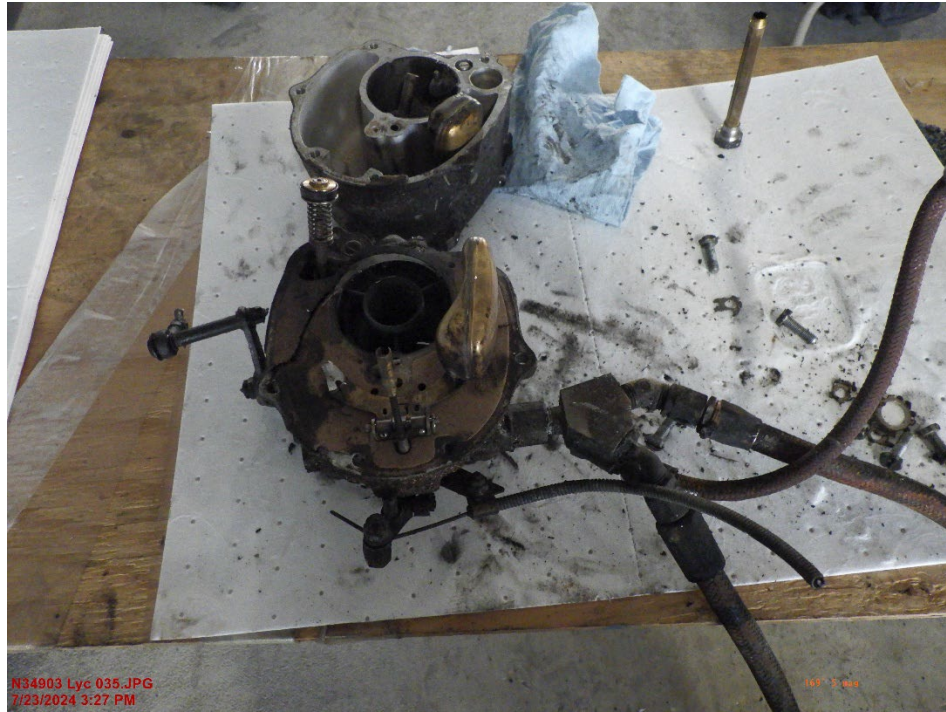
The carburetor was observed partially separated at the flange. It was disassembled and found to be thermally damaged. One float was separated from the float assembly. Melted solder was noted. (see figure 13)

Figure 13. Disassembled carburetor (courtesy of Lycoming)

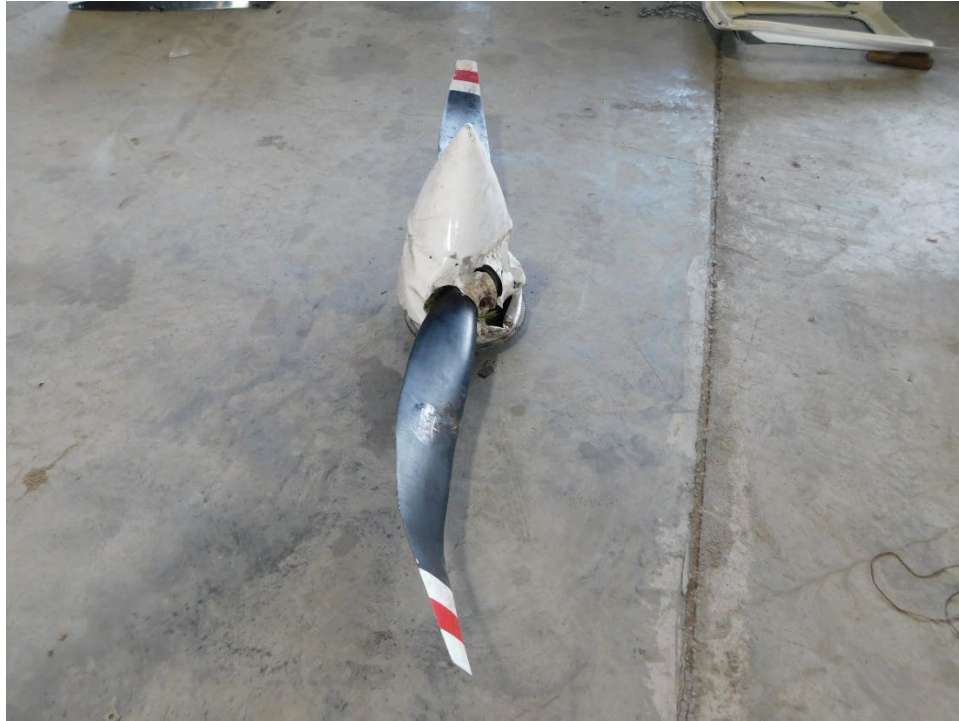
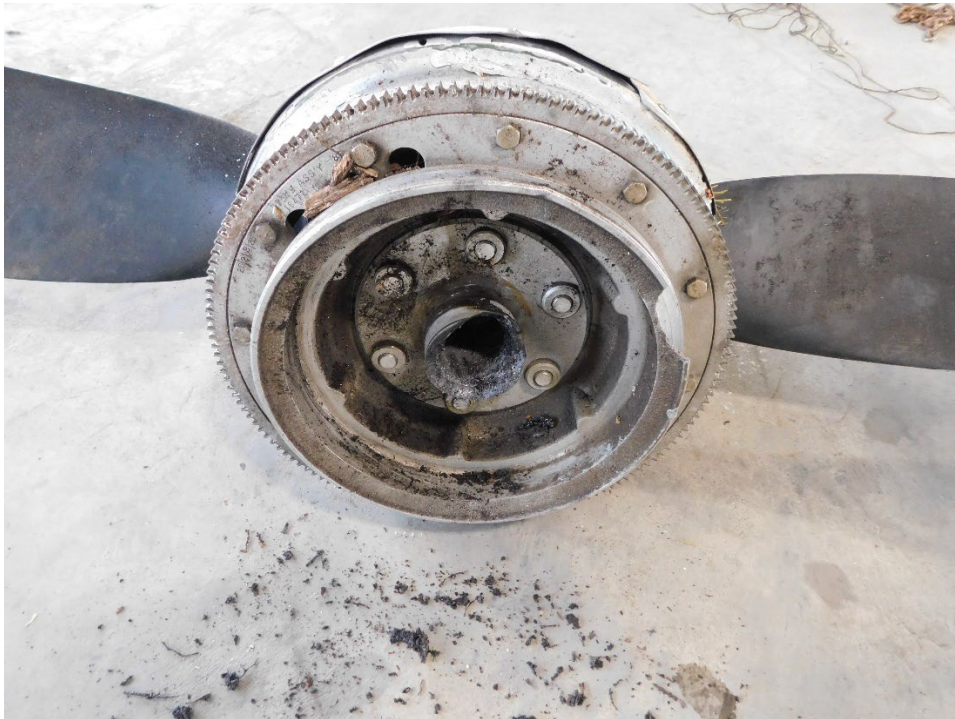
The engine's propeller assembly separated from the crankshaft at the aft side of the crankshaft flange. The flange and both blades remained attached to the hub. Blades A and B displayed forward bending and leading edge scraping on the outboard half of the blades. (see figures 14-17)

Figure 14. View of propeller assembly.

Figure 17. Aft view of propeller hub assembly and aft side of crankshaft flange.

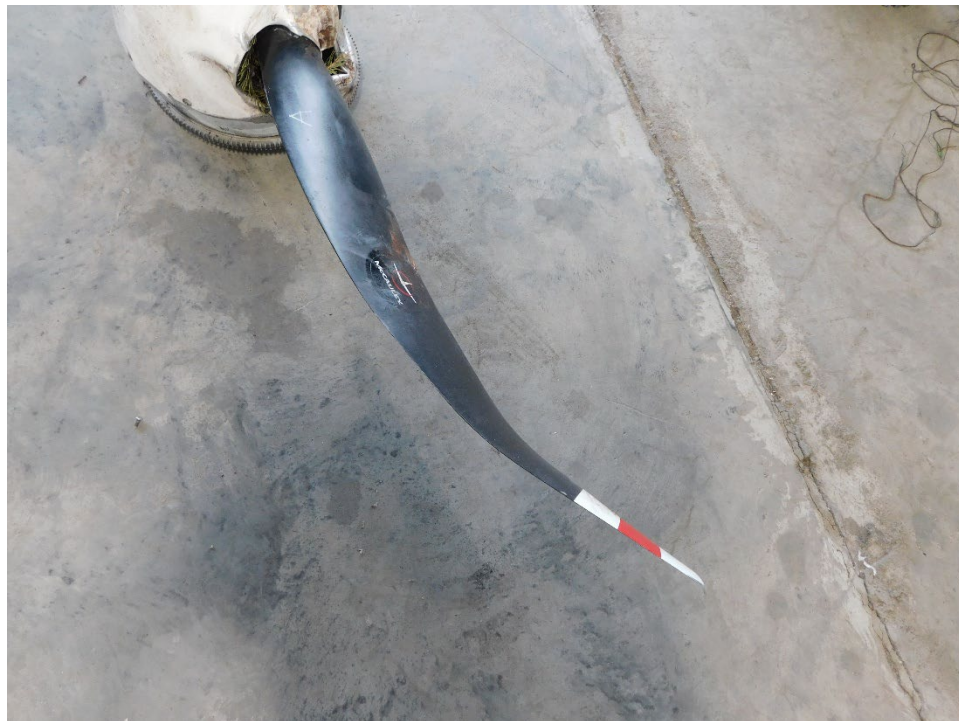
Figure 15. Blade A forward bending.

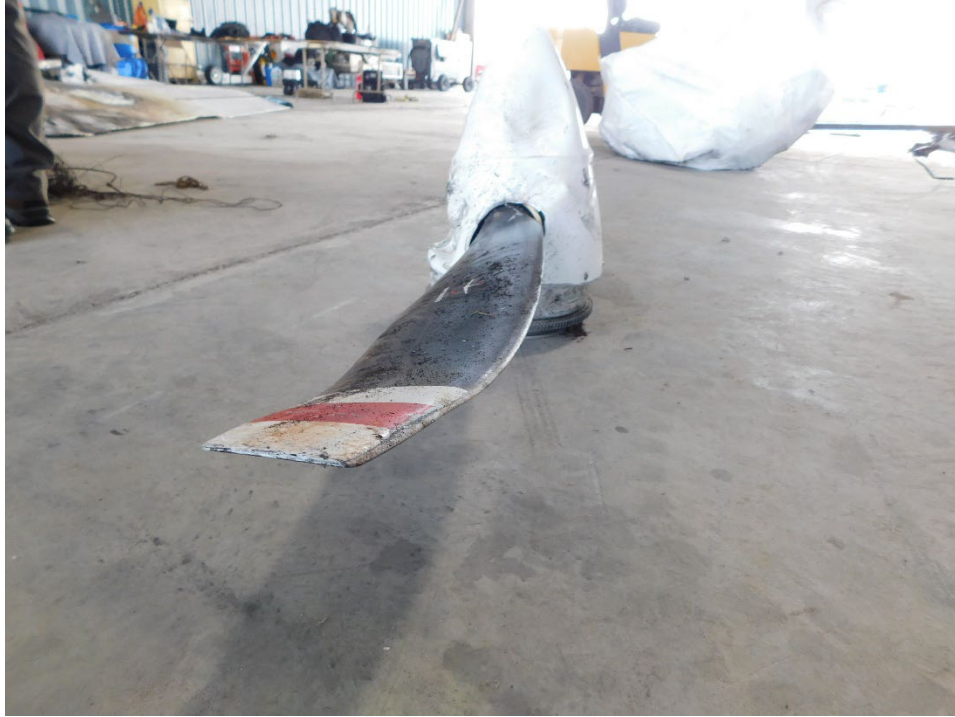
Figure 16. Blade B forward bending.

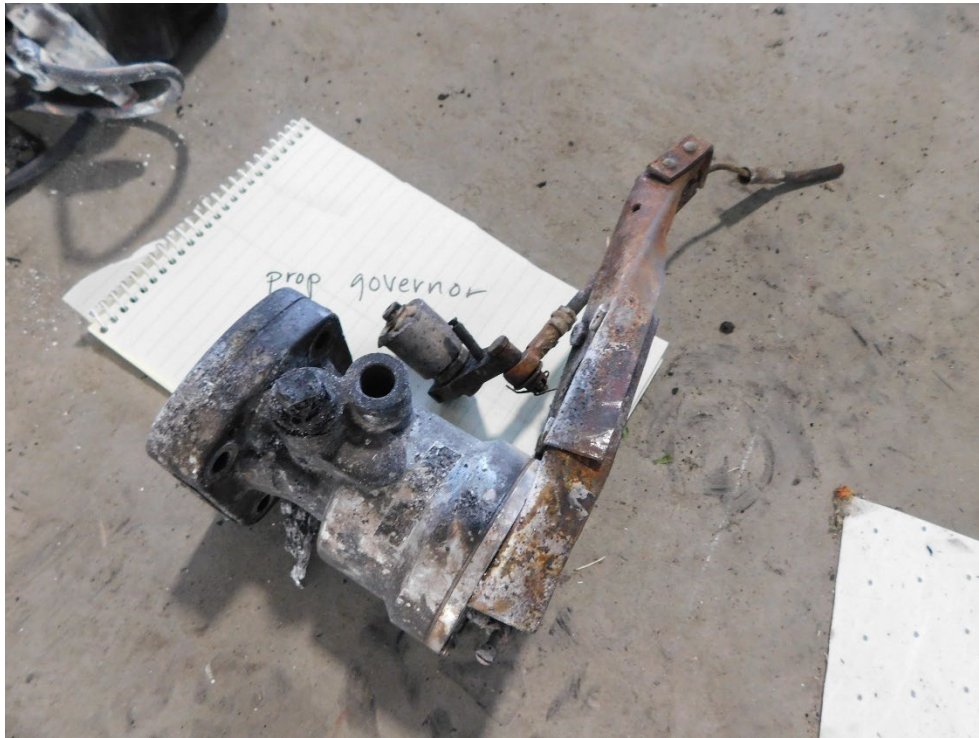
The propeller governor was removed. The control arm and post were separated from the governor, consistent with impact damage. The control cable was attached to the

arm and control cable continuity was confirmed through the firewall, to the cockpit control. (see figure 18) The propeller governor oil screen free of debris.

Figure 18. Propeller governor.
