# National Transportation Safety Board

WPR24FA190

## METEOROLOGY

Date: June 12, 2024  
Time: 1006 Pacific daylight time (PDT)  
1706 coordinated universal time (UTC)  
Location: Elk River, Idaho  
Aircraft: Cessna 177 Cardinal      Registration: N34903

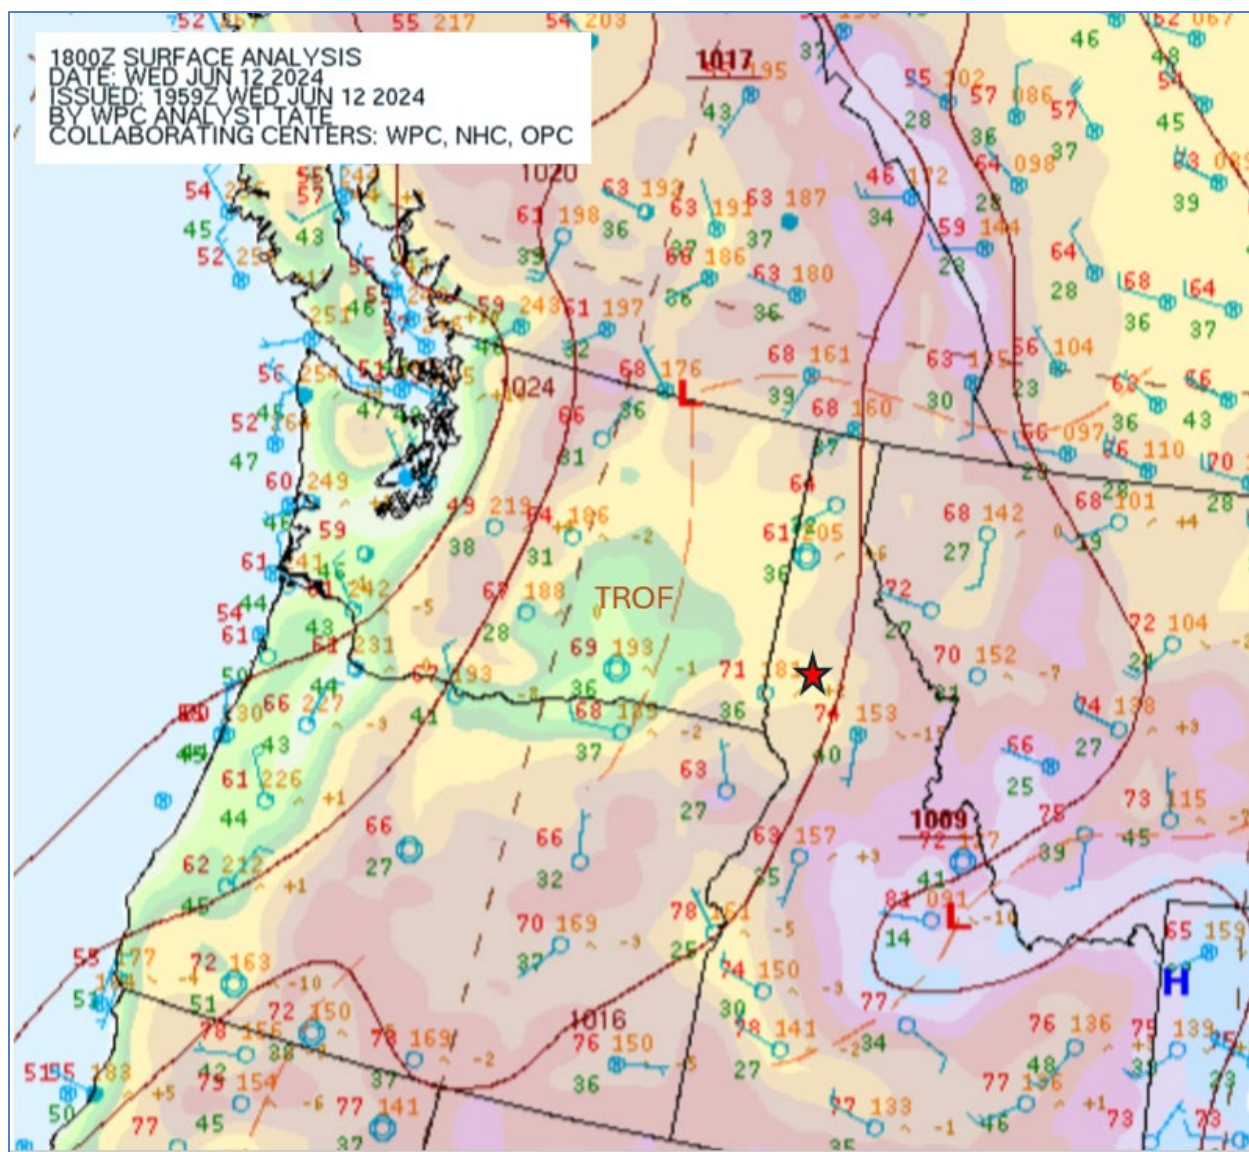
The NWS northwest section of the Surface Analysis chart for 1100 PDT (1800Z) is included as figure 1 with colored topography. The chart depicted a low-pressure system at 1017-hectopascals (hPa) over the British Columbia and the Washington border with a trough (abbreviated TROF) of low pressure extending southward over eastern Washington and Oregon. Another low at 1009-hPa and trough was located over central Idaho to the southeast of the accident site. The accident site was located ahead of the trough over Washington and in an area of light winds with no other boundaries in the vicinity of the accident site. The closest station model for Lewiston (KLWS), Idaho, southwest of the accident site indicated calm wind, clear skies below 12,000 ft agl, a temperature of 71° Fahrenheit (F), and a dew point temperature of 36°F. No significant weather was indicated over the area at the time.

**Figure 1 - Northwest section of the NWS Surface Analysis Chart for 1100 PDT with the approximate accident site marked by the red star.**

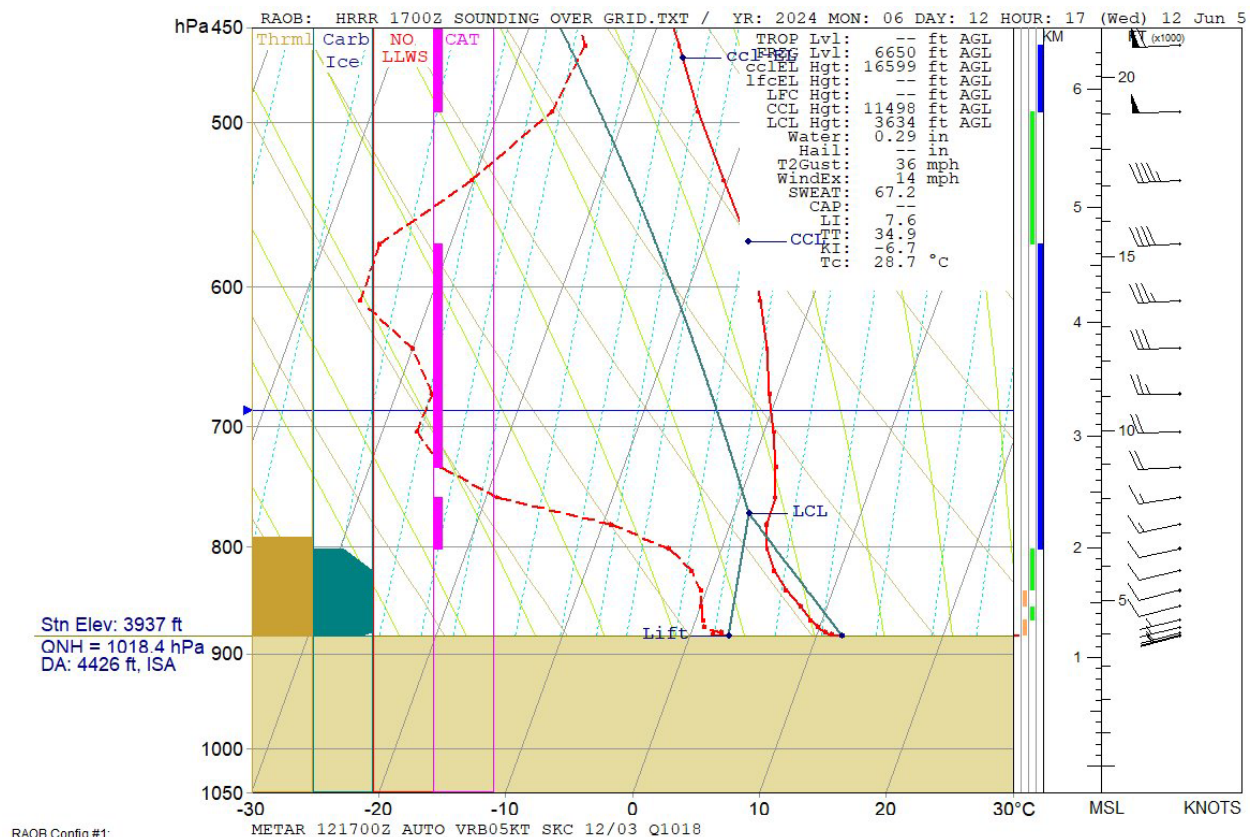
A High-Resolution Rapid Refresh (HRRR) numerical model data were retrieved from the NOAA Air Resource laboratory for the closest grid point to the accident site. The data was then plotted on a standard Skew T/Log P diagram using the RAOB Analysis software. Figure 2 is the HRRR sounding plot for 1000 PDT from the surface to 450-hPa or approximately 21,000 ft.

**Figure 2 - High-Resolution Rapid Refresh (HRRR) numerical model over the closest grid point to the accident site for 1000 PDT depicting the vertical structure of the atmosphere over the area.**

The sounding indicated an elevation of 3,937 ft over the grid point with a near surface temperature of 53.6°F (12°C), a dew point temperature of 37.6°F (3.1°C), with a relative humidity of 54%, which resulted in a density altitude of 4,426 ft. The sounding indicated a dry low-level environment with the lifted condensation level (LCL) at 3,634 ft agl, which supported thermals from the surface through 3,000 ft. The atmosphere was characterized as stable above 3,300 ft agl with a Lifted index (LI) of 7.6, with no positive convective available potential energy (CAPE) indicated. The precipitable water content was 0.29 inches and the freezing level was identified at 10,587 ft, with no structural icing conditions indicated. Based on the sounding temperature and moisture profile the RAOB Analysis program indicated a severe risk of carburetor or induction system icing from the surface through 6,000 ft (indicated by dark green shading on left axis).

The sounding wind profile indicated a westerly wind at 5 knots, with winds slowly increasing with altitude to 20 knots at 9,000 ft. No strong vertical or horizontal wind shears were noted below 12,000 ft to suggest anything but light turbulence.

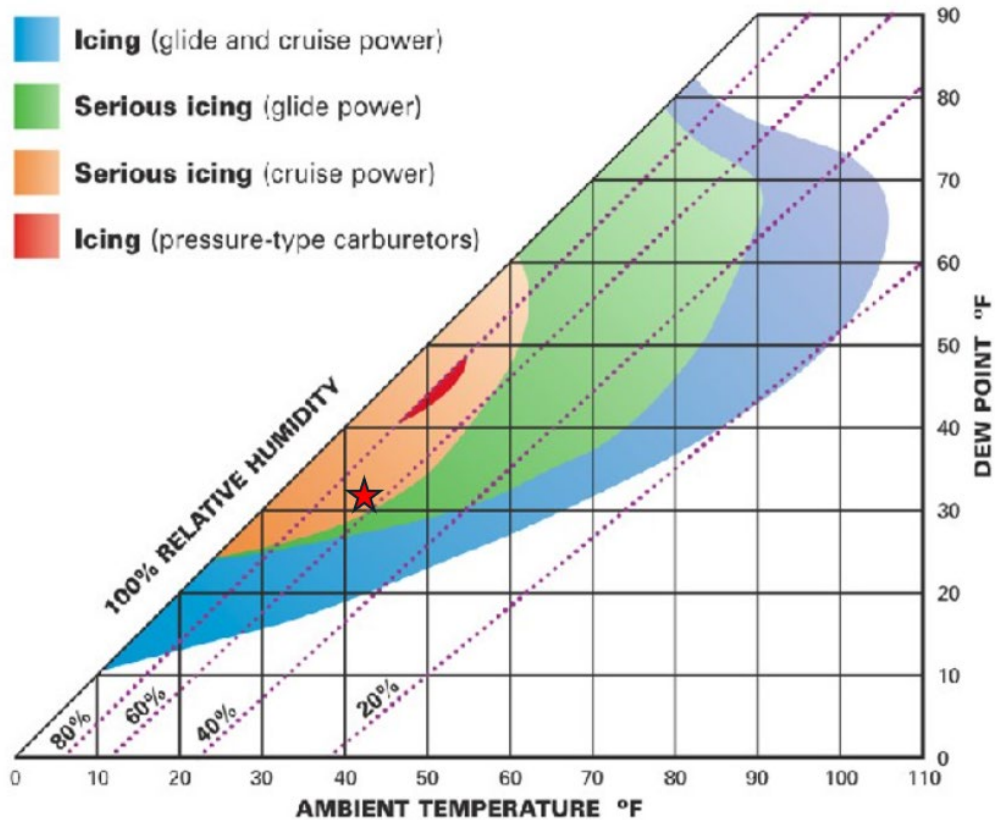
At the last radar hit at 1003 PDT the accident airplane was at 5,400 ft. The HRRR indicated at 5,294 ft the forecast temperature was 42.8°F (6°C), the dew point temperature was 31°F (-0.4°C), with a relative humidity of 62%, and a density altitude of 5,390 ft. The RAOB Analysis program indicated severe carburetor icing at cruise or climb power based on the SAE 1970s Fuel and Lubricants Laboratory study on carburetor. The FAA carburetor icing chart given the weather conditions is plotted in figure 3, and indicated a serious icing condition in climb and cruise power.

**Figure 3 - FAA Carburetor icing Potential given the conditions over the area at 1000 PDT.**
