# National Transportation Safety Board

WPR24FA190

## **ON SCENE SUMMARY REPORT**

Location: Elk River, Idaho  
Date: June 12, 2024  
Time: 10:06 Pacific daylight time  
Airplane: N34903, Cessna 177B

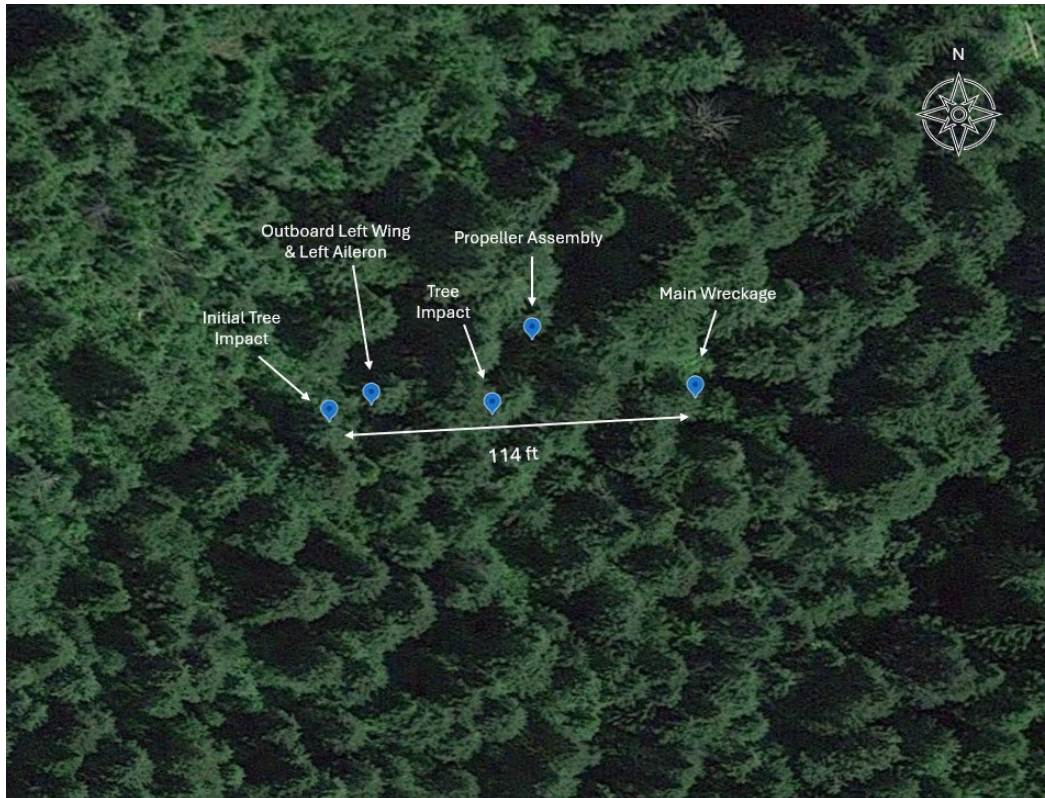
Examination of the accident site revealed that the airplane impacted 45° sloping, wooded terrain about 5.2 miles north of the departure end of ID85's runway 35. The first identifiable point of contact (FIPC) was an approximately 120 ft tall tree and the debris path was oriented on a magnetic heading of about 086°. The second identifiable point of contact was a pair of approximately 100 ft tall trees, one that had been topped immediately adjacent to the other and displayed an impact scar about 8 ft long and 3 ft wide. The FIPC was about 114 ft from the main wreckage, and the second point of contact was about 80 ft from the main wreckage. The outboard 2-3 ft of the left wing and the left aileron were located about 103 ft from the main wreckage. The propeller assembly was located about 67 ft from the main wreckage. The

fuselage came to rest inverted, on an approximate heading of about 153° magnetic, at an elevation of 3,755 ft msl. An area of burnt vegetation surrounded the empennage in about a 6 ft radius. All major components of the aircraft were observed throughout the debris field. (See figure 1.)

Figure 1. Debris path.

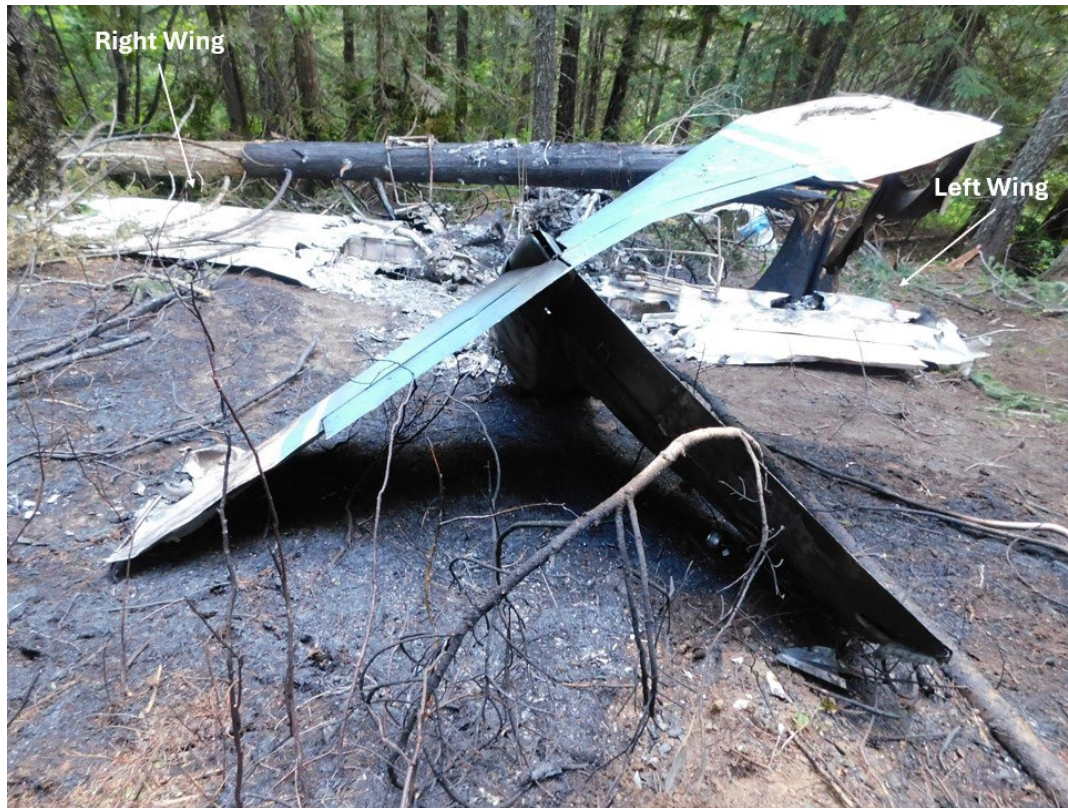
Both wings remained attached at their roots. The carry through spar was thermally damaged. The inboard sections of both wings were thermally consumed. The outboard 2-3 ft of the left wing was observed separated and located 103 ft from the main wreckage. The left aileron remained attached to the separated left wing segment. The right aileron remained attached to the right wing. The left and right wing flaps remained attached to their wings. (See figure 2.)

Figure 2. Main wreckage.

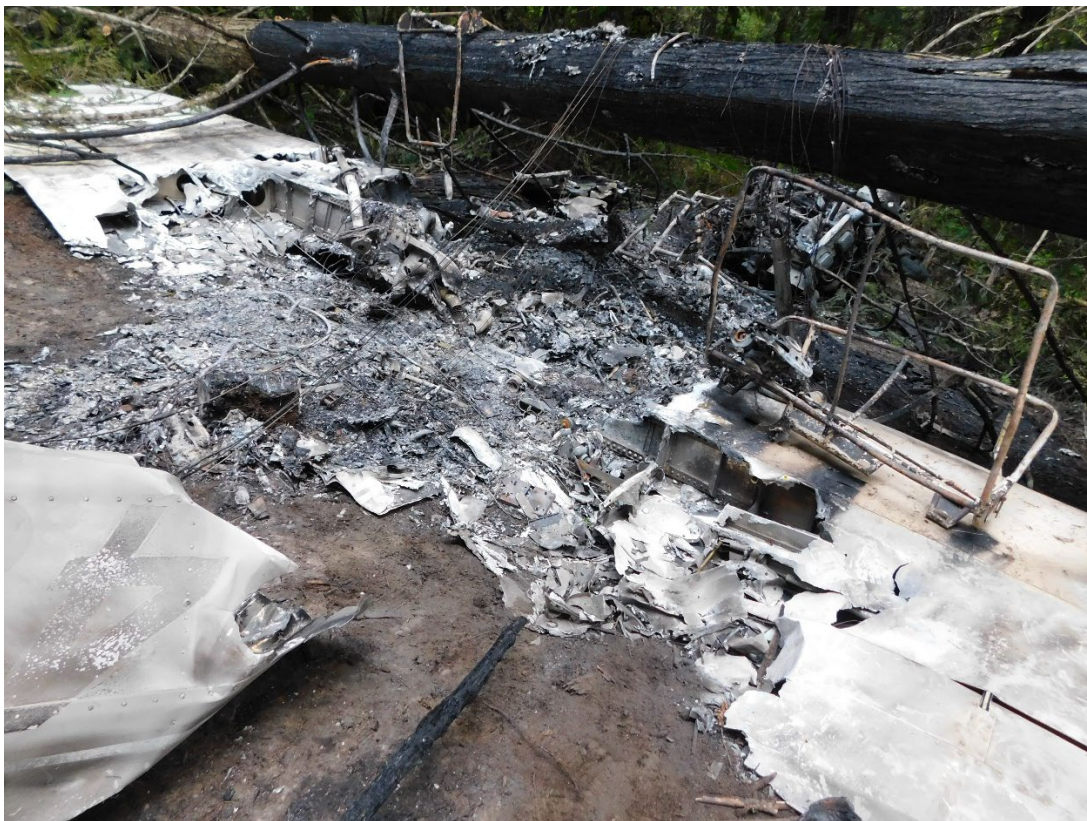
The cabin area and instrument panel were thermally destroyed. The cockpit seats were observed loose in the wreckage. The seat tracks were not observed, consistent with thermal consumption. The seat belt webbing was thermally consumed. Three seat restraint buckles were observed. One cockpit three point seat belt buckle was observed latched, with the shoulder strap portion also latched. (See figure 3.)

Figure 3. Cockpit/cabin area.

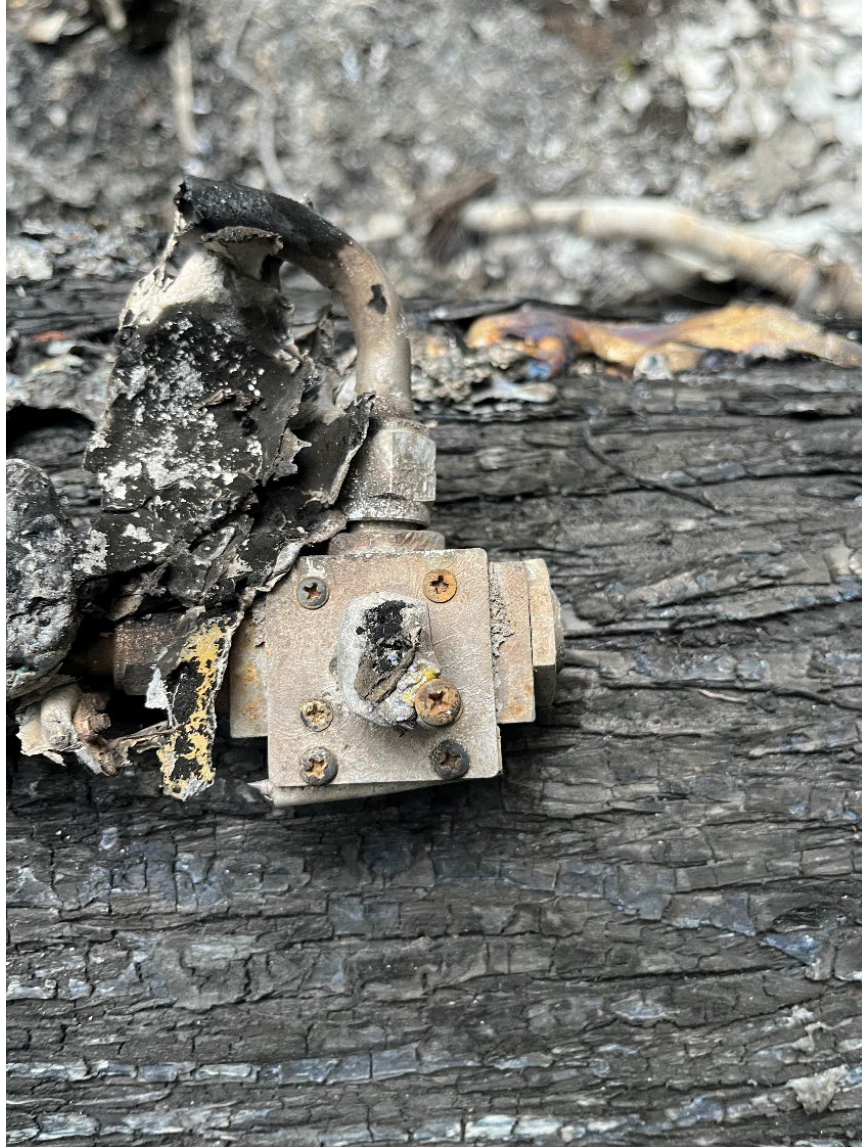
Portions of the aluminum fuel lines from the wing tanks to the fuel selector valve and fuel shutoff valve were thermally consumed. The fuel selector valve exhibited thermal damage and was observed laying on top of a fallen tree, with 2 inch segments of thermally separated fuel lines attached. (See figure 4.) The valve was in the BOTH position. The fuel shutoff valve was observed open. The fuel tanks were observed breached and thermally damaged. The header tank was not observed.

Figure 4. Fuel selector valve, as observed on fallen tree. (Courtesy of Textron)

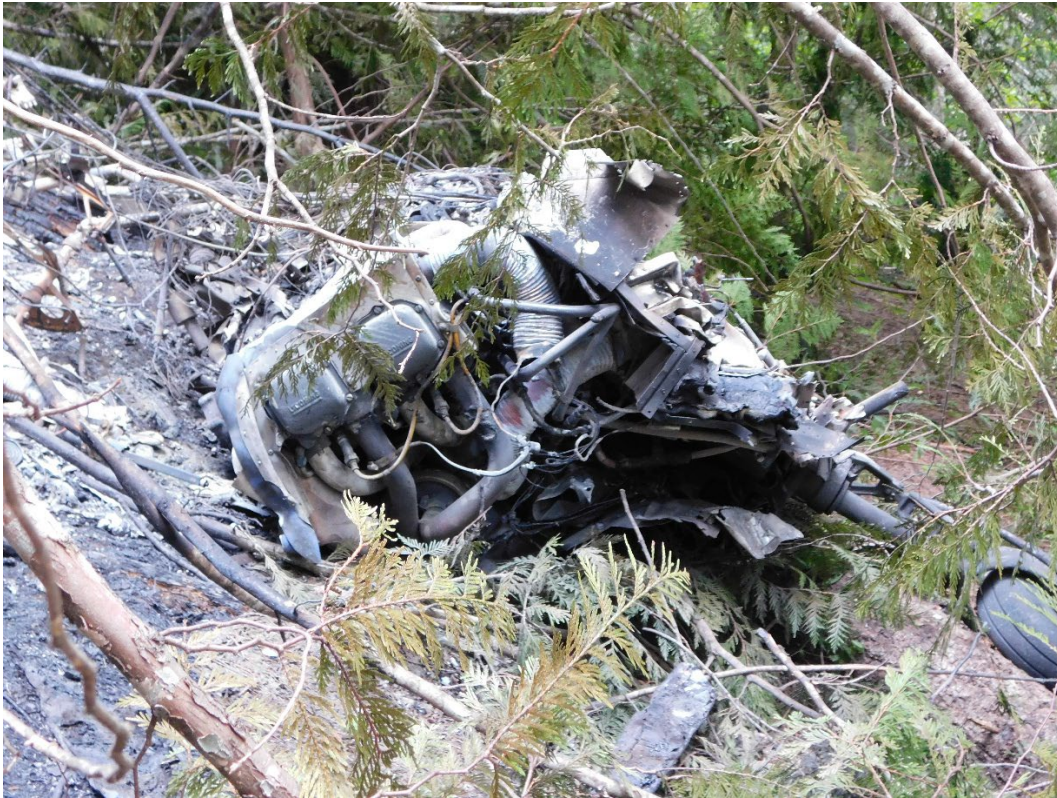
The engine was thermally damaged and remained attached to its engine mount and the firewall. It came to rest in a nose low position, facing aft. The firewall was thermally separated from the fuselage. (See figure 5.) The engine controls were observed thermally separated from the instrument panel mount. The upper engine cowling was

Figure 5. Engine on scene.

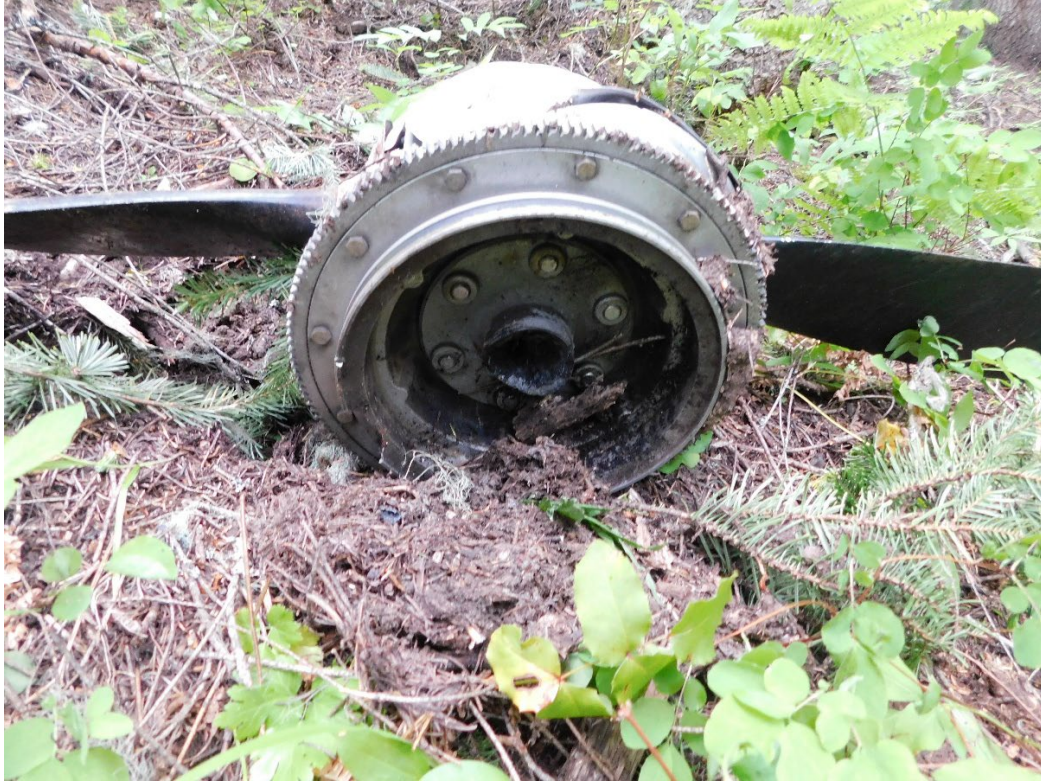
The engine's propeller assembly was separated at the aft side of the crankshaft flange. (See figure 6.) The crankshaft flange and both propeller blades remained attached to the hub. Both propeller blades displayed leading edge polishing and scuffing, and both blades displayed forward bending. (See figure 7.) The spinner displayed bending, crushing, aluminum tearing, vegetation and brown colored transfer, consistent with contact with trees. (See figure 8.)

Figure 6. Propeller assembly at aft side of hub.

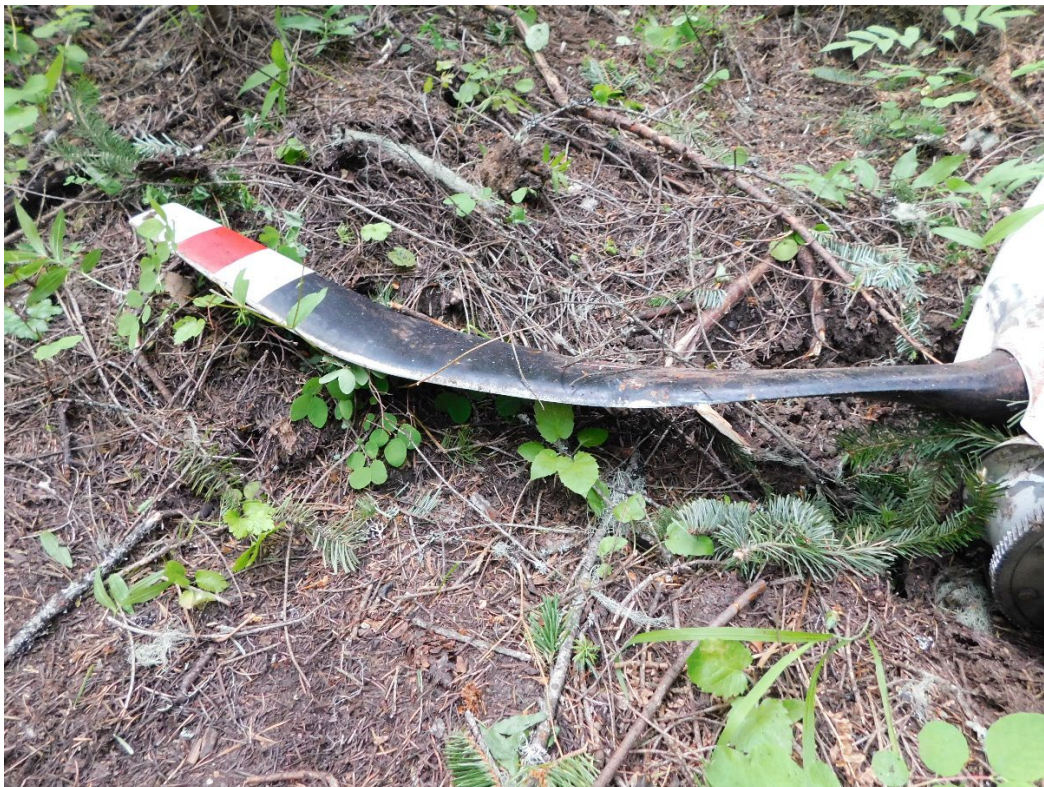
Figure 7. Forward bending of propeller blade.

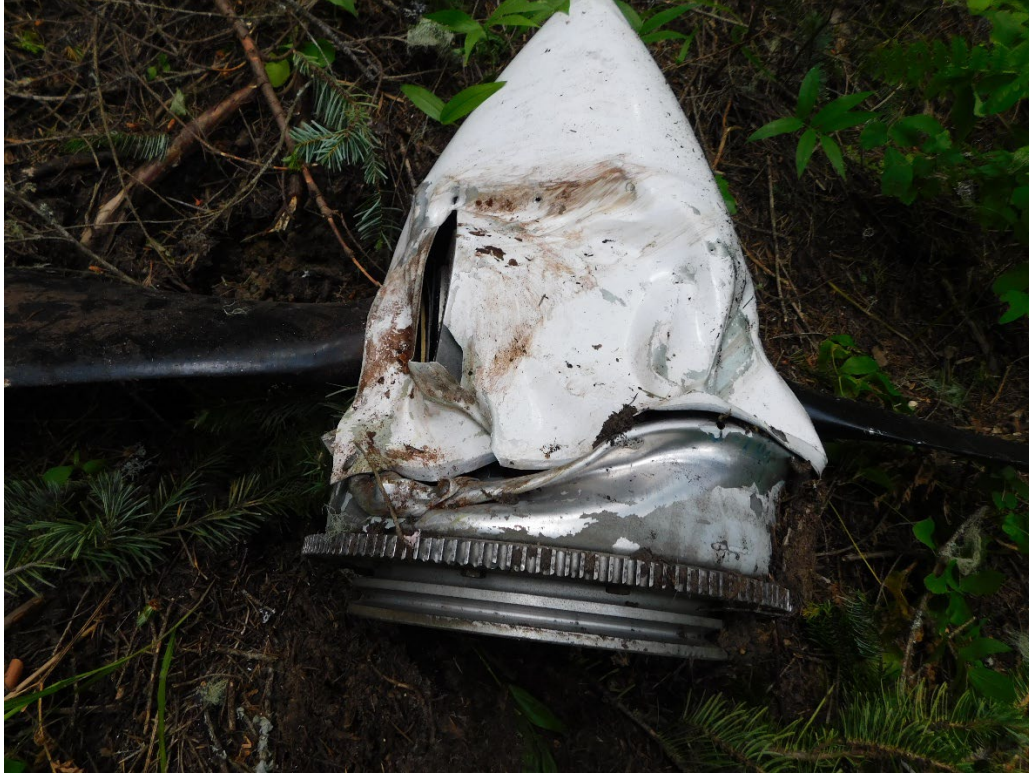
Figure 8. Propeller spinner.
