# National Transportation Safety Board

WPR24FA195

## **ACCIDENT SITE EXAMINATION SUMMARY**

Location: South Lake Tahoe, California  
Date: June 12, 2024  
Time: 1300 PDT  
Airplane: N37081, Luscombe 8A

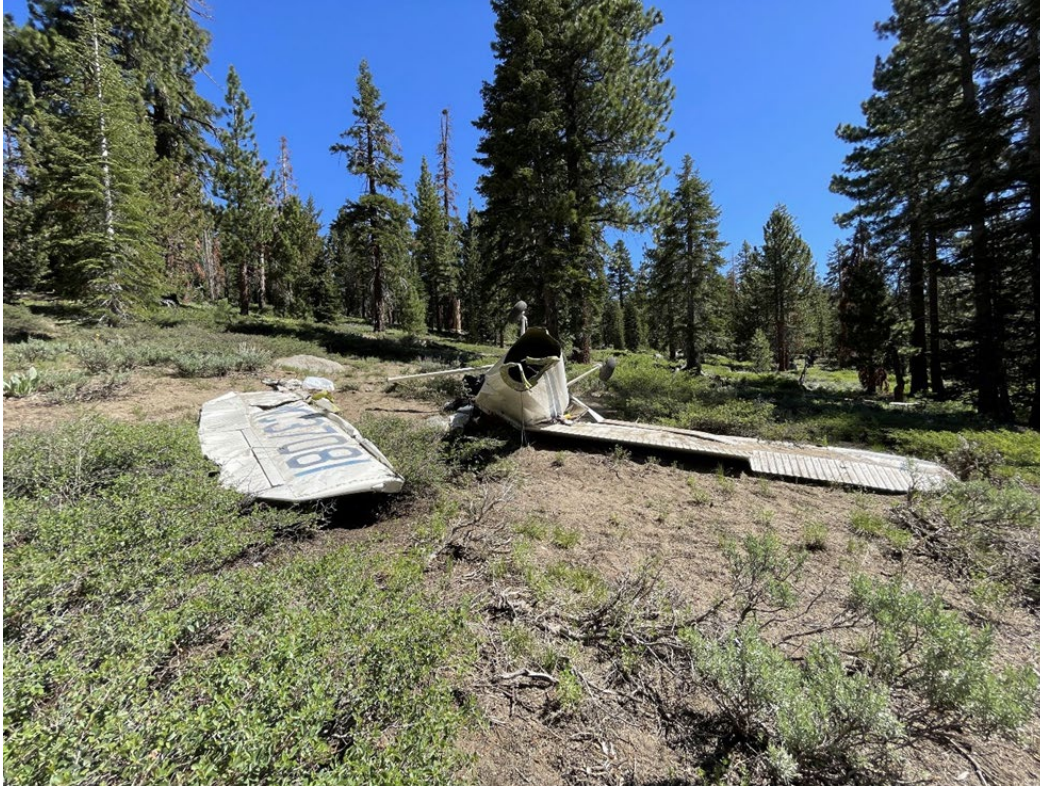
The first identified point of contact was a 75-ft tall tree that was missing limbs and a portion of the tree trunk, which were located within the debris path. Also in the debris path, about 25 ft from the initial tree strike, was a portion of the empennage and tail section that was lodged in the top of an approximate 15- ft- tall tree. The main wreckage was located about 10 ft beyond the that tree. All major structural components of the airplane were located throughout the wreckage debris path.

**Photo 1: Rear view of the accident airplane.**

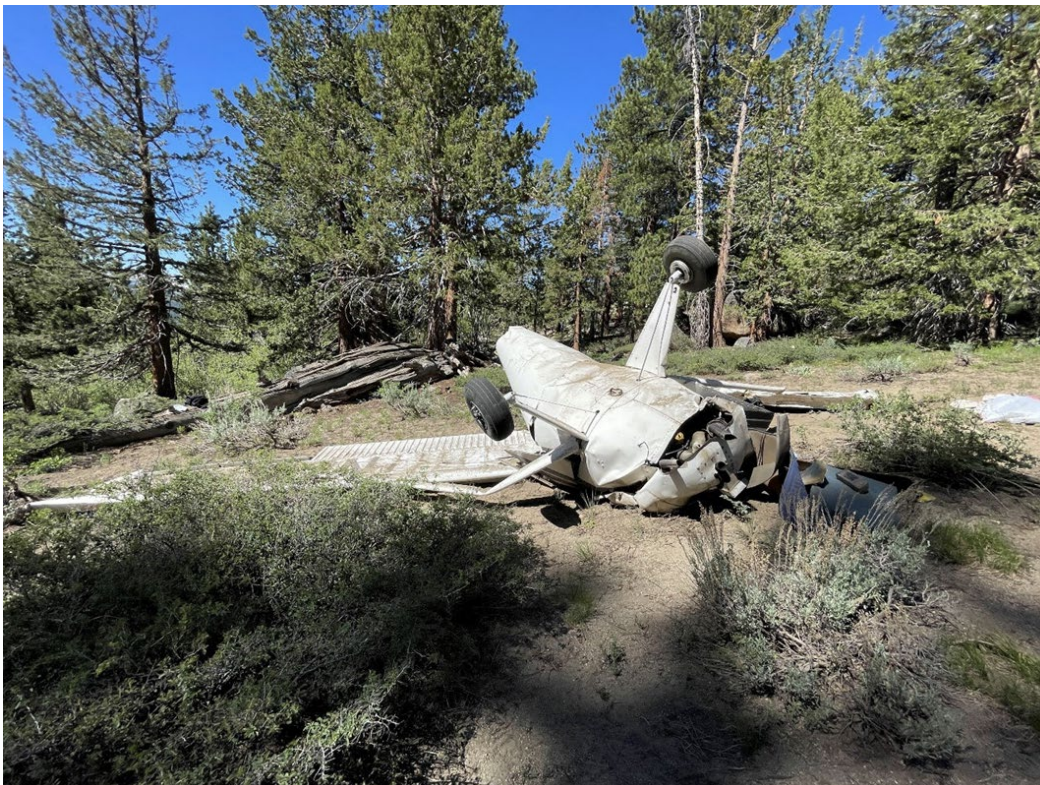
**Photo 2: Forward view of the accident airplane.**

The airframe came to rest inverted on a northerly heading. The propeller blade assembly remained attached to engine, and the engine remained attached to the airframe. The right wing remained separated from the airframe but remained connected via its flight control cables. The left wing remained attached to airframe. The tail section separated from the empennage at the rivet line.

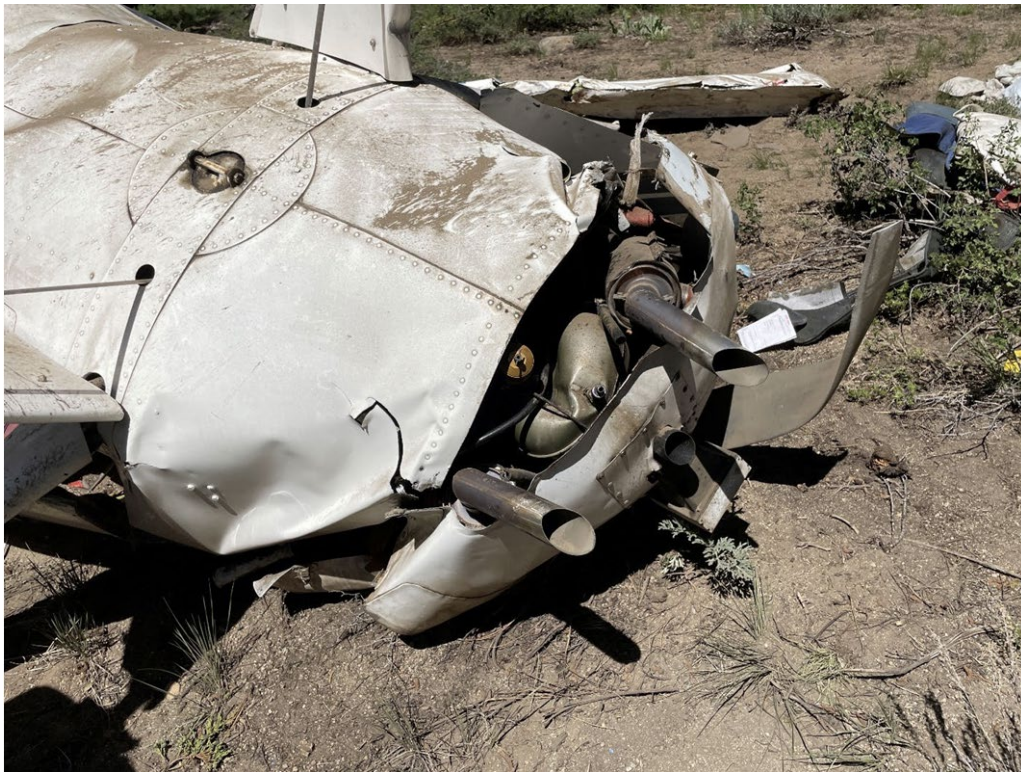
The engine remained attached to the airframe. The cowlings were compressed around the engine, with the bottom cowl open exposing the bottom of the engine; the oil sump, intake and exhaust, and fuel pump were visible.

**Photo 3: View of the engine.**
