# National Transportation Safety Board

WPR24FA200

## **AIRFRAME & ENGINE EXAMINATION REPORT**

Location: Bluestem, Washington  
Date: June 19, 2024  
Time: 1620 Pacific daylight time  
Helicopter: Robinson R-44 II Raven / N323TT

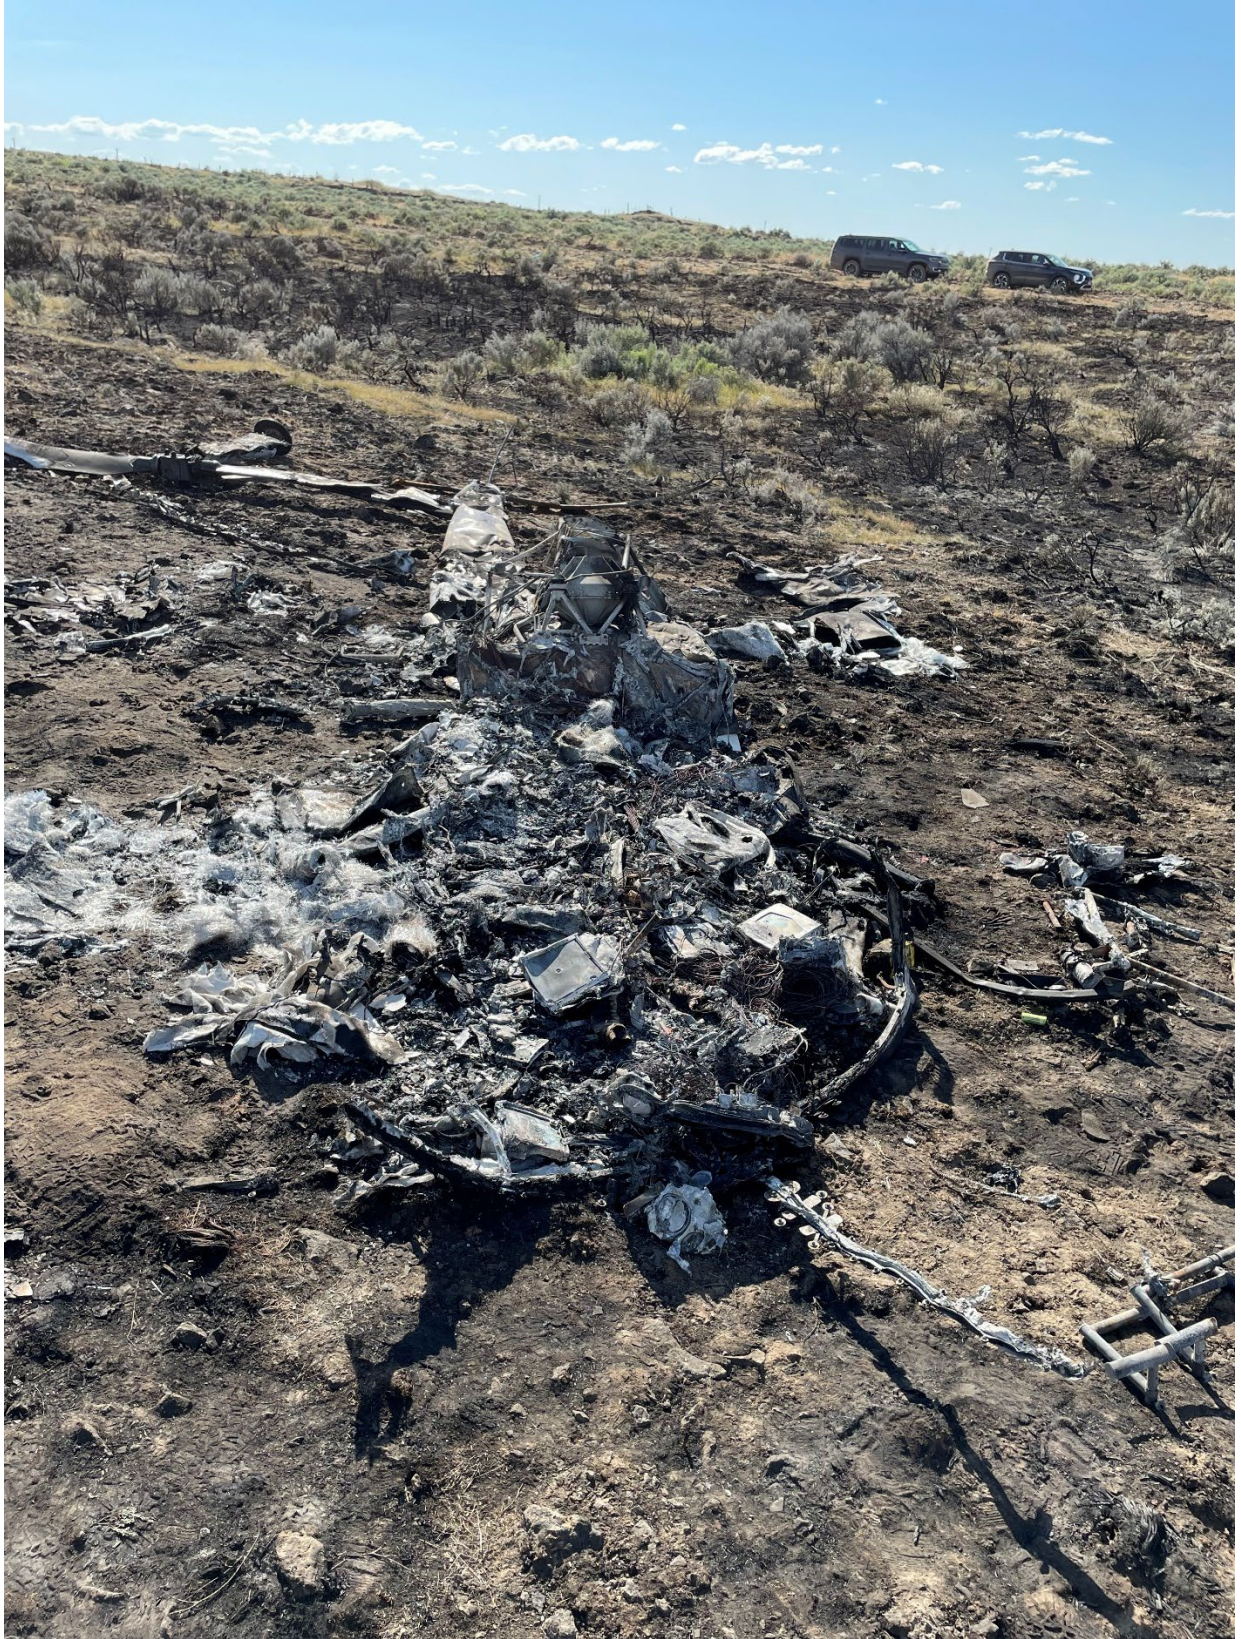
The helicopter (figure 1) came to rest upright on a heading of 086° magnetic, at an elevation of 2,182 ft mean sea level (msl). The terrain was in an unpopulated, open area west of the Bluestem Creek. The terrain consisted of rolling hills with small rocks and loose soil, covered with small vegetation. No trees or other significant obstacles existed near the accident site. The empennage and both main rotor pitch horns were scattered in a debris field around the helicopter. The location of the site was N47° 32' 48.2" W118° 09' 19.4" (figure 1). The location of the tail rotor assembly and the end of

Figure 1. N323TT front view.

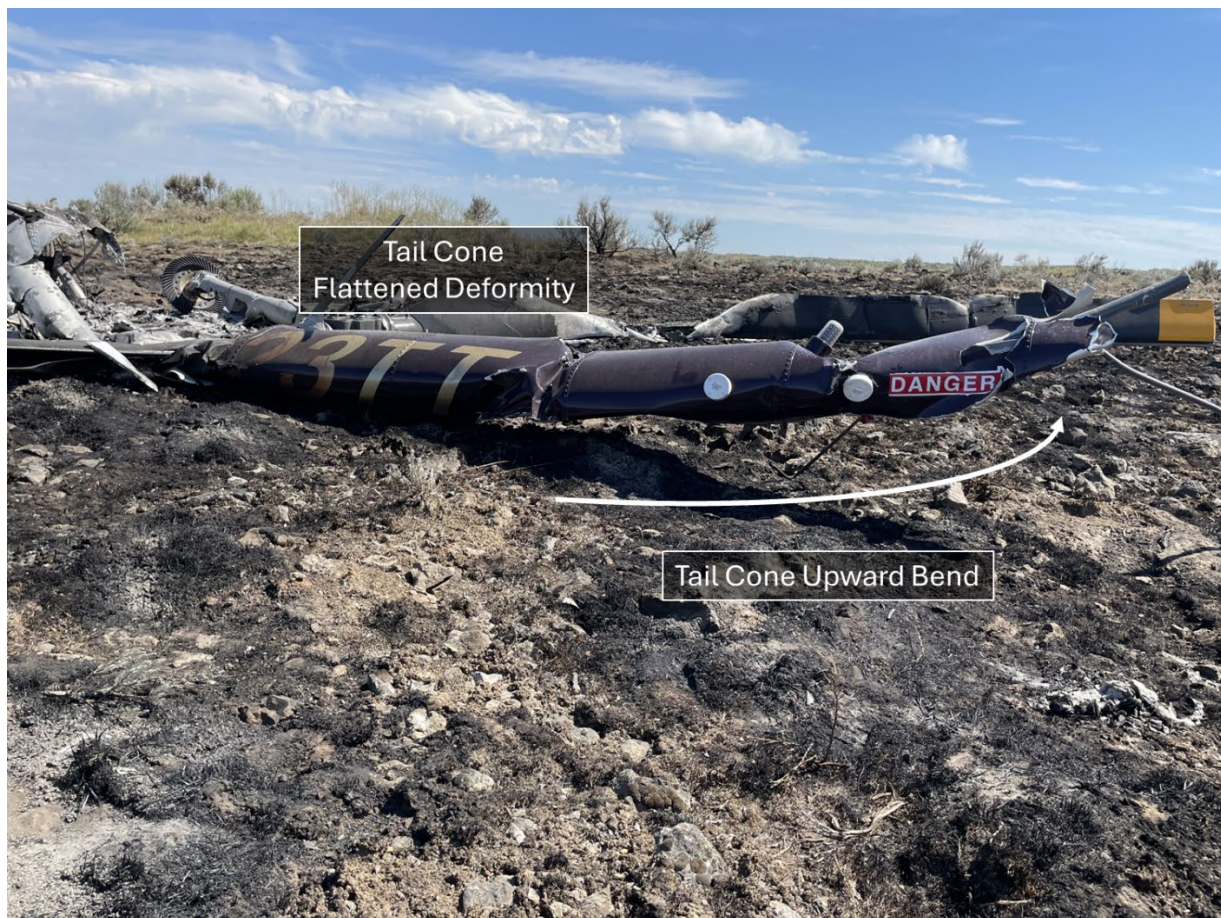
The tailcone remained attached to the aft fuselage (figures 2 and 3) and exhibited thermal damage at the fuselage end and a fracture separation at the gearbox end. The entirety of this section of tailcone exhibited a flattened profile. This section of tailcone also exhibited a uniform upward "scorpion" bend. The tail rotor drive shaft extended out from the tail rotor end and exhibited bends and a fracture separation from the gear box end.

Figure 2. Tailcone. Fuselage end on the left, bear box end on the right.

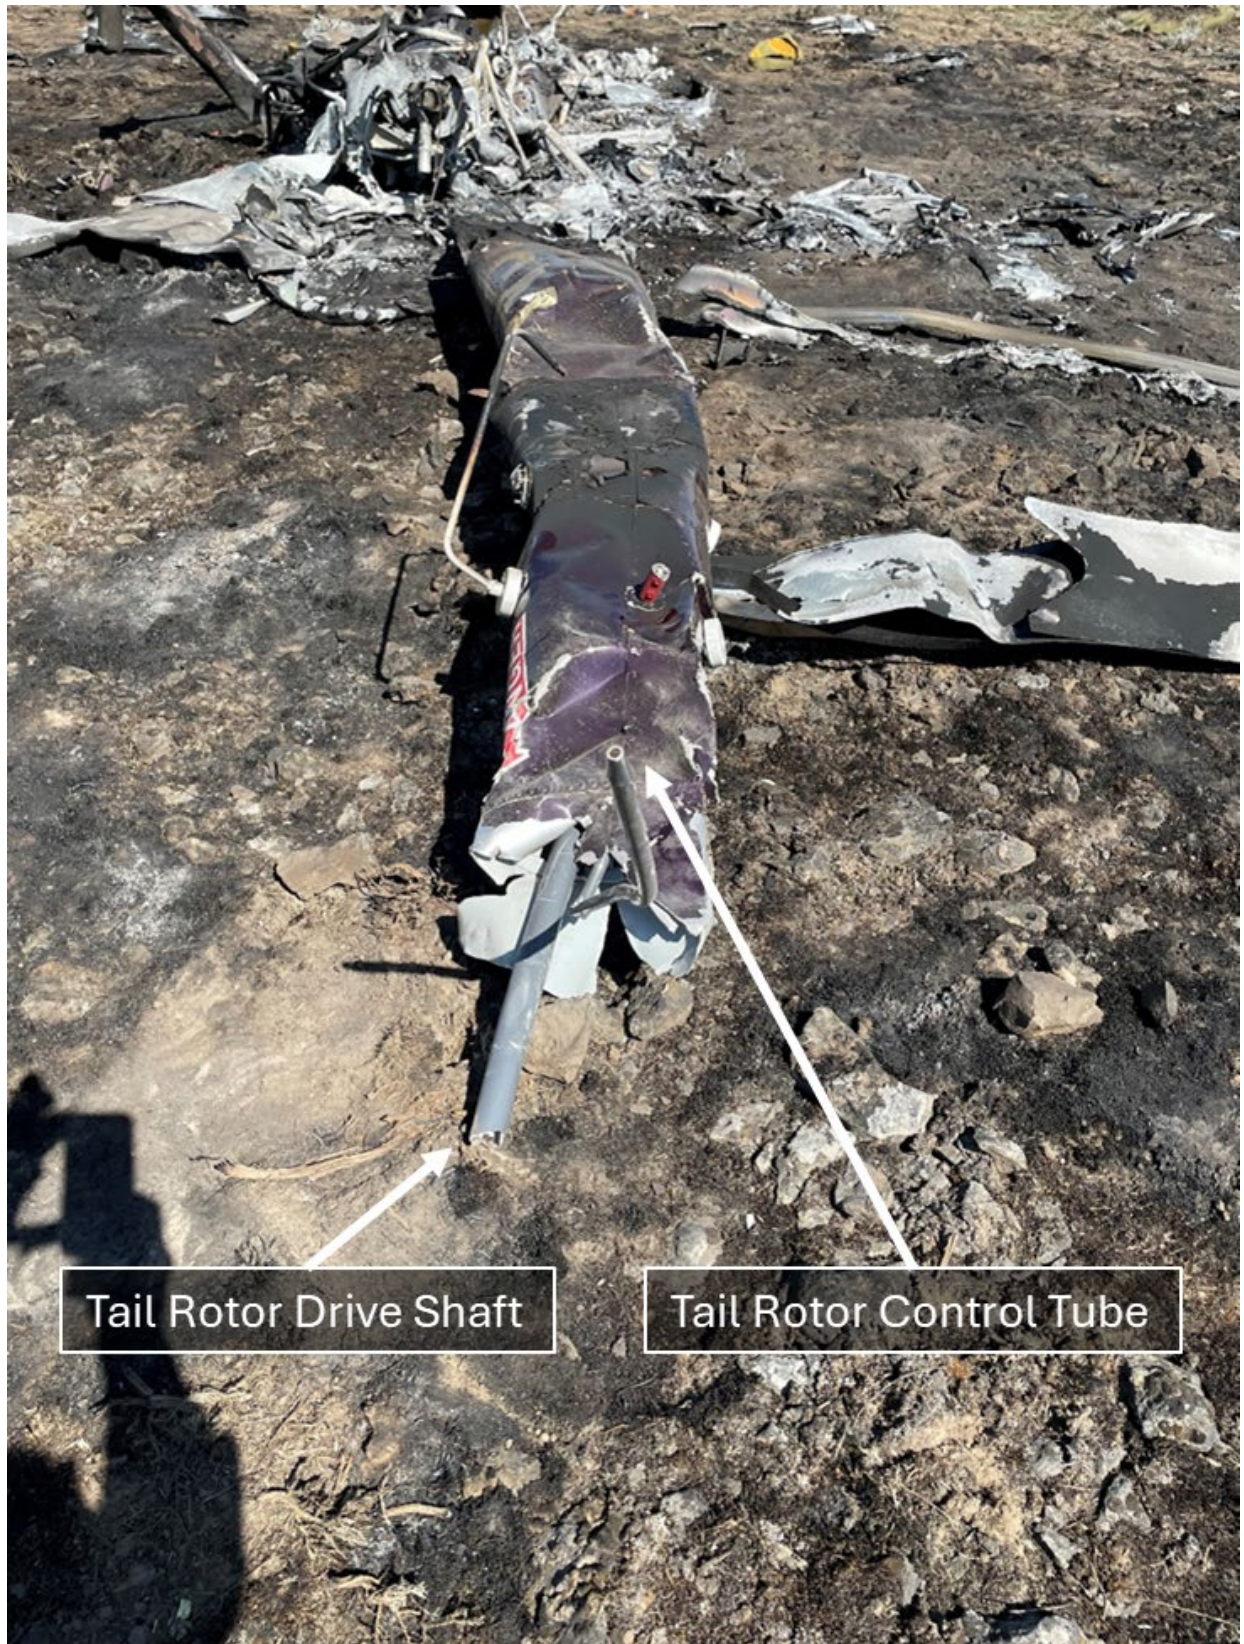
Figure 3. Tailcone rear view.

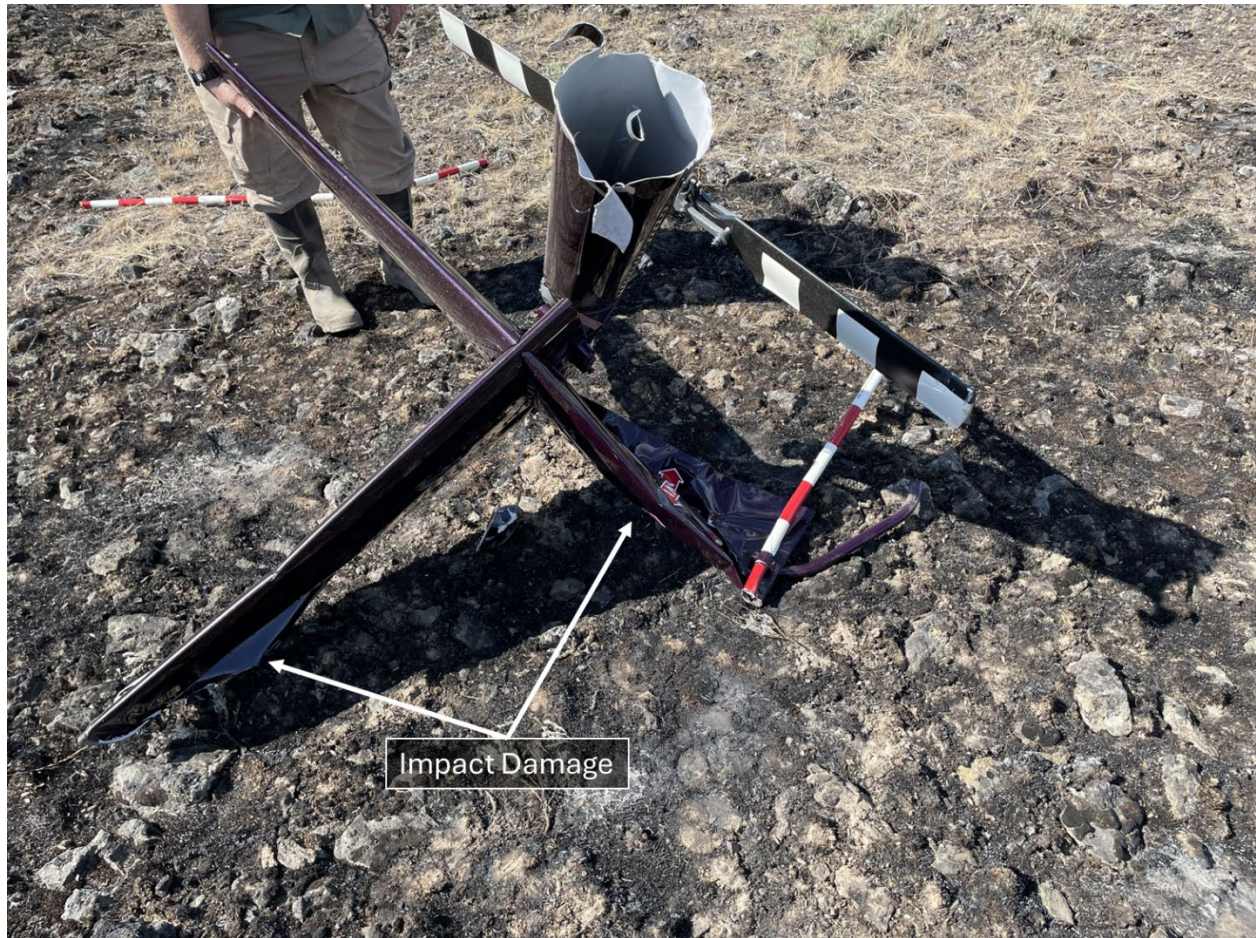
The empennage separated from the tailcone as a unit (figures 4 and 5) and consisted of the end of the tailcone, tail rotor gearbox, tail rotor assembly and the horizontal and vertical stabilizers. The lower section of the vertical stabilizer and the outboard end of the horizontal stabilizer both exhibited ground impact damage. The tail rotor gearbox remained secured to the end of the tailcone and exhibited minimal damage, contained oil, and rotated freely.

Figure 4. Empennage.

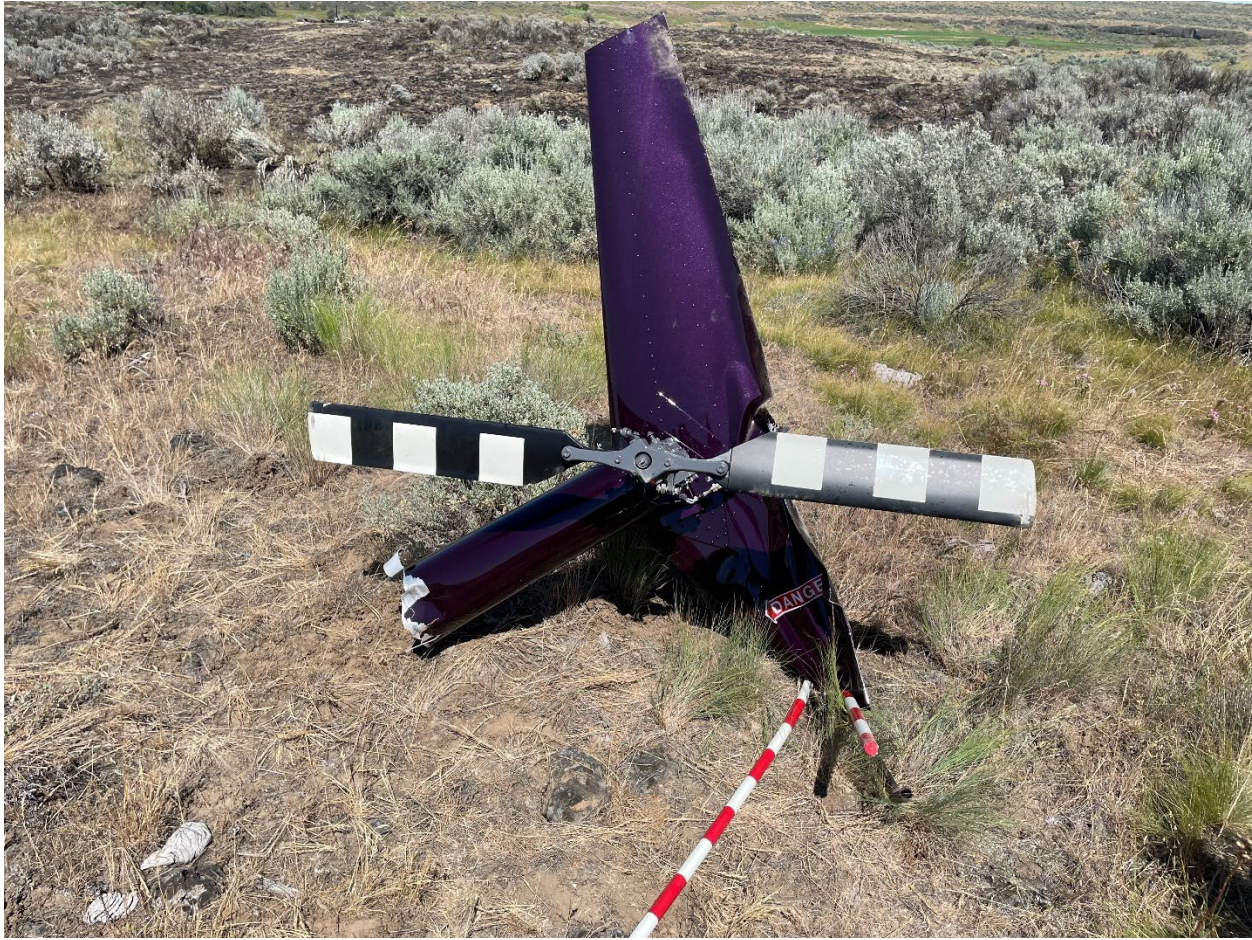
Both tail rotor blades exhibited damage at the tips to about three inches inboard of the tips. There were no indications of damage to the leading edges. The tailcone exhibited an inward dent and striations consistent with tail rotor blade tip contact. No evidence of smoke or soot was observed on the empennage or tail rotor assembly.

The tail rotor drive shaft remained attached to the clutch shaft yoke flex plate. There was a break in the drive shaft near the fractured end of the tailcone. The tail rotor control tube also remained attached at the forward bellcrank assembly and

exhibited a break near the fractured end of the tailcone. The tail rotor gear box remained attached to the aft end of the tailcone and rotated freely.

Figure 5. Empennage and tail rotor assembly, left-side view.

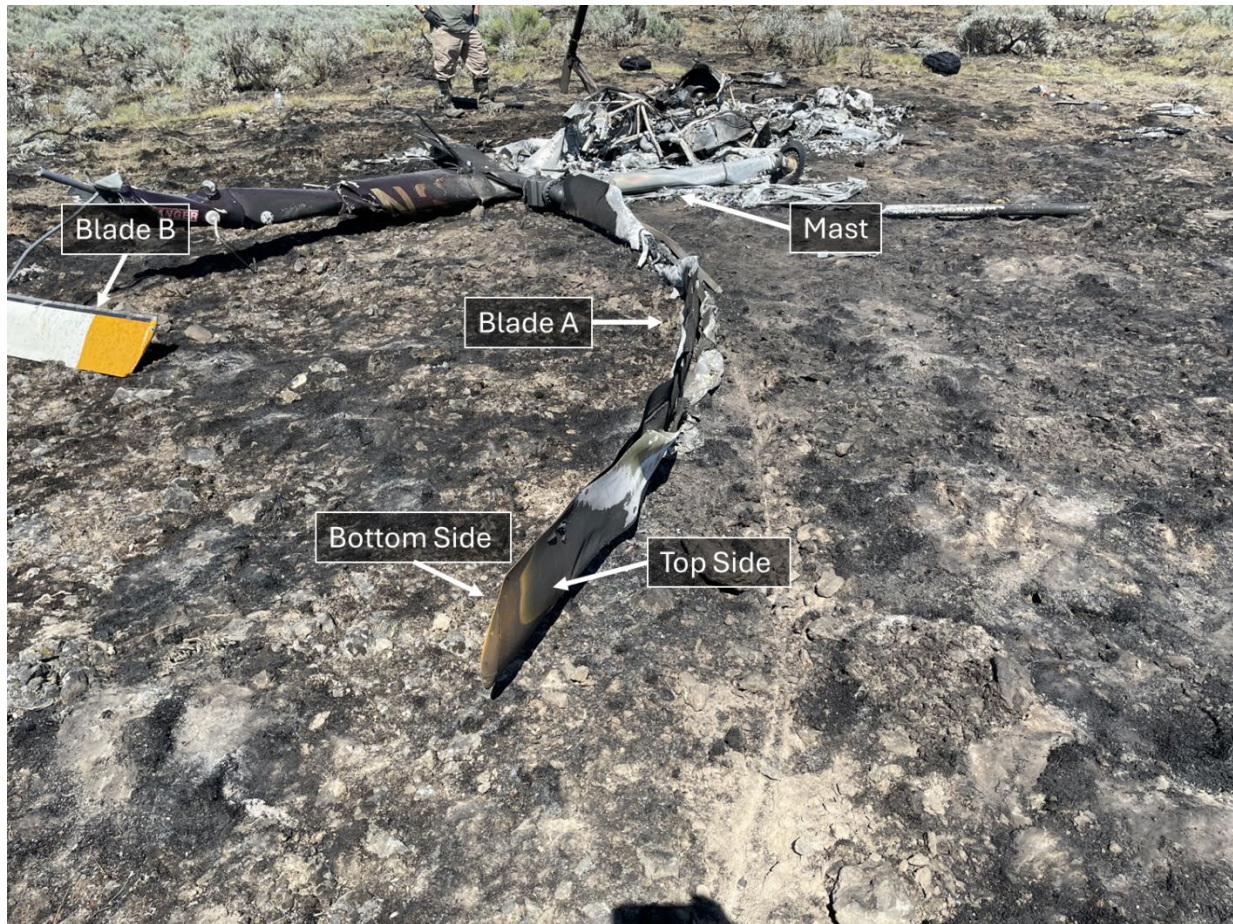
The main rotor assembly remained attached to the mast. One blade, identified as blade A (figure 6), remained whole and exhibited a uniform downward bend. The blade was thermally damaged. As mentioned earlier, the pitch horn and the rod end bearing of the pitch control rod fractured and separated from the blade grip and was found in the debris field.

Figure 6. Main rotor, blade A. Blade B tip in view.

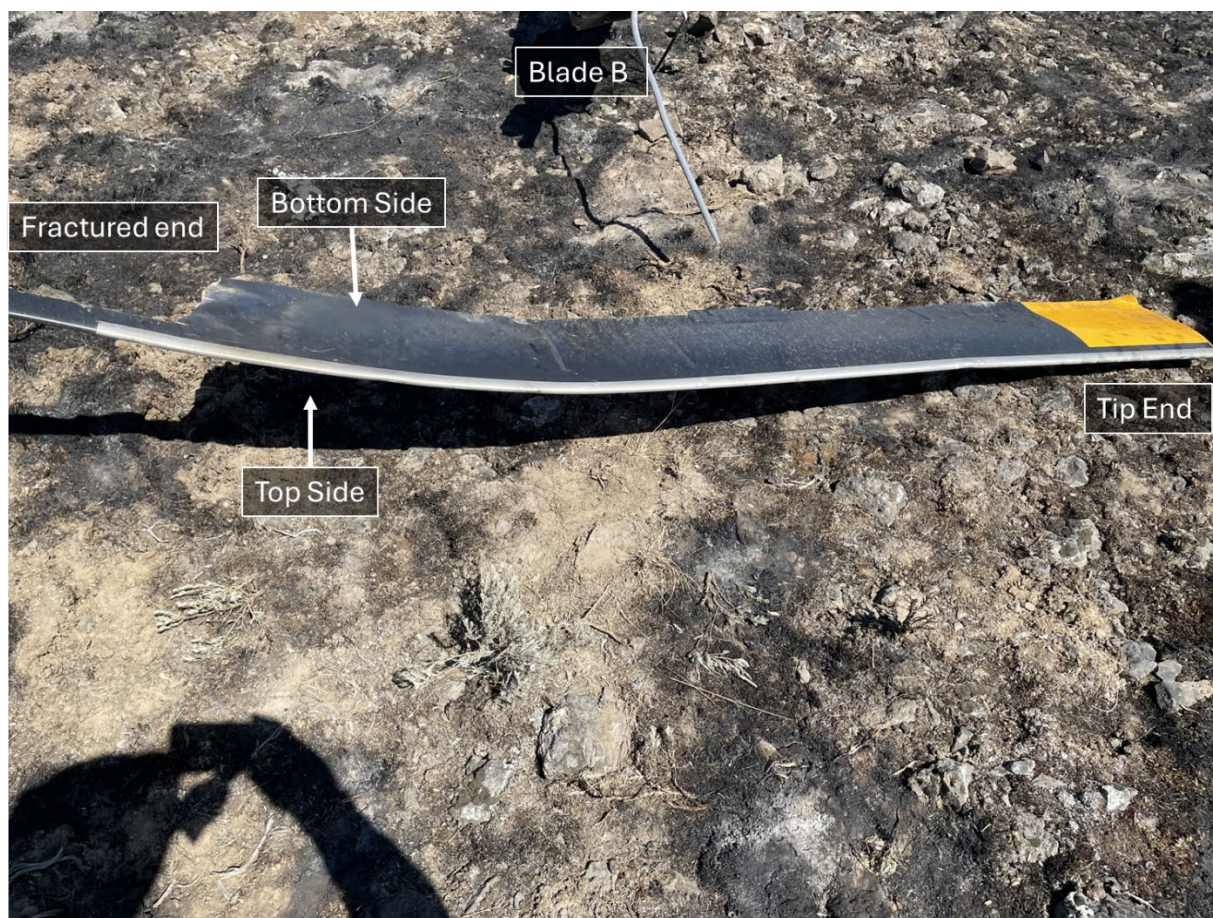
Figure 7. Blade B Tip

The other blade, identified as blade B (figure 7), fractured into three major sections, and a section of the blade, about 5 ft inboard of the tip, separated from the blade and came to rest several feet from the main wreckage. A section of this blade, about 24 inches inboard of the tip exhibited purple color transfer, consistent with the color of the fuselage and tailcone (figure 8). The pitch horn and the rod end bearing of the pitch control rod, fractured and separated from the blade grip and was found in the debris field (figure 9). The blade sections exhibited a downward bend across the entire blade.

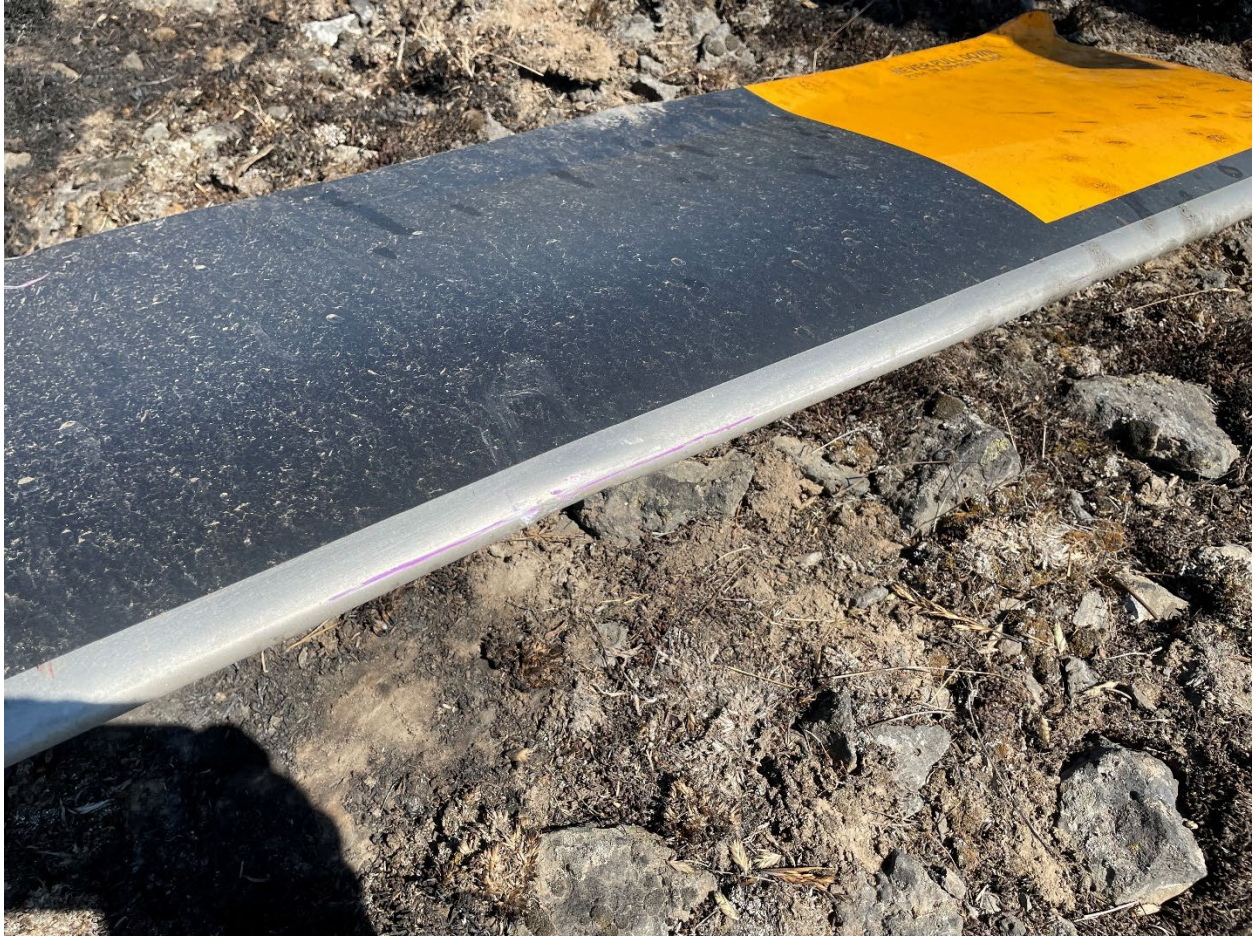
Figure 8. A section of Blade B showing color transfer like the color of the fuselage and tailcone paint.

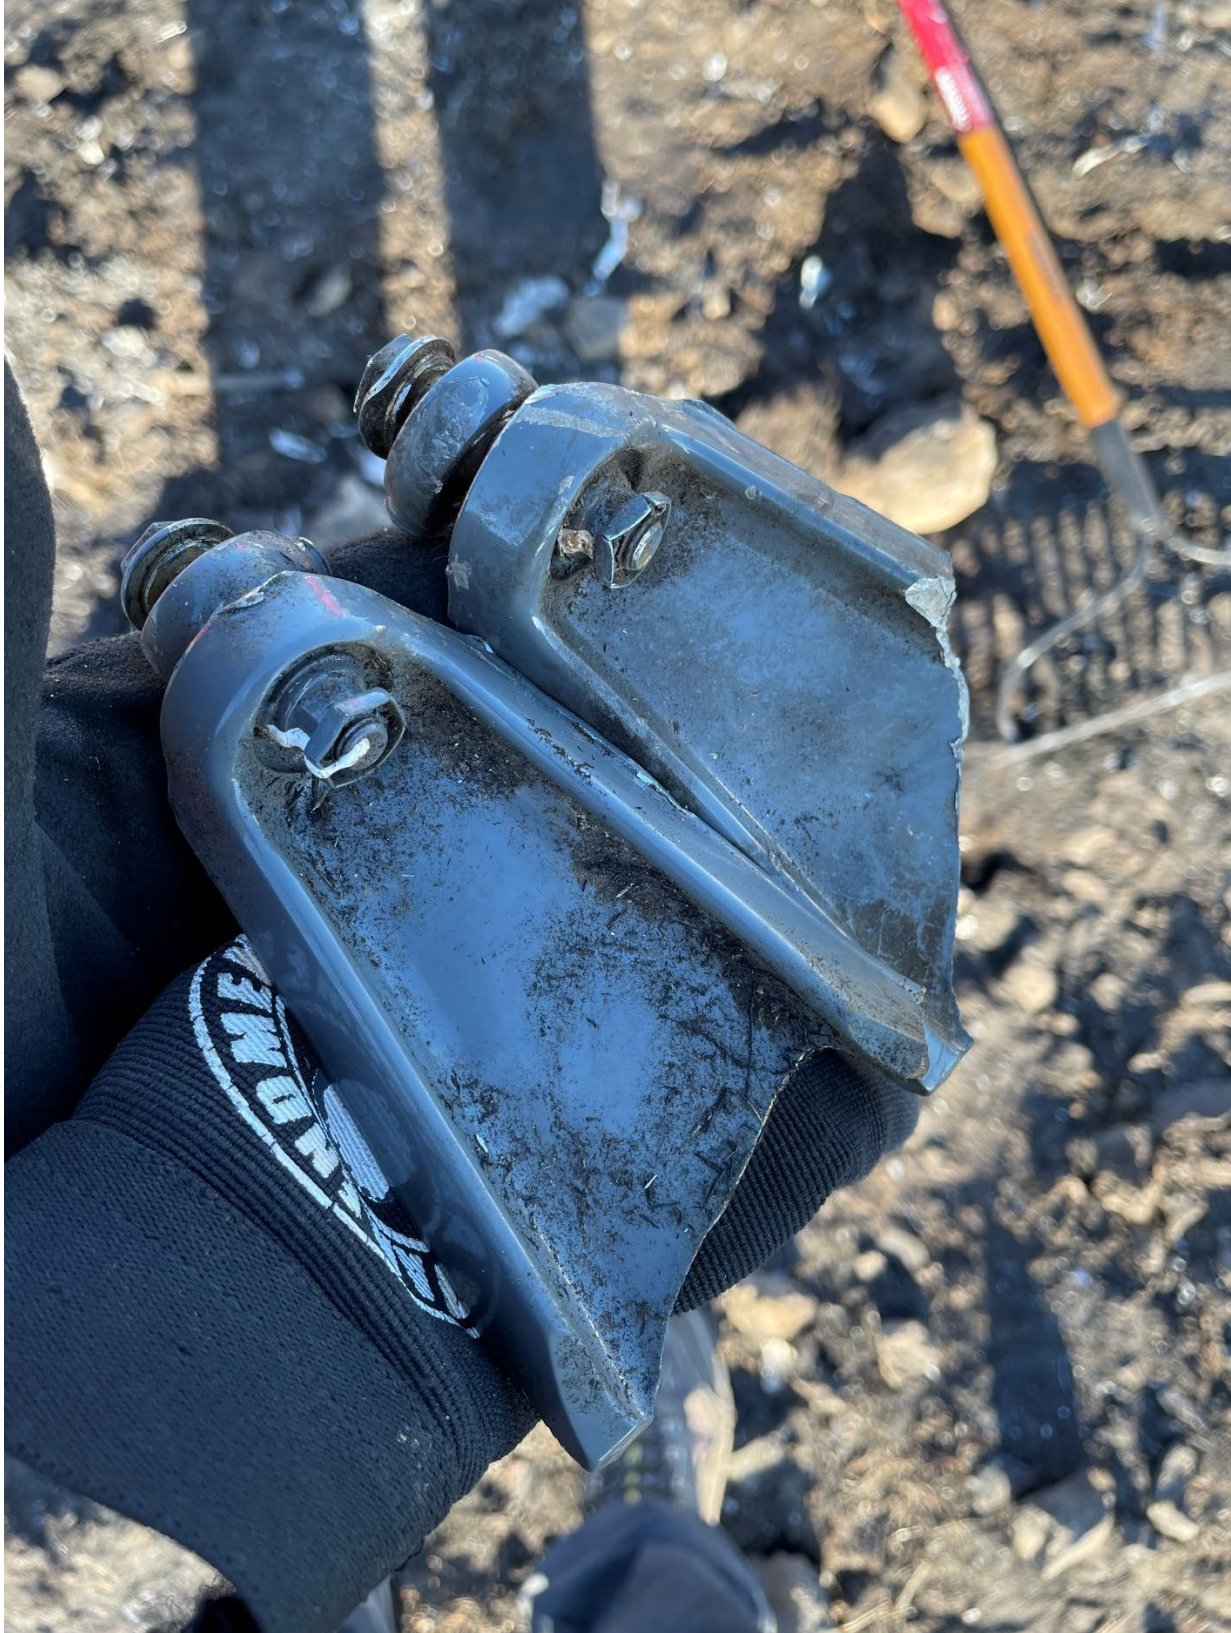
Figure 9. Blade A and blade B pitch horns, control rod ends and hardware.

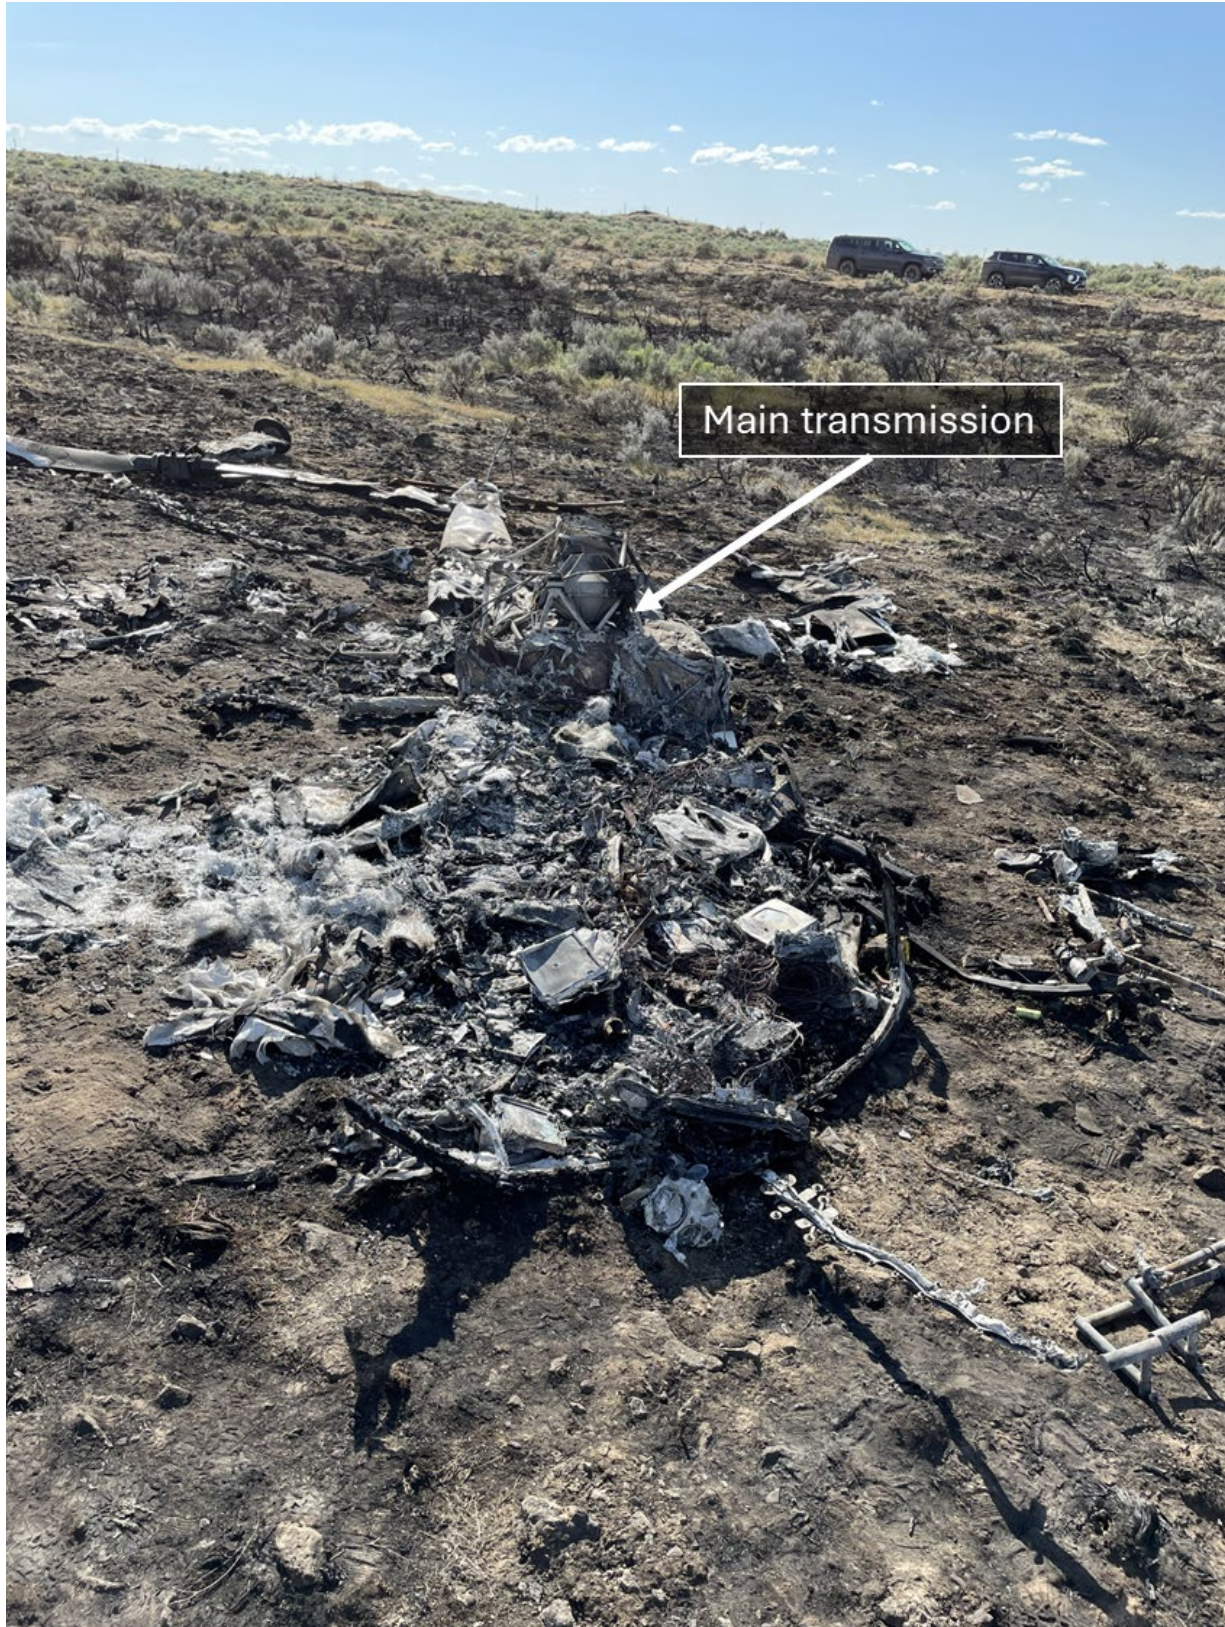
Figure 10. Transmission base.

The transmission base remained attached to the transmission mounts. The transmission top fractured and the mast was found near the transmission. The mast retained the large gear attached to the base (figures 10 and 11).

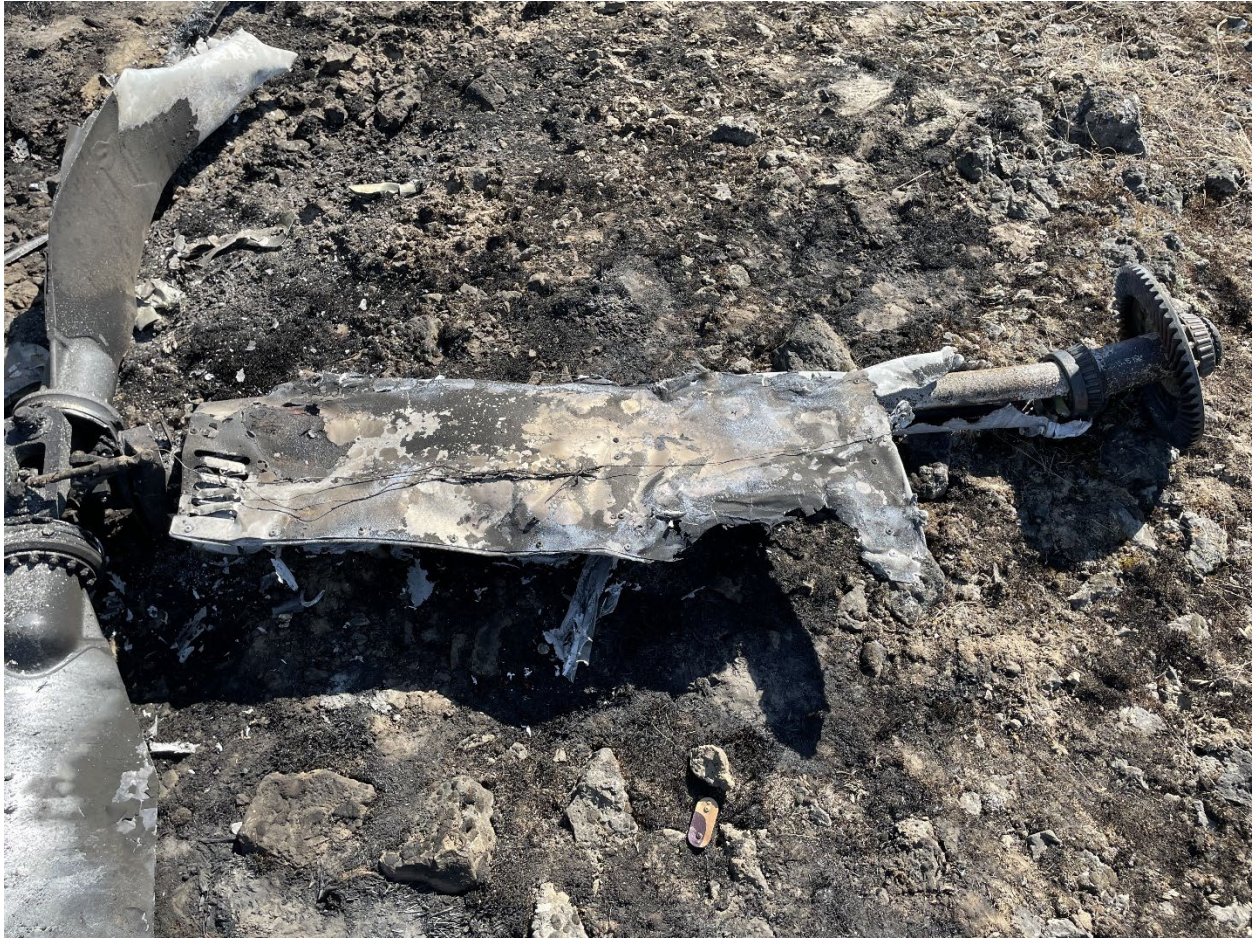
Figure 11. Main rotor mast.

The main rotor hub remained secured to the mast. Both blade grips remained secured to the hub. Both droop stop tusks exhibited no damage. Both elastomeric teeter stops were crushed. The mast exhibited a large bend near the base.

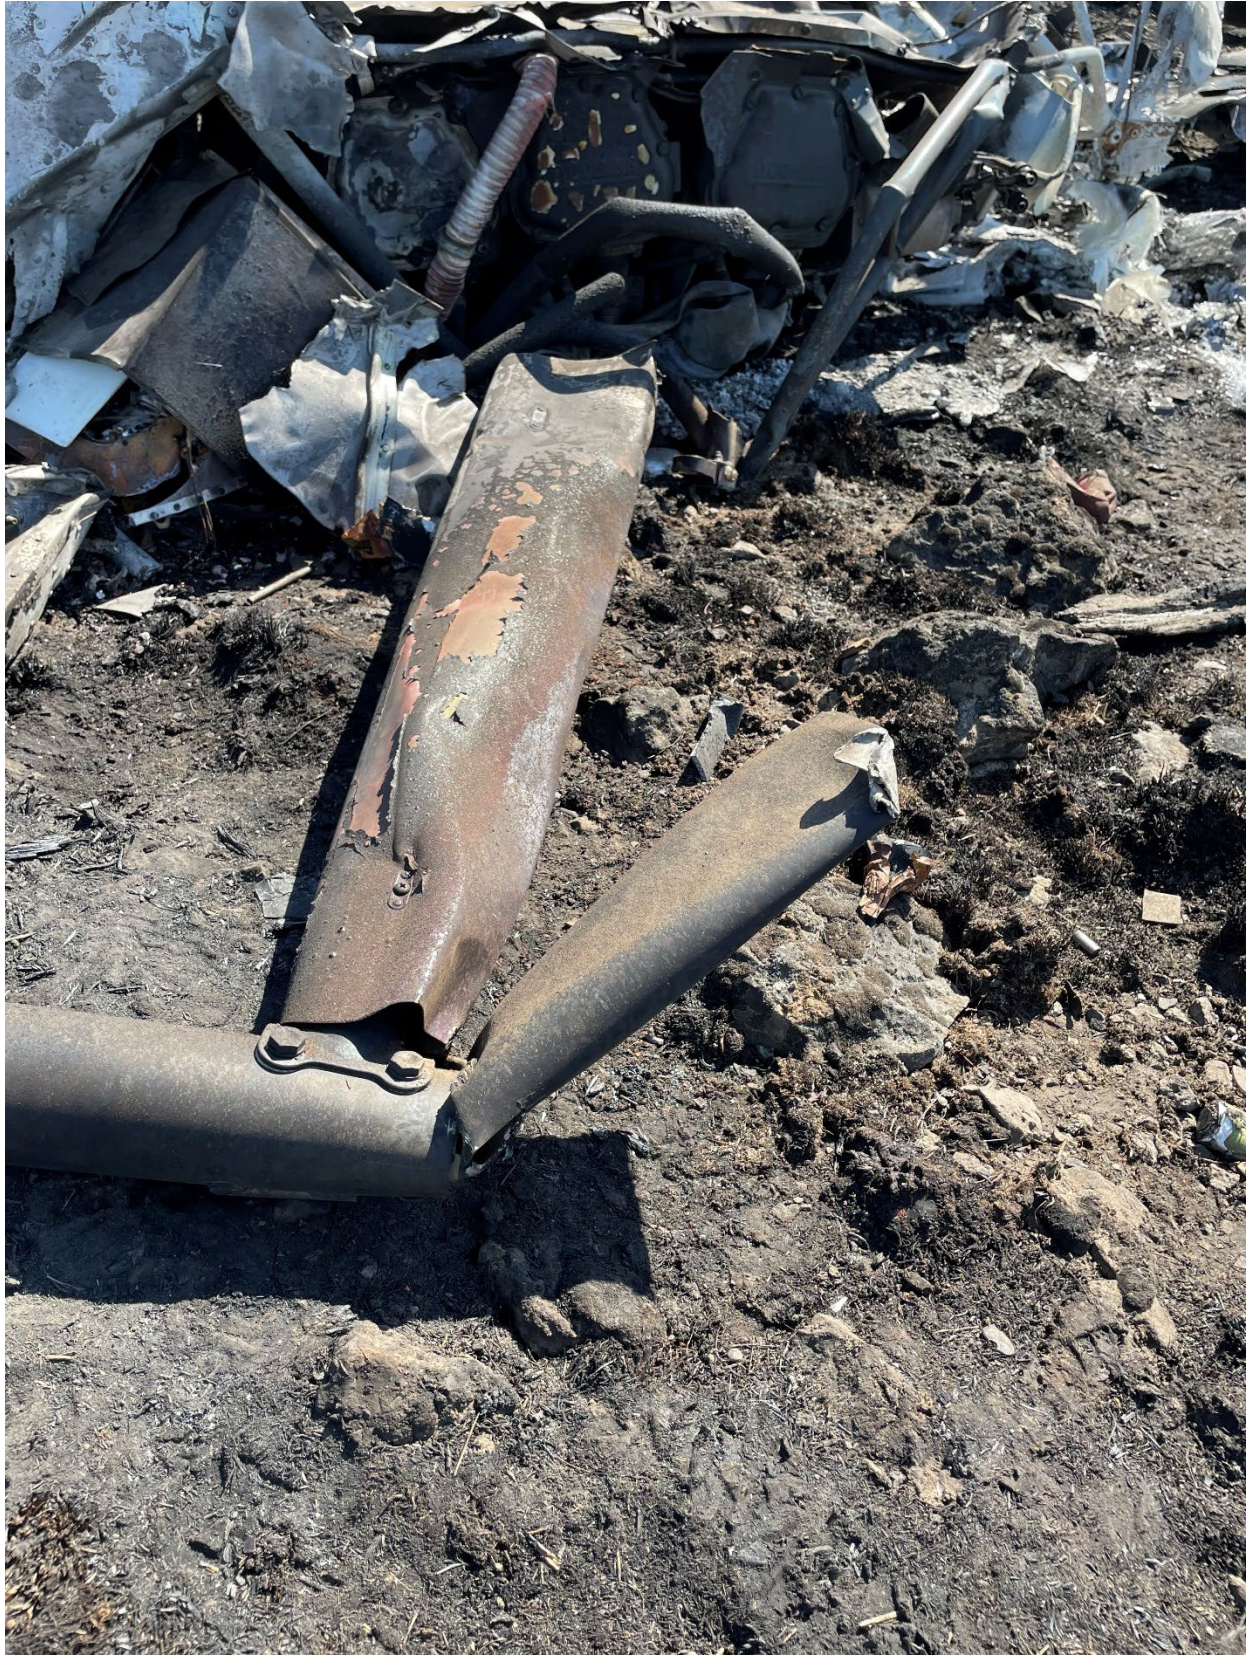
The skid landing gear exhibited impact damage that spread the landing gear outward and forward to the point that allowed the belly of the helicopter to contact the ground. The landing gear components were fractured into multiple sections and thermally damaged. The landing gear was equipped with non-OEM steps. The steps fractured and separated from the struts/skids. The aft end of the left skid exhibited an upward bend of about 45° (figure 12).

Figure 12. Left skid, aft end.

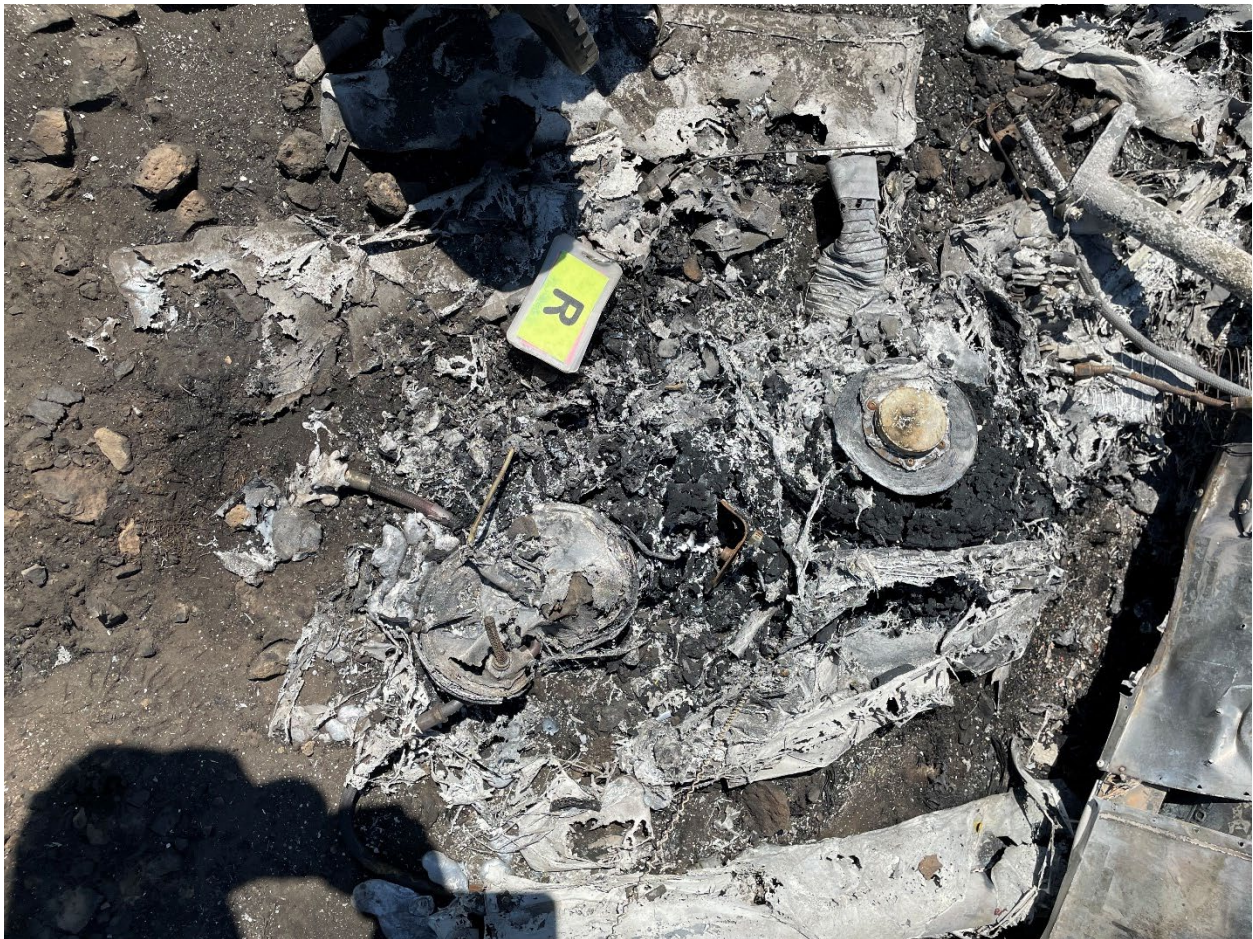
The entire fuel delivery system was thermally damaged and mostly reduced to ash. The fuel servo was thermally damaged and separated from the engine. Both fuel caps were located and the thermally damaged fuel tank components were identified but too thermally damaged to assess their preaccident condition. See figures 13 and 14.

Figure 13. Right fuel tank components.

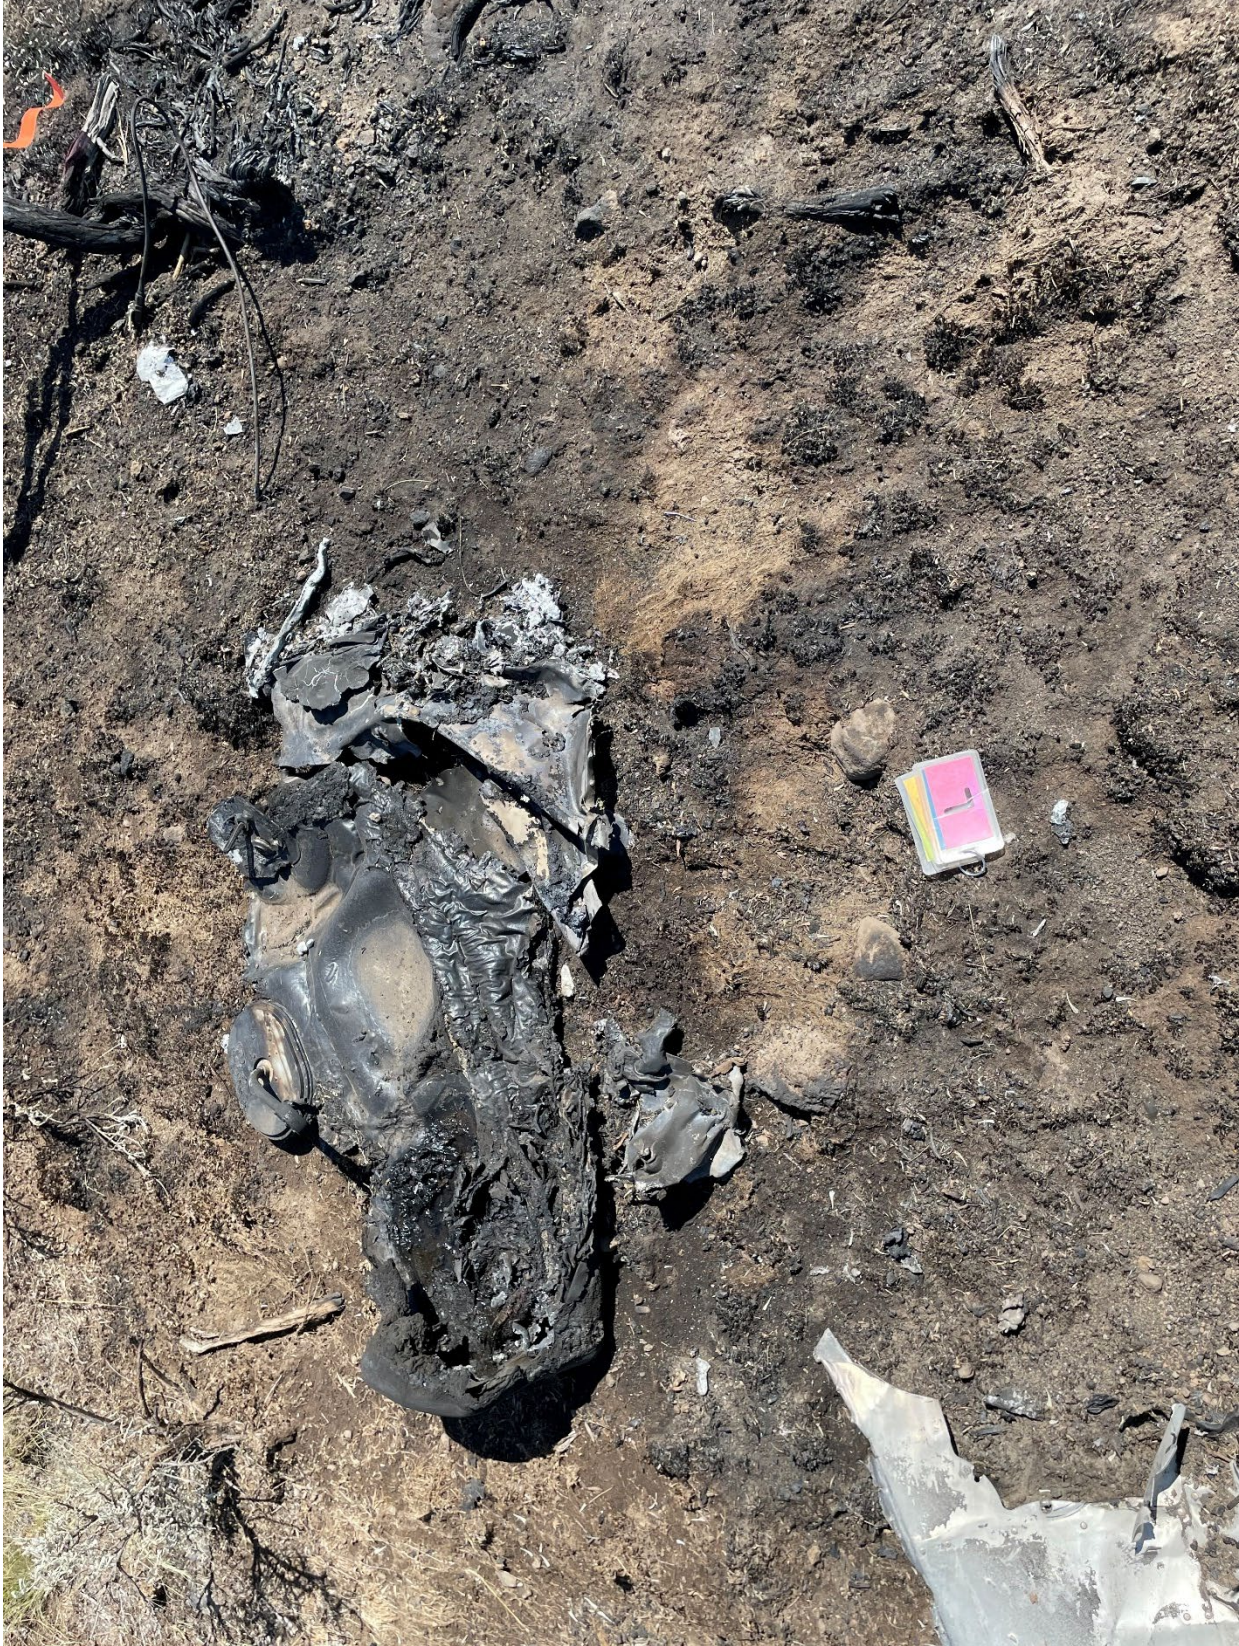
Figure 14. Left fuel tank components.
