# National Transportation Safety Board

WPR24FA200

## **AIRFRAME & ENGINE EXAMINATION REPORT**

Location: Bluestem, Washington  
Date: June 19, 2024  
Time: 1620 Pacific daylight time  
Helicopter: Robinson R-44 II Raven / N323TT

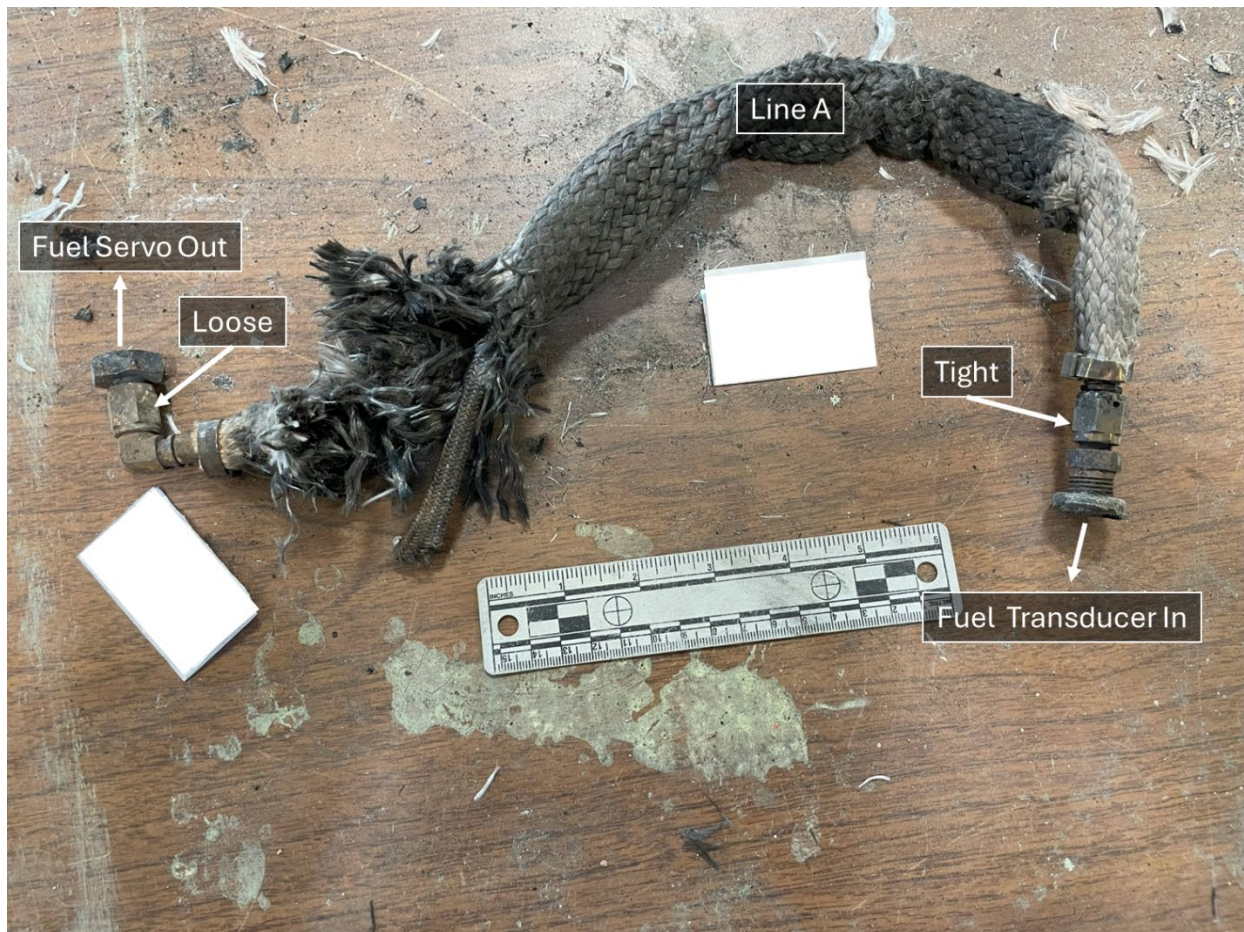
Figure 15. Fuel line A.

The fuel servo to fuel flow transducer line was identified as line A (figures 15 and 16). Line A was originally found laying on the fuel servo and was thermally damaged. Most of the outer fabric webbing remained loosely around the line. Molten metal that hardened on the fuel servo created a cradle that the line rested in. The fuel transducer in port fractured and remained secured to one end of line A. The other end had separated from the fuel servo along with the fuel servo attachment point. This end had fractured and separated from the fuel line and was held in place by the webbing fabric. The B-nut at the fuel servo out was loose.

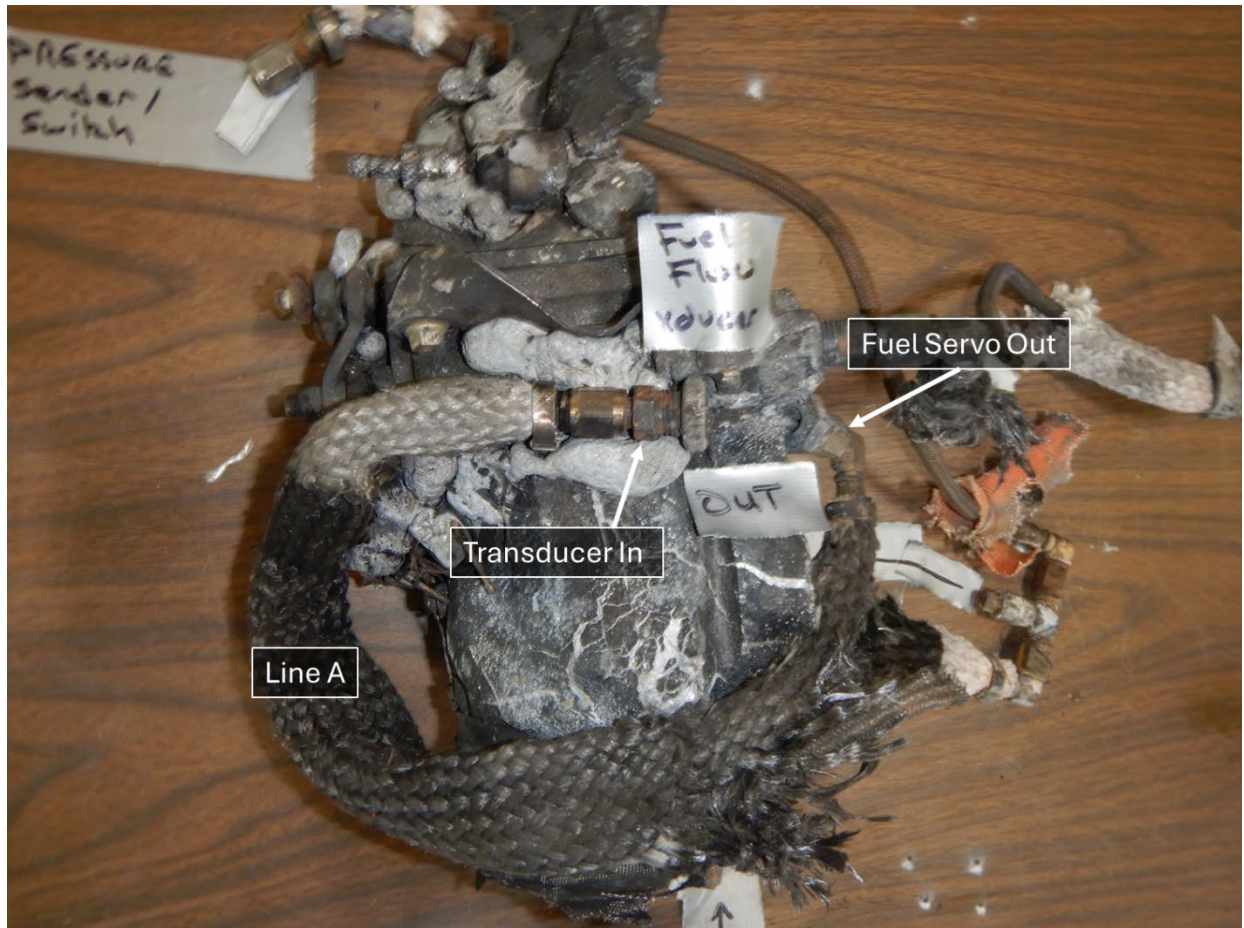
Figure 16. Fuel line A, as found on the fuel servo.

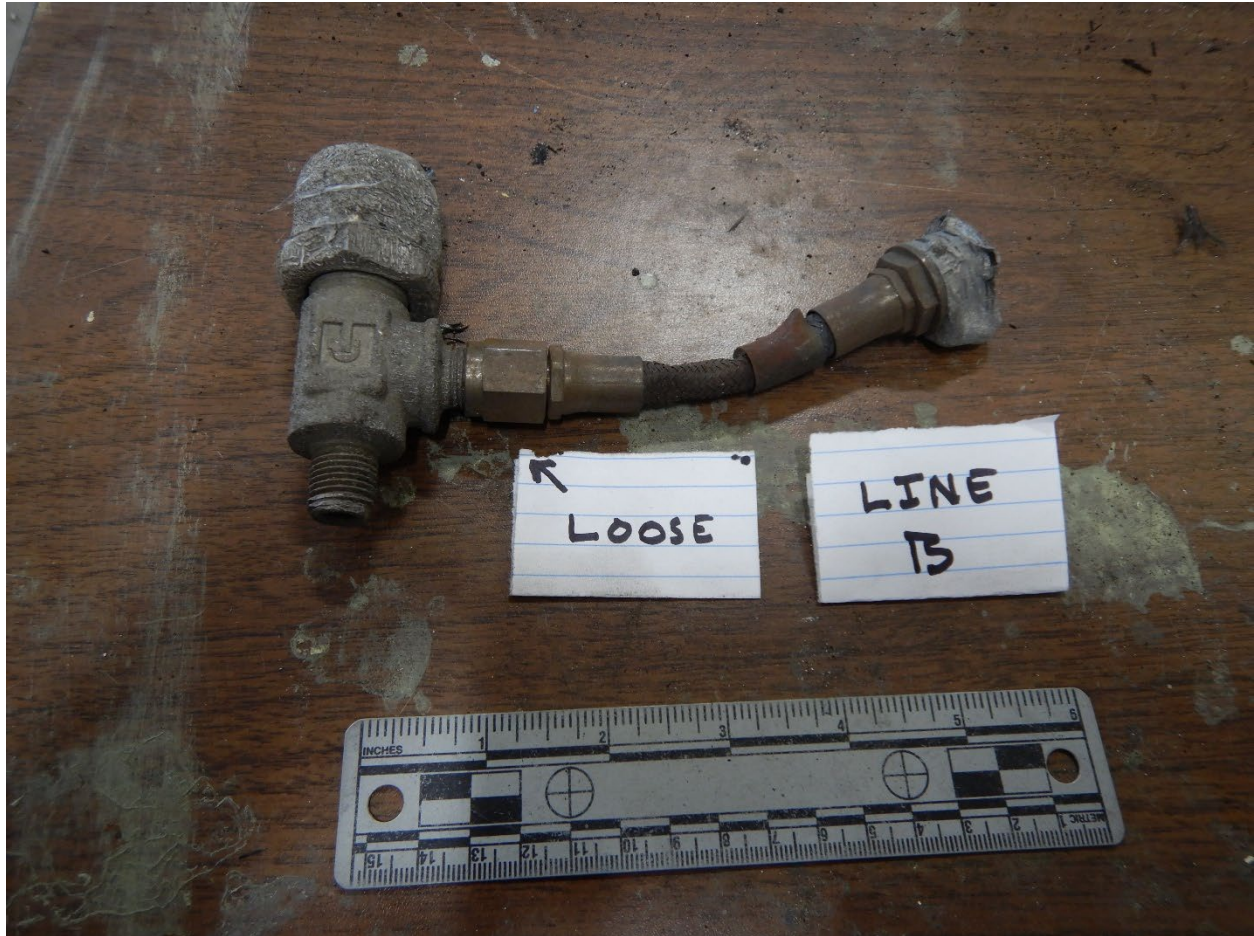
The pressure relief valve to the tank line was identified as Line B (figure 17). The B-nut on one end, the end that attached to a T-fitting, was found loose. The other end had separated along with material from the attachment point.

Figure 17. Fuel line B, Pressure relief valve assembly.

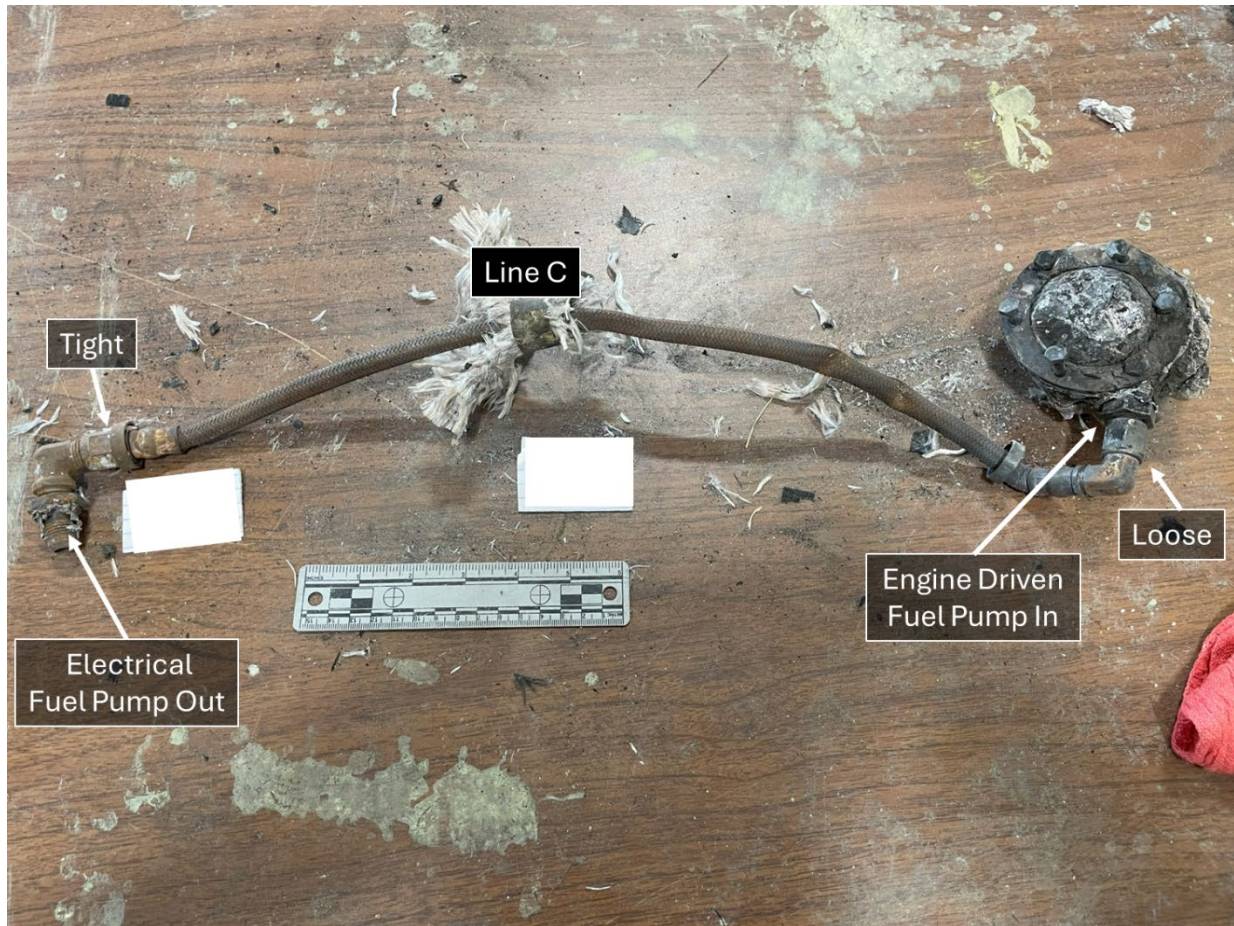
Figure 18. Fuel line C.

The electric fuel pump to the EDFP was identified as line C (figure 18). Line C remained attached to the EDFP and was thermally damaged with the webbing burned away. The B-nut on this end was loose. Some of the webbing was cut away to facilitate examination of the line. The EDFP separated from the engine and was thermally damaged. The electrical fuel pump out end of the line remained tightly attached to a 90° fitting.

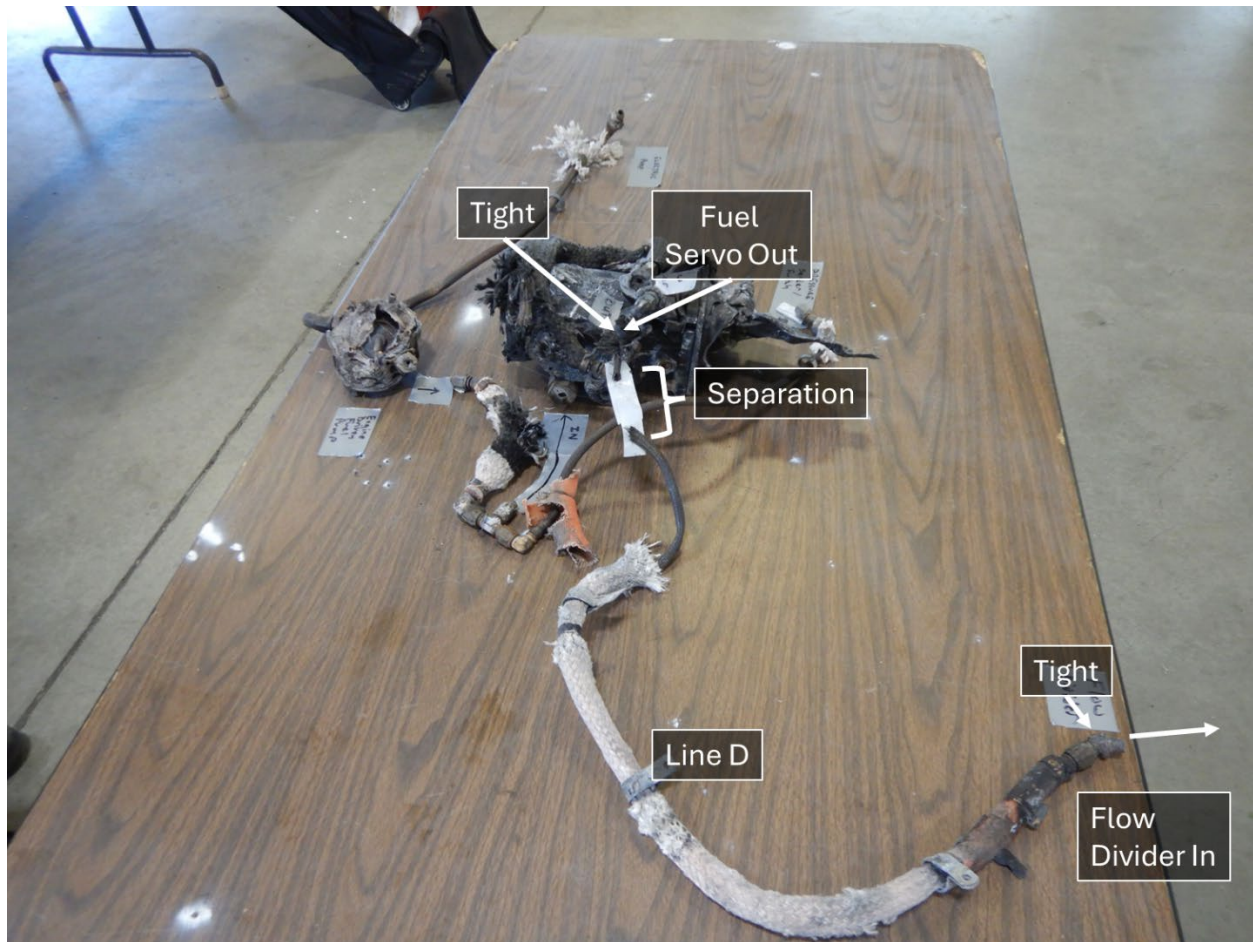
Figure 19. Fuel line D.

The fuel flow transducer to fuel divider line was identified as line D (figure 19 and 20). Line D remained attached to the airframe and was thermally damaged, with most of the fabric webbing remaining around the line. The line was found separated from the thermally damaged flow divider. The line had fractured and separated from the fuel servo end. The remaining section of line E remained tightly attached to the fuel servo.

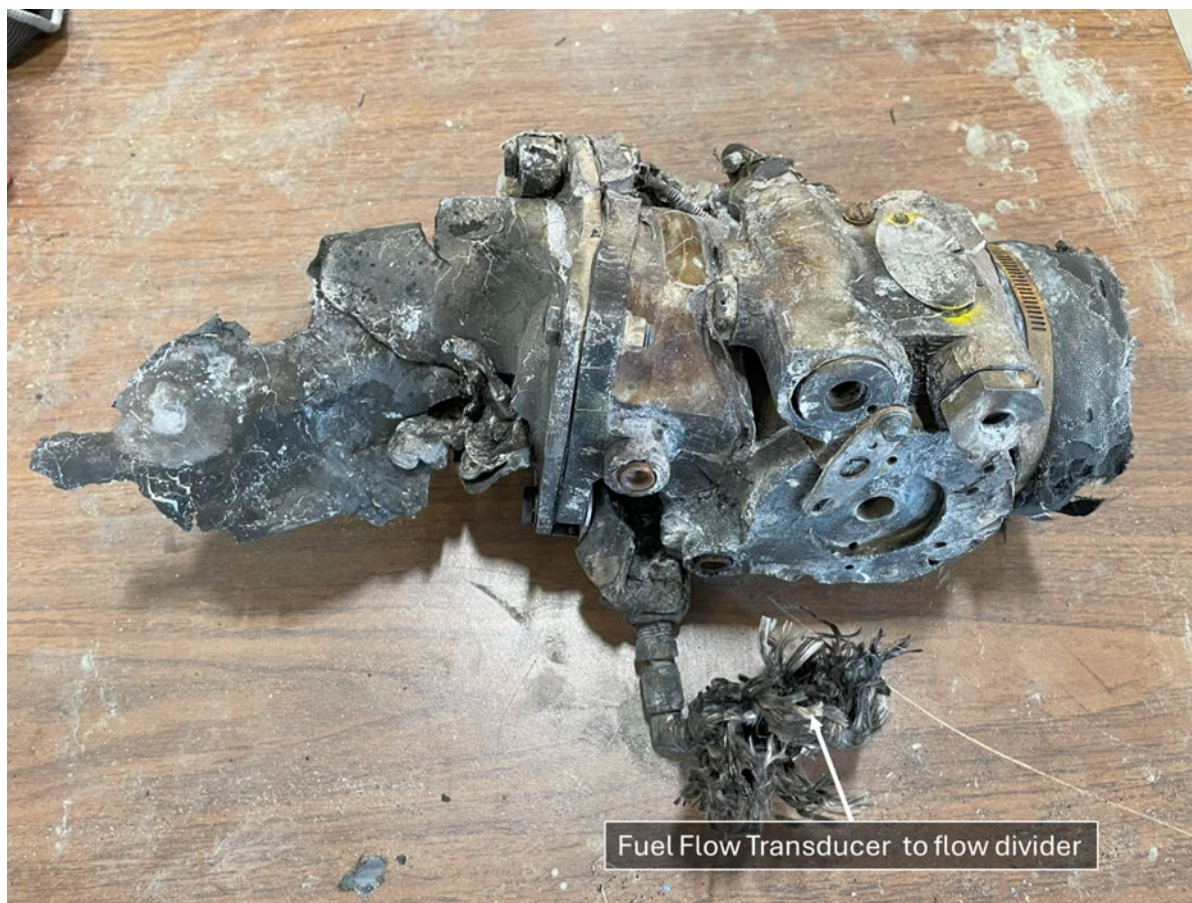
Figure 20. Line D, fractured end.

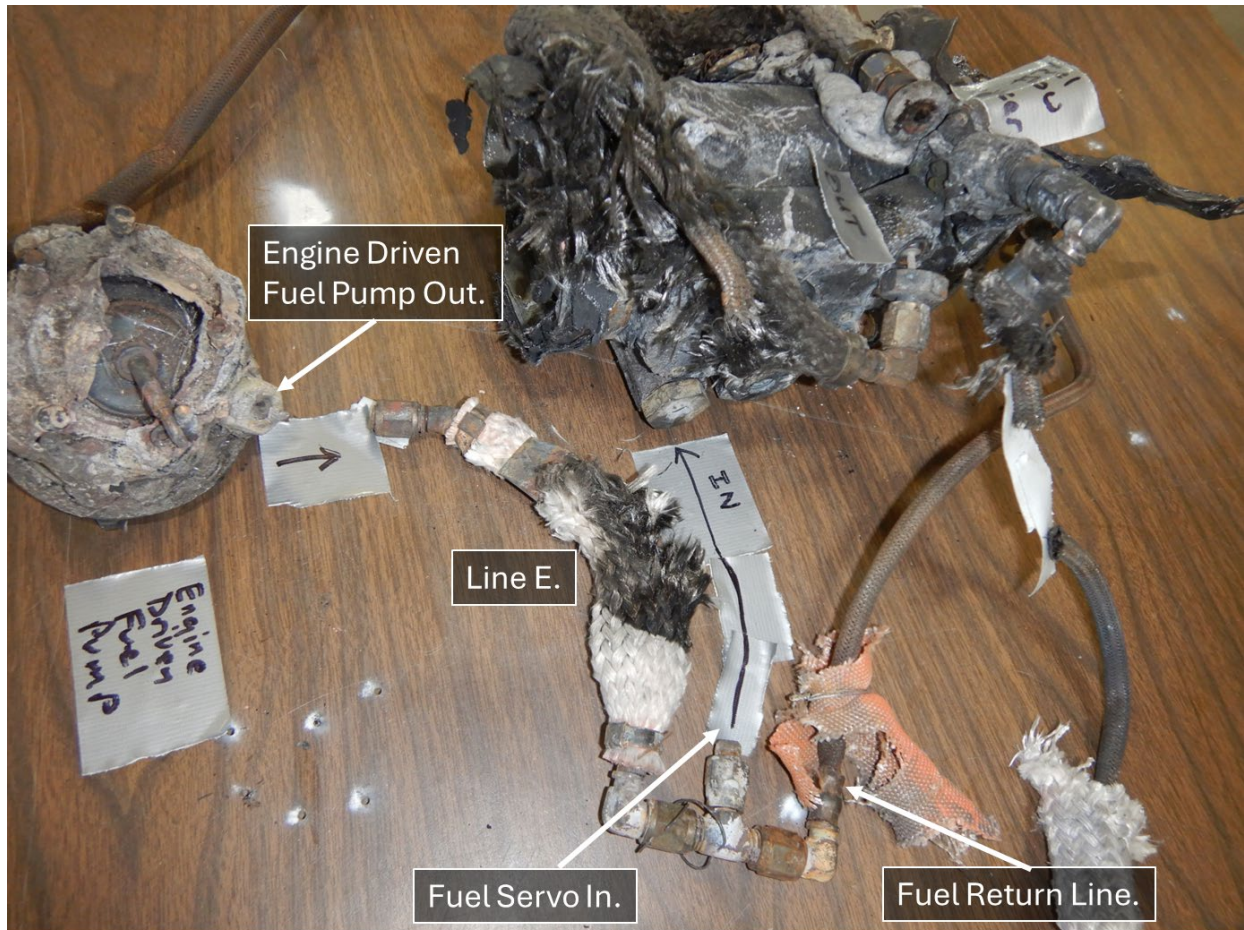
Figure 21. Fuel line E.

The line from the EDFP to a T-fitting was identified as Line E (figure 21). Line E separated from the thermally damaged EDFP at the B-nut. The other end remained tightly secured to one end of a T-fitting. The middle outlet of the T-fitting was missing the line but connected to the fuel manifold input. The second outlet of the T-fitting was connected to the fuel return line.
