**Air Tractor, Inc.**  
Accident Investigation

**Airframe Final Report**

**WPR24FA201**

**6/24/24**  
**Arco, ID**

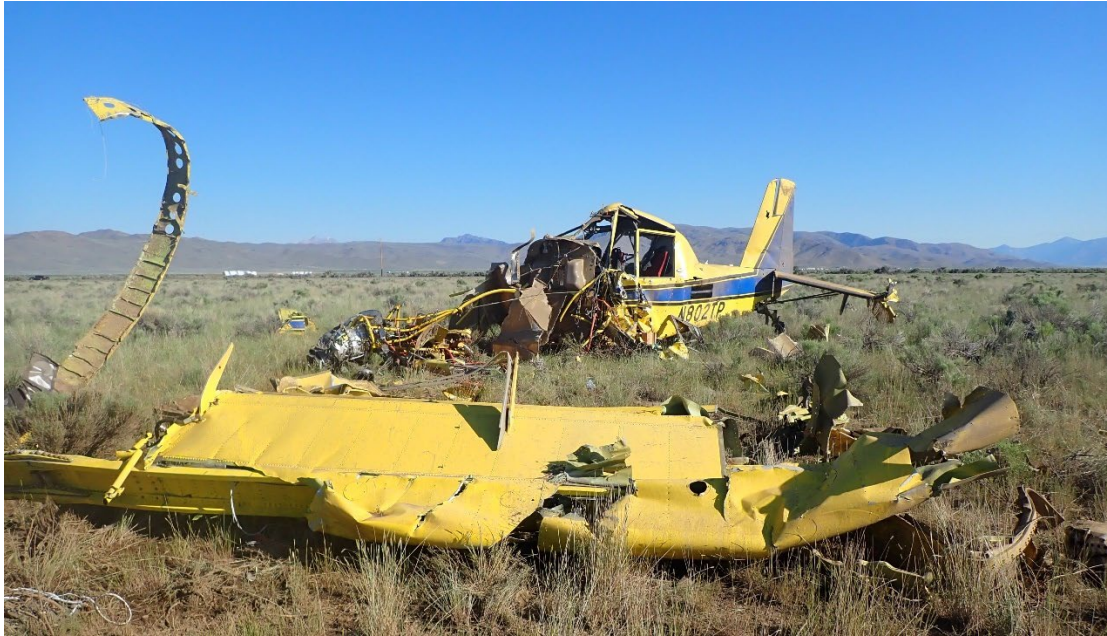
The wreckage of N802TP was found upright in a sage rangeland with no signs of fire or heat damage. A ground scar containing left wing tip pieces and outboard wing segments was found approximately 285 feet south of the main wreckage. A ground scar consistent with forward fuselage impact containing propeller blades was found approximately 65 feet north of the initial impact scar. The ground scar of N802TP had an approximate direction of 325° (true).

### **N802TP Main Wreckage**

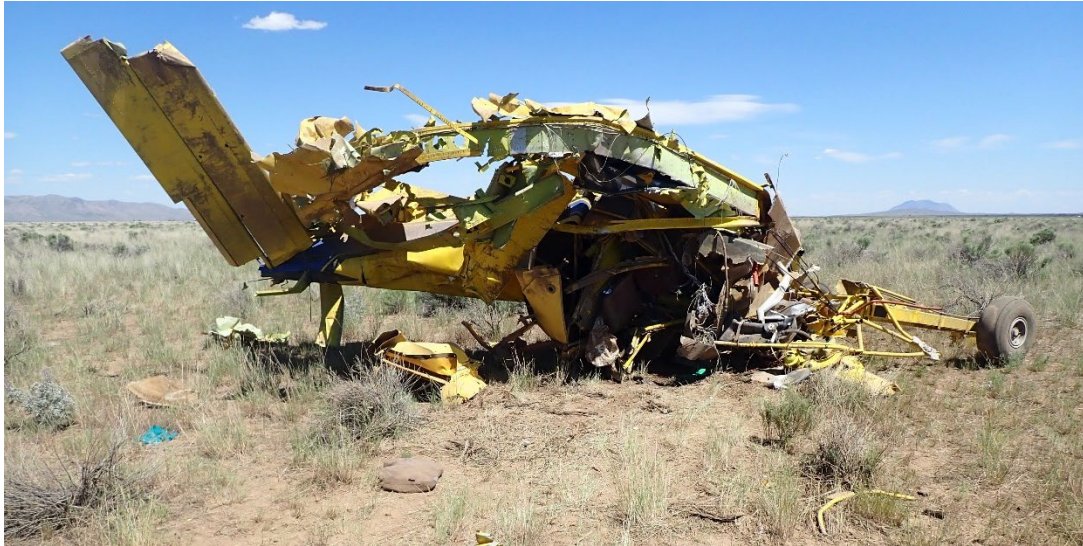
The wreckage of N581TW was found inverted in a sage rangeland with no signs of fire or heat damage. The nose and engine sections of the aircraft was found bent upward and aft underneath the fuselage. The wreckage of N581TW was found approximately 1680 feet south of N802TP. A ground scar consistent with left wing impact containing left wing tip pieces was found approximately 250 feet south of the main wreckage. A ground scar consistent with forward fuselage impact containing propeller blades was found approximately 40 feet south of the initial impact scar. The ground scar had an approximate direction of 110° (true).

**N581TW Main Wreckage**

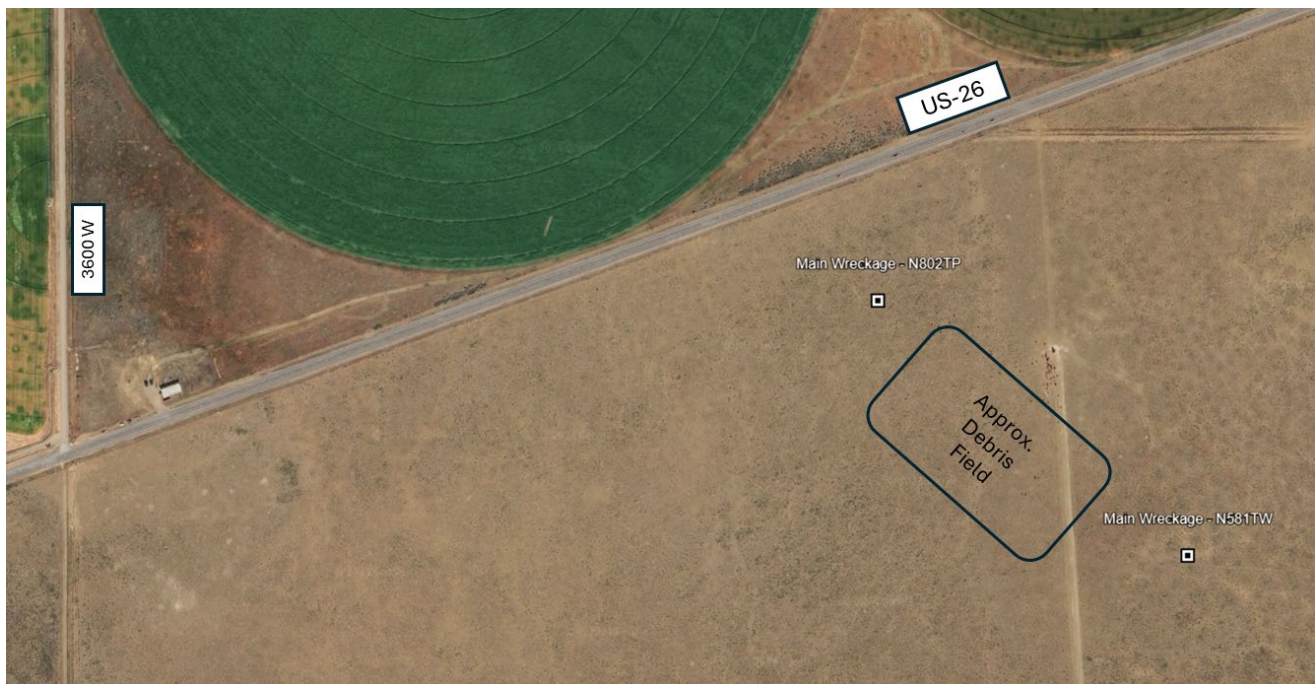
A debris field approximately 735 feet x 600 feet consisting of paint flakes, wing fragments, and empennage fragments was located approximately 600 feet southeast of the wreckage of N802TP and 625 feet north of the wreckage of N581TW. A segment of the outboard right wing of N581TW was found in the debris field with a segment of the aileron still attached. The right flap of N581TW was found in the debris field north of the right wing segment. The right horizontal stabilizer, right horizontal stabilizer V-Strut, rudder, and elevator of N581TW was found in the debris field south of the right wing segment. A segment of right wing wingtip, right wing aileron segments, and right wing outboard segments of N802TP was found in the debris field.

**Accident Map**

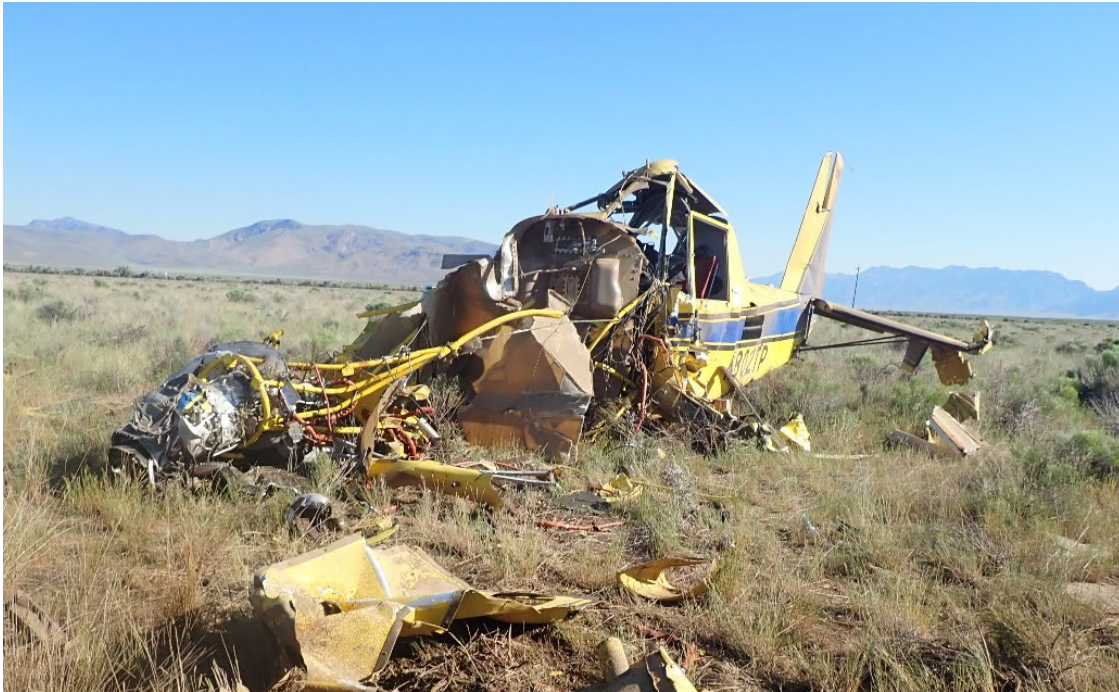
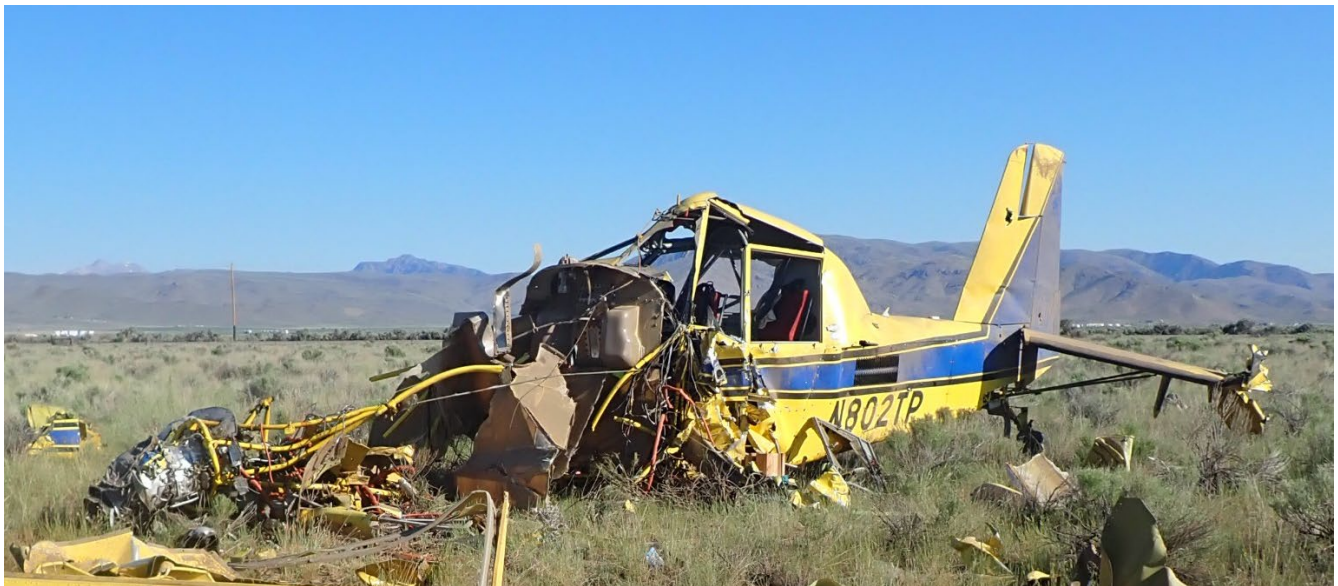
The fuselage of N802TP was found upright. The forward fuselage had significant crush damage with multiple separations around the hopper. The engine mount was found to be connected to forward fuselage members with attach hardware. The canopy was found to be bent upwards and aft. The heading of the fuselage was found to be 202° (magnetic).

**N802TP Main Wreckage**

**N802TP Fuselage**

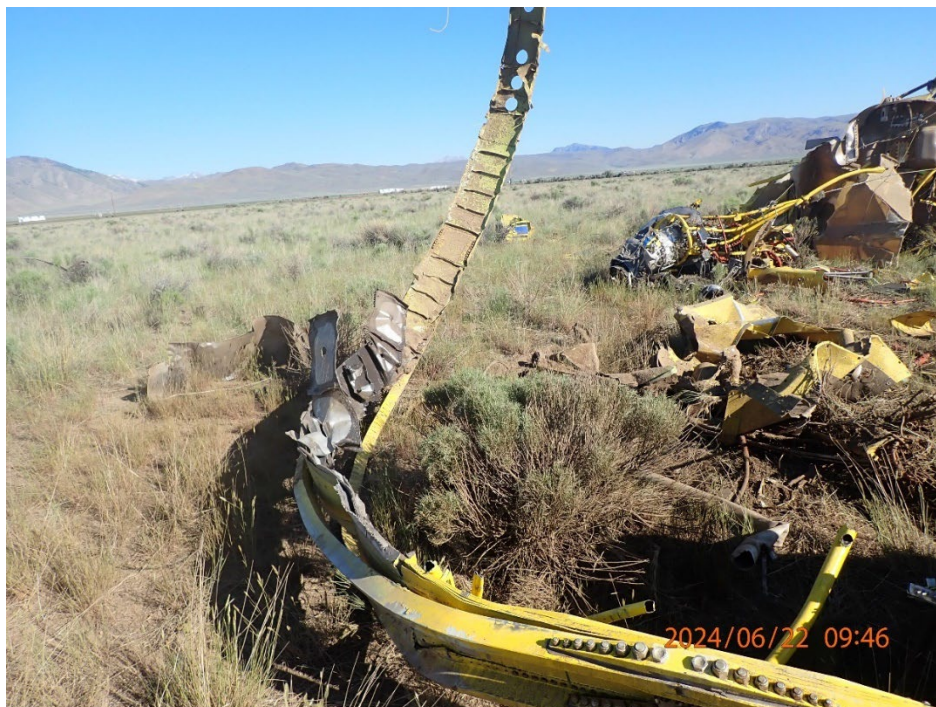
The left wing front spar was found bent aft and downwards with the ribs and skins found between the initial impact and the main wreckage. The left flap, left aileron, left aileron counterweight, and left wing outboard segments were found in the ground scar leading up to the main wreckage. The left wing fuel tank segments were not attached to the main spar.

**N802TP Left Wing Spar**

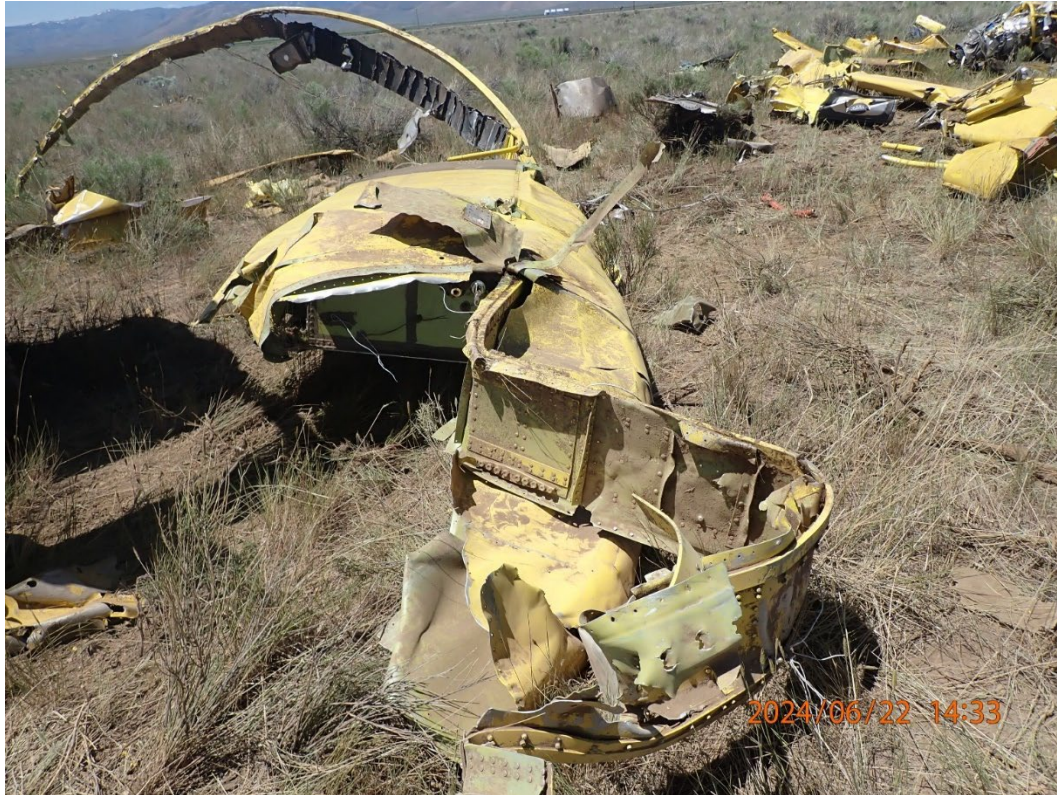
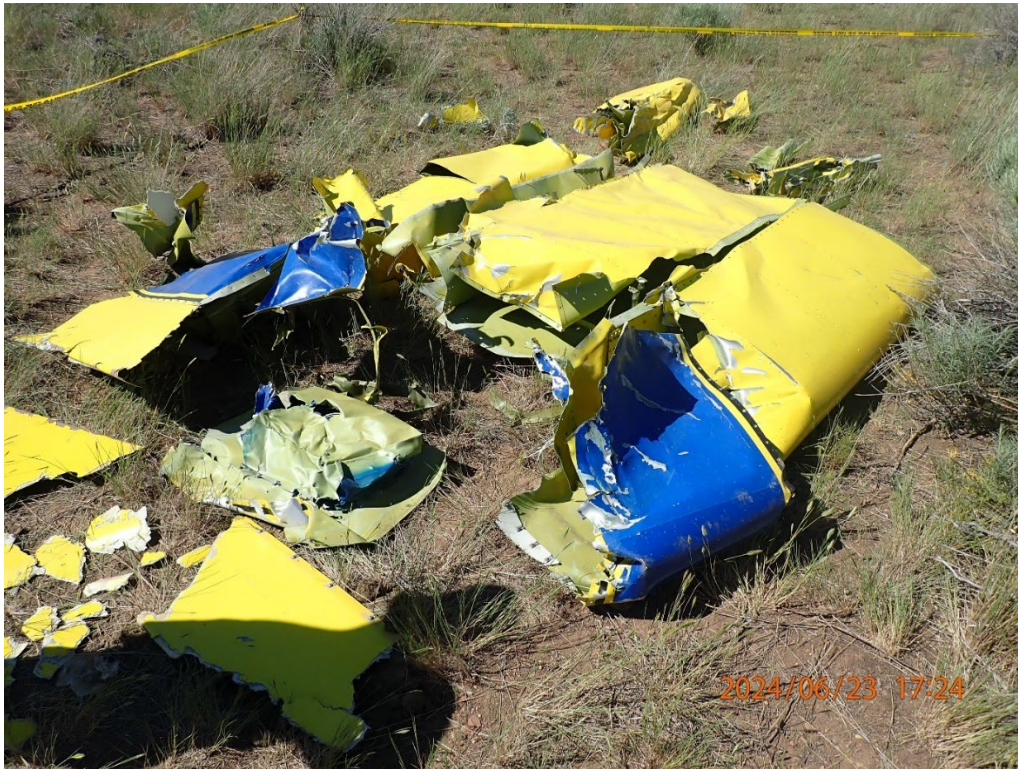
The right wing main spar had a separation near the middle section of the wing. The right wing fuel tank was ruptured. The fuel tank cap was found in place and the fuel tank placard stated 153 gallons of fuel. The right flap was found near the ground scar leading up to the wreckage. The right aileron, right aileron counterweight, right outboard section of wing, and right wing tip was found in the debris field located between N802TP and N581TW. The right wing damage and the location of right wing components of N802TP were consistent with the right wing contacting N581TW mid-air.

**N802TP Right Wing**

### **N802TP Outboard Right Wing Layout**

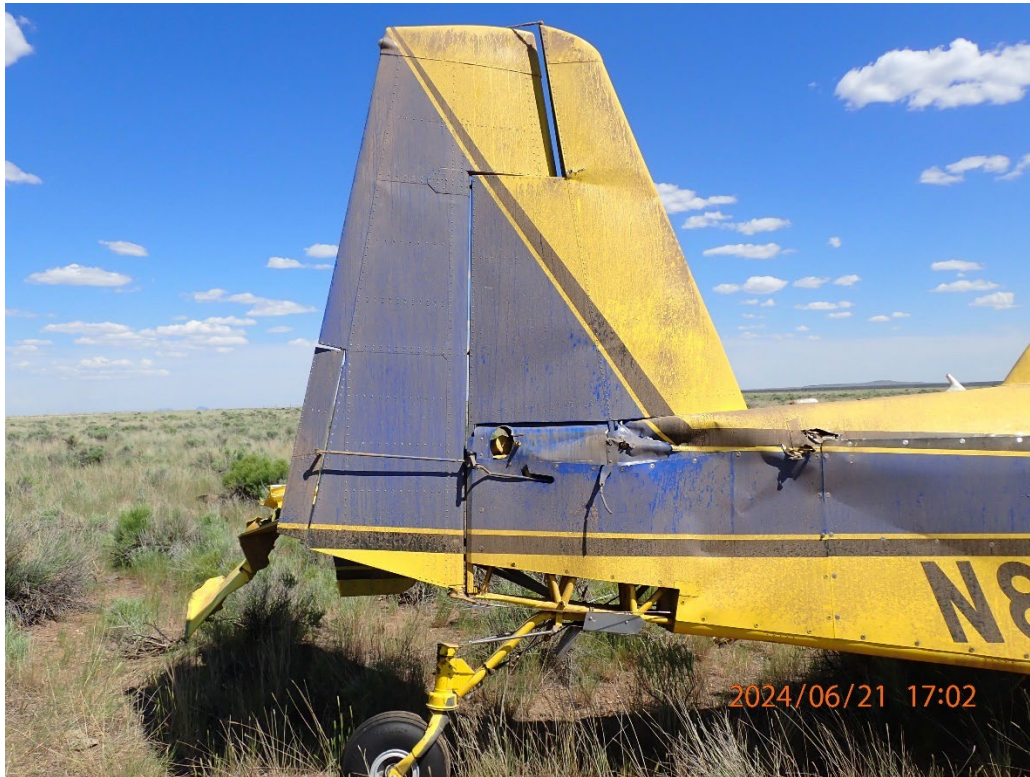
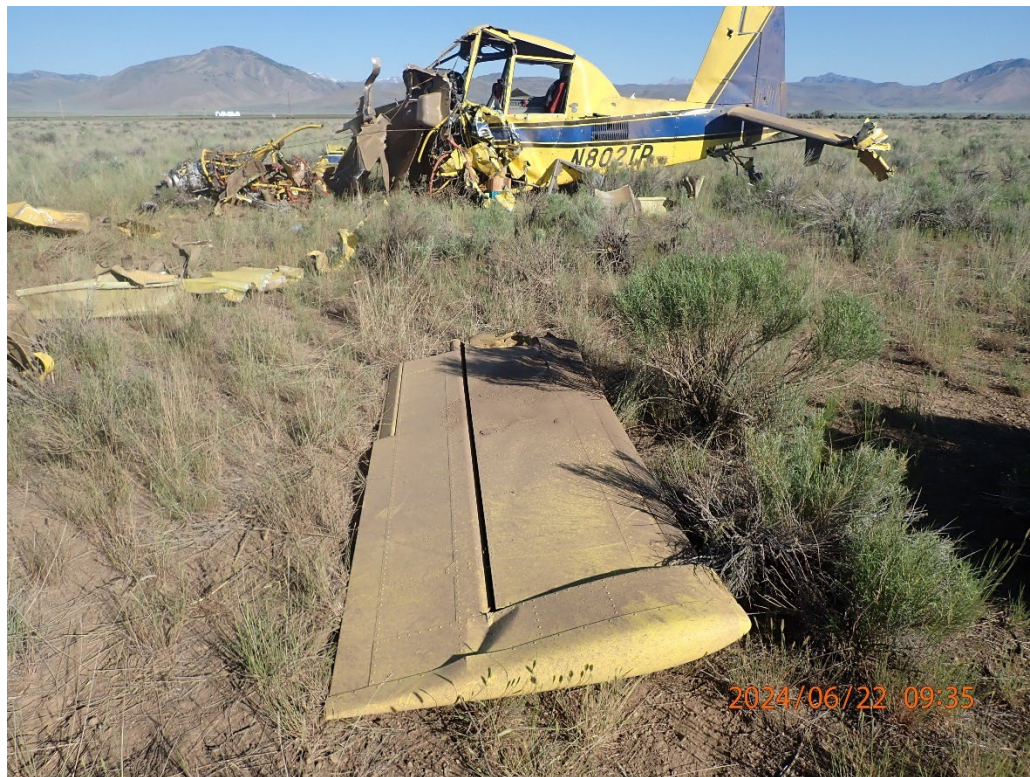
The right horizontal stabilizer and attached elevator were found separated and laying approximately 10 feet south of the empennage section of the aircraft. The horizontal stabilizer v-strut was connected to the horizontal stabilizer. The left elevator counterweight and balance horn of the left elevator was found south of the main wreckage near the ground scar. The left horizontal stabilizer, left elevator, and rudder were found attached to the fuselage with hinges and hardware intact.

**N802TP Empennage (Right Side)**

**N802TP Empennage and Right Horizontal Stabilizer & Elevator**

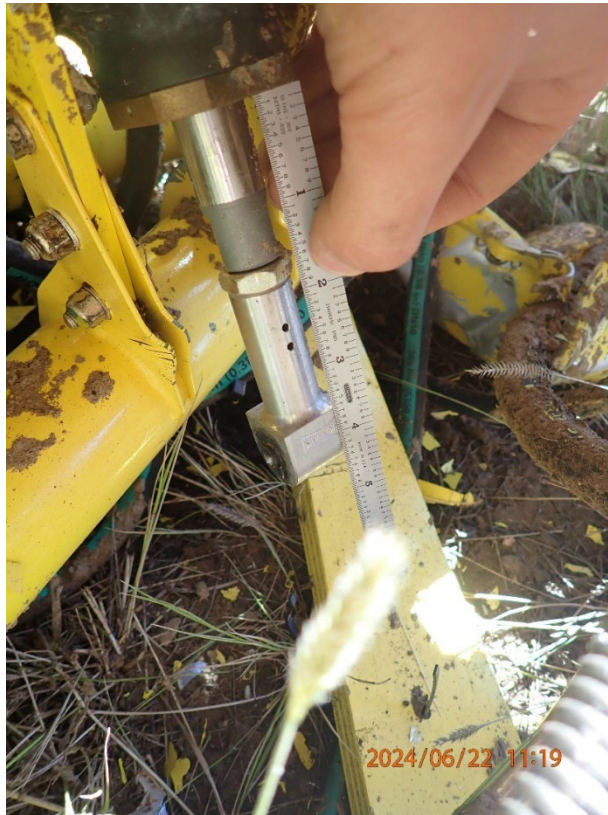
N802TP was equipped with an aftermarket hydraulic flap actuator. The hydraulic flap actuator was found separated from the frame structure. The left and right flaps were found to be continuous from the flap actuator to a separation in the push rod bearings that connect to the flap control horn.

**N802TP Aftermarket Hydraulic Actuator**

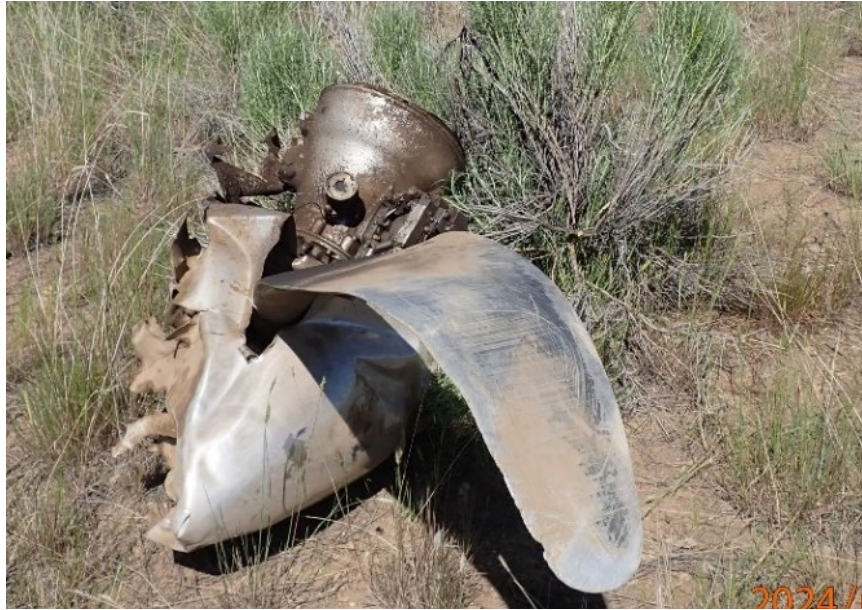
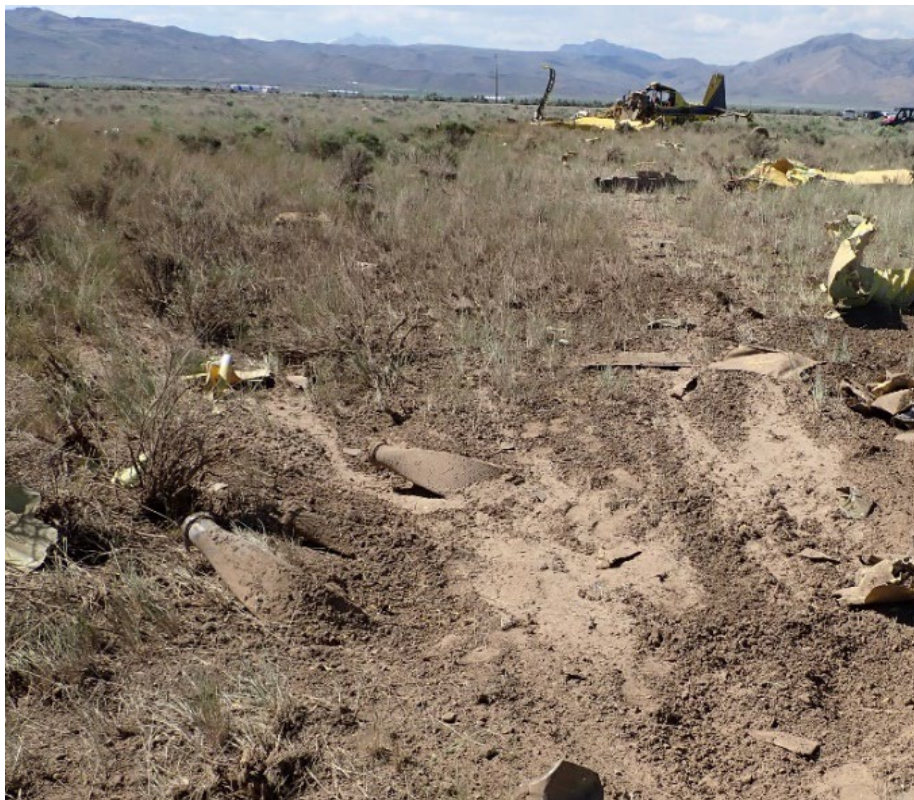
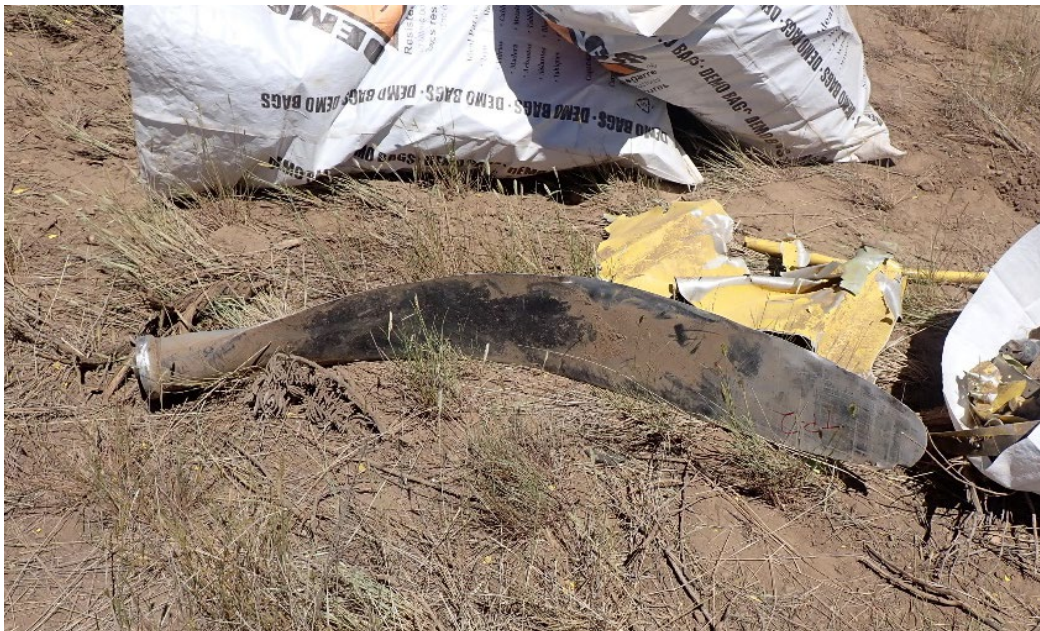
The powerplant was found with the forward fuselage wreckage. The engine was found with impact damage and to be separated at the “A” flange. The engine was equipped with a five-bladed constant speed, fully reversible, propeller. Four blades were found separated from the propeller hub. Three of the four separated propeller blades were found in the main ground scar leading up to the main fuselage wreckage of N802TP all exhibiting bending towards the camber side of the blade. One of the four separated blades was found approximately 40 feet east-southeast of the main fuselage wreckage of N802TP with bending towards the face side of the blade. The one blade that remained attached to the propeller hub was found bent toward the camber side of the blade. The engine was confirmed to be a PT6-67AG, serial number PCE-RD0307.

**N802TP Propeller Hub and 1 Prop**

**N802TP 3 Propellers in Ground Scar**

**N802TP Propeller (moved during recovery)**

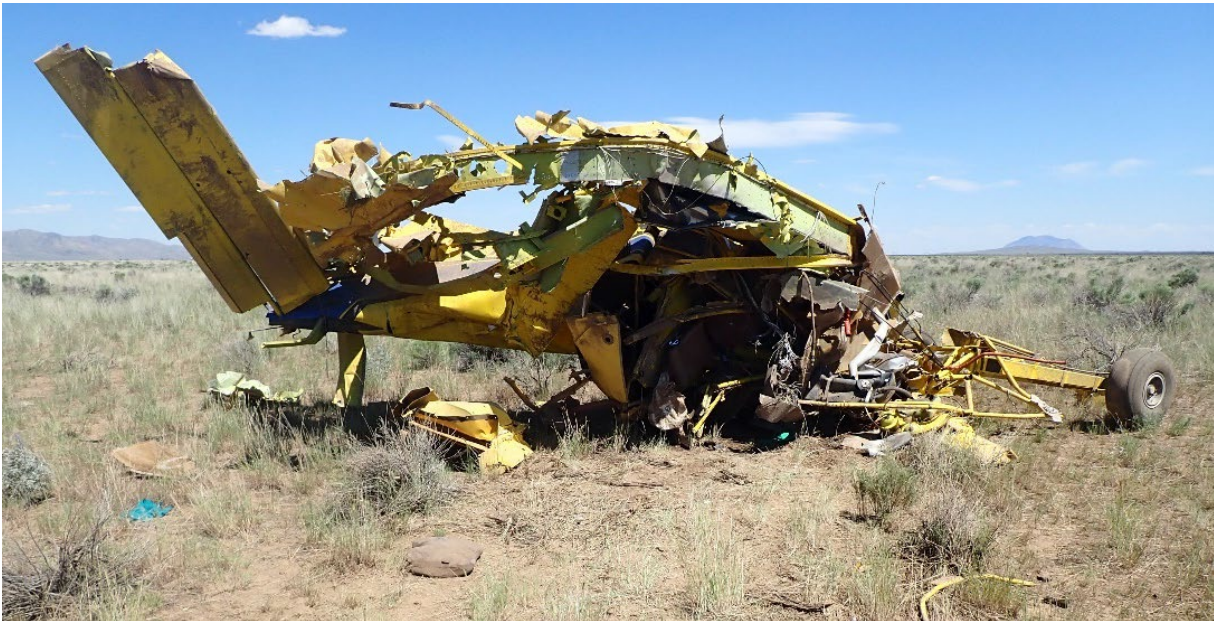
The fuselage of N581TW was found inverted. The fuselage forward of the cockpit was heavily damaged with hopper and engine structure underneath the fuselage. The heading of the fuselage was found to be 175 (magnetic).

**N581TW Fuselage**

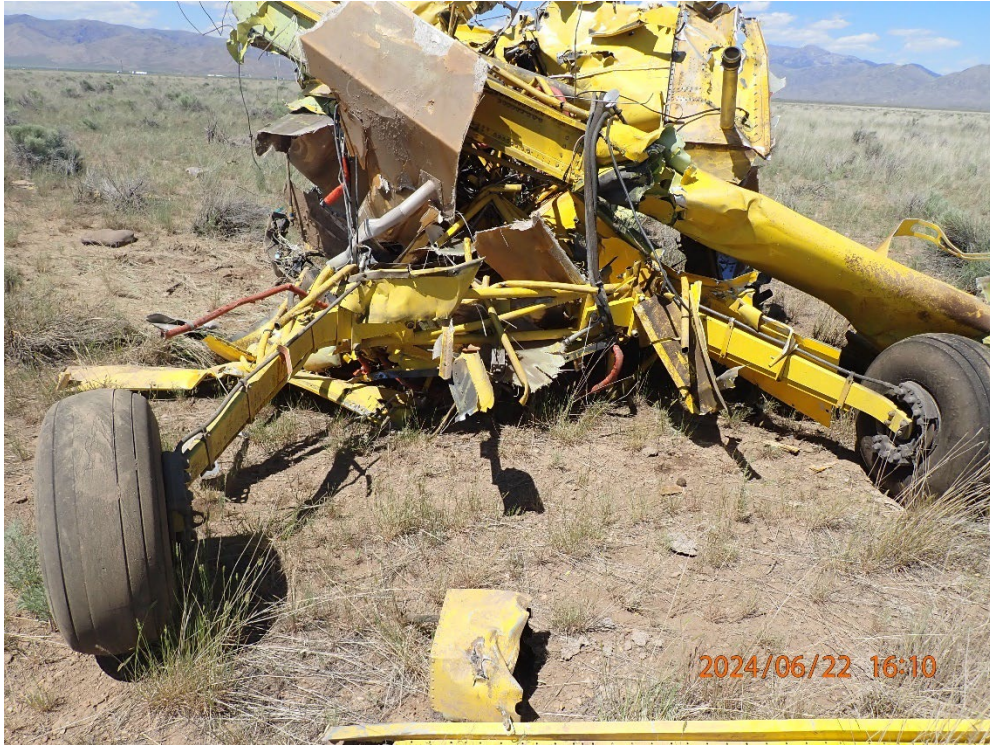
The left and right landing gear was found connected to the main wreckage with attachment hardware still in place. Both gears had non-factory wire cutters installed on the leading edges.

### **N581TW Landing Gears and Fuselage**

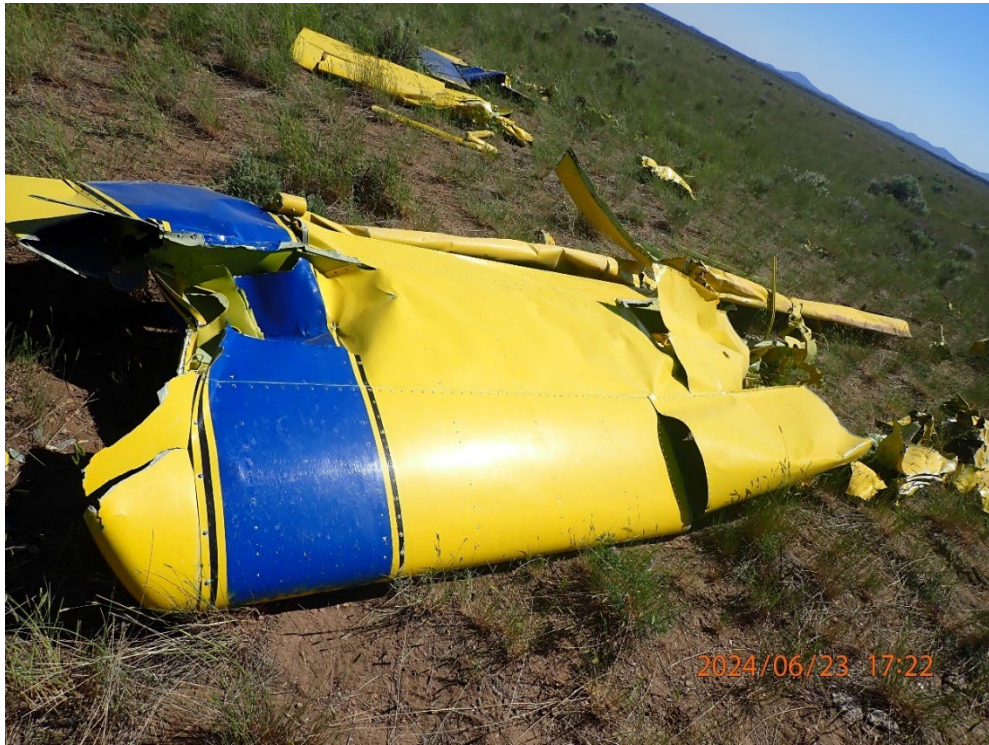
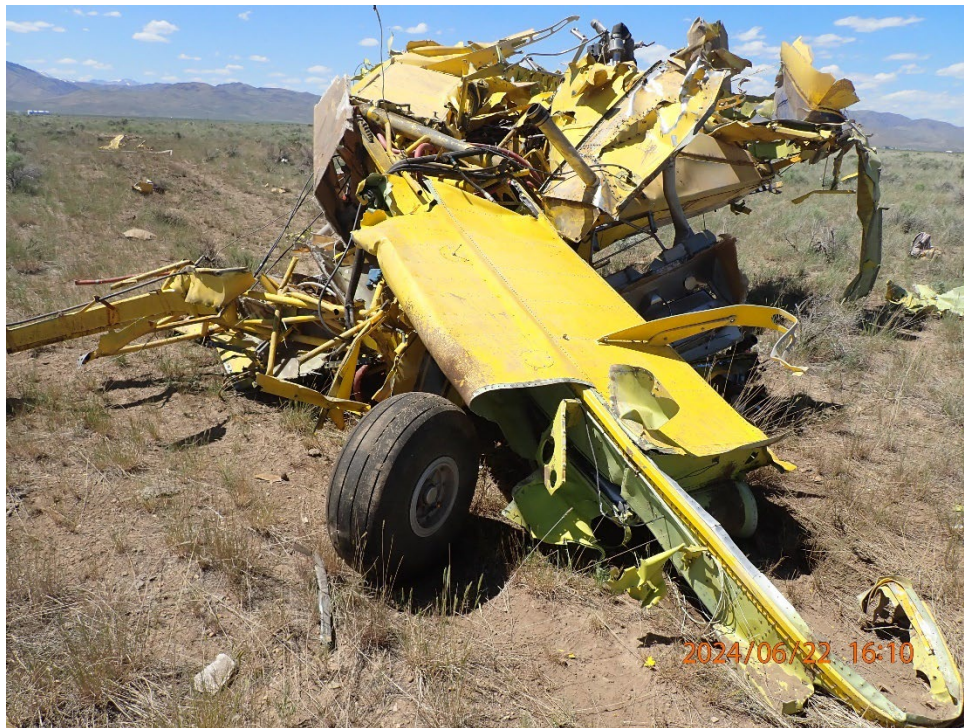
The right wing main spar had a separation near the middle section of the wing. The right wing fuel tank was ruptured. The fuel tank cap was found in place and the fuel tank placard stated 83 gallons. An outboard segment of N581TW right wing was found in the debris field with the aileron and aileron counterweight attached. The right flap was also found in the debris field near the outboard section of right wing.

**N581TW Outboard Right Wing Layout**

**N581TW Inboard Right Wing**

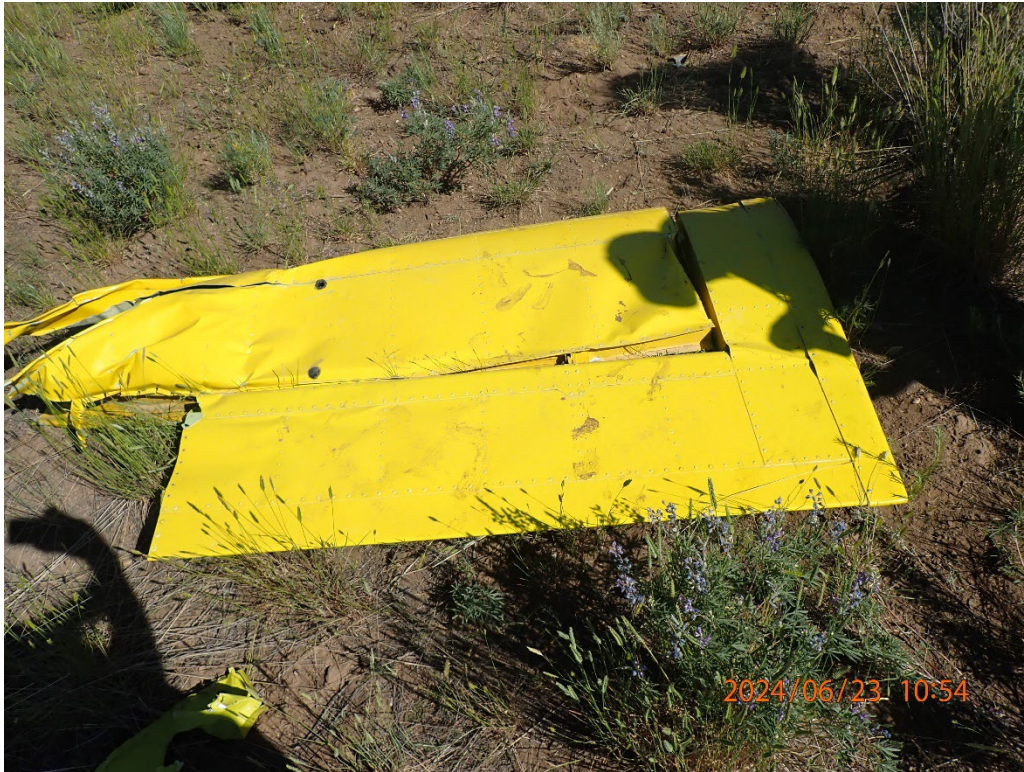
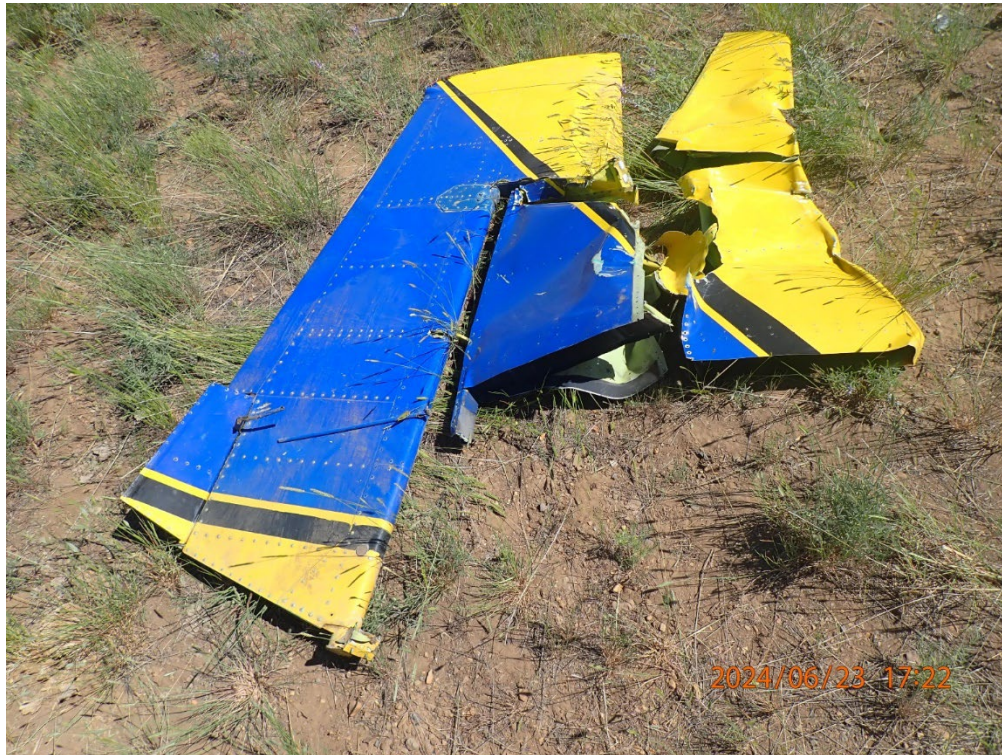
The right horizontal stabilizer, right horizontal stabilizer v-strut, right elevator, vertical stabilizer, and rudder of N581TW were found in the debris field. The right horizontal stabilizer and right elevator were found separated into two pieces near the middle. The left horizontal stabilizer was found attached to the fuselage with the forward attachment separated from the frame attachment point.

**N581TW Right Horizontal Stabilizer and Elevator**

### **N581TW Rudder and Vertical Stabilizer (Layout)**

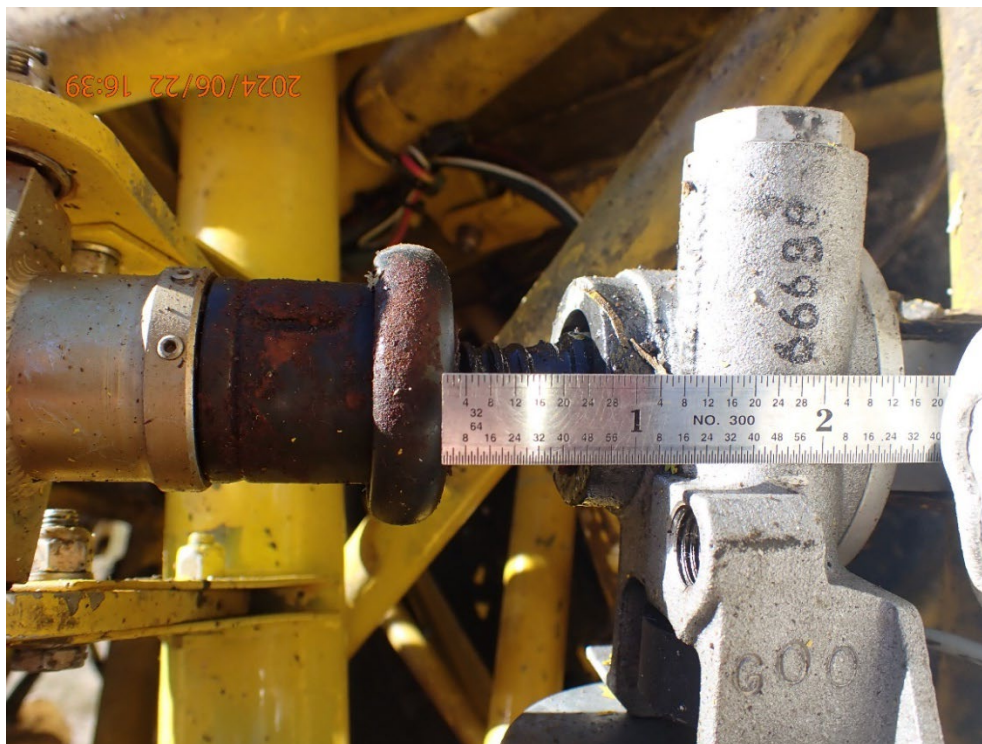
The left flap controls was found to be continuous from the flap actuator to the flap control horn. The right flap controls were found to be continuous from the flap actuator to the flap control horn. The flap control horn was found separated from the flap. The flap actuator extension was found to be 7/8 inches which corresponds to a flap extension of approximately 5°

**N581TW Flap Actuator Measurement**

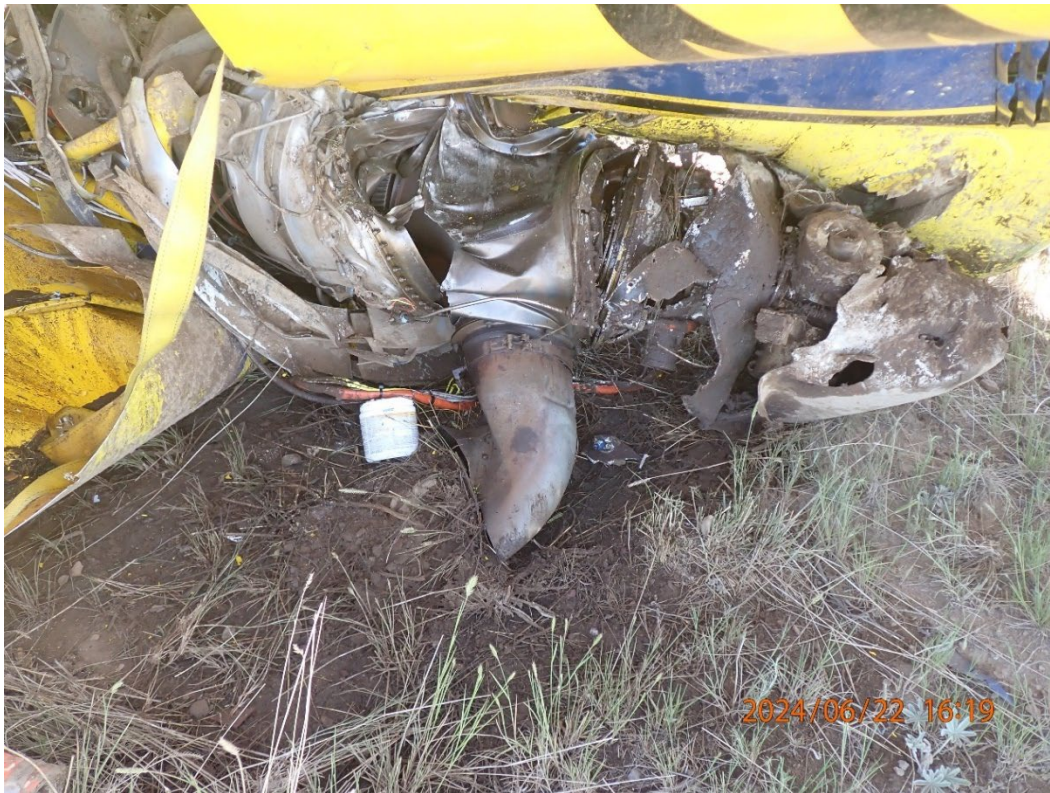
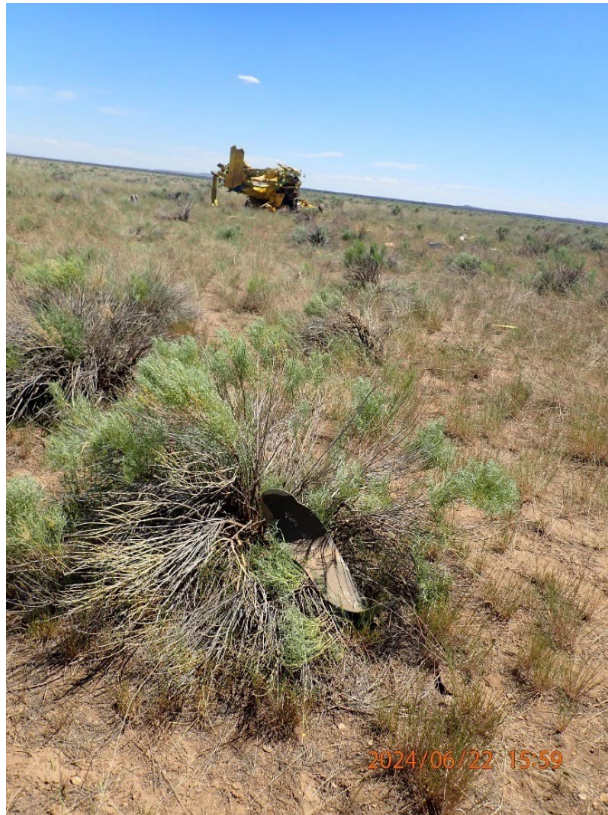
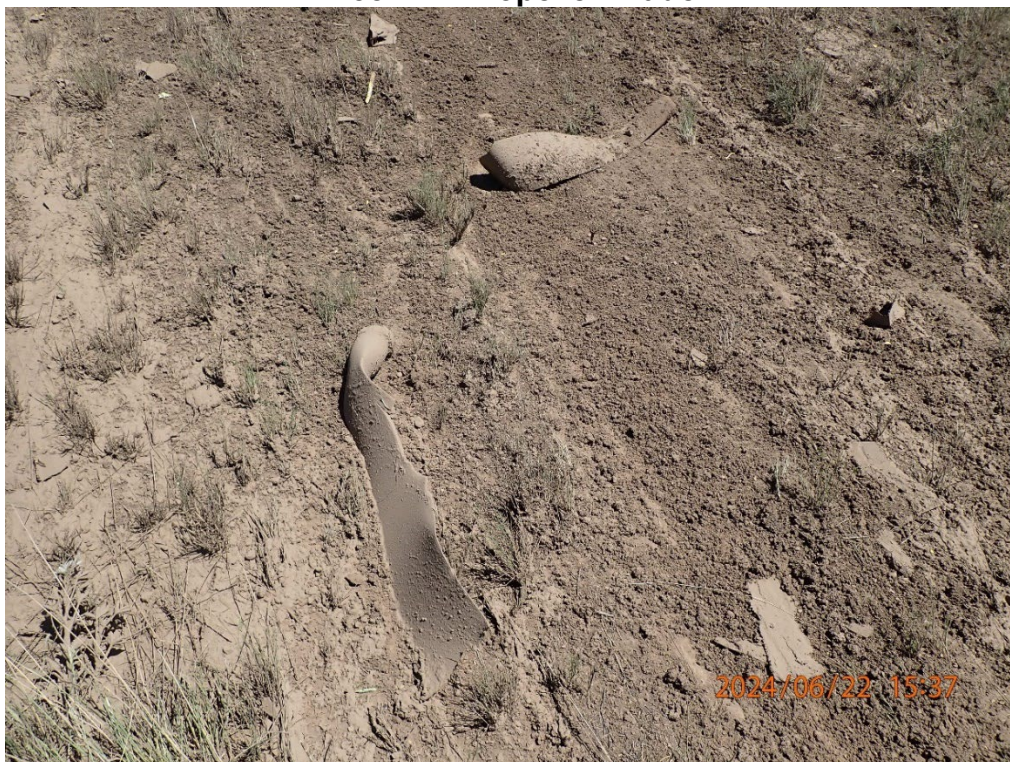
The engine was equipped with a 3-bladed constant speed, fully reversable, propeller. One of the propeller blades was found attached to the propeller hub and was separated about half of the blade length. 2 fragments of disconnected blades were found separated at the hub located in the ground scar leading to the main wreckage.

**N581TW Powerplant**

**N581TW Propeller Blade**

**N581TW Two Propeller Blades in Ground Scar Leading to Main Wreckage**
