# National Transportation Safety Board

WPR24FA202

## **ACCIDENT SITE SUMMARY**

Location: Capitan, NM  
Date: 6/21/2024  
Time: 1045 MDT  
1745 UTC  
Airplane: N331BS, Air Tractor AT-802A

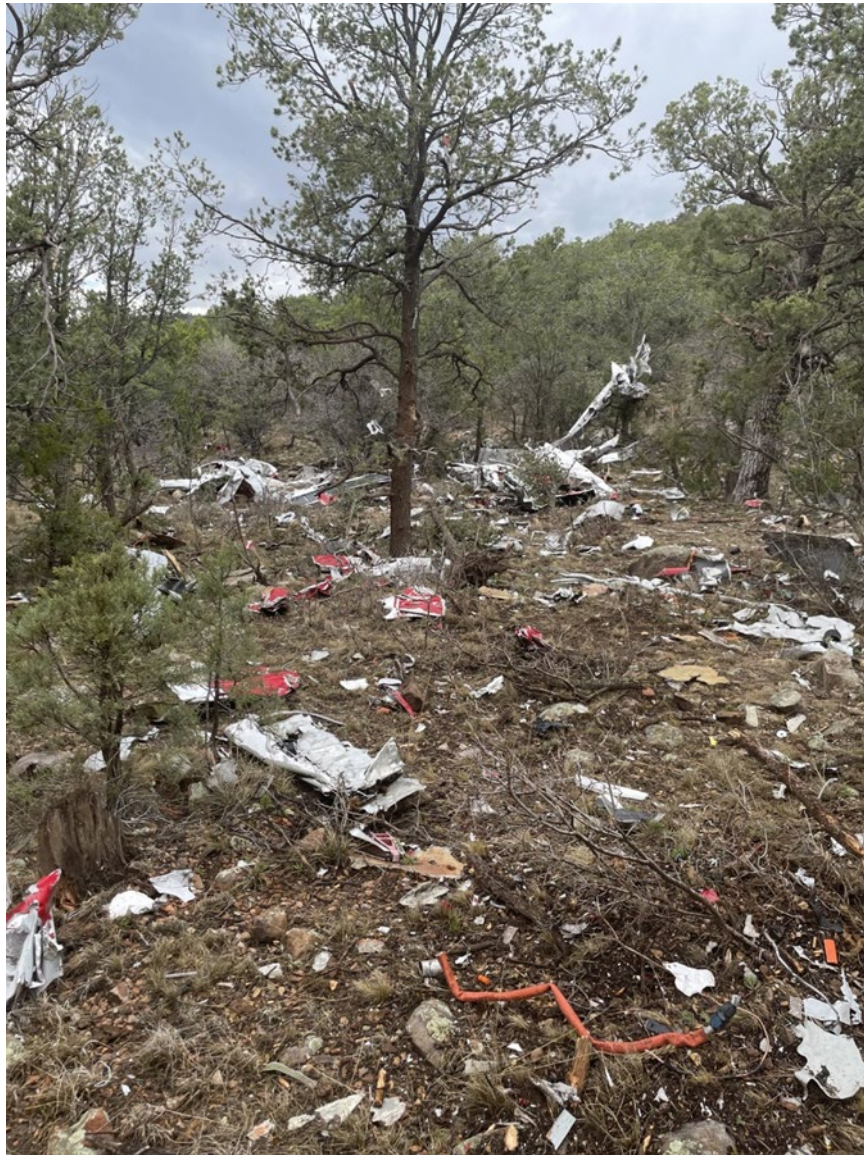
The primary debris field was about 120 ft long on a heading off about 335° magnetic. The first identified point of initial contact was a tree, where portions of the right-wing tip were located. From that point a ground scar led to a large ground disturbance where the engine was embedded into the ground. The disturbance was about 6 ft

wide x 15 ft long x 1 ft in depth. The largest part of the main fuselage (empennage) of the airplane wreckage came to rest on its left side. Most of the debris found uphill from the debris path was from the top portion of the airplane and most of the debris found below the debris path was from the bottom of the airplane. Some fragments were scattered in each direction of the debris path. The furthest airplane fragment was located about 300 ft from the main debris path. The debris path and ground scars were consistent with a high speed and nearly level flight path at impact.

**Figure 1: Airplane wreckage debris trail.**
