**Subject:** WPR24FA202 Memorandum for Record - Record of Conversation

- ON JUNE 21, 2024, AT APPROXIMATELY 1100 MST, AN AIR TRACTOR AT-802, CRASHED WHILE IN CRUISE FLIGHT IN MOUNTAINOUS TERRAIN 6 MILES ENE OF CAPITAN, NM. THE COMMERCIAL PILOT WAS KILLED. THE AIRCRAFT WAS DESTROYED. THE AIRCRAFT WAS A PART OF A THREE-PLANE FERRY DEPARTING ALPINE-CASPARIS AIRPORT, TX (E38) TO GALLUP MUNICIPAL AIRPORT, NM (GUP) AFTER BEING RELEASED FROM USFS FIREFIGHTING OPERATIONS. THE FLIGHT WAS OPERATING VFR AT 9,500 FEET. NO FLIGHT PLAN WAS FILED. THE LEAD PILOT STATED THAT, WHILE ENROUTE TO GUP, THEY ENCOUNTERED A RAIN SHOWER IN THE CAPITAN AREA. HE DIRECTED THE OTHER TWO AIRCRAFT TO TURN 30 DEGREES AND CLIMB TO REACQUIRE VISUAL CONTACT WITH ONE ANOTHER. HE REPORTED THAT SHORTLY AFTER THAT, HE AND THE NUMBER TWO AIRCRAFT REGAINED VMC AND VISUAL CONTACT. HE THEN RADIOED THE MISHAP AIRCRAFT TO ASCERTAIN HIS SITUATION AS THAT AIRCRAFT WAS SEEN TURNING TO THE WEST. THE ONLY RESPONSE WAS, "OH, I GOT THIS..." THE TWO AIRCRAFT CONTINUED TO GUP EXPECTING TO FIND THE THIRD THERE. THE LEAD PILOT CONTACTED ATC AND THE COMPANY CHIEF PILOT TO INITIATE LOST AIRCRAFT PROCEDURES. WHEN LOCATED SEVERAL HOURS LAT

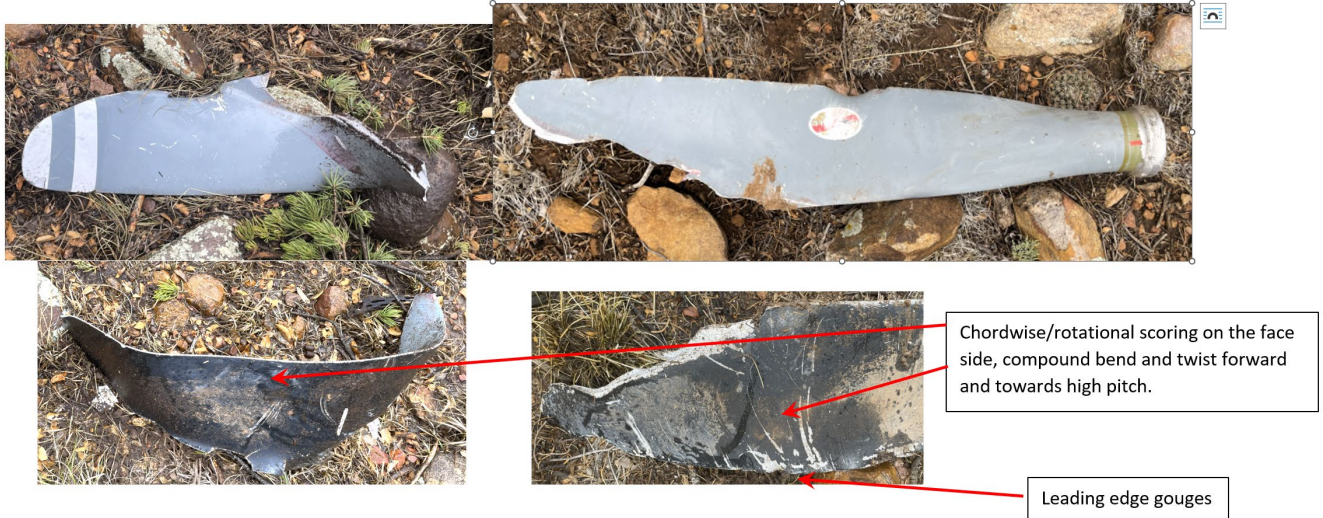
- WPR24FA202 Propeller Blade Damage Observations:
- Prop Model: HC-B5MA-3D/M11691NS
- S/N: HBA2306
- Installation Data Sheet No.: 1789
- One of the five blades impact-separated from the propeller assembly retention clamp and was found in two, large pieces near the main wreckage (Photo #1 montage). The blade fractured in the mid-blade area. Both pieces exhibited chordwise/rotational scoring, primarily on the face side. The outboard section of the blade was bent forward in the thrust direction with chordwise/rotational scoring on the face side. A small fragment of another blade tip that impact separated was also seen near the wreckage (Photo #2). These impact signatures indicate rotation at high RPM, high power and generating thrust at the time of impact.

- Photo #1 - Montage of fractured blade

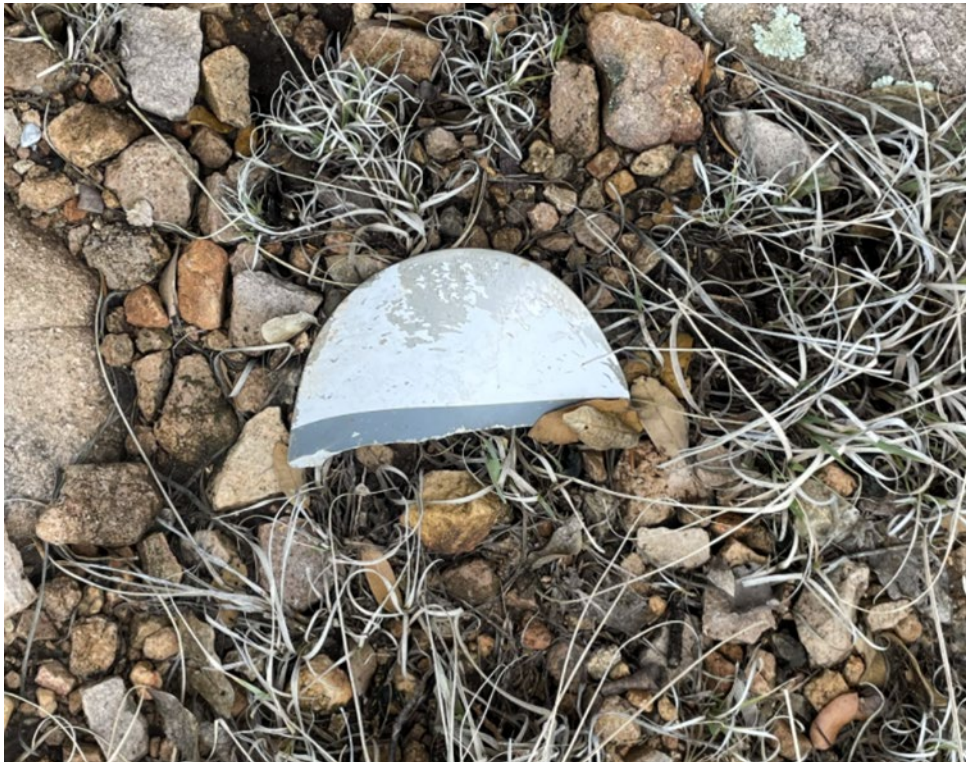
- Photo #2 -Tip fracture of another blade.
