# National Transportation Safety Board

WPR24FA226

## **MATERIALS LABORATORY**

Factual Report 24-065

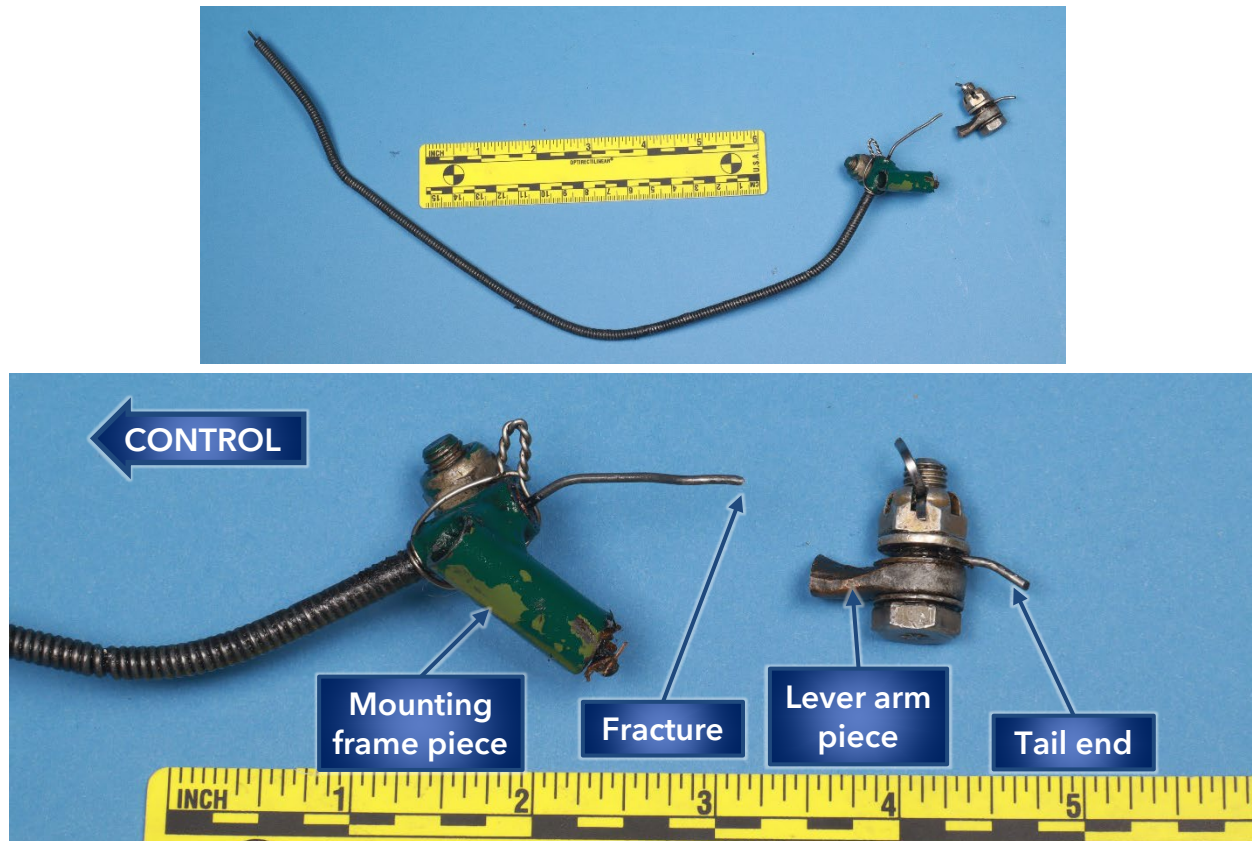
An overall view of the submitted mixture control cable pieces with attached lever arm and mounting frame pieces is shown in figure 1. The mounting frame was clamped to the engine end of the cable sheath, and the cable was fractured 1.121 inches away from the edge of the mounting frame clamp. The cable on the control side of the clamp was bent in several locations along its length, and the cable did not translate within the sheath when pushed by hand. The tail piece of the cable with the mating side of the fracture was loosely attached to the lever arm piece.

**Figure 1.** Overall view of the submitted pieces (upper image) with a closer view of the cable fracture location (lower image).

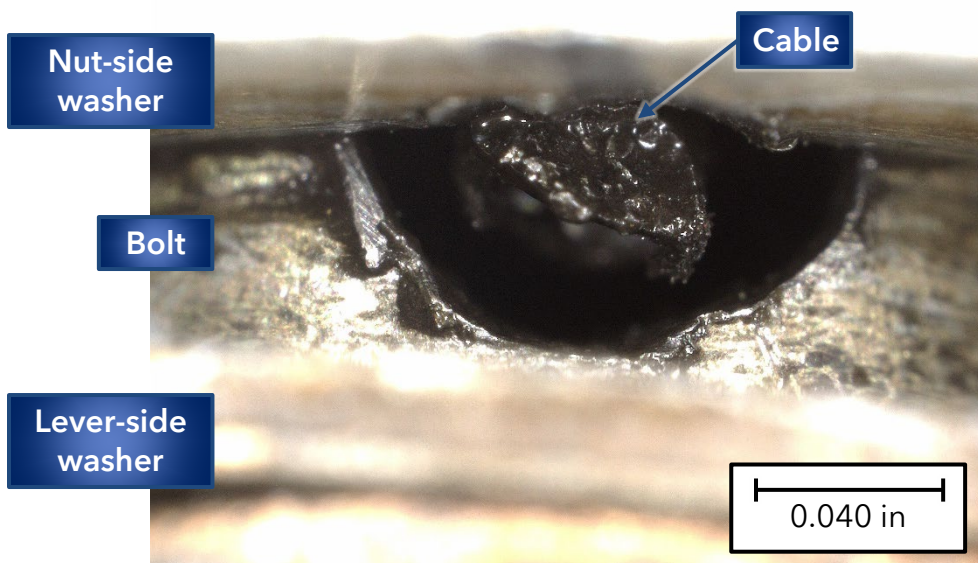
Next, the terminal end of the tail piece was pushed into the attachment bolt until resistance was met. With the terminal end pushed inward to the point of resistance, the oil-covered fractured end of the piece was visible on the control side of the attachment as shown in figure 2. In that position, the tip of the fracture surface

on the tail piece was approximately flush with the outer diameter of the bolt shank on the control side of the assembly.

**Figure 2.** View of the grease-covered fracture surface on the tail piece held within the lever arm attachment hardware after initial cleaning.

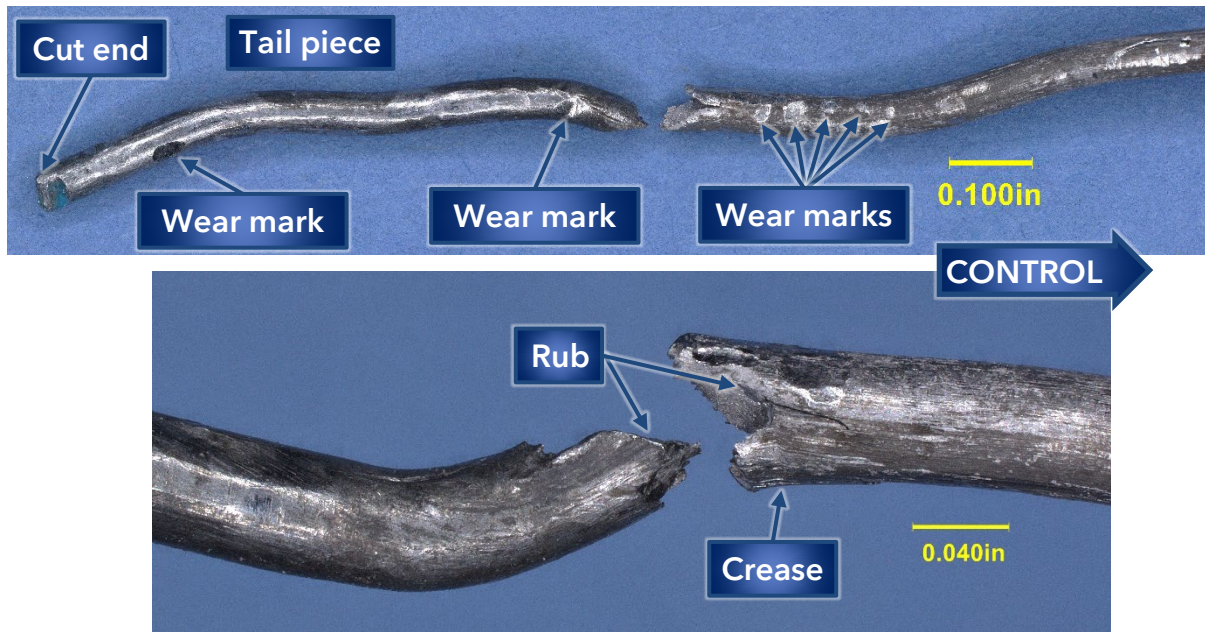
Views of the cable at the fracture location after cleaning are shown in figure 3. The cable pieces were bent in alternating directions near the fracture location as shown in the upper image in figure 3. Two relatively deep wear marks were observed on the tail piece, and multiple shallower wear marks were observed on the cable near the fracture on the control side as indicated in figure 3. The outside edges of the indicated wear marks on the tail piece were approximately 0.52 inches apart, which was equal to the outside diameter of the nut-side washer. The series of five discrete wear marks on the control side piece were spaced approximately evenly along a distance of 0.157 inch. The mark closest to the fracture was located up to 0.076 inch from the closest part of the fracture surface. For comparison, the width of the nut side washer flat (outside radius minus inside radius) was 0.1265 inch.

A closer view of the fractured ends of the control cable is shown in the lower image in figure 3, where the cable pieces are shown rotated approximately 180 degrees about the axis relative to the upper image. The tail piece was bent approximately 45 degrees adjacent to the fracture location. The fracture was mostly on slant planes roughly with a chisel shape on the tail side and a notch shape on the control side. The notch was offset relative to the cable axis, producing a longer leg and a shorter leg of the notch. A crack extended from the base of the notch on the control side roughly parallel to the plane of the longer notch leg, and the adjacent shorter leg of the notch was bent outward. A deformation crease was observed on the outside diameter at the base of the bent notch leg as indicated in the lower image in figure 3. Rub damage was observed on mating sides of the fracture surface on the longer notch leg as indicated in the lower image in figure 3, which corresponded to sliding contact associated with the bending deformation on the shorter notch leg.

**Figure 3.** Close views of the fracture location after the tail piece had been removed from the attachment hardware, the control side had been cut from the rest of the cable, and both sides had been cleaned.

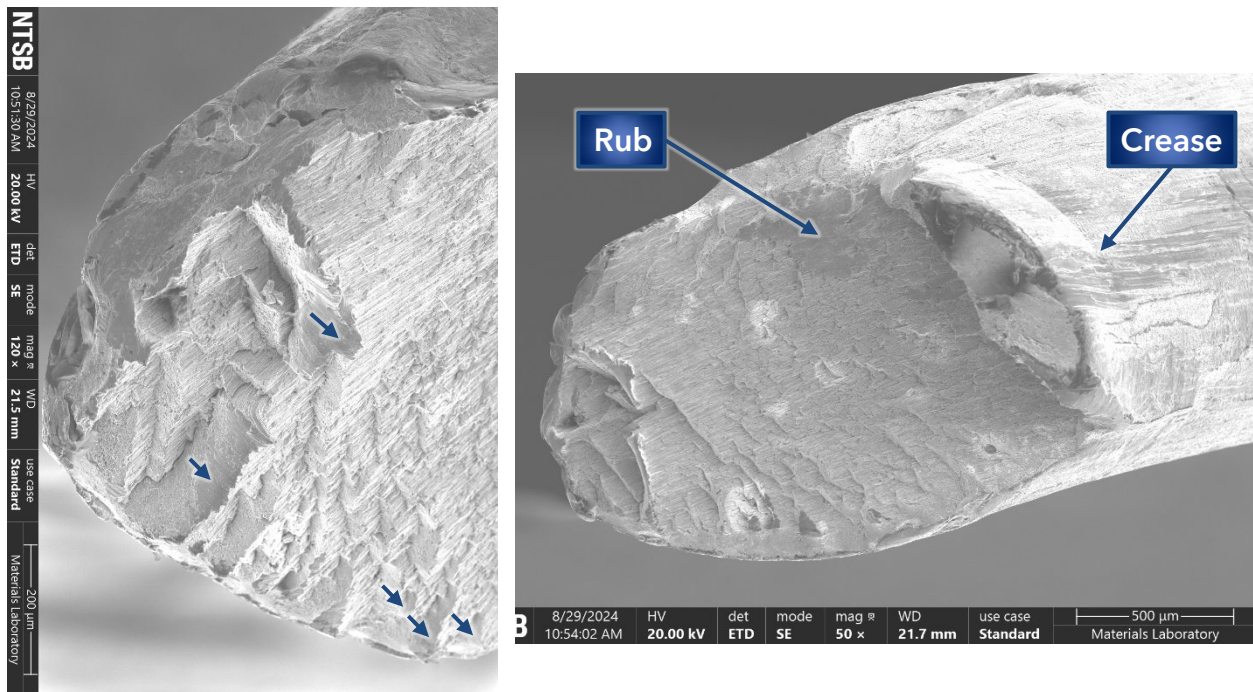
The fracture surface on the cable piece from the control side was further examined using a scanning electron microscope (SEM). Aside from smooth areas corresponding to contact damage or local shearing, the fracture surfaces had dimple features consistent with ductile overstress fracture. An overall view of the fracture surface is shown at the right side in figure 4. The fracture surface on the longer leg of the notch showed textured features with step-like terraces. An area of rub damage near the base of the notch and the crease on the outside diameter associated with the bent shorter leg of the notch are indicated. The tip portion of the longer leg of the notch is shown at the left in figure 4. Some of the steps were smeared consistent with local shearing deformation. At the tip of the shorter notch leg, the fracture progressed in a transverse plane and exhibited round dimples, consistent with tension overstress. The cross-sectional area associated with the transverse fracture was approximately  $2.3 \times 10^{-4}$  square inch.

**Figure 4.** SEM images of the control side of the fracture. Unlabeled arrows in the left image show areas of sliding contact deformation on step features near the tip end of the fracture surface.

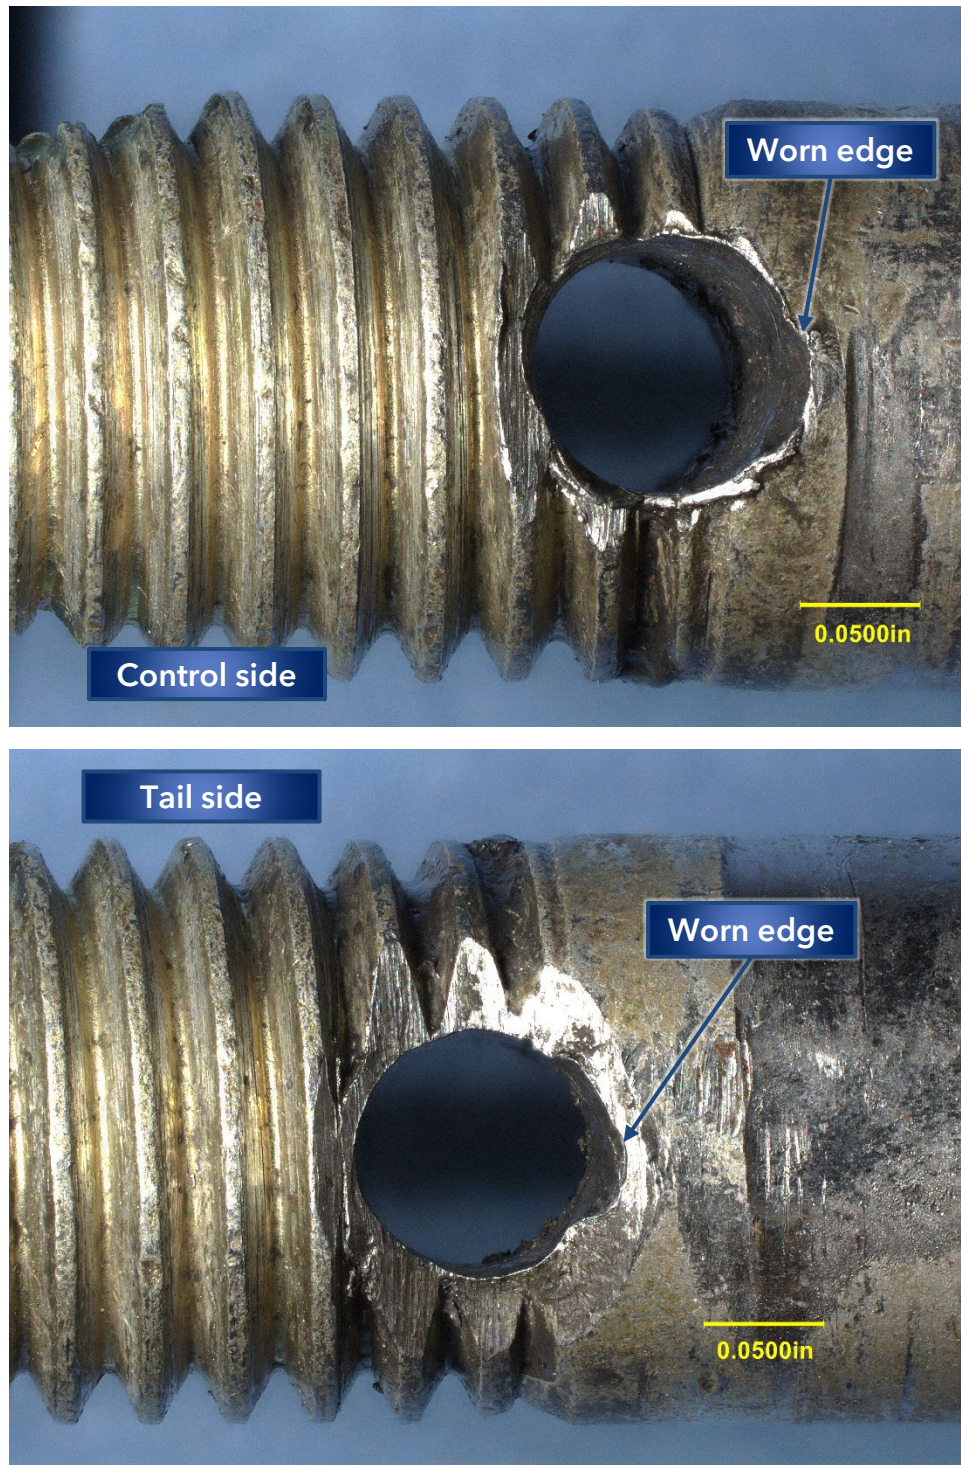
Views of the cleaned attachment bolt shank at the through hole are shown in figure 5. The shank surface on the control side of the hole is shown in the upper image in figure 5, and the corresponding terminal end-side of the through hole is shown in the lower image. On both sides of the shank, the hole's edge furthest from the nut-side washer was worn.

**Figure 5.** Views of the cable attachment bolt shank showing wear at the edge of the through hole for attaching the mixture control cable.

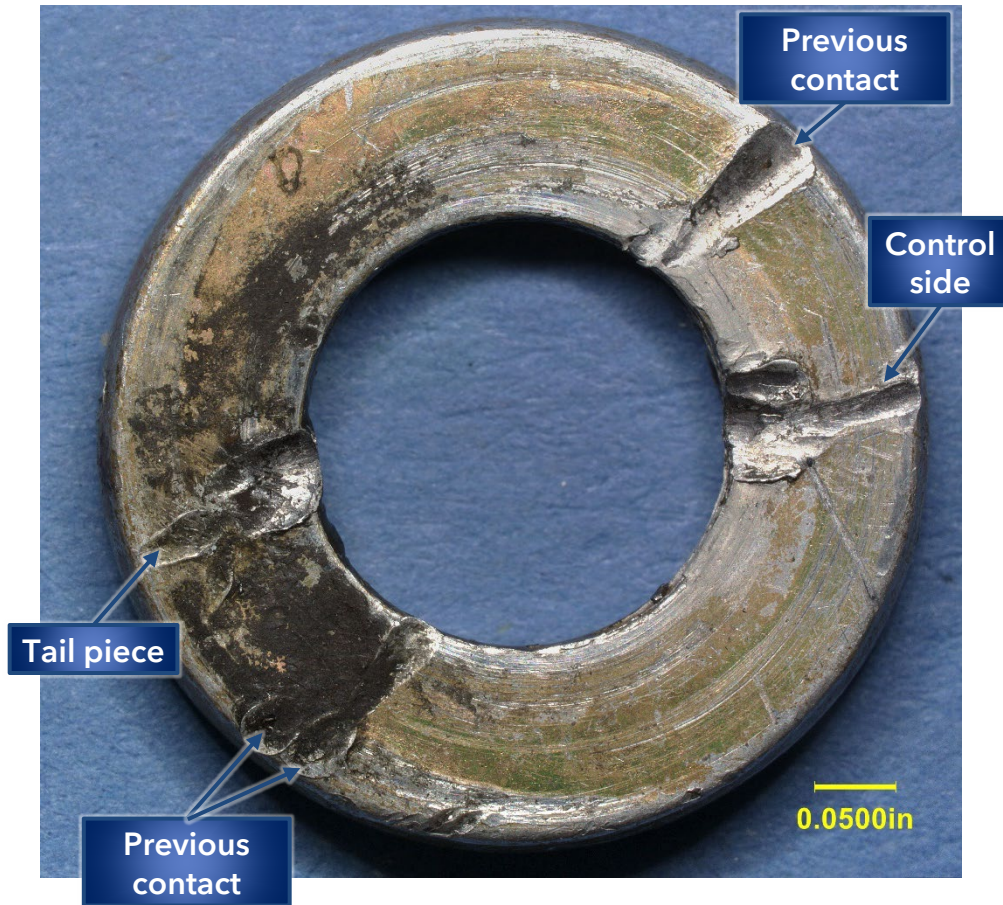
The washer from the nut side of the assembly is shown in figure 6, where the side of the washer that faced the control cable is displayed after cleaning had removed most of the oily deposits. The washer had multiple cylindrical wear grooves consistent with wear against the control cable. In figure 6, the grooves associated with the tail piece and the control side of the cable at the time of fracture are indicated near the 9 o'clock and 3 o'clock positions, respectively. Additional wear grooves from previous control cable positioning were noted as indicated near the 7:30 and 1:30 clock positions. At the 9 o'clock and 3 o'clock positions, the wear grooves were deepest and widest near the inside diameter of the washer. At the contact wear grooves associated with the previous installation position, the wear grooves were relatively deeper and wider at the outside diameter of the washer when compared to the grooves at the fracture positions.

**Figure 6.** View of the nut-side washer showing the side that faced the control cable after some cleaning. Wear marks associated with contact with the tail piece and control side of the cable at the time of the accident are indicated. Wear marks associated with previous cable contact are also indicated.
