# National Transportation Safety Board

WPR24FA226

## **MATERIALS LABORATORY**

Factual Report 25-017

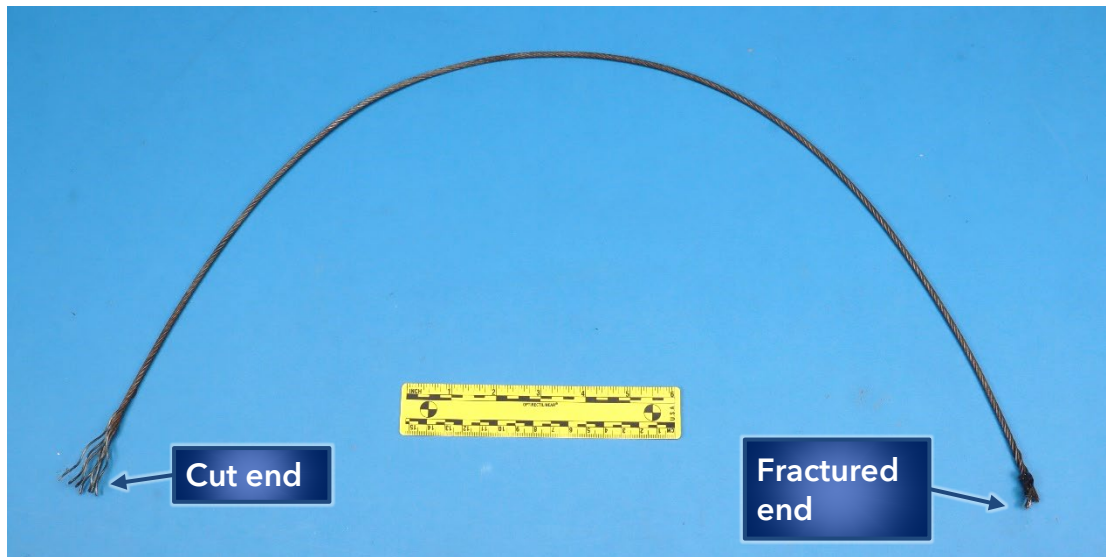
An overall view of the submitted cable piece as received is shown in figure 1. The cable was fractured at one end and cut at the other end as indicated in figure 1. The control surface associated with the cable was unknown. The cable had 7 strands with 19 wires each, consistent with a 7x19 steel control cable.

**Figure 1.** Overall view of the submitted cable piece as received.

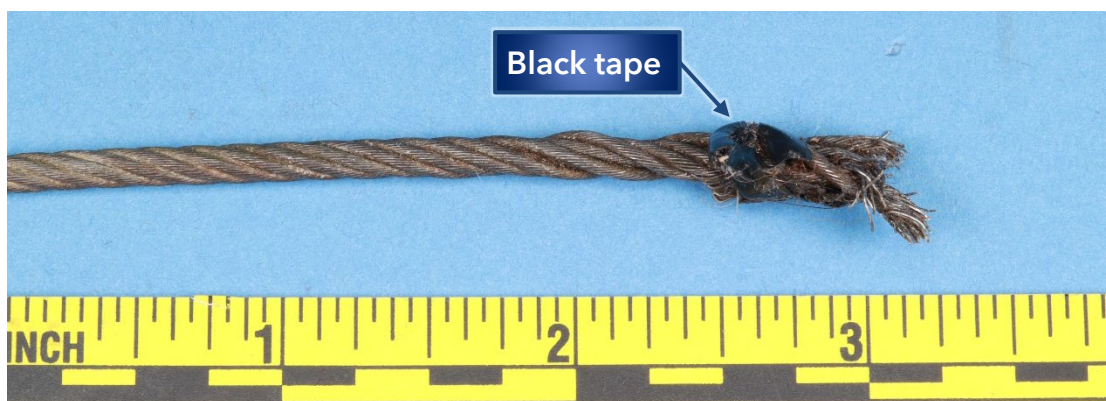
A closer view of the fractured end as received is shown in figure 2. Black flexible tape consistent with electrical tape was wrapped around the cable adjacent to the fracture. The tape was wrinkled and covered with debris.

**Figure 2.** Close view of the fractured end as received.

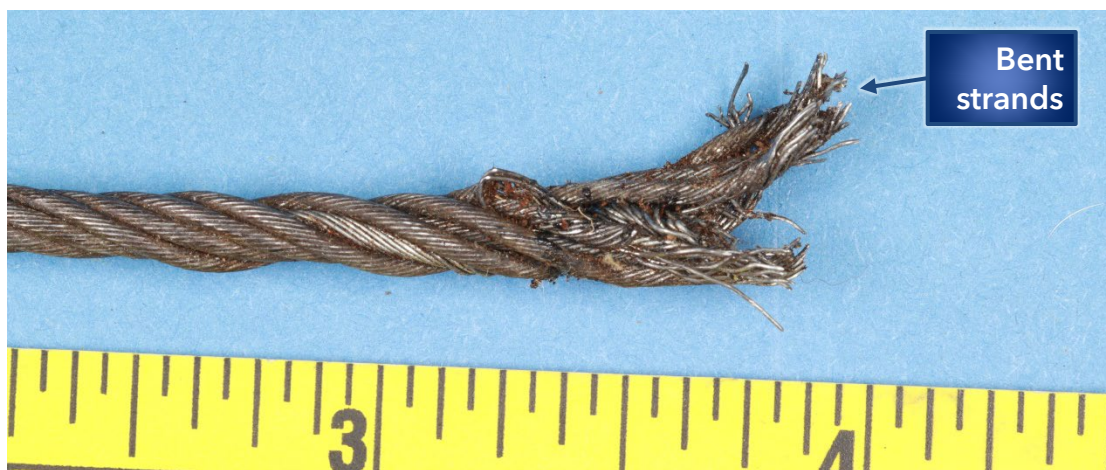
The black tape was cut longitudinally on one side and removed with tweezers. A view of the fractured end after the tape was removed is shown in figure 3. Several strands were displaced within approximately 1.5 lays from the fractured end. Individual wires on multiple strands were crushed and bent back away from the fractured end. The three longest strands were similarly bent as indicated in figure 3.

**Figure 3.** Fractured end after the tape was removed.

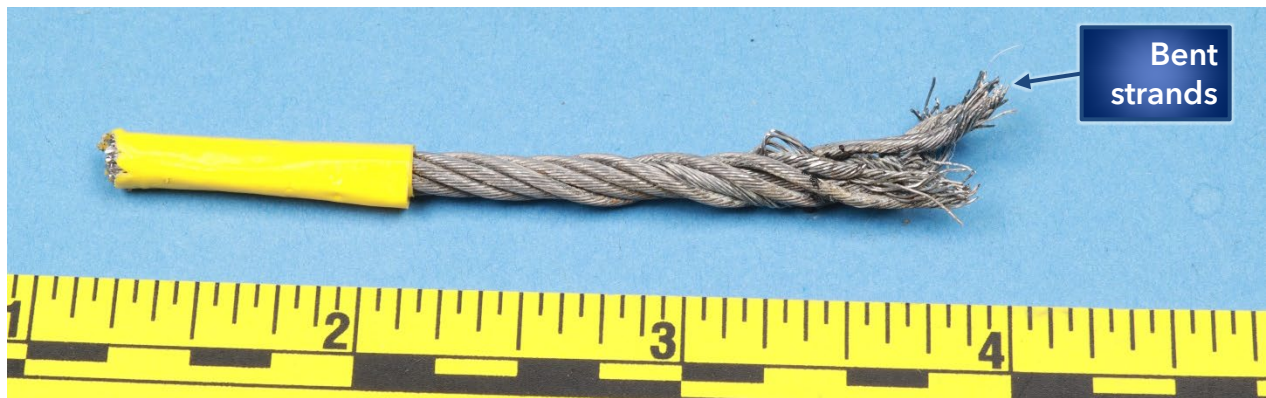
The cable piece was wrapped with yellow duct tape approximately 2 to 4 inches from the fractured end and was cut with a cable cutter within the newly taped section. The cut piece with the fractured end was then submerged in a solution of Alconox detergent and warm water while cleaned using an ultrasonic cleaner for approximately 10 minutes. The cleaned piece was then rinsed with water followed by ethanol and was then dried with compressed air. The resulting cleaned piece is shown in figure 4.

**Figure 4.** Fractured end of the cable after cutting and cleaning.

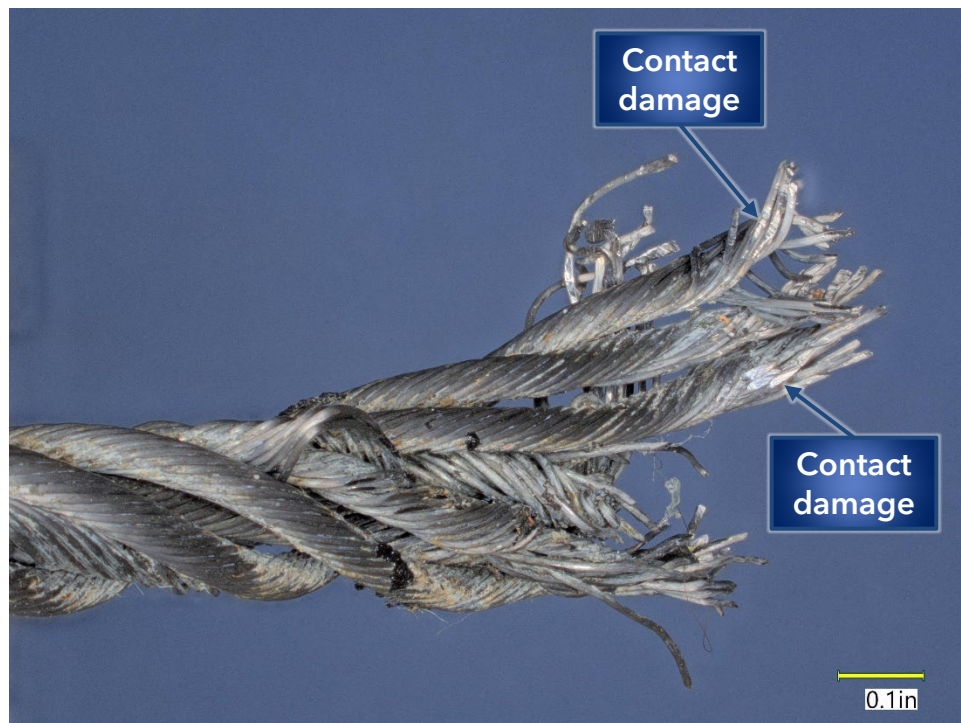
A closer view of the fractured end after cleaning is shown in figure 5. The image in figure 5 was obtained using a Keyence VHX-7000 operated in depth mode with the high dynamic range (HDR) image enhancement setting enabled. In figure 5,

the cable was positioned to show the side of the cable at the inside of the bend for the three bent strands indicated in figures 3 and 4. The external surface of several wires in two of the strands had flattened surfaces consistent with damage from contact with another object at the inside of the bend. In other strands, many of the wires were flattened and deformed consistent with contact with adjacent wires within the cable. All wires had thinning and deformation patterns consistent with ductile overstress fracture. No evidence of a progressive fracture mechanism or significant wear or corrosion was observed.

**Figure 5.** Optical image of the cable end obtained using a Keyence VHX-7000 in depth mode with HDR showing contact damage on the inner radius of the bent strands.
